VICKSBURG NATIONAL MILITARY PARK  
**PEMBERTON'S HEADQUARTERS**  
(WILLIS-COWAN HOUSE)

# HISTORIC STRUCTURE REPORT

2005

For  
**Cultural Resources, Southeast Region**  
**National Park Service**

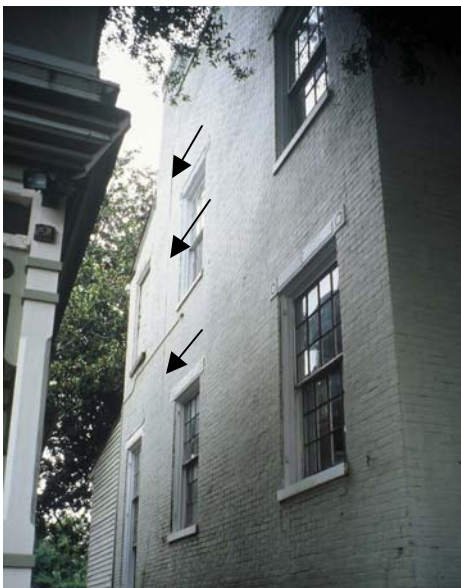
*Figure C – 1* Stack joint on east elevation

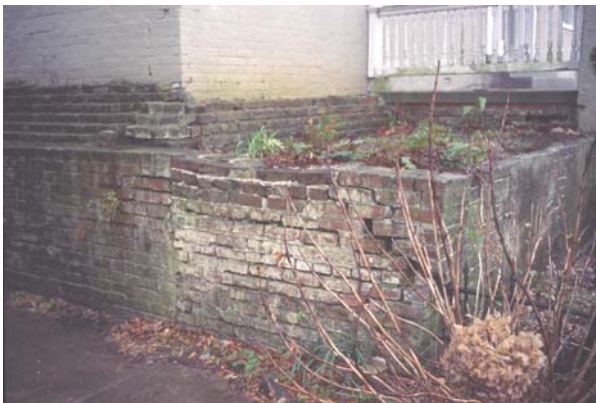
*Figure C - 2 Retaining wall*

lintels. The cracks appear to be active. The outward thrust of the east wall is the result of the cutting back of the grade along the east elevation. This was done to construct the corner house in the later nineteenth century. A low brick wall that separates these two property lots acts as a retaining wall of the higher grade of the Willis-Cowan House property, but it clearly is inadequate as evidenced by the numerous extensions, repairs and current poor condition.

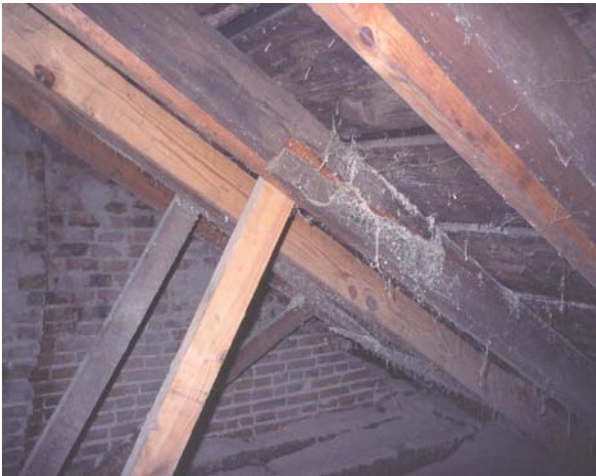
*Figure C - 3 Split rafters*

judging from the amount of discoloration and dirt at the split, open wood. It is damage caused by a distributed load applied from above, probably the collapse of the adjoining, southwest chimney. Additional framing dating to the twentieth century now sister and provide post support to the damaged rafters.

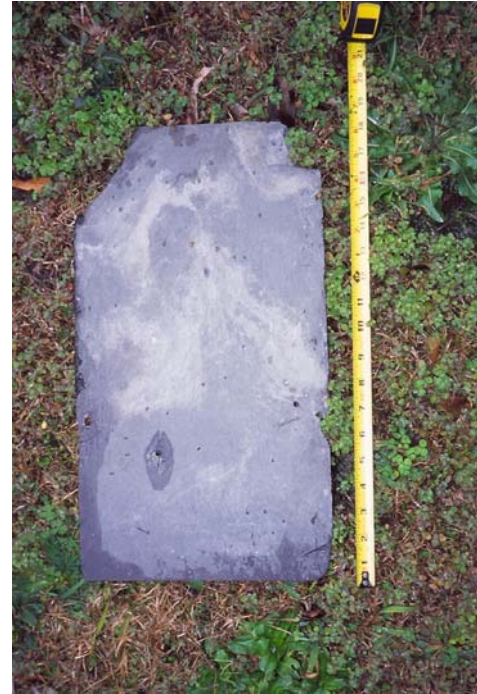
*Figure C - 4 Roofing slate*

***Roof & Rainwater Collection/Dispersal:*** The pitched roofs are covered with a dark purple slate, 10" x 18," with square edge and 8" weather exposure. The ridges are covered with a clay tile, 6" x 18," with dark brown glazing. The low-sloped, side sections of the main entrance portico (north elevation) are covered with flat-seamed, terne-metal roofing.

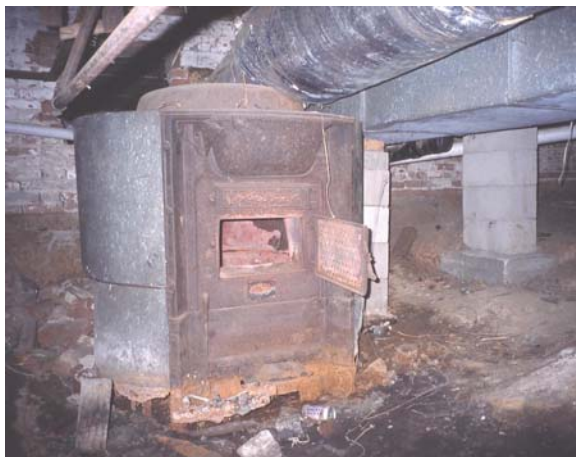
*Figure C – 51 Abandoned furnace*

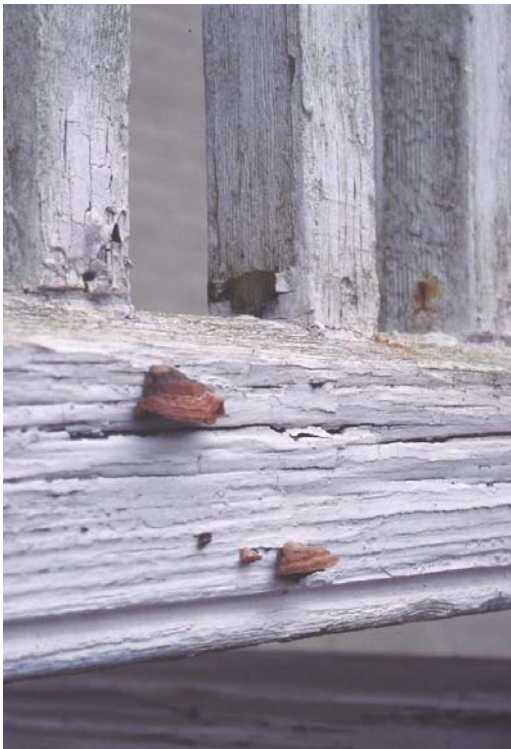
*Figure C – 52 Fungus growing on the west porch balustrade*
