NPS Engineering Evaluation/ Cost Analysis Field Activities Report

Virgin Islands National Park

**Caneel Bay Resort Site
St. John, USVI
EDL Number 5SER3346**

March 12, 2021

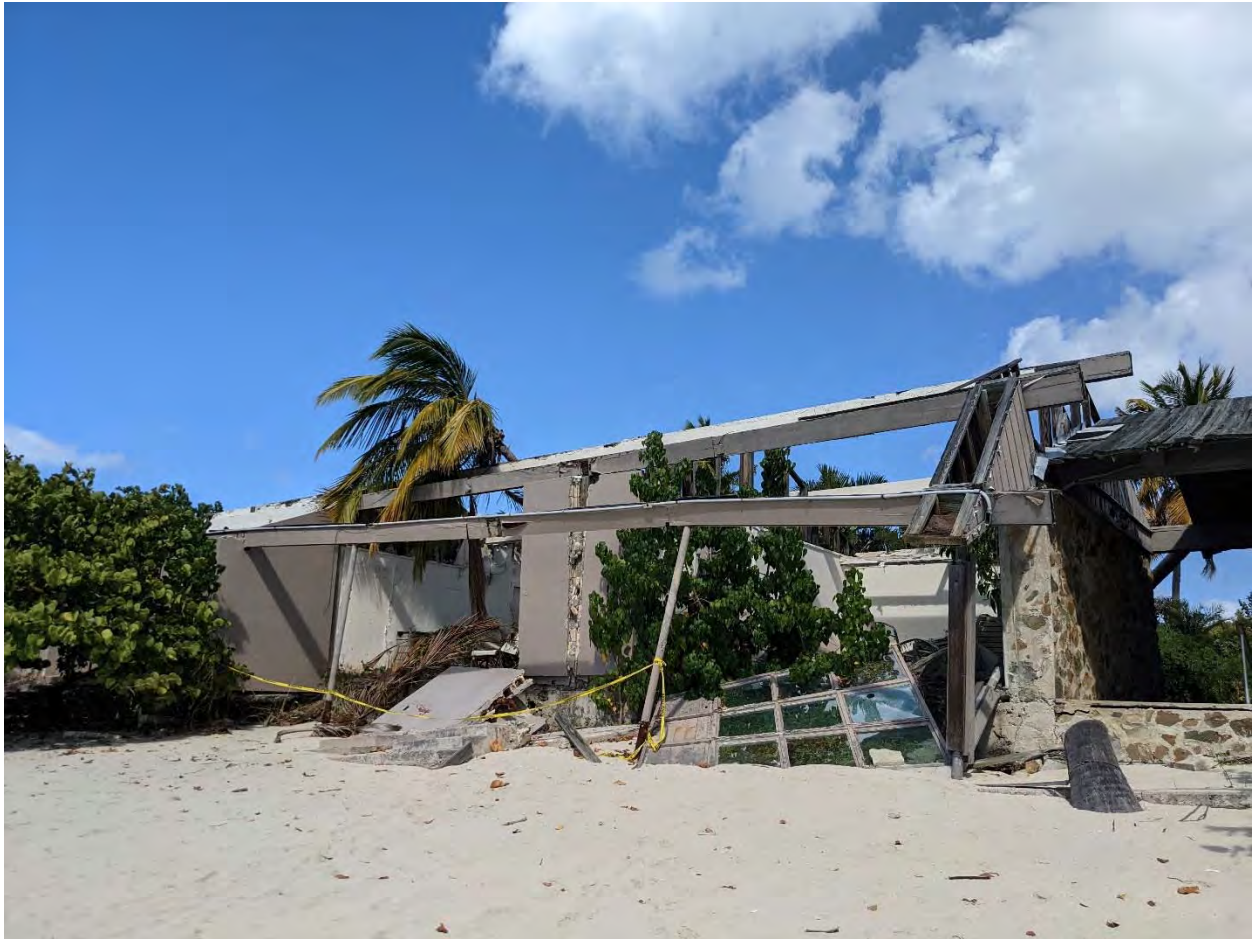
Photograph 1. View of construction and damage typical of Site structures along Scott Beach. VHB selected discrete surface soil samples for lead analysis to be representative of groups of buildings based on apparent similarity of construction and damage. Sample SC-Bldg-05 collected from along drip lines in the back of these structures. SC-Bldg-06 collected from along drip lines of debris piles in this area.

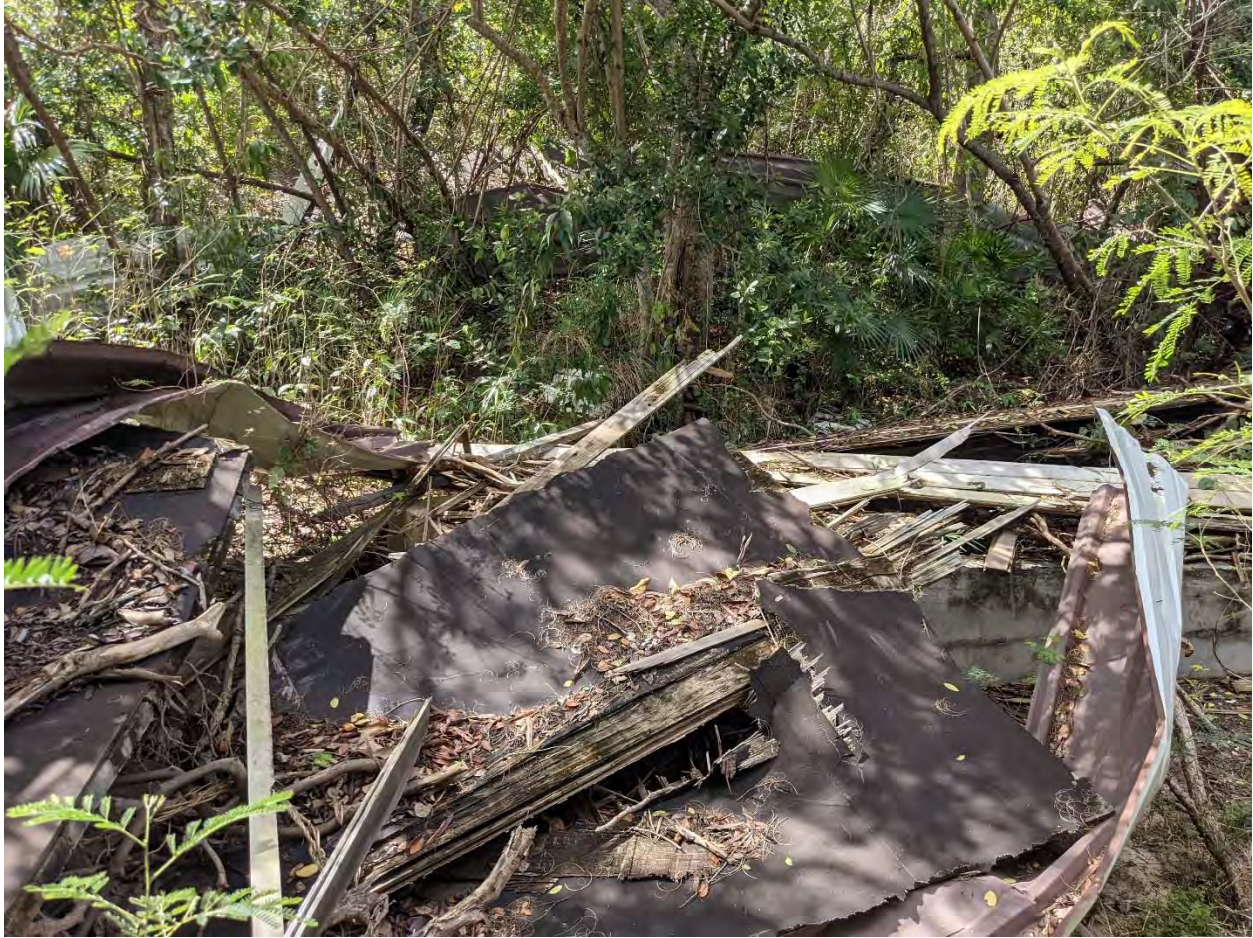
Photograph 2. View of roofing debris typical of that observed scattered across Site. Debris includes wood, sheet metal, and damaged tar paper with visible exposed fibers (possibly asbestos).

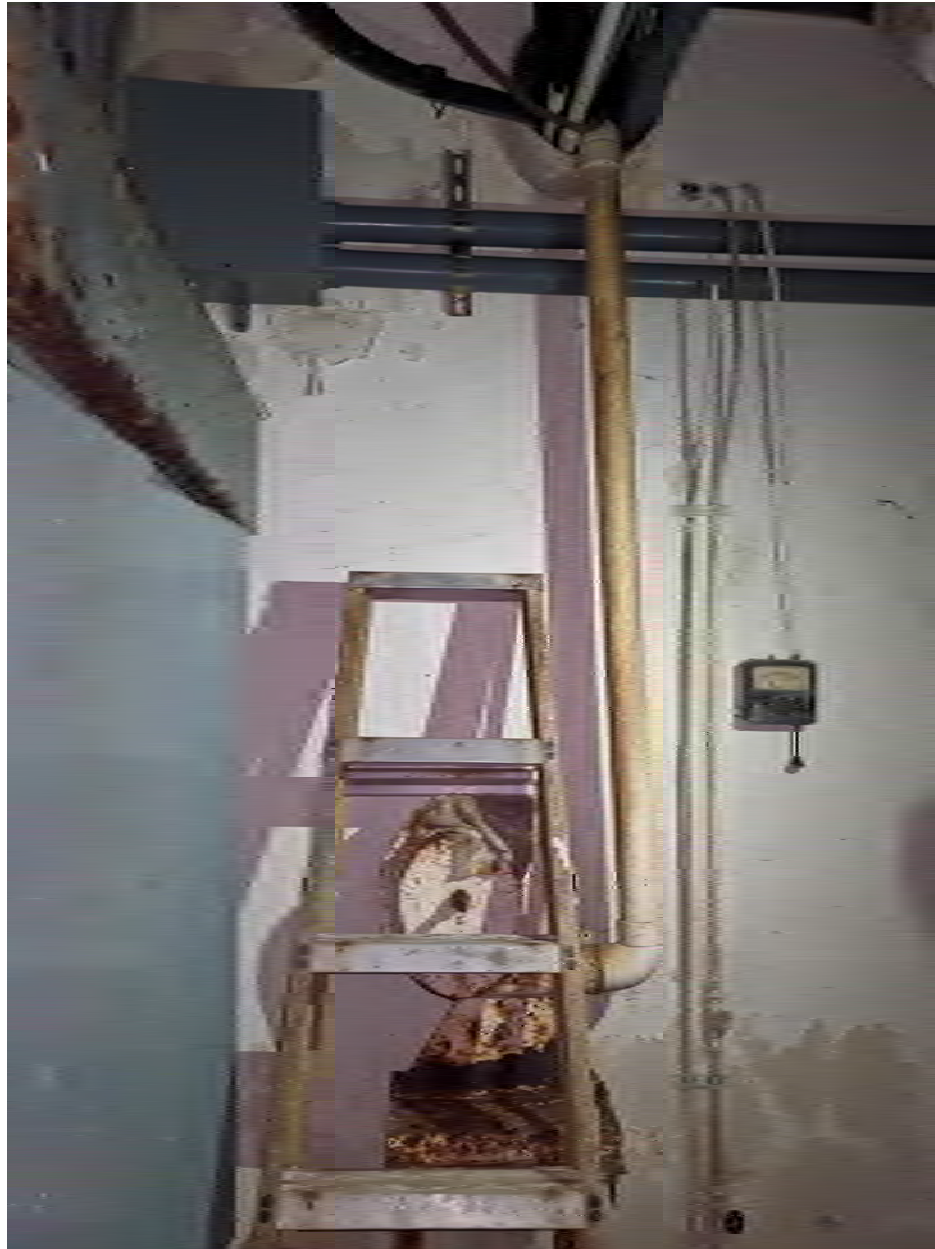
Photograph 4. View of tank level gauge and suspected metallic fuel lines observed in the basement at Cottage 7 (identified as the former bomb shelter by CBIA representatives). Metallic lines were traced to the exterior of the building using EMI.

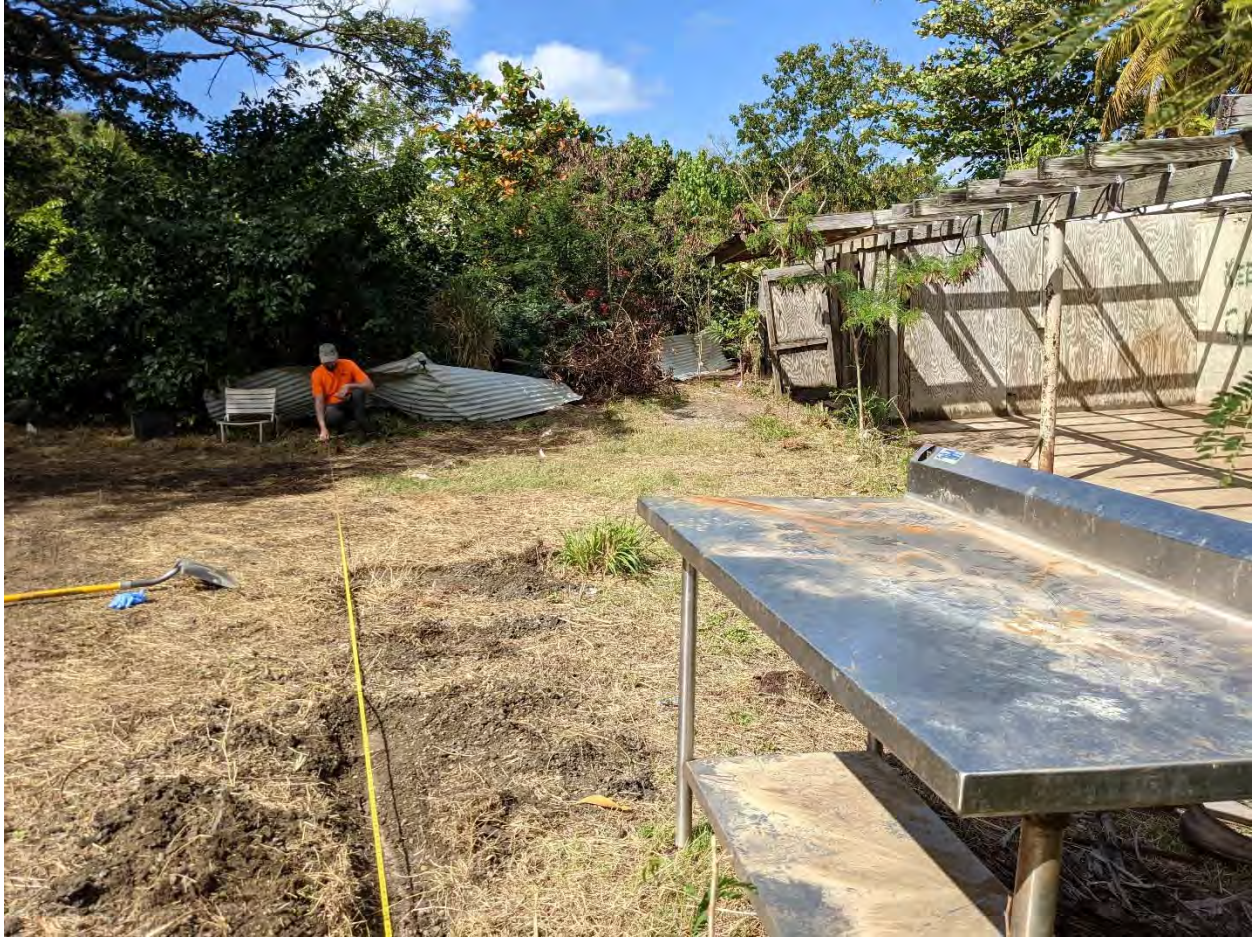
Photograph 5. View of asbestos pipe identified during the Level 2 investigation in Area 2 located and exposed. Pipe appears to head to the west towards the former greenhouses. Similar, possible asbestos pipes were observed in other areas of Area 2 and in Areas 1 and 3. Debris in background limited access to parts of IA-2-04.

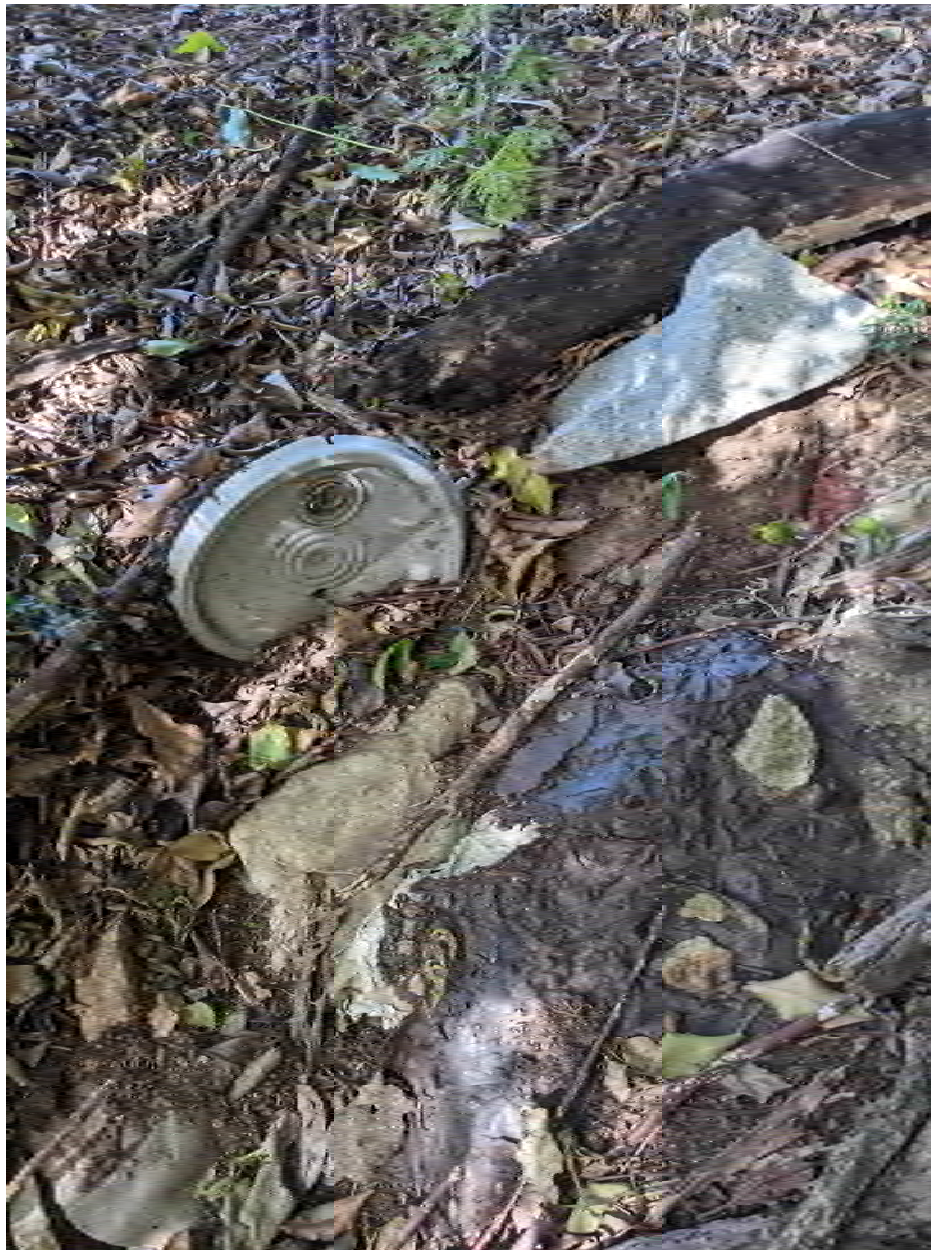
Photograph 6. View typical of area of paint apparently dumped on ground surface in southeastern portion of Area 1. VHB defined surface soil decision unit IA-1-03 to encompass this area.

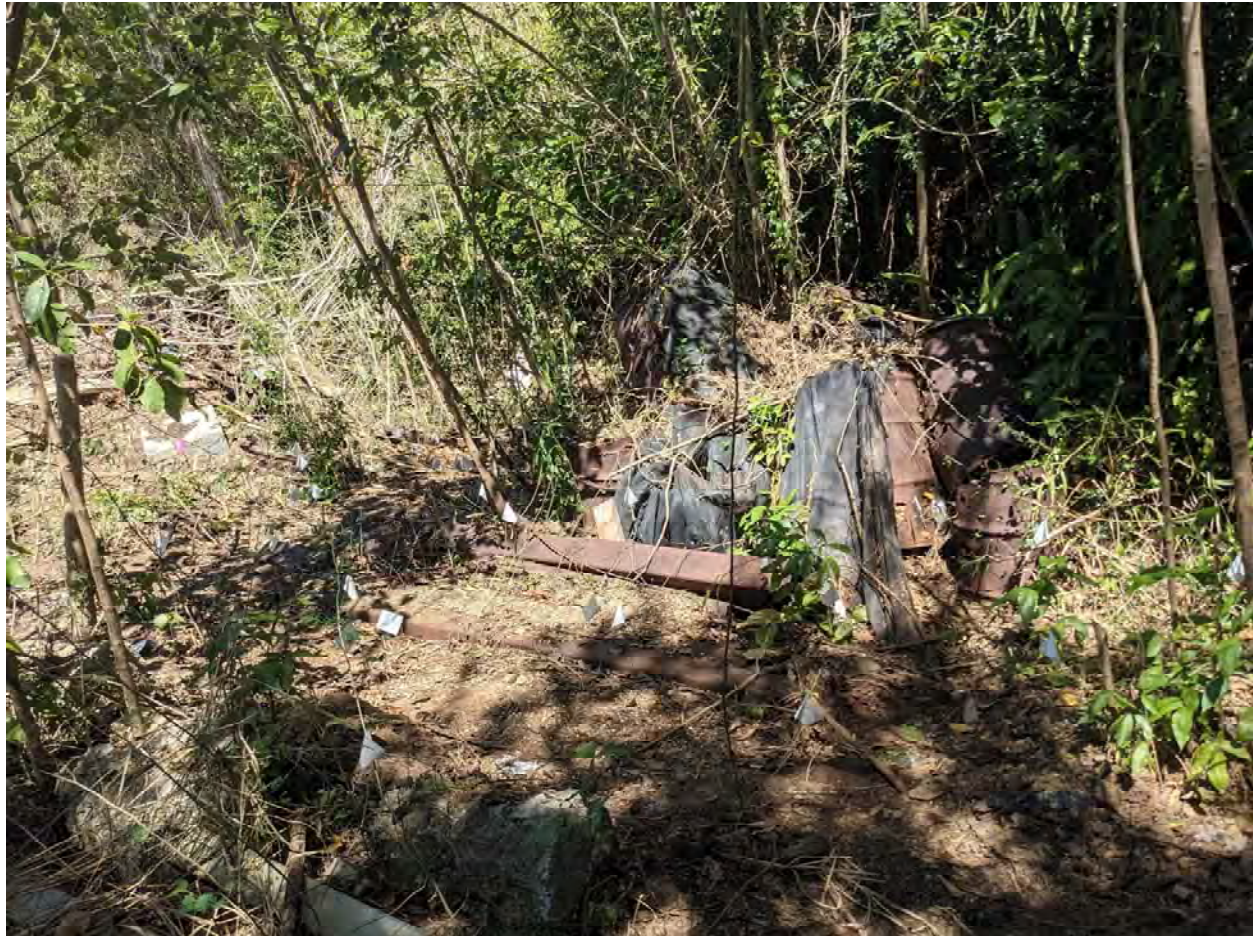
- While marking out the ISM sampling boundaries in Area 1, VHB encountered previously unobserved conditions. At least 12 partially buried and rusted

drums were observed in the eastern portion of the gravel staging area, in the same area as identified in the 2017 Removal Site Evaluation report. Some of the drums appear to have contained washed pebbles. Dried paint, apparently released directly to the ground surface, was observed in the southern portion of the gravel staging area. NPS elected adjust the boundaries of the ISM DUs to avoid both the drums and paint. VHB created separate surface soil DUs at each of these two areas.

Photograph 7. View of at least 12 partially buried, rusted drums observed in eastern portion of Area 1. The drums contained washed gravel. VHB defined surface soil decision unit IA-1-03 to encompass this area.

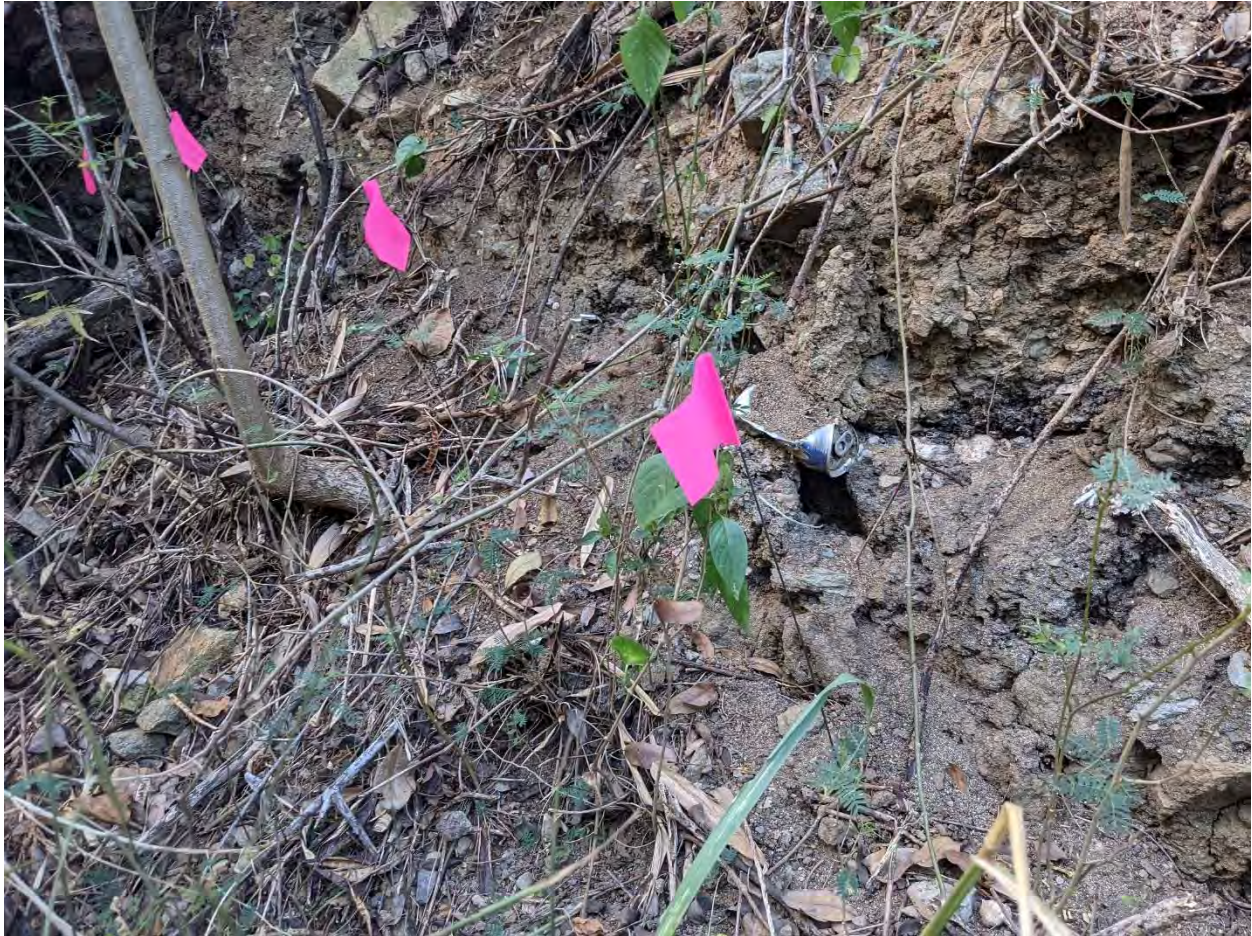
Photograph 8. View of exposed waste (including aluminum, steel, plastic, building materials, and unknown organic material) along the landfill's southern face and apparent seeps. VHB defined surface soil decision unit IA-3-04 to encompass the seep area and characterize potential contaminant migration to the apparent wash.

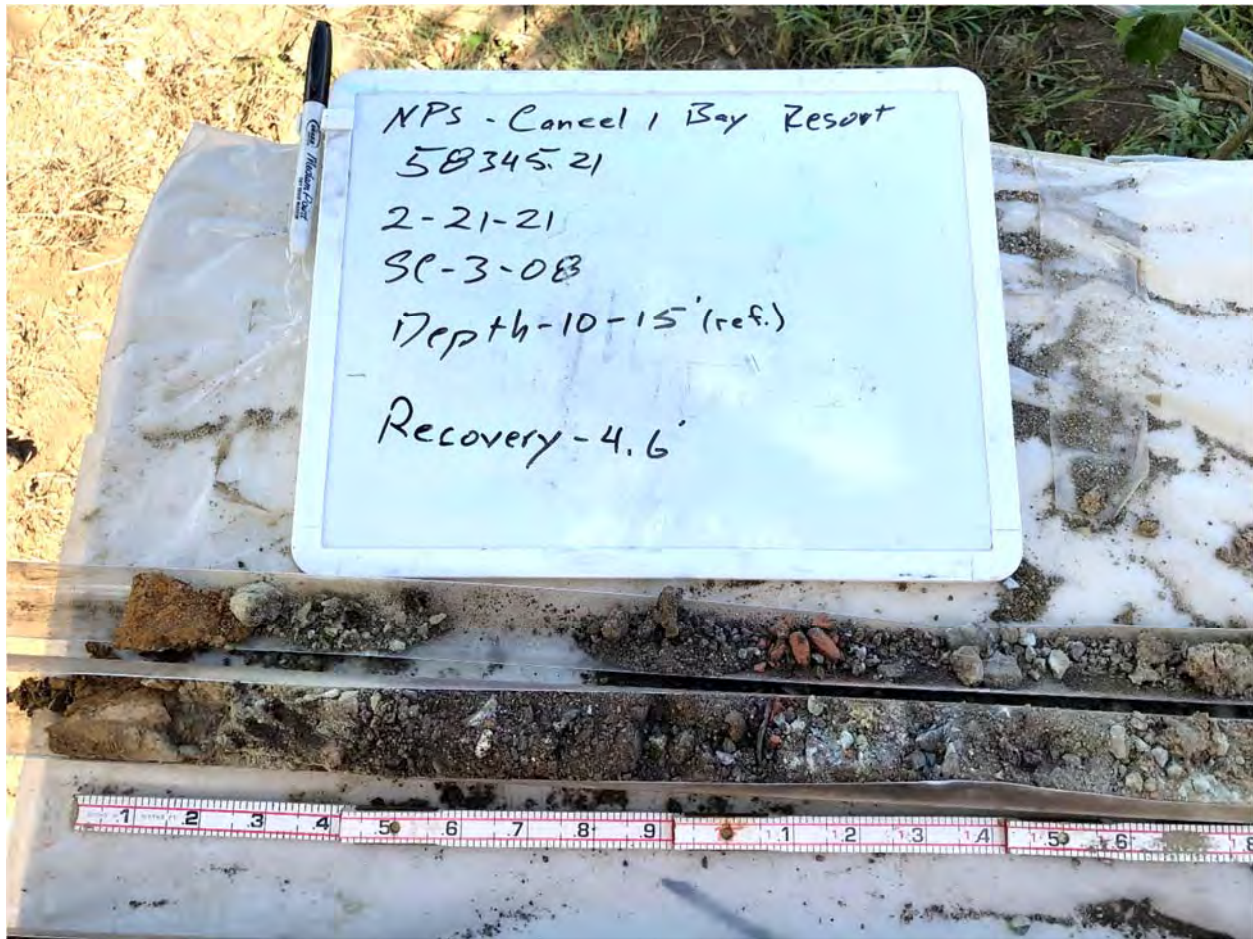
Photograph 9. View of soil core collected at SC-3-08 from 10 to 15 ft bgs, typical of waste/fill material observed in cores collected in the debris landfill. Waste/fill observed in cores included sandy silt, gravel, brick, glass, plastic, tar paper, concrete, fabric, wire, unknown organic matter, wood, and leaf litter.

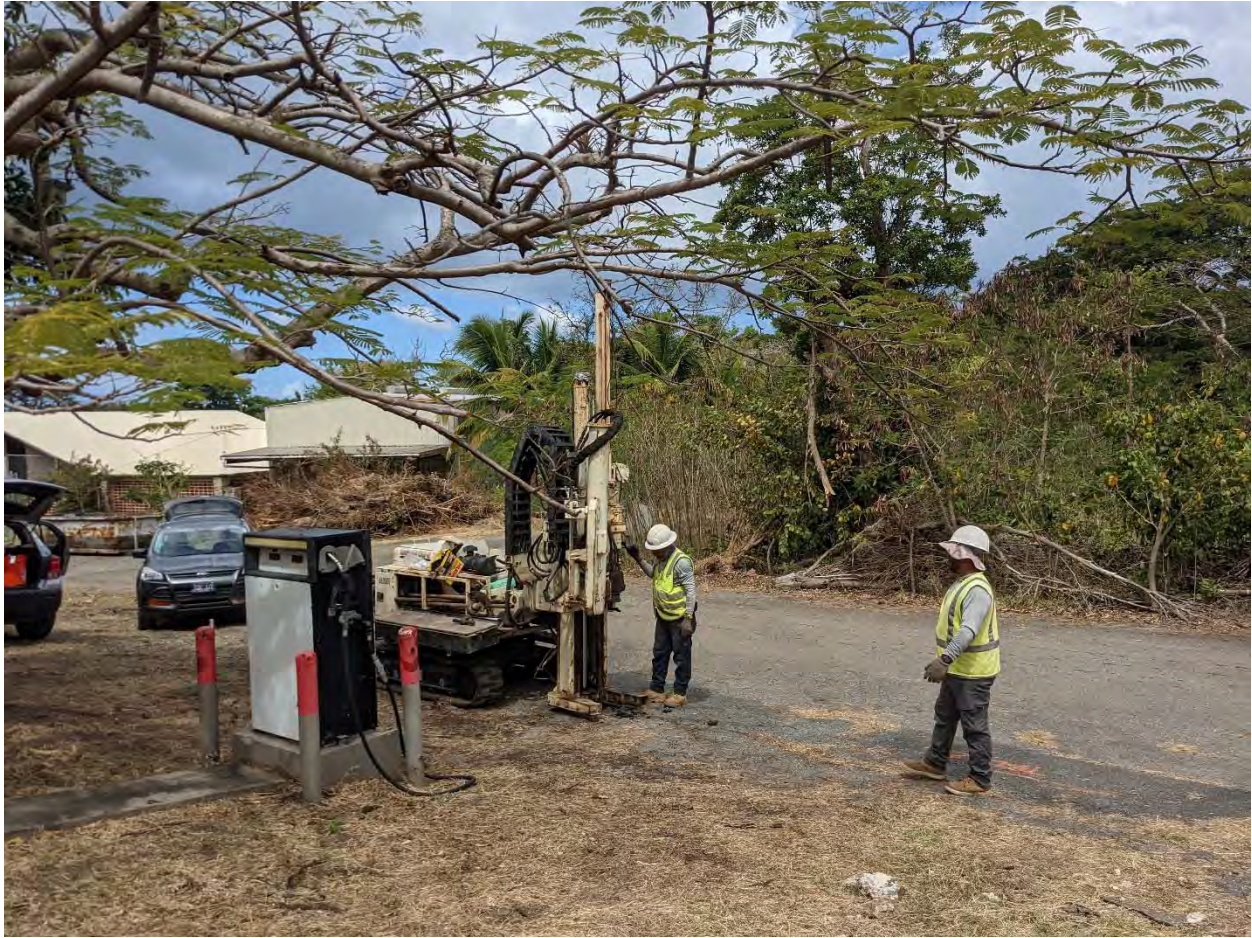
- VHB observed visual, olfactory, and photoionization detector (PID) evidence of the presence of petroleum contamination in soil cores collected at two Area 2 boring locations in the vicinity of the fuel pump (SC-2-03 and SC-3-05). Evidence of petroleum contamination was observed from between 3.5 and 5 ft bgs to near boring refusal at between 13 and 23 ft bgs. As discussed above, no wells were installed at these locations.

Photograph 12. View of subsurface soil sampling at SC-2-05, immediately to the north of the fuel dispenser. VHB observed visual, olfactory, and PID evidence of petroleum contamination in the soil core at this location from approximately 3.5 to near refusal at 23 ft bgs.

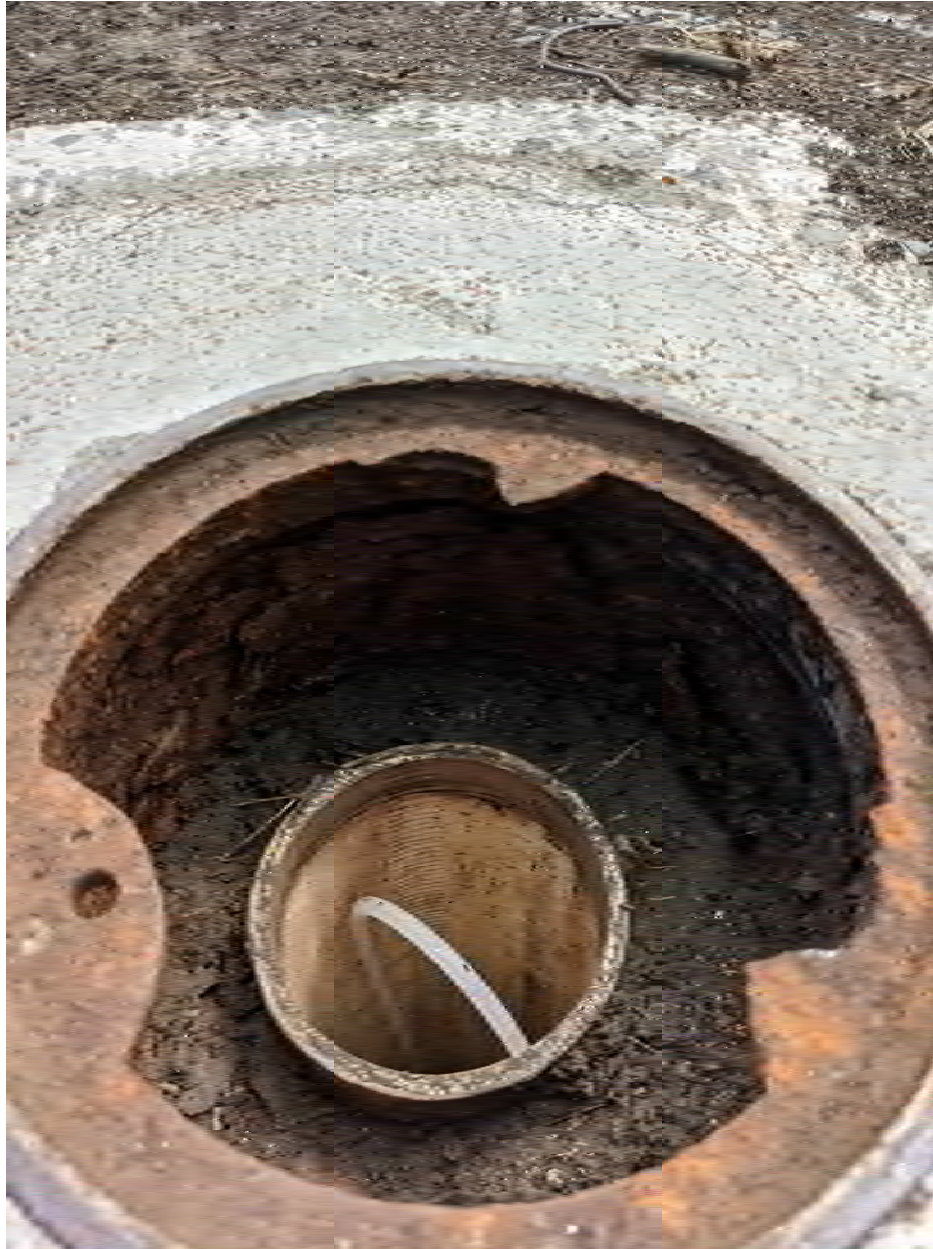
- VHB developed the existing monitoring well in Area 2, MW-1, and the well slowly recharged. VHB observed that the well screen extends to the surface and the well may collect rainwater from the surrounding concrete pad. The water level did not recover completely, and the volume of water in the well was sufficient only to collect samples for analysis of VOCs, metals, and PAHs. There was insufficient water for the pesticide sample or quality control samples.

Photograph 13. View of surface completion of existing monitoring well MW-1. The vault and well screen/riser are perforated to the ground surface. Well may receive surface runoff from surrounding paved area.

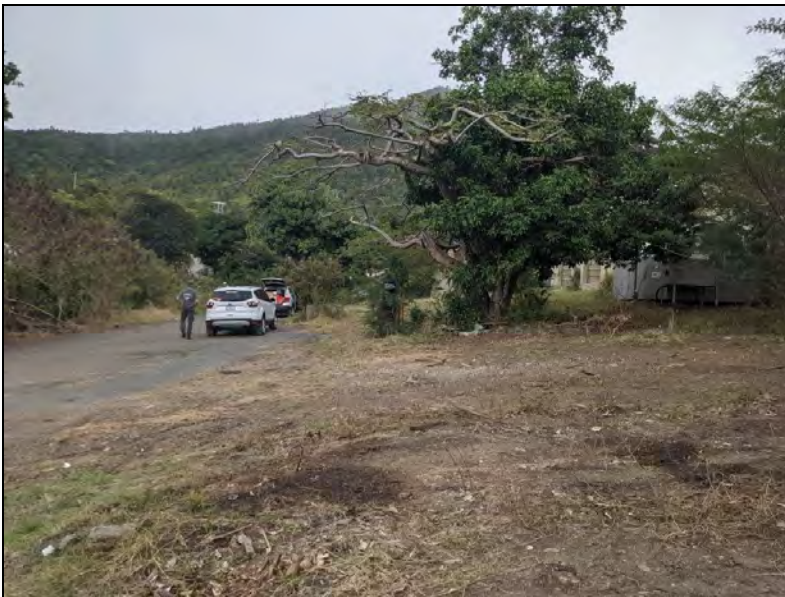
View of Area 2 AST area looking SE. Stained soil visible in foreground.

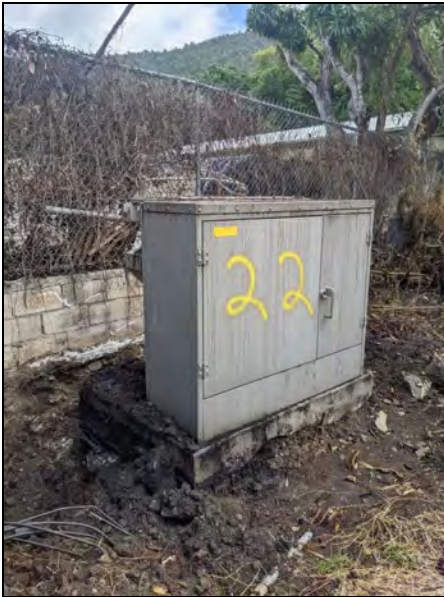
Leaking transformer within IA-2-02. Soil has been cleared away from transformer.

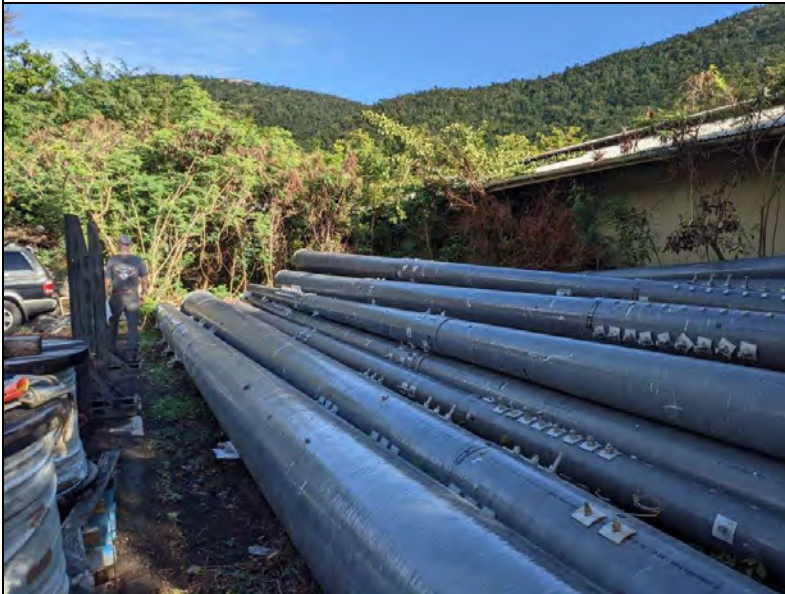
Utility poles stacked in IA-2-02, blocking access to part of the DU.

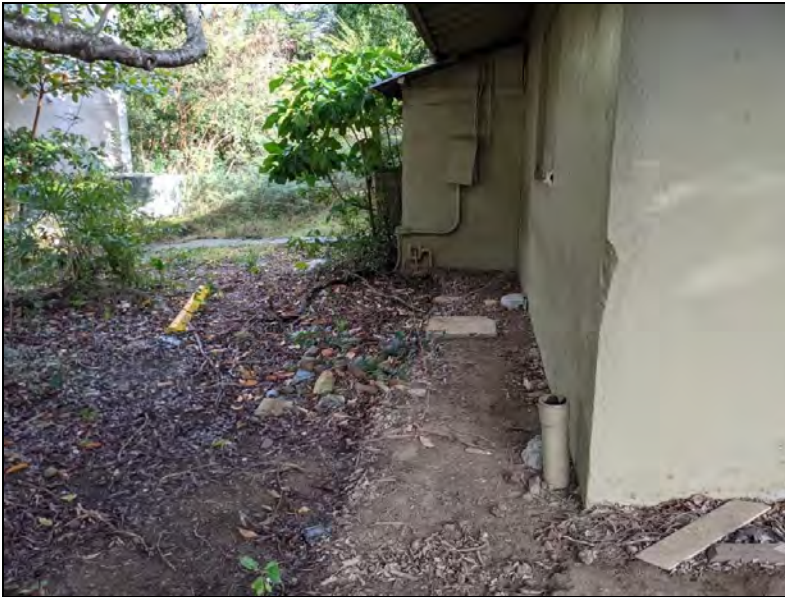
4-inch standpipe at corner of building in Area 2, identified by Fred Ianazzi as possible asbestos.

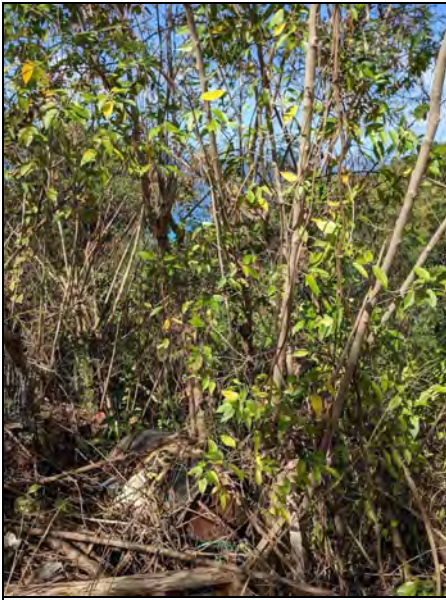
View to east of rusted oil drum and other debris - including metal, concrete, buckets, etc - downslope of storage area below catchment.

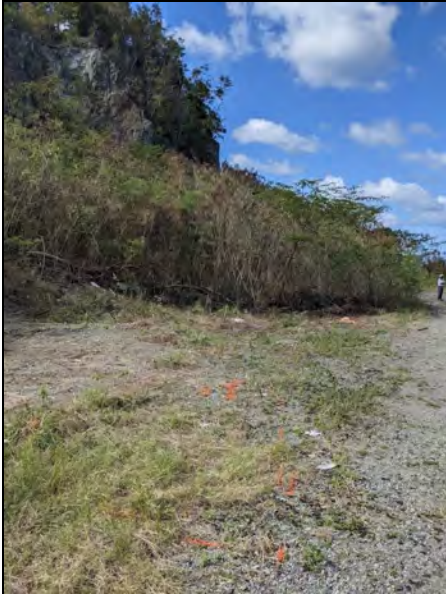
View to north of GPR anomaly (5'w x 22'L x 2'bgs) in clearing within storage area below catchment. Possible quarry area behind.

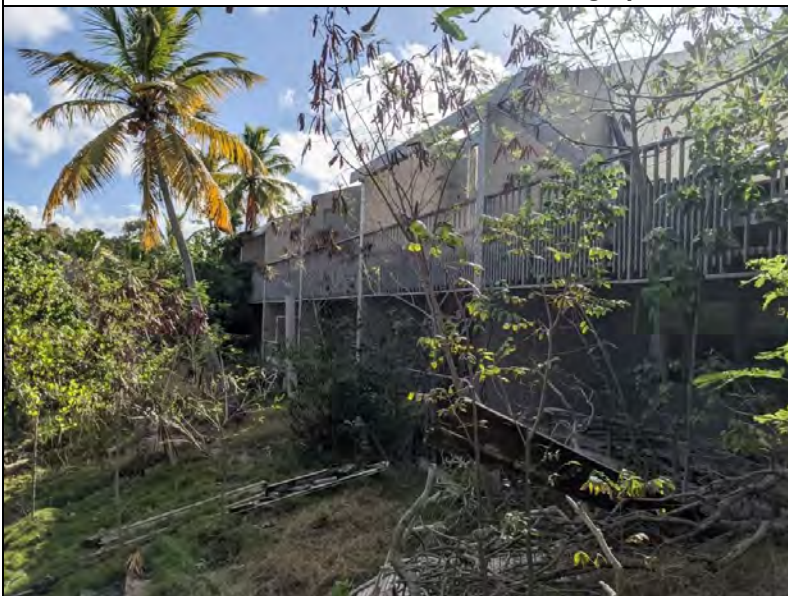
1. View to south of north side of Turtle Bay Beach rooms. Note extensive damage to second floor rooms.

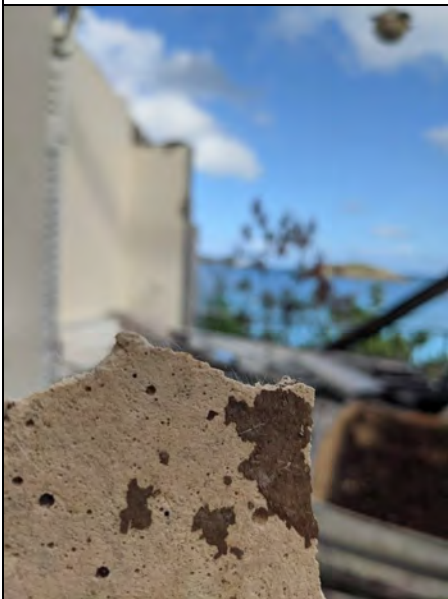
2. Fragment of plaster with visible fibers observed at Turtle Bay Beach rooms. Fragments were observed outside to the south of the rooms.

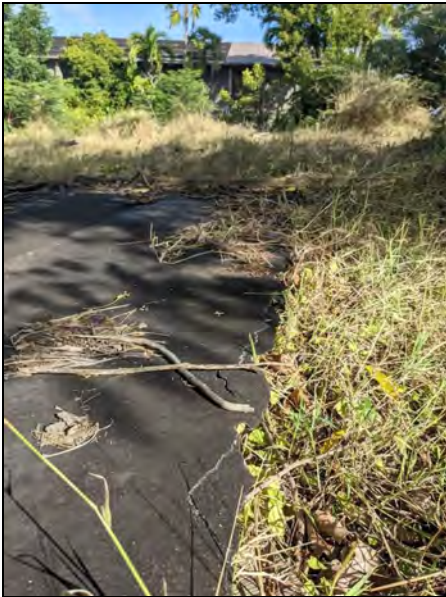
3. Roofing debris to south of Turtle Bay Beach, including roll tar paper with visible fibers. Turtle Bay Beach rooms visible in background.

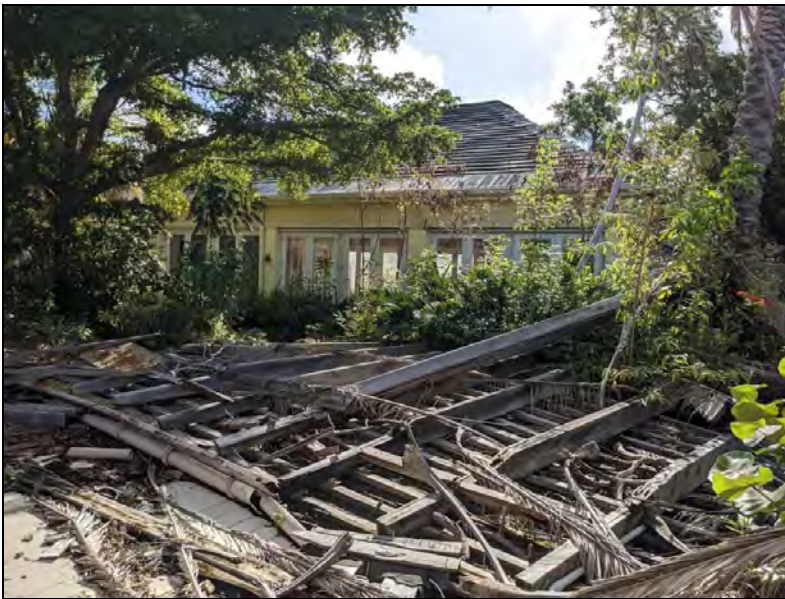
5. Larger view of roofing debris in Turtle Bay Courtyard

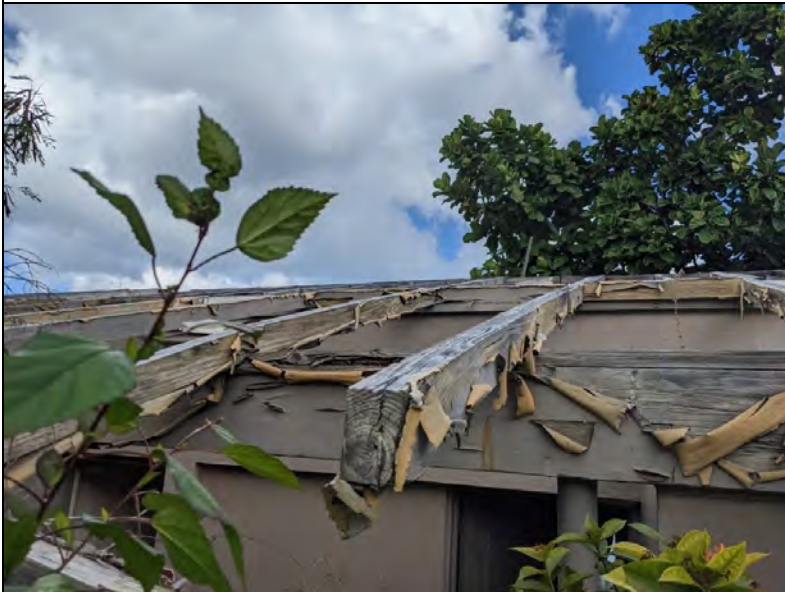
6. Roof and paint damage at Rooms 101 and 102 at Turtle Bay Estate.

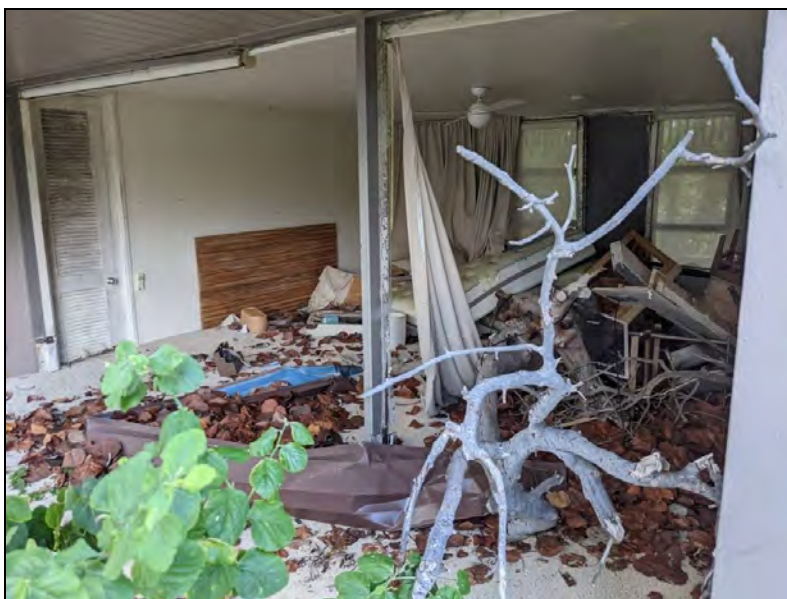
7. View through east side of first floor room at Hawksnest Beach. >1 foot of sand in room.

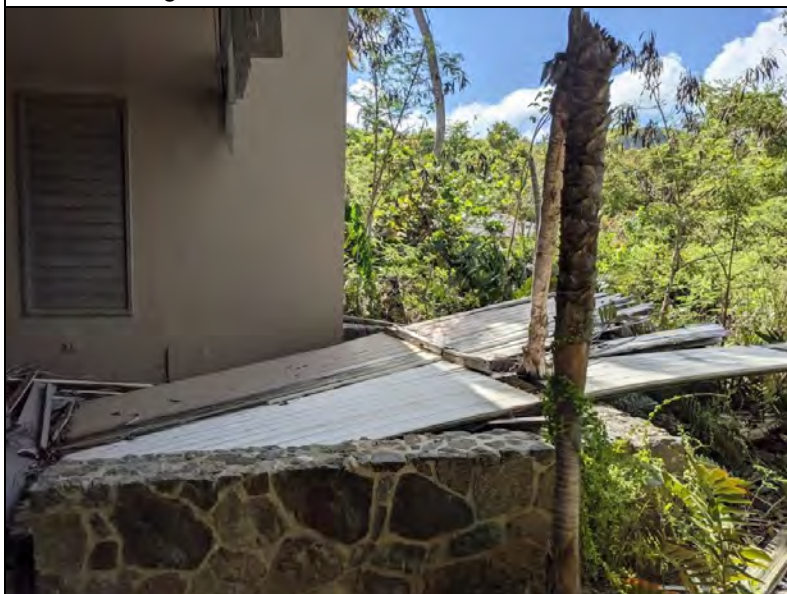
8. View to east of Hawksnest Beach rooms. Roofing debris, with roll tar paper with visible fibers, from different building (possibly Scott Beach ~500 feet to the east) visible in foreground.

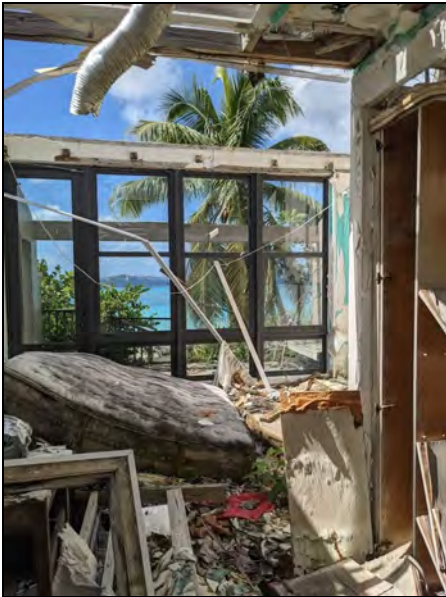
9. View of damage to Scott Beach rooms - view through room to west. Note missing roof and missing/damaged sheetrock/plaster ceiling.

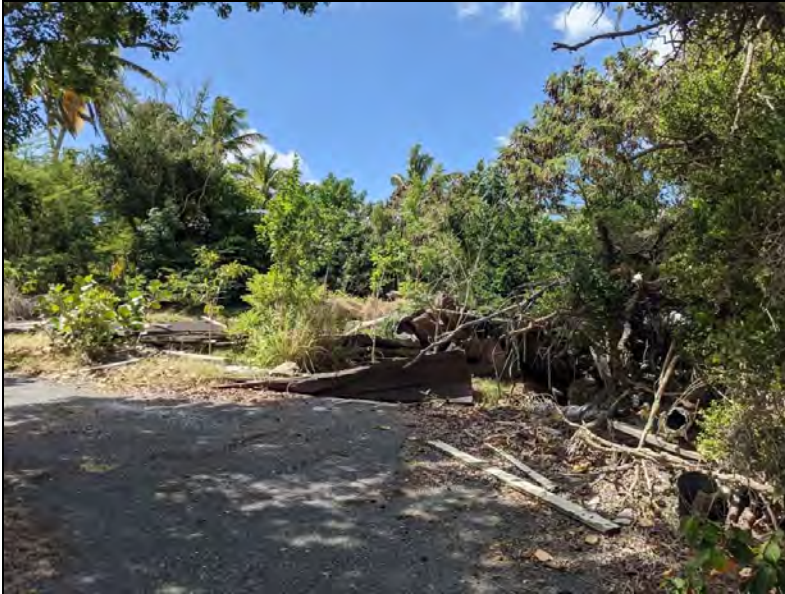
10. Scattered roofing debris, including tar paper with visible fibers, to east of Scott Beach.

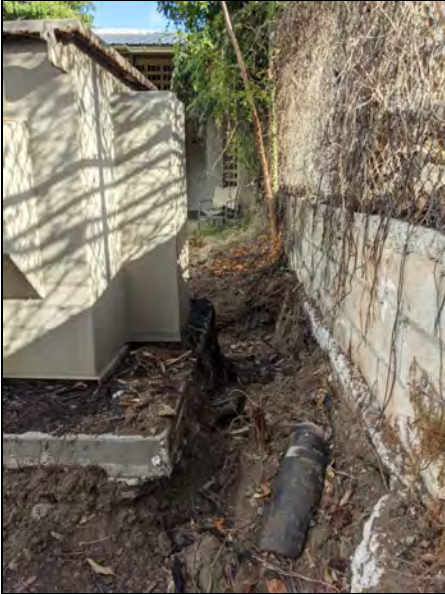
1. View behind leaking Transformer 22, in IA-2-02. Possible broken asbestos pipe in excavation.

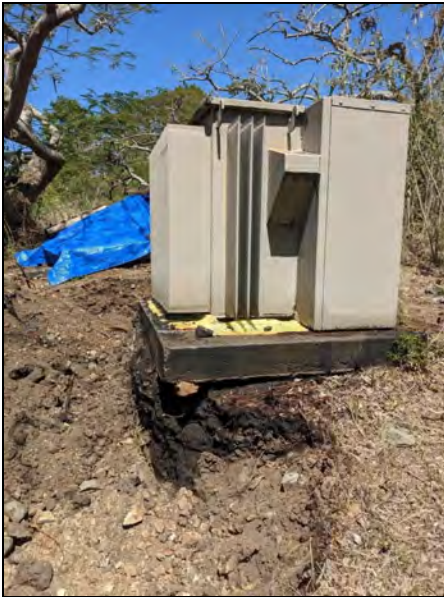
3. View of leaking transformer 23 near Sugar Mill Ruins. Note soil pile behind. Note concrete is wet with oil, sorbent pads are saturated; transformer appears to be continuing to leak.

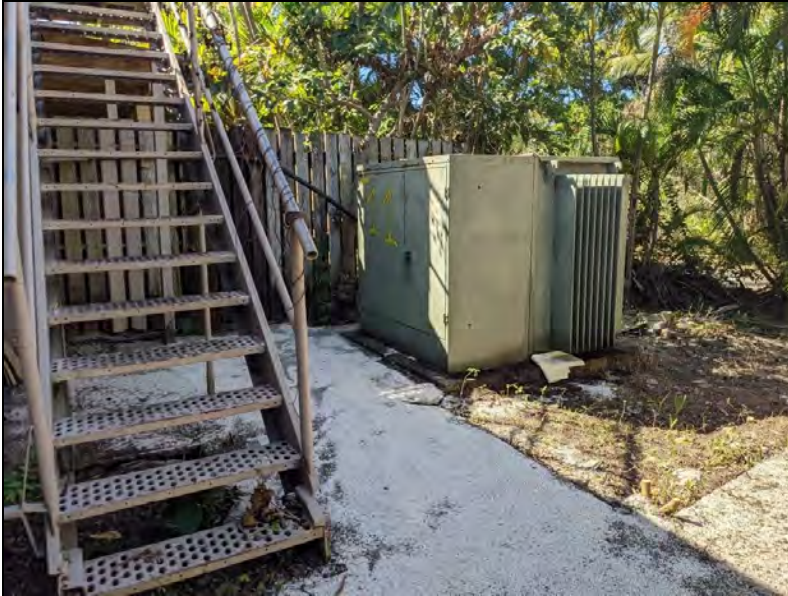
4. View of leaking transformer 11, near Beach Terrace dining room

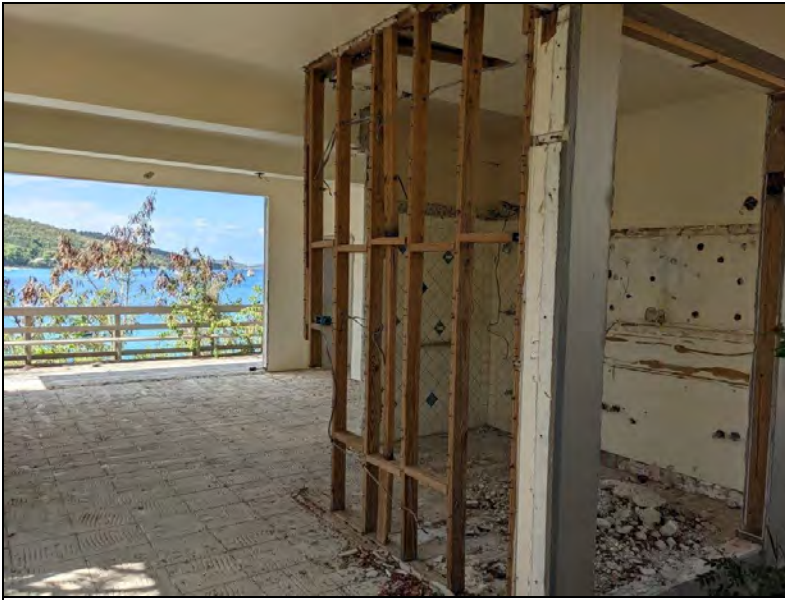
5. Partial demolition of Cottage Point rooms. Note removed tile and drywall and masonry, plaster, drywall, rubble with possible ACM.

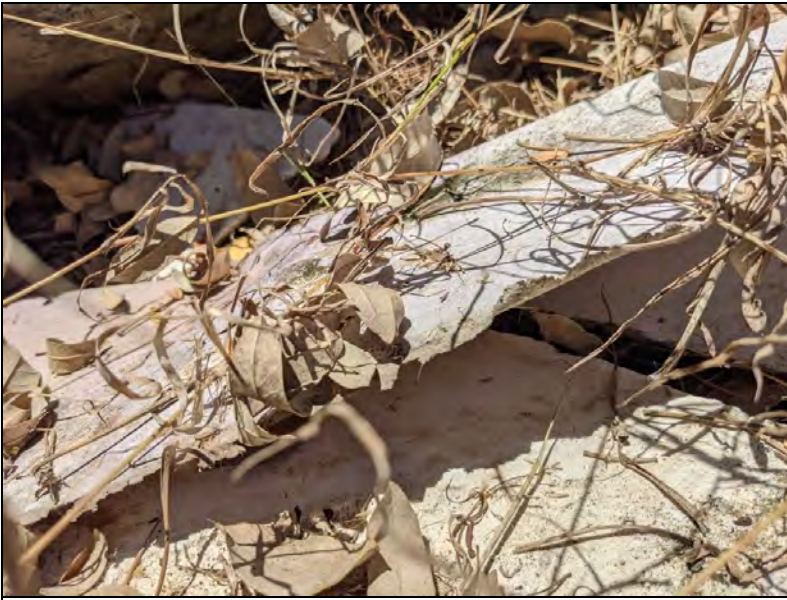
7. Drywall debris with visible fibers to east of Caneel Beach rooms.

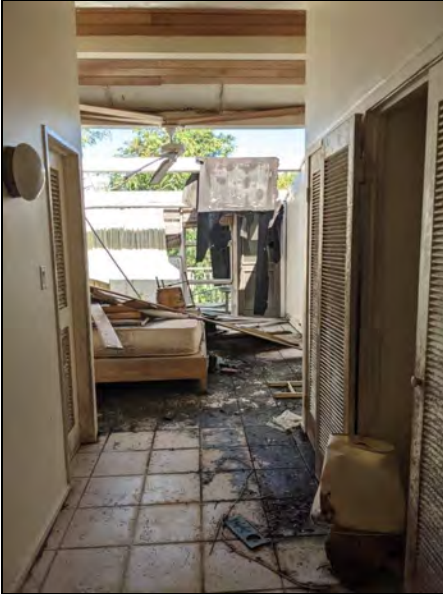
1. View of damage to second floor room at rooms 143-152. Roll tar paper with visible fibers behind.

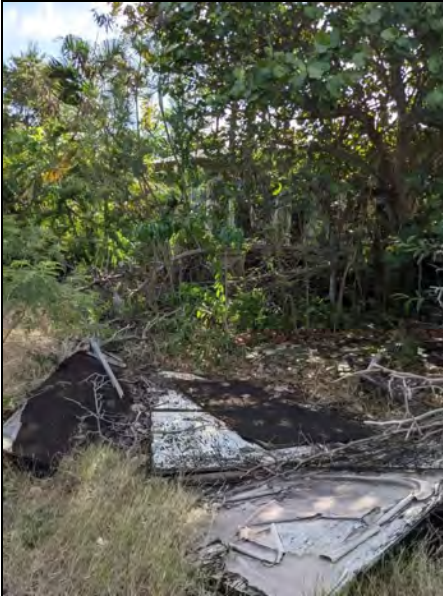
2. Roofing debris, including tar paper with visible fibers to west of fitness center. Fitness center behind.

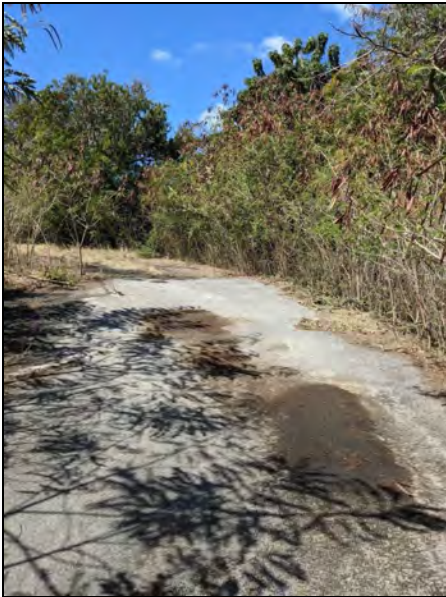
3. View looking west of oil stain on drive to residence near Equator Restaurant. Possible granular sorbent on surface.

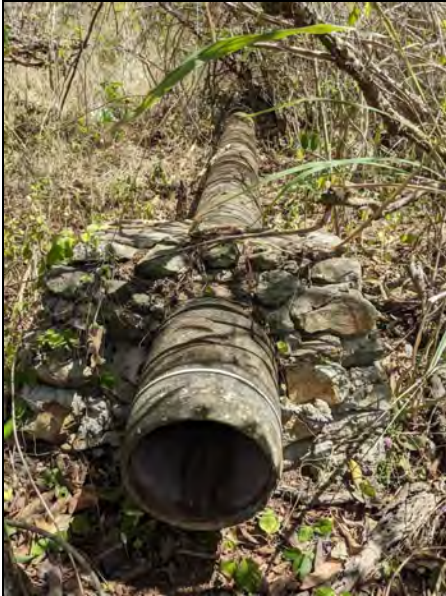
4. Possible asbestos-cement pipe north of landfill access road.

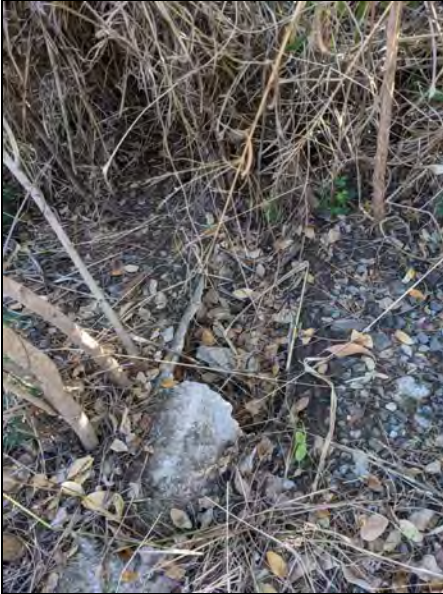
1. Closeup of broken possible asbestos pipe in grounds and landscaping area to south of equipment maintenance building.
