NPS Engineering Evaluation/ Cost Analysis Field Activities Report

Virgin Islands National Park

**Caneel Bay Resort Site
St. John, USVI
EDL Number 5SER3346**

March 12, 2021

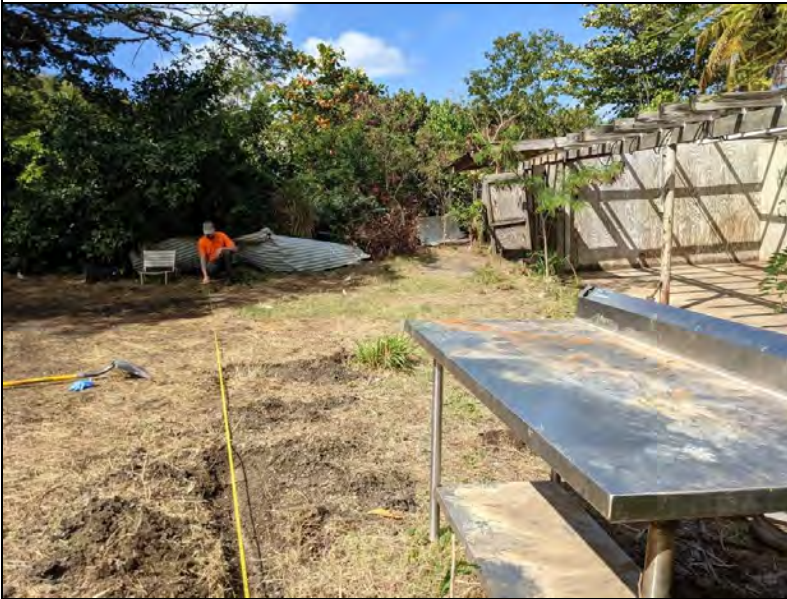
2. Exposed approximately 14 feet of possible asbestos pipe around landscaping shed in Area 2.

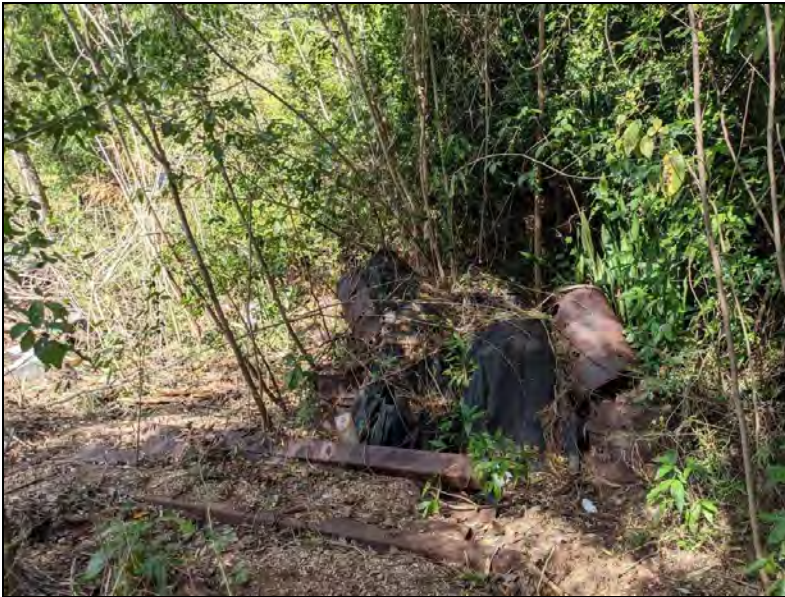
3. Partially buried 55-gallon steel drums (at least 12) in eastern part of gravel staging area. Note drums are heavily rusted.

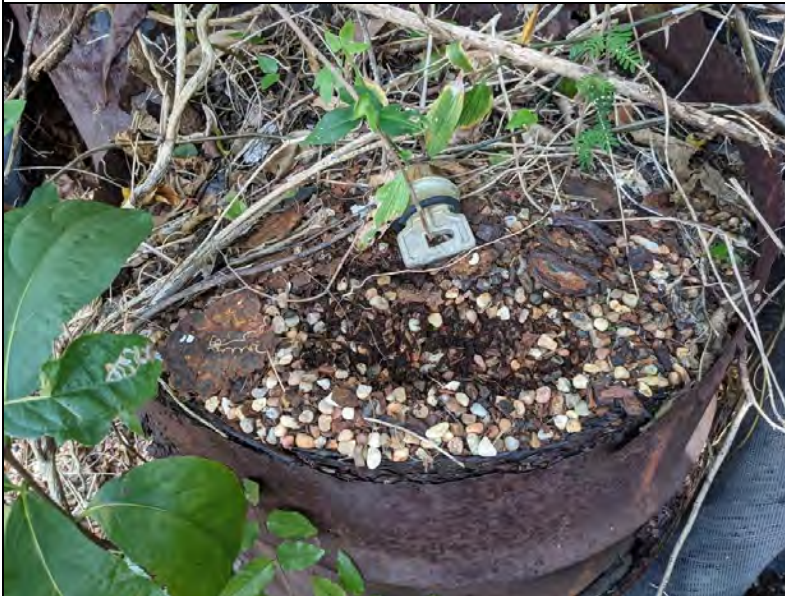
4. Top of partially buried 55-gallon steel drum in gravel staging area. Some drums appear to have contained washed pebbles

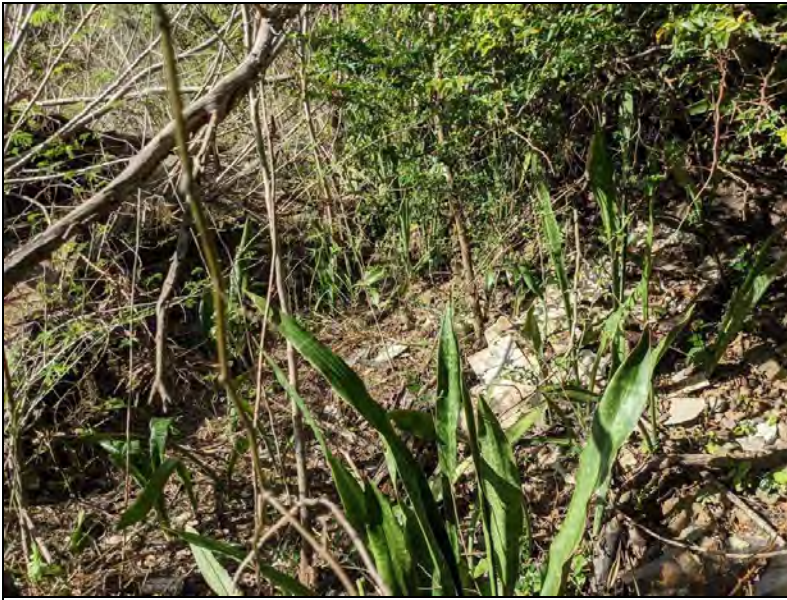
5. Possible ACM tile in eastern portion of gravel staging area.

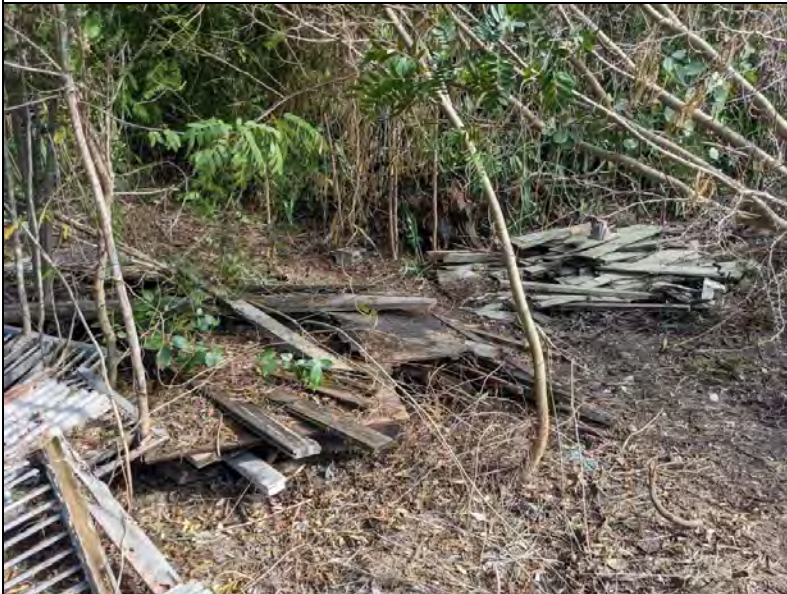
6. View to east of building debris piles in center of gravel staging area. Piles include painted materials and tar paper with visible exposed fibers.

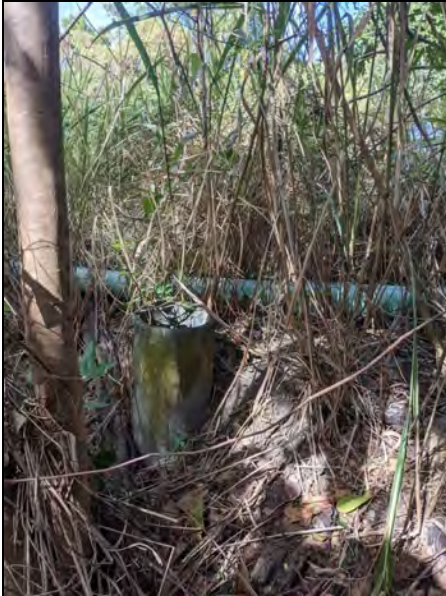
4. Possible asbestos-cement pipe identified in the northeastern corner of IA-2-01.

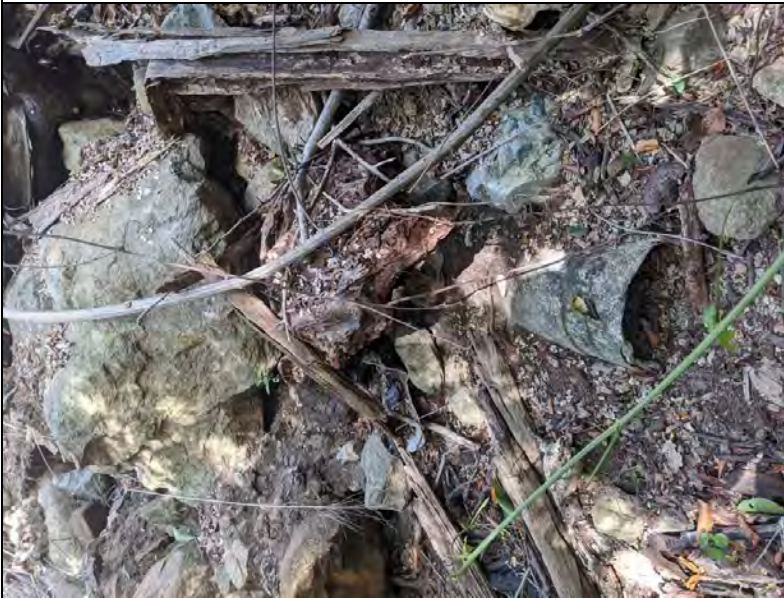
2. Possible asbestos-cement pipe at the northwestern toe of the landfill.

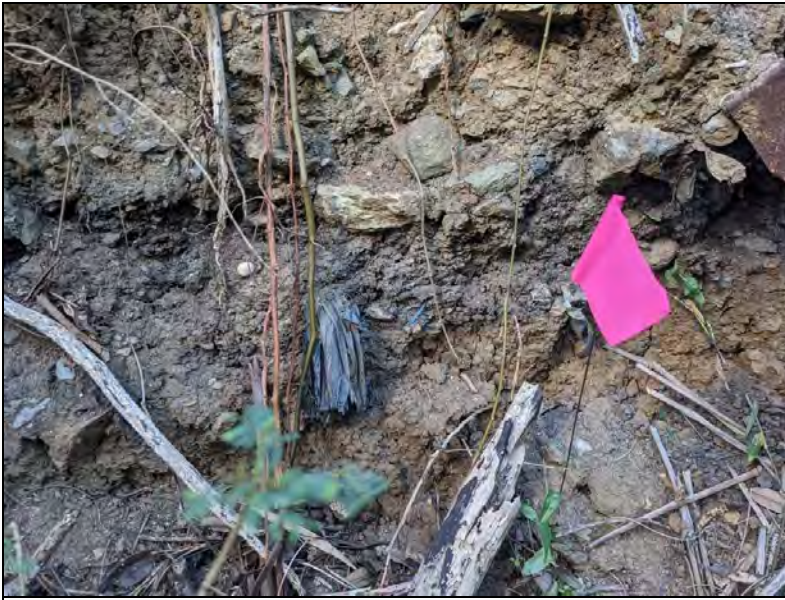
3. Exposed waste along exposed southern face of landfill/wash. Area included in IA-4-04.

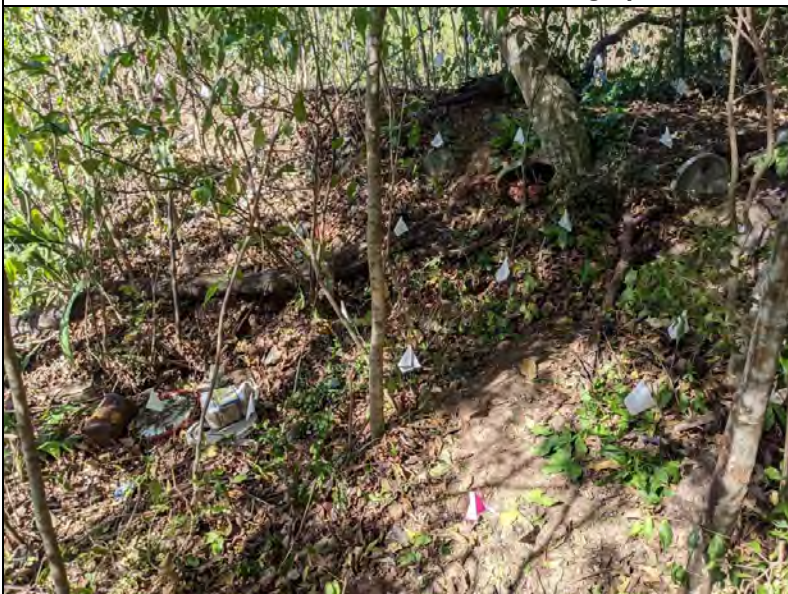
1. View of IA-1-03 staked out for ISM sampling at southern end of Area 1. Note dumped paint on slope and discarded paint cans, etc.
