# Historic Resource Survey Form

## Wright House

Cumberland Township, Adams County, Pennsylvania

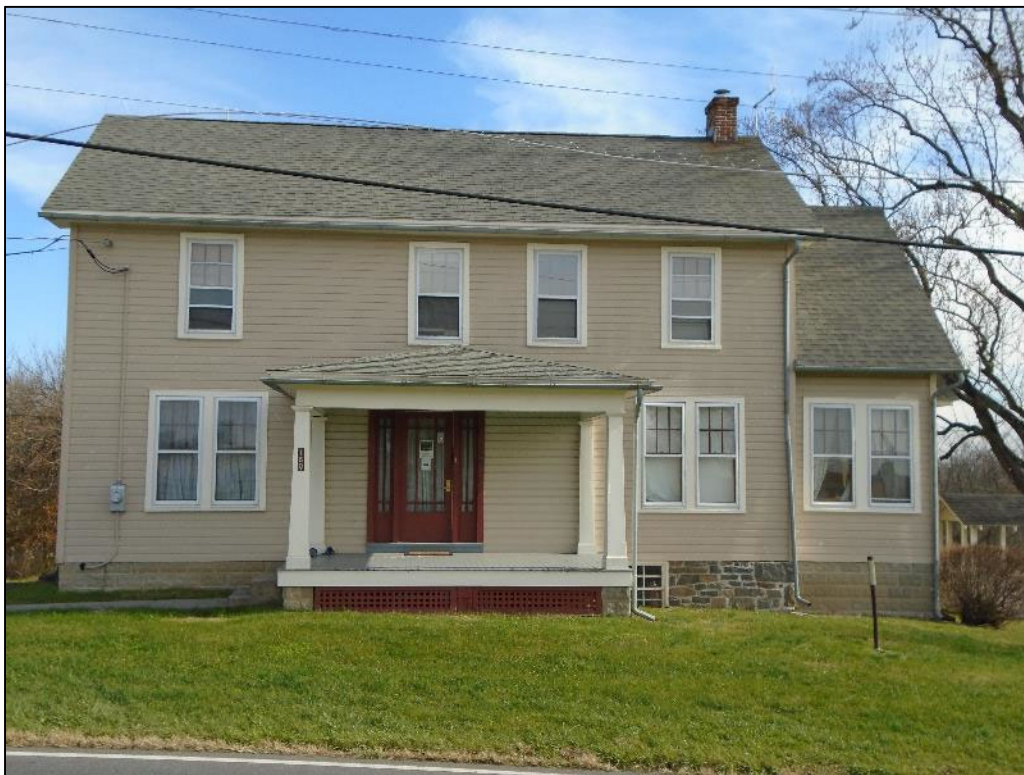
Photograph 1 – Façade (west elevation) of the dwelling; looking east.

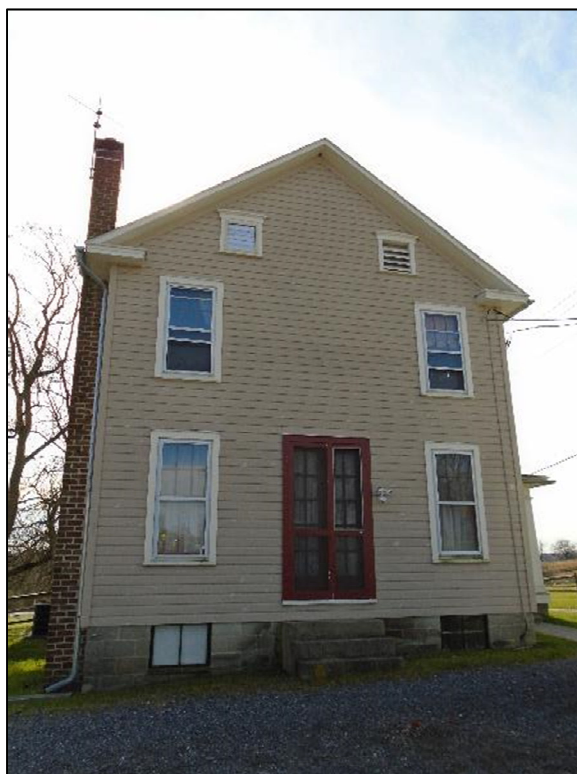
Photograph 2 – Side (north elevation) of the dwelling; looking south.

The north elevation of the house faces the gravel parking area and features a centered secondary entrance with 10-light wood French doors protected by a double screen door (Photograph 2). The entrance is accessed by three concrete steps. The door is flanked by two windows. Two shorter windows on the second floor are vertically aligned above the first-floor windows. Two louvered vents are located in the gable. These vents replaced two original, four-light wood casement windows sometime after 1975. The 1975 List of Classified Structures Inventory Report for the Wright House mentions the two, four-light wood casement windows; therefore, the windows were replaced with louvered vents sometime after 1975 (National Park Service *LCS Wright House* 1975: 5). The exposed, raised concrete block foundation contains two two-light, wood, hopper windows. A carport addition was previously located off the north elevation but was removed ca. 2013.

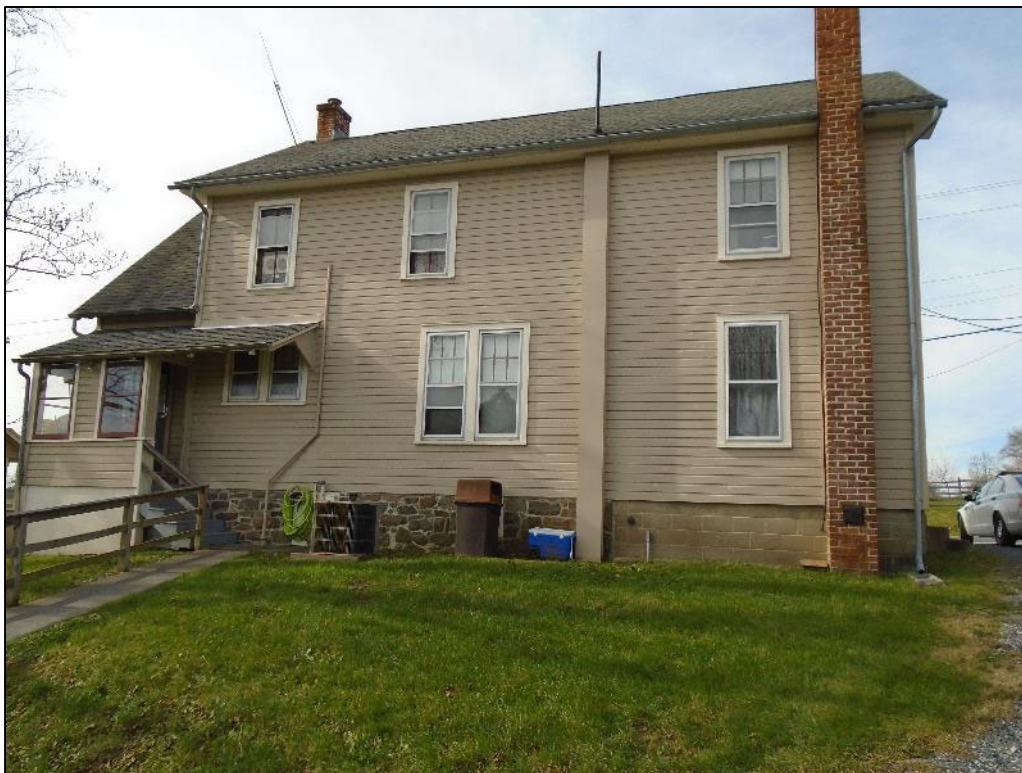
Photograph 3 – Rear (east elevation) of the dwelling looking west.

The south end of the east elevation has a small, enclosed entryway that leads into the south addition. This entryway features a shed roof with exposed rafter tails and contains three windows, two on the east elevation and one on the south elevation. All three windows are one-over-one, wood awning windows. The shed roof of the entryway extends north to shelter a small pair of six-over-one, wood, double-hung windows located on the first story of the original section of the house. Additional fenestration on the original section of the dwelling includes an additional pair of windows on the first story and two, two-over-two, wood, double-hung windows on the second story. The original section of the house and the northern addition are visually separated by a vent pipe enclosed on three sides with plywood painted to match the siding. Two windows are located on the east elevation of the north addition of the house; one on the first story and one vertically aligned on the second story. To the north of these windows is a brick exterior furnace chimney that was added in 1975. The exposed foundation consists of mortared stone under the original section of the house and CMU under the north addition (Photograph 3).

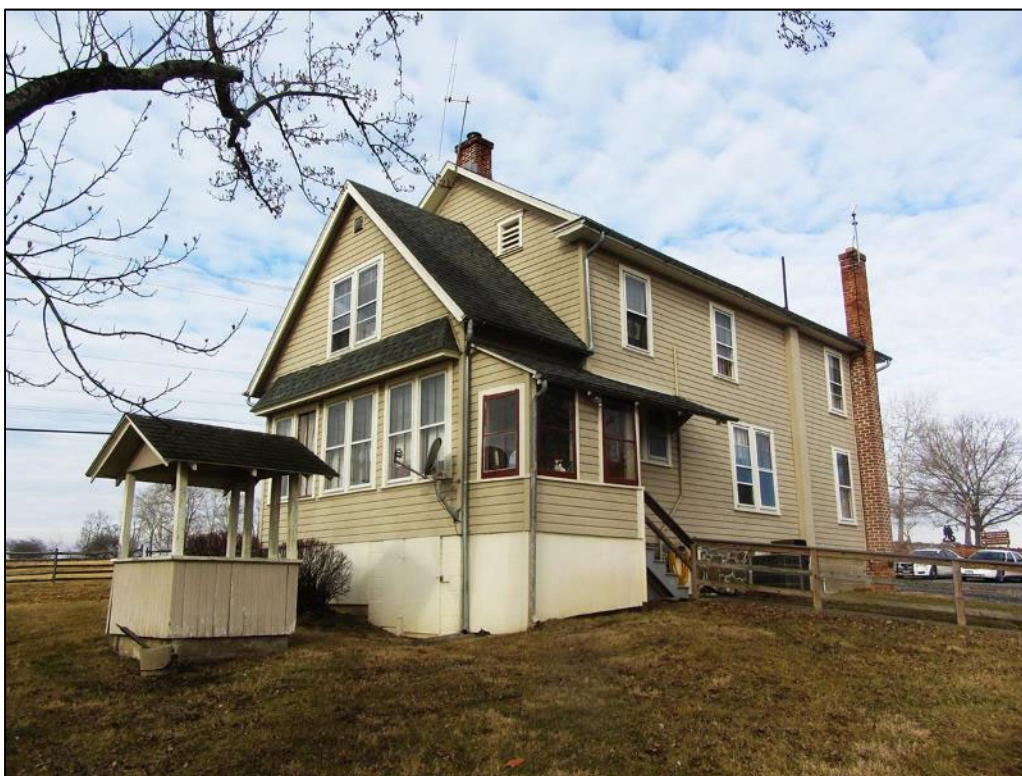
Photograph 4 – Rear (east elevation) and side (south elevation) of the dwelling; looking northwest.

The south elevation of the house features the ca. 1930 one-and-a-half-story south addition, which is attached to the southern gable end of the original section of the dwelling. The addition is capped by a steeply-pitched gable roof and is situated on a foundation of exposed concrete block piers enclosed with painted plywood. The first floor of the addition contains three pairs of evenly-spaced two-over-two, wood, double-hung windows. A pent eave spans the area directly above the first-floor windows. A pair of two-over-two, wood, double-hung windows is centered in the gable peak directly above the pent eave. A small metal vent is located in the gable peak. The south elevation of the original section of the house features two louvered vents on either side of the addition's roof, which provide circulation to the attic. A single jib door is located in the additions exposed foundation, between the eastern-most piers, providing access to the cellar (Photographs 4-5).

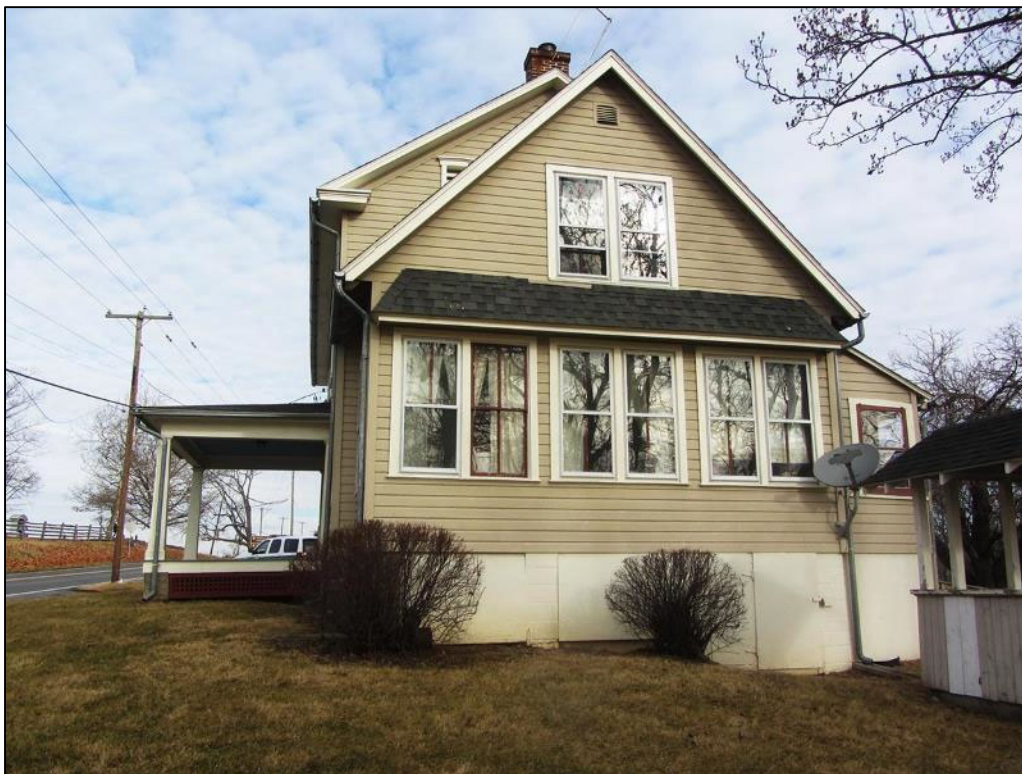
Photograph 5 – Side (south elevation) of the dwelling; looking north.

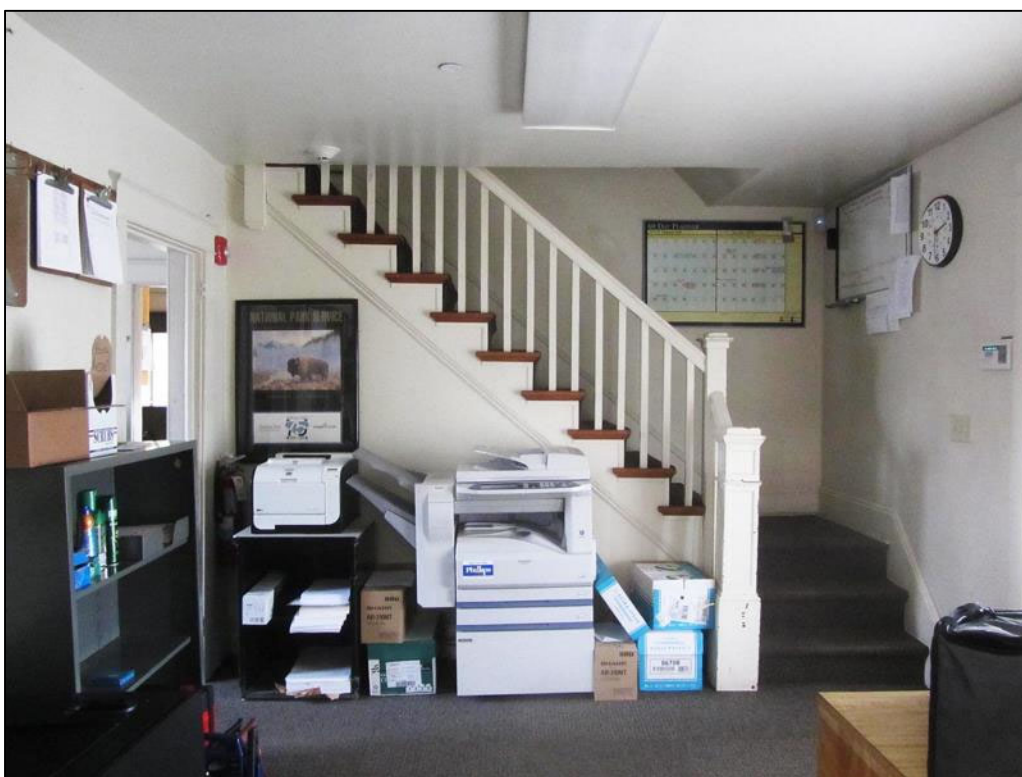
Photograph 6 – Entry hall and stairway in first floor of dwelling; looking south.

newel post and molded stringers (Photograph 6). To the left (north) of the entrance hall is a full depth room contained in the northern addition. This room is separated from the entrance hall by French doors (Photograph 7). Behind the entrance hall, is an east room through which the kitchen is accessed (Photograph 8). A five-panel, wood door located in the southwest corner of the west wall of this room provides access to the basement stairs that are situated beneath the main stairs (Photograph 9). The kitchen, which was renovated in 1973, provides access, at two points to the south addition (Photograph 10). The kitchen, east room and entrance hall make up the original section of the home. The first floor of the southern addition contains two small rooms each accessed by doorways in the kitchen.

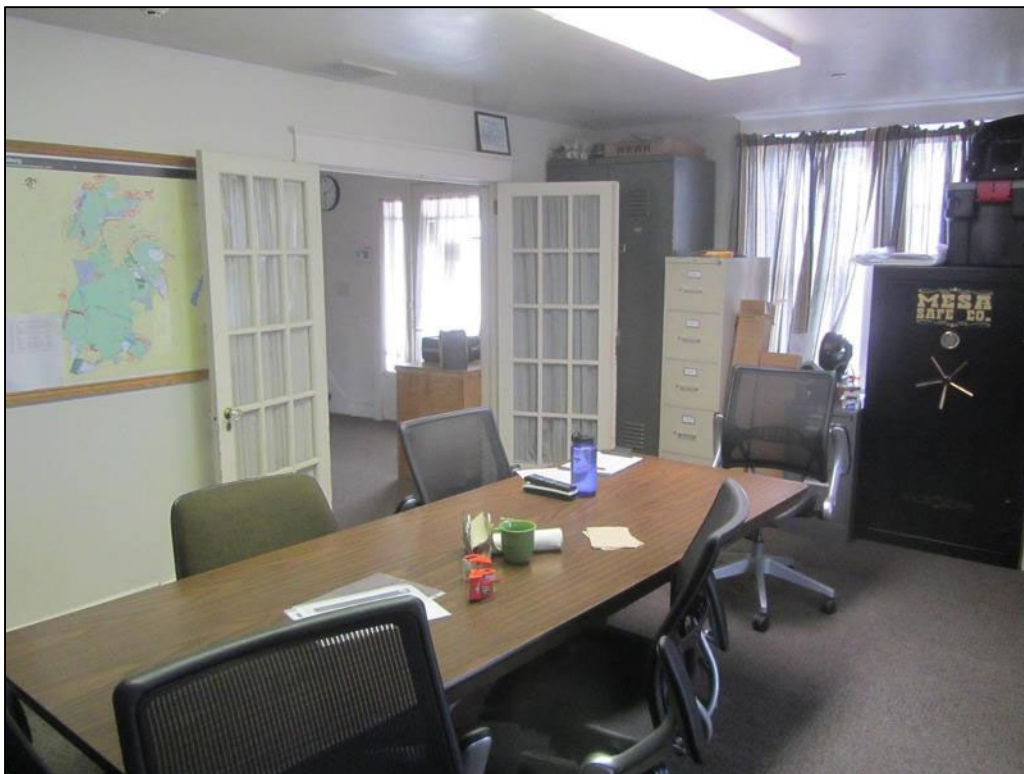
Photograph 7 – Room in northern addition, first floor; looking south.

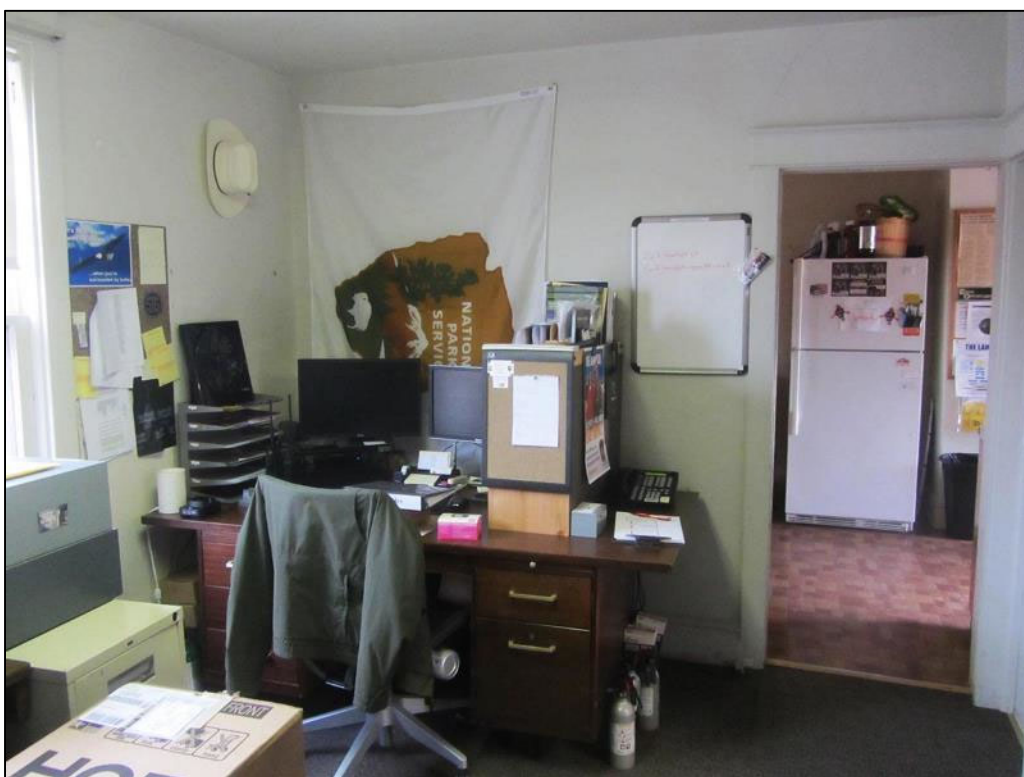
Photograph 8 – East room, looking south into kitchen.

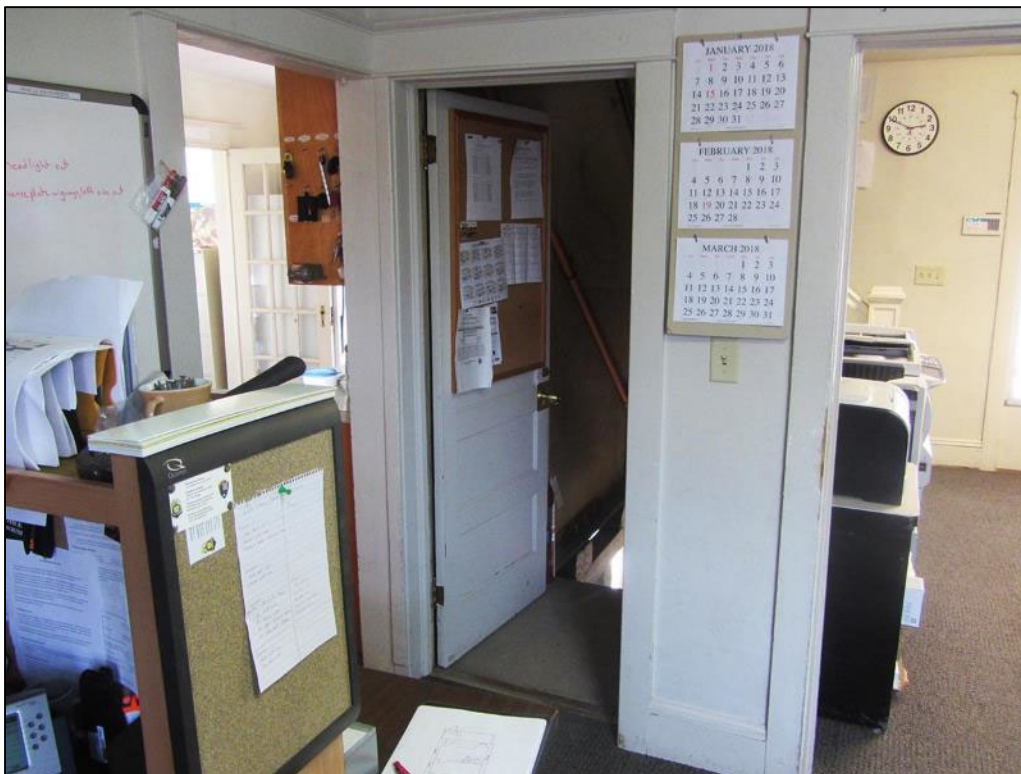
Photograph 9 – Access to basement located in eastern room, looking west.

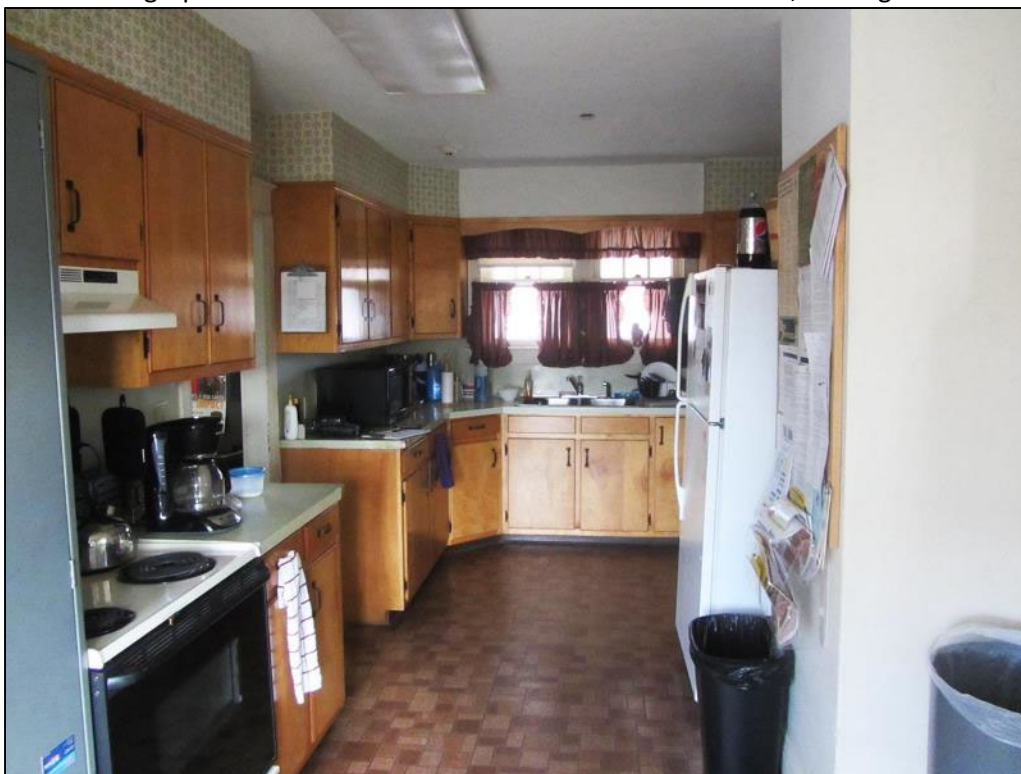
Photograph 10 – Kitchen on first floor, looking east.

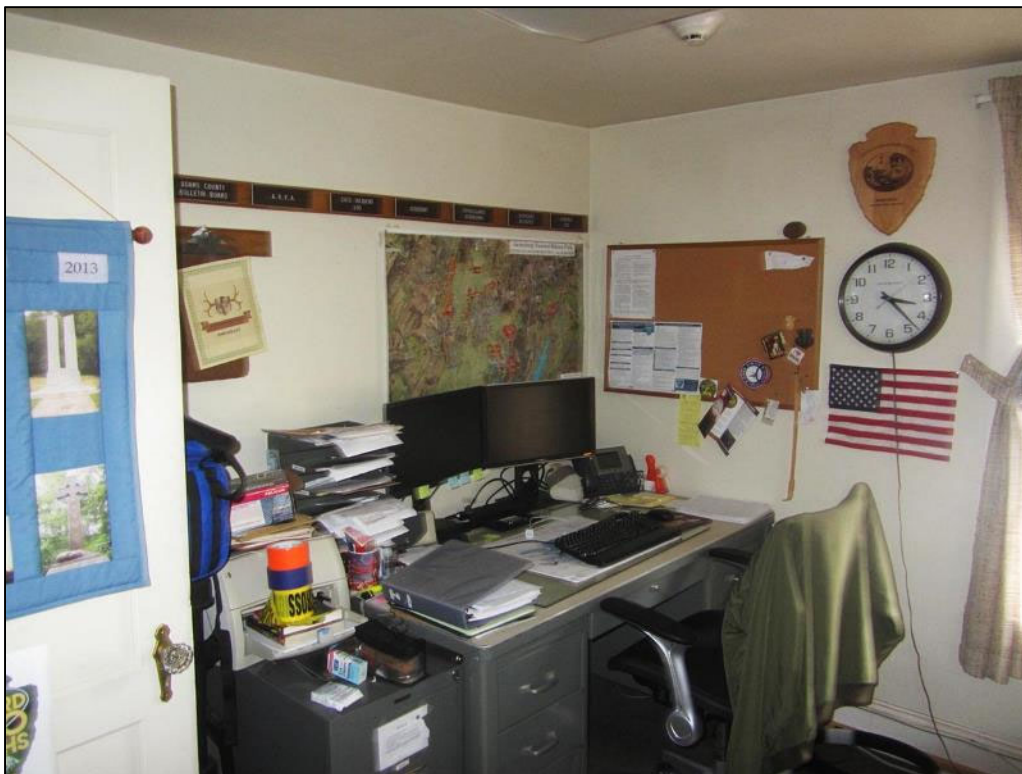
Photograph 11 – Northeast room in the northern addition of the second floor; looking northwest.

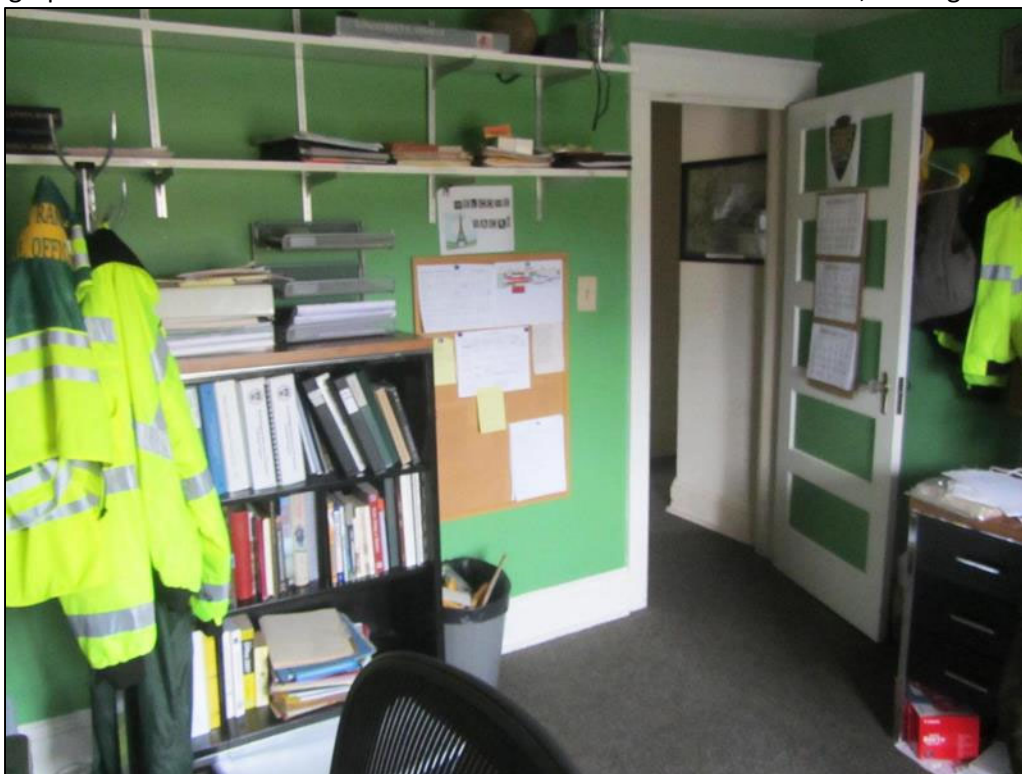
Photograph 12 – Northwest room in the northern addition of the second floor; looking east.

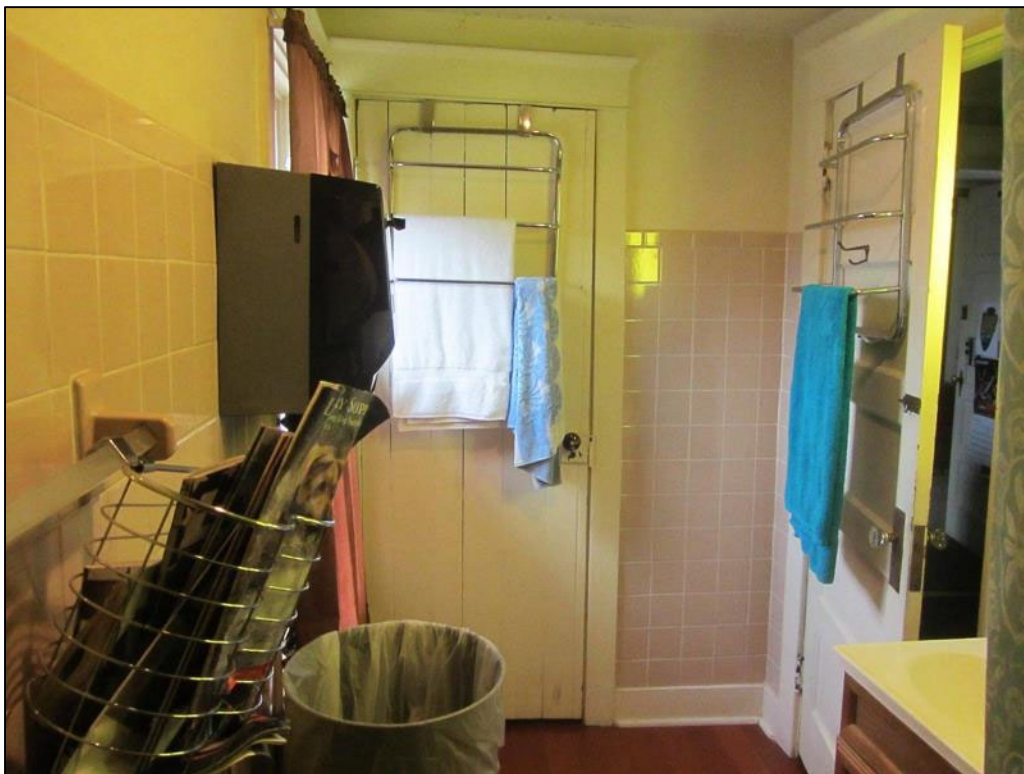
Photograph 13 – Bathroom, second floor, looking south.

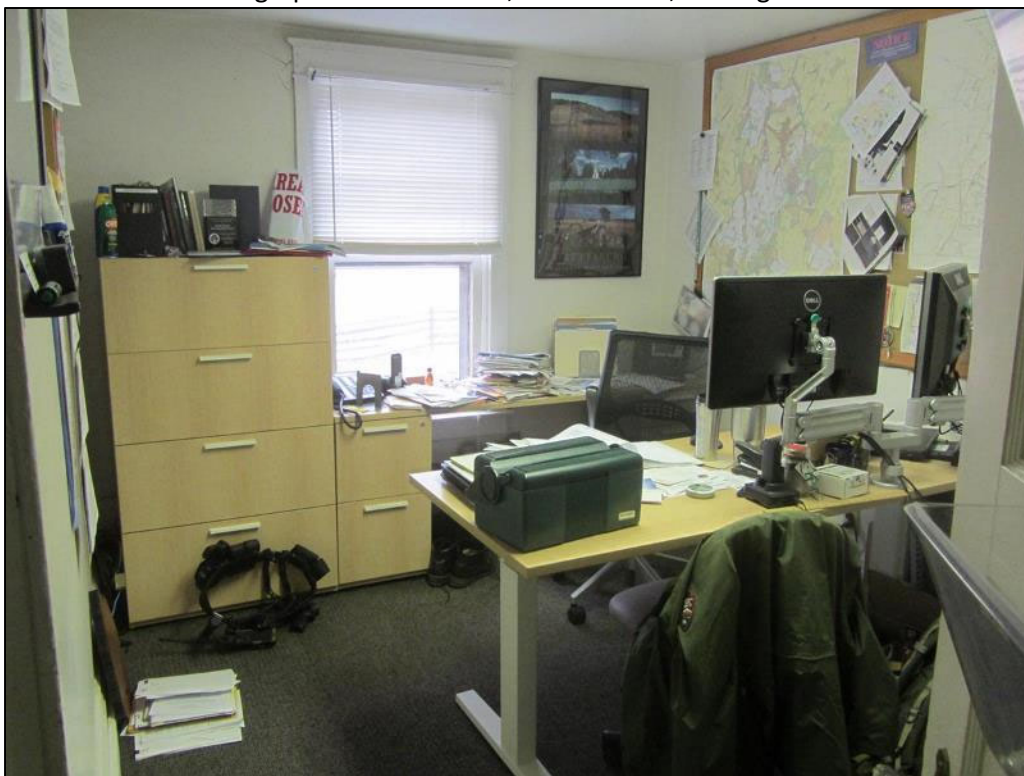
Photograph 14 – West room, second floor, looking west.

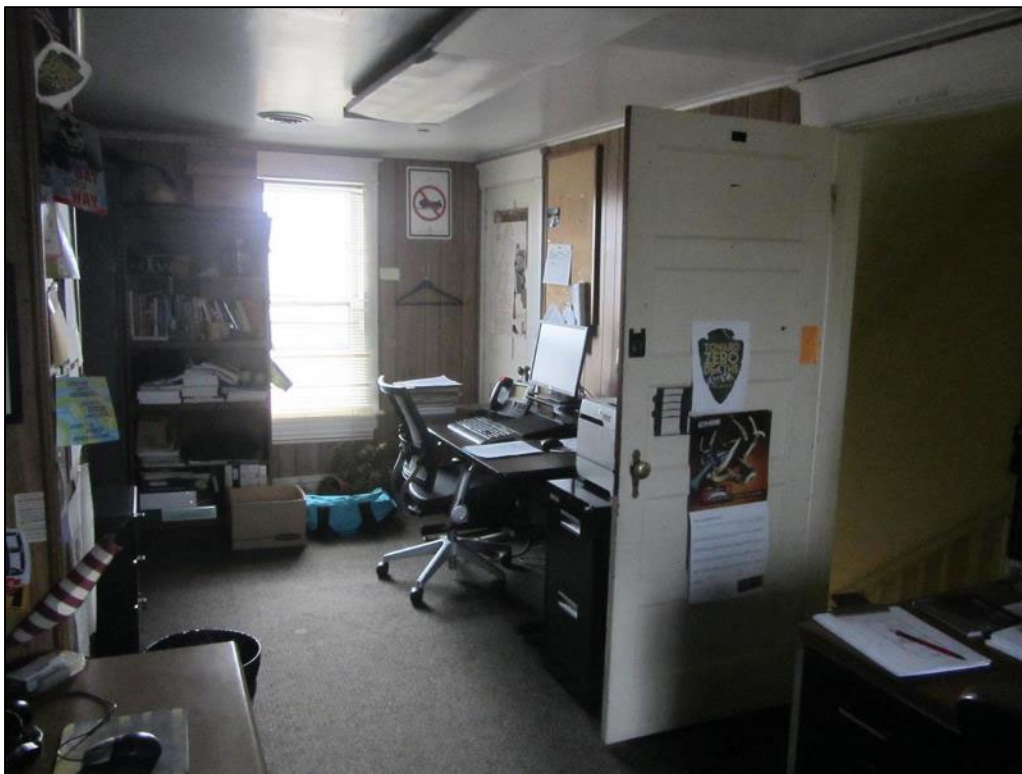
Photograph 15 – Full-depth south room, second floor, looking west.

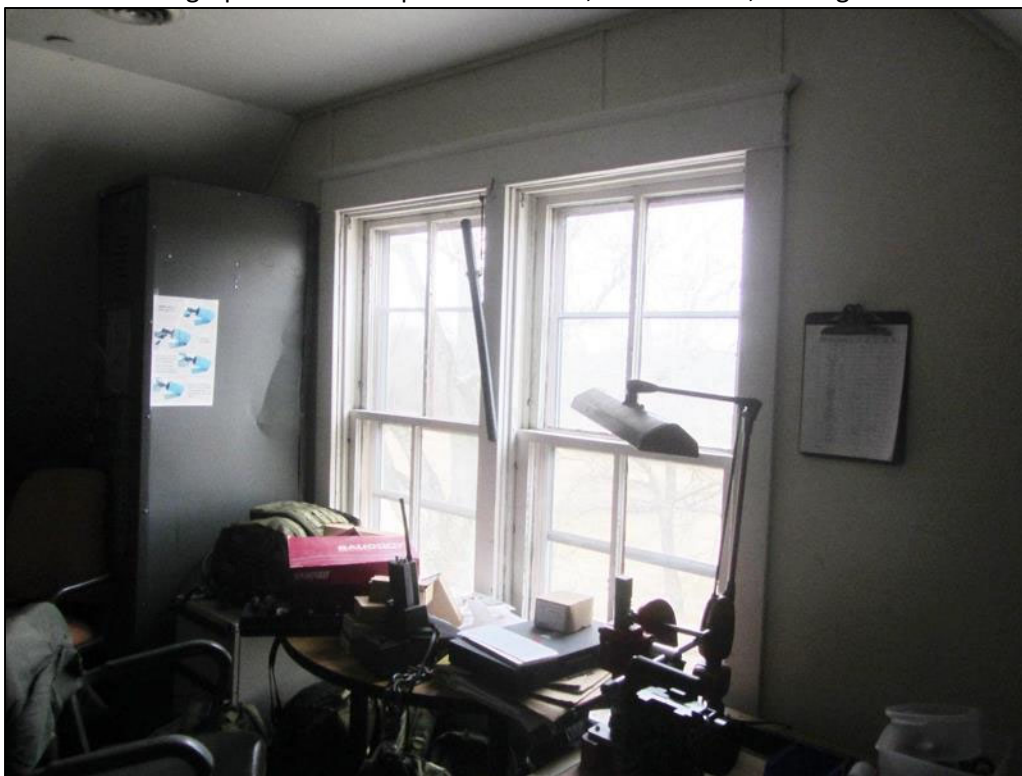
Photograph 16 – Southern addition, second floor; looking south.

Within the original section of the dwelling are two rooms and a bathroom. The bathroom is accessed off of the east wall of the hallway and has a five-panel, wood entry. The bathroom walls are a combination of plaster and tile and a modern laminate overlay covers the floor (Photograph 13). A closet on the south wall of the bathroom has a batten door. One of the original rooms is accessed through a five-panel, wood door located on the west wall of the hallway. This west room contains a closet with a four-panel, wood door located on the east wall (Photograph 14). The additional original room is accessed via a five-panel, wood door on the south wall of the hallway, at the top of the stairs. This room is the full depth of the dwelling and provides access to the attic and the second story of the south addition. This room features a closet with a four-paneled, wood door on the east end of the north wall. A four-panel, wood door on the west end of the north wall provides access to the attic stairs (Photograph 15). Two additional four-panel, wood doors on the south wall provide access to the second story of the southern addition. The southern addition is comprised of a single room with a pair of windows located on the south wall (Photograph 16).

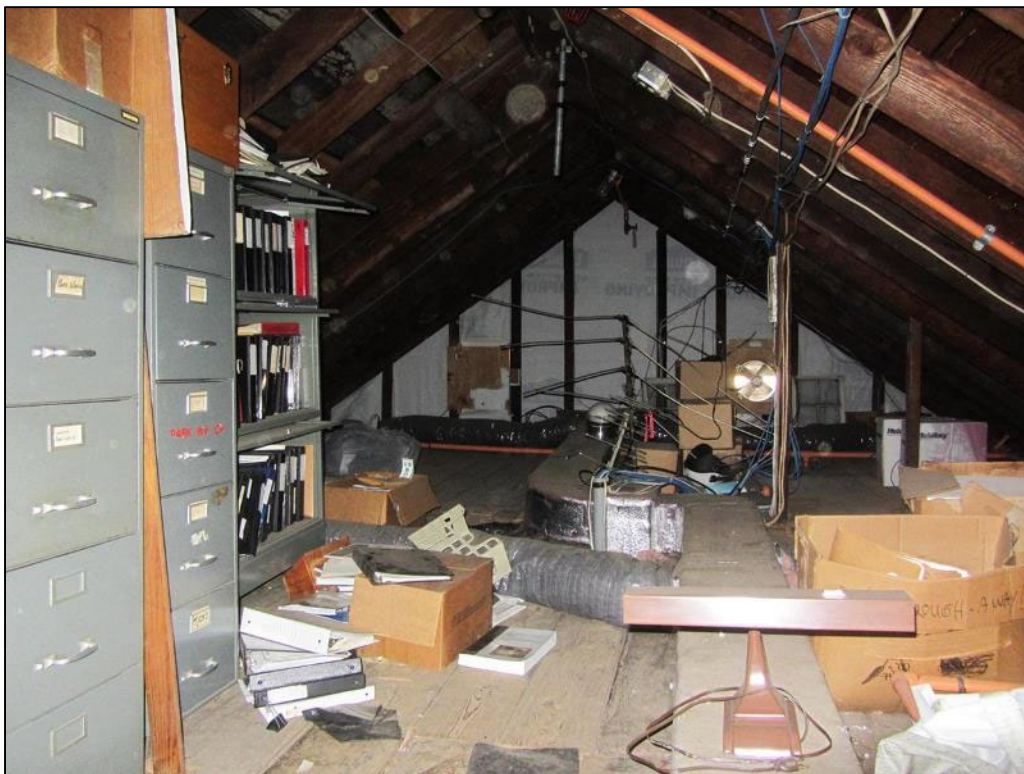
Photograph 17 – Attic, looking south.

The attic is accessed by a flight of stairs, with a 90-degree turn from a landing. The stairway features plastered and wallpapered walls. The attic spans the original section of the house as well as the north addition. It is unfinished and has tongue and groove flooring throughout most of the area. The space is used for storage and houses the heating and air conditioning equipment. The roof rafters, ridge board and sheathing are all exposed (Photograph 17).

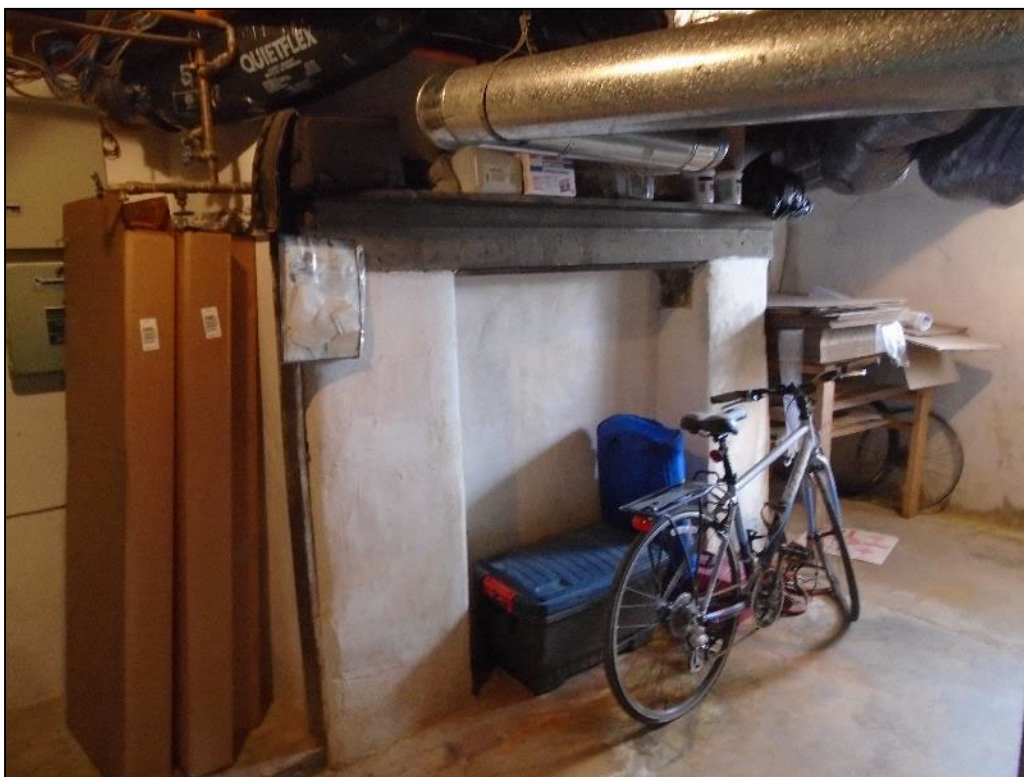
Photograph 18 – Infilled fireplace in basement, looking southwest.

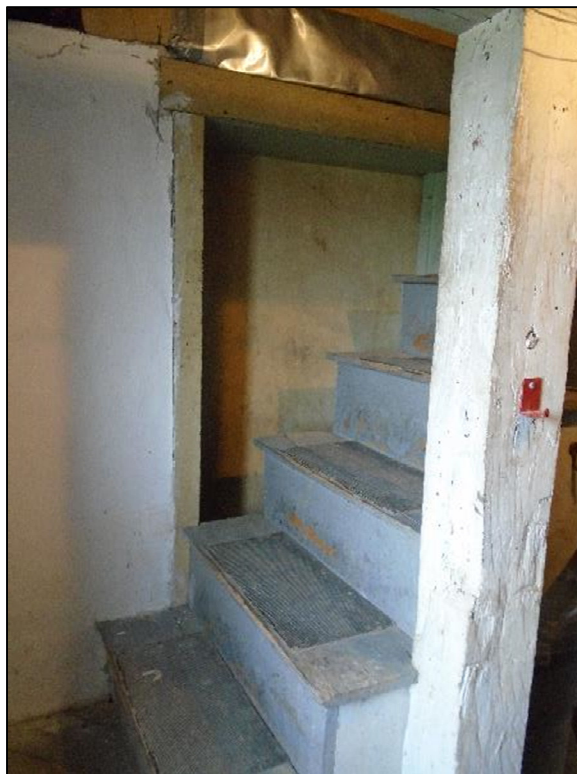
Photograph 19 – Original cellar door blocked by current basement stairs; looking northwest.

The current stairs from the first floor into the basement block a door that once connected the north section and the south section of the original basement, demonstrating that the stairs were a later addition (Photograph 19). The foundation walls of the original section are all stone clad covered in plaster. A concrete block wall separates the original basement from basement beneath the northern addition. The exposed underside of the first floor of the original section of the house reveals hand-hewn log joists and old tongue and groove flooring.

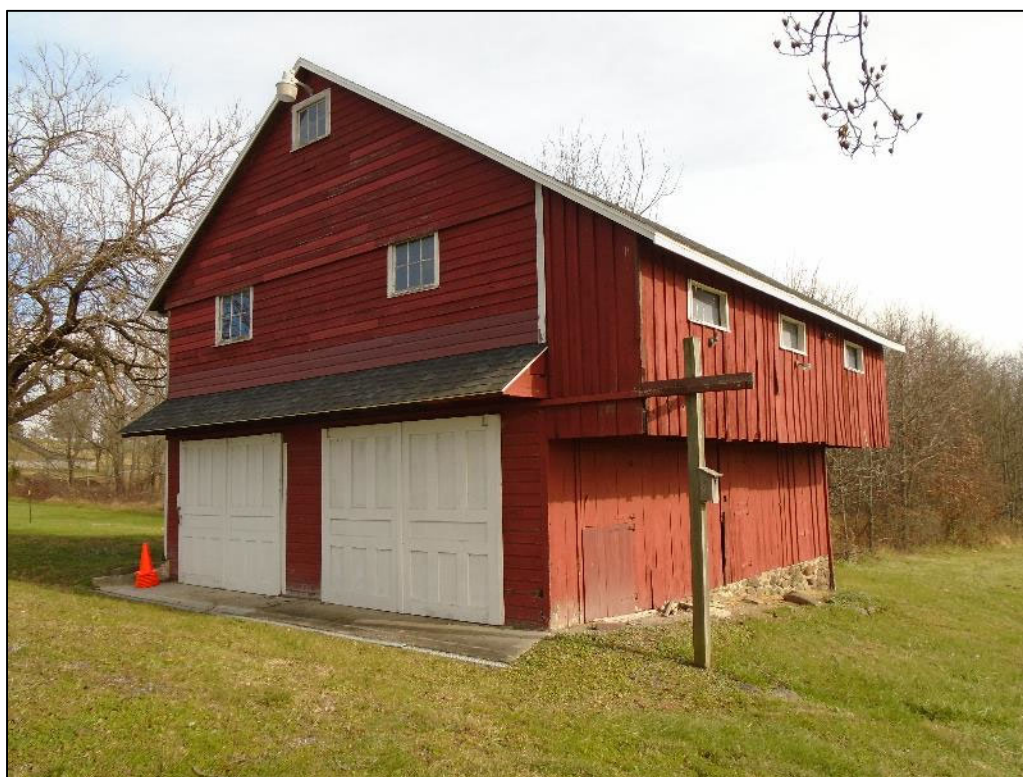
Photograph 20 – Façade (west elevation) of carriage house and shed; looking northeast.

A two-and-a-half-story, ca. 1920 carriage house and stable sits directly to the rear (east) of the house (Photographs 20-22). It rests on a stone foundation, is clad in a combination of weatherboard and board-and-batten wood siding and is capped by a front-gable roof clad in asphalt shingles. The building's west-facing façade features two equally spaced pairs of sliding wood paneled barn doors sheltered beneath a pent eave overhang. Two original six-light, wood hopper windows are on the second story vertically aligned above the first-floor barn doors. A single, original, six-light, wood hopper window sits in the gable peak. The south elevation features a Dutch door located at the west end of the first floor. Three replacement, single-light, fixed wood windows are evenly spaced across the second-floor overhang. The east (rear) elevation features two, original, two-over-two, wood double-hung windows equally spaced on the second story. The north elevation features two window openings on the first floor that have been infilled with plywood. A wood double door is located in the west corner of the second story.

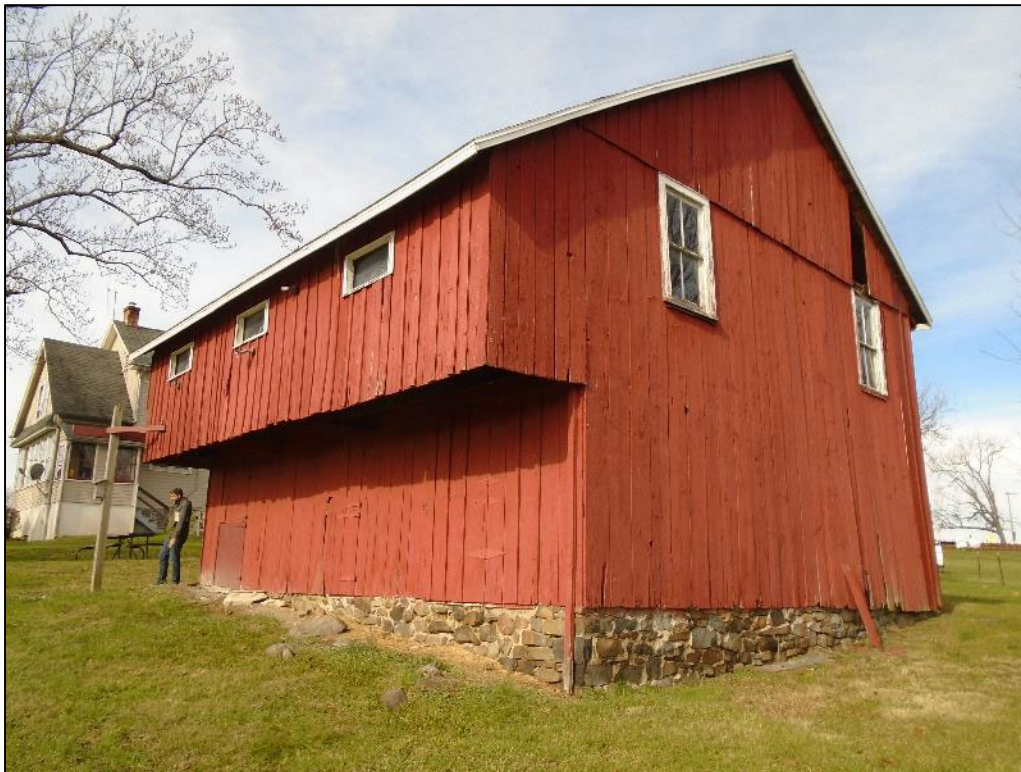
Photograph 21 – Side (south elevation) and rear (east elevation) of carriage house and shed; looking northwest.

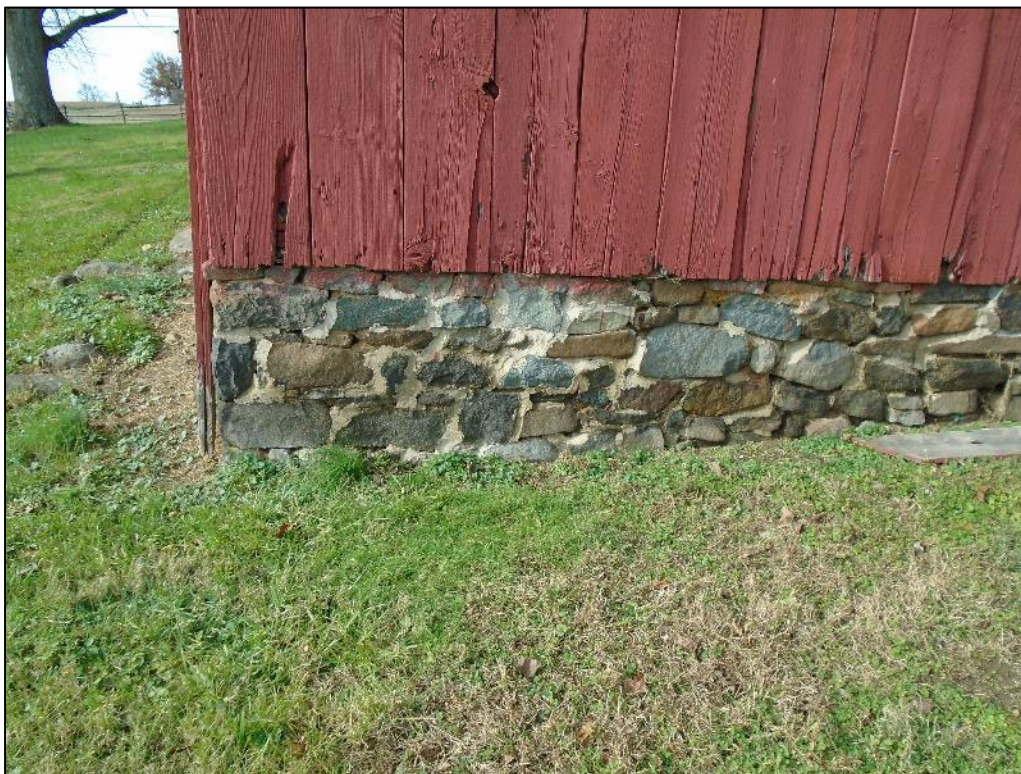
Photograph 22 – Detail of foundation on carriage house and shed.
