Chapter 3: Existing Conditions / Affected Environment

The *Secretary of the Interior's Standards for the Treatment of Historic Properties* require a comprehensive understanding of the current conditions to provide a baseline for the development of treatment recommendations. This chapter provides a thorough inventory of the existing conditions of the environmental context, cultural resources (including cultural landscapes, buildings, and archeological sites), wildlife, socioeconomics, visitor experience, and park operations related to the Delta-01 and Delta-09 sites.

Minuteman Missile National Historic Site
Historic Structures Report/Cultural Landscape Report/Environmental Assessment

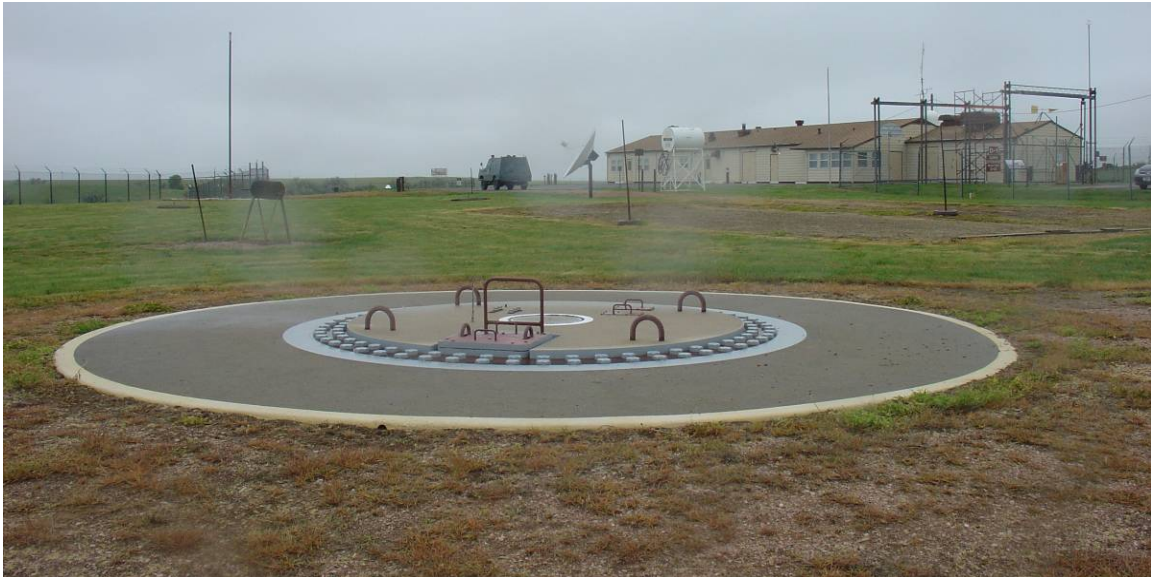
Small Scale Features	Description/Condition	Figure #
Hardened high frequency transmit antenna (HS 104, IDLCS 100480)	<i>Blast-hardened antenna, constructed in 1963, deactivated in early-1970s. Includes underground, reinforced-concrete cylinder, approximately twenty-one feet in diameter and fifty feet deep. Cylinder well contains a telescoping, four-sided radio antenna that was capable of extending to a maximum height of 120 feet.⁵ The antenna is in good condition.</i>	3-10
Hardened high frequency receive antenna (HS 105, IDLCS 100481)	<i>The antenna is set into the ground about 160 feet south-southeast of the LCF support building. Built in 1963, the structure consists of a reinforced-concrete cylinder covered by a concrete cap and measuring approximately sixteen feet in diameter and thirty-seven feet deep (outside dimensions). Five small ports are distributed evenly around the perimeter of the structure. Each port contained a slender, ballistically actuated, steel, monopole antenna. The antenna system was deactivated circa 1987-88.⁶ The antenna is in good condition.</i>	3-11

Figure 3- 10: Hardened High Frequency Transmit Antenna, facing northwest, June 2009 (QEA 3438)

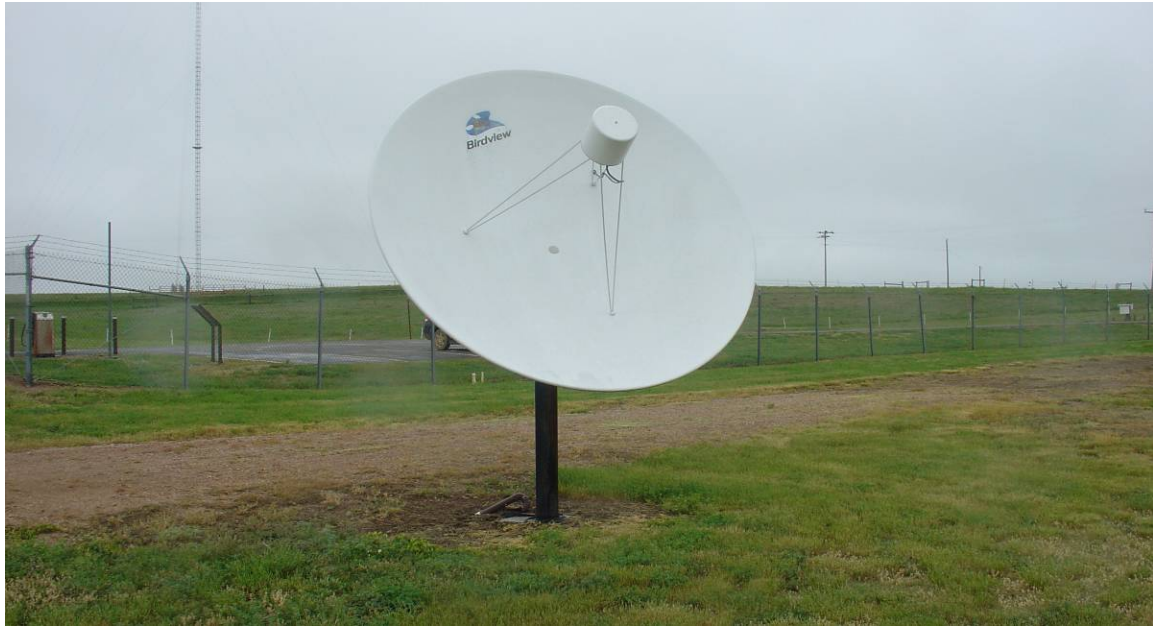
Television satellite dish (HS 121, IDLCS 398298)	<i>Installed circa 1987-88, the satellite dish is located in the grassy area in front (south) of the LCF support building. The satellite dish is in good condition.</i>	3-17
HICS	<i>Underground cable connecting Delta-01 to Delta-09. The cable was severed as part of the decommissioning of the site. The cable no longer functions, it is in poor condition.</i>	Not visible above ground at Delta-01.
Security fencing (HS 113, IDLCS 287263)	<i>Eight-foot high chain-link fence topped with barbed wire. The security fencing is in good condition.</i>	3-10, 3-11, 3-12, 3-16, 3-17, 3-20, 3-22, 3-24, 3-25, 3-27
Sewage lagoon fencing / Livestock fencing (HS 125, IDLCS 754342)	<i>Four-foot high barbed wire fence with red t-posts. The fences are in good condition.</i>	3-14
Cattle-guard (HS 129, IDLCS 754354)	<i>Horizontal metal grate at the intersection of the entrance driveway and Jackson County Road CS23A. The cattle-guard is in good condition.</i>	3-18

Figure 3- 17: Television satellite dish, facing northeast, June 2009 (source: QEA 3414)

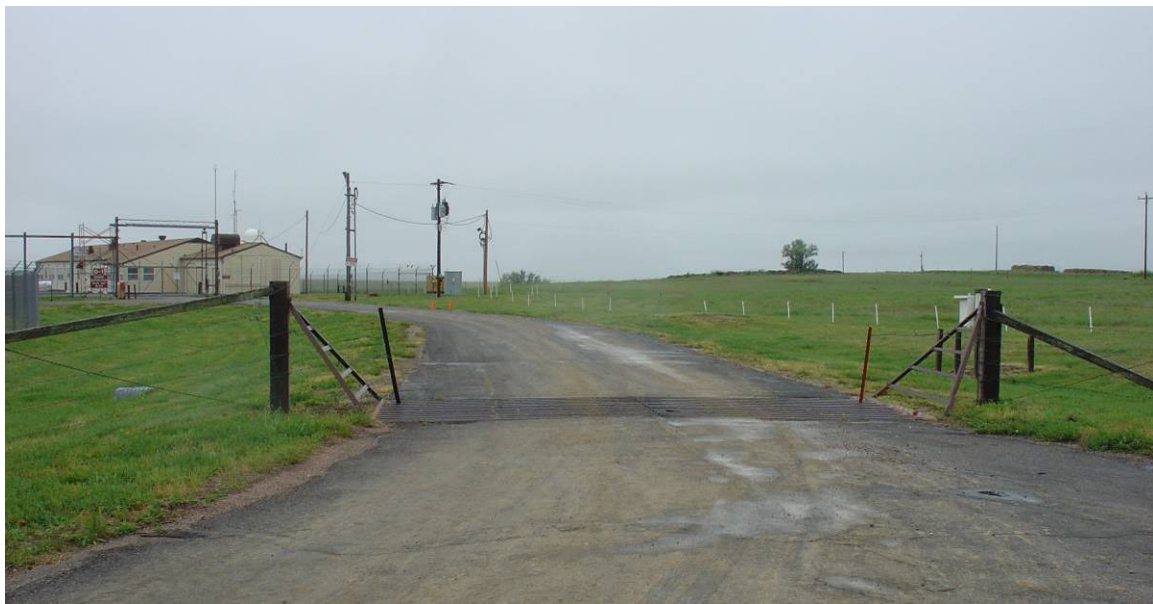
Figure 3- 18: Cattle guard at entrance drive, facing northwest, June 2009 (source: QEA 3472)

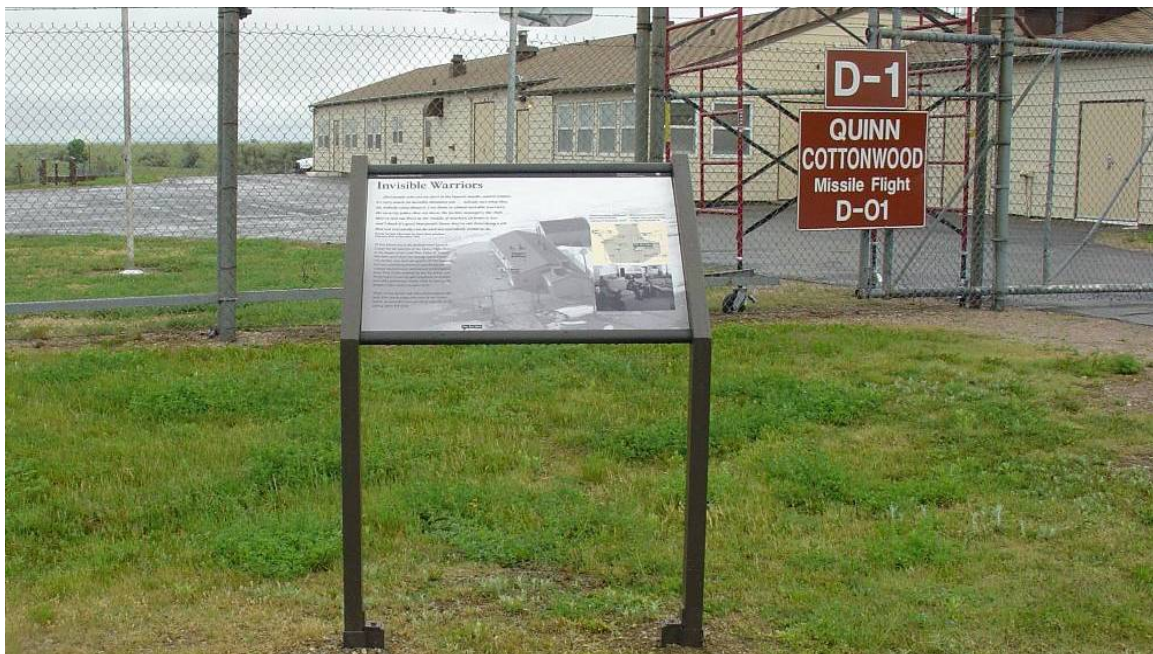
Electric fence	<i>Gray t-posts painted red on top and white plastic posts with a single low voltage electrical wire at about two-feet off the ground. Erected by the National Park Service to prevent livestock from damaging vehicles on the entrance drive. The electric fence is in good condition.</i>	3-19
Historic signage (HS 117, IDLCS 354856)	<i>Brown metal signs with white lettering hung on the security fence, warning signs, and no smoking signs. The signs are in good condition.</i>	3-20

Figure 3- 20: Interpretive wayside and historic signs in background, facing northwest, June 2009 (source: QEA 3253)

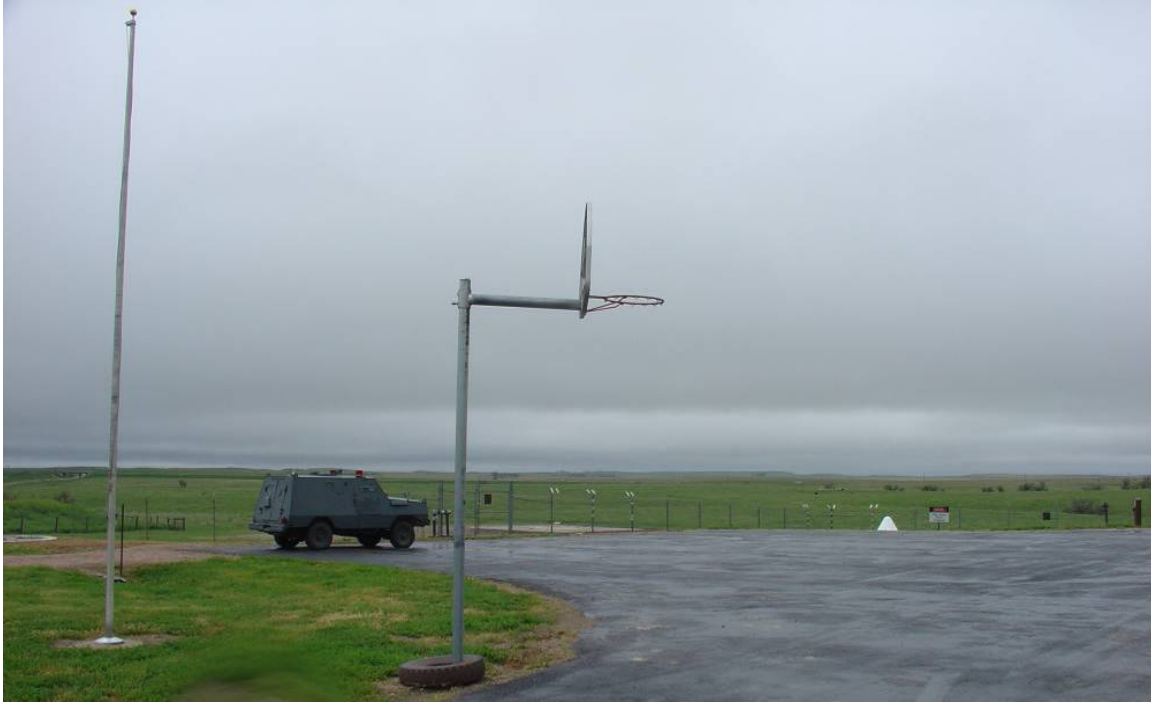
Small Scale Features, cont.	Description/Condition	Figure #
Protective bollards (HS 116, IDLCS 354857)	<i>Wood and concrete bollards painted brown located near the buildings and other features to prevent damage from large vehicles. The bollards are in good condition.</i>	3-21
Access road and parking area (HS 119, IDLCS 390289)	<i>Asphalt drive and parking area. The pavement is in fair condition.</i>	3-22, 3-23
Well and water tanks (HS 118, IDLCS 354851)	<i>Brown metal box approximately four foot square and one foot tall is visible above ground. The portion of the well and water tanks that is visible is in good condition. The condition of the underground features is unknown.(verify)</i>	3-12
Flagpole (HS 120, IDLCS 398270)	<i>Metal pole. The flagpole is in good condition.</i>	3-23
Basketball goal (HS 112, IDLCS 287625)	<i>Metal basketball post with goal. The basketball goal is in good condition.</i>	3-23

Figure 3- 23: Driveway and parking inside security fence, flagpole and basketball goal, facing southwest, June 2009 (source: QEA 3274)

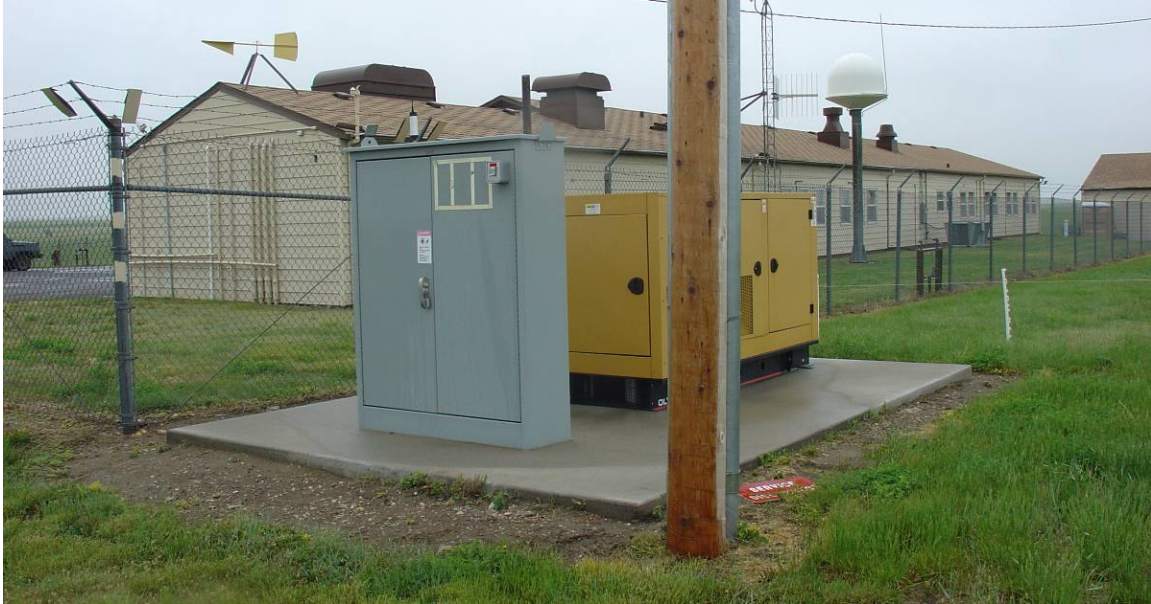
Volleyball court (HS 115, IDLCS 287266)	<i>Sand/dirt court with net supported by metal posts. The volleyball court is in fair condition. There are weeds encroaching into the sand.</i>	3-24
Horseshoe court (HS 114, IDLCS 287261)	<i>Two u-shaped wood pits with stakes aligned with each other. Grass is growing between the dirt pits. The horseshoe pits are in fair condition.</i>	3-25
Code burner (HS 111, IDLCS 287264)	<i>Small concrete square flush at the ground is visible. The code burner is in good condition.</i>	3-26
Interpretive wayside	<i>NPS wayside with historic photographs and text describing the "invisible warriors." Fiberglass panel mounted on aluminum posts. The wayside is in good condition.</i>	3-20
Portable toilet	<i>Tan plastic portable toilet building. The portable toilet is in good condition.</i>	3-16
Concrete pad, transfer switch, and generator	<i>Concrete slab and electrical transfer switch, and generator the generator is yellow. The pad, generator and switch are in good condition.</i>	3-27

Figure 3- 27: Concrete pad, transformer and generator, facing southwest, June 2009
(source: QEA 3458)

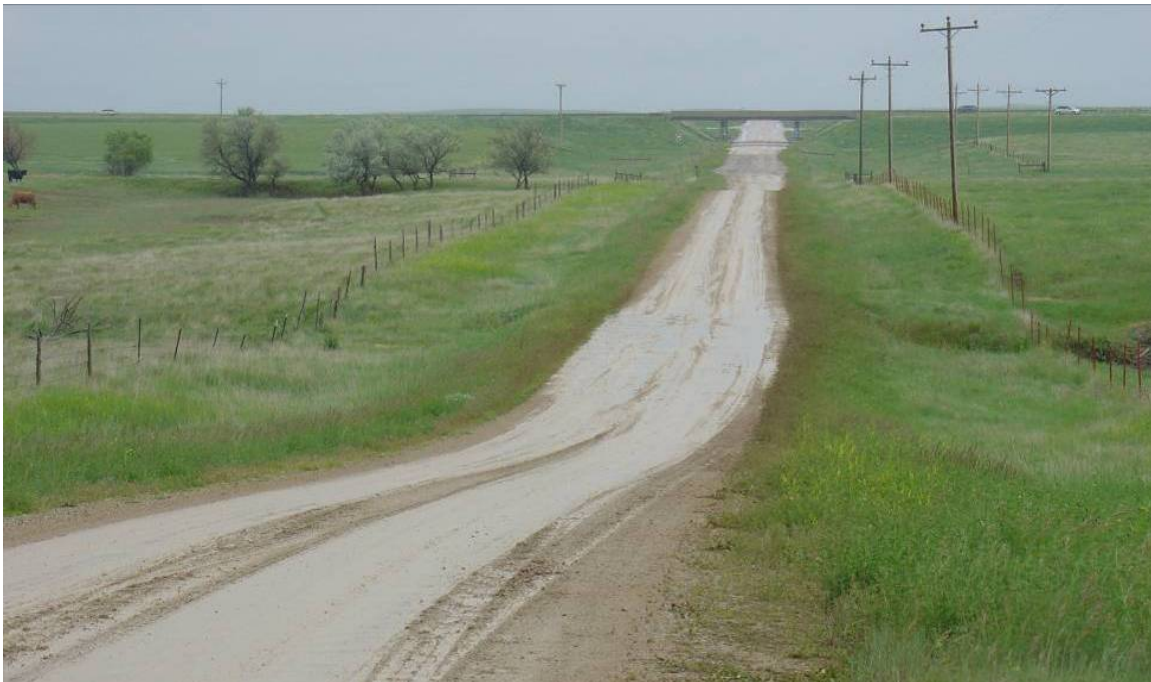
Ranch	<i>A ranch complex is located to the northwest of the property. The complex includes a residence and several outbuildings. The ranch pre-dates the Delta-01 implementation and was present the entire time that the site was operational.</i>	3-9
Jackson County Road C23A	<i>Improved gravel road provides access to Delta-01 site. The road contains many potholes and washouts. It is in poor condition.</i>	3-28

Figure 3- 28: Jackson County Road CS23A, with Interstate Highway 90 overpass in background, facing south, June 2009 (source: QEA 3627)

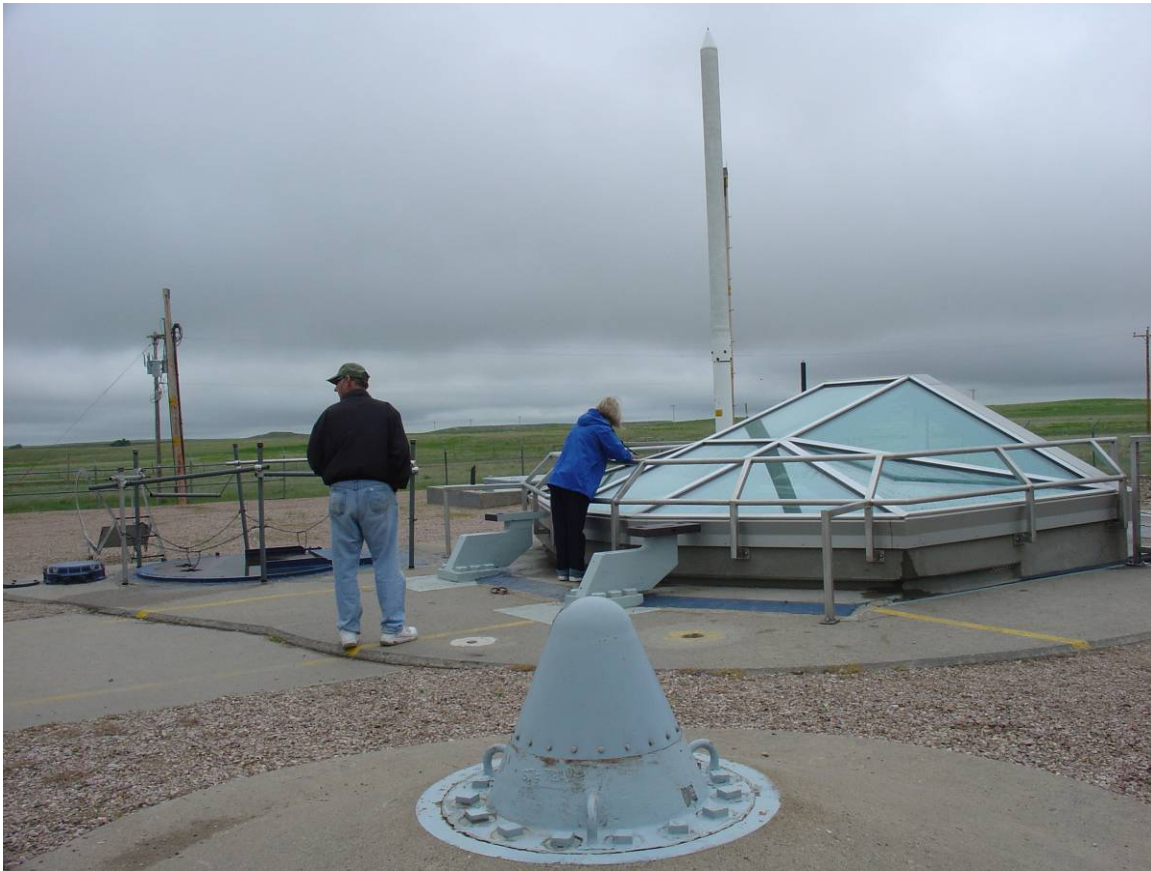
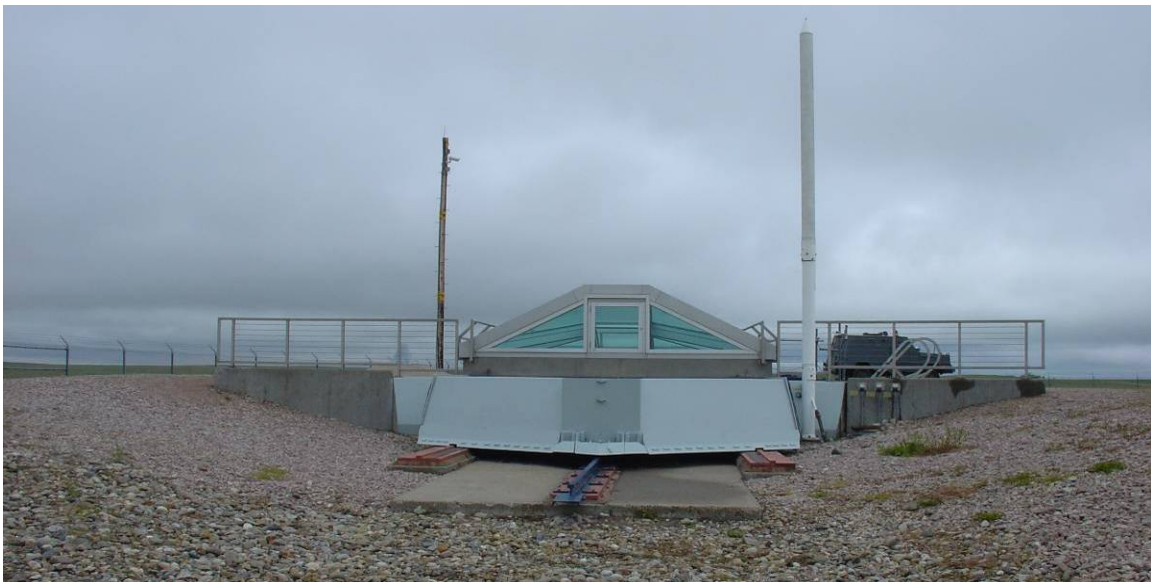
Small Scale Features	Description/Condition	Figure #
Glass viewing enclosure	<i>A glass and aluminum viewing enclosure installed over the opening of the missile launcher in 2001. The enclosure is in good condition.</i>	3-33, 3-34
Improved Minuteman Physical Security System (IMPSS) antenna (HS 903, IDLCS 100489)	<i>White fiberglass monopole that rises from the base of the roof slab on the east side of the closure door opening of the missile launcher. Installed 1989. Microprocessor-based surveillance system designed to detect outer zone intruders. The antenna is in good condition. (verify)</i>	3-34
Hardened UHF antenna (HS 904, IDLCS 100491)	<i>Installed circa 1968 to link the Launch Facility with the SAC's airborne launch control center. It is located a few feet to the northwest of the silo opening and rests atop a thirteen-foot-diameter, reinforced-concrete base, shaped like an inverted saucer. The antenna is housed inside a cast-steel frustum capped with a conical, gray fiberglass weather dome. The antenna is in good condition. (verify)</i>	3-33

Figure 3- 33: Missile Launcher viewing enclosure with the hardened UHF antenna in the foreground, facing southeast, June 2009 (source: QEA 3578)

Figure 3- 34: Missile Launcher, facing north, the IMPSS antenna is the tall structure on the right of the viewing enclosure, the post on the left is a light post, June 2009 (source: QEA 3549)

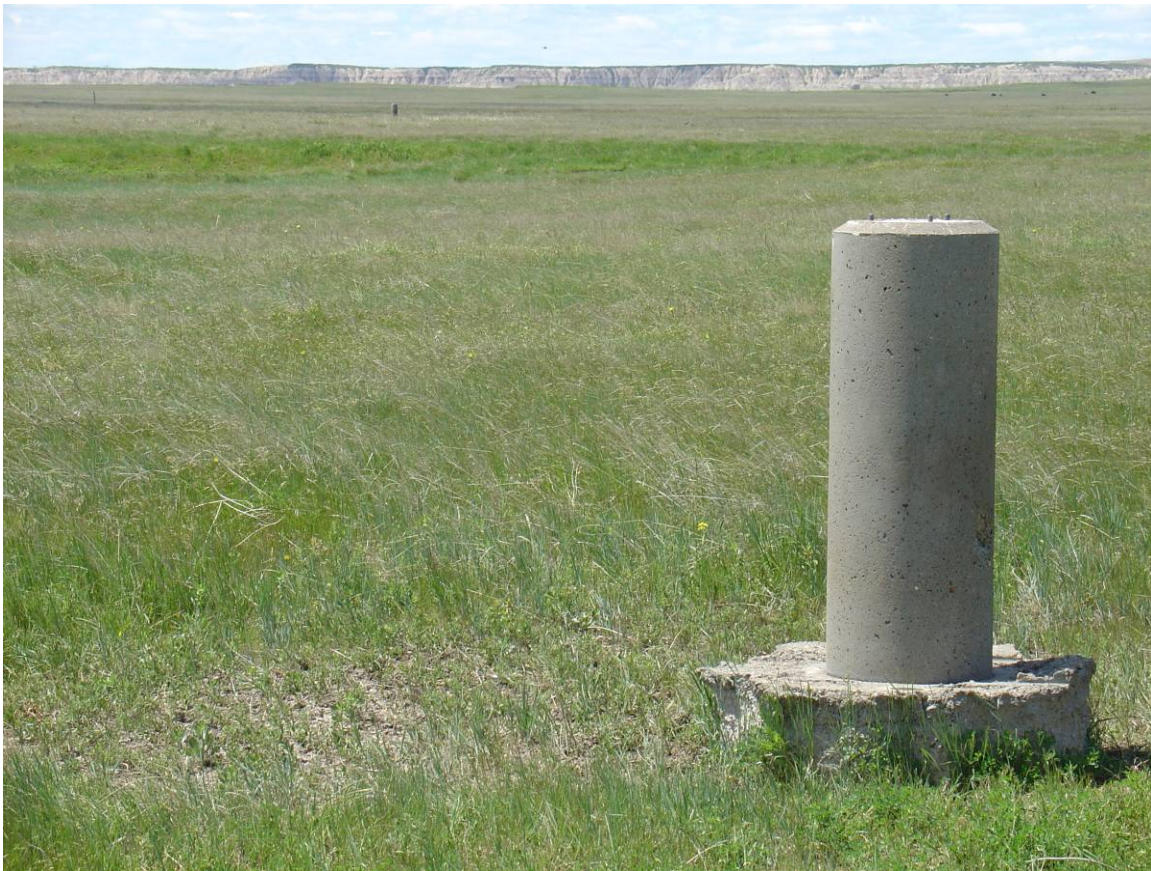
Cathodic protection rectifier (HS 912, IDLCS 390310)	<i>Installed 1982-83. Located on the south side of the access drive, approximately 160 feet east of the security fence. The below ground portion consists of a well approximately 220 feet deep that contains eleven graphite anodes. The system is not operational. It is in poor condition.</i>	3-35
Two azimuth markers (HS 905, IDLCS 100492)	<i>Used in conjunction with the autocollimator to align the Minuteman guidance system. They are located approximately one thousand feet from the launcher—one to the north-northwest and one to the north-northeast. Each marker consists of a cylindrical concrete pylon, three feet in diameter and eight feet deep, set vertically into the ground. The visible (above-ground) portion of each pylon is approximately eighteen inches in diameter and four feet high. A disc-shaped aluminum alloy survey plate is set into the top of each pylon. The azimuth markers are in good condition.</i>	3-36

Figure 3- 36: Azimuth marker at Delta-09 with badlands formations in the background, June 2009 (source: QEA 3144)

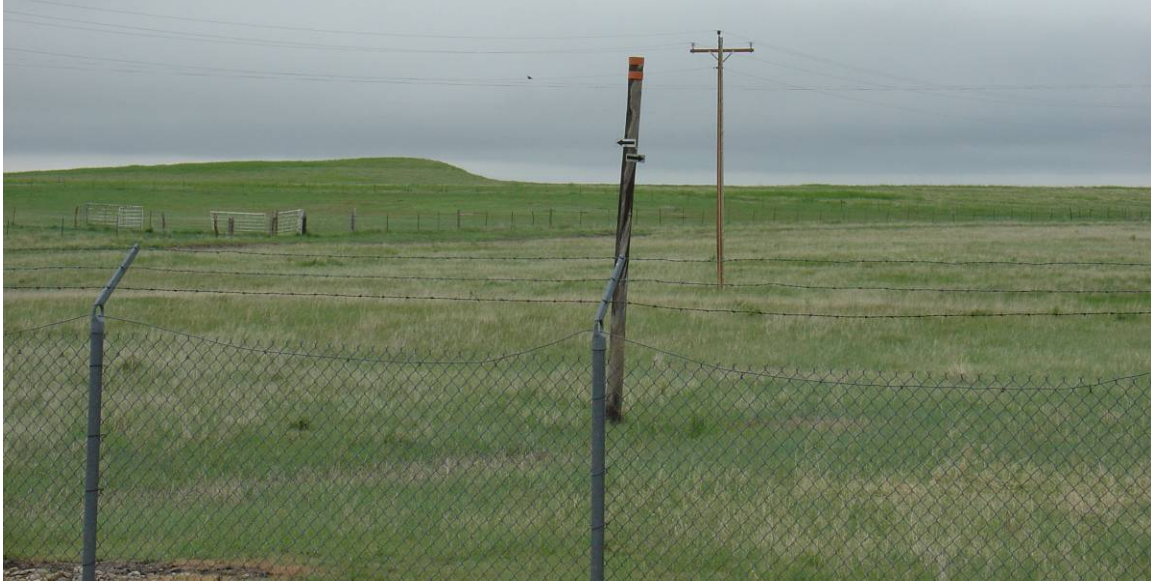
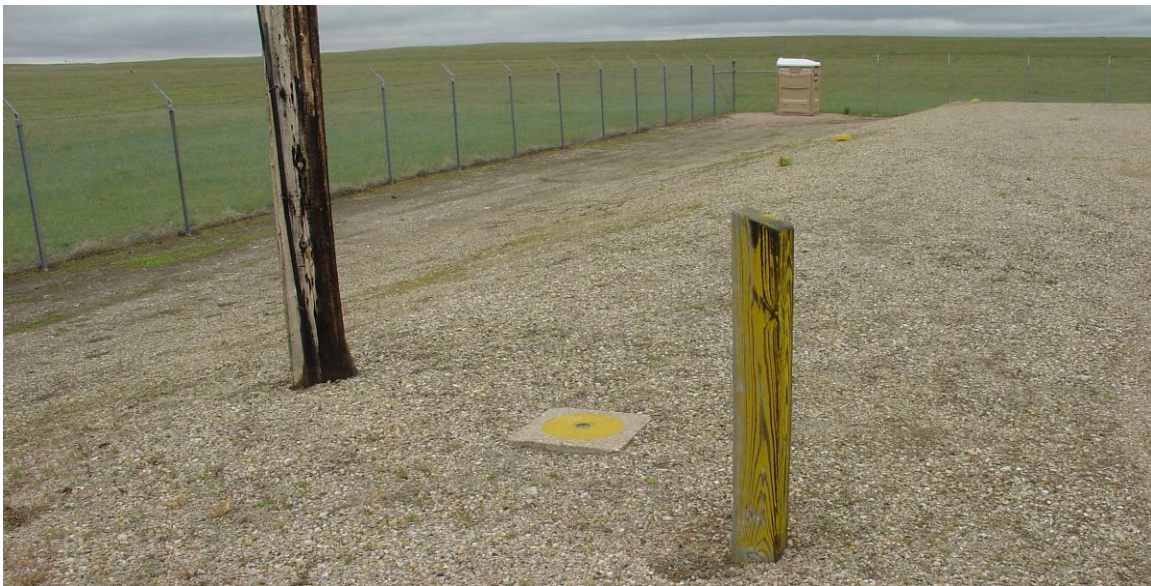
Two HICS marker posts (HS 907, IDLCS 345796)	<i>Located to the south of the security fence. The wooden posts are about twelve feet tall with orange bands around the top and directional arrows to mark the location of the underground HICS. The marker posts weathered and are in fair condition.</i>	3-37
Security fence (HS 906, IDLCS 295903)	<i>Eight-foot high chain link security fence topped with barbed wire. The fence is in good condition.</i>	3-37, 3-38

Figure 3- 37: HICS marker post, with security fence in foreground and utility pole and ranch fence in background, facing south, June 2009 (source: QEA 3572)

Figure 3- 38: Wood bollard and lower portion of light post, with security fence and portable toilet in the background, facing northwest, June 2009 (source: QEA 3582)

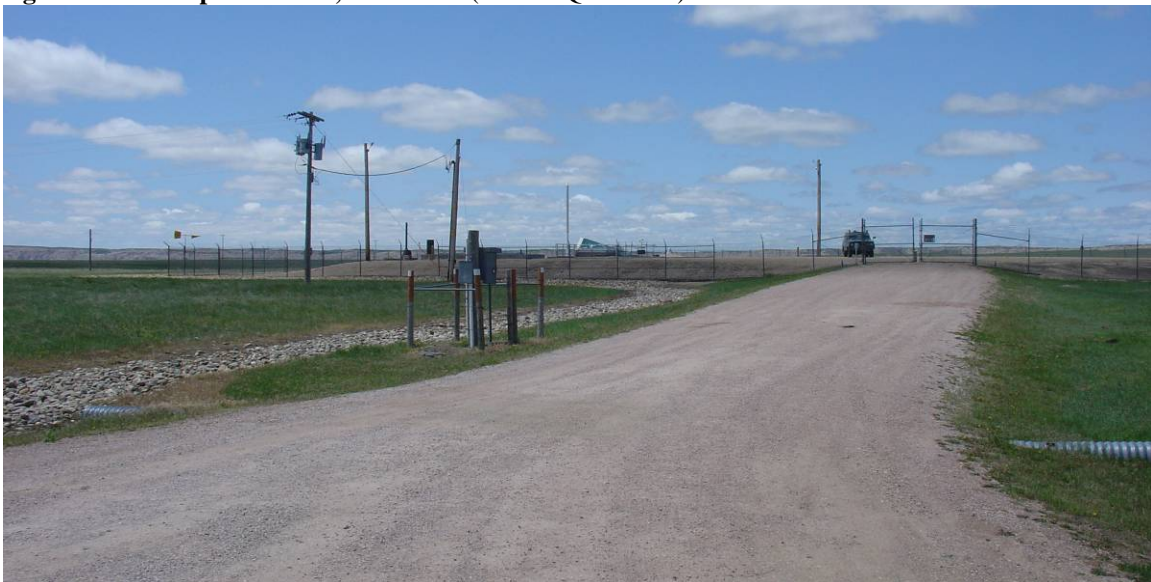
Small Scale Features, cont.	Description/Condition	Figure #
Light posts (HS 908, IDLCS 354853)	<i>Two floodlights atop wooden utility poles provided illumination for nighttime maintenance activities at the site. The light posts are in good condition.</i>	3-38, 3-39
Bollard (HS 909, IDLCS 354859)	<i>Wood post painted yellow, approximately three feet tall. The bollards are in good condition.</i>	3-38, 3-39
Helipad & Markers (HS 910, IDLCS 354855)	<i>Level, square, raised gravel platform on north side of area enclosed by security fence with four small concrete cones painted yellow, one at each corner of the helipad. The helipad is in good condition.</i>	3-39, 3-40
Access Road and Maneuvering Area (HS 911, IDLCS 390310)	<i>Raised gravel road bed and elevated gravel platform designed to provide space for the truck-like transporter-erector vehicles to maneuver. The gravel surface is loose and plants are encroaching in some areas. It is in fair condition.</i>	3-41

Antenna piers (HS 913, IDLCS 400831)	<i>Two remnants of the concrete-based pad from early outer zone security system antennas. One is a square concrete pad with four reflector mount pedestals located southwest of the missile launcher. The other is a clutter monument and footing of the antenna pedestal located to the south of the launch support building. The antenna piers are in good condition, although the antenna is no longer operational.</i>	
Transporter erector pylons (HS 914, IDLCS 412538)	<i>Six steel elements located on the north side of the missile launcher at the four corners of a rectangular concrete pad used by the transporter-erector vehicles. The pylons are in poor condition.</i>	3-42
Launch facility warning signs (HS 915, IDLCS 754362)	<i>Metal signs mounted to the outside of the security fence. The signs are in good condition.</i>	
Culvert	<i>Metal culvert at the intersection of the access drive and County Road T512. The culvert is in good condition.</i>	3-41

Figure 3- 41: **Access drive at Delta-09, facing west, June 2009. Culvert under drive in foreground, cathodic protection device in middle, and gravel ditch to the left of the image.** (source: QEA 3115)

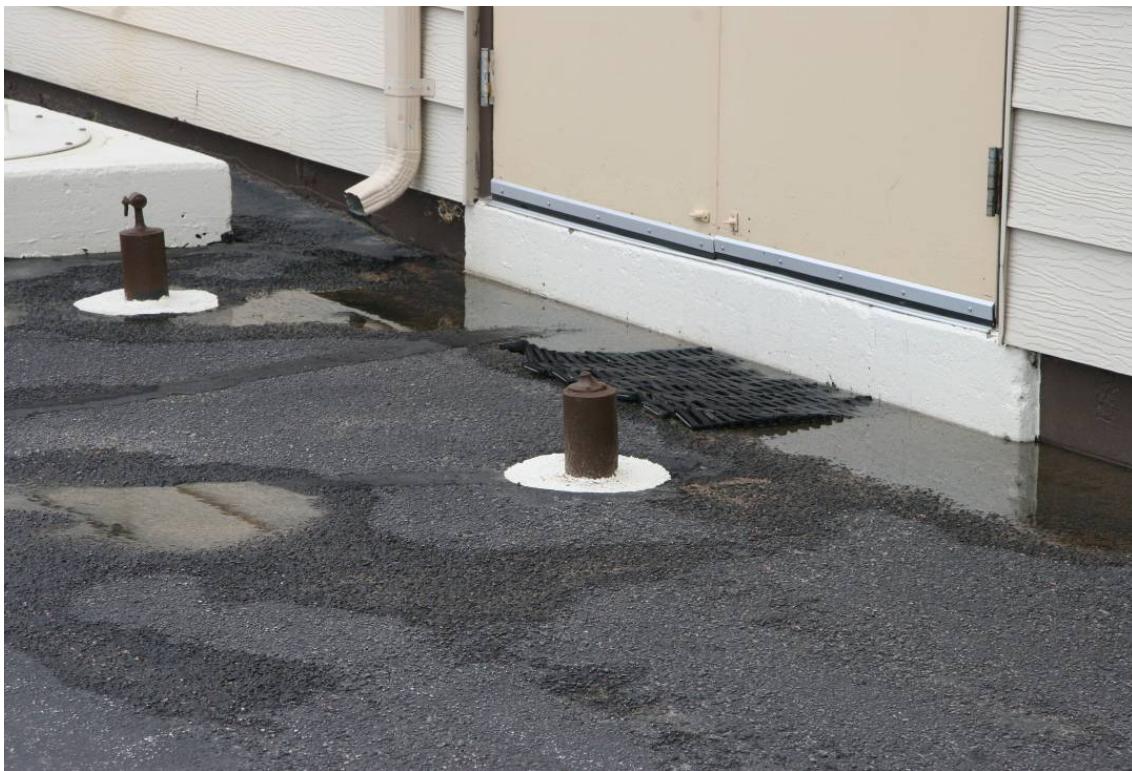
Foundation: The 8 inch thick reinforced concrete foundation wall is in good condition with a couple areas of minor blemishes along the north and south elevations. The grade, especially along the south elevation, slopes towards the foundation wall allowing water to pond against the surface (figure 3-46). The presence of water and ice standing against the concrete foundation can, over time, deteriorate the concrete and negatively affect the structural steel rebar encased in the concrete as well as causing deterioration of the wood wall structure. The face of the wall is painted a dark chocolate brown, except below the door sills where it is painted off-white. The paint is in good condition.

Figure 3- 46: Ponding at south elevation foundation wall (source: QEA 0008)

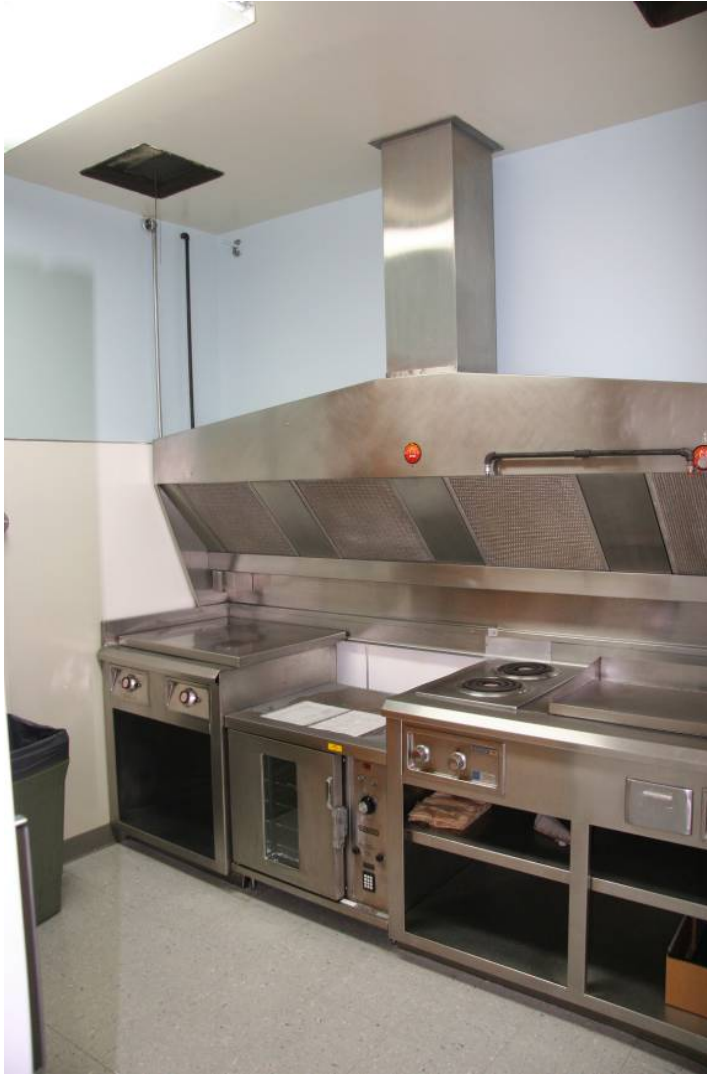
- The exhaust hood, base cabinets, food warmer, and griddle all appear to be original equipment and in good condition (figure 3-57).
- The original range (4 burner) with oven appears to have been replaced with a commercial oven unit, between 1980 and 1983, which is in good condition.
- The original deep fat fryer appears to have been replaced with a two burner cook top unit, between 1980 and 1983, which is in good condition.
- Refrigerator, unknown date, is in good condition.
- Dishwasher: The original dishwasher was relocated on the north wall to the east, circa 1980, and is in good condition (figure 3-54). It is unknown if this unit is still the original.

Figure 3- 57: Kitchen stove, looking southwest (source: QEA 0071)

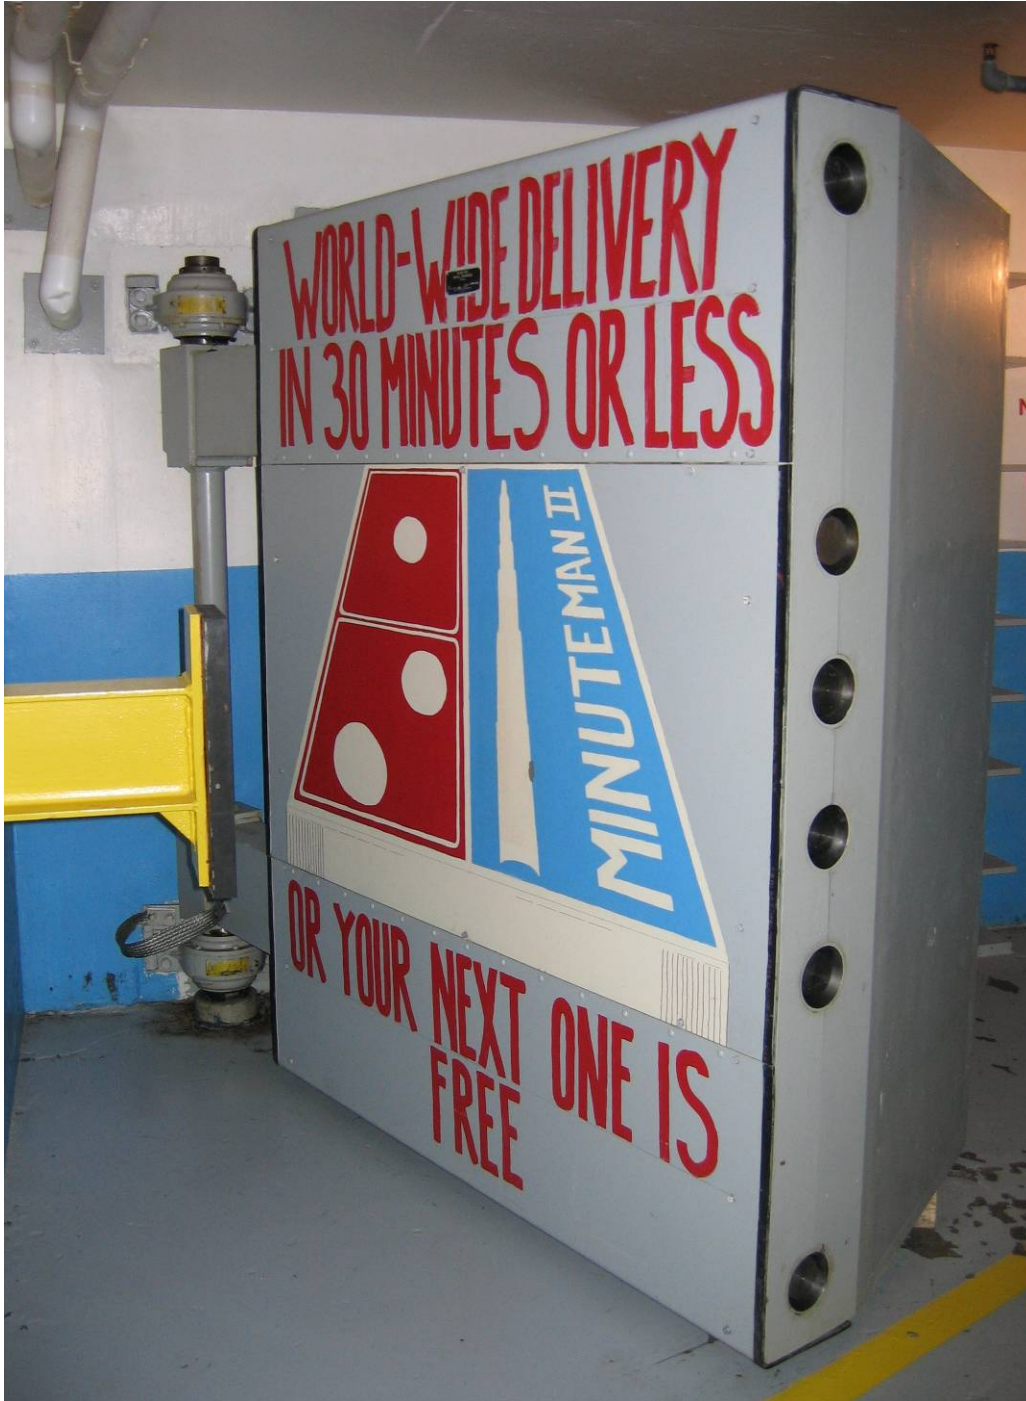
Blast Door and Door Stop: The original 8-ton, blast-proof, steel and concrete door is painted light grey and in good condition (figure 3-62 and 3-63). See Part 1-A Historical Background for discussion on decorative paintings on the face of this door. The steel door stop is bolted to the concrete wall 3'-5" high to the center and painted bright yellow with a rubber or neoprene bumper pad attached to the end. The door stop is in good condition.

Figure 3- 62: LCC Vestibule, blast door (source: QEA 7015)

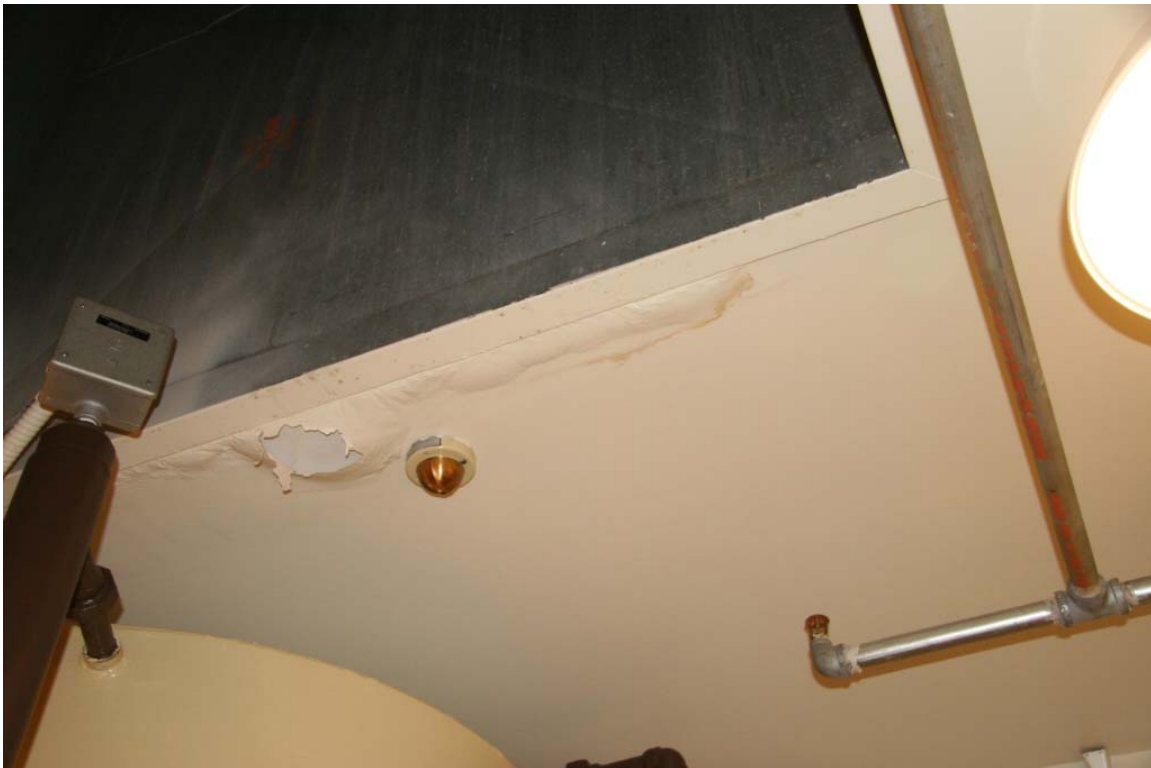
Figure 3- 73: Launch Control Support Building, flaking paint at Generator Room 105 (source: FSE 1056)

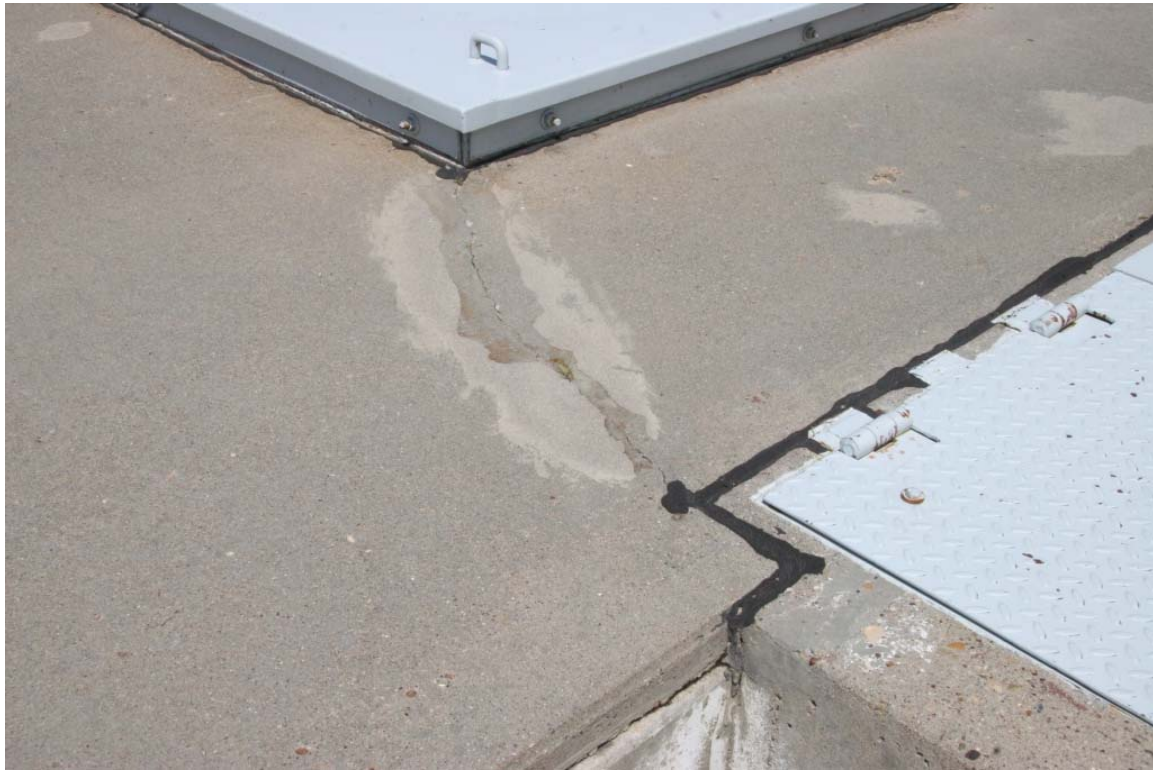
Figure 3- 75: Previously patched cracks at Delta-09 (source: FSE 010)

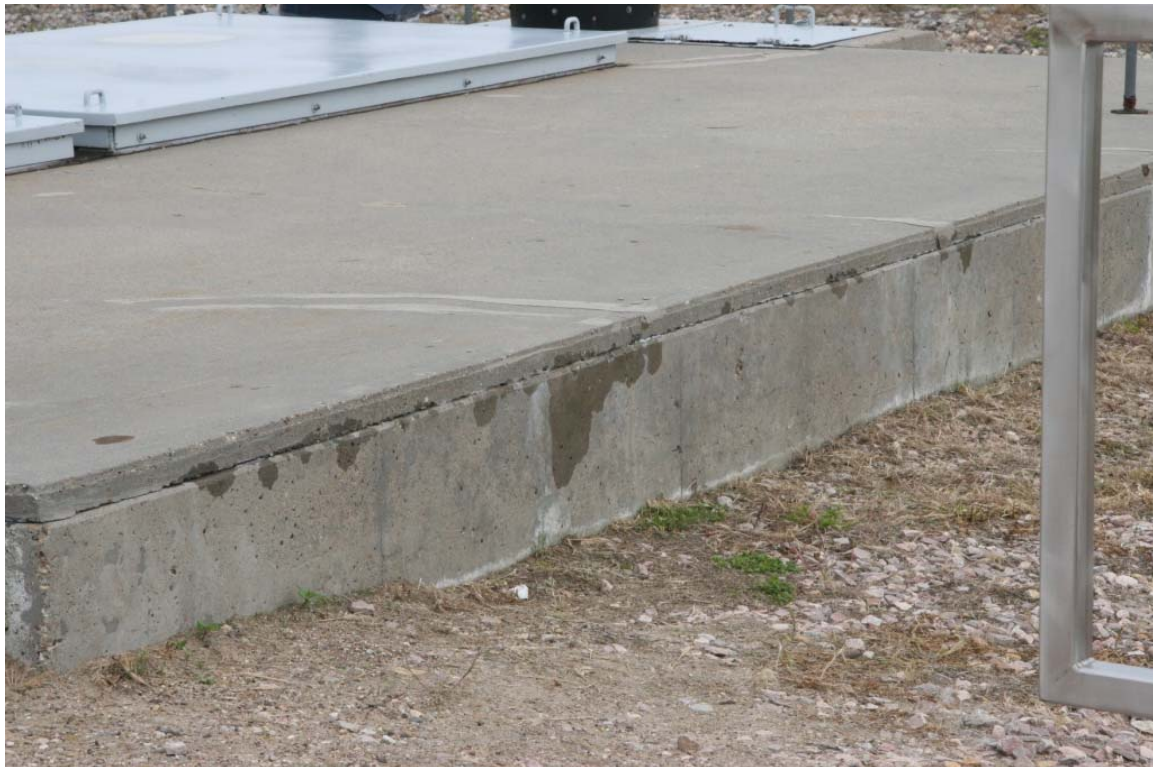
Figure 3- 76: Moisture migrating out from cracks at Delta-09 (source: FSE 051).

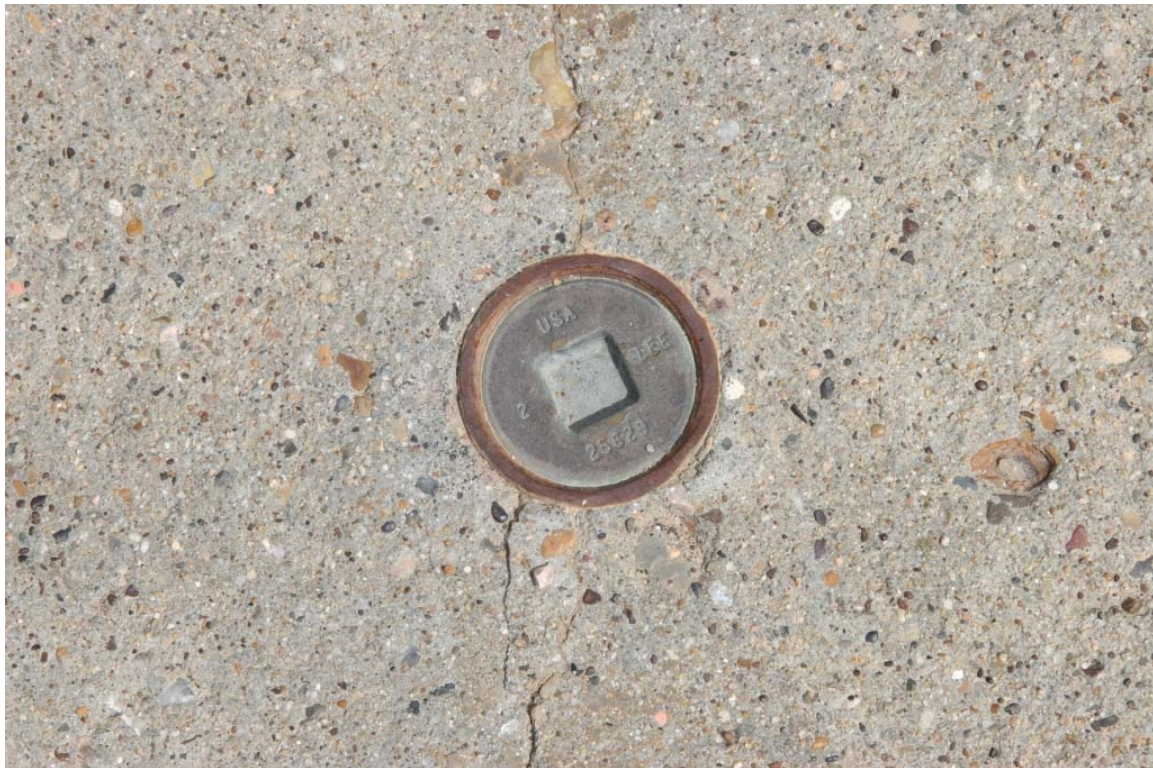
Figure 3- 77: Slab deterioration at north side of silo (source: FSE 038).

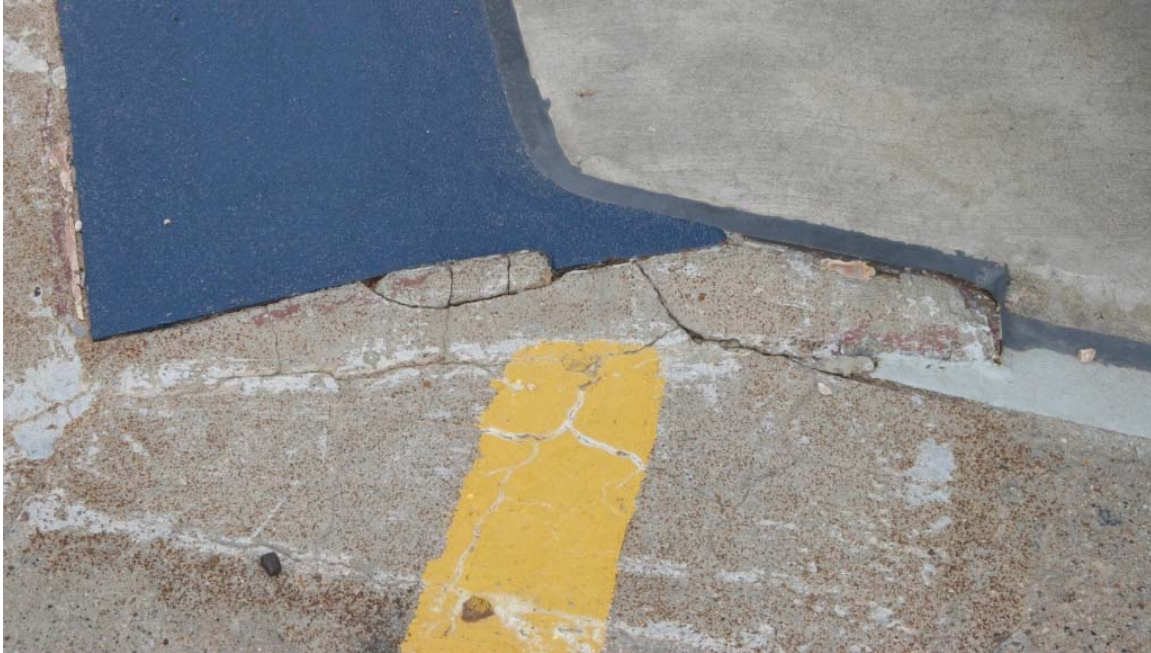
Figure 3- 78: Cracking of grout and concrete near silo metal plates (source: FSE 049)

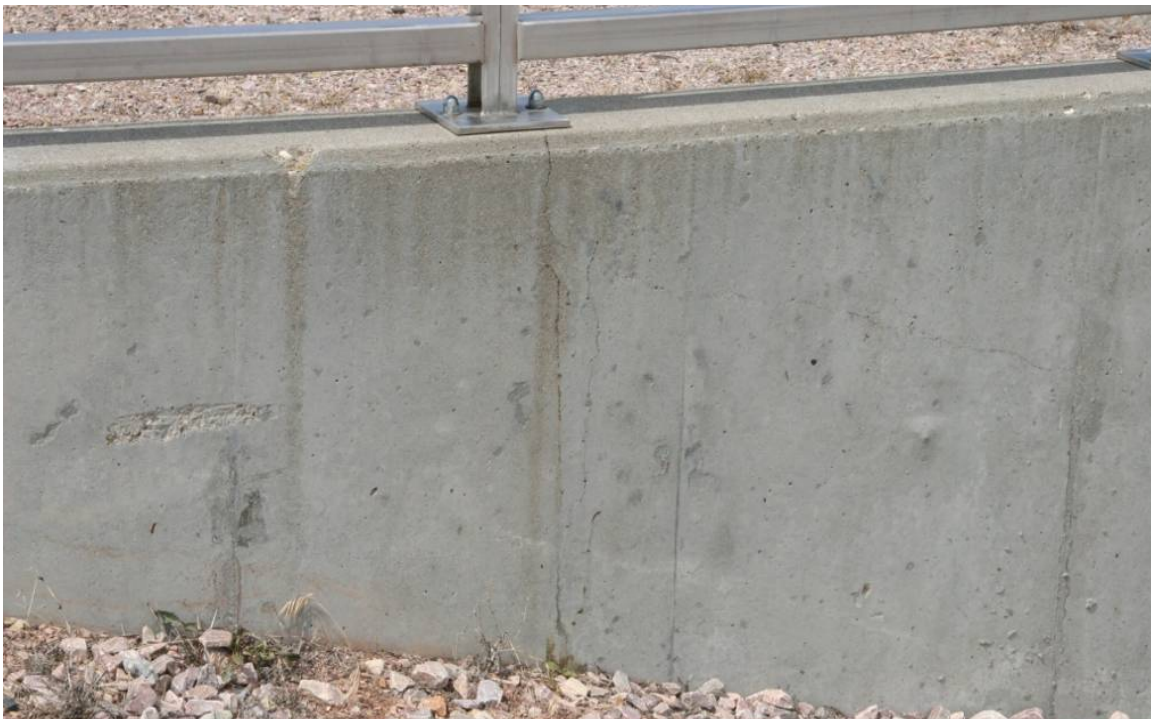
Figure 3- 79: Cracking in head walls at silo (source: FSE 040)
