1 **POWER HOUSE**

2 **Chronology of Alterations and Use**

1 *Power House Photographs, 2009*

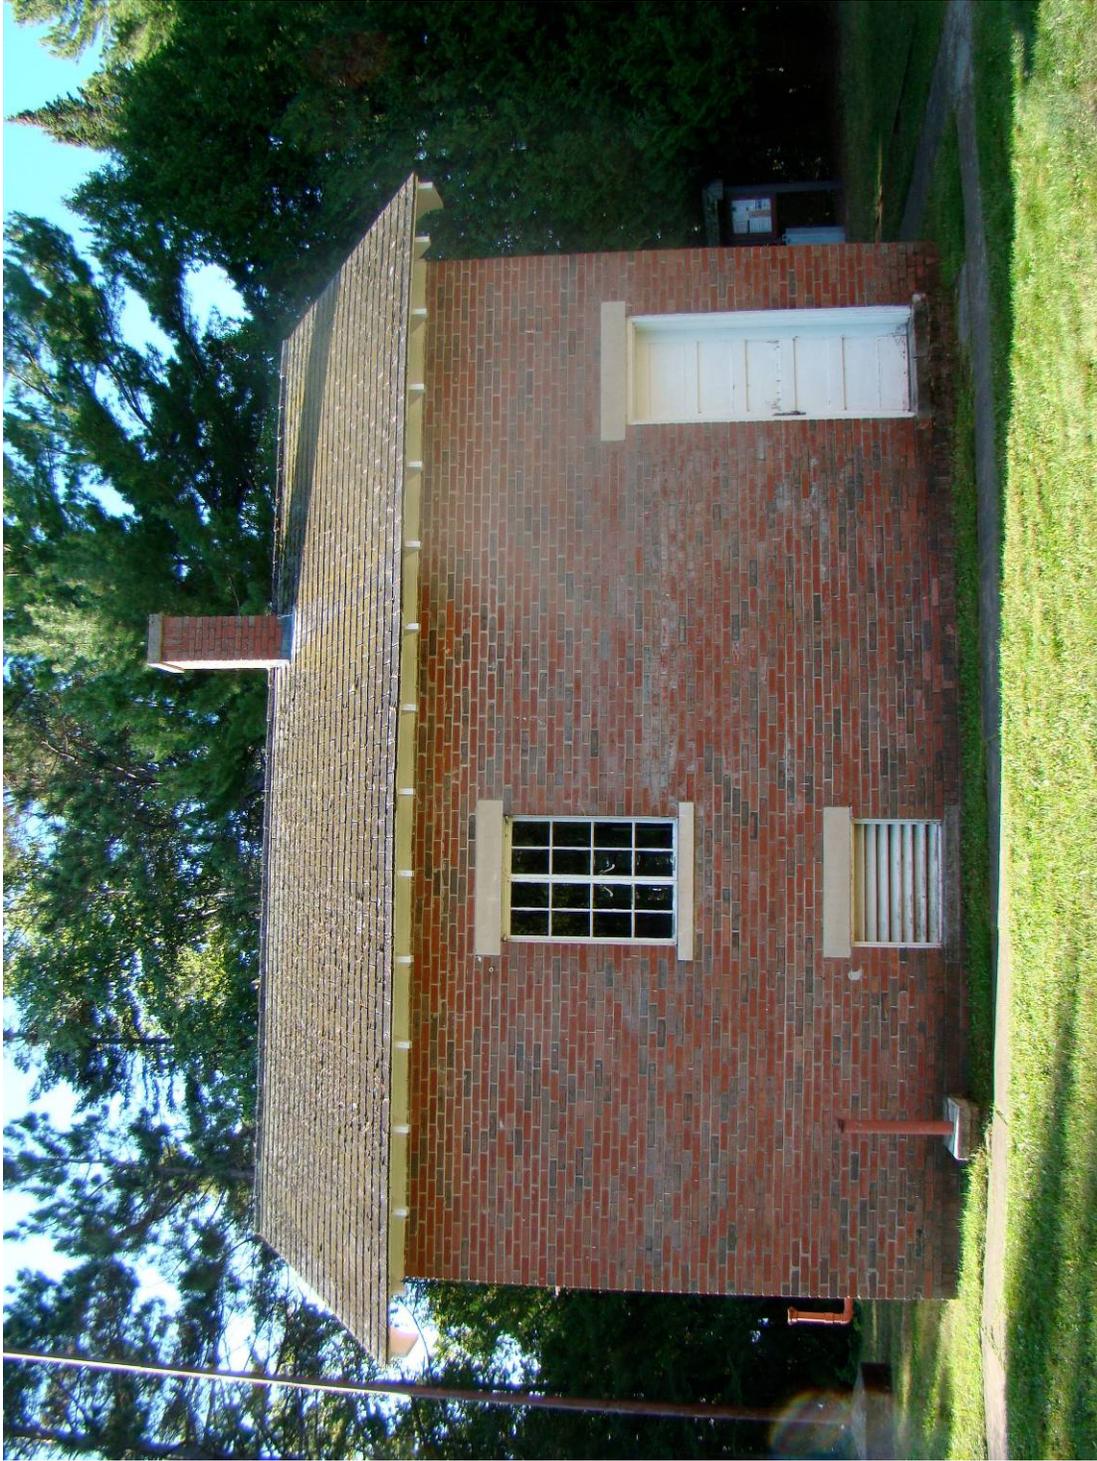
3 The exterior walls are in good condition with the exception of efflorescence at the north wall and damage  
4 due to the roof drainage drip line at the south appurtenance's east and west stem walls (MI-PH-04, MI-PH-  
5 08 and MI-PH-22 to 24).

MI-PH-04: North elevation, 2009 (Source: A&A DSC00646)

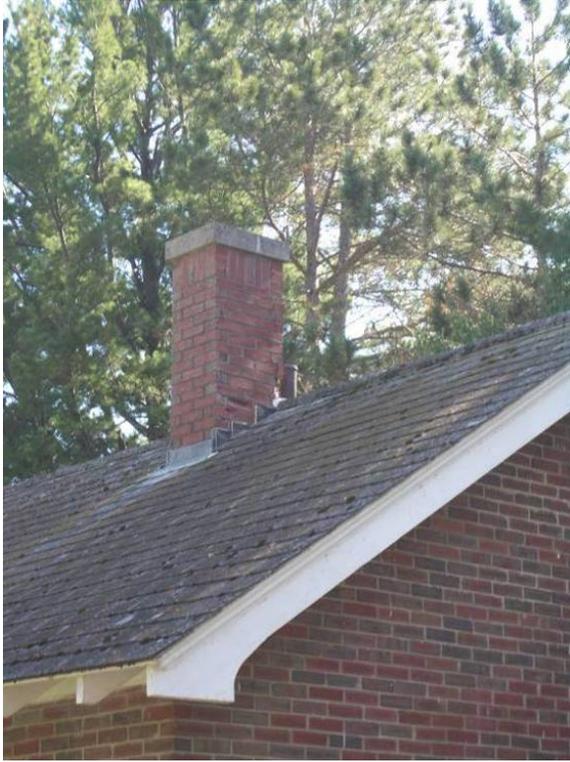
13 The chimney is red brick with a stone cap and a vent flue located due south of the chimney (MI-PH-06).

42 The chimney is in poor condition due to spalling and cracks at the southwest and west faces, likely due to  
43 the proximity of the adjacent pipe/vent.

1  
2 *MI-PH-06: Chimney, trim, and roof (Source: A&A IMG2836)*  
3

41 Repair chimney by replacing brick in-kind where spalling is evident. Repoint with mortar to match  
42 existing. Coordinate chimney repair with roof work to allow proper step flashing. Consider relocating the  
43 roof vent to allow better clearance to chimney to prevent future damage.  
44  
45

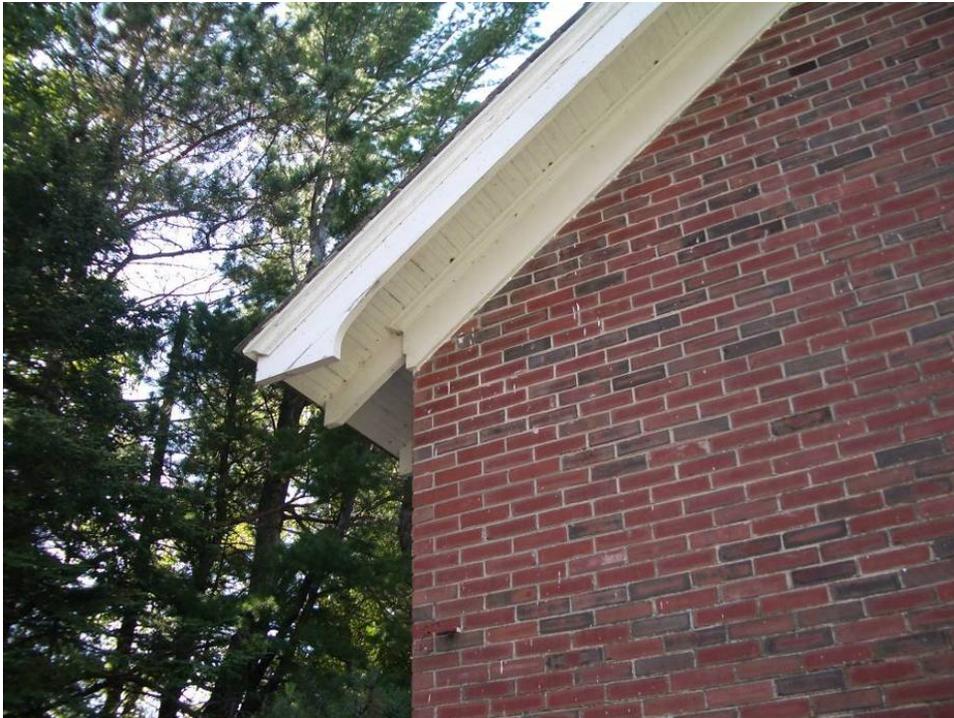
1 sheathing is painted, tongue and groove. The eave, extends 1'6" and consists of exposed rafter tails with a  
2 1x fascia and frieze board with an ogee closure trim, all wood painted white (MI-PH-07).

4  
5 *MI-PH-07: Roof, trim, and eaves (Source: A&A IMG2837)*

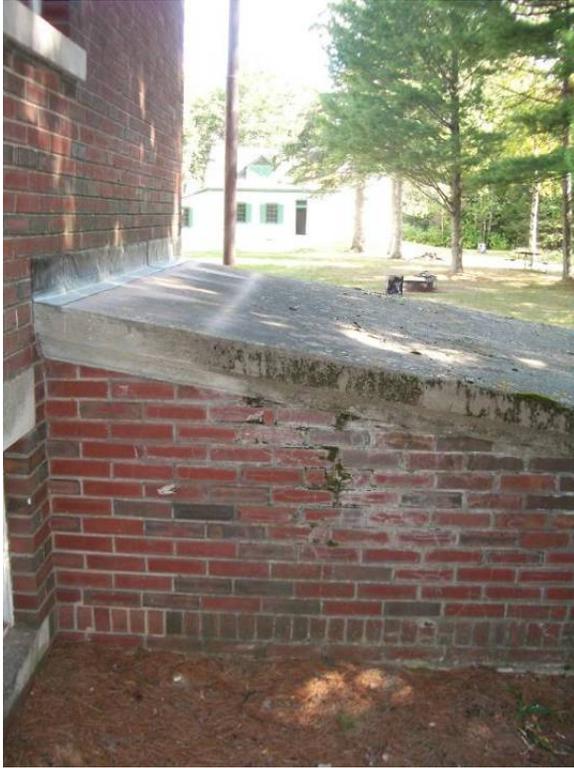
MI-PH-08: Detail of south appurtenance, east elevation (Source: A&A IMG2842)

48 Repair damage due to the roof drainage drip line at the south appurtenance’s east and west stem walls.  
49

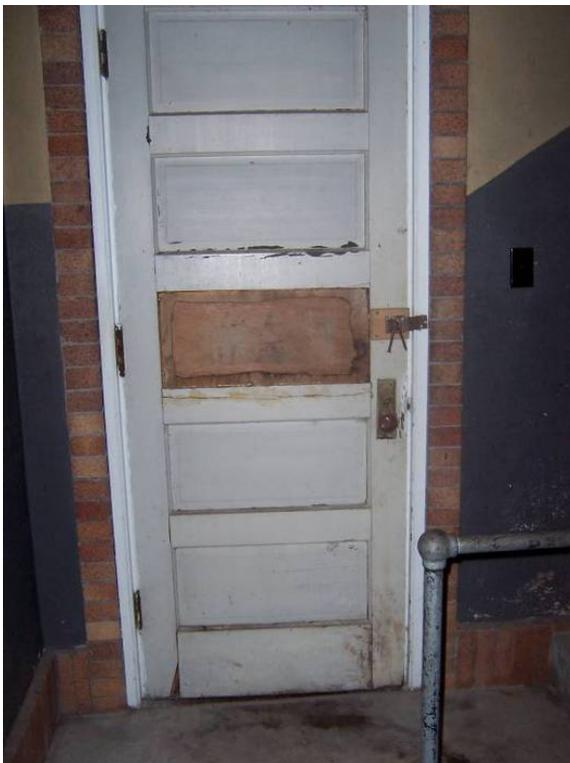
39 The original two exterior doors are five-panel, painted wood doors with raised panels. These doors have  
40 wood frames set into masonry openings with brick trim at the interior. The exterior trim has a stone header,  
41 possibly limestone, and a concrete sill. The doors have metal thresholds, a padlock on the south elevation  
42 door, and three ball-tipped hinges per door. The doors are 2'8" × 7'0" × 1¾" (MI-PH-13).

19 The doors are in good condition, but there is one panel missing at the north elevation exterior door and the  
20 hardware is loose.

*MI-PH-13: North entry, interior (Source: A&A 102\_9579)*

Replace in-kind the one panel missing at the north elevation exterior door and repair existing hardware as required to allow smooth operation.

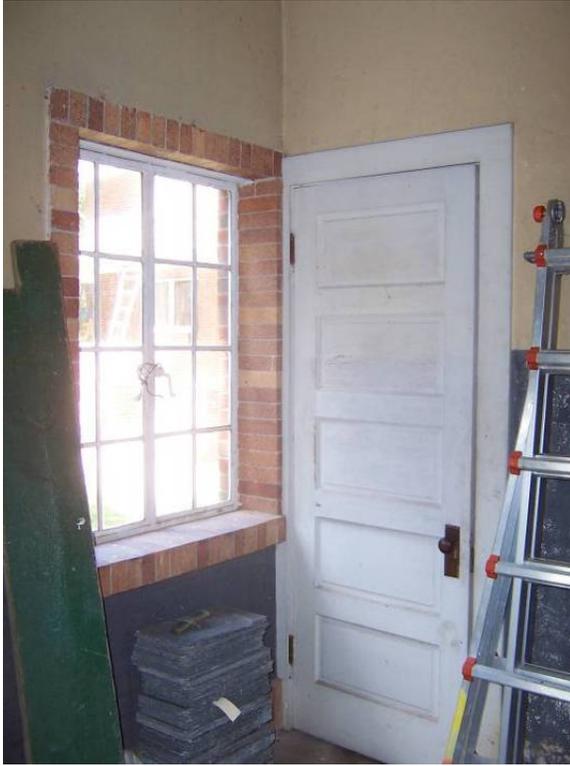
26 **Typical Windows.** These windows are steel casements with eight lites and are paired. The windows are  
27 painted white and trimmed with beige brick on the interior. Each window has a limestone header and sill.  
28 The sills have drip edges. The typical dimensions for these windows are 3'2" × 4'3". These windows are  
29 original (MI-PH-14 and 21).

1  
2 *MI-PH-14: Hoist room, looking north (Source: A&A 100\_9684)*  
3

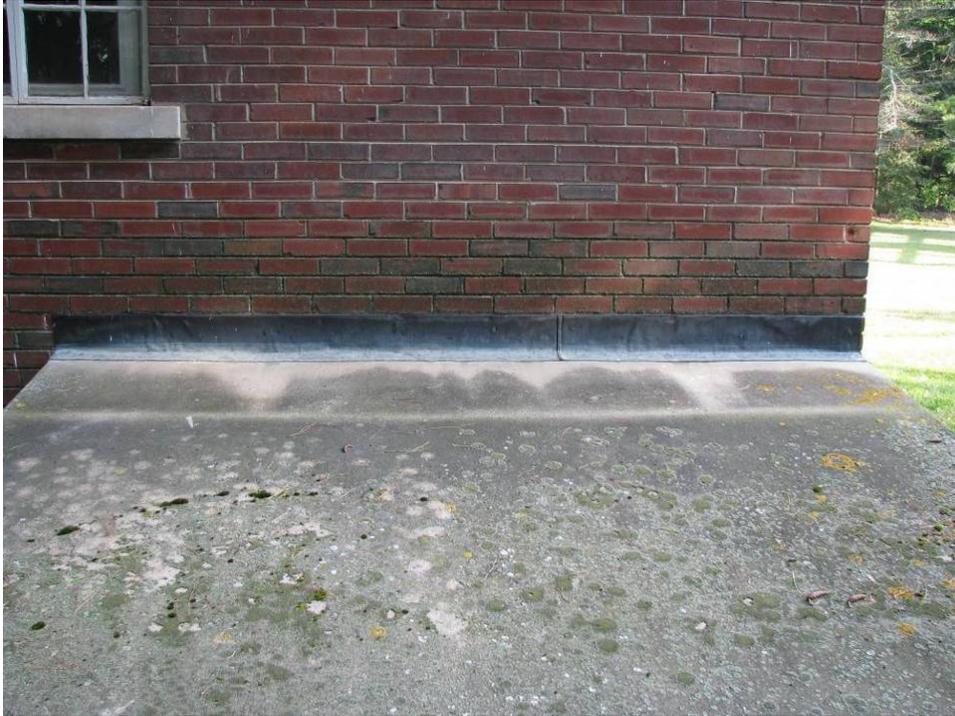
31 The wood roof framing is in good condition. The concrete roof over the brick extension of the basement is  
32 in fair condition. The lower corners of the roof and the top surface are deteriorating due to freeze/thaw  
33 damage and the growth of moss and lichens (MI-PH-22 and 23).

*MI-PH-22: Roof damage (Source: Martin/Martin)*

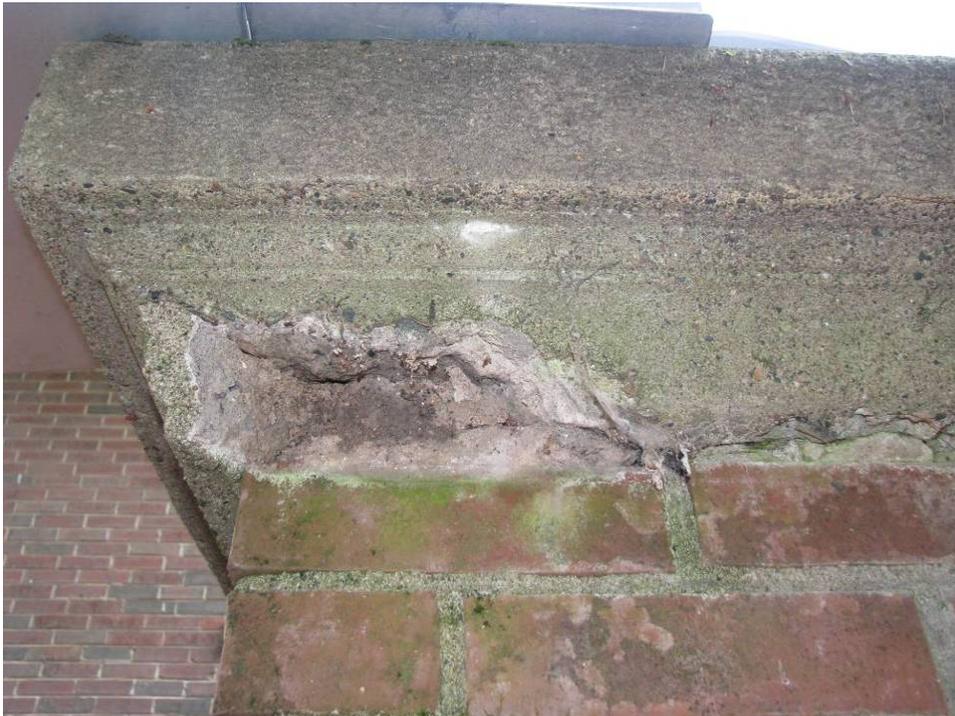
*MI-PH-23: Roof damage (Source: Martin/Martin)*

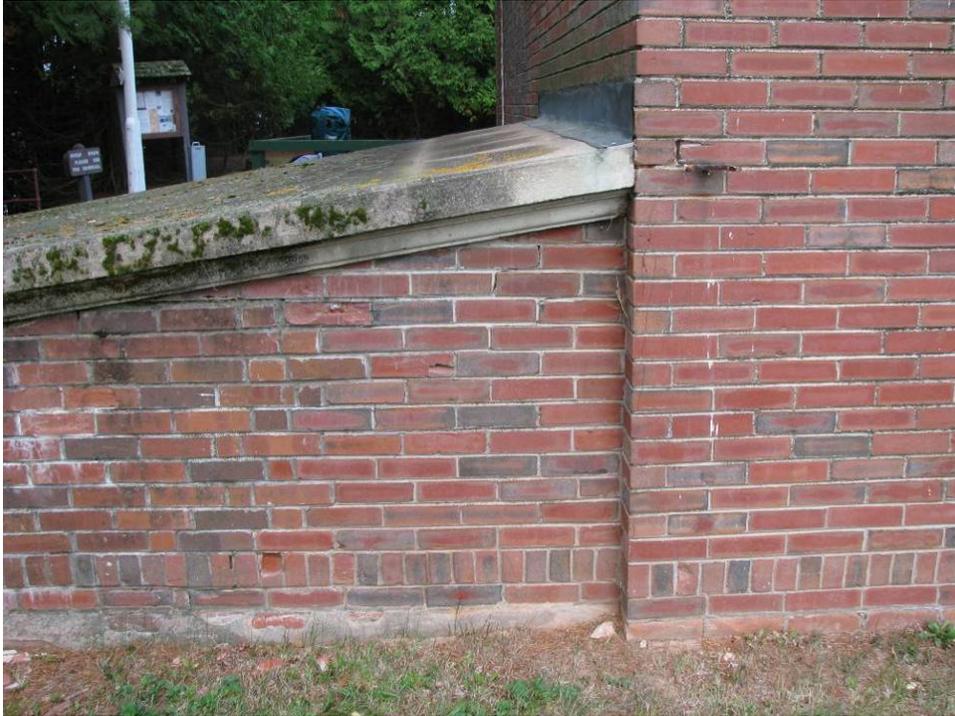
43 The interior walls are in good condition. The exterior walls are in good condition with the exception of the  
44 walls supporting the concrete roof. These walls are deteriorating due to freeze/thaw damage and the growth  
45 of moss and lichens (MI-PH-24).

MI-PH-24: Masonry wall deterioration (Source: Martin/Martin)

26 The damaged walls under the concrete roof slab should be repaired or reconstructed and protected from  
27 future deterioration.

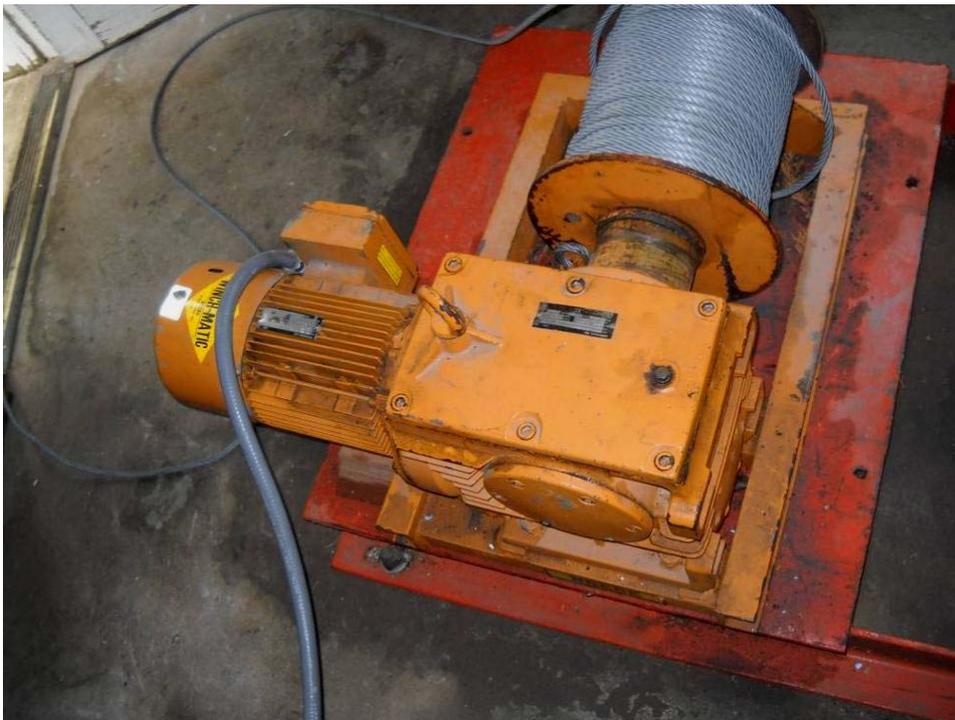
27 The tram hoist, although in good condition, is not supported by its manufacturer (MI-PH-25). Parts and  
28 service are very difficult to obtain. PV system equipment is relatively new and is in good condition.

MI-PH-25: Tram hoist winch (Source: RMH)

7 The existing tram hoist is beyond its useful life and replacement parts are no longer available. Recommend  
8 replacing with a self-contained diesel powered winch.
