MARCH 22, 2010

BENITO PABLO JUAREZ MONUMENT CONDITION ASSESSMENT  
OHRLEIN & ASSOCIATES ARCHITECTS

INVESTIGATIVE CONDITION ASSESSMENT AND REPORT FOR BENITO PABLO JUAREZ MONUMENT AND PLAZA		
SHEET # OF #	SUB-SHEET	SHEET TITLE
1 OF 8	CS-1	COVER
2 OF 8	C1.0	EXISTING CONDITIONS - PROJECT SITE
3 OF 8	C2.0	EXISTING CONDITIONS - PLAZA & PEDESTAL
4 OF 8	A1.1	PLAZA PLAN
5 OF 8	A2.1	NORTH & WEST ELEVATIONS
6 OF 8	A2.2	SOUTH & EAST ELEVATIONS
7 OF 8	A2.3	SECTIONS
8 OF 8	A4.1	DETAILS

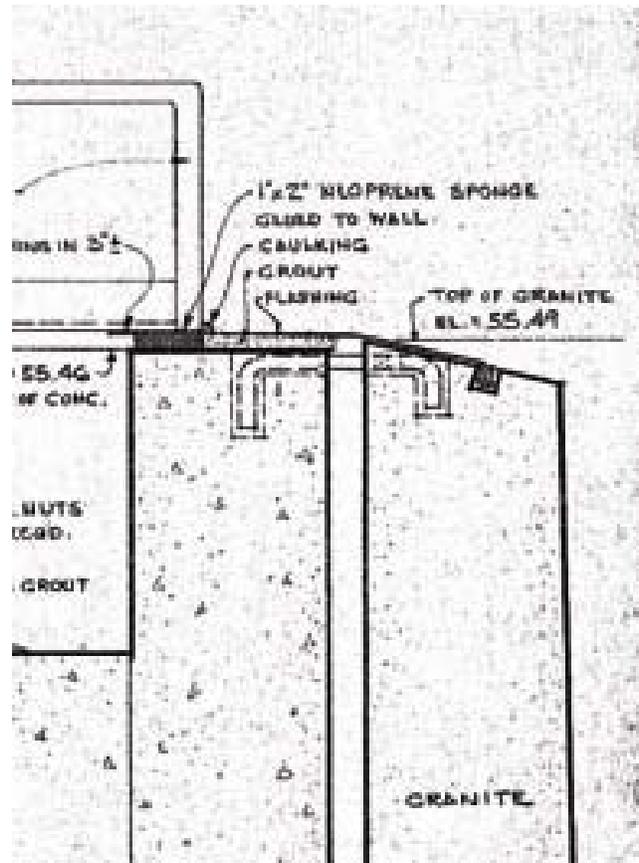
The lead-coated copper flashing consists of four pieces and appears to extend beneath the bronze base of the statue as is indicated in the original as-built drawings. The as-built drawings depict the flashing extending 3 inches under the base of the statue, but that could not be verified. The pieces of lead coated copper overlap at the corners and are in fair condition. The original drawings call for the flashing to fully engage the reglet, return on itself and be held in place with some manner of wedge. This is a common method of installation, however, removal of a portion of the deteriorated sealant at the reglet showed that the flashing extends only approximately ¼” into the stone reglet with no return or wedges. The minimal degree to which this flashing edge engages the reglet compromises the level of protection from moisture infiltration that was originally intended. The burden for moisture protection falls entirely on the sealant thereby leaving this seam especially vulnerable when the sealant fails. The oxidation and corrosion products present at the concealed surfaces of the flashing indicate that moisture has penetrated the sealant joints for an extended period of time.

*Detail of the original as-built drawing showing the flashing condition at the top of the granite pedestal dado. Detail also shows the metal clamp used to anchor the granite to the concrete. See Appendix A for full set of as-built drawings.*

W1.1 - Replace existing lead-coated copper flashing with new lead-coated copper flashing. Extend the flashing to fully engage the stone reglet and install a lead wedges to secure the flashing in place. Install elastomeric sealant at the reglet, statue base and flashing overlaps. Install a lead joint cover over the sealant at the stone reglet. This approach essentially replaces the flashing that is currently in place, but corrects the termination detail at the reglet by extending the flashing fully into the reglet. Installation of the lead joint cover at the perimeter sealant will extend the life of the sealant by protecting it from exposure and UV degradation. If the flashing is properly installed and the sealant is maintained, the flashing itself should last decades.

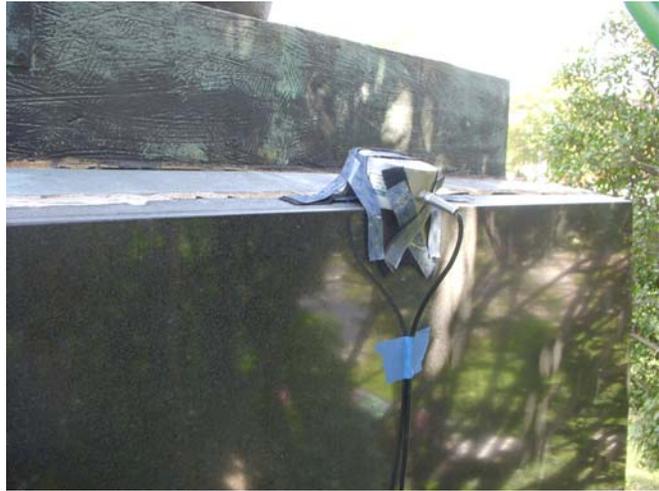
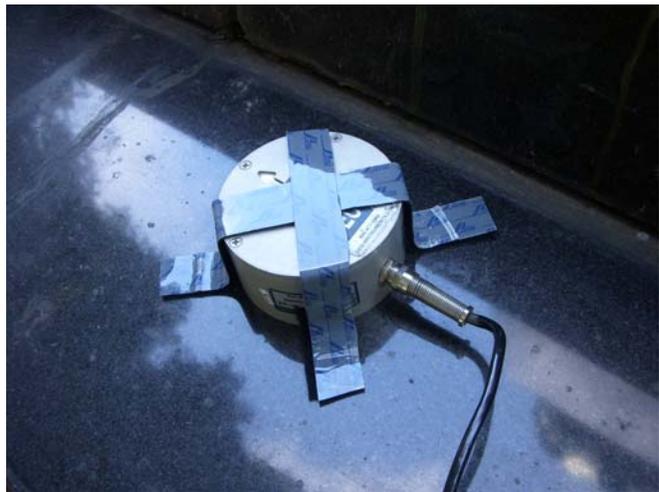
The recorded data indicated that there is not a level of vibration occurring at the monument significant enough to cause movement of the stone. The vibration events that were recorded over the course of the month were characterized as short-duration and long-duration events with periods of vibration ranging from one minute to two days. Both types of vibration event occurred only during rainy periods and were likely weather-related. Regardless of the cause, the recorded vibration events were well within an acceptable range and posed no threat to the integrity of the monument. None of the recorded vibration events could be associated with tunnel traffic; they did not relate to periods of high traffic or occur on a regular basis as one would expect from daily traffic patterns. The entirety of the data was graphed and compiled in a report on the findings which is attached to this assessment in Appendix D.

*The pair of vibration sensors installed at the monument's pedestal base. Sensors were linked to an on-site recording device.*

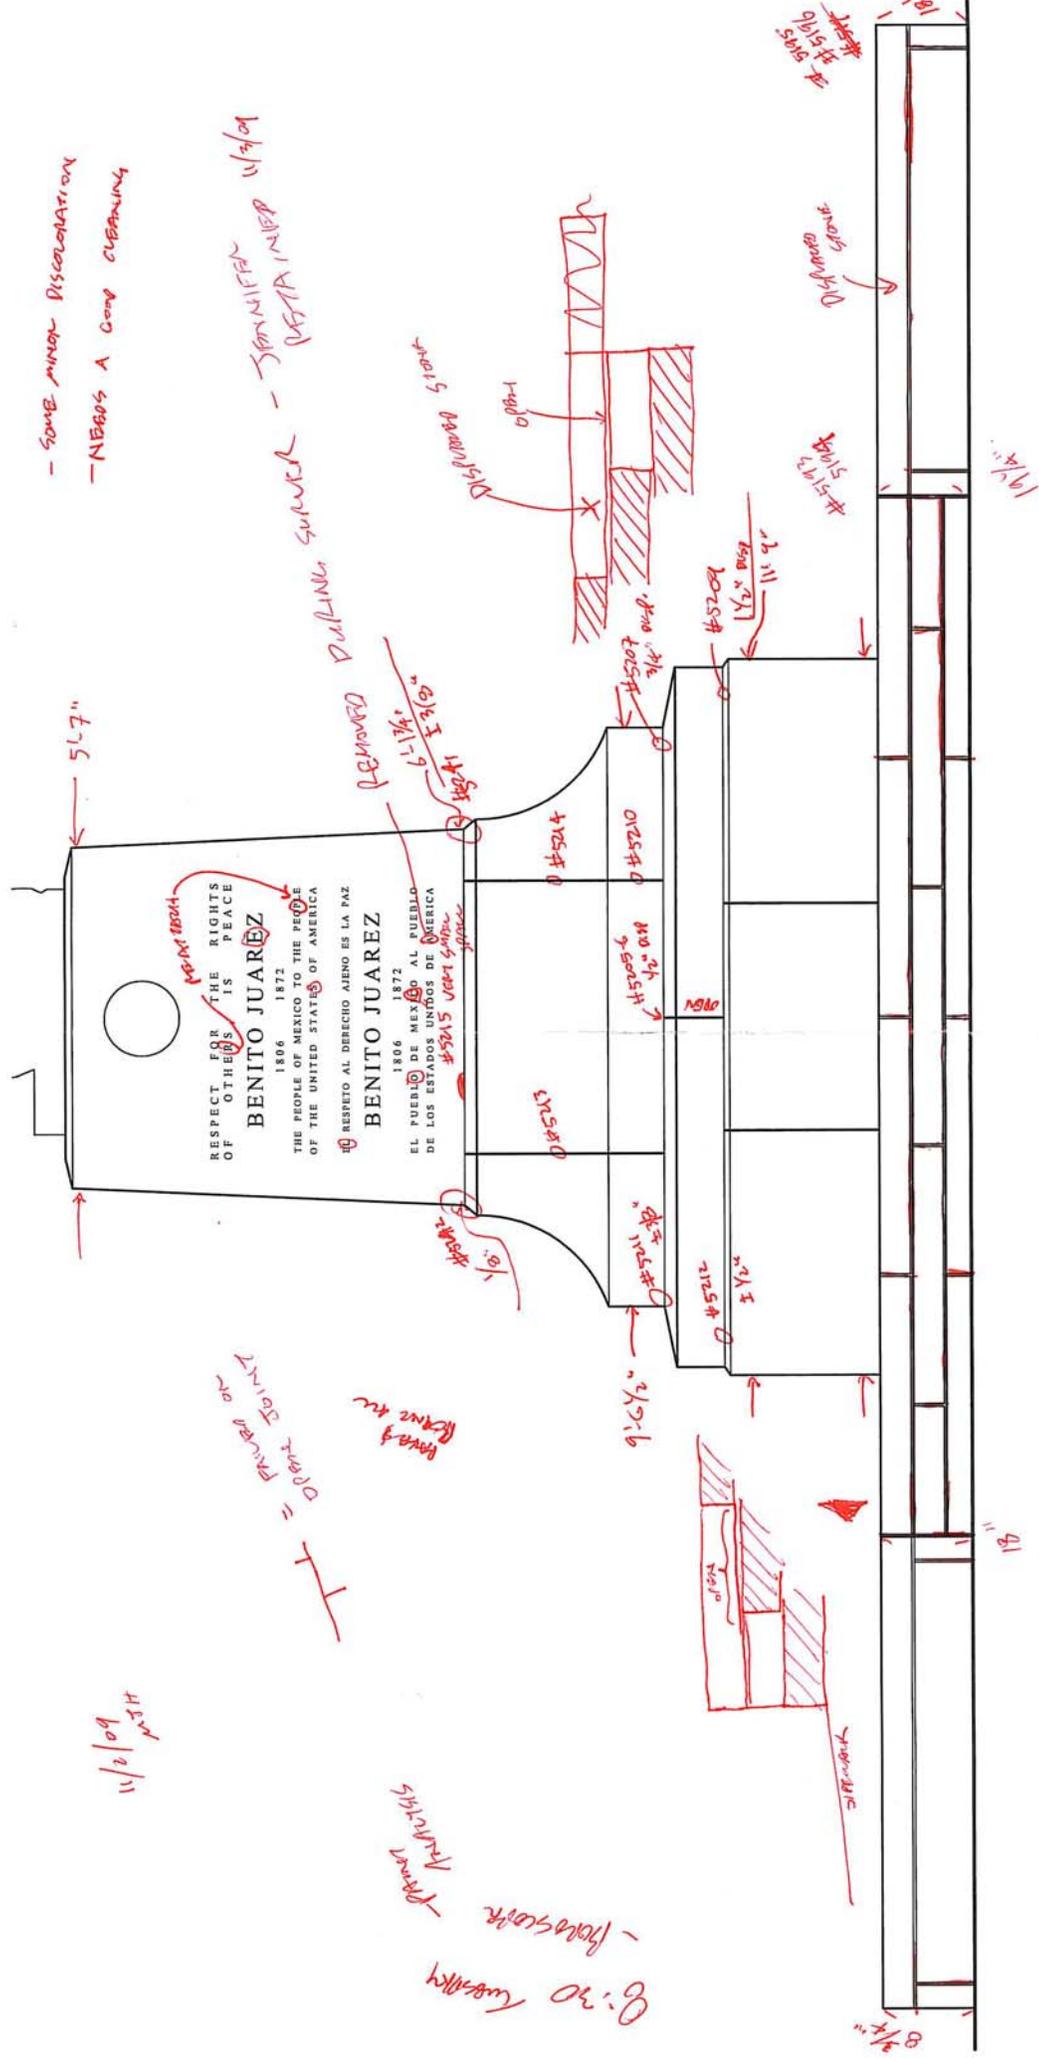
- SOME MINOR DISCOLORATION  
- NEEDS A GOOD CLEANING

11/2/11  
DULLING SURFACE - SPANNING  
REPAIR

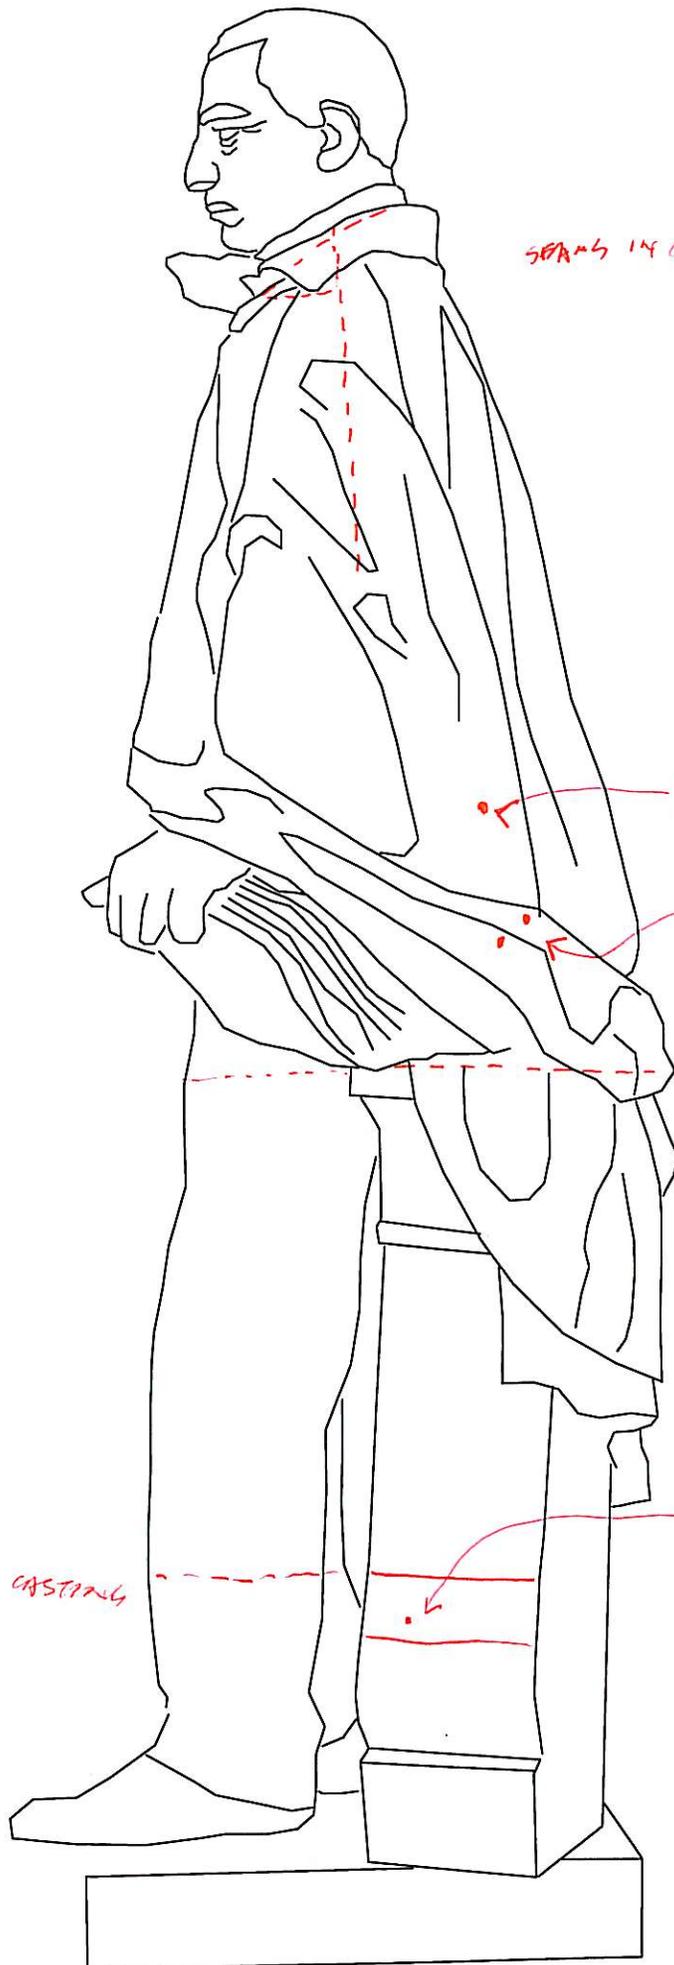
SEAMS IN CASTING

Fill Hair
