1/25/10 10:45 BROEDER R17 \\FS1\JUAREZ MONUMENT\875\_83420 NAMA INVESTIGATIVE CONDITION ASSESSMENT AND REPORT FOR BENITO PABLO JUAREZ MONUMENT AND PLAZA\FINAL AE DELIVERABLES\01 DRAWINGS\CADD\ARCH\EXISTING CONDITIONS\A2.3 - SECTIONS.DWG XREFS: ..\XREF\A-MONUMENT.DWG;

BENITO PABLO JUAREZ MONUMENT CONDITION ASSESSMENT  
OEHRLEIN & ASSOCIATES ARCHITECTS

**SUBJECT: Report of Vibration Monitoring  
The General Juarez Memorial  
Washington, DC  
FEA Project No. R01.2009.006314**

**BENITO JUAREZ MONUMENT**  
**Petrographic and Chemical Studies of Mortar**

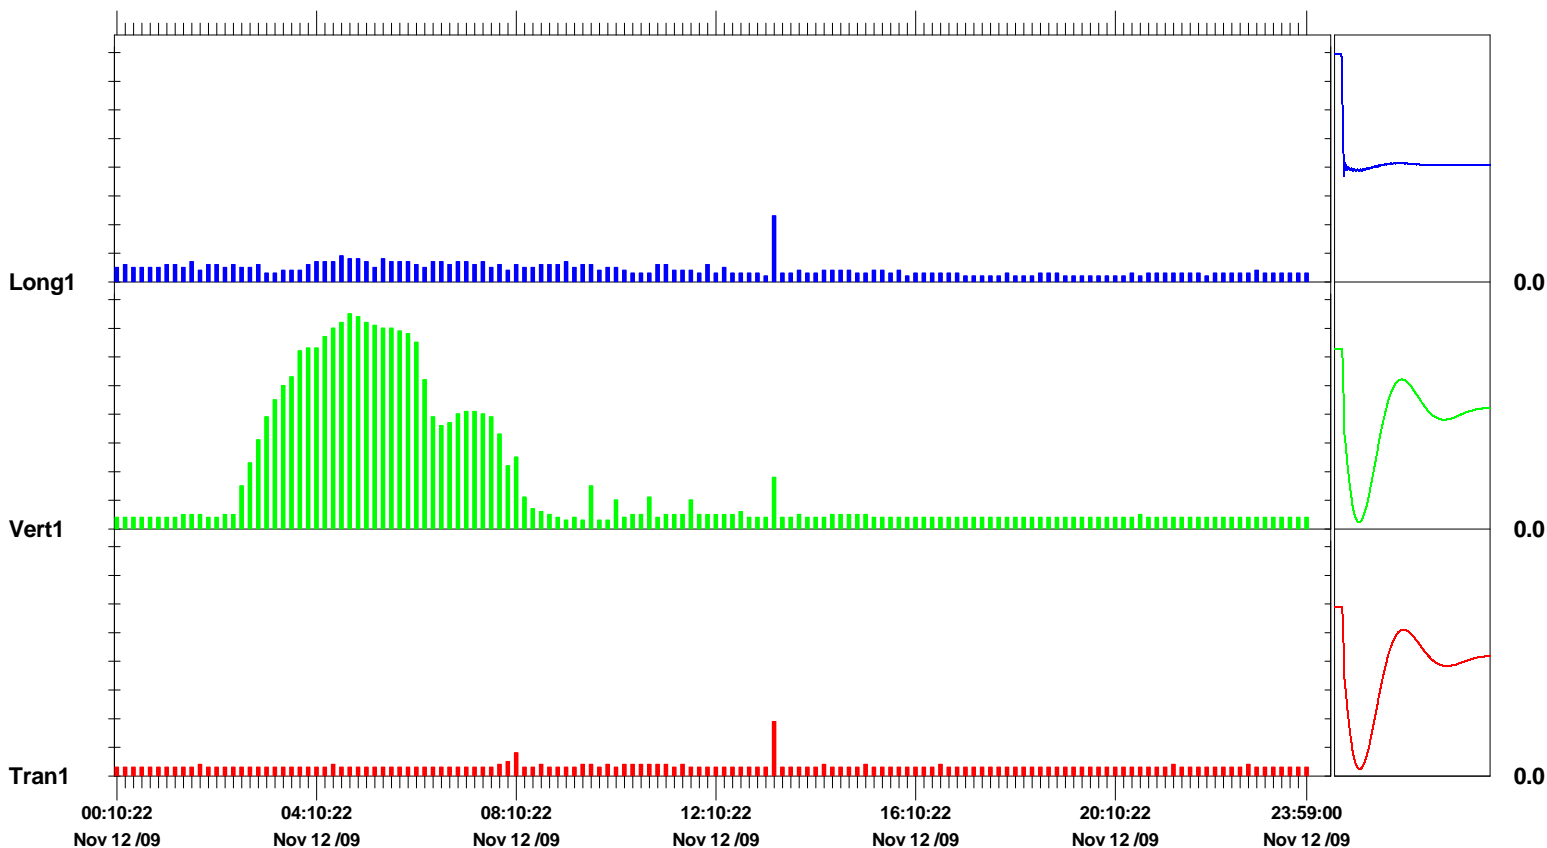
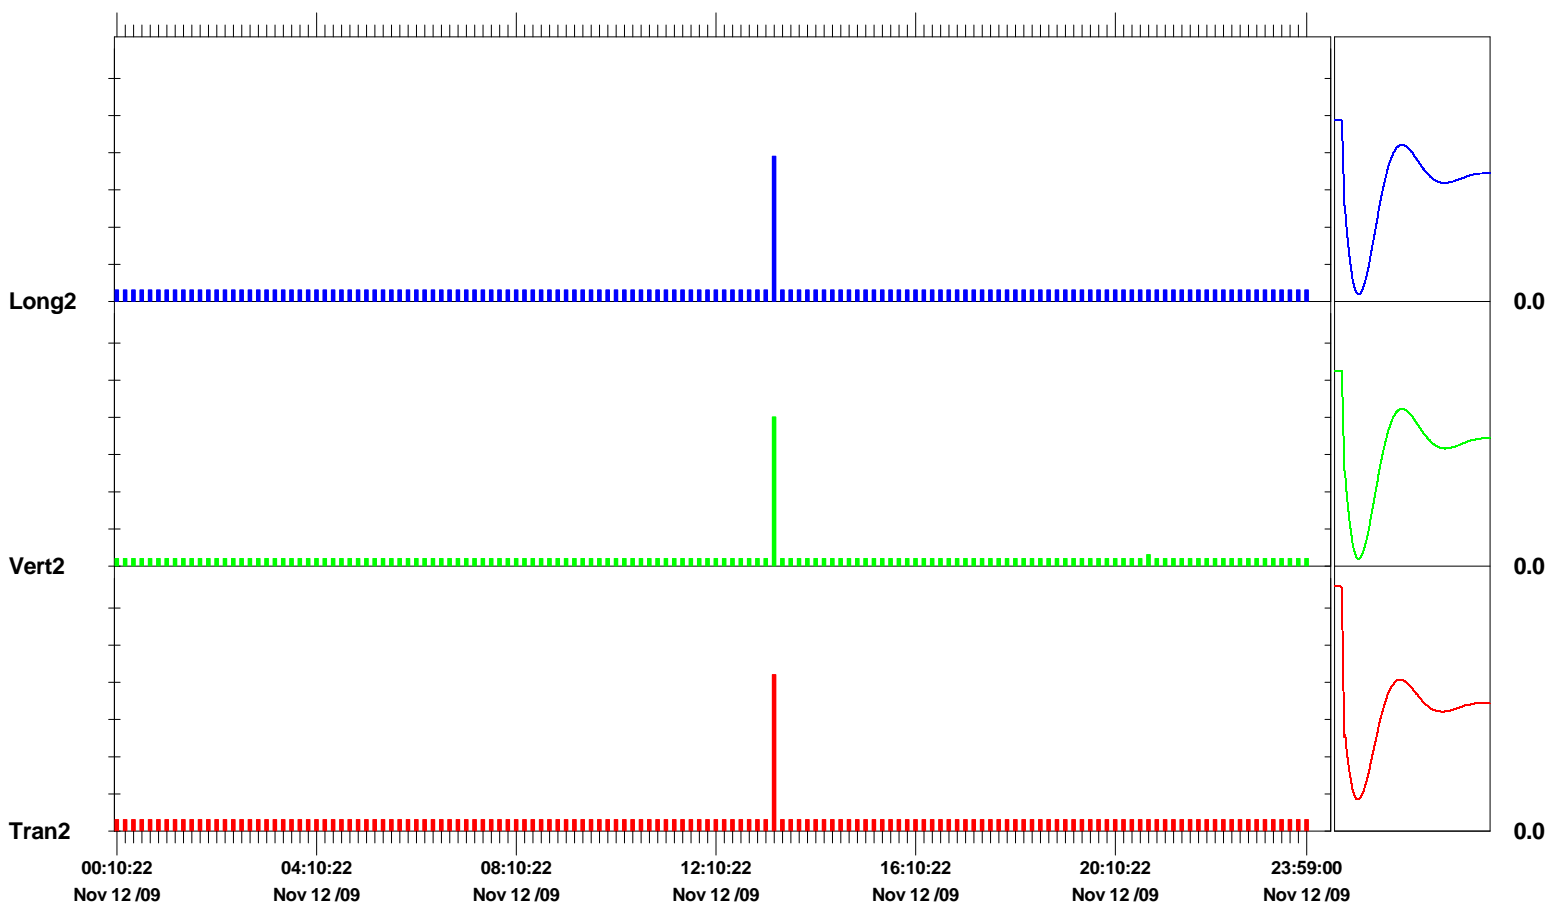
The short-duration events were also only observed when it rained, but the vibration levels were greater in all directions during these events. Each event was only recorded for a one-minute period, showing a spike in the readings. The short-duration events were greater in the sensor at the base of the pedestal, which is the opposite of what was observed during long-term events. These events may be caused from the weather; however, this cannot be determined as a certainty as no personnel were on-site at the time of these events. However, all PPV values recorded during the monitoring period were less than the generally acceptable threshold for vibrations affecting structural integrity.

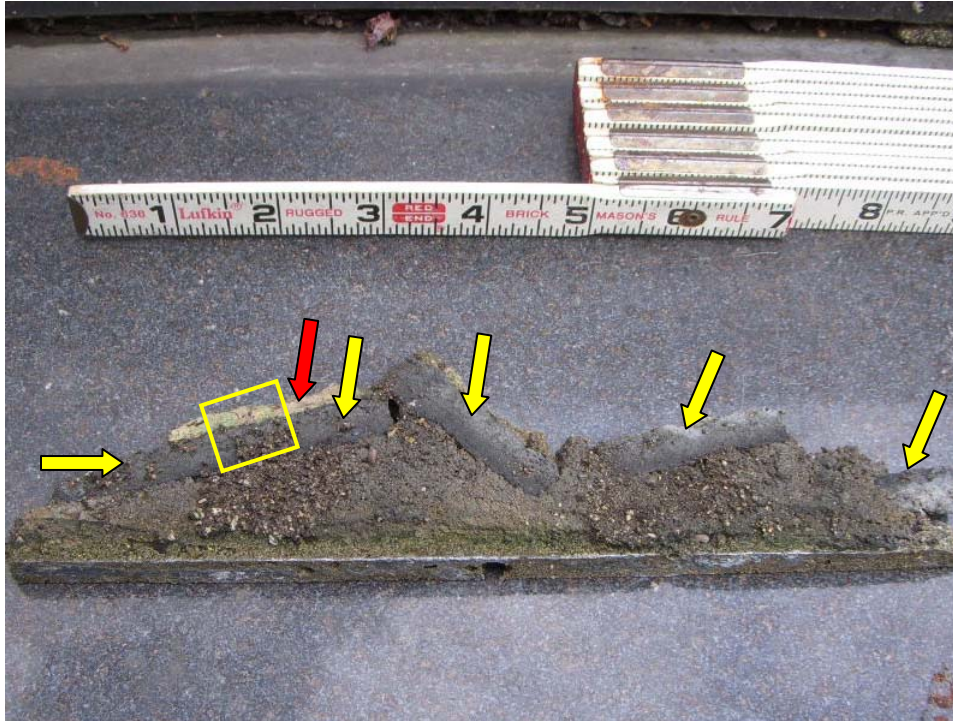
A representative portion of the as-received mortar specimen was used for petrographic studies (Figure 1). Four thin slabs were cut from the portion of the mortar specimen. Three of these slabs were embedded in epoxy and a thin section was prepared of the three slabs (Figure 2). The remaining portions of the mortar were submitted for chemical studies using the appropriate analytical methods outlined in ASTM C 1324, *Standard Test Method for Examination and Analysis of Hardened Masonry Mortar* and for studies to determine the gradation of the sand used in the mortar.

*Figure 1. Photo supplied by Oehrlein & Associates. The yellow arrows mark the material of interest that was removed from the submitted sample for the current studies. The portion of the mortar outlined by the yellow box was used for preparation of a thin section and subsequent petrographic studies. The remainder of the material marked with the yellow arrows was used for the chemical composition studies and the sand gradation studies. The material of interest is medium to dark gray and appears to have shifted in the joint due to installation of additional pointing material. The red arrow marks some white colored mortar that appears to be located behind the medium dark gray mortar that is the subject of the current studies. This white mortar layer was also intersected by the thin section that was prepared as part of the current studies.*

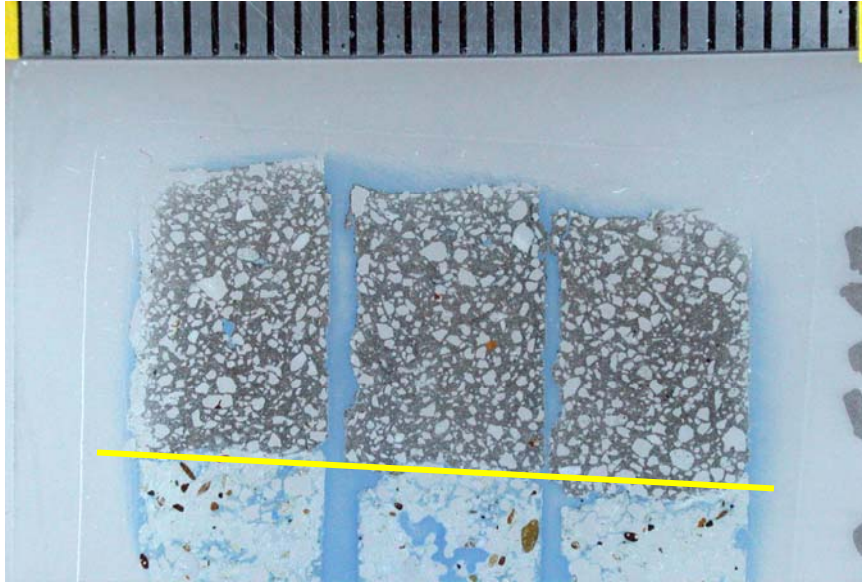
Inspection of the thin section (Figure 2) reveals that the sand aggregate contained in it had a maximum nominal dimension of about 0.8 mm. The sand is uniformly distributed. The lapped surface for the remainder of the epoxy-encased mortar used for the studies is pictured in Figure 3. Inspection of the lapped surface reveals the presence of a few sand-sized white lumps. When viewed at higher magnification some of the white lumps can be seen to have absorbed blue epoxy during sample preparation (Figure 4). Microfractures that are consistent with freeze-thaw distress were also detected in the mortar (Figure 4).

*Figure 2. A photograph of the thin section that was prepared for the current studies is pictured. Three separate pieces of the mortar were mounted on the same thin section to increase the area of the mortar available for examination. The portion of the mortar located above the yellow line is the medium to dark gray mortar that is the subject of the current studies. The mortar below the yellow line is the white material marked with a red arrow in the previous figure. The width of the field of view is 3 cm. A millimeter scale is visible along the top of the figure.*

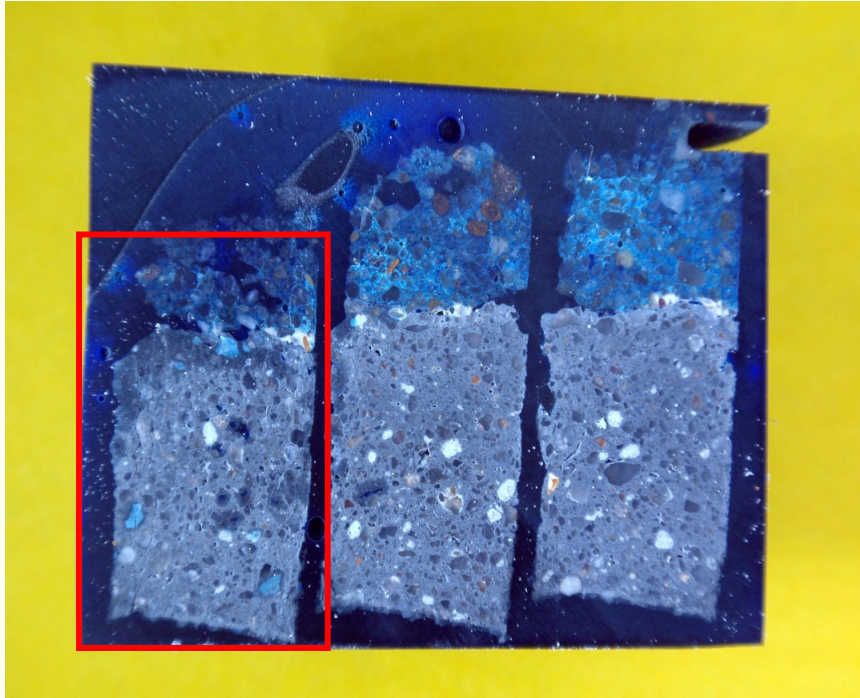
*Figure 3. The lapped surface of the impregnated specimen that remained after the thin section had been cut is shown above. The sample was produced by embedding three thin slabs that had been cut from the sample perpendicular to the mortar bedding plane. The red box outlines the portion of the sample viewed at higher magnification in Figure 4. The width of the field of view is 3 centimeters.*

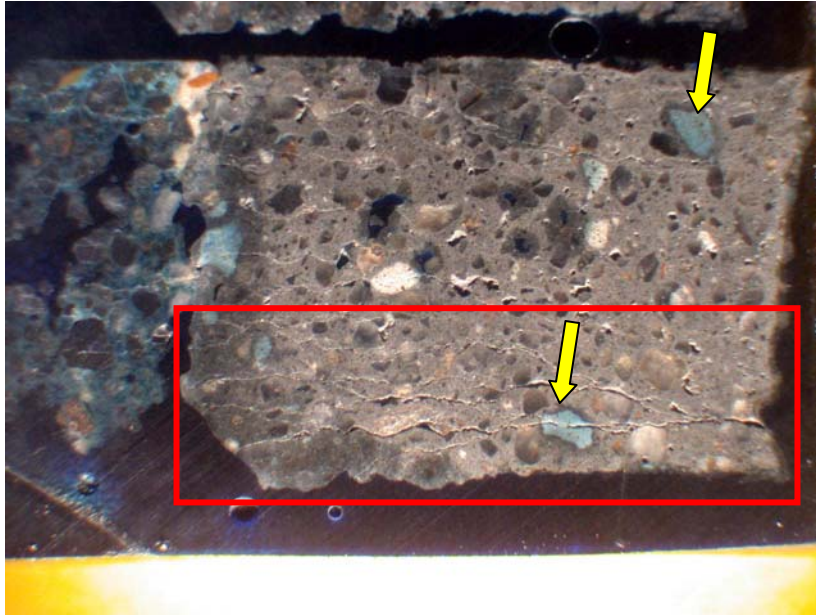
*Figure 4. A close-up of the mortar fragment outlined by the red box in Figure 2 is shown above. Freeze-thaw cracks are visible in the area outlined by the red box. The white sand-sized particles marked with yellow arrows are cement lumps (not lime lumps) that were porous and preferentially absorbed blue epoxy during thin section preparation. Note non-air entrained nature of the mortar (although some irregularly-shaped voids are present). The width of the field of view is 0.5 inch.*

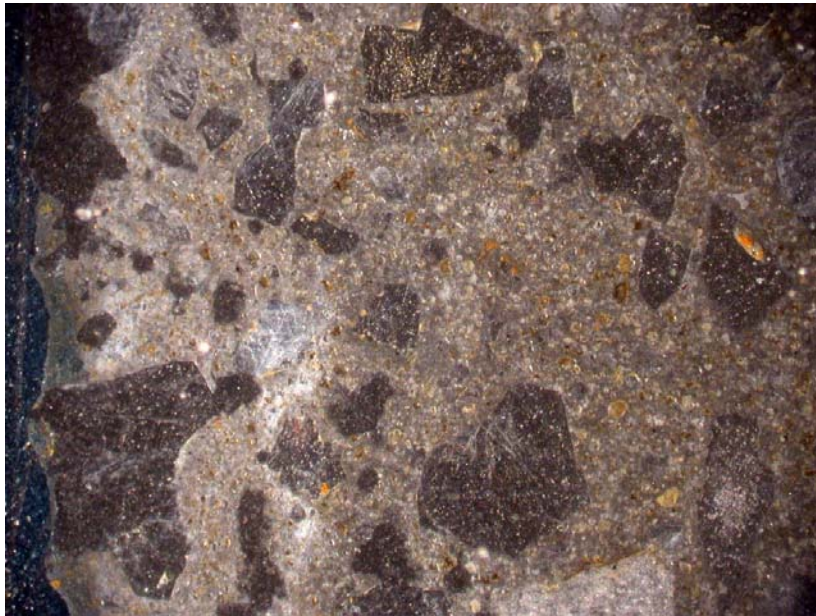
When viewed at higher magnification using the petrographic microscope, the angular nature of the quartz sand was apparent (Figure 5) and the cementitious matrix located adjacent to the original exposed face of the mortar is carbonated (Figure 6).

*Figure 5. The near-surface region of the mortar as viewed in thin section using reflected light is shown above. The light brown to tan particles are composed of residual portland cement. The width of the field of view is 2.5 mm.*

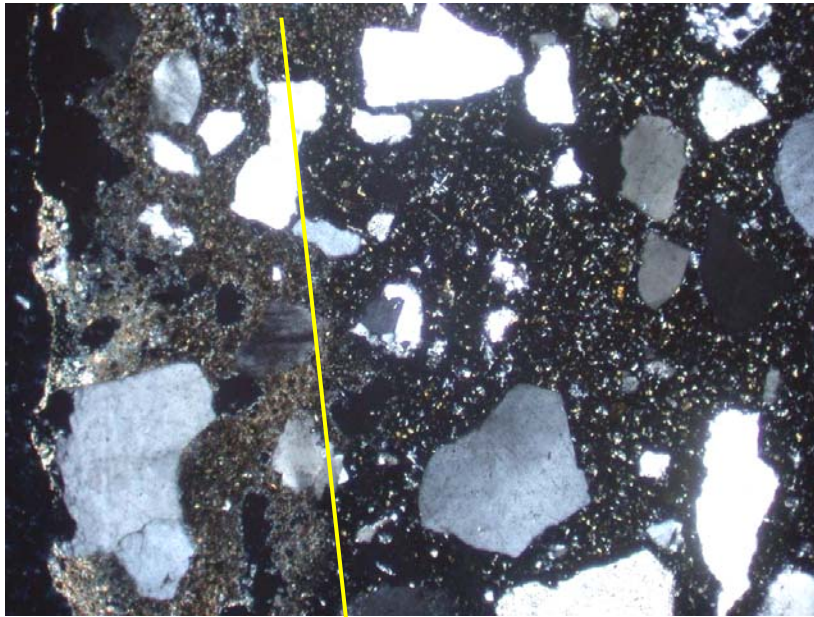
*Figure 6. The same area shown in Figure 5 using polarized light is shown above. The bright region of the matrix to the left of the yellow line is carbonated. The width of the field of view is 2.5 mm.*

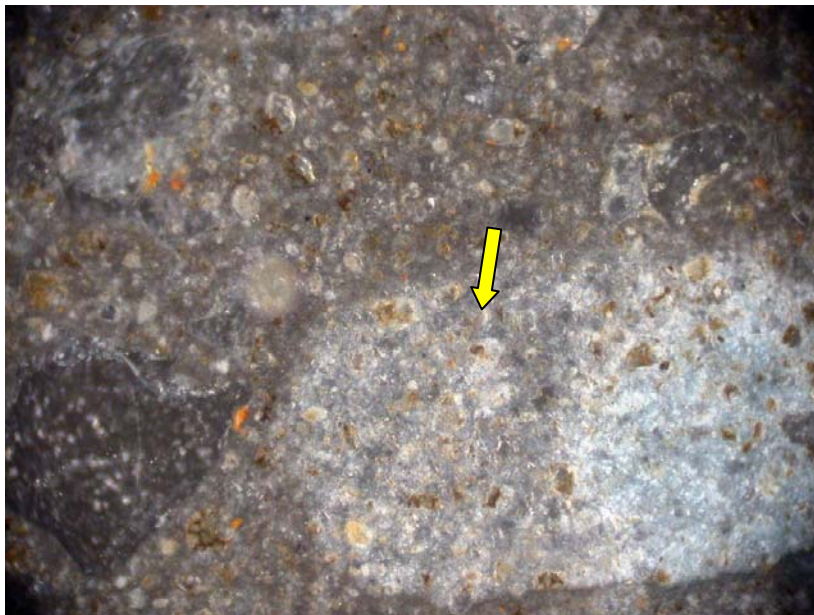
*Figure 7. A cement lump in the mortar is marked with an arrow. Note the variable density in the lump, which may be related to internal differences in w/c. Note that the lump is lighter in color than the surrounding (probably pigmented) mortar. The photo was taken using reflected light. The width of the field of view is 1.0 mm.*

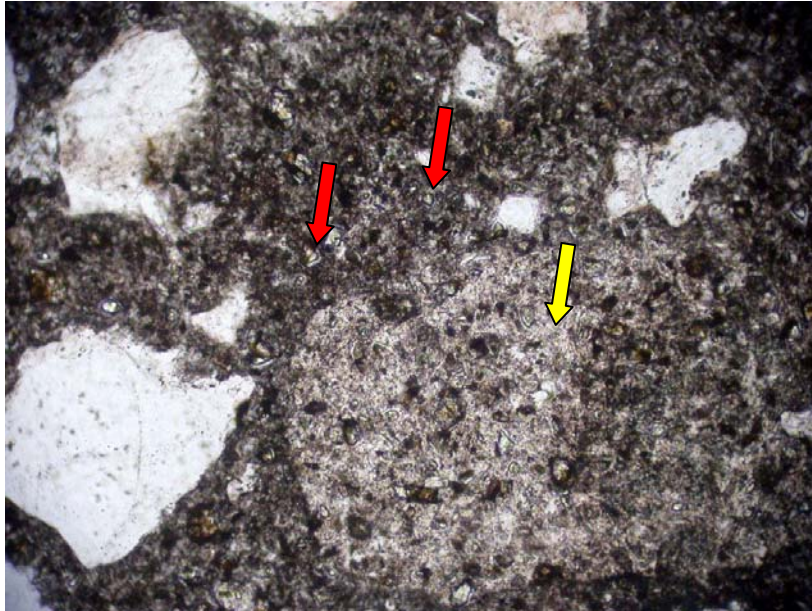
*Figure 8. The same area shown in Figure 7 as viewed using transmitted light is pictured. Note the variation in opacity of the cement lump (marked with a yellow arrow). Cement particles that are surrounded with clear rims are also visible and two of them are marked with red arrows. The width of the field of view is 1.0 mm.*

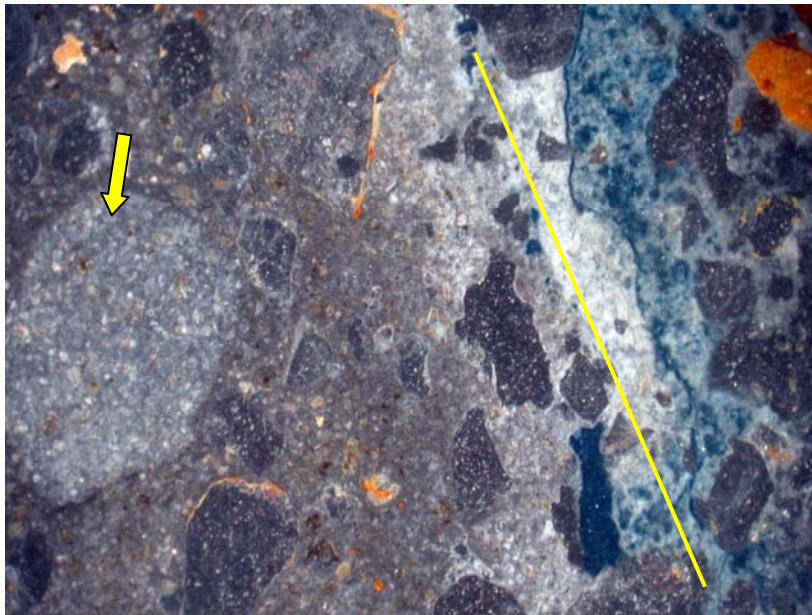
*Figure 9. The interface between the mortar that is the subject of the current studies and the possible sand lime material located behind it is marked with a yellow line. The yellow arrow marks the location of another cement lump in the mortar. The photo was taken using reflected light. The width of the field of view is 2.5 mm.*

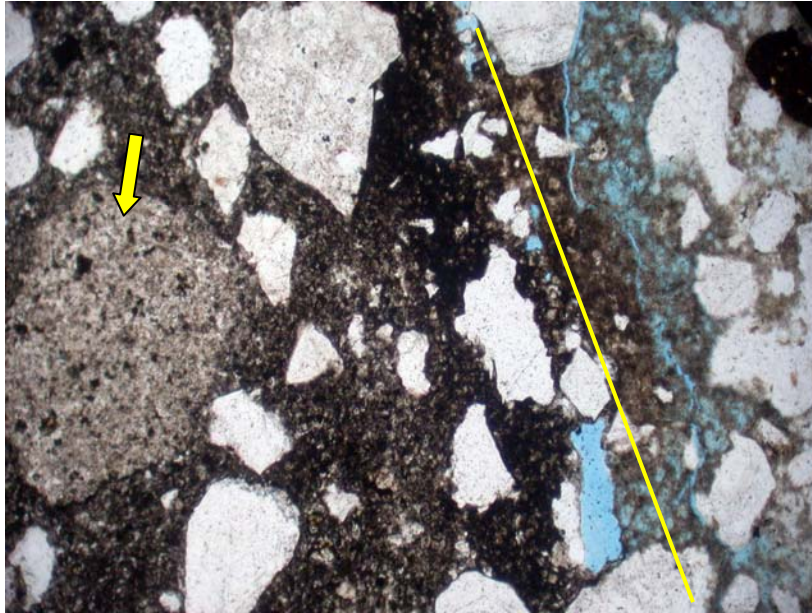
*Figure 10. The same area shown in Figure 9 as viewed using transmitted light is shown above. The cement lump has reduced opacity to transmitted light relative to the bulk of the matrix. The width of the field of view is 2.5 mm.*

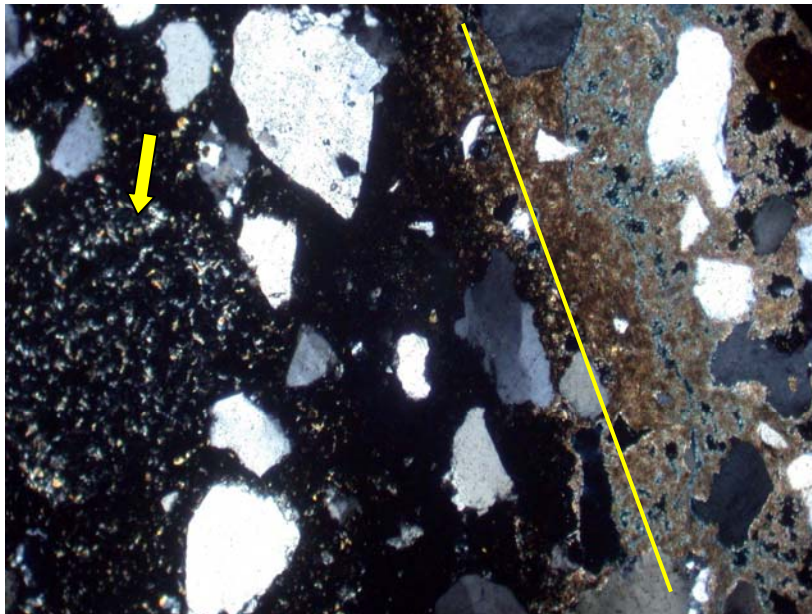
*Figure 11. The same area shown in Figure 10 as viewed using polarized light is shown above. The cement lump contains discrete calcium hydroxide crystals that are uniformly dispersed, as would be expected if they formed due to hydration of the cement. The bright (highly birefringent) condition of the likely sand/lime mortar to the right of the yellow line is due to nearly complete carbonation of the matrix in this material. The width of the field of view is 2.5 mm.*

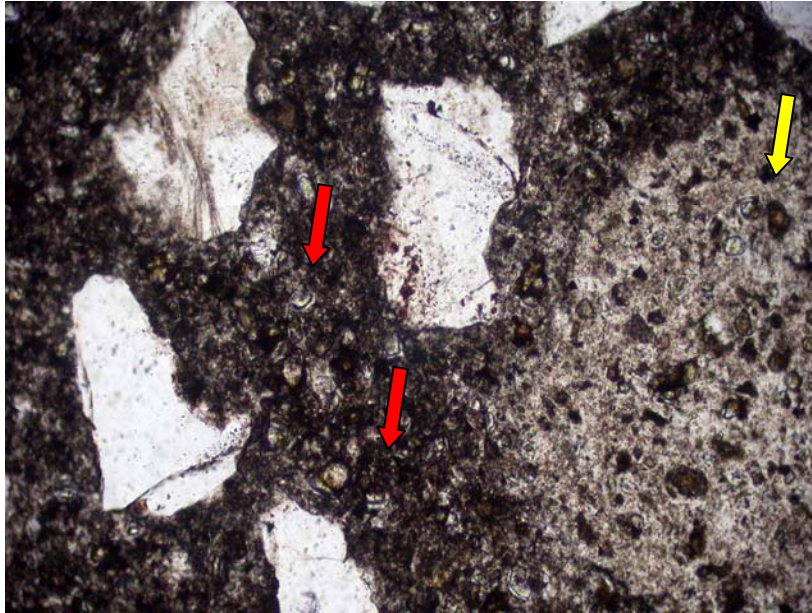
Figure 12. A close-up of a cement lump similar to that shown in Figure 8 as viewed at higher magnification is shown above. The lump is marked with a yellow arrow. Cement particles that are surrounded with clear rims are also visible and two of them are marked with red arrows. The width of the field of view is 1.0 mm.

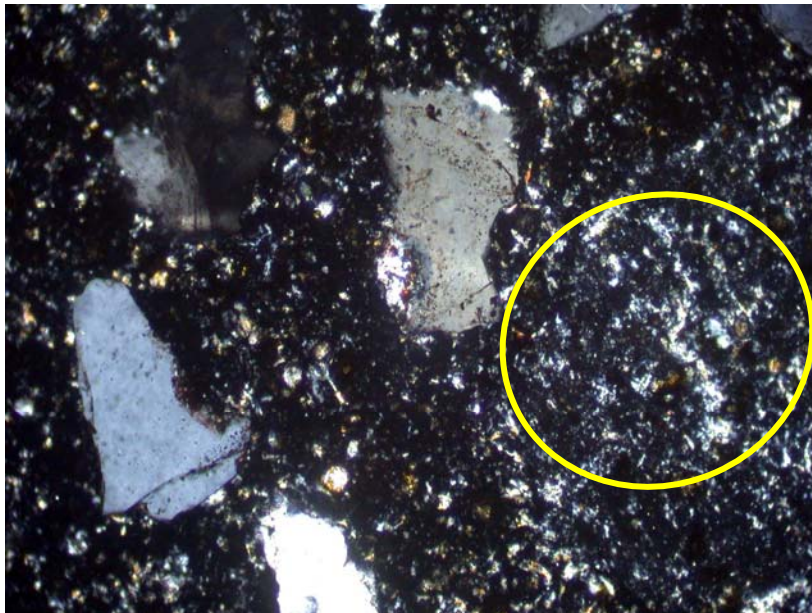
Figure 13. The same area shown in Figure 12 as viewed using polarized light is shown above. Note the higher concentration of calcium hydroxide within the cement lump (light gray to white regions in the area outlined by the ellipse). The width of the field of view is 1.0 mm.
