Chapter 3. Existing Conditions and Analysis

DECEMBER 2012		HSTR 492 116050	
UNITED STATES DEPARTMENT OF THE INTERIOR TRUMAN FARM NATIONAL HISTORIC SITE		TITLE OF PROJECT TRUMAN FARM CULTURAL LANDSCAPE REPORT TITLE OF DRAWING CONTRIBUTING FEATURES	
		NAME OF PARK TRUMAN FARM - HARRY S TRUMAN NATIONAL HISTORIC SITE	
REGION MIDWEST		COUNTY JACKSON	STATE MISSOURI

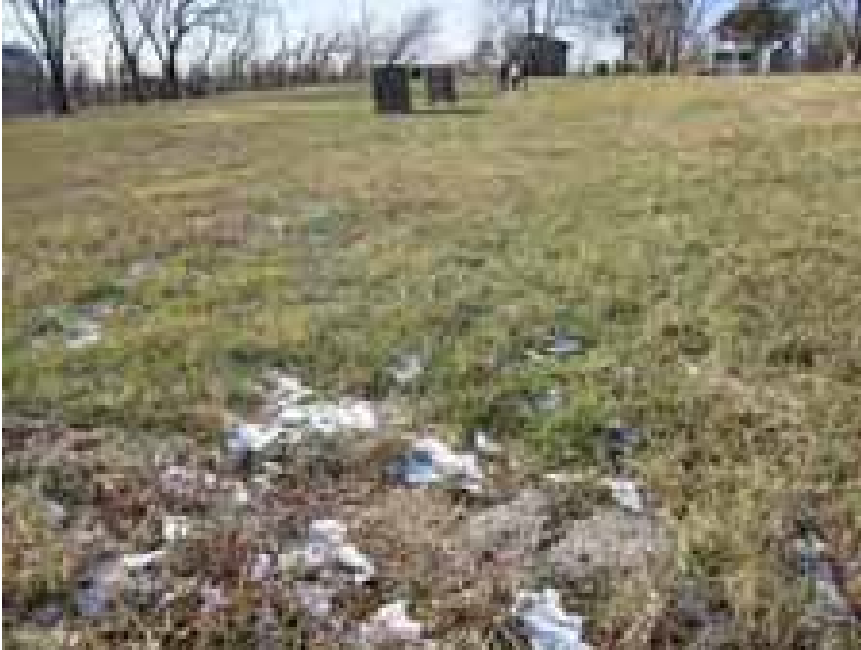
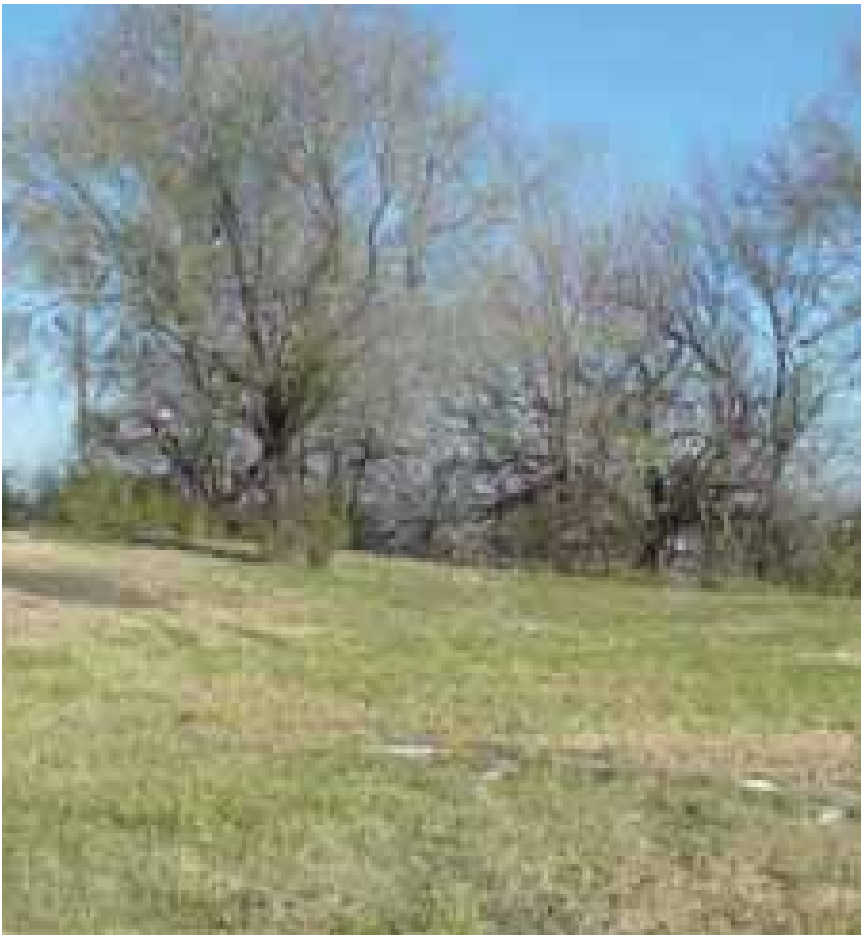
¹ Figure 3-3. The concrete foundation in the east field. It was possibly poured as a foundation for a hog
² house and is a contributing feature. SS 12/6/11

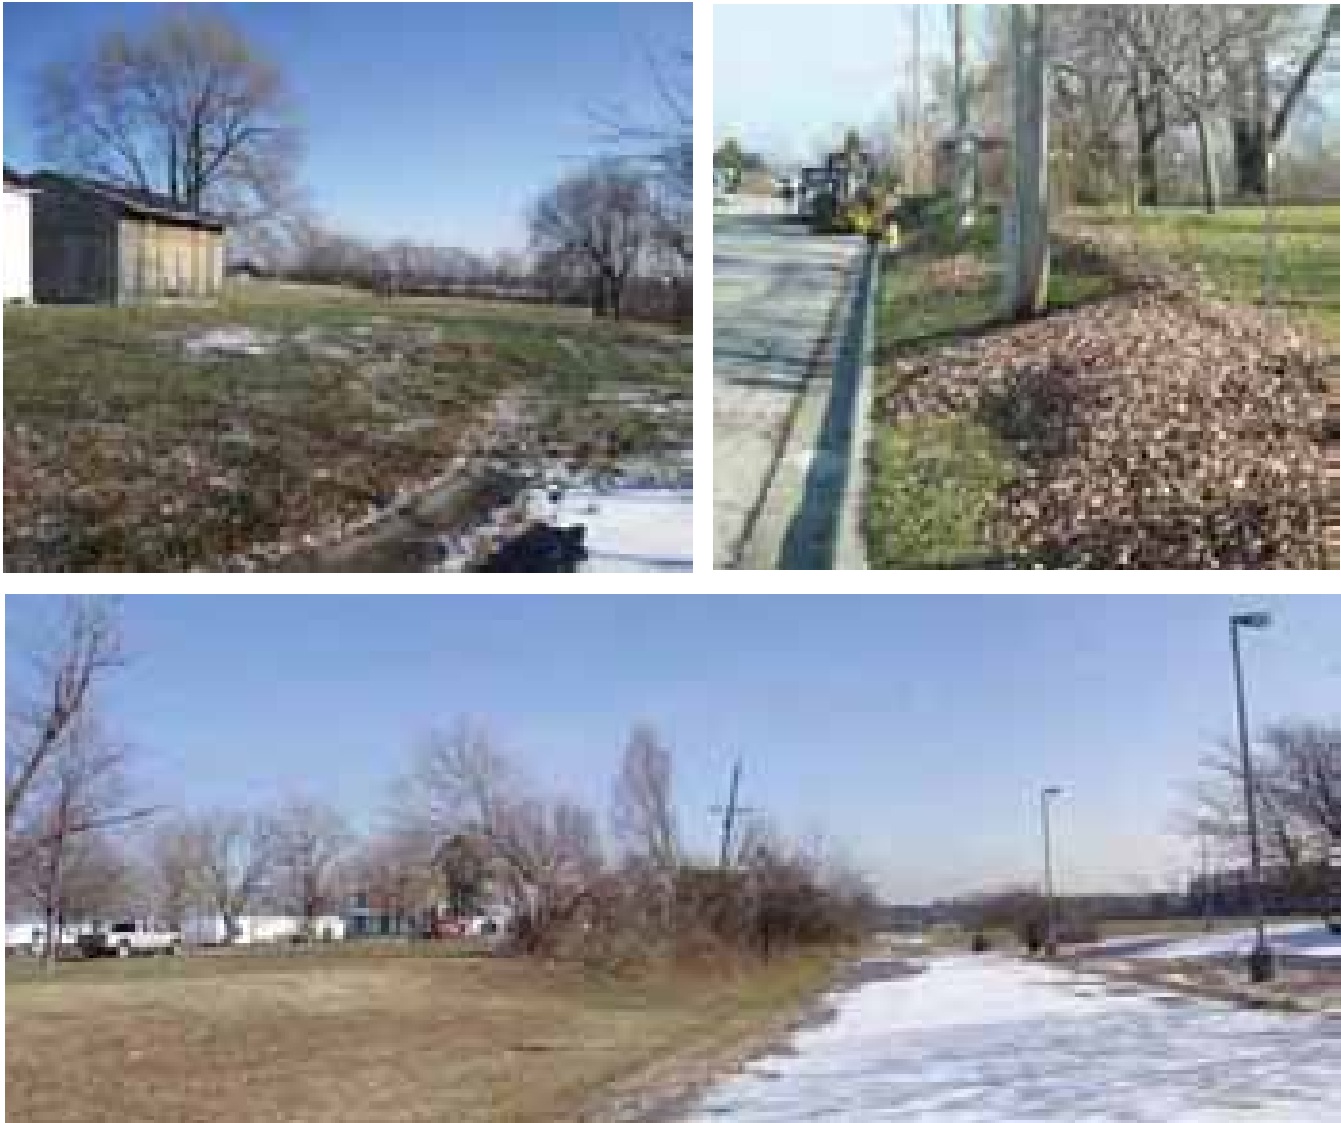
1 Figure 3-13. A slight roadway trace exists between the parking area and the eastern field (upper left). The
2 north portion of the property is level with its edges sloping down significantly. On the south, this slope con-
3 nects to the south field. On the north and east, it slopes down to adjacent properties. The slope at the north
4 edge of the site was built in the late 1980s with adjacent commercial development (upper right). A steep
5 slope was built in the late 1950s separating the farm from the future development (bottom). SS 12/6/11

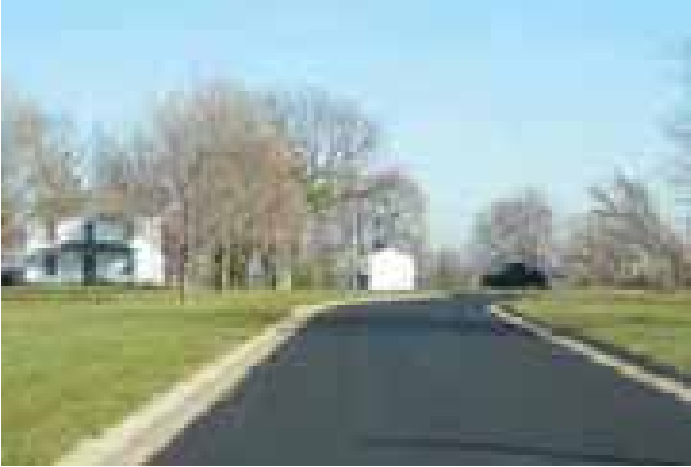
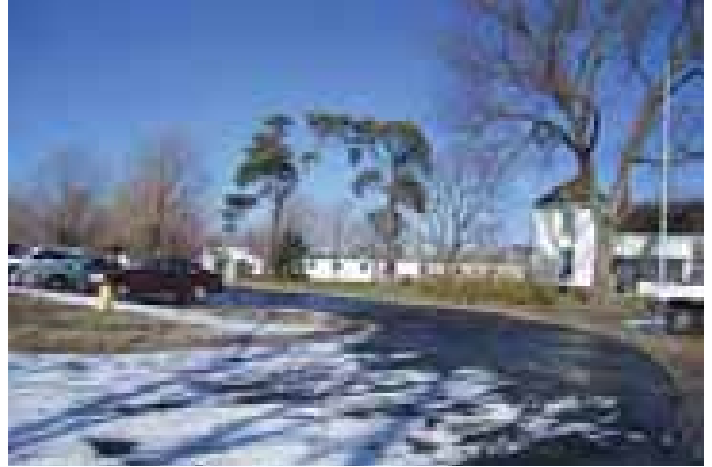
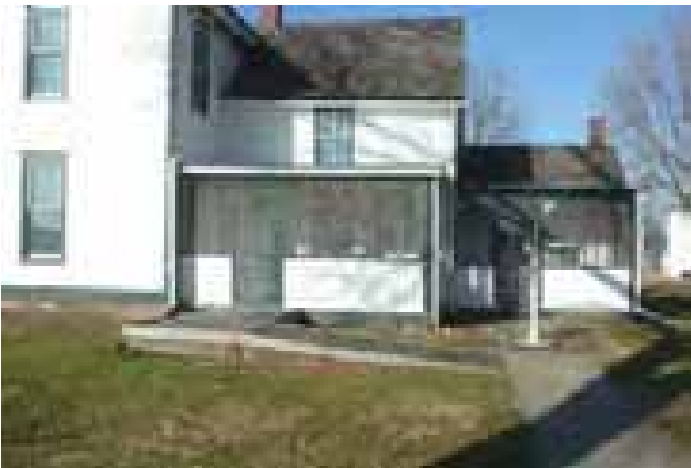
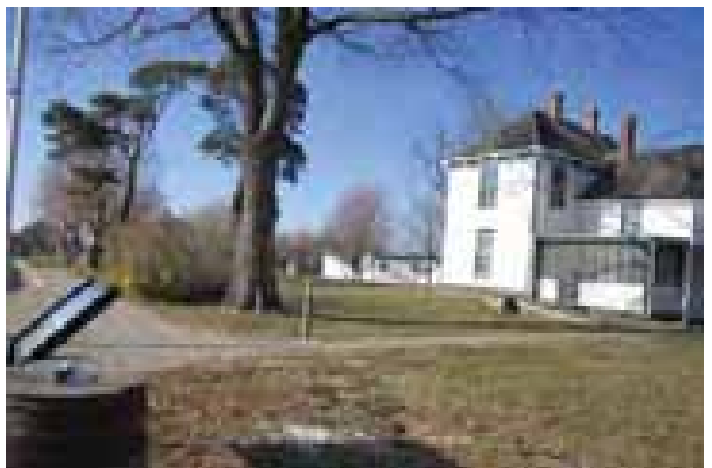
1 Figure 3-17. Vehicular access to the property is from Blue Ridge Boulevard, via a 20-foot wide asphalt entrance drive
2 that leads to a parking area located just southwest of the Farm Home (top). Concrete paths connect the parking area
3 with the Farm Home. A wood accessible ramp provides access into the Farm Home. SS 12/6/11
4

1 entering into the dining room. The ramp
2 is in good condition, as are the concrete
3 paths. The remainder of the pedestrian
4 circulation is informal throughout most
5 of the site and no other developed paths
6 exist.

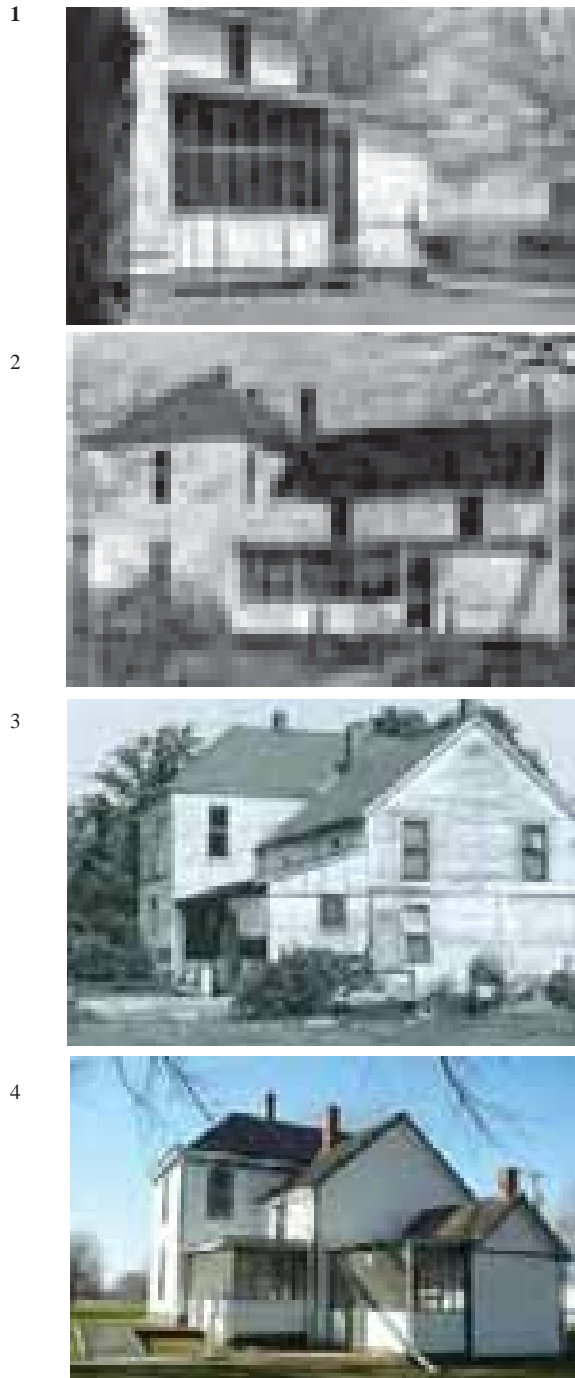
Figure 3-19. Historically, a path connected the Garage to the Farm Home (top). By c.1960, a raised, likely paved, pathway connected the two. Later a concrete pad occurred directly south of the Farm Home (middle photos). The concrete pad is now gone. The path from the parking area to the back door of the Farm Home remains in essentially its historic alignment (bottom). HSTL 029005, c.1940; HSTL 61-66-02, c.1961; Al O'Bright 8/83; SS 12/6/11

36
37 Photographs from the 1980s taken prior
38 to repair work, indicate a large concrete
39 pad covered the well and formed a paved
40 area on the south side of the Farm
41 Home. This has since been removed and
42 replaced with the existing concrete paths.
43 Photographs from the 1980s also indicate
44 a concrete pad in front of the Garage, but
45 it is unknown when this first was built.

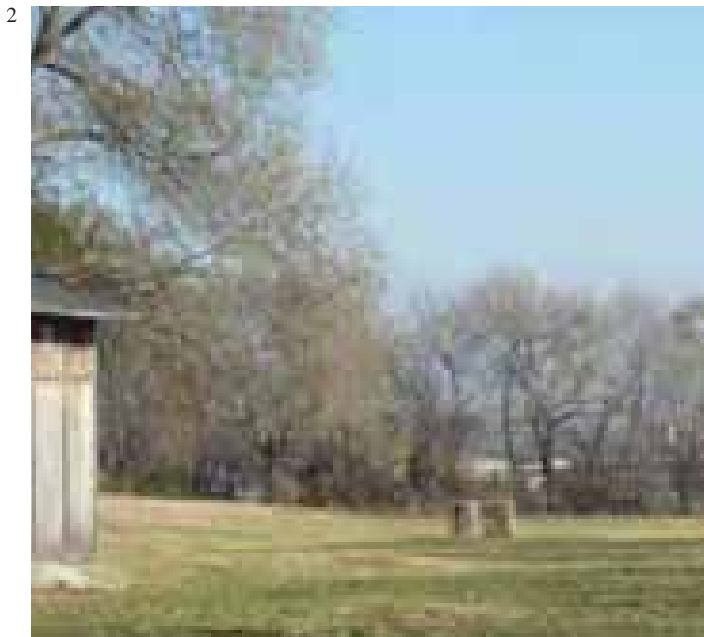
3 **Figure 3-21.** Historically, the entrance road continued
4 beyond the Garage, past the kitchen garden, to the
5 barnyard (top). Today, this road is barely visible as it
6 was allowed to fade once farming waned and the barns
7 were removed (bottom). HSTL 80-8, c. 1910; SS 12/6/11

16 Archeological evidence and historic
17 aerials indicate that historically the
18 entrance road continued beyond the
19 Garage, and the kitchen garden to the
20 barnyard between the Solomon Young
21 Barn and the granary. This road was
22 likely present from Solomon Young's time
23 on the farm (1867) and appears clearly in
24 an aerial photograph from 1959. It likely
25 faded after farming activities ceased and
26 the Solomon Young Barn burned in 1966.
27 Traces of this road are visible today.

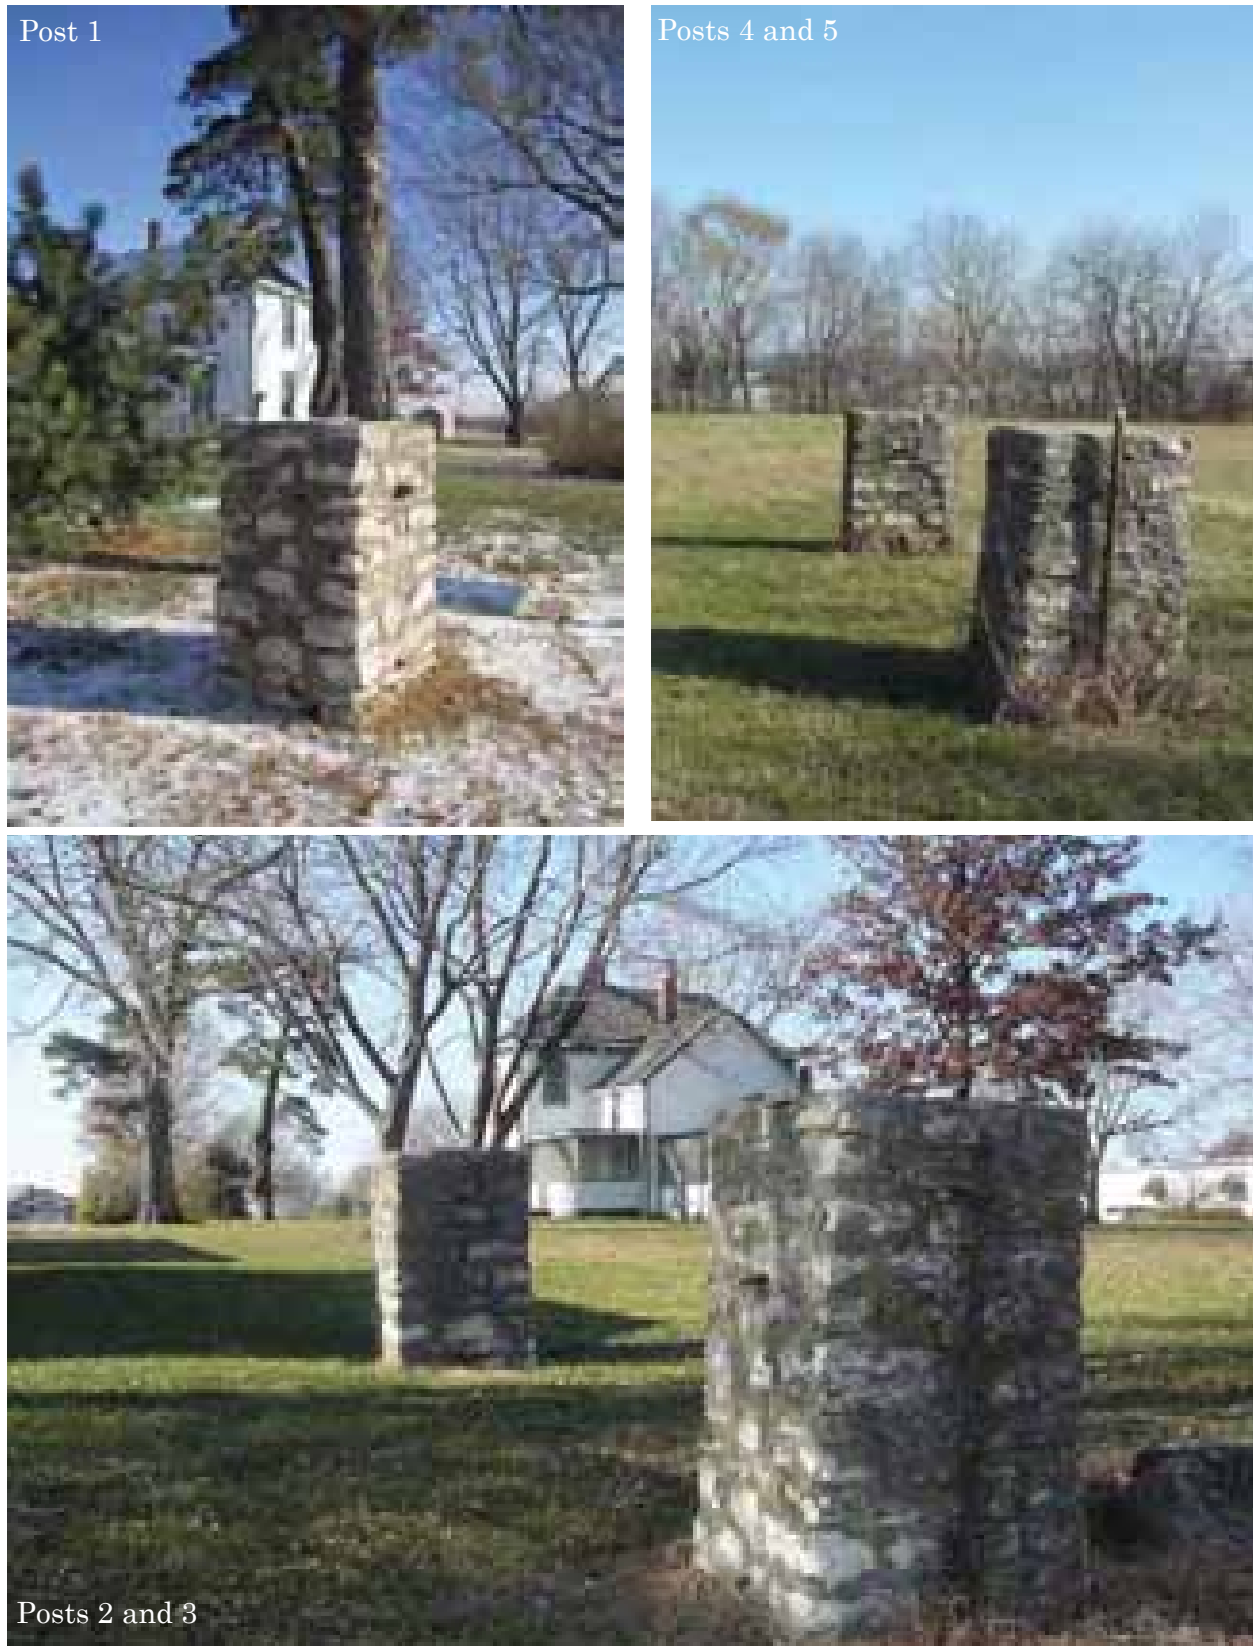
1 **Figure 3-22.** There are five standing stone posts built of coursed limestone and mortar with concrete
2 caps. The posts occur along an east west line south of the Farm Home and historically supported
3 fences and gates. SS 12/6/11; BN 11/23/11

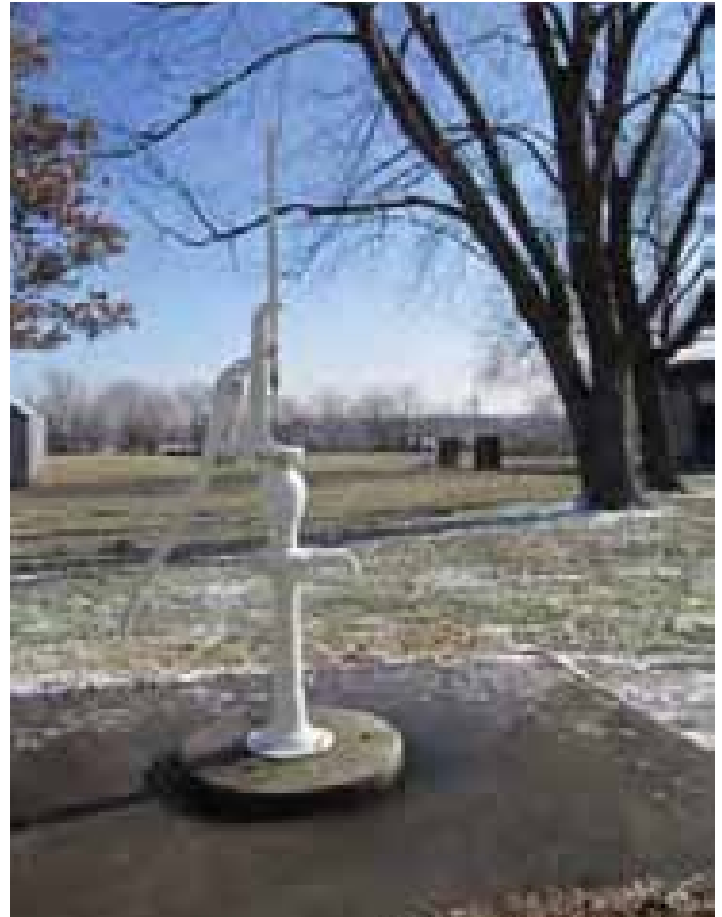
1 Figure 3-23. The Truman Farm Well and Pump is
2 immediately south of the Farm Home. The pump is
3 not original, is of a slightly different style and faces
4 a different direction from the one that stood in this
5 location historically. SS 12/6/11

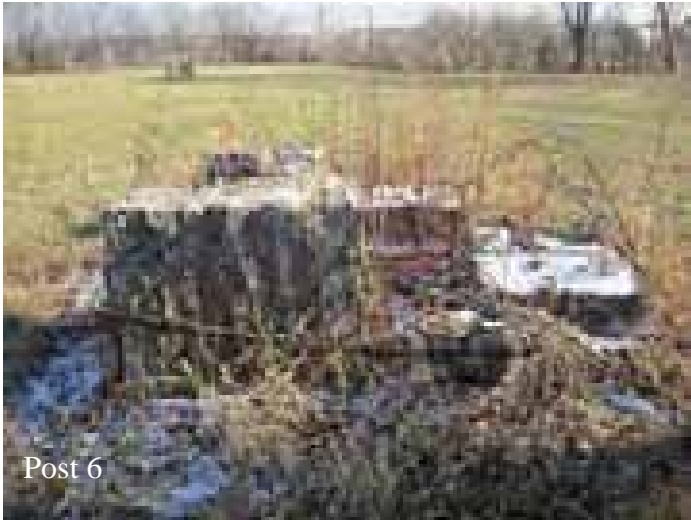
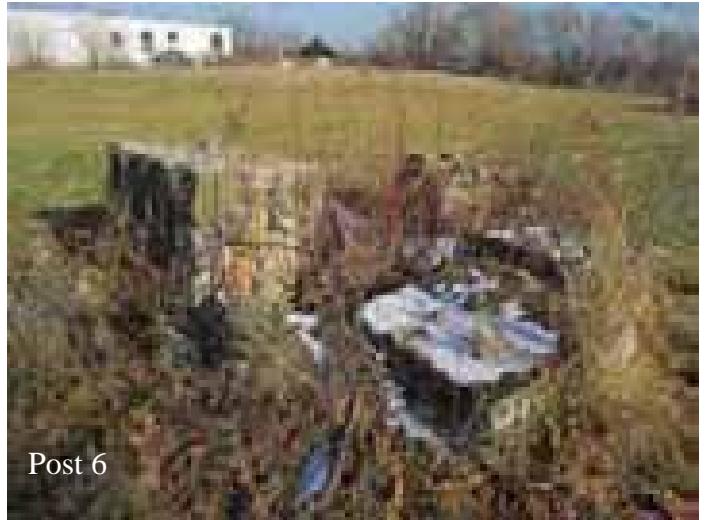
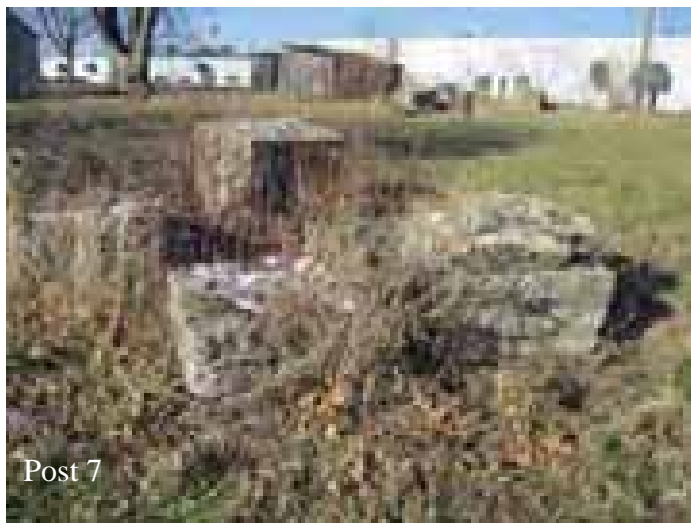
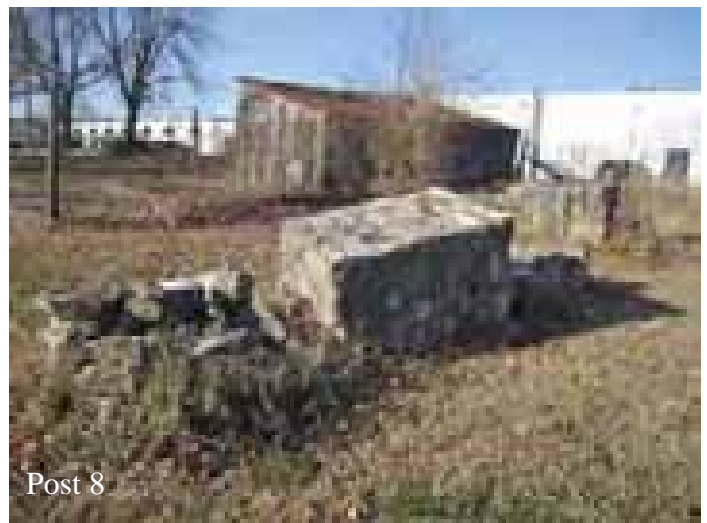
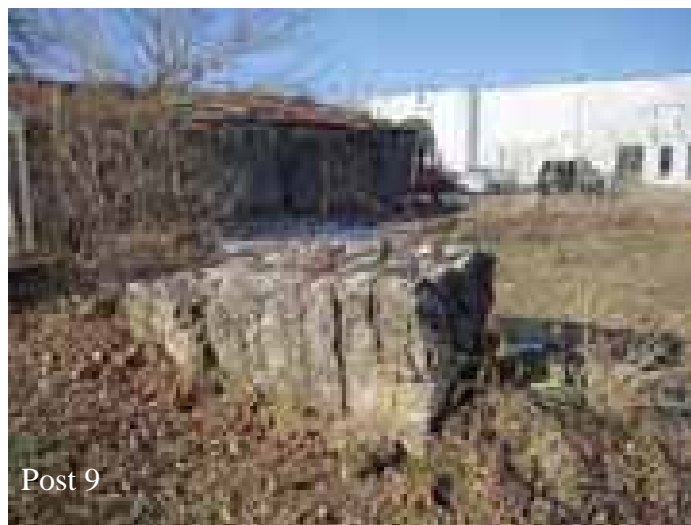
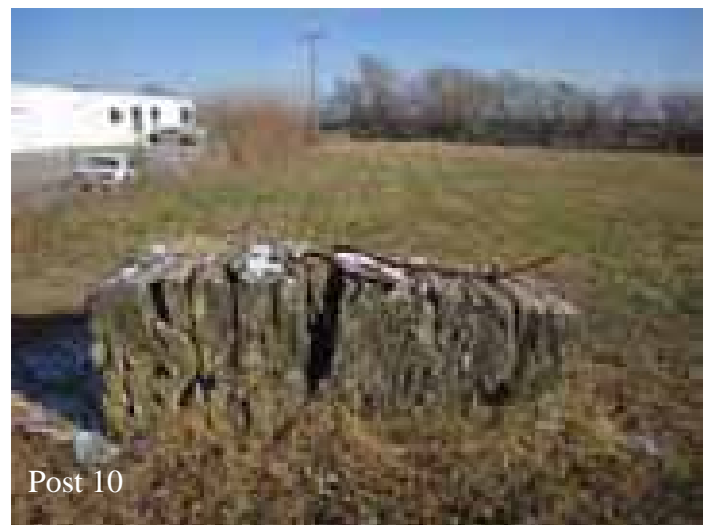
26
27 Posts 6 and 7 are closest to Post 3 in a
28 cluster of debris and are both broken
29 into large pieces. The largest piece of
30 Post 6 measures 34-inches by 33-inches
31 and is 39-inches long. An iron pole flanks
32 one side. Two other pieces nearby are
33 approximately 12-inches high, with one
34 measuring 35-inches square and the other
35 18-inches by 24-inches. Within this same
36 stone debris are remnants of Post 7. Part
37 of this post is set upright and is 35-inches
38 square and 27-inches in height; the other
39 portion of this post is 13-inches in height
40 and 35-inches square.

41
42 Further north are Post 8 remnants. This
43 post is broken into two pieces. The largest
44 piece is 55-inches long and 35-inches
45 square at one end, and 31-inches square
46 at the opposite end. The other portion
47 of Post 8 measures 35-inches square by
48 12-inches in height.

¹ Figure 3-29. Five posts were removed during the 1987 construction of the Truman Farm Shopping Center on the
² land north of the Truman Farm that was historically Vivian Truman's farm. They were placed in the field east of
³ the Farm Home. Posts 6 through 10 are broken and lying on their sides. SS 12/6/11

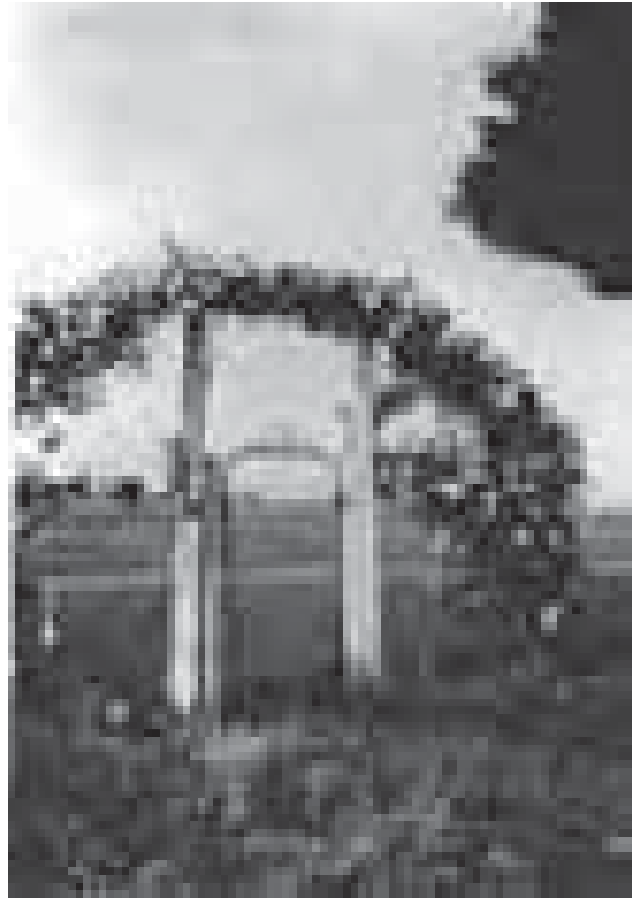
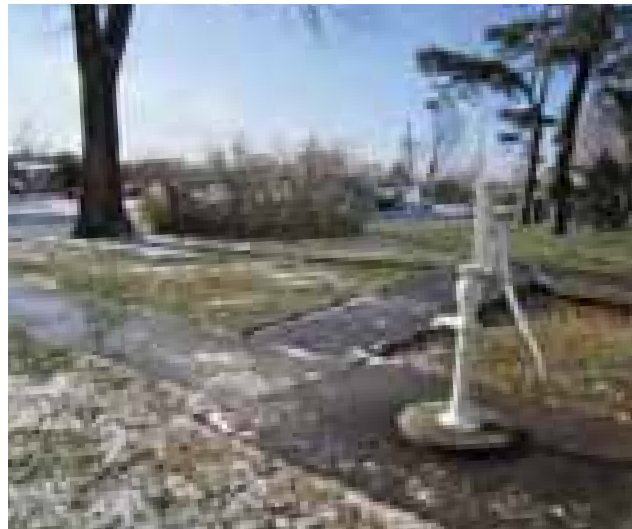
1 Figure 3-37. Rose arbors grew along the fence that
2 bordered the Farm Home yard. One was over the
3 south gate (top). These rose arbors were present
4 between the 1920s and 1950s, but today no indica-
5 tion of their presence remains (bottom). HSTL
6 84-82-1, c.1930; SS 12/6/11

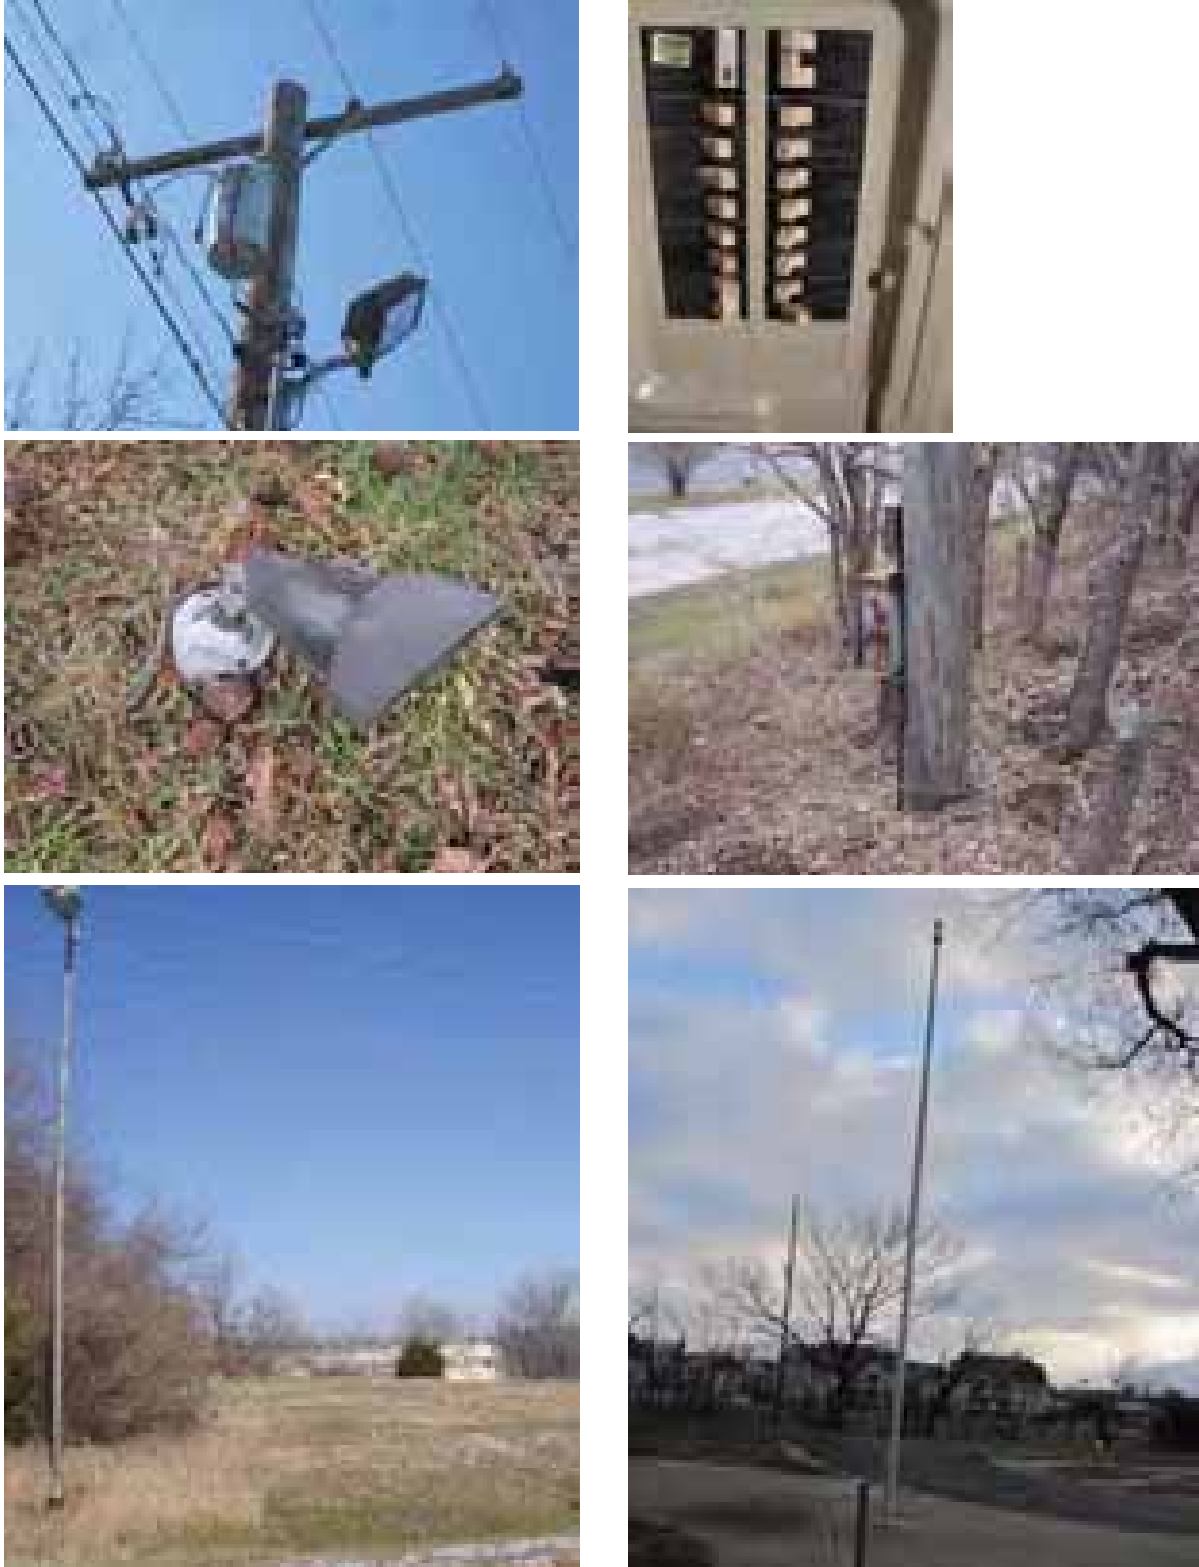
¹ Figure 3-41. Photographs noted the following from top left clockwise to lower right: Existing Pole
² Mounted Transformer; Existing Main Electrical Panel; Existing Building Floodlight; Existing Aban-
³ doned Electrical Service; late 1950s Historic Cobra Head Light; Existing Flagpole. JB 12/6/11; TB 12/6/11

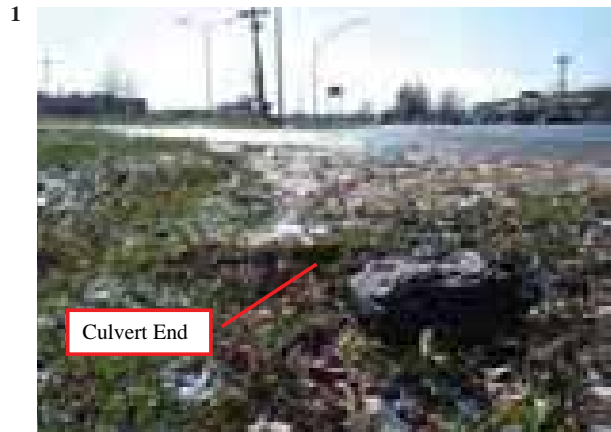
2 **Figure 3-43.** Existing culvert beneath the
entrance drive at Blue Ridge Boulevard. MT
12/6/11
