BUILDINGS AND STRUCTURES

BUILDINGS EXISTING CONDITIONS & CONDITION ASSESSMENTS

NOVEMBER 2012	TITLE OF PROJECT TRUMAN FARM HISTORIC STRUCTURES REPORT		
UNITED STATES DEPARTMENT OF THE INTERIOR TRUMAN FARM NATIONAL HISTORIC SITE	TITLE OF DRAWING COVER & INDEX		
EXISTING CONDITION DRAWINGS SHEET 1 OF 11	NAME OF PARK TRUMAN FARM - HARRY S TRUMAN NATIONAL HISTORIC SITE		
	REGION MIDWEST	COUNTY JACKSON	STATE MISSOURI

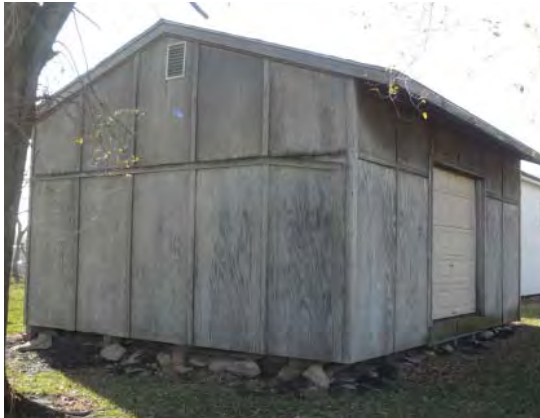
Figure 3-50: Three non-contributing structures exist on the Truman Farm. The maintenance shed was added by the NPS in 1995 (top). The smokehouse was moved to the Truman Farm by the Truman Farm Home Foundation in 1985 (middle), and the outhouse was placed on the property c.1985 (bottom). SS 12/6/11

39
40 The shed is in good condition. It is not
41 a historic structure and its presence
42 detracts from the historic setting. The
43 shed is to be removed once storage for
44 maintenance equipment is provided at
45 Tract 3 or an alternate facility.

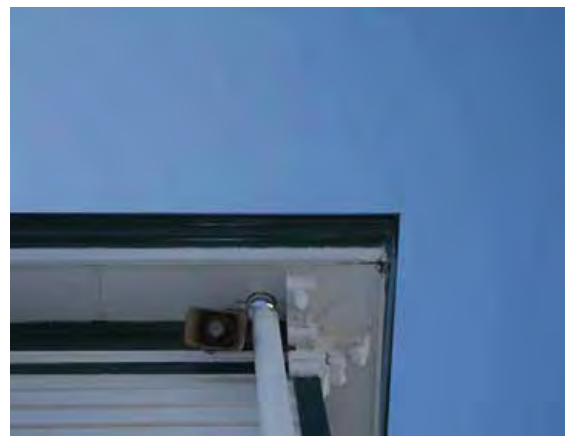
The gutter of the main roof consists of a newer stainless steel integral gutter c. 1984. This system drains to two 4" round downspouts on the east side – at the north and south ends, each with a 10' extension at grade. The north downspout is currently disconnected at the top.

Figure 3-56: Detached north downspout, EMH 12/6/11

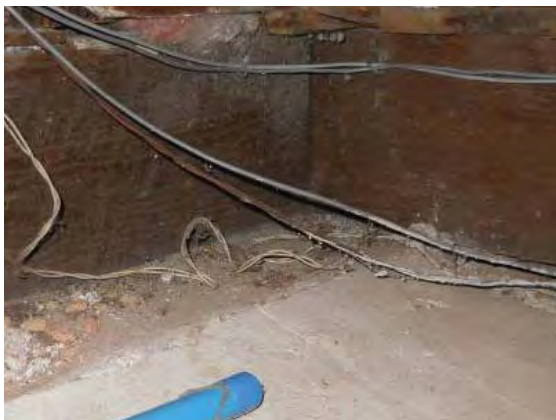
10 The first floor framing over the basement
11 consists of 1 1/2" x 7 1/2" wood joists
12 spaced at about 24" on center (o.c.).
13 The joists span east-west a distance of
14 approximately 16' and are sheathed with
15 solid 3/4" thick tongue and groove wood
16 flooring. The joists are supported on the
17 perimeter foundation walls by bearing on
18 an embedded wood sill plate (following
19 figure). The basement floor framing at
20 the stair opening is supported by 2 x 4
21 propped posts which extend from the
22 underside of the floor framing and bear
23 on the slab on grade. Likewise the stair
24 to the basement has framing that bears
25 directly on the slab on grade and is
26 decaying.

40 Figure 3-86: Embedded wood sill plate on the
41 stone foundation wall, northeast corner of the
42 basement, PD 12/6/11

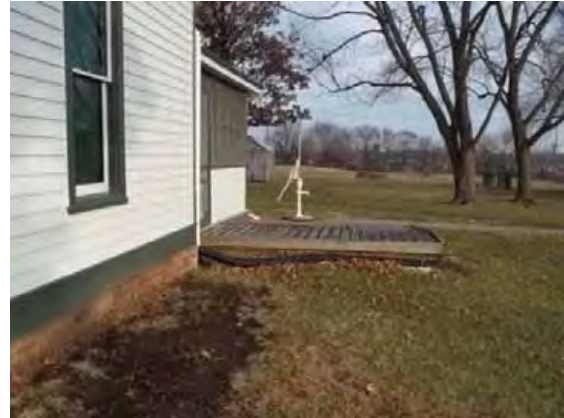
New condenser water lines and a new vertical bore field were installed for the geothermal system. The vertical borefield is located in the parking lot south of the building and consists of five bores approximately 300' in depth. The borefield piping is routed from top of each borefield well, ganged together and routed into the south side of the basement. Disturbed ground on the south edge of the house is evident as well as the asphalt repair in the parking lot and a replaced concrete curb section.

Figure 3-90: Disturbed ground on south side of building where geothermal lines enter building, DMD 12/6/11

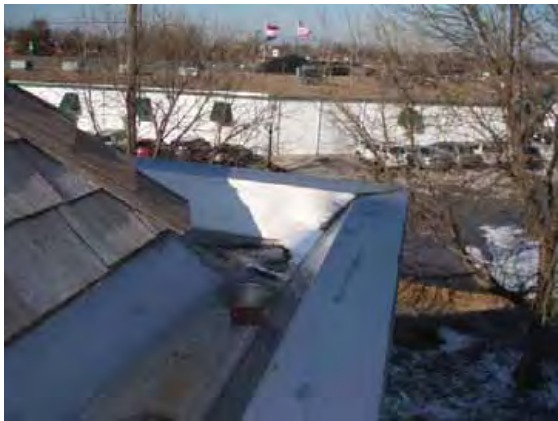
All are in good condition. However, the fascia at each integral gutter corner of the west wing exhibits some minor damage at the vertical joint at each corner. It is unknown what is causing the damage but it could possibly be from differentiation of expansion between the wood and stainless steel gutter, causing a gap at the end grain of the fascia members.

Figure 3-117: c.1984 stainless steel integral gutter, minor damage at corner joint, EMH 12/6/11

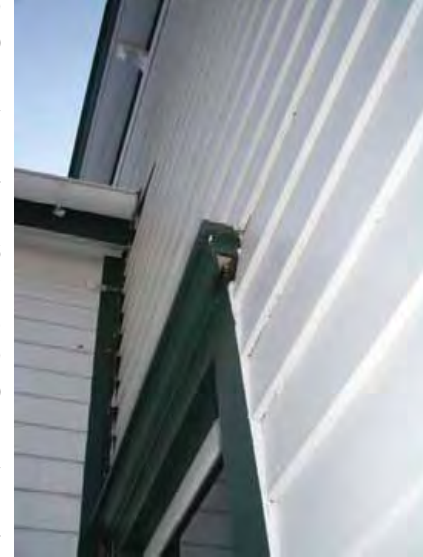
All appear to be in good condition, with the exception of the separation issue.

Figure 3-118: Separation of central and east wing, EMH 12/6/11

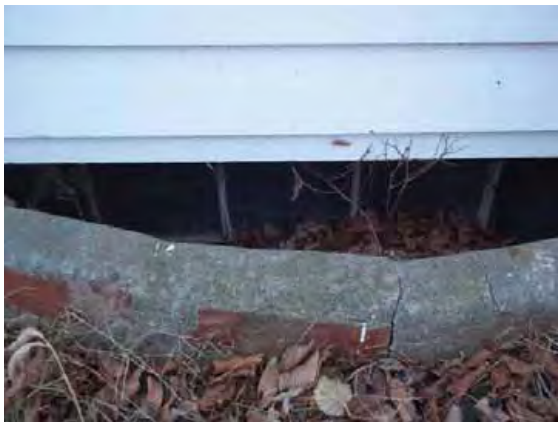
Central Wing: The first and second floor wood windows are in good condition. The basement windows are in fair to poor condition. Debris has covered a portion of the exterior and has trapped moisture against the windows. The window wells themselves are small, with minimal air circulation or space for maintenance.

Figure 3-119: Basement window well condition, NAA 12/6/11

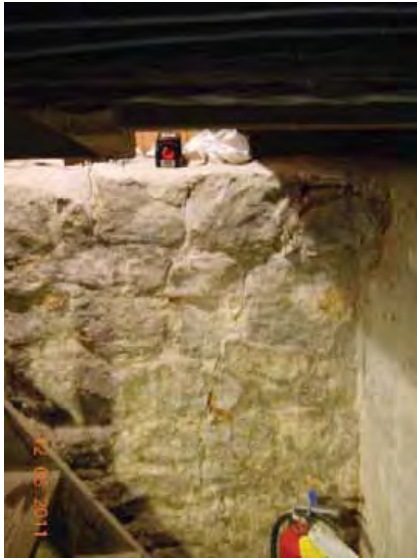
Figure 3-121: Basement wall crack, PD 12/6/11

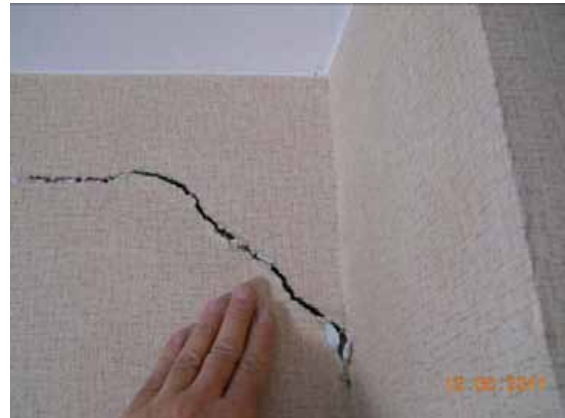
Figure 3-122: West wing wall cracking, second floor hall 201 adjacent to north chimney, PD 12/6/11

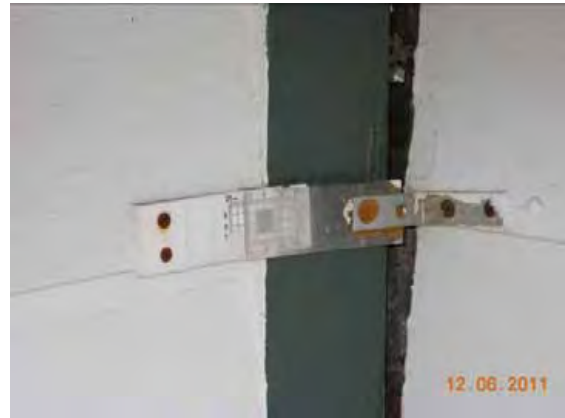
Figure 3-123: Separation of west wing from center of house as measured by crack monitor installed in 2004, PD 12/6/11

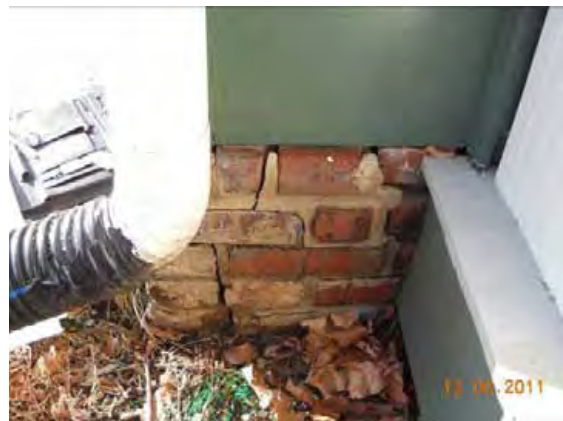
Figure 3-124: Deteriorated bricks and mortar, brick grade beam, southeast corner of west wing, PD 12/6/11

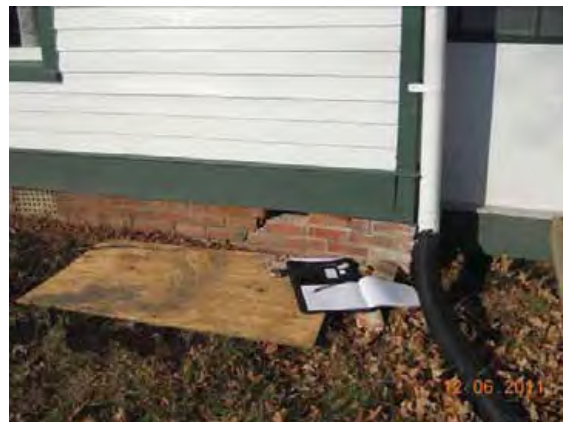
Figure 3-125: Cracking and Rowlock brick easily removed from south grade beam of west wing, PD 12/6/11

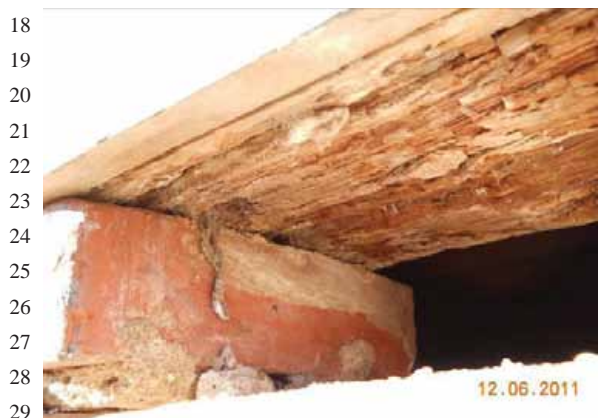
Figure 3-126: Decayed wood sill plate (or beam?) on brick grade beam, south wall west wing, PD 12/6/11

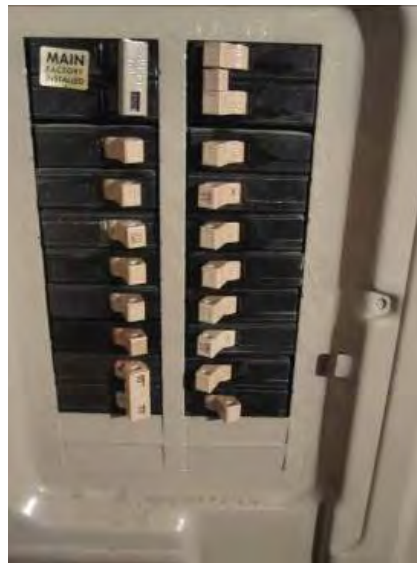
Existing infrastructure appears to be sized appropriately for the loads served, equipment is in fair condition with 10-15 years of remaining useful life.

Figure 3-127: Existing main electrical panel, Jon Brooks 12/6/11

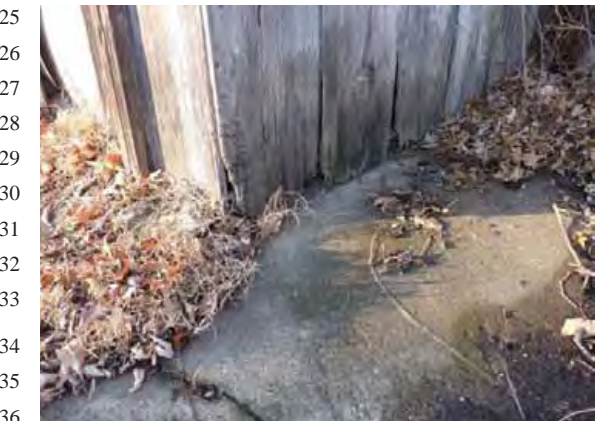
Figure 3-152: Bottom of wall showing decay and no foundation, PD 12/6/11

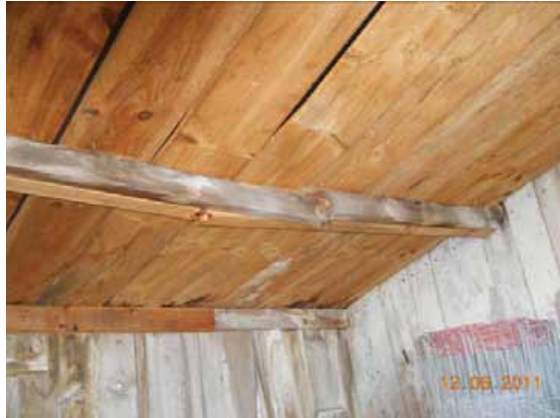
Figure 3-153: Cracked original and new 2x4 purlins, PD 12/6/11
