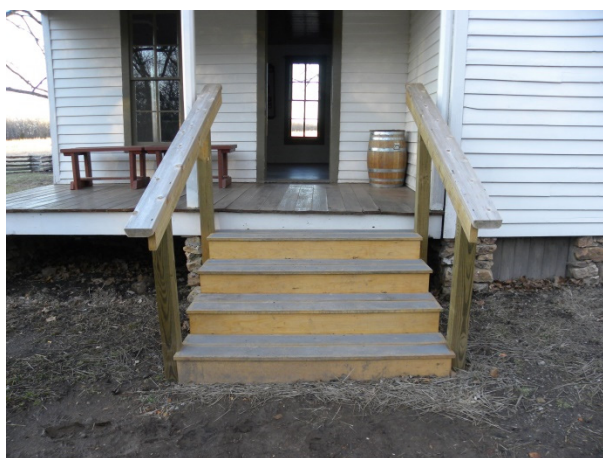
3 **FIGURE 129.** View of the rear porch stair and floor.
4 The porch stairs were rehabilitated in 2014.

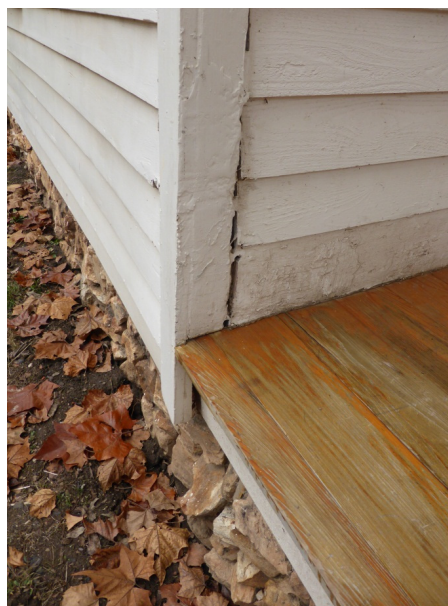
7 **FIGURE 131.** Detail of the junction of the front porch
8 and the main house showing the separation of siding
9 and porch elements caused by settlement and
10 movement.

11 The house is generally in good condition and is
12 well maintained. The paint coating at exterior
13 wood siding, trim, and window sashes is
14 performing well, although the transparent porch
15 floor finish is worn and in fair to poor condition
16 due to wear and weathering. Some minor
17 settlement has occurred since the building was
18 rehabilitated in 2005. Evidence of this settlement
19 occurs at the southwest and southeast corners of
20 the house; the settlement is causing some
21 separation of wood trim elements at the porch
22 floors and wood siding (refer to Figure 131). The
23 rubble stone masonry foundation is in good
24 condition. It appears that the stone was repointed
25 in 2005, but it is unknown if the entire foundation
26 was rebuilt. The exterior wood doors are in good
27 condition; they are somewhat protected from the
28 elements by the cover offered by the porches. The
29 open riser wood stairs are in fair condition and

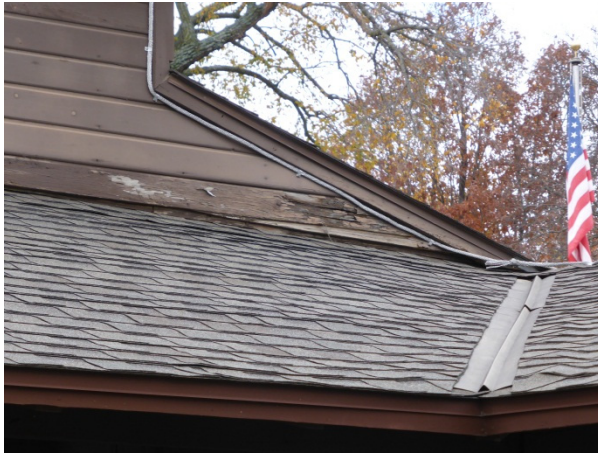
FIGURE 137. Detail showing the deteriorated siding and paint at the junction of the breezeway roof and the visitor center.

edges, gutters, and downspouts are in good condition, but paint failure is widespread. Wood siding is in various states of repair, from fair to deteriorated. Many areas of rotted wood siding were observed, especially at exposed high roof/wall junctions. The majority of the paint coatings at areas of wood siding was either faded or deteriorated. Other painted wood surfaces at underside of the eaves and the covered breezeway are in good condition.

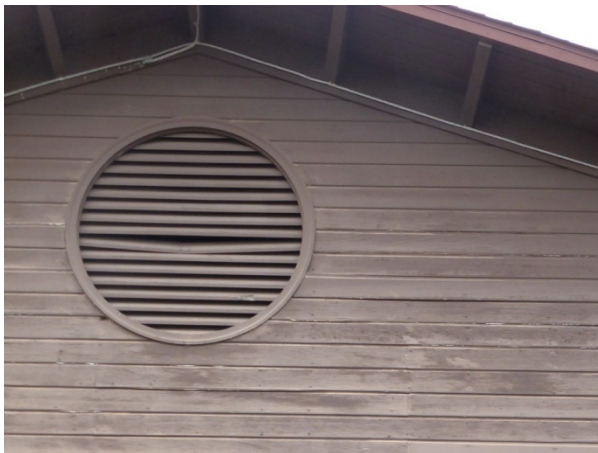
FIGURE 138. Detail of the warped and deteriorated wood siding and paint, as well as the damaged ridge vent, under the roof.

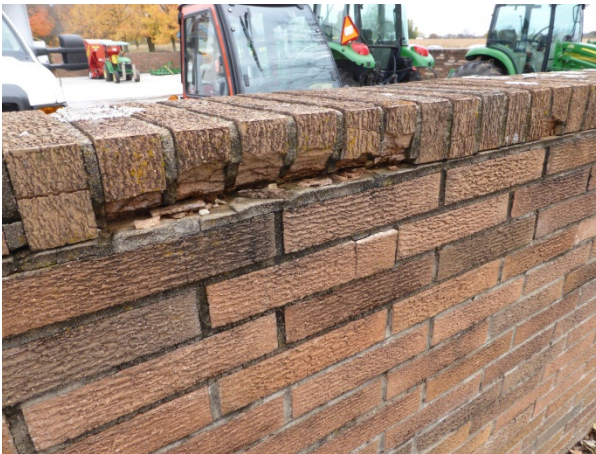
5 **FIGURE 142.** Detail of the deteriorated masonry wall
6 surrounding the maintenance yard.

32 The maintenance building is generally in fair
33 condition but contains some areas which are
34 experiencing advanced deterioration. Brick
35 masonry is in good condition, with no evidence of
36 settling or deteriorated mortar. Limestone
37 window sills and decorative panels, while
38 containing some organic growth or dirt, are also in
39 good condition. Steel windows are in good to fair
40 condition, with some peeling paint and
41 deteriorated sealant. Three-tab asphalt shingles
42 and the majority of the wood fascia and metal drip
43 edges are in good condition, but paint failure is
44 evident. The overhead doors appear to be
45 operable and in fair condition. The low brick
46 masonry walls surrounding the maintenance yard
47 are in poor condition. Large areas of spalling
48 masonry and eroded mortar are evident at the east
49 and west sections of the enclosure wall.

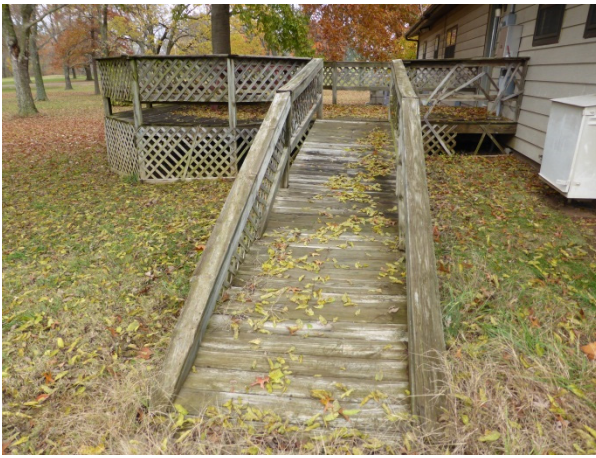
FIGURE 146. Detail of a deteriorated wood ramp and deck behind the Superintendent's residence.

The residence is generally in fair to poor condition. The siding, while mostly intact, shows signs of fading paint and deterioration. Some metal fascia panels are missing, and many are loose, allowing water into the cladding systems and causing deterioration of wood wall elements. Shingle roofing systems are also in fair to poor condition. Several loose and detached asphalt shingles are evident. Paint and sealant at the wood windows is also in poor and deteriorated condition. Both wood ramps and the rear deck contain organic growth and many warped and rotted members. Two large ground mounted HVAC units located at the rear of the house are ducted into the main house. These units are apparently still in use to provide heating and cooling to the residence but their age and condition is unknown.

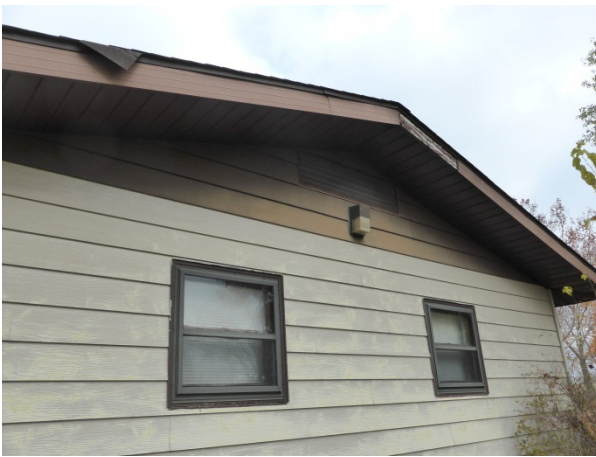
FIGURE 147. Detail of the west gable showing the deteriorated fascia and roofing.

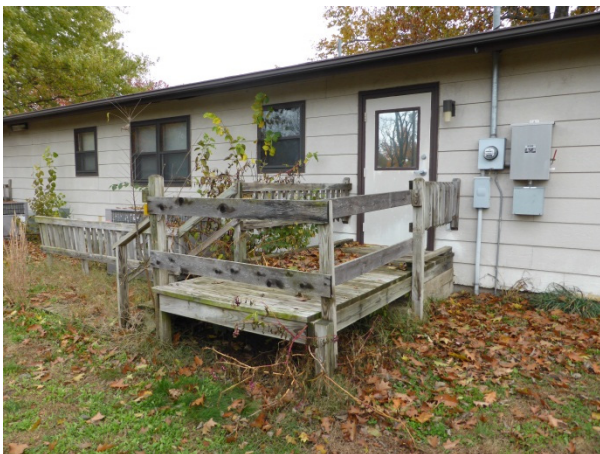
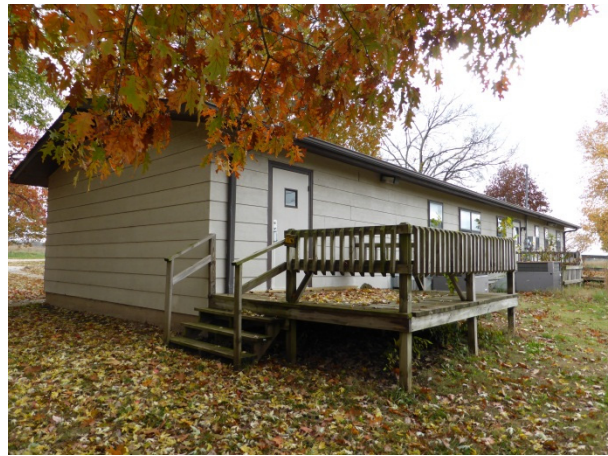
5 **FIGURE 150.** Detail of the rear wood deck.

6 **FIGURE 151.** Detail of the rear wood deck.

27 The residence is generally in poor condition. The
28 siding is deteriorated, with fading paint and areas
29 of rot or deterioration. Wood fascias are warped
30 and have severely deteriorated paint coating. Paint
31 and sealant at the wood windows are also in poor
32 and deteriorated condition. The wood ramp and
33 two rear decks contain many warped, rotted, and
34 missing members.

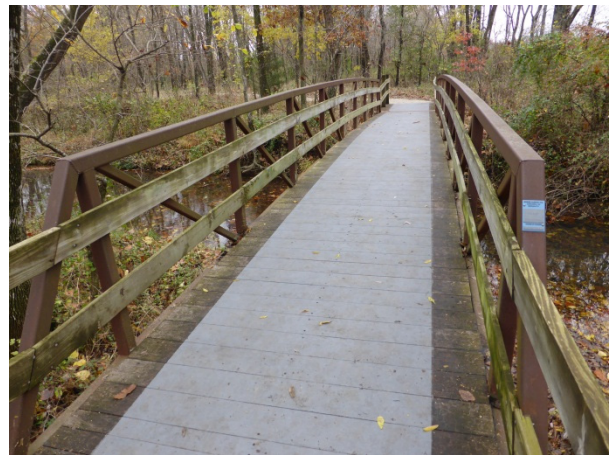
23 **FIGURE 161.** View of wood decking and the wood
24 railings.

31 Both bridges are in good to fair condition. The 2x6
32 wood railings are warped and contain organic
33 growth. Several elements of the wood approach
34 structures also have rotted wood components
35 including vertical posts and railings. Corten steel
36 elements appear to be in good condition and are
37 performing well. Paint at the wooden bridge floor
38 is worn in some areas and also contains organic
39 growth.
