Morris Arboretum's Urban Forestry Consultants

RE: Brick Walkway at 2nd Bank Building – National Park Service

At your company's request, I met you and Kathryn Diserens from the National Park Service to inspect tree-related issues for the brick walkway around the 2nd Bank building at Independence Square on 09 July 2013. This report details findings, discussions, and recommendations from my site visit.

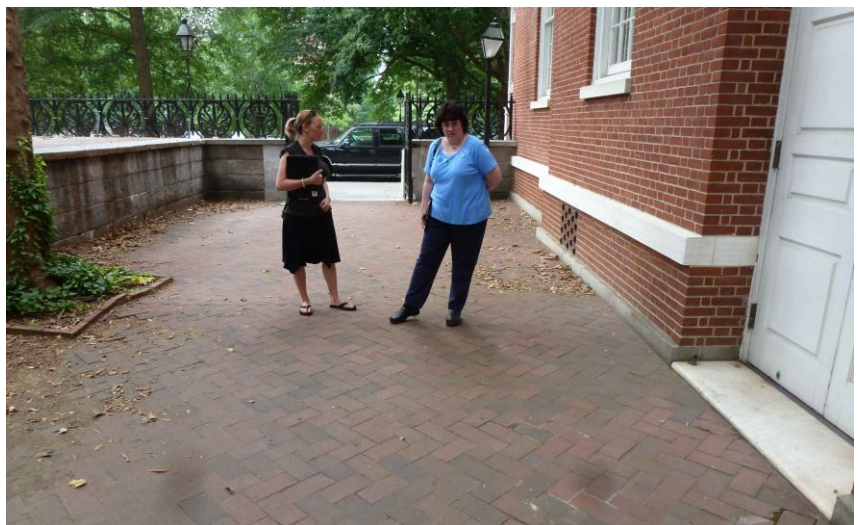
Photo 1: Kathryn (NPS) and Debby (Hunt Engineering) standing on area that is raised from tree root growth (note hump on tree pit border). This raised area is directing stormwater towards Library Hall entrance on right.

The roots of the southwestern-most tree are causing stormwater to flow towards Library hall where, purportedly during extreme rain events, stormwater flows over the ~1" high threshold into the building.

Stormwater issues: The goal for stormwater runoff is to have it flow down the middle of the walkway and into the drain on the southeast side without ponding or overflowing into Library Hall. One way this can be accomplished without harming tree roots is by installing ½ thickness frost-resistant bricks in the walkway's center in such a way as to join the full-size bricks evenly, without causing a tripping hazard. This will decrease the present brick level about 1 ½ inches, perhaps more if there is clearance between the brick and tree roots. If the Library Hall entrance requires more protection from runoff, walkway bricks could be raised gently to become level with the marble threshold; however, this may conflict with the historical fabric of Library Hall as the threshold was originally elevated from the sidewalk given that it has a full bullnose (1/2 rounded face). All brickwork should be done without damaging tree roots.

- In the area between the most southwestern tree and Library Hall entrance, install ½ thickness frost-resistant bricks in the walkway's center in such a way as to join full-size bricks evenly, without causing a tripping hazard. This should be done in such a way as to encourage stormwater to flow down the walkway's center.

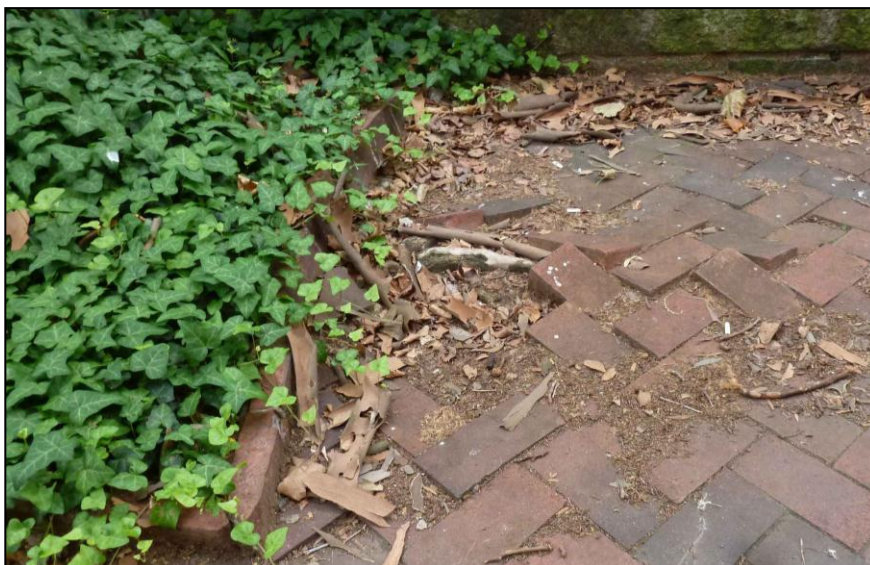
- **Brick Displacement:** Many bricks have been displaced by root growth; nearly all of the displaced bricks are directly adjacent to the tree pits (Photo 2).

Photo 2: Tree roots displacing brick just outside of tree pit.

The most egregious brick displacement issues occur around the tree's base, where structural roots must expand more radically to hold the tree upright. Therefore, to largely eliminate tripping hazards from displaced bricks, it would be prudent to expand the tree pits from five foot wide to 15 feet wide and add about two feet of width (east-west) to the pits. Quadrupling the tree pit's area will also benefit the tree, as small tree pits constrict tree growth. Increasing the pit size will not substantially impact/constrict pedestrians using the walkway.

- Increase all of the west-side tree pits from 5' x 5' to 15' x 7' to eliminate tripping hazards. Care should be taken when bricks are removed/installed not to wound tree roots. Removed walkway bricks should be retained and used to patch the area of concrete from the electrical repair. Fill in new pit areas with high-quality topsoil.

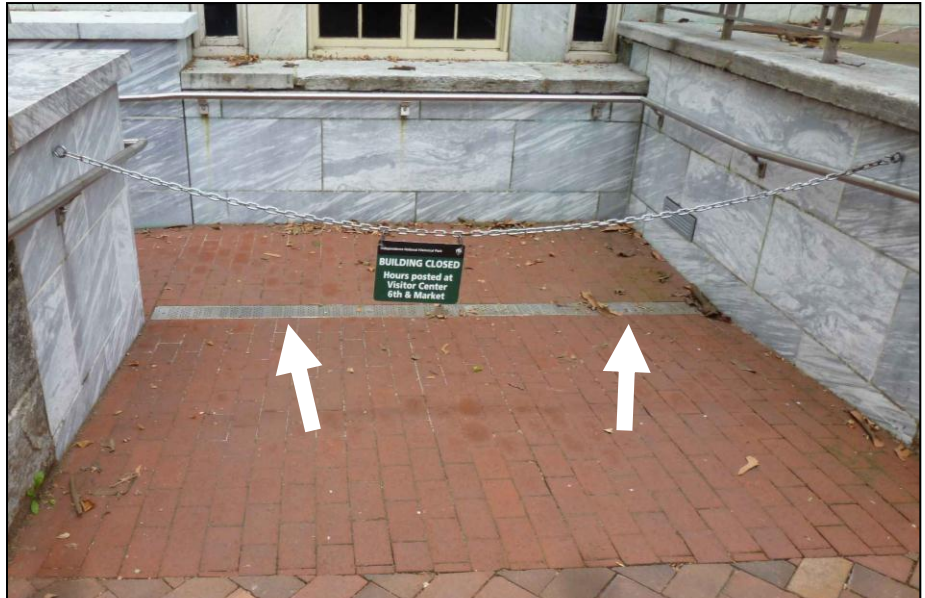
- **Trees clogging gutters/drains:** Kathryn stated that the 2nd Bank building's roof gutters were being clogged by the London plane's leaves and seeds, and that the trench drains in the basement access walkway (Photo 3) get clogged with seeds.

However, they are living organisms that must be maintained, especially in an urban setting. Part of that maintenance includes cleaning roof gutters and trench drains. These types of drainage devices must be periodically cleaned to function properly. Cleaning drains becomes a vital activity during the late summer-fall or when leaves and seeds drop.

Photo 3: Trench drain on basement walkway

- Establish a maintenance program for the roof and trench drains that anticipates the timing of seed and leaf fall.
- Remove the ivy and Virginia creeper from the tree trunks every two years at minimum.

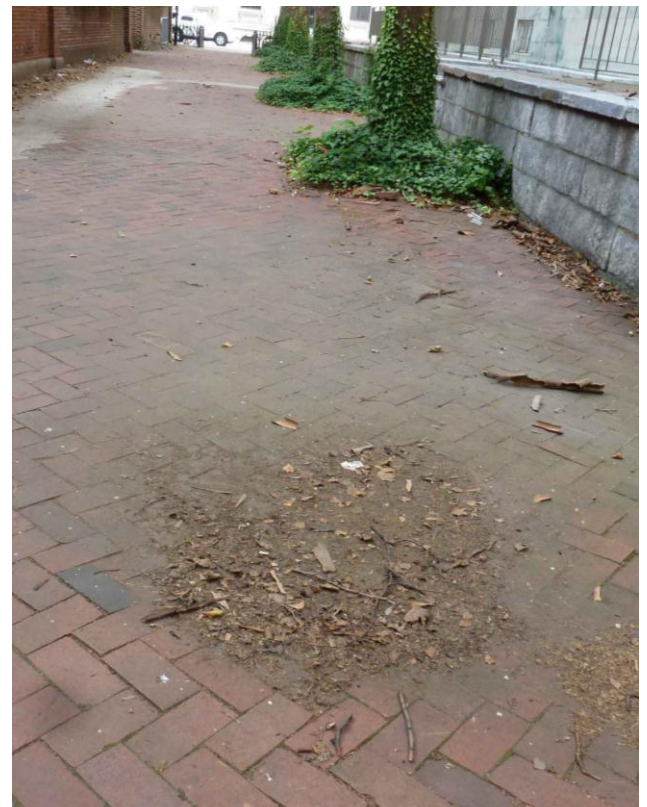
results in small areas where stormwater ponds as well (Photo 4).

Photo 4: Stormwater ponding behind raise in grade due to of root growth.

Areas of water ponding should be identified and demarked; and the present bricks could be lifted, sand backfilled and reset to reduce or eliminate water ponding.

- Identify and demark areas of stormwater ponding on the walkway. Within these areas, lift the bricks and backfill enough sand so that the areas will be level with or above the surrounding walkway when the bricks are reinstalled.
