# Northern Hydrology & Engineering

## **TECHNICAL MEMORANDUM**

**Re: Recommendations for Trail Crossings and Erosion Sites for Redwood Creek Trail Project**

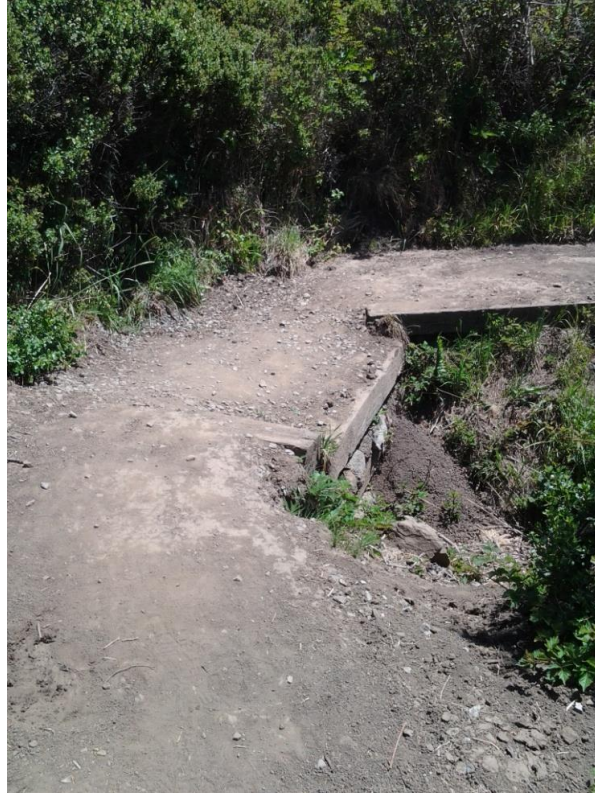
A crib wall (2.2 ft high, 5 ft wide, and 8.1 ft long) is installed across the drainage at Bridge 10 (Figure 1, Figure 2). Bridge 10 will be replaced by a spanning bridge (design by others). The channel in the vicinity of the crib wall is densely vegetated upstream with shrubs and vines, downstream is relatively open with some grasses, poison oak and blackberry. Upstream of Bridge 10, a sediment plug has filled the channel creating a relatively flat grade. The sediment plug is approximately 30 feet long and has a small incised channel running through it. The onsite sediment is mostly soil with sparse 2 - 4 inch rock. Downstream of the crossing, the channel has an approximate grade of 23%, the width of the channel bed varies around 1.2 ft, while the top width is around 4.5 feet.

**Figure 2. Crib wall at Bridge 10. Photo credit: GGNPC**

The recommendations for Bridges 10, 11 and 12 are to remove the crib wall and construct a rock lined channel in its place (See Appendix I, Sheet C1). The design rock channel will stabilize the upstream sediment plug and dissipate hydraulic energy from the drop. The design channel will conform to existing bed slope and bank grade at the upstream and downstream tie-ins. All disturbed areas will be covered with erosion control fabric and re-vegetated (See Appendix I, Sheet C1 and Appendix II).

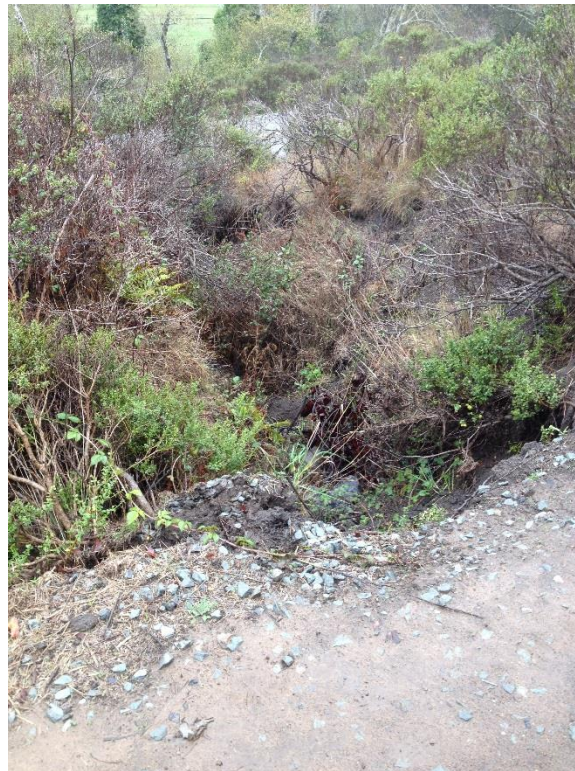
There are no erosion control features at the crossing to protect the trail tread during storm events. A loose pile of large rock has been placed in the channel below the spur trail to slow erosion, but the rock is being actively undercut and new failures are occurring adjacent to the large rock.

**Figure 3. Trail Crossing 2, looking downstream at actively eroding channel.**

- Trail Crossing 2 Action: Maintain wet trail crossing and reduce excessive erosion with rock structure.
  - C DPR Trails staff determined that upgrading the trail crossing to a bridge, similar to other sites would require substantial changes to the trail and placement of additional infrastructure.

- C DPR design includes:
    - Grading of downstream channel bank, construction of an armored wet crossing, rock wall to protect the trail and a rock energy dissipater. Rock will be extended downstream in the channel and along the left and right banks to control erosion.

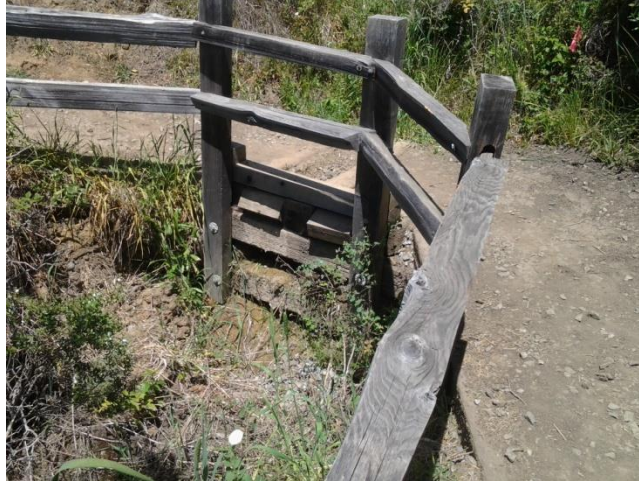
A crib wall (3.2 ft high, 5 ft wide, and 7.6 ft long) is installed across the drainage at Bridge 11 (Figure 1, Figure 4). The trail is cut into the hillslope on the north and south sides of the crib wall. Bedrock is exposed on the north side of the crossing and on the south side of the channel. The channel flows over the top of trail/crib wall. A split rail fence borders the trail crossing on the down slope side. Bridge 11 will be replaced by a spanning bridge (design by others). The channel in the vicinity of the crib wall is densely vegetated with shrubs, vines and small trees. Downstream of the crossing, the channel has an approximate grade of 7%, the width of the channel bed varies around 2 ft, while the total channel width is around 5 feet. Upstream of Bridge 11, a sediment plug has filled the channel creating a relatively flat grade. The sediment plug is approximately 26 feet long and has a small incised channel running through it. The onsite sediment is primarily soil, but there is a significant component of 2 - 12 inch rock.

**Figure 4. Crib wall at Bridge 11. Photo credit: GGNPC**

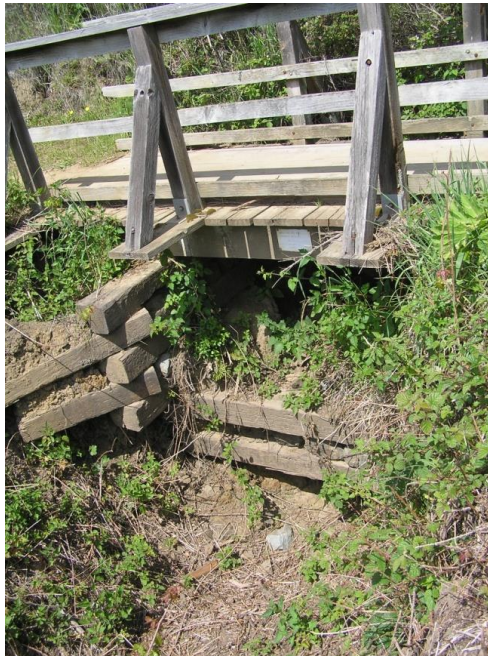
A crib wall (3.2 ft high, 4.7 ft wide, and 5.8 ft long) is installed across the drainage at Bridge 12 (Figure 1, Figure 5). On top of the crib wall parallel to the banks of the channel, wood beams and rock serve as bridge abutments. A wooden bridge rests on these abutments spanning the crib wall and allowing water to pass under the bridge and over the crib wall (Figure 5). Bridge 12 (crib wall and existing bridge) is scheduled to be replaced by a spanning bridge (design by others). The channel in the vicinity of the crib

wall is densely vegetated with shrubs, vines and small trees. Downstream of the crossing, there is a small channel within a gully that has an approximate grade of 14%, the width of the smaller channel bed varies around 1 ft, while the total small channel width is around 4 feet. Upstream of Bridge 12, a sediment plug exists although the dense vegetation obscures reasonable vantage to determine its extent. The onsite sediment is primarily soil, but there is a significant component of 2 - 8 inch rock.

**Figure 5. Crib wall at Bridge 12. A wood bridge spans the crib wall. Photo credit: GGNPC**

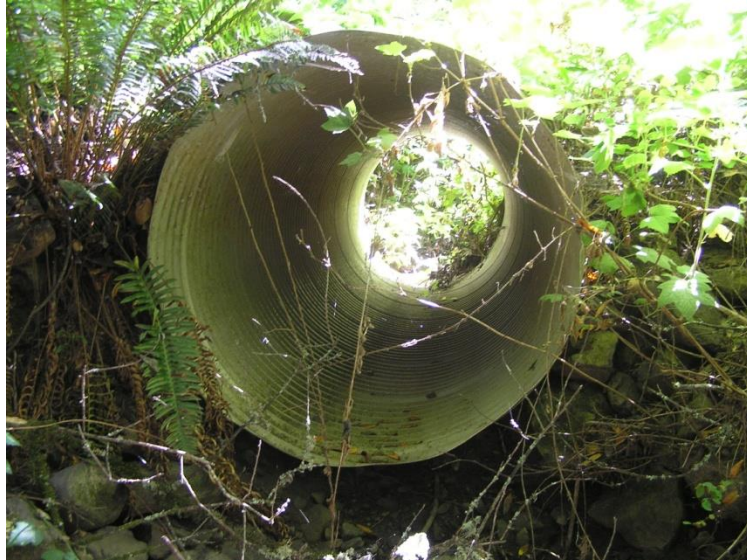
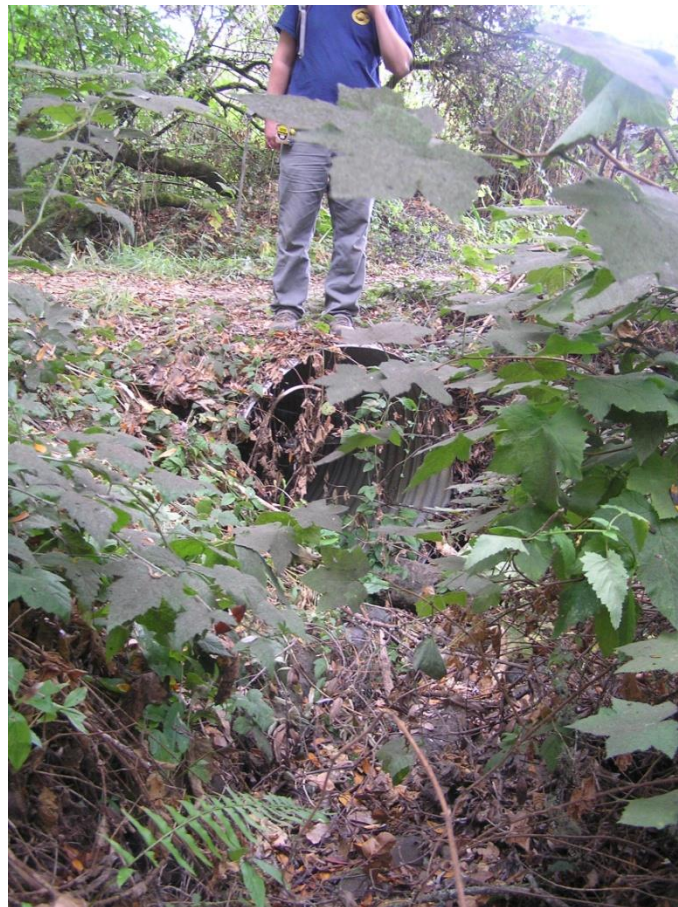
Culvert 1 (4 ft diameter, 14 ft long) is a metal culvert (Figure 1, Figure 6 and Figure 7). The trail in the area of Culvert 1 is scheduled to be decommissioned. The culvert appears to have been placed near channel grade, but at the outlet there is a ~18 inch deep scour hole. The culvert has a minimal fill prism with a soil cap (<0.5ft) that creates the trail crossing. Upstream, both banks are lined with manmade rock walls that are approximately 10 feet long and ~5 feet tall. Downstream, on the right bank, a two terrace rock walls line the bank and are approximately 8 feet long and ~5 feet tall. The culvert bedding material and the extent the rock walls protrude into the banks is unknown. The channel is fairly open in the vicinity of Culvert 1 and the over bank areas are well vegetated. The channel bed is a gravel/cobble mix (1/2 to 7 inch). The banks beyond the rock walls are primarily soil. The channel slopes are 7% upstream and 1-2% downstream. The culvert grade is estimated at 2.6%.

**Figure 6. Culvert 1, looking upstream through culvert. Photo credit: GGNPC**

**Figure 7. Culvert 1, looking downstream. Photo credit: GGNPC**

- Culvert 1 and 3 Action: The trail and crossing will be decommissioned.
  - Decommissioned crossings will be restored. This action includes:
    - Removal of the culvert and all associated structures including, but not limited to, rock walls, wood retaining walls, etc.

The general recommendation for culvert sites is to remove the culvert and all associated structure including, but not limited to, rock walls, wood retaining walls, etc. The design channel geometry for the culvert sites is based on the measured channel bottom width upstream and downstream of the crossing and a target bank side slope of >1.5H:1V. Bank slopes, bed width and top width transition to conform to existing bed width and bank slopes at the upstream and downstream tie-in. The channel slope will transition from the upstream channel grade to the downstream channel grade.

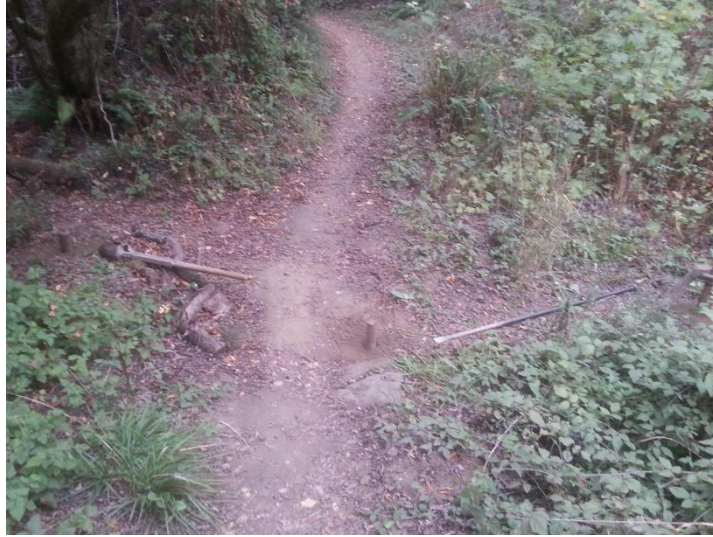
Trail Crossing 1 is a wet crossing on the Miwok Trail (a spur trail off of Redwood Creek Trail) approximately 90 feet upstream of Culvert 1 (Figure 1). The trail in the area of the wet crossing is scheduled to be decommissioned. The channel shallows and widens in the downstream direction as the channel approaches the trail, typical of a sediment wedge. Downstream of the trail, there is thick vegetation overlying woody debris where layers of intertwined woody material ranging from 2 to 6 inches diameter. While there was an obvious drop downstream of the woody material, the channel bed and banks were too obscured with vegetation to assess whether there is active erosion occurring in the vicinity of the crossing. There is no visible infrastructure associated with the trail crossing, no subsurface structures were discovered during investigative digging (Figure 8). Given the lack of infrastructure and established vegetation, no additional site work beyond the general recommendations for trail decommissioning is recommended.

**Figure 8. Trail Crossing 1, a stream crossing on Miwok Trail. Displayed in the photo are the investigative digging locations (round posts sticking out of the ground): the trail hole where the digging bar is pointing (photo center), the upstream hole where the post hole digger is pointing, and the downstream hole where the handle end of the digging bar is pointing (far right in the photo). Photo credit: GGNPC**

- Trail Crossing 1: The trail and crossing will be decommissioned.
  - No additional site work is recommended due to lack of infrastructure found at the wet crossing (no culvert, crib walls, etc.) and presence of dense vegetation downstream of crossing.

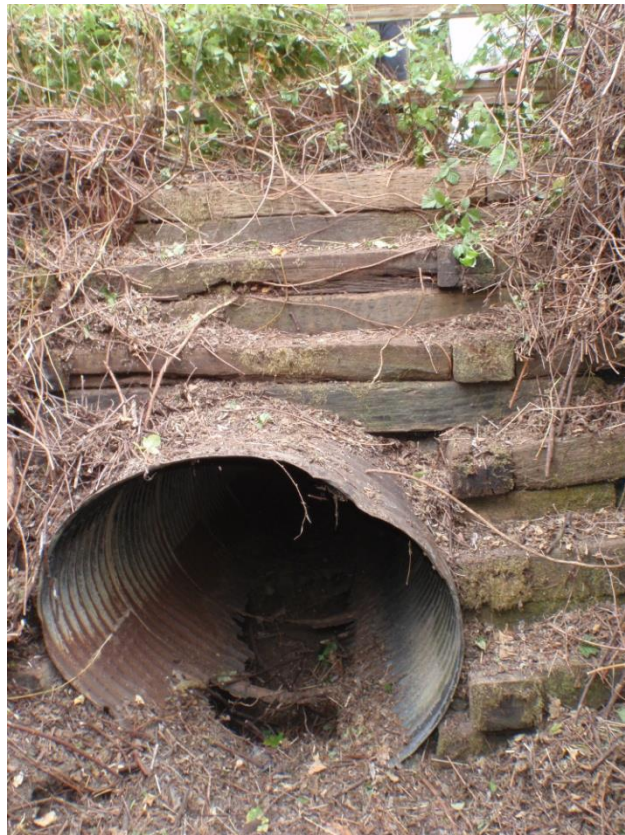
Culvert 3 (4 ft diameter, 20 ft long) is a metal culvert (Figure 1, Figure 9). The trail in the area of Culvert 3 is scheduled to be decommissioned. The culvert appears to be at grade with the channel bed but the bottom of the culvert has rusted away and this has created scour pockets under the culvert. The culvert has a fill prism of unknown material that creates the trail crossing, the fill is contained from the channel bed to the trail (~7 feet) by a wood beam retaining wall on both ends of the culvert. The extent the wood retaining walls extend into the banks is unknown. The culvert bottom has rusted away in some areas and it appears the culvert bedding may be native material. The channel in the vicinity of Culvert 3 is fairly open, but the banks and over bank are densely vegetated. The channel bed upstream is finer grain material, than the channel downstream, which has coarse material (4-6 inch) that lines the channel bed. The banks are primarily soil.

**Figure 9. Culvert 3. Photo credit: GGNPC**

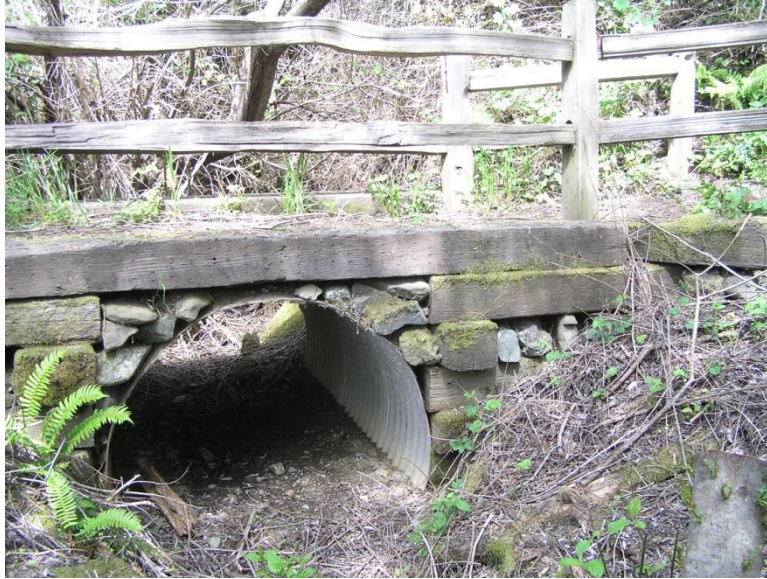
Culvert 4 (4 ft diameter, 8 ft long) is a metal culvert that intersects Redwood Creek Trail (Figure 1, Figure 10). The culvert is to be replaced by a spanning bridge (design by others). The culvert has a natural layer (~4 inches) of deposited bed material lining its bottom, and sits at grade with the channel bed. The culvert has a minimal fill prism of unknown material that creates the trail crossing and is retained with a combination of rock and wood beams, including wood wing walls. The culvert bedding material and the extent the wood and rock retaining material extend into the banks is unknown. There are wood controls in the channel bed upstream and downstream of the culvert. The channel in the vicinity of Culvert 4 is fairly open, but the banks and over bank are fairly vegetated. The channel bed is primarily soil with some scattered rock (1/2 to 6 inch diameter). The banks are primarily soil. No significant erosion exists in the vicinity of the culvert.

**Figure 10. Culvert 4. Photo credit: GGNPC**

- Culvert 4 Action: Maintain and upgrade trail crossing from a culvert to a bridge.
  - Remove the culvert and all associated structure including, but not limited to, rock walls, wood retaining walls, etc. Bank slopes, bed width and top width transition to conform to existing bed width and bank slopes at the upstream and downstream tie-in. The channel slope will transition from the upstream channel grade to the downstream channel grade.

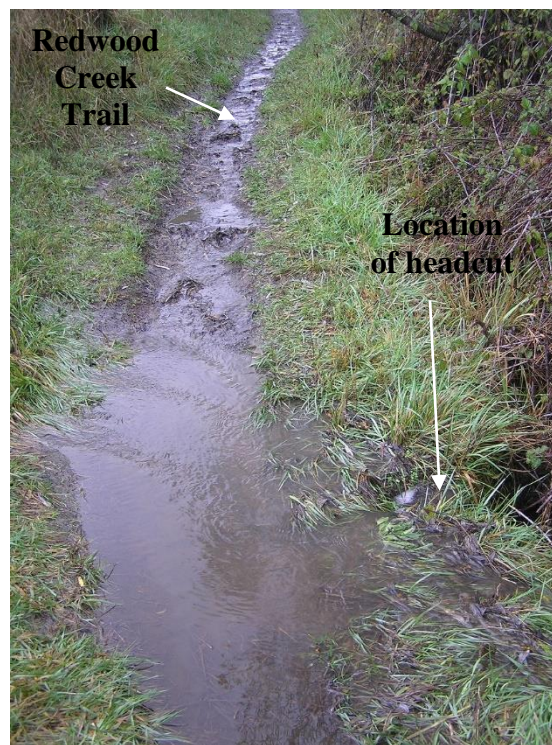
Erosion Site 1 is a small headcut that has developed immediately adjacent and downslope of Redwood Creek Trail, about 75 feet northeast of Erosion Site 2 (Figure 1, Figure 11). The headcut is currently at the edge of the trail and has begun to cut underneath it. Downslope of the headcut, there appears to be a broader swale that extends to the Redwood Creek channel. This broader swale may be a former trail alignment or cattle access point. The active portion of the headcut appears to have formed at a low point in the trail grade as the trail traverses a hillslope. Flow concentrated along the trail enters the head of the channel (Figure 11). Upslope, there is not defined channel or erosional features. The trail in the area of Erosion Site 1 is scheduled to be decommissioned.

**Figure 11. Erosion Site 1 is a small headcut that has developed immediately adjacent and downslope of Redwood Creek Trail (in the picture, the headcut is at bottom right where water is flowing off the trail). Photo credit: GGNPC**

The recommendation for Erosion Site 1 is to demolish the trail, fill the headcut with soil and cover with erosion control fabric and re-vegetate (See Appendix I, Sheet C7). The headcut will be filled with native soil, covered with erosion control fabric, and re-vegetated (See Appendix II).

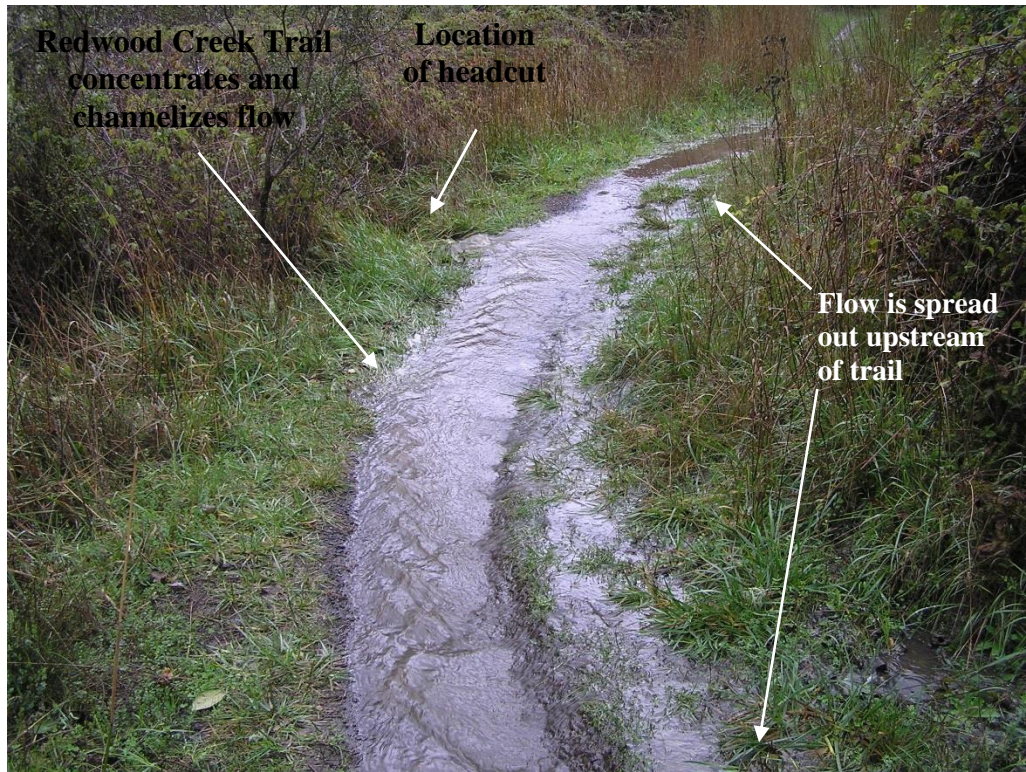
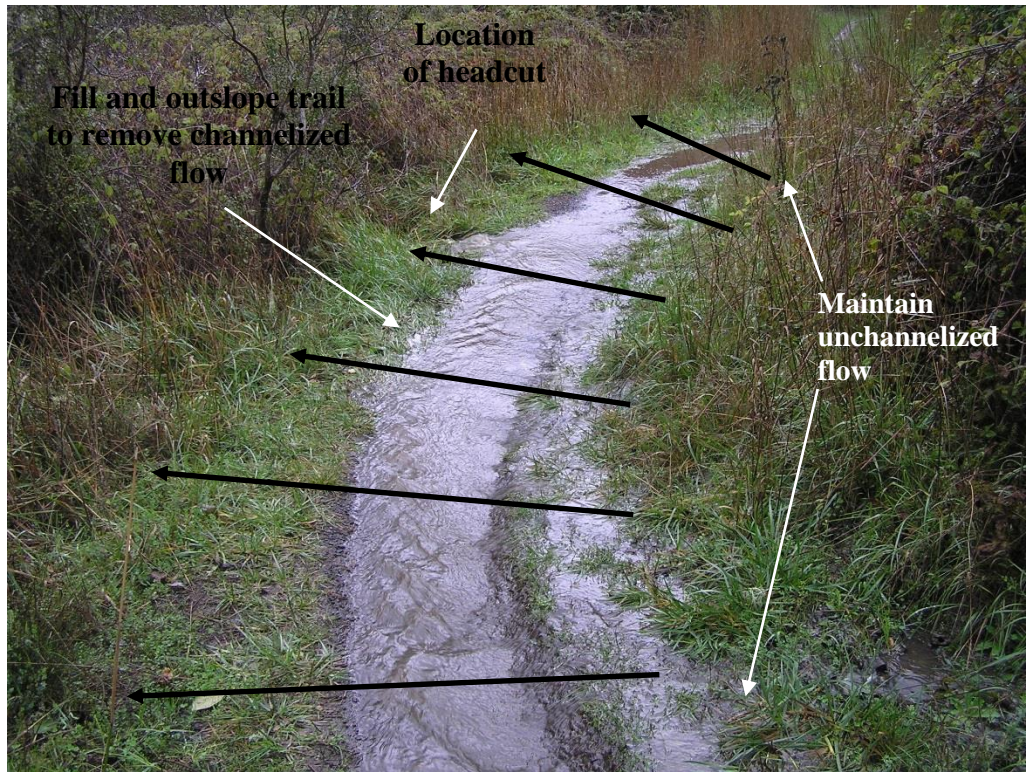
Erosion Site 2 is a small headcut that has developed immediately adjacent and downslope of Redwood Creek Trail (Figure 1, Figure 12). The trail in the area of Erosion Site 2 is scheduled to be decommissioned. The headcut has formed at a low point in the trail grade. Upslope of the erosion area (~300 feet) a well-defined larger swale is evident, nearer the trail (~25 feet) a shallow channel (4 inches deep) is evident but ceases to be defined at the trail. The headcut adjacent to the trail is associated with water that flows directly down the swale, but also receives significant water flowing down the channelized trail grade (Figure 12). The headcut is currently at the edge of the trail and has begun to cut underneath it.

Below the trail and headcut the channel is defined (roughly 1 foot wide by 1.5 feet deep) and deepens toward Redwood Creek. Large tree roots cross the channel and form a ceiling over portions of the channel composed of roots and soil. Dense vegetation obscures much of the channel. From a vantage point below the trail, looking up the channel, it appears that another headcut is working its way upslope adjacent (north) to the aforementioned headcut. This headcut is likely forming due to concentrated trail runoff. The extent of additional erosion was obscured by vegetation.

**Figure 12. Erosion Site 2 following high rainfall. Water is flowing along Redwood Creek Trail into headcut. Photo credit: GGNPC**

**Figure 13. Erosion Site 2 following high rainfall with target flow paths that maintain unchannelized flow.**  
Photo credit: GGNPC

- Erosion Sites 1 and 2 Action: Decommission trail and stabilize headcut.
  - Apply erosion control fabric over re-contoured trail to ensure that re-channelization does not occur.

- Fill headcut(s) at a maximum slope of 2H:1V with native soil, cover disturbed areas with erosion control fabric, and re-vegetate.
  - Do not disturb existing woody vegetation

- Erosion Site 2: exposed portions of the channel between root masses may be carefully backfilled with logs and small woody debris to increase roughness, reduce erosion and promote trapping of fine sediments.
