## Riprap Condition Report

# **MUIR WOODS NATIONAL MONUMENT**

## **2016 REDWOOD CREEK RIPRAP ASSESSMENT**

March 2017

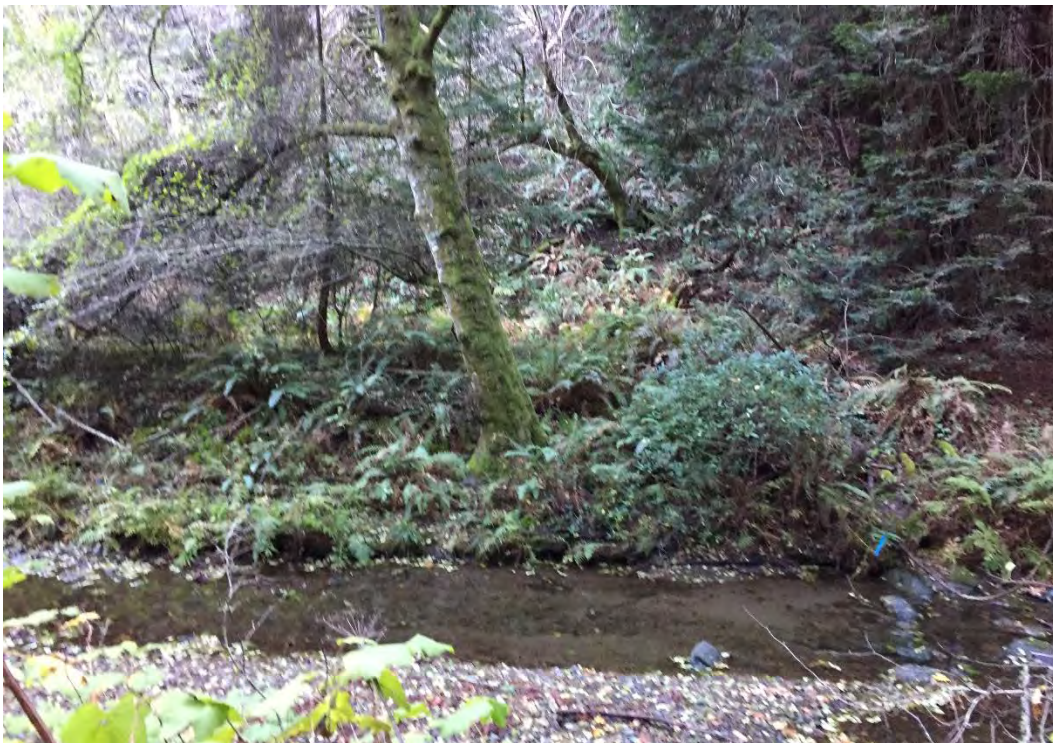
**Figure 8.** Center-west stretch of Section R1A, view south from creek bed, showing riprap in good condition beneath vegetation and with trees growing from some areas

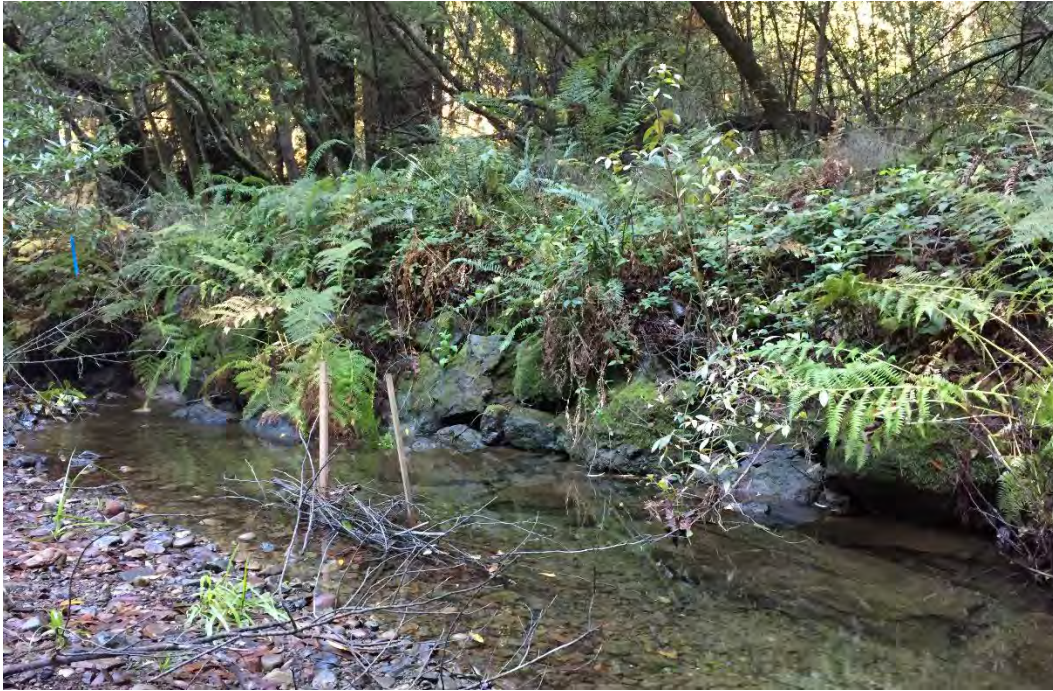
**Figure 9.** Eastern stretch of Section R1A, view south from creek bed, showing larger rocks, some of which are out of place

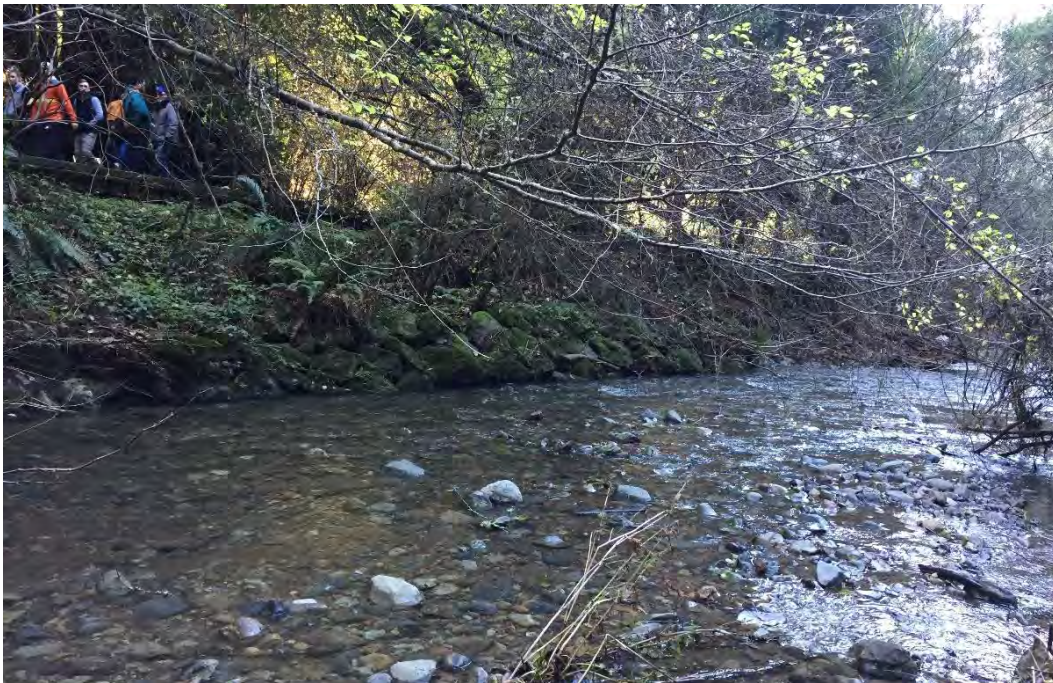
**Figure 12.** Section L1B and boardwalk, view east from right bank, stretch with medium rocks in fair to good condition center frame

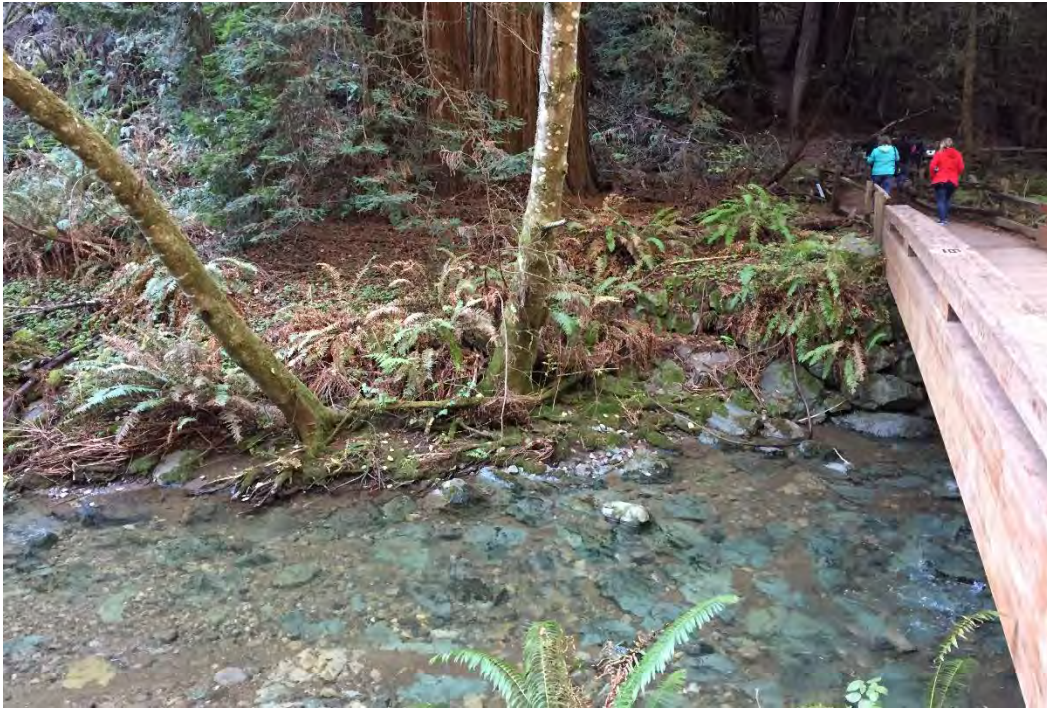
**Figure 14.** Section R1B and Bridge 1, view southwest from left bank, showing riprap in good condition under bridge and obscured by trees and ferns to the east

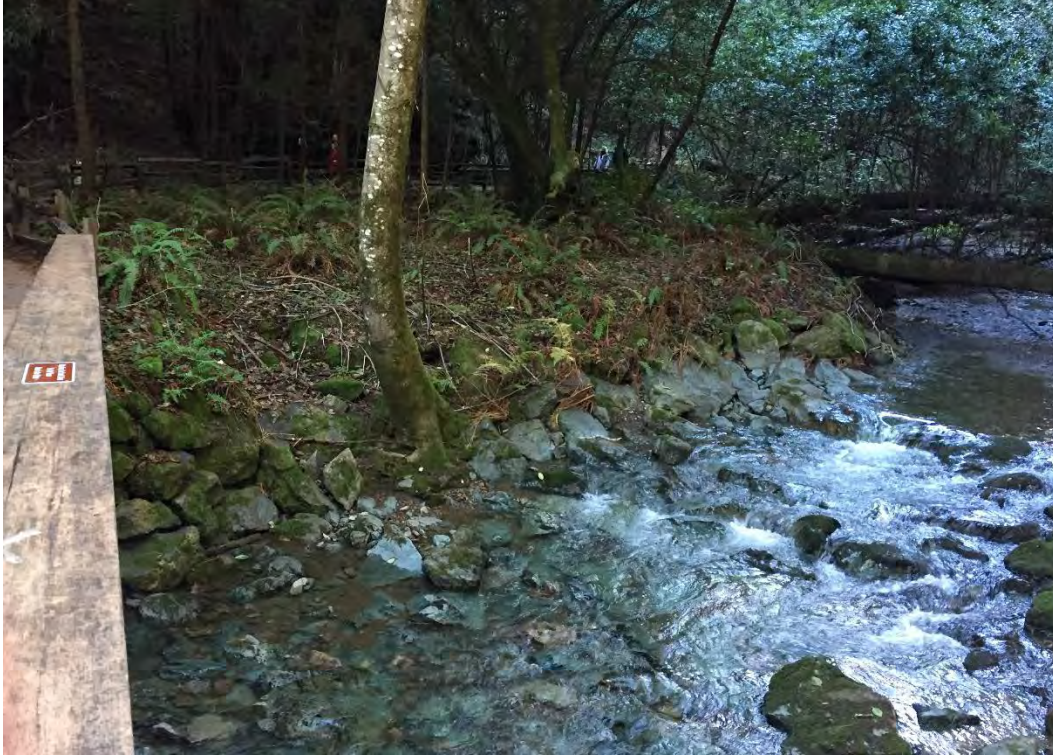
**Figure 16.** Western stretch of Section R1B upstream of Bridge 1, view southwest from Bridge 1, showing riprap in fair condition partially obscured by a tree and other vegetation

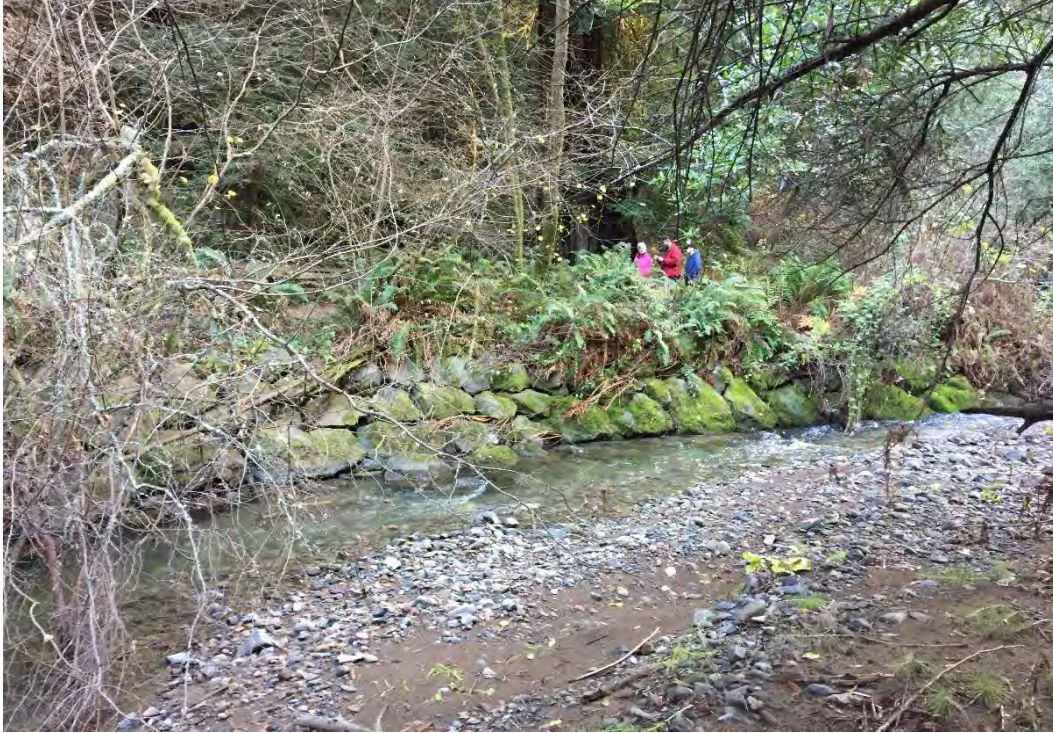
**Figure 18.** Section R2 viewed from left bank, camera facing southwest, showing tightly placed medium-sized rocks in good condition

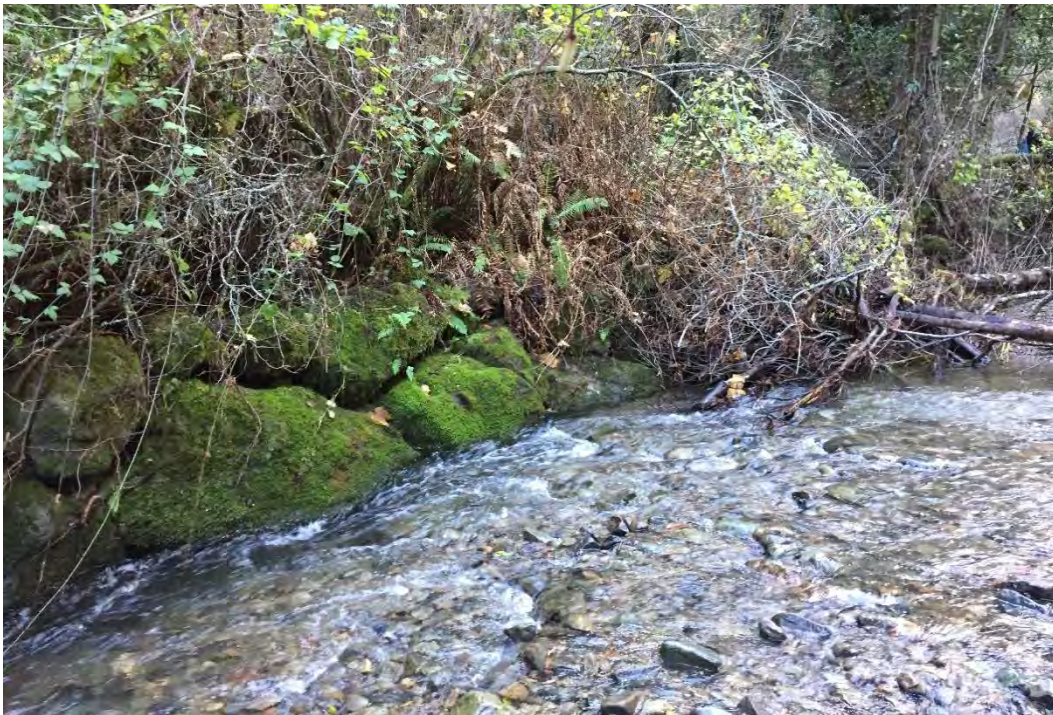
**Figure 19.** Section R2 viewed from left bank, camera facing west, showing upstream stretch with larger boulders in excellent condition

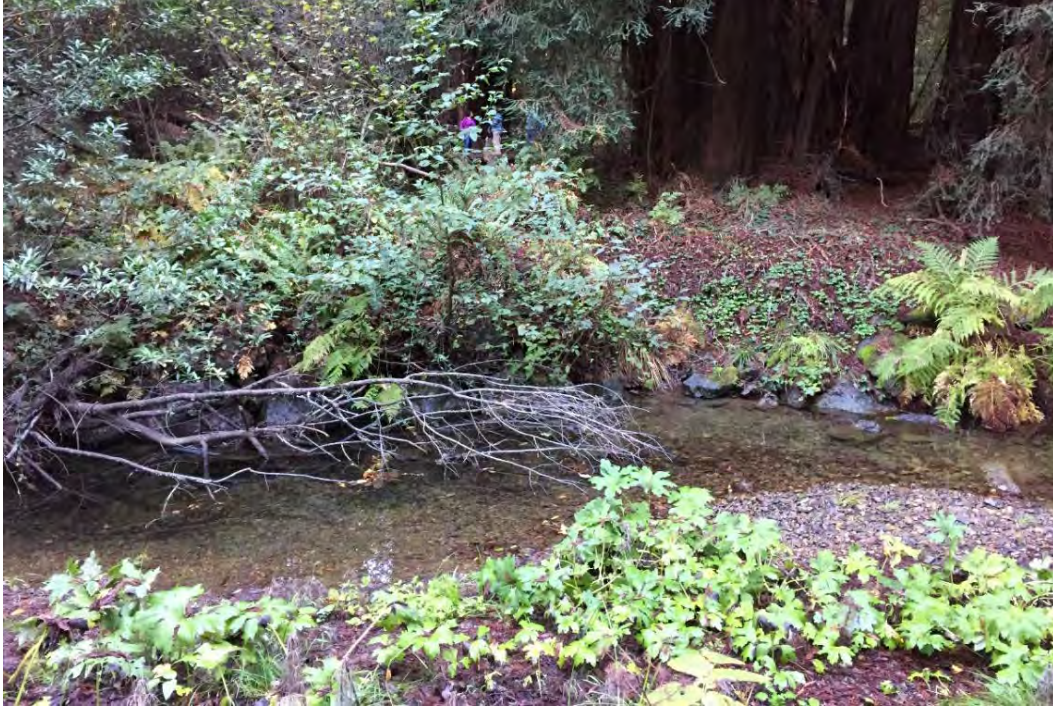
**Figure 21.** Central stretch of Section L2, view northwest from right bank, showing riprap in excellent condition beneath ferns and other vegetation

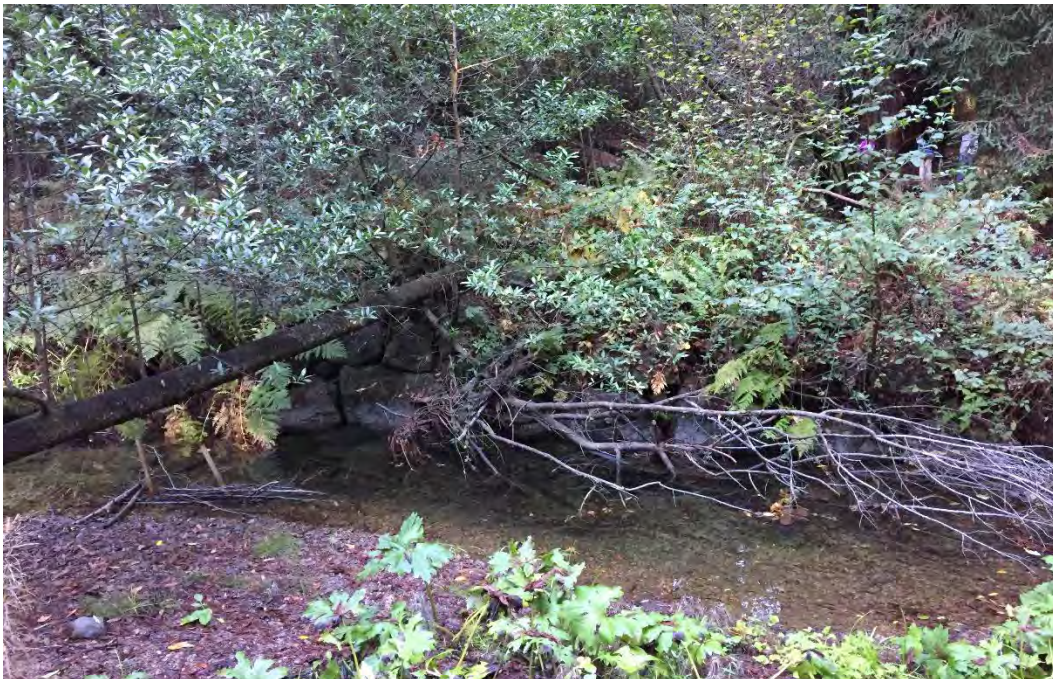
**Figure 22.** Northwest (upstream) stretch of Section L2, view north from right bank, showing riprap under vegetation and woody debris

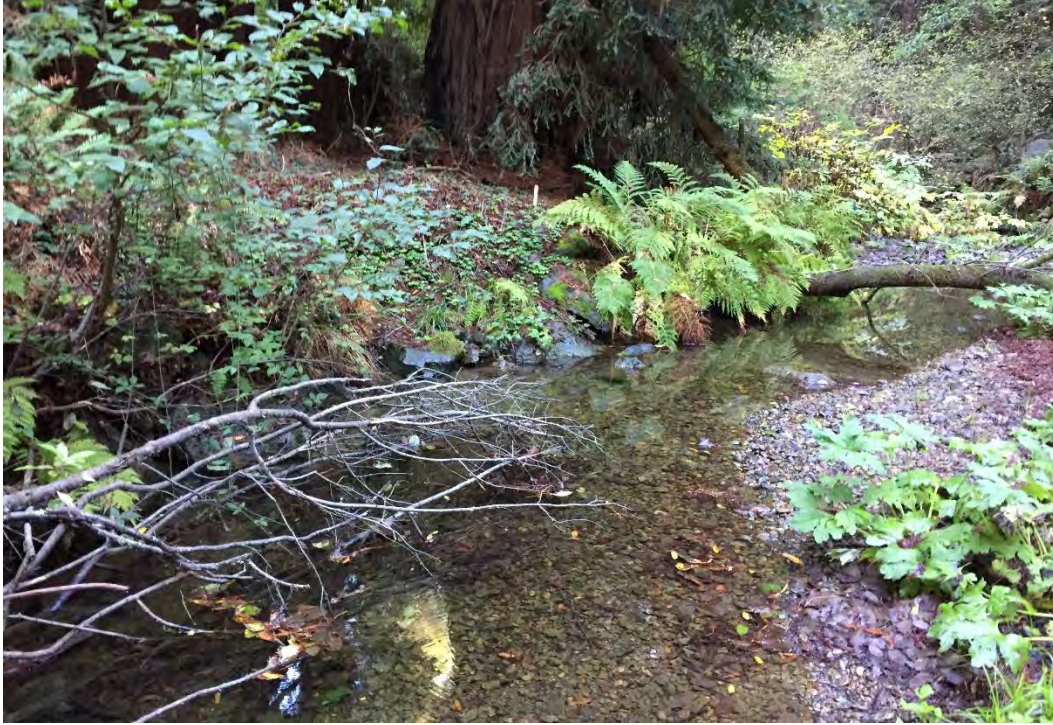
**Figure 23.** Poor condition downstream stretch of Section L2, view east from right bank, showing deteriorating riprap with woody debris, ferns, and other vegetation

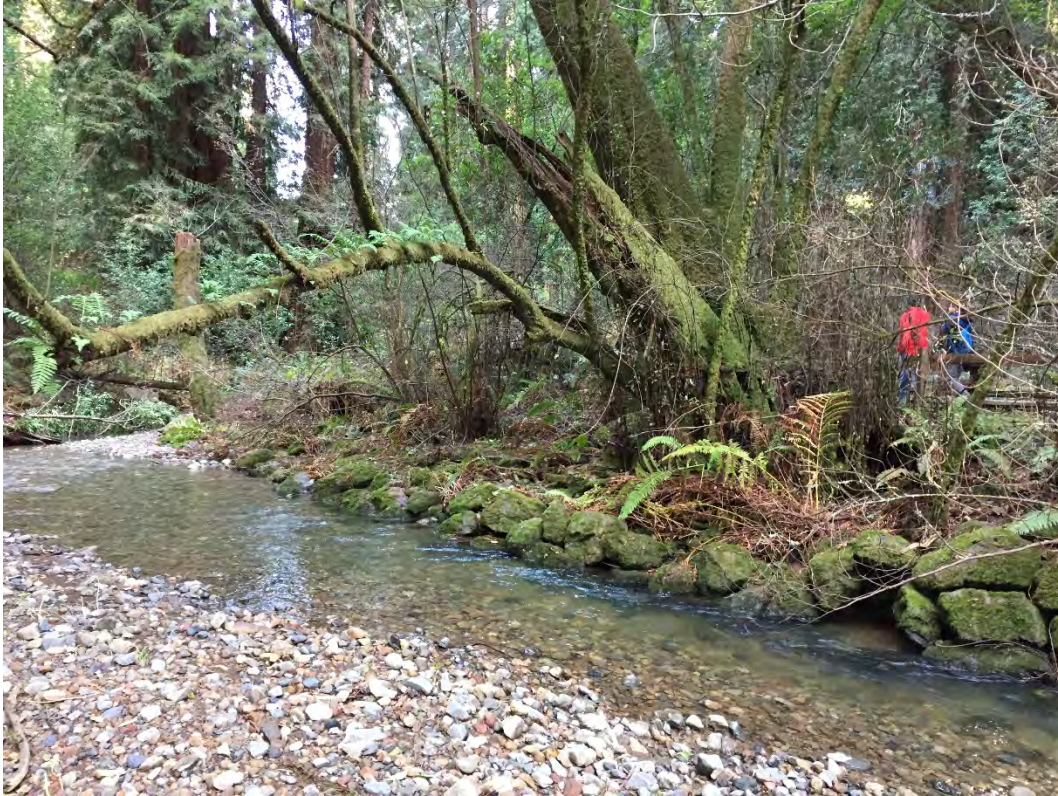
**Figure 26.** Section R3A from left bank, camera facing east, showing east stretch with 2-4 course riprap in excellent condition

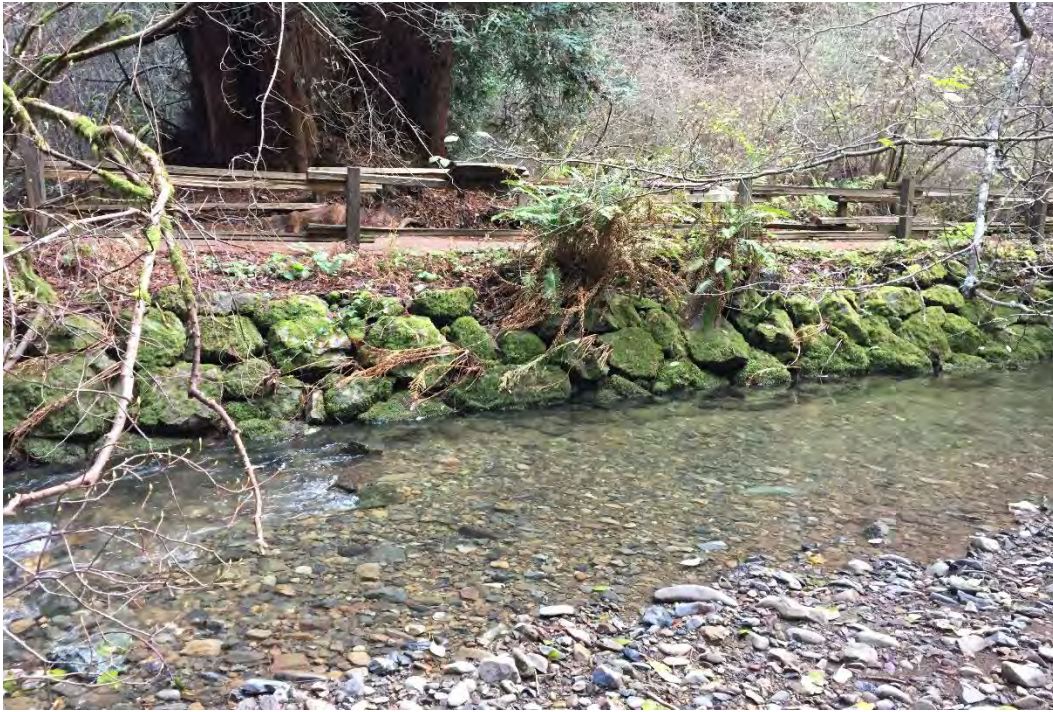
**Figure 27.** Section R3A from left bank with path visible in background, camera facing southwest, showing center-west stretch with 4-5 course riprap in excellent condition with minimal vegetation

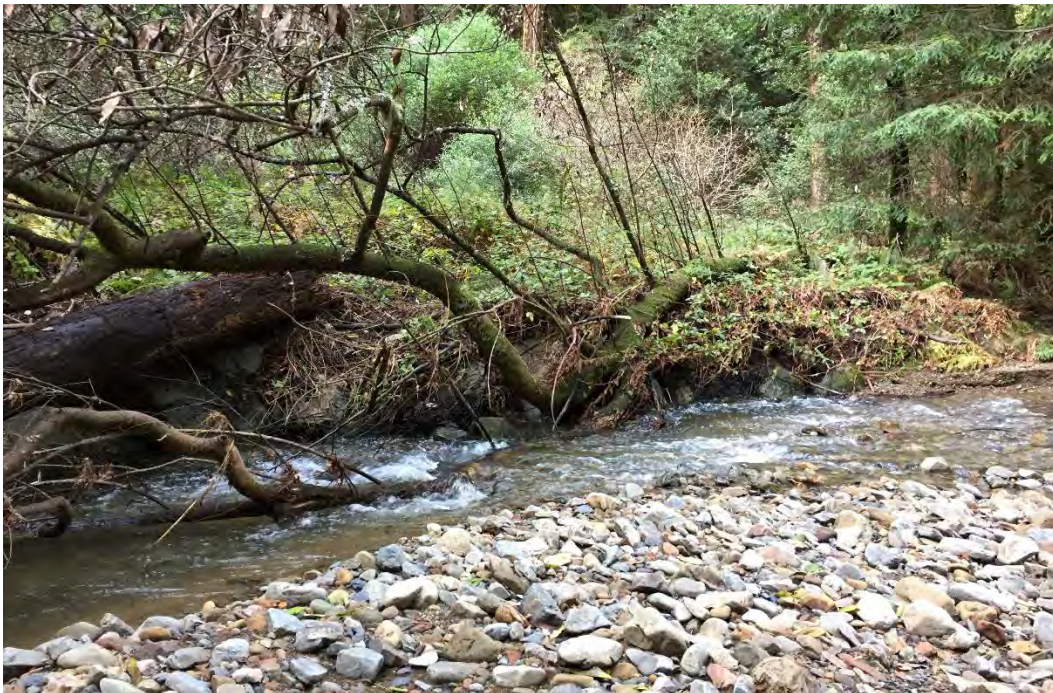
**Figure 28.** West stretch of Section R3A obscured by log jam viewed from left bank, camera facing west, riprap is in good condition beneath vegetation and woody debris

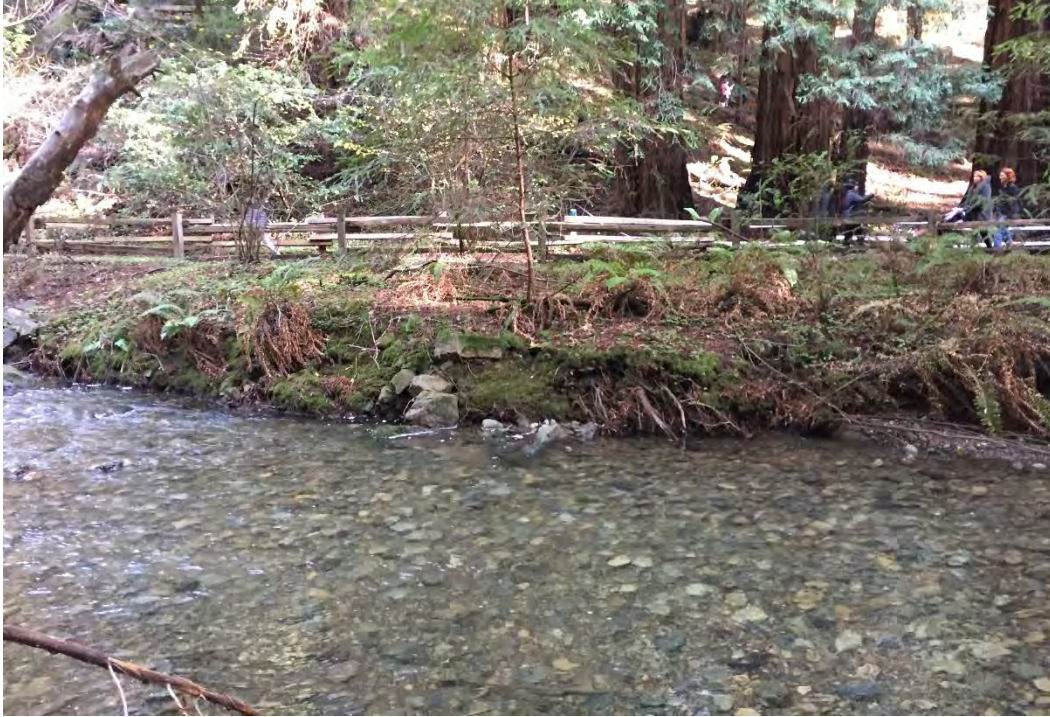
**Figure 33.** Section L3 seen from right bank, camera facing northeast, showing occasional rocks beneath moss, ferns, and other vegetation. The shape of the bank suggests riprap is in poor condition

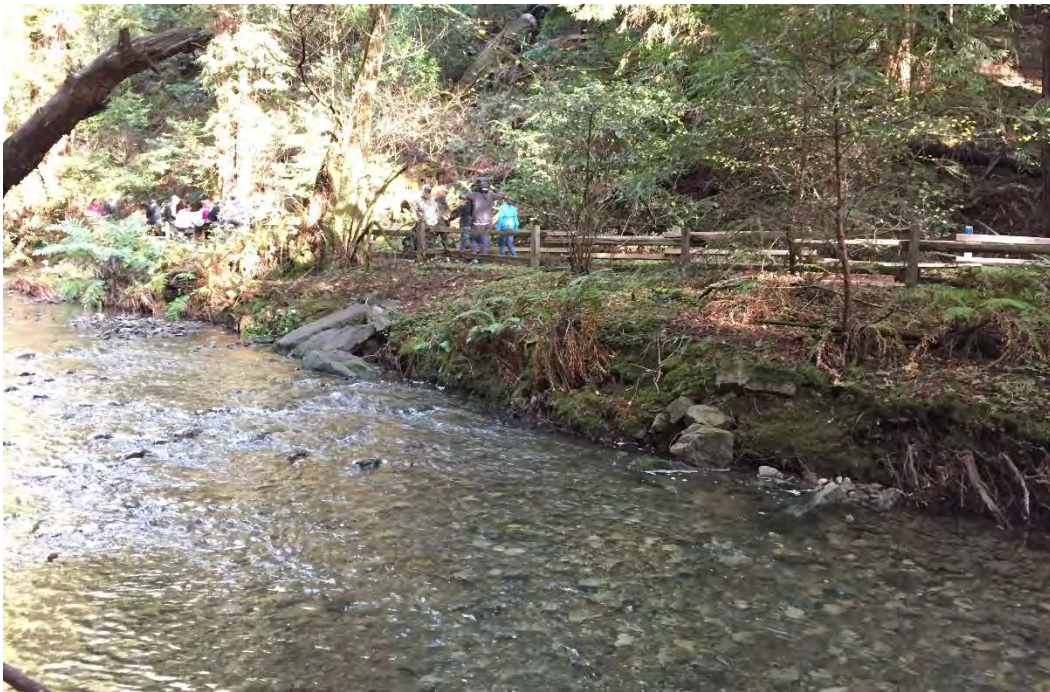
**Figure 34.** Overview of Section L3, camera facing east, showing area slightly to the east of Figure 30 which is also obscured by vegetation but appears to be in fair to poor condition

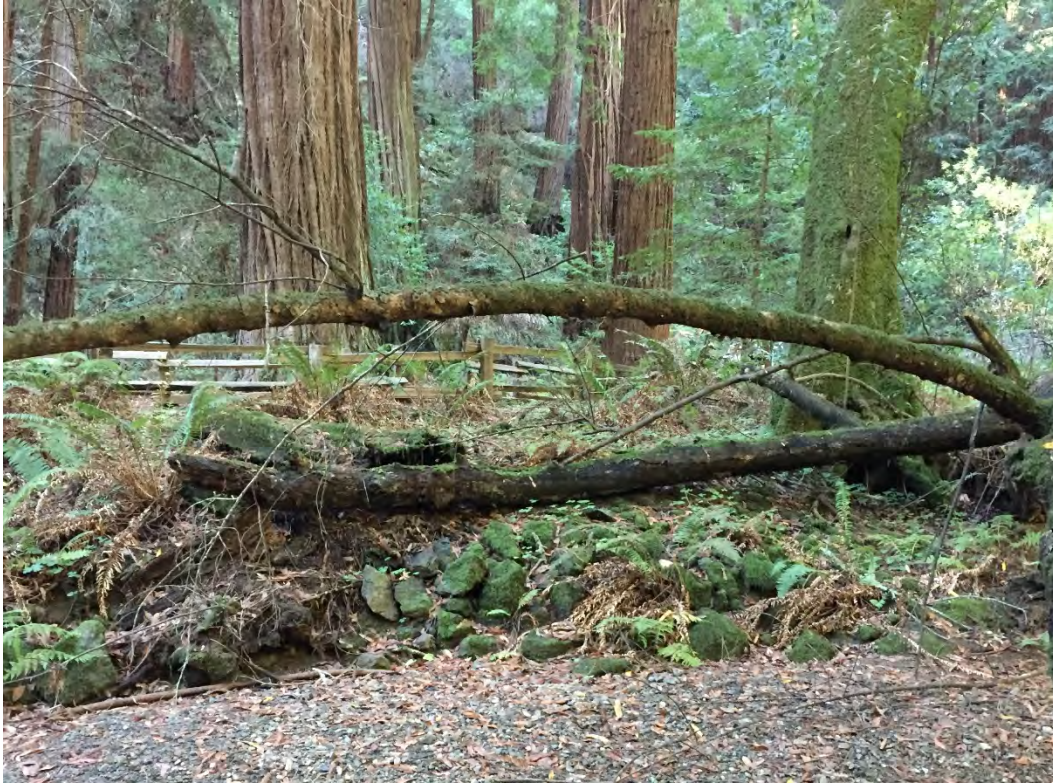
**Figure 36.** Overview of Section R4, view west, showing displaced riprap beneath fallen logs

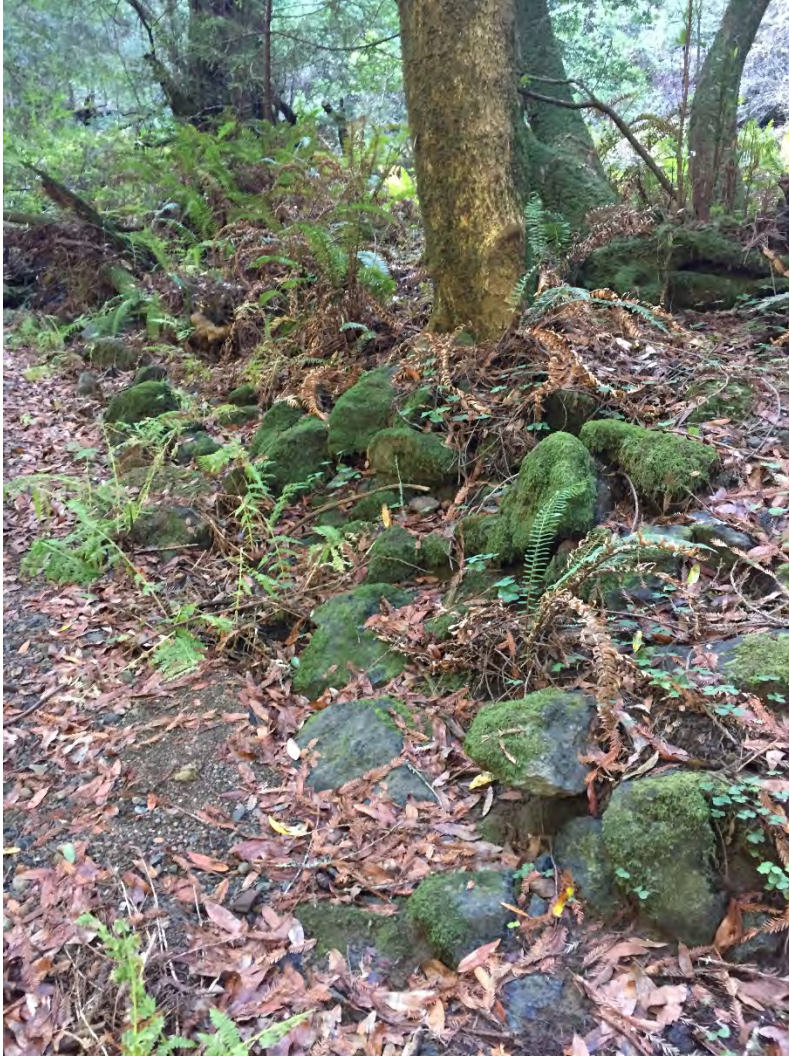
**Figure 37.** Detail, Section R4, view south, showing riprap in fair condition with ferns and a tree growing out of it

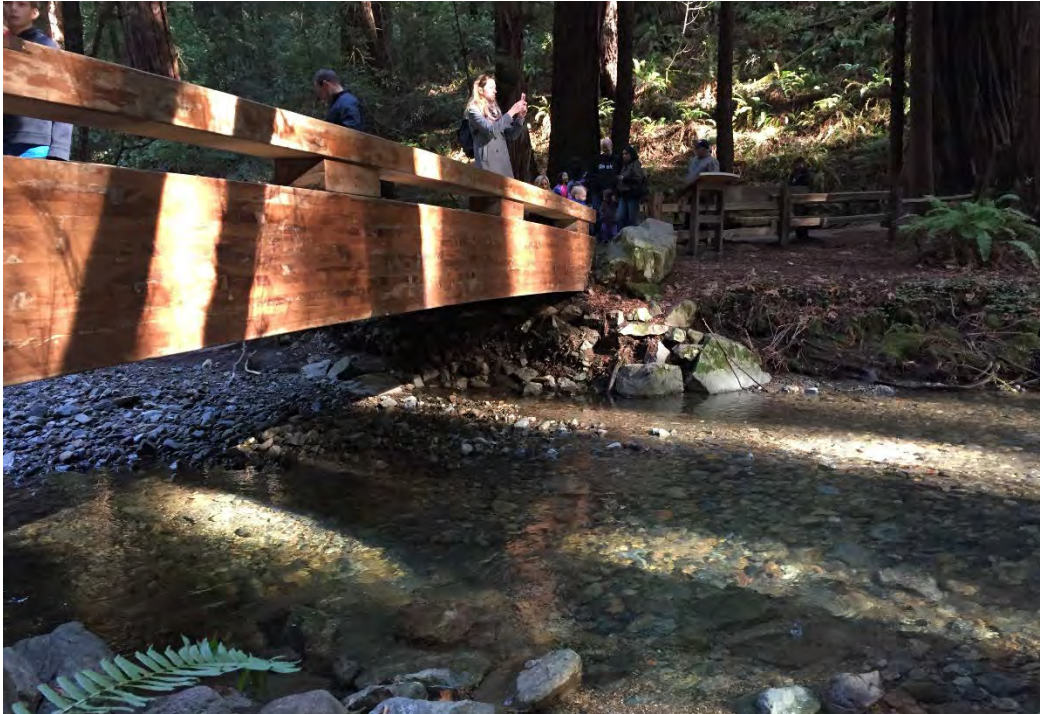
**Figure 39.** View of Section L4 from right bank, camera facing northeast, showing variable-sized displace rocks

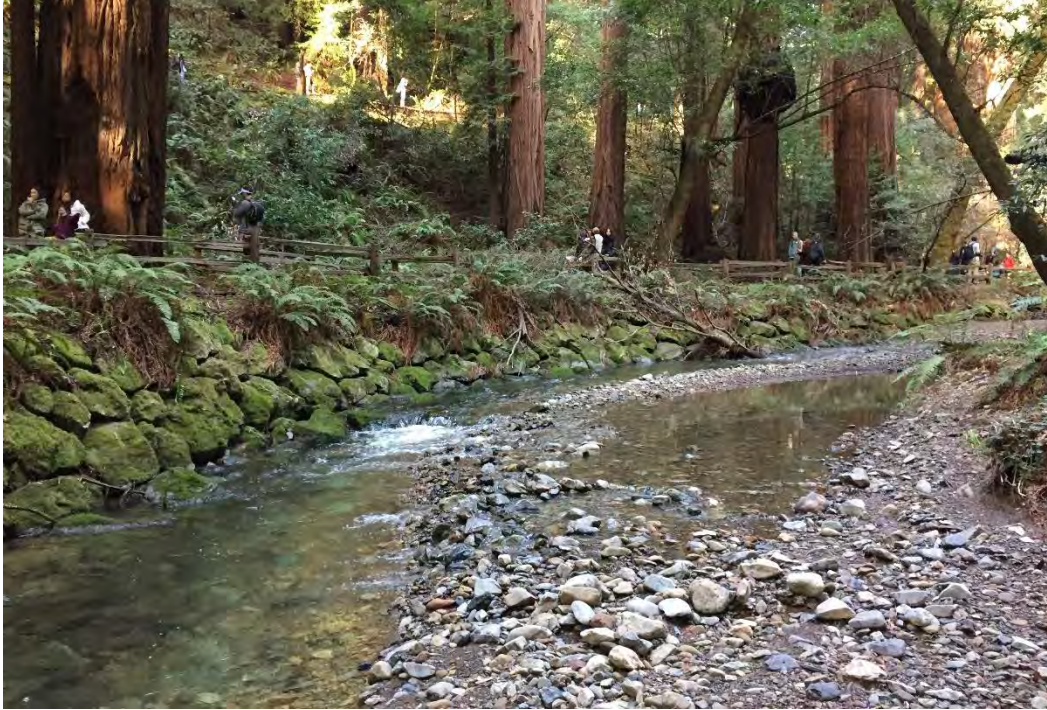
**Figure 42.** View of Section R4 with trail in background from left bank, camera facing northwest, showing medium-sized rocks in excellent condition with some light fern growth above

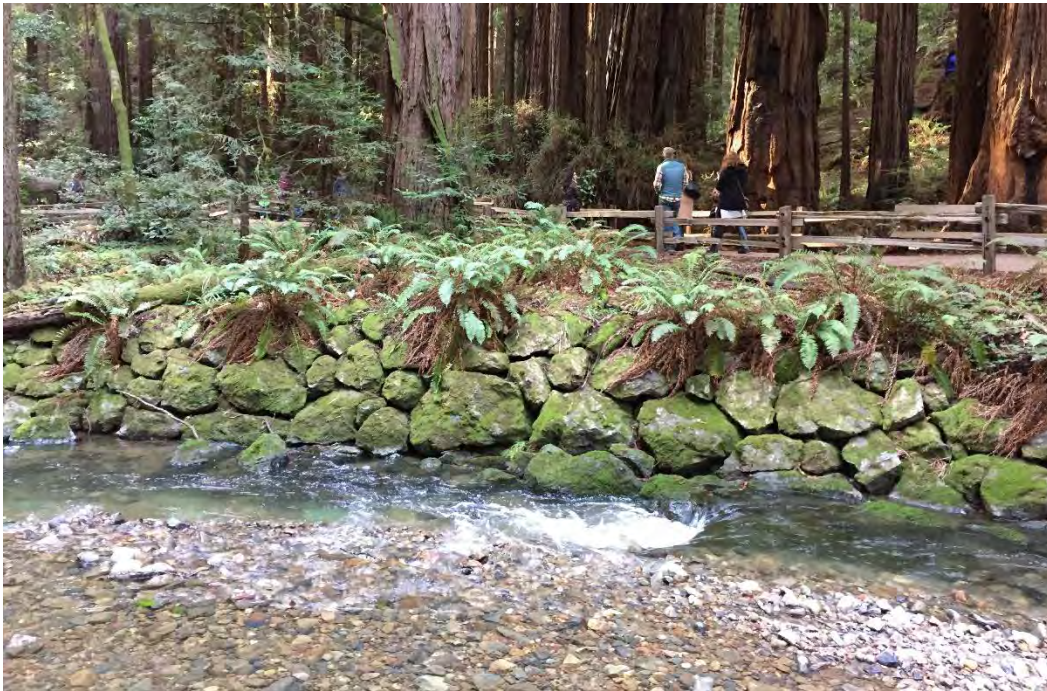
**Figure 43.** View of Section R4, camera facing southwest, large- and medium-sized rocks in excellent condition below fern growth

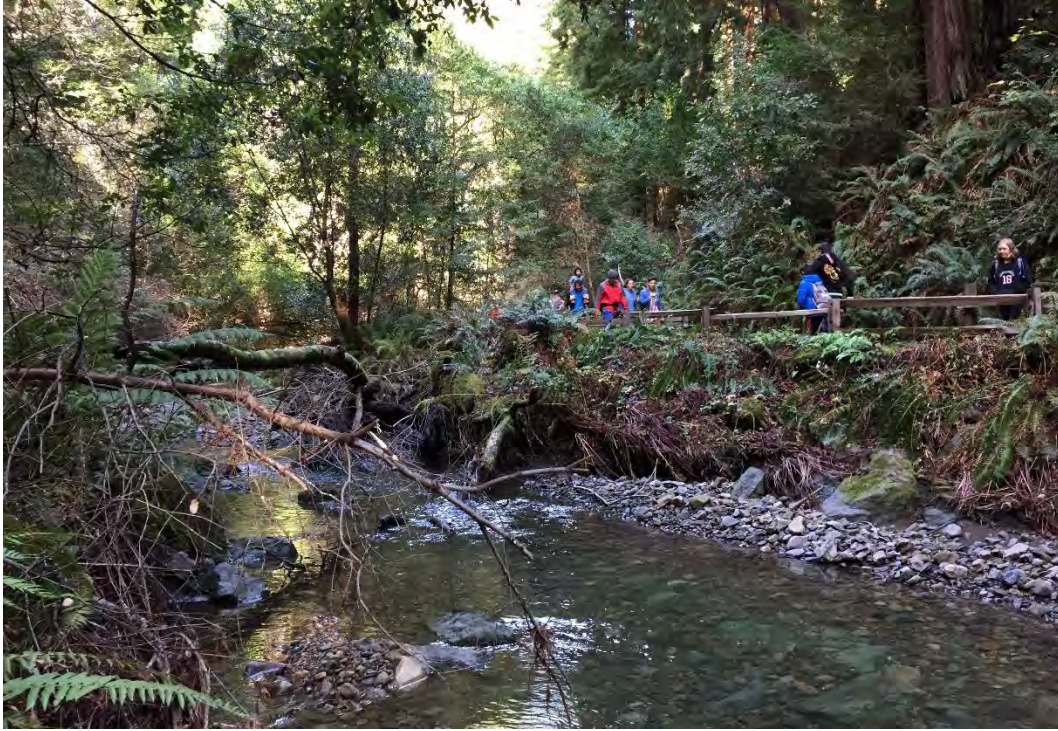
**Figure 45.** Portion of Section L5 mostly obscured by woody debris, camera facing north

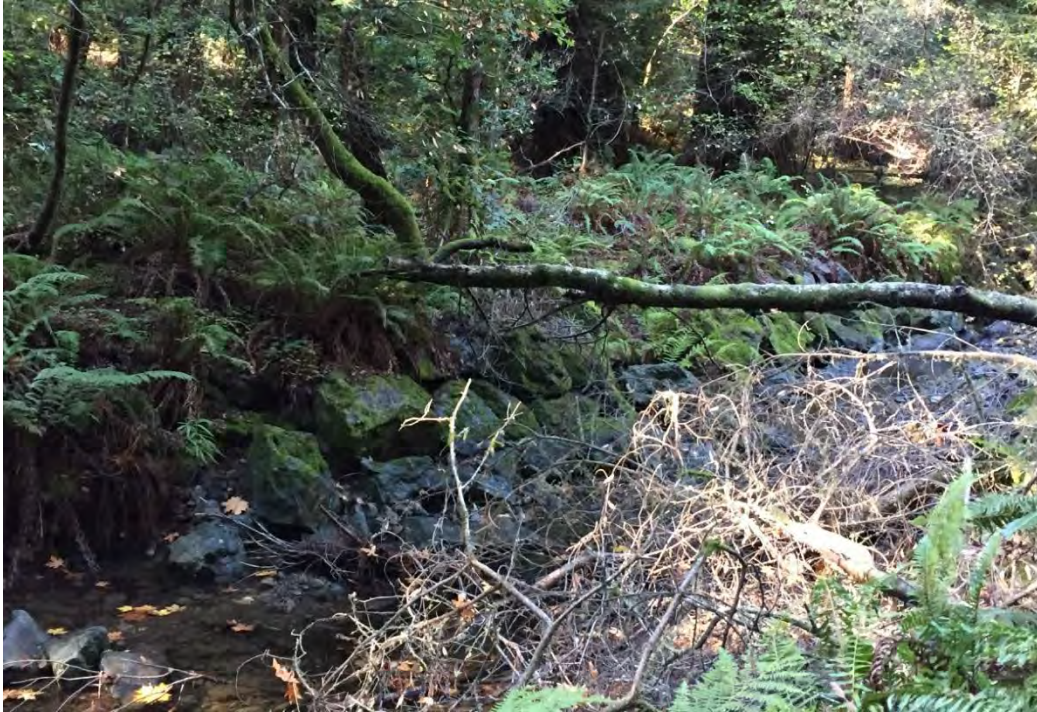
**Figure 49.** South stretch of Section R6, view west from trail showing riprap in excellent condition with some woody debris around it and trees and ferns on top of the bank

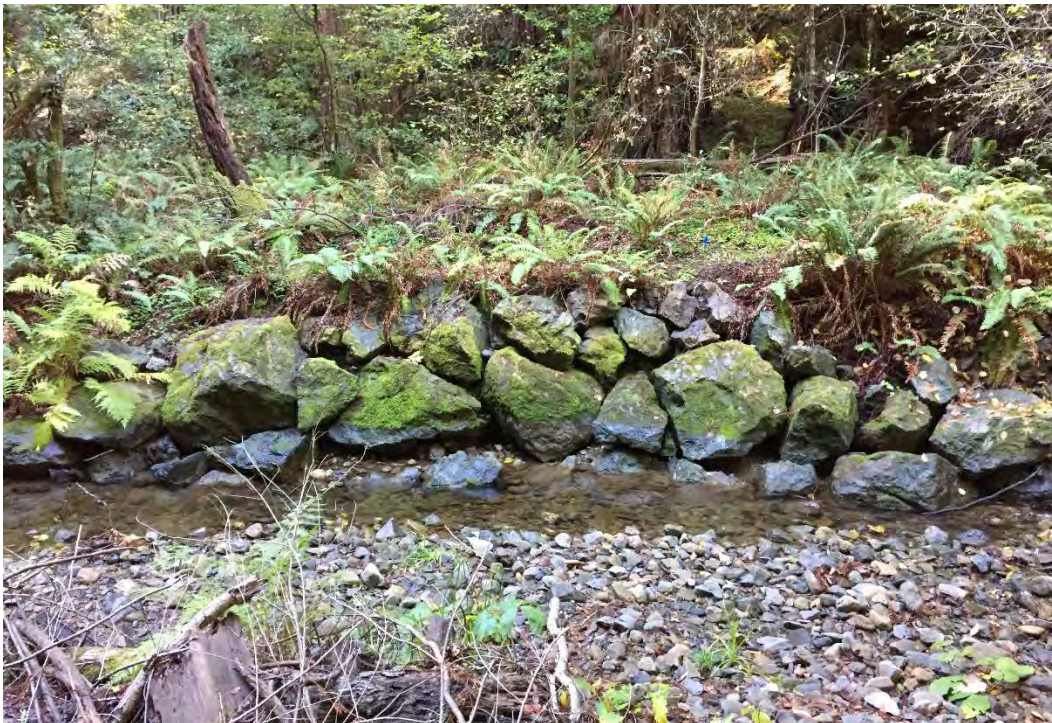
**Figure 50.** Center-south stretch of Section R6, view west-southwest showing riprap in clearly visible and in excellent condition with ferns above

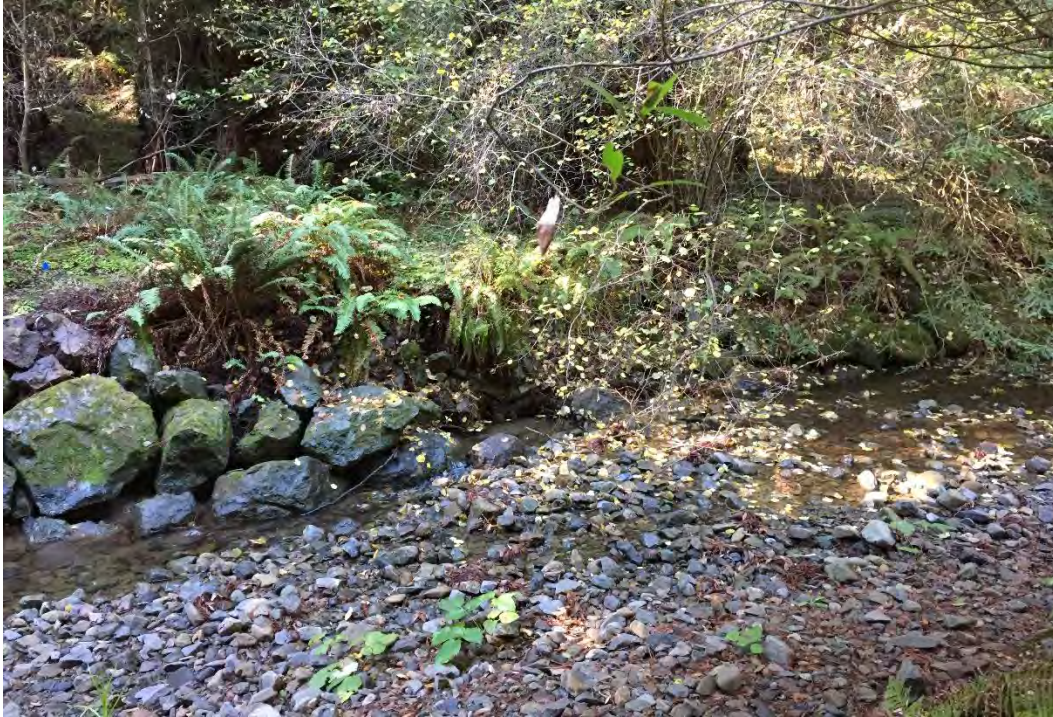
**Figure 51.** Center-north stretch of Section R6, showing riprap in good condition to south with area obscured by ferns and other vegetation to north

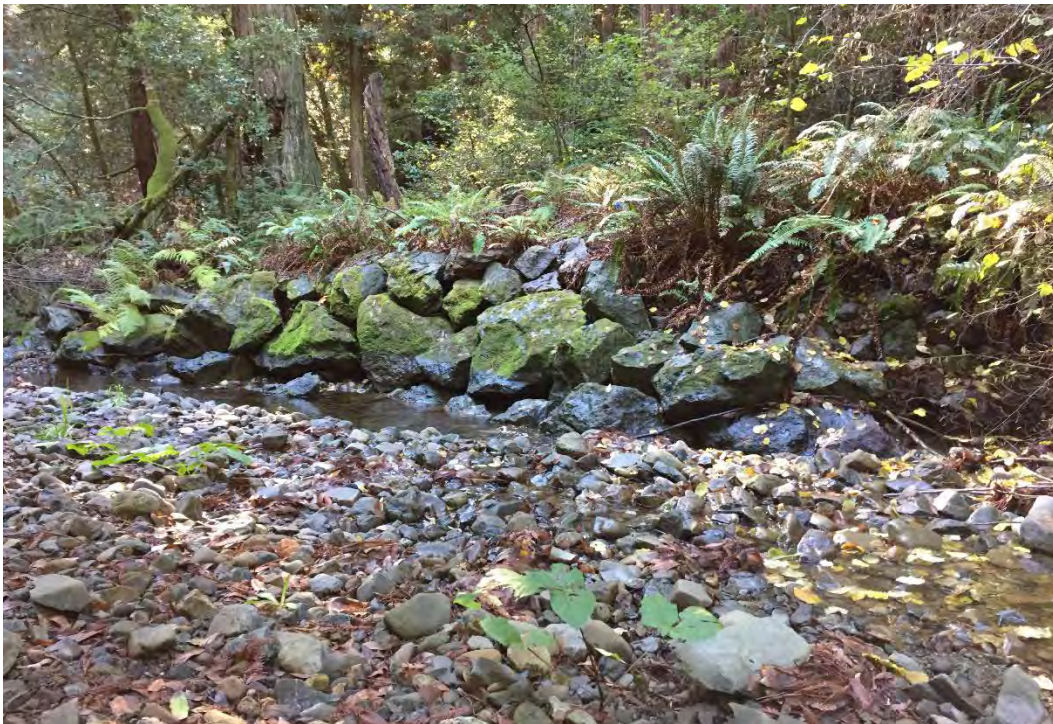
**Figure 52.** North stretch of Section R6, view west showing riprap in very good condition with small areas of deteriorated or obscured by vegetation at either end

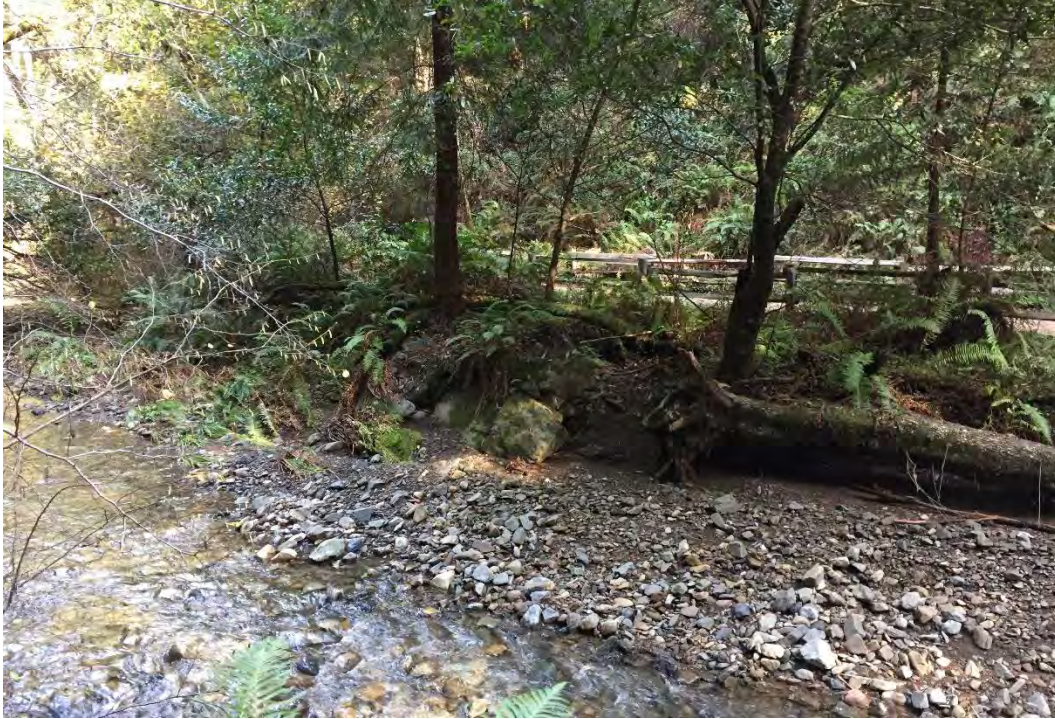
**Figure 54.** Section L6 from right bank, camera facing northeast, showing riprap in poor condition center frame and otherwise obscured by vegetation

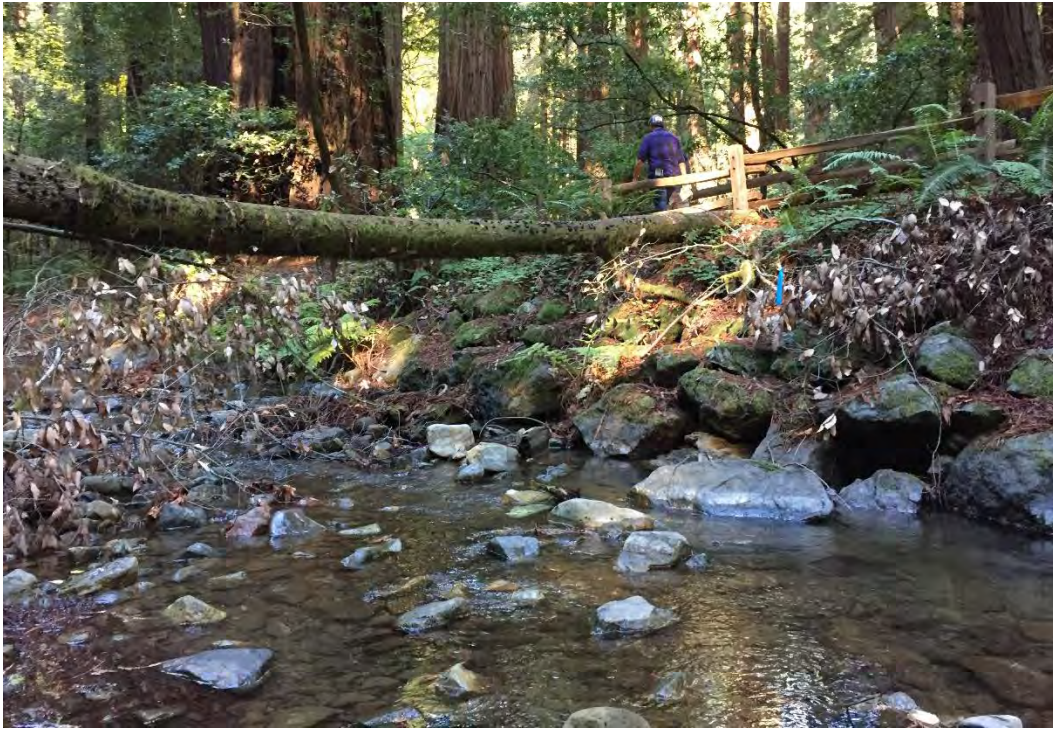
**Figure 56.** West stretch showing poor condition/obscured stretch left of frame, view northwest from creek bed

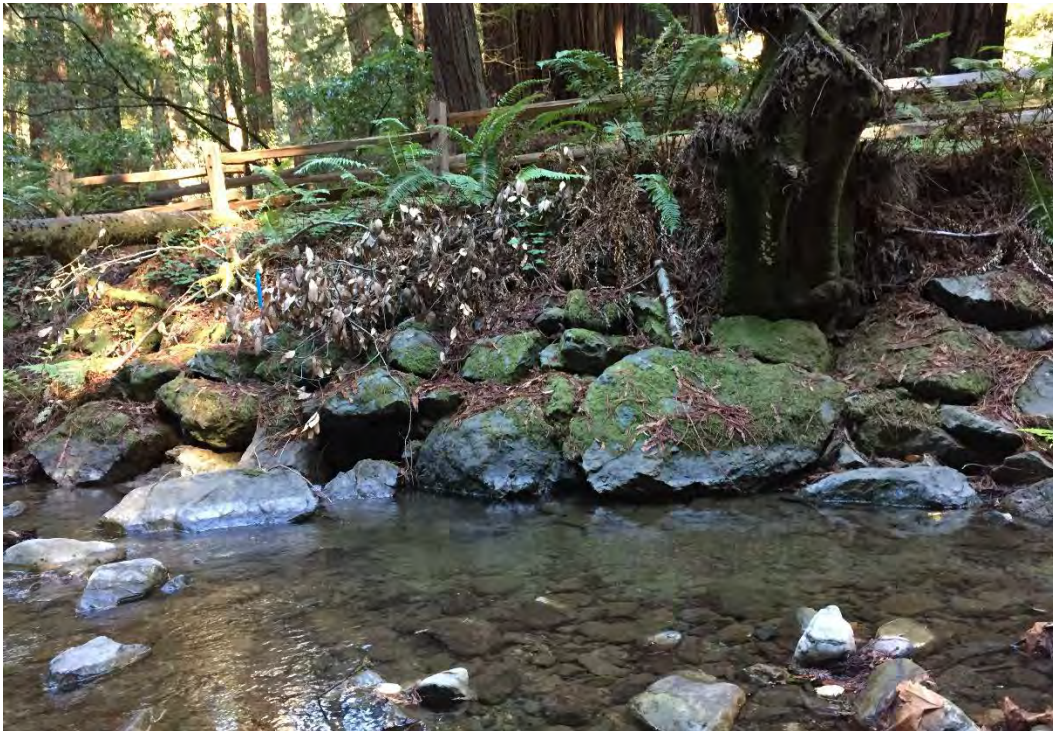
**Figure 57.** Center section, view north-northeast from creek bed, showing well-stacked boulders beneath tree stump, ferns, and the trail

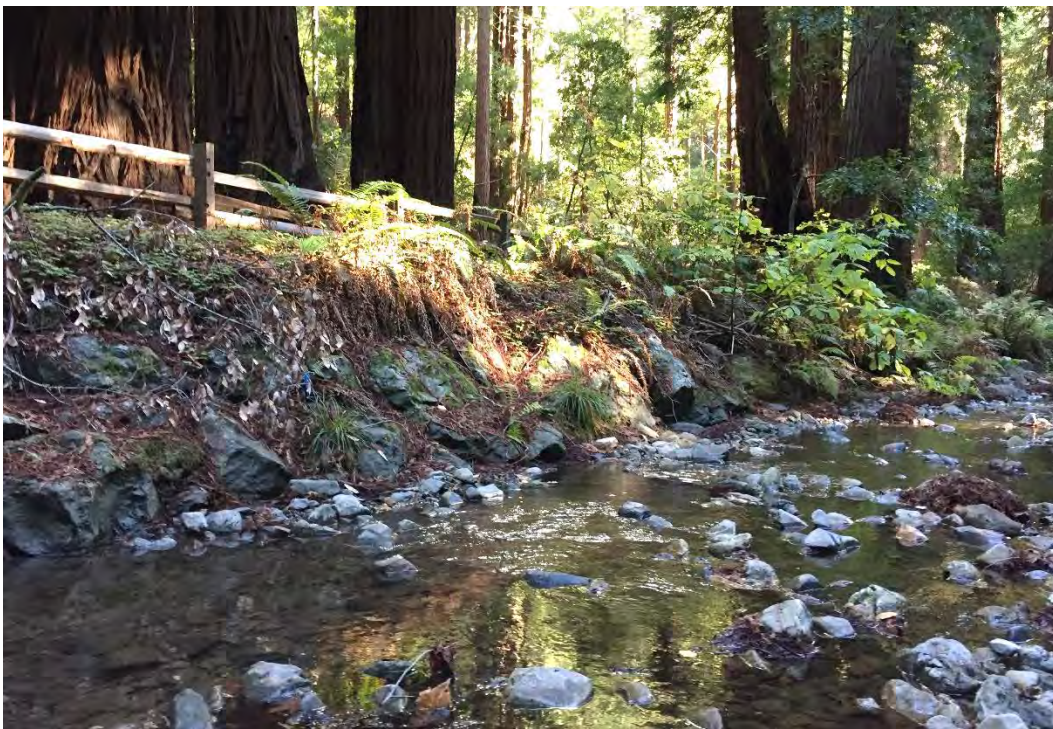
**Figure 59.** Overview, east stretch, view east from creek bed, showing riprap in good condition partially obscured by ferns and young trees
