## Riprap Condition Report

# **MUIR WOODS NATIONAL MONUMENT**

## **2016 REDWOOD CREEK RIPRAP ASSESSMENT**

March 2017

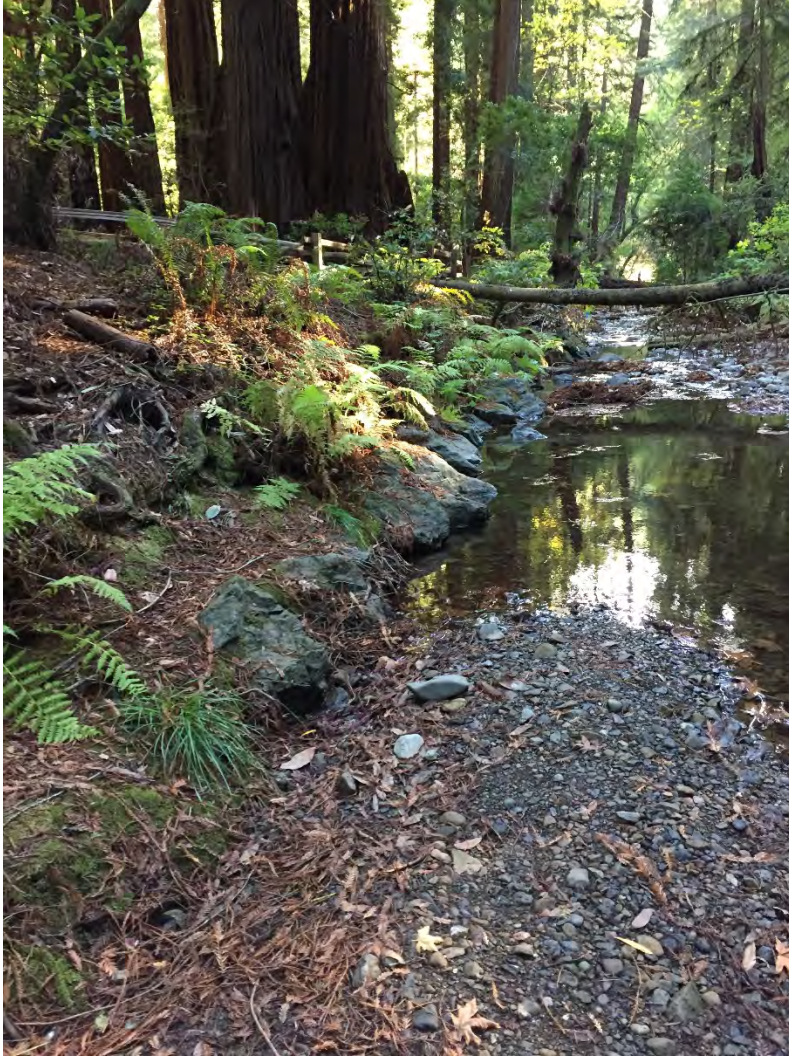
**Figure 60.** Overview, view east from creek bed at east end of Section L7, riprap clearly visible below ferns

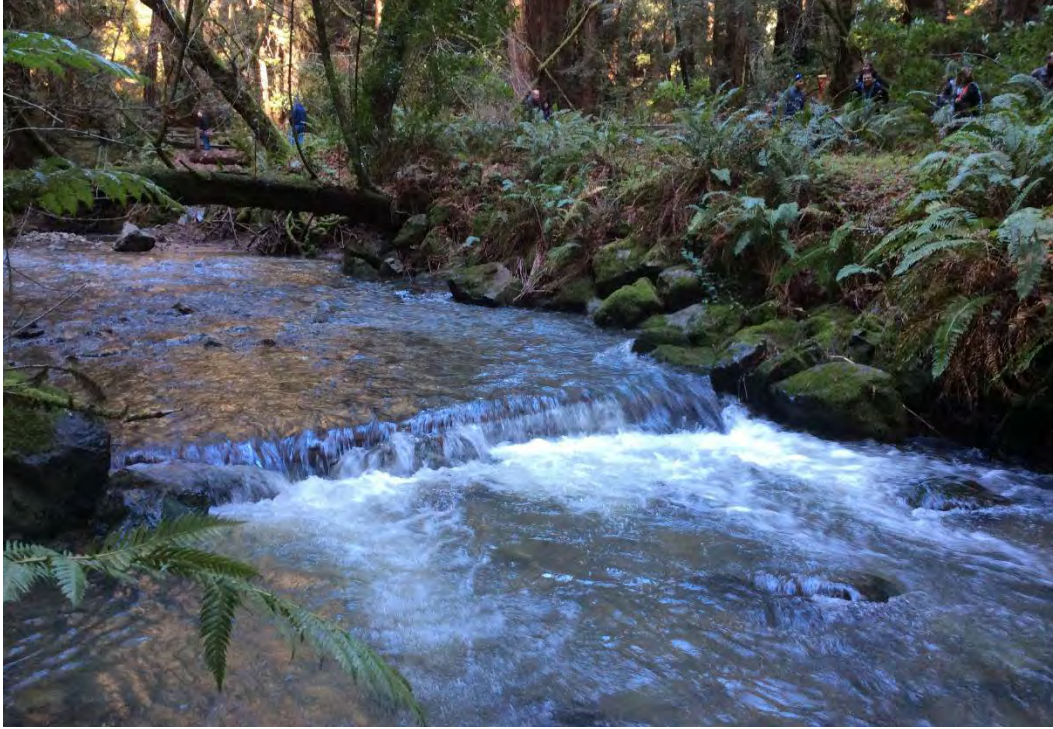
**Figure 63.** Section L8, view north from creek bed, showing riprap in good condition with ferns above and some woody debris

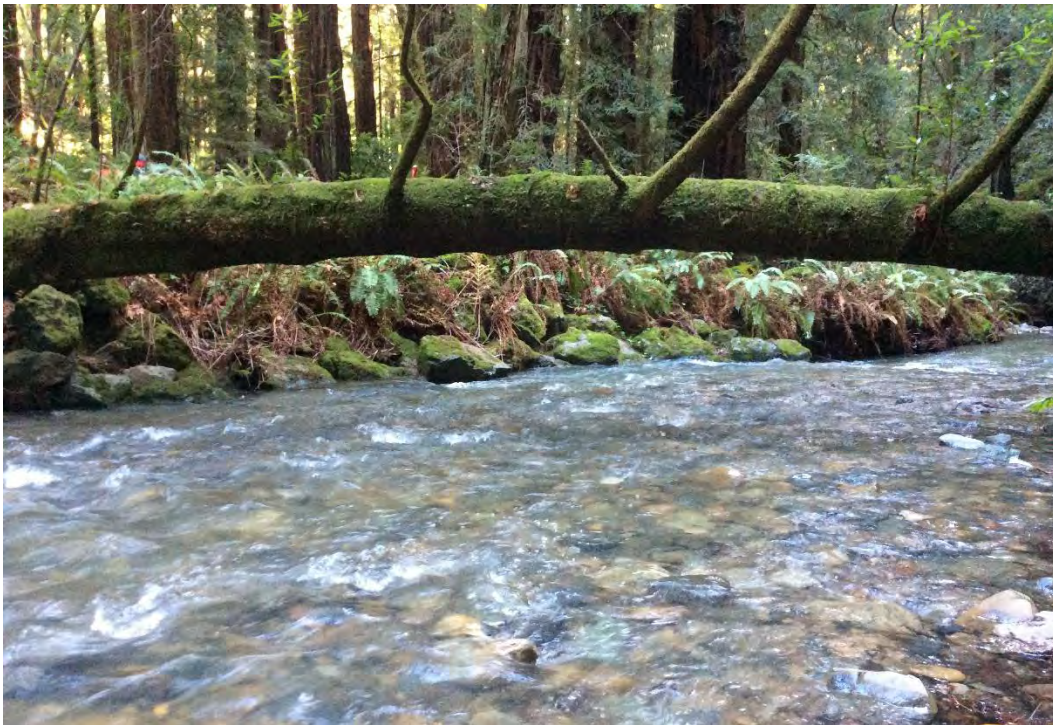
**Figure 64.** Section L8 looking east from creek bed, showing medium-sized boulders in good condition with some areas covered by ferns

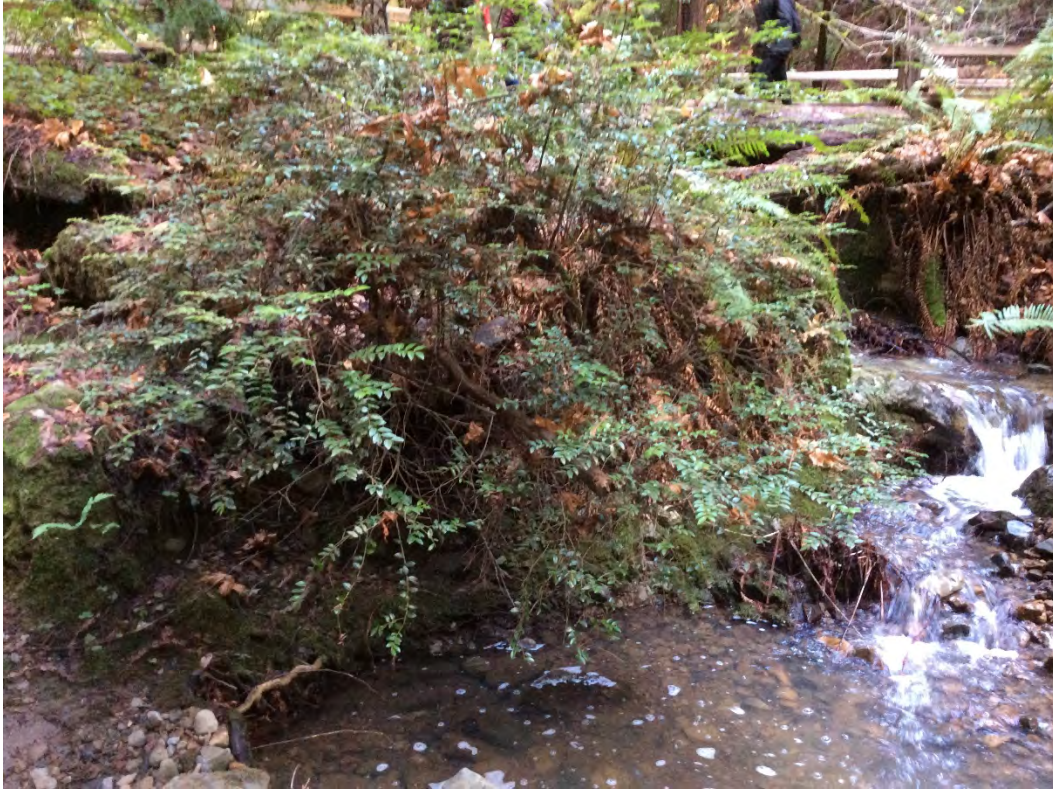
**Figure 66.** Section L8.5, view north from creek bed, showing heavy seasonal vegetation with what appears to be riprap fallen away in the creek

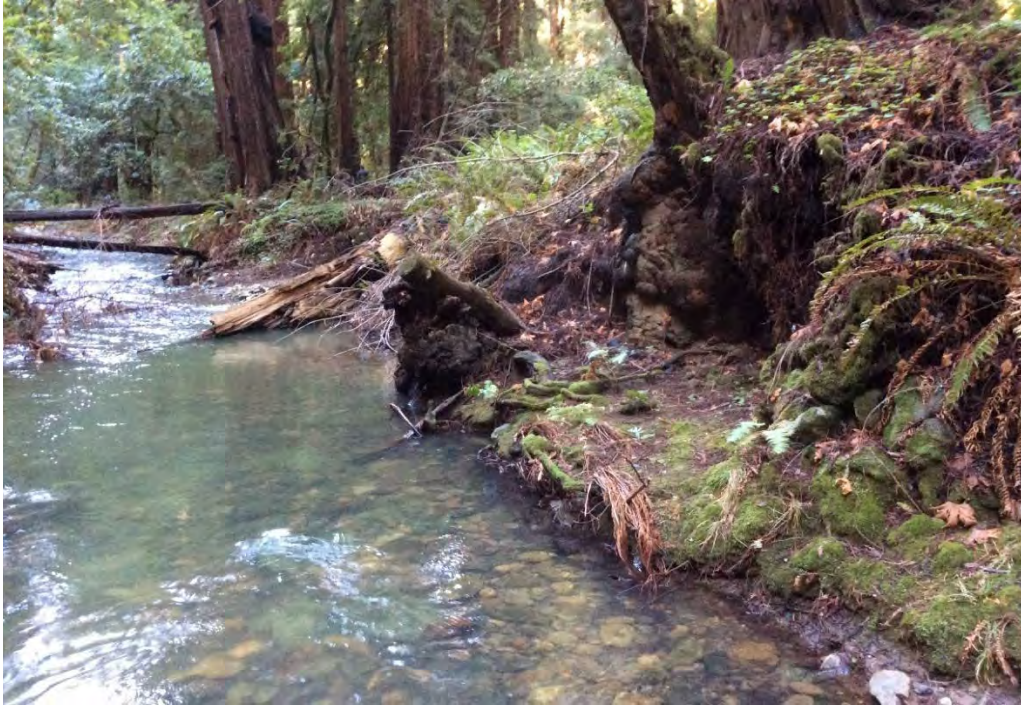
**Figure 68.** Section L9, view north from creek bed, showing nearly horizontal riprap of small rocks under moss below a vertical creek bank supporting ferns and tree roots

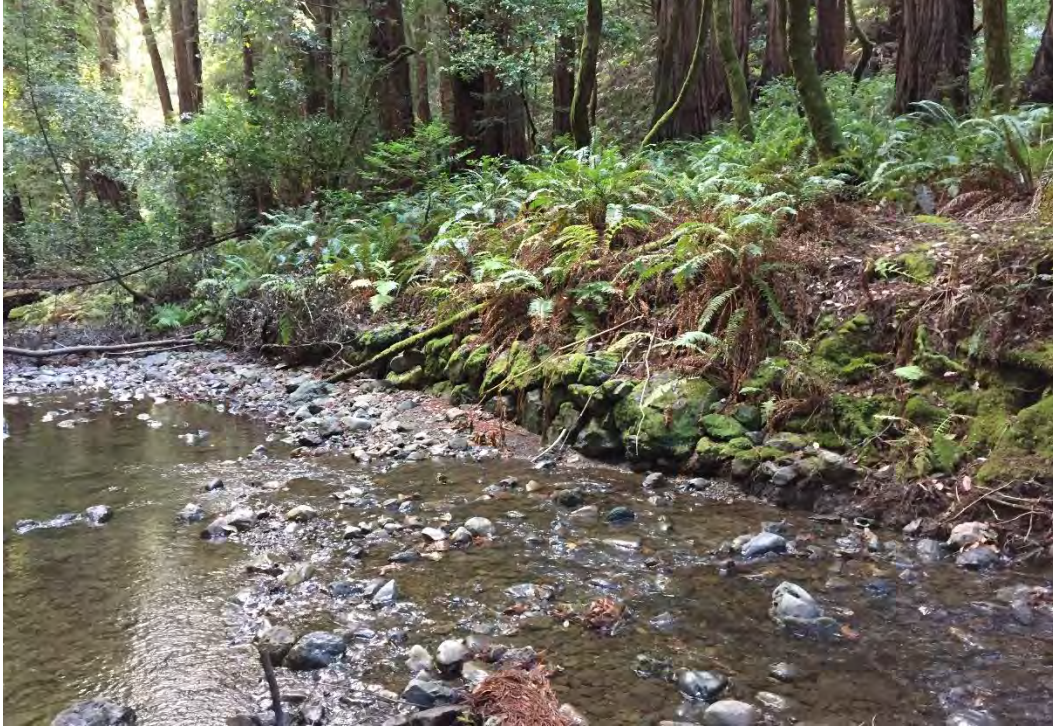
**Figure 71.** Overview, northwest stretch of Section R7, view south-southeast from creek bed, showing 2-3 courses of tightly stacked boulders of variable size with ferns and trees above

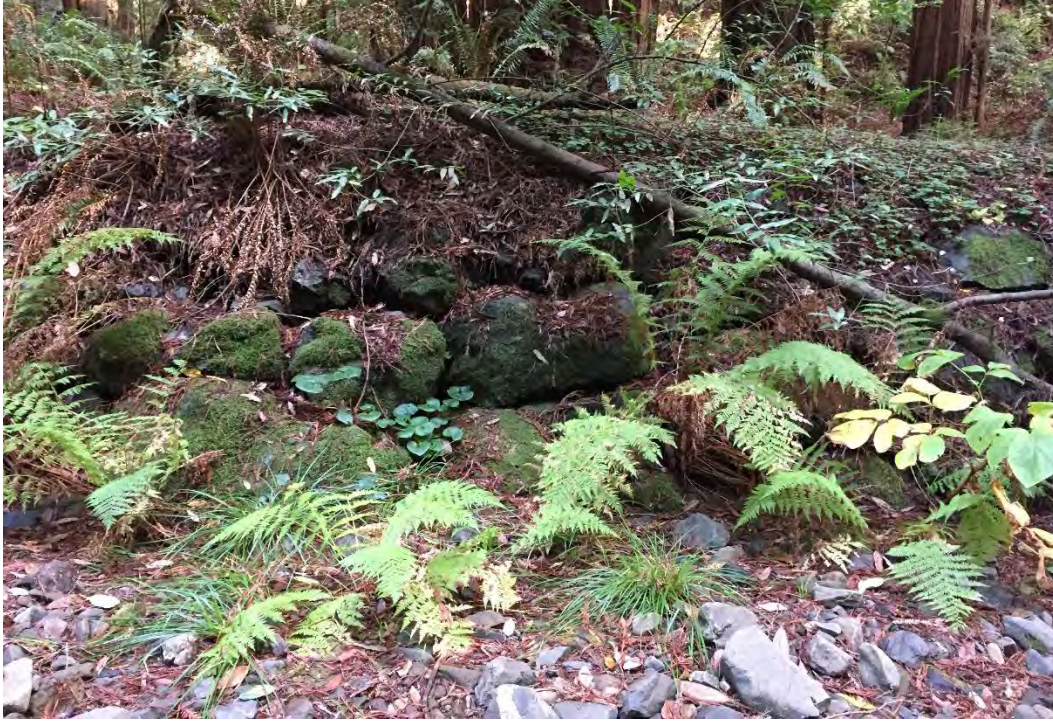
**Figure 75.** West stretch, view north from creek bed, showing riprap in fair condition beneath vegetation

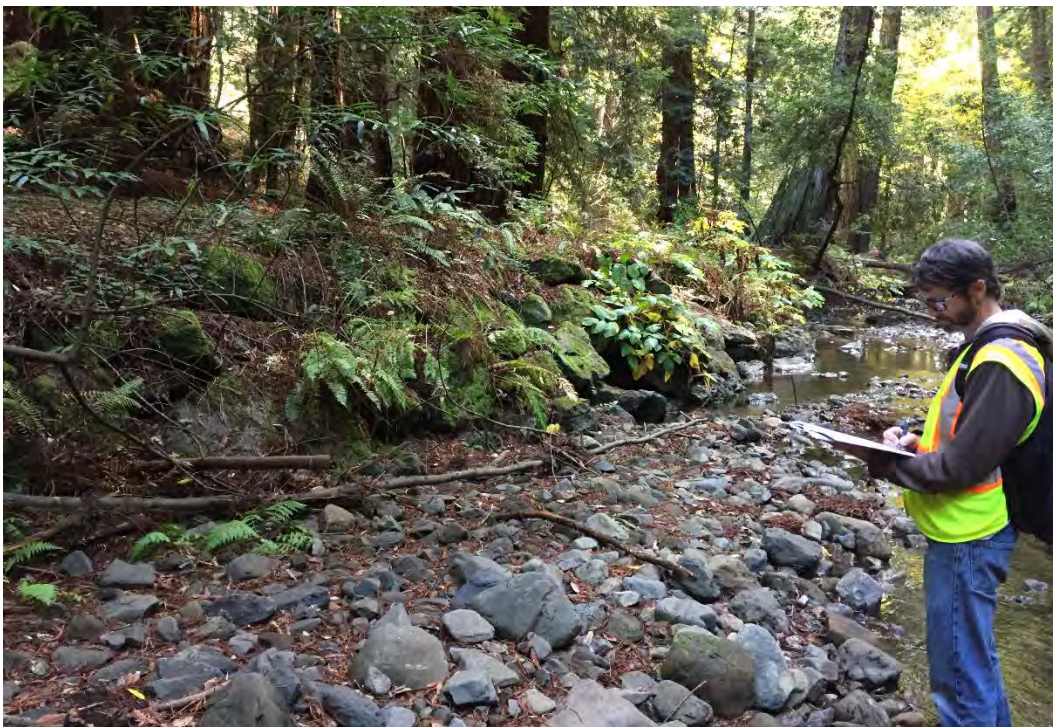
**Figure 76.** Center stretch, view east from creek bed, showing ferns and small tree grown atop riprap in good condition

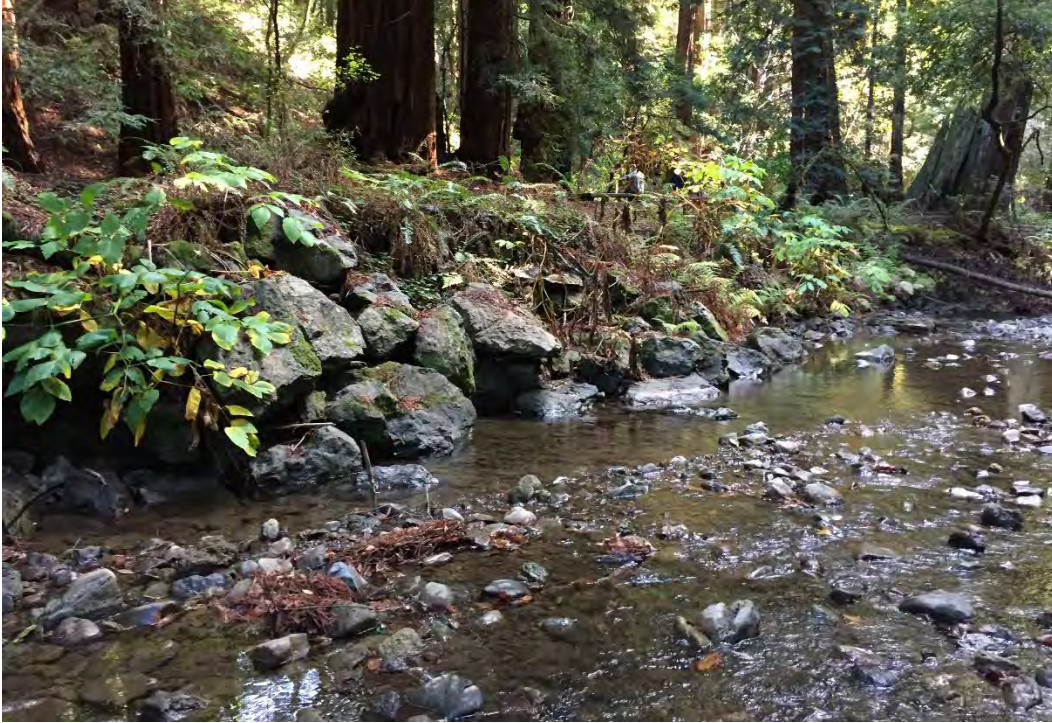
**Figure 77.** Center-east stretch, view east-northeast from creek bed, showing riprap in good condition

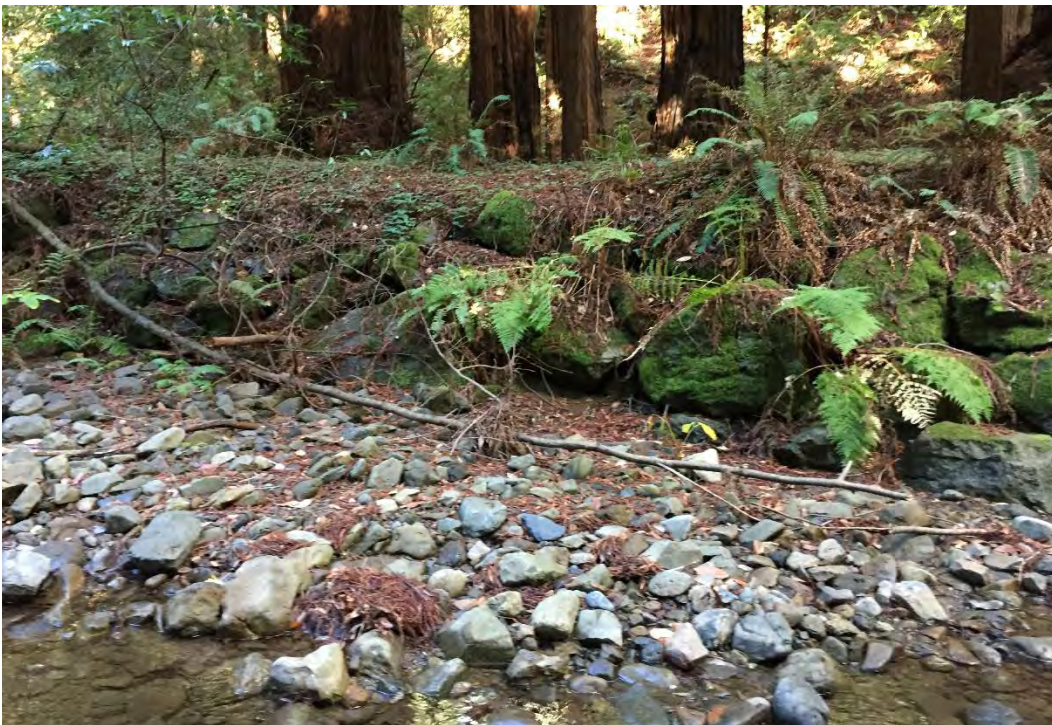
**Figure 78.** East end showing some displaced boulders with most riprap in good condition beneath light vegetation growth

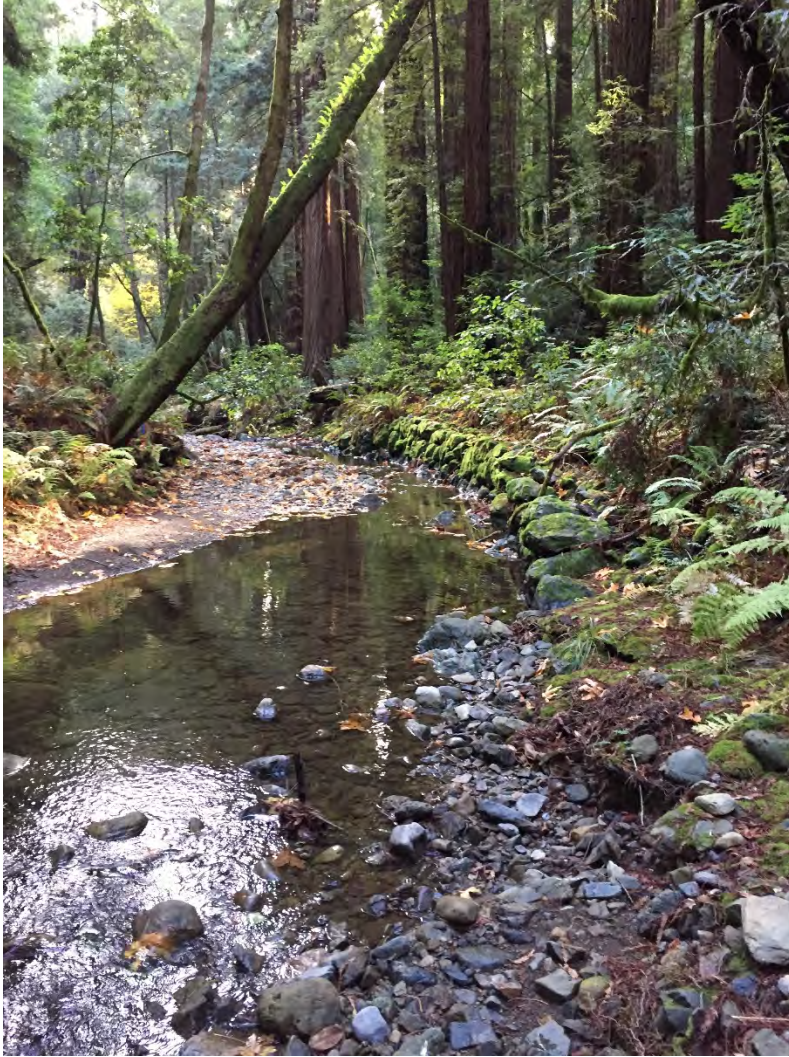
**Figure 80.** Section R8 overview, view west from creek bed showing riprap of medium-sized boulders, with smaller rocks fit in to form a relatively solid wall of 3-4 courses, in excellent condition

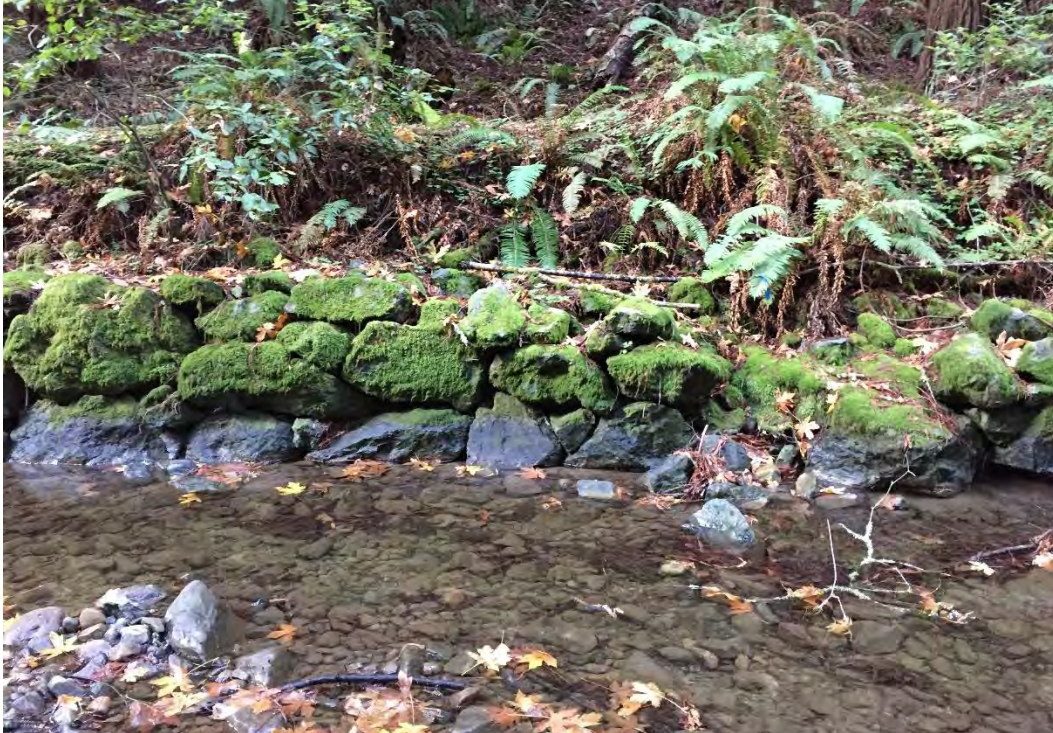
**Figure 81.** Detail, west stretch, showing riprap in excellent condition with ferns above

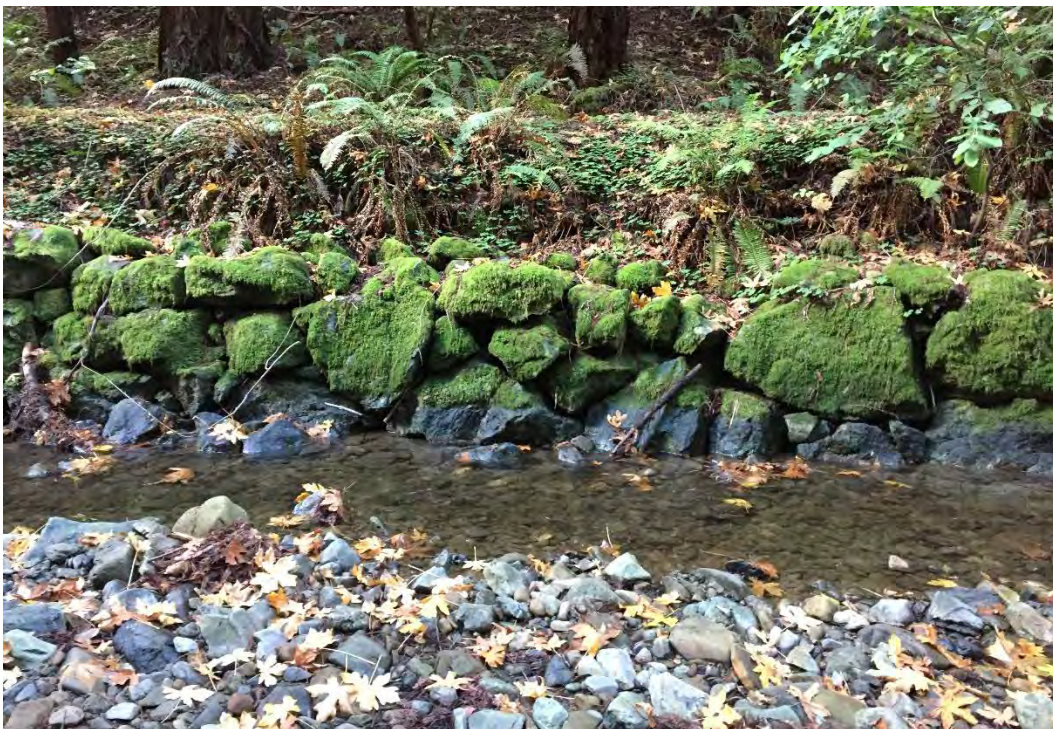
**Figure 82.** Detail, center-west stretch showing riprap in excellent condition with ferns above

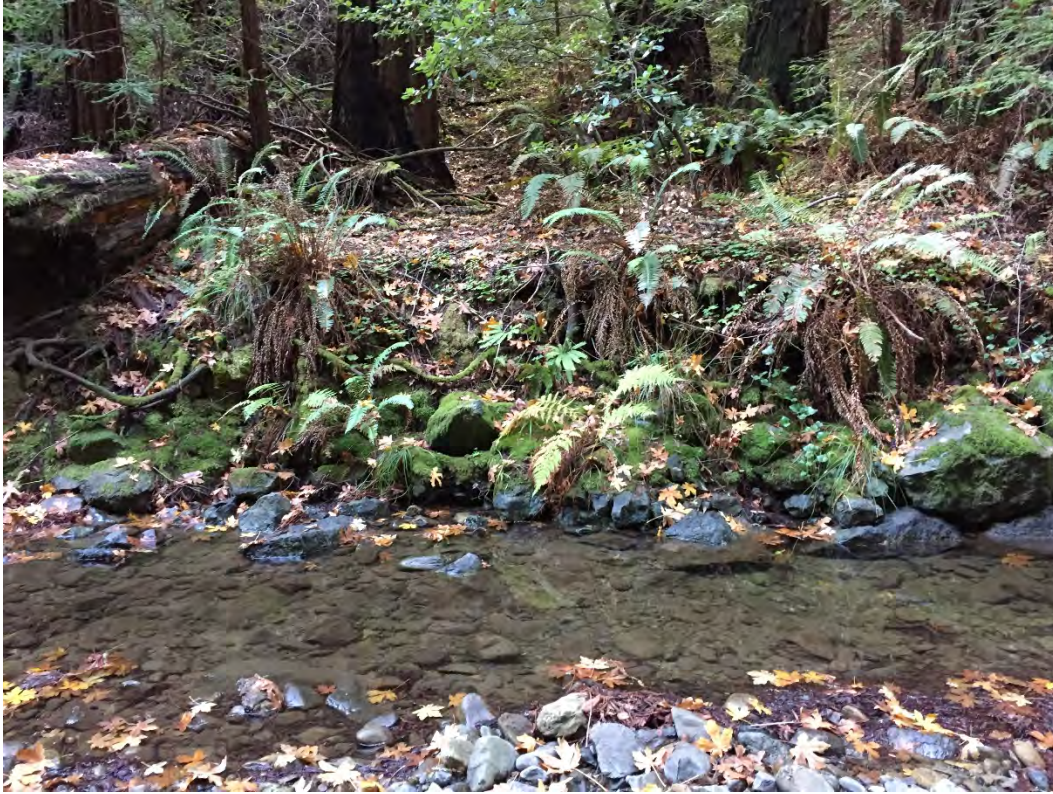
**Figure 83.** Detail showing good-fair condition of east stretch with ferns and vegetation partially obscuring riprap

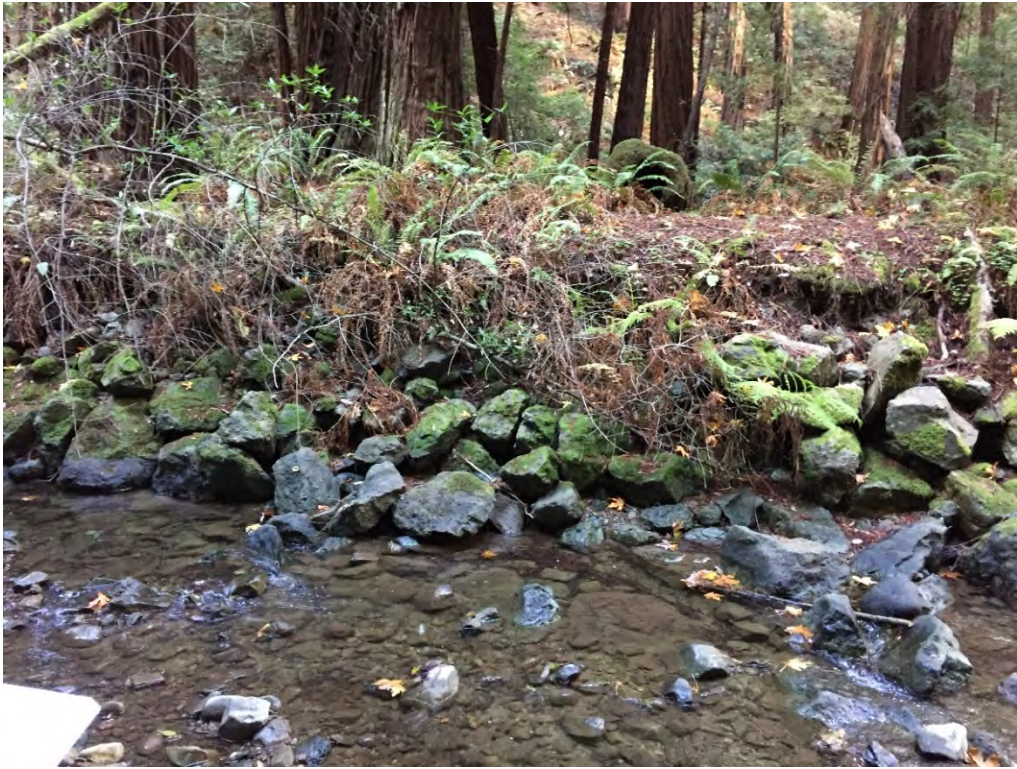
**Figure 85.** West stretch, view north from creek bed, showing riprap in fair-poor condition with ferns partially obscuring

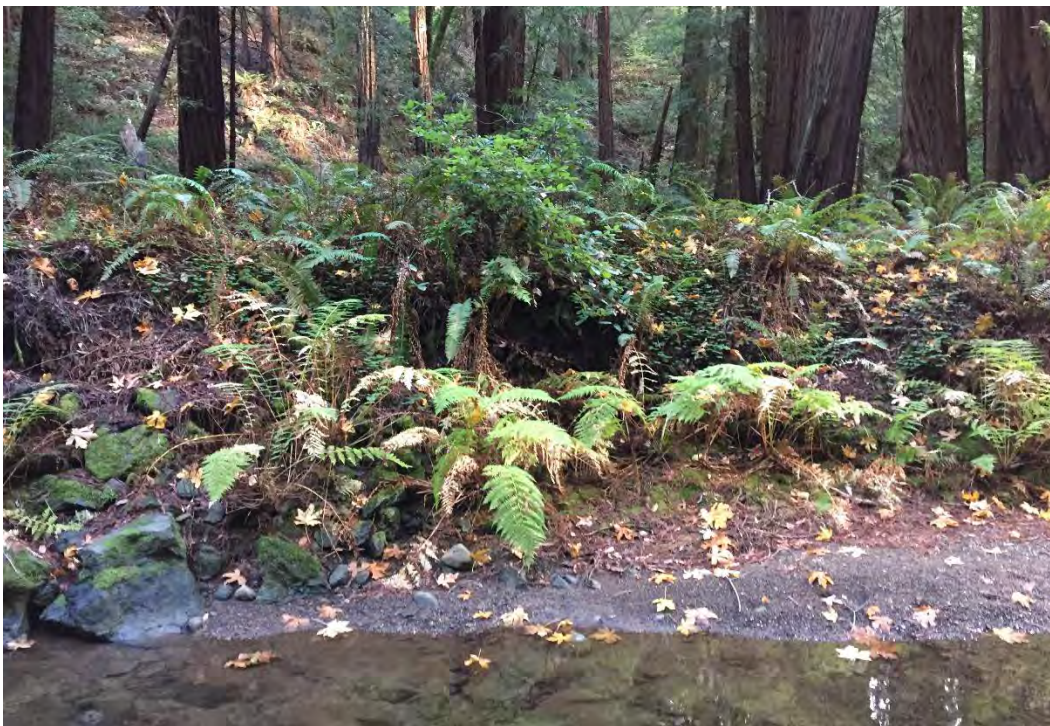
**Figure 86.** East stretch, view north from creek bed, where riprap is missing or completely obscured by ferns and other vegetation

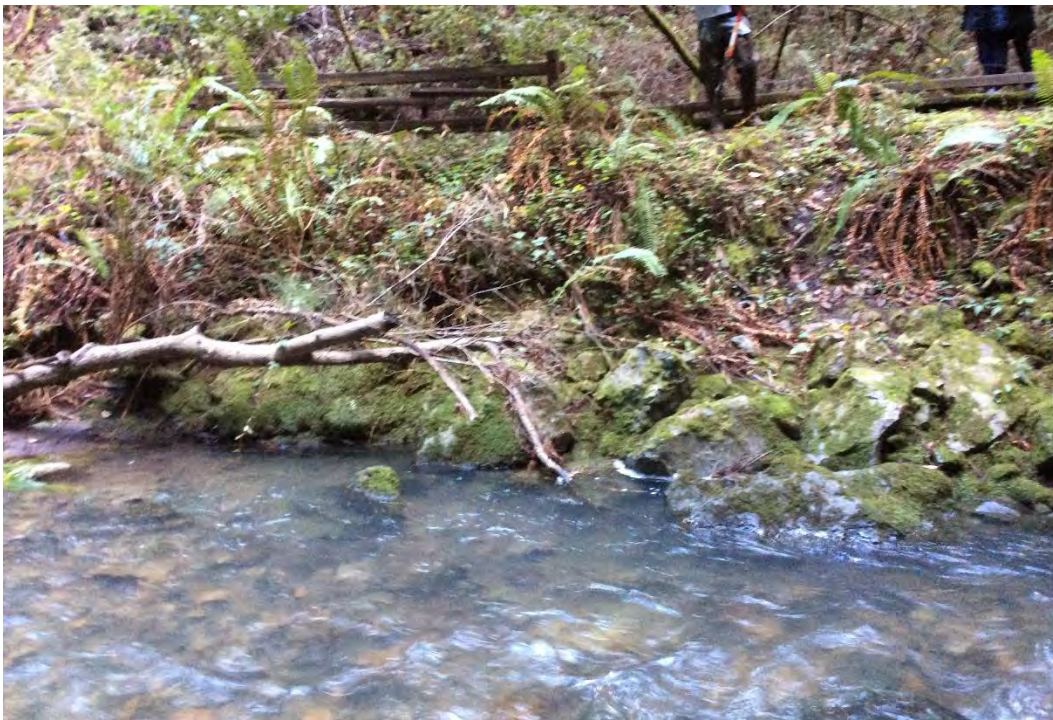
**Figure 89.** Center stretch of Section L11B, view northeast from creek bed, showing riprap in good condition with some woody debris and heavy moss growth

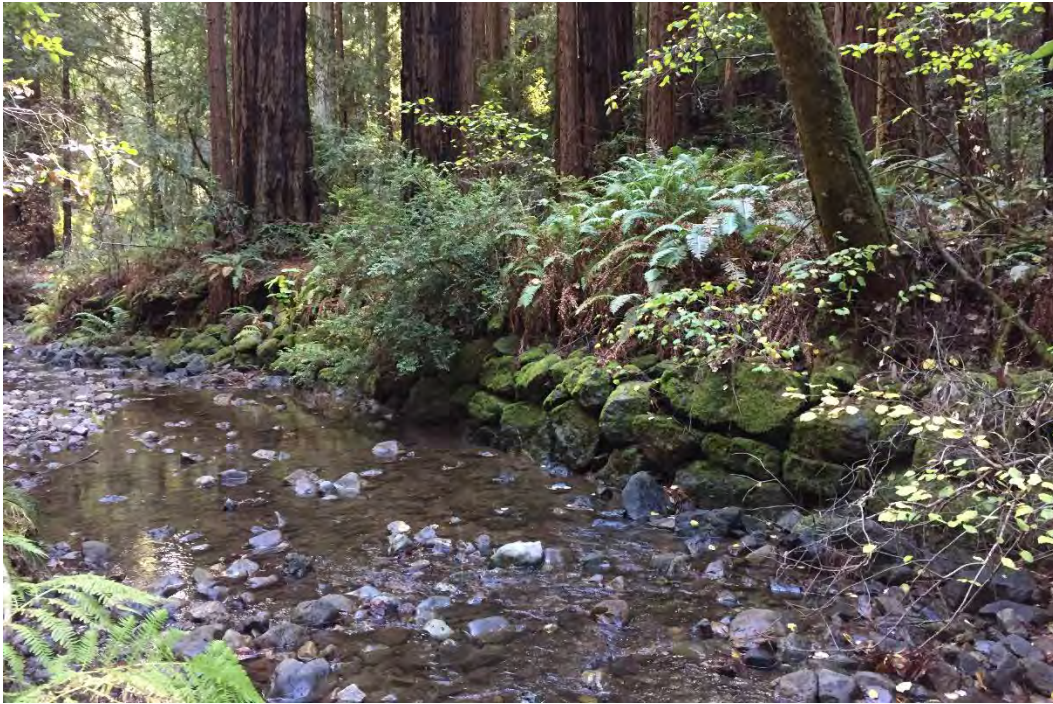
**Figure 92.** Overview of Section R9, view southeast from creek bed, showing riprap tightly stacked into 3 to 4 courses that form a nearly upright wall beneath trees, ferns, and other vegetation

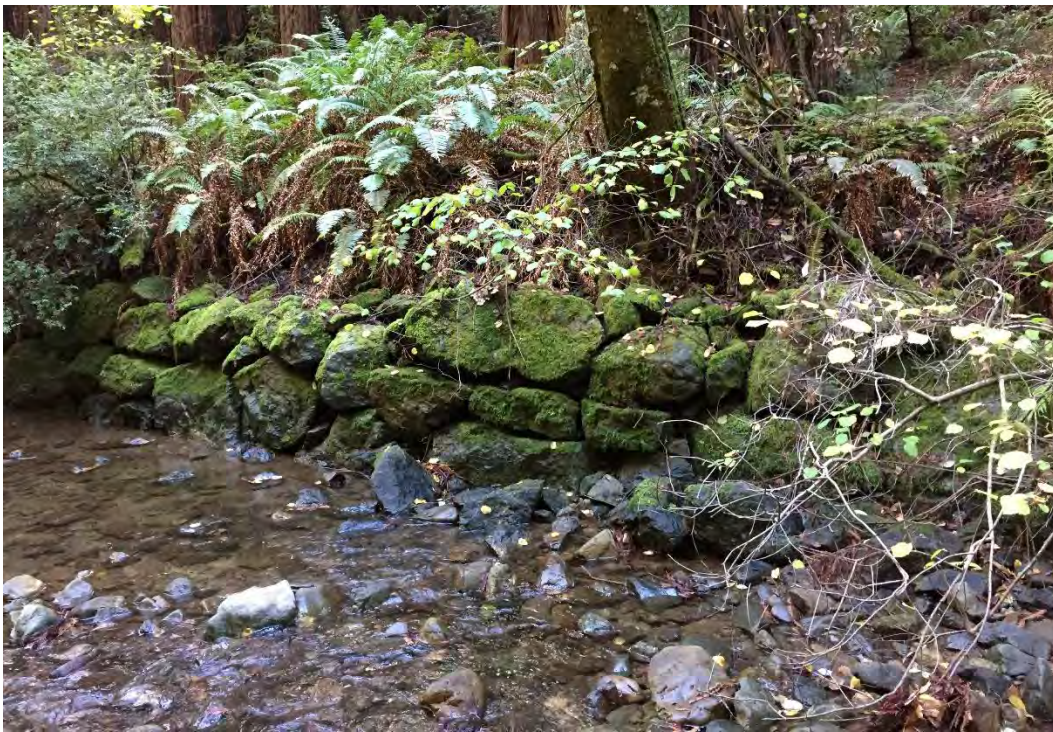
**Figure 93.** Detail, west stretch view south, showing riprap in excellent condition

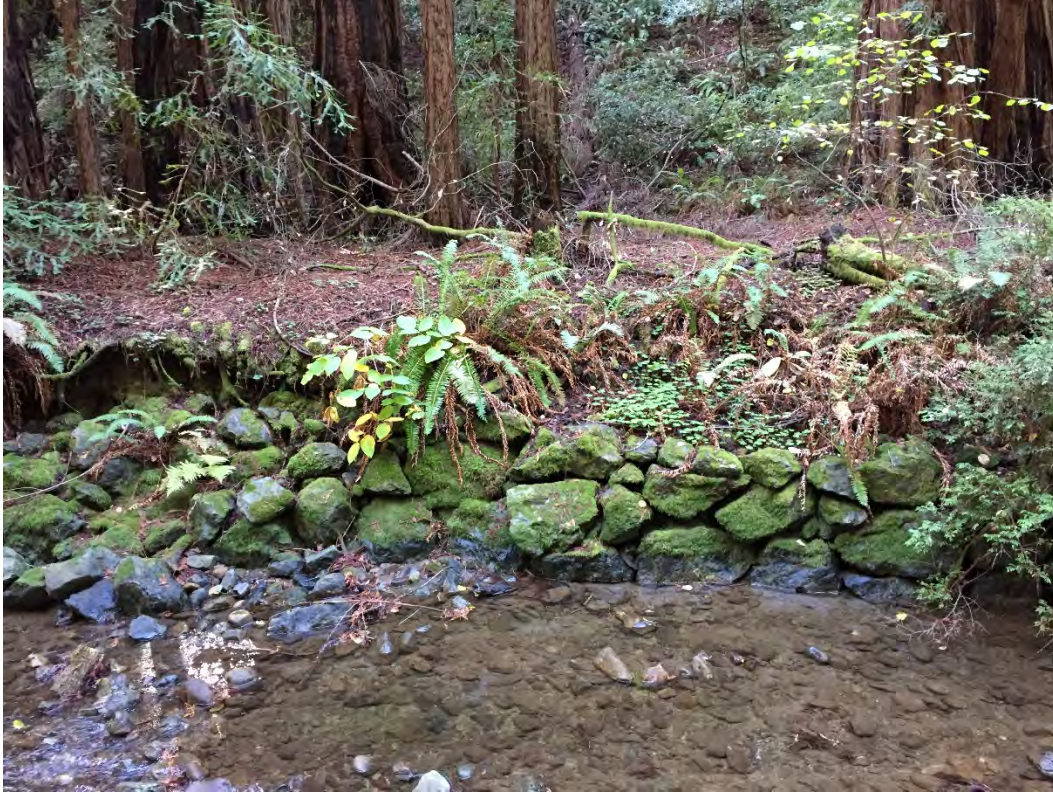
**Figure 94.** Detail, east stretch view southeast, showing riprap excellent condition with small collapsed area left of frame and ferns growing above

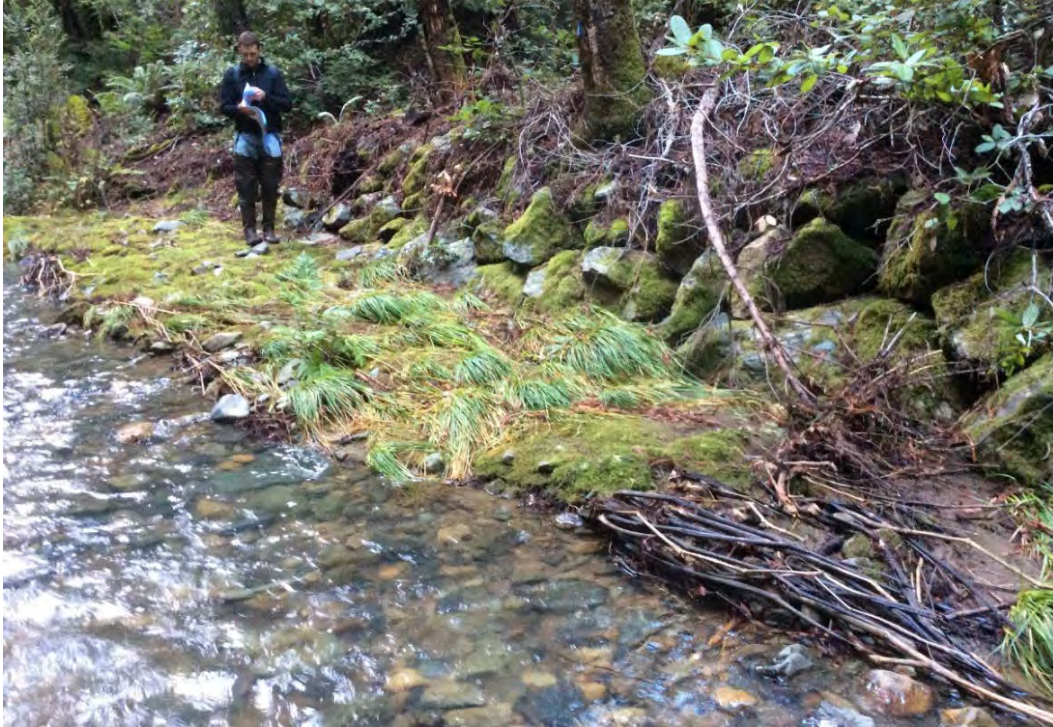
**Figure 96.** Upstream (west) stretch of Section L12 with toe material below riprap wall in good condition, view northeast from creek bed

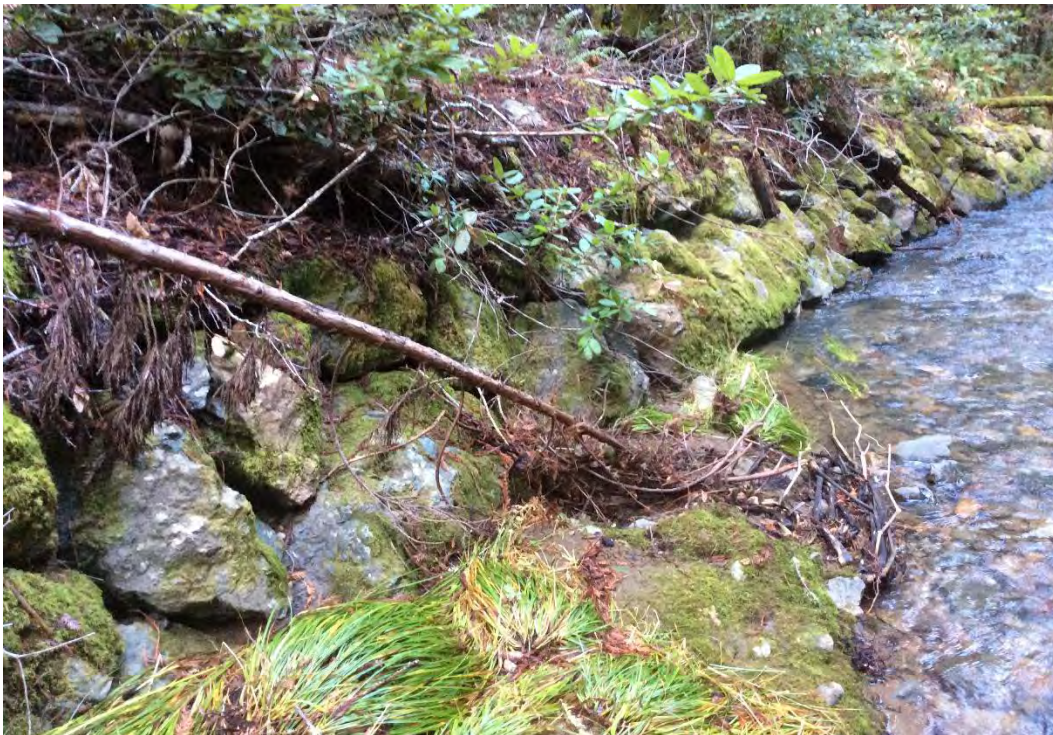
**Figure 97.** Center stretch of Section L12, view west from creek bed, showing riprap tightly-stacked and in excellent condition

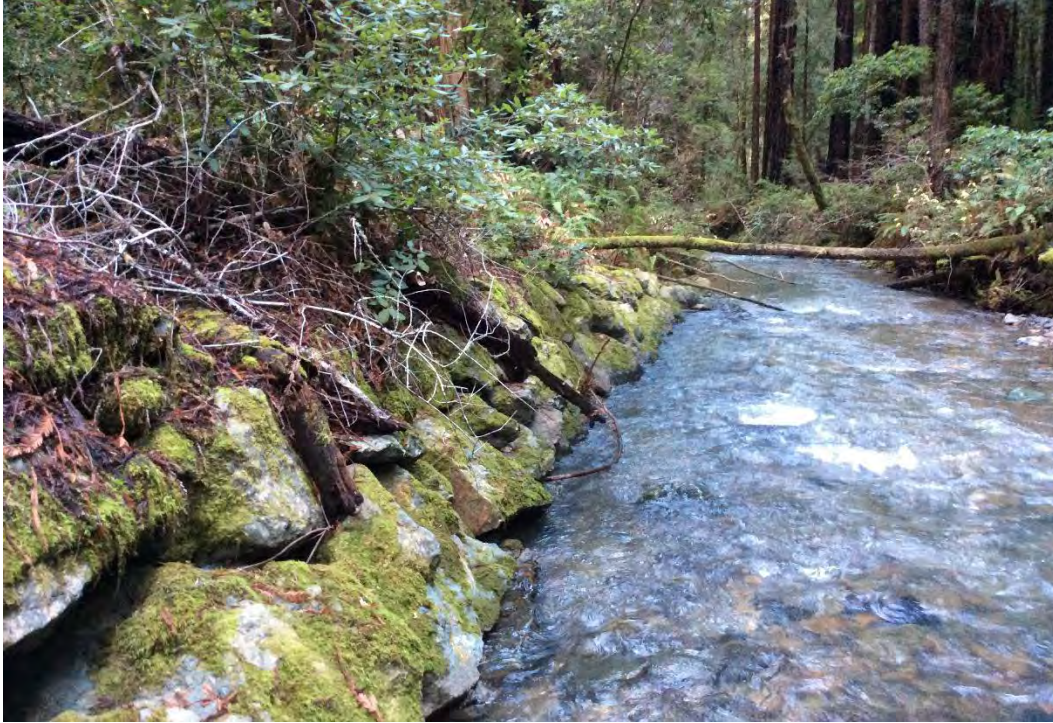
**Figure 98.** Downstream stretch of Section L12, view west from creek bed, showing riprap tightly-stacked and in excellent condition

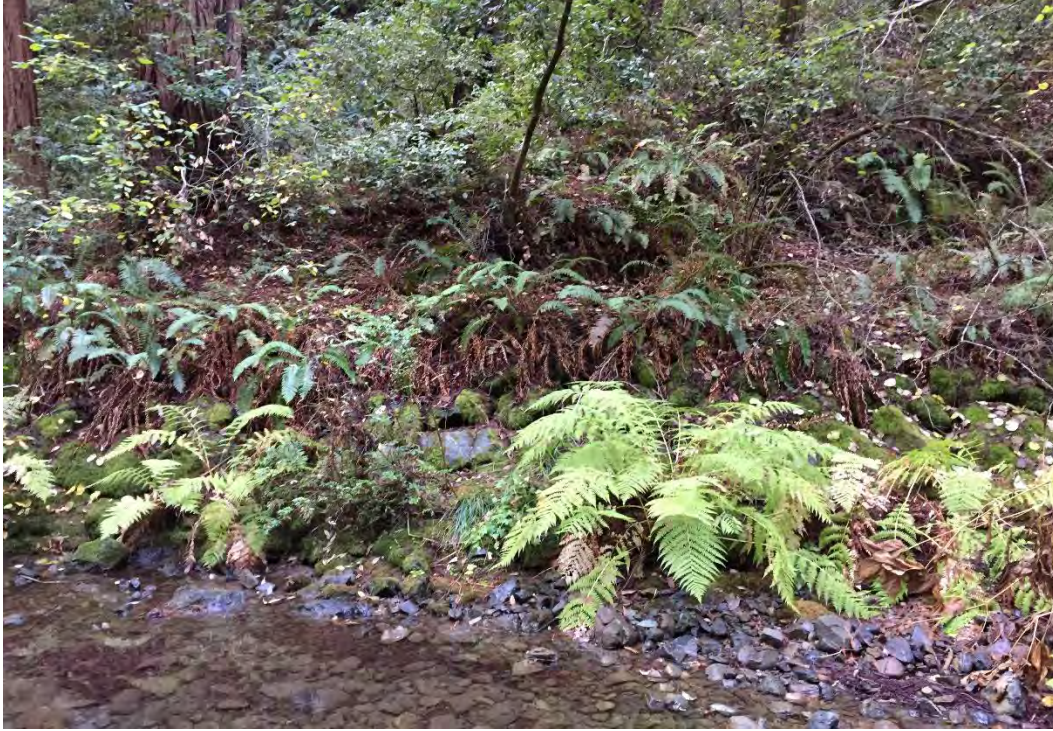
**Figure 100.** Western stretch, view southwest from creek bed with riprap in good condition behind ferns

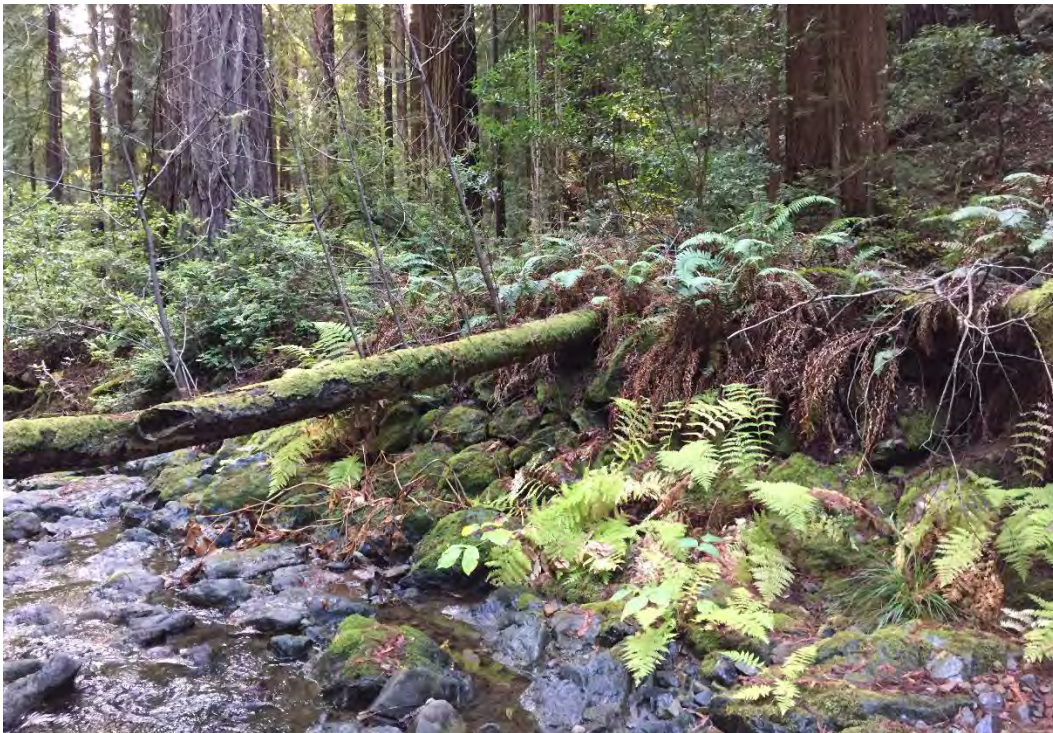
**Figure 101.** Detail, east stretch, showing tightly stacked wall in excellent condition beneath ferns and some woody debris

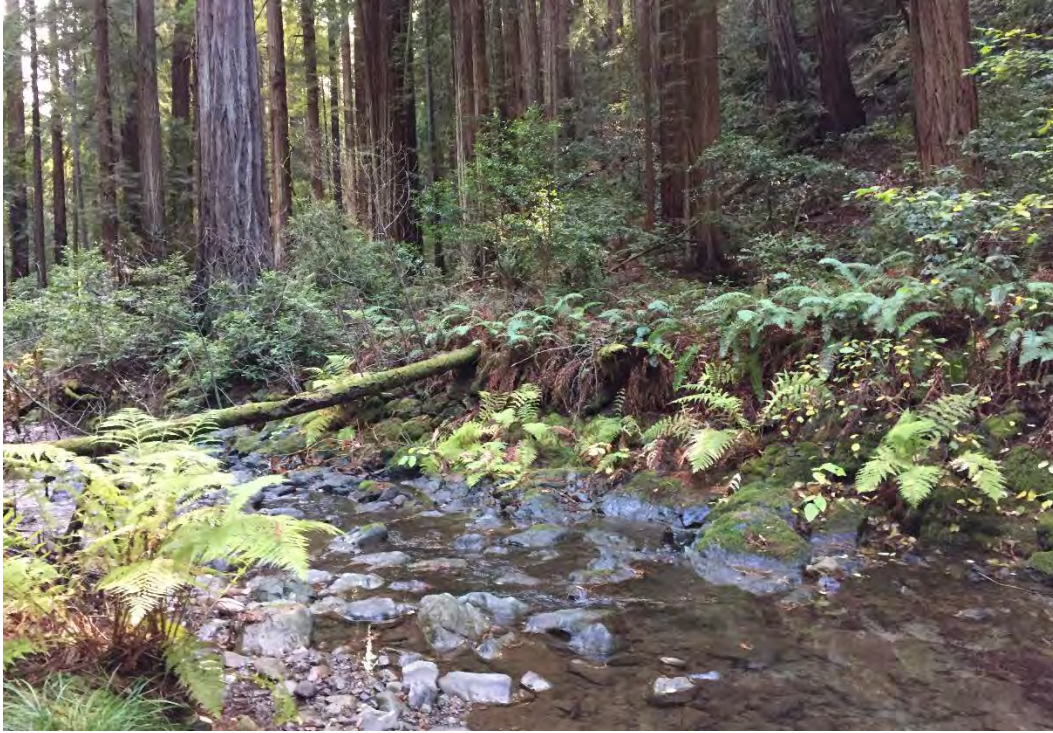
**Figure 102.** Central stretch, view south showing heavy toe material with ferns and woody debris covering riprap that is in excellent condition

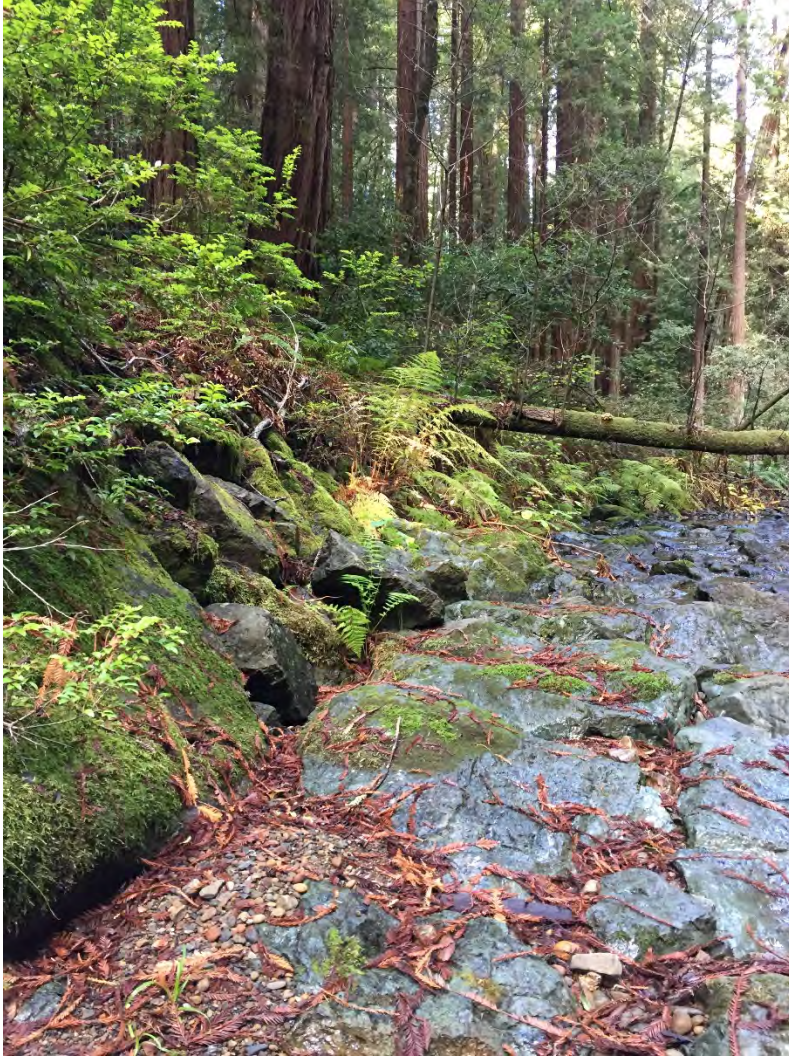
**Figure 103.** View west toward east stretch with large boulder riprap and toe material/check dam

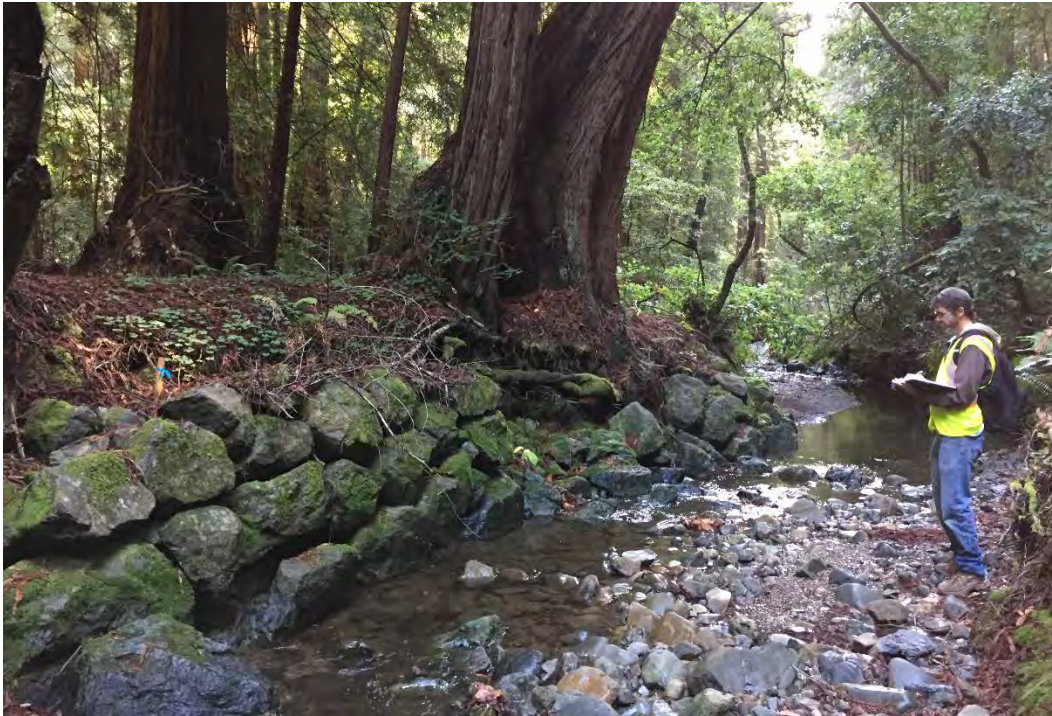
**Figure 114.** Overview, Section L13, view east from creek bed, well-stacked western stretch left of frame
