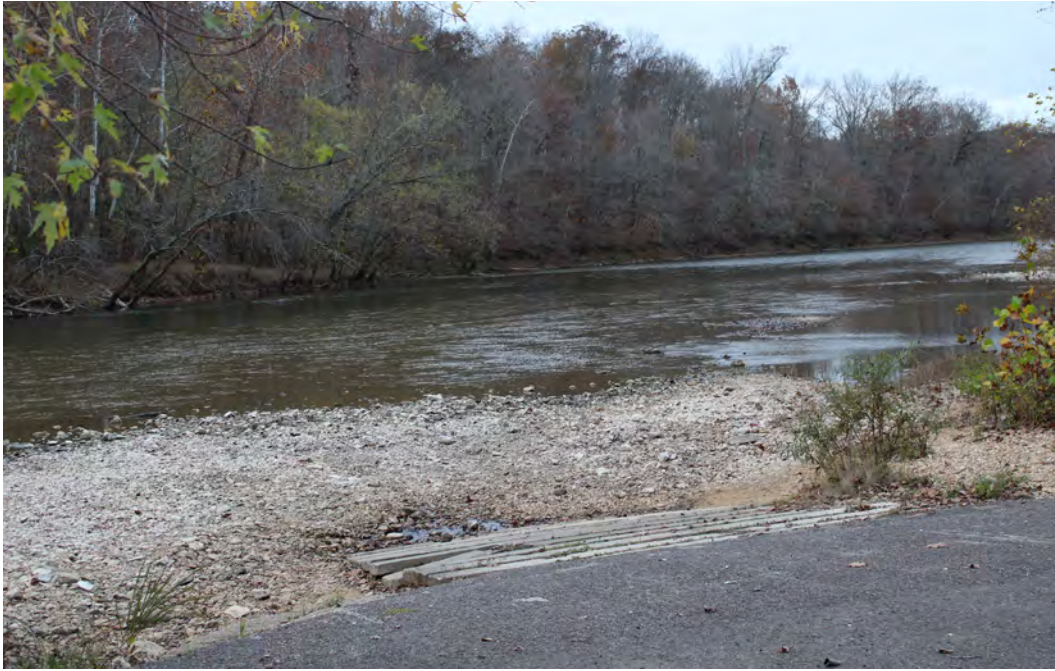
Figure 3-15. Two boat ramps occur at the Current River, connected by a parking area and accessed by Peavine Road. (Mundus Bishop 2015)

1 ramps are available, separated by a wide
2 parking area that accommodates boat trailers.
3 The boat ramps and parking area are in good
4 condition.

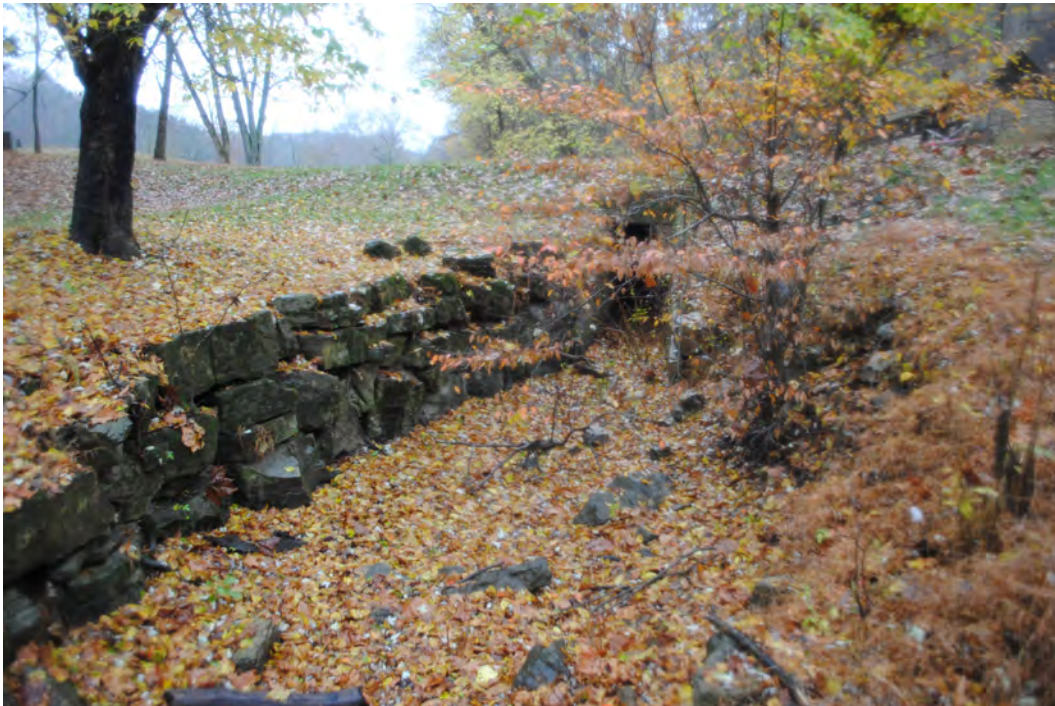
Figure 3-16. Stone Retaining Wall and Abutments (HS-423A). (Mundus Bishop 2015)

17
18 The revetment walls along Big Spring branch
19 are no longer visible. Segments of the stone
20 abutments have been removed at the boat
21 ramp and others have either become eroded
22 or overgrown with vegetation.

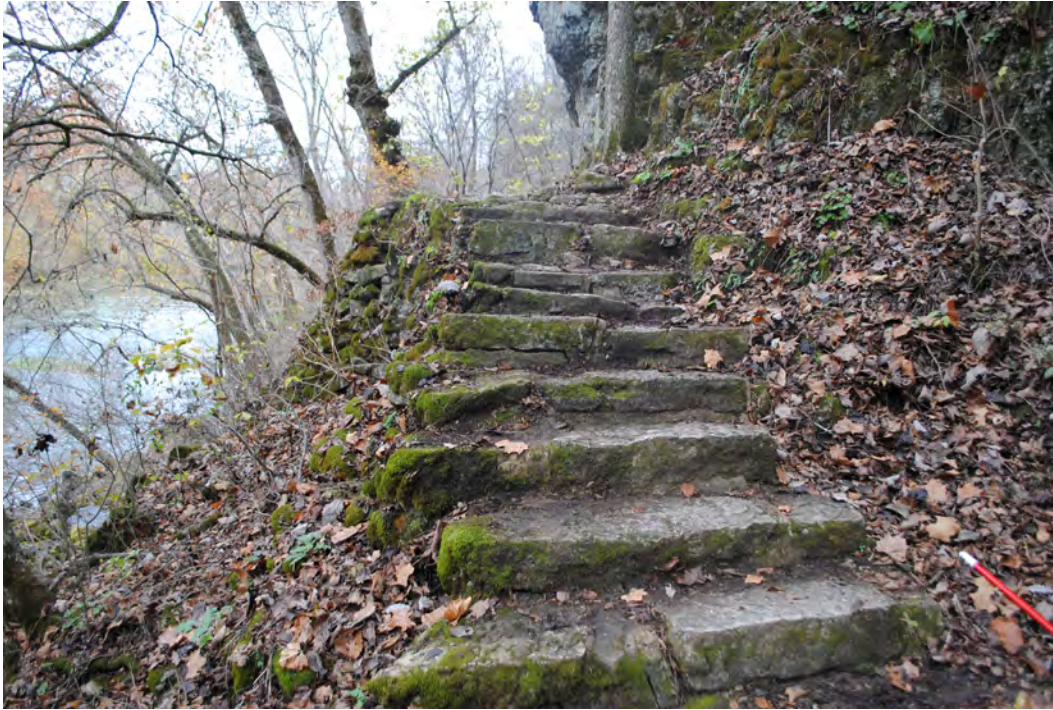
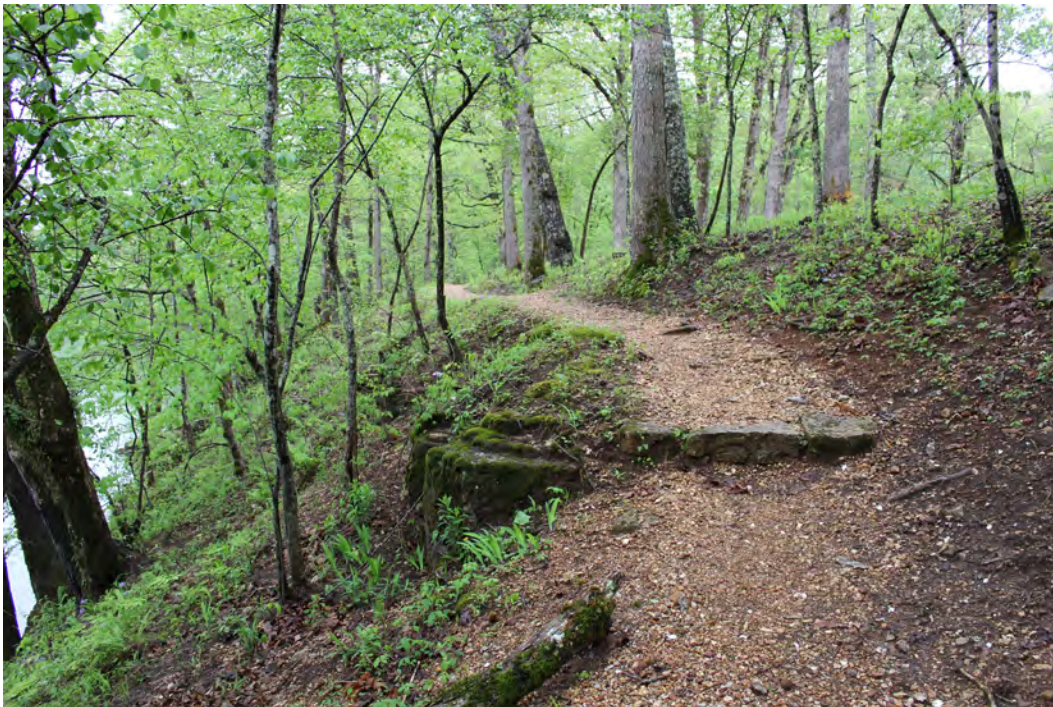
Figure 3-23. Pedestrian circulation is primarily narrow and rugged recreational trails constructed by the CCC, such as the Big Spring Trail (above) Chubb Hollow Trail (below). (Mundus Bishop 2016)

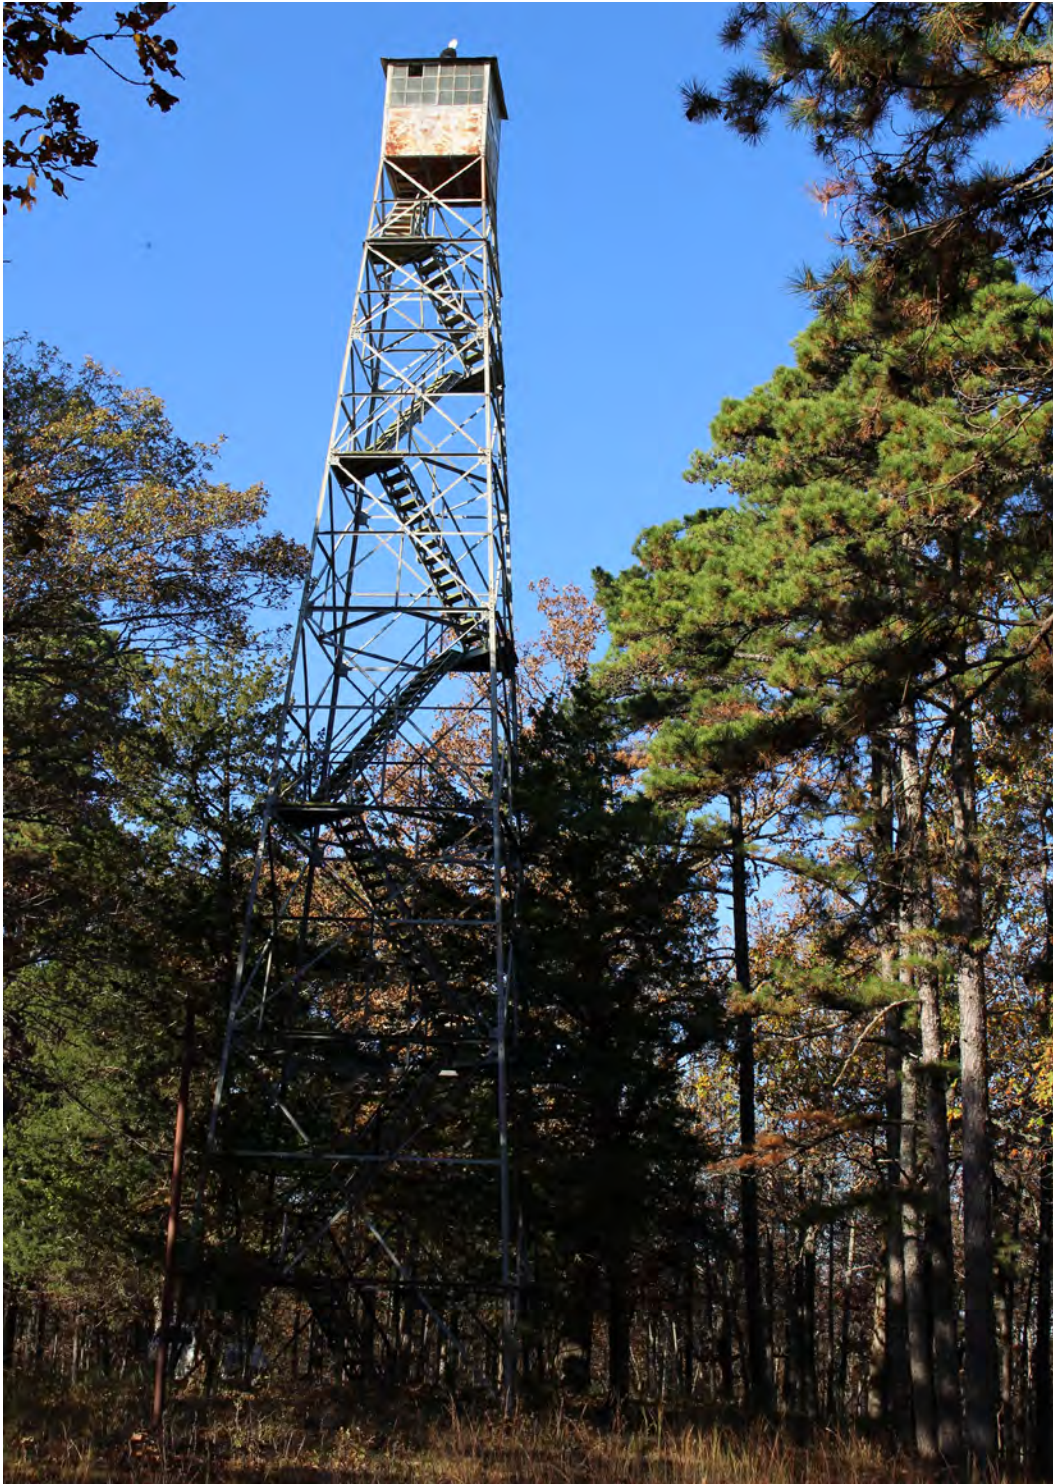
Figure 3-26. The Fire Tower / Lookout Tower (HS-1404) is no longer used for fire monitoring and is closed to public use, however it continues to provide the historic vantage point of the 1930s and 1940s, with views of the Current River, the Courtois Hills and the surrounding forest.(Mundus Bishop 2015)

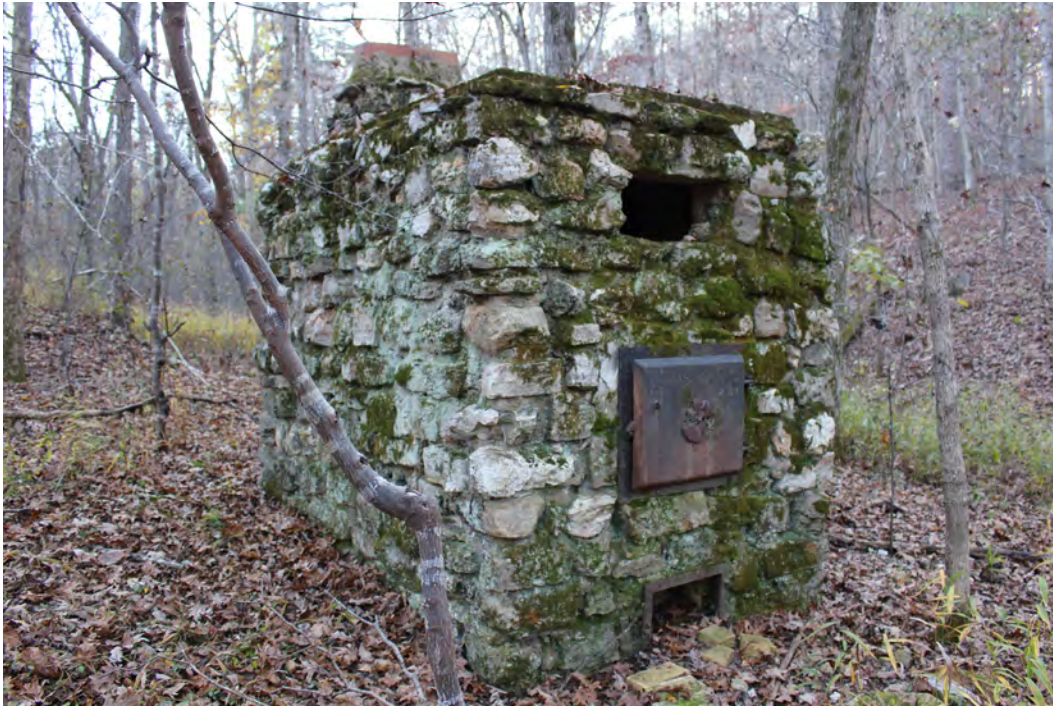
Figure 3-27. The Dump Incinerator (HS-432B) was used to discard flammable construction debris. The Dump Incinerator, and surrounding CCC Dump, are extant from the period of significance. (Mundus Bishop 2015)

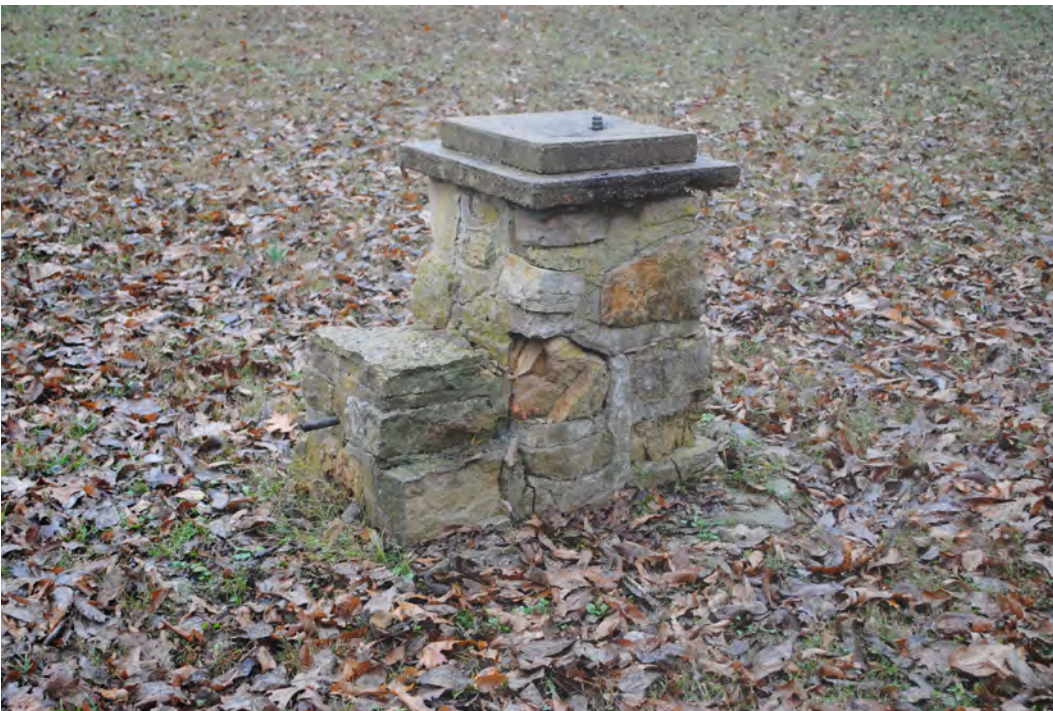
Figure 3-28. One of seven stone Fountains (HS-712) in the study area. (Mundus Bishop 2015)

1 The Fountains are rough-cut stone with one
2 step at the base and a concrete basin on top.
3 They are in varying stages of disrepair, but
4 contribute to the cultural landscape.

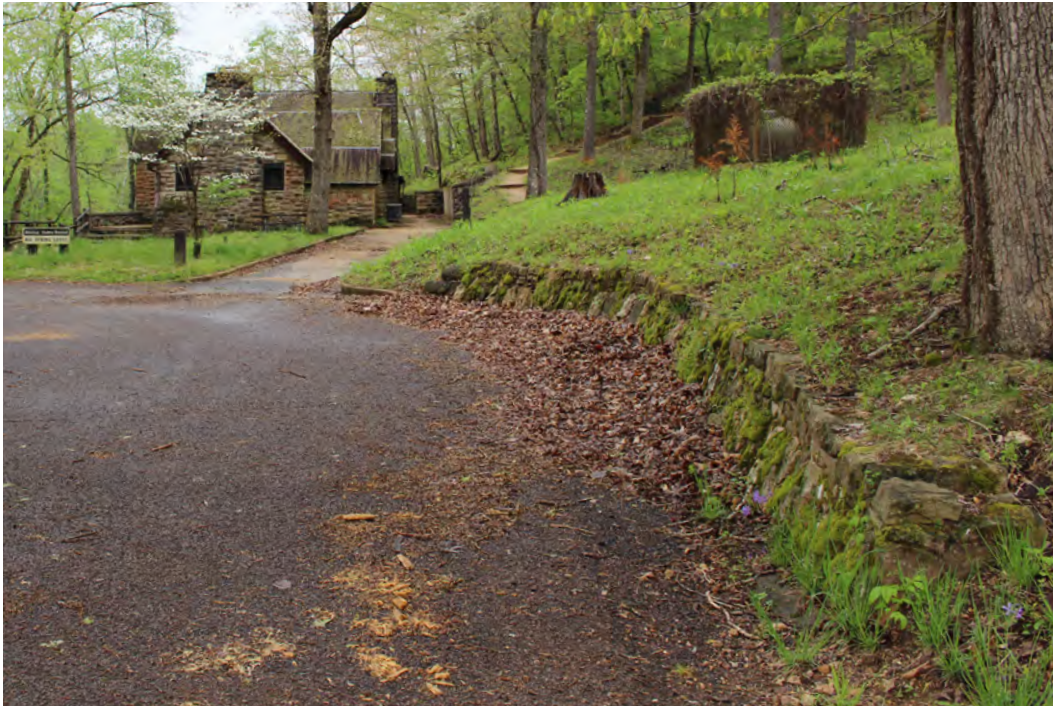
31 Today, the mortared native stone retaining
32 walls at parking areas, buildings, and at Big
33 Spring remain. Many are in disrepair with
34 failing mortar joints and damaged stones.
35 While minor maintenance has occurred
36 to repair the existing walls, the CCC stone
37 retaining walls remain largely as they did
38 during the period of significance. There is an
39 upcoming project to stabilize and repair the
40 masonry of the stone retaining walls at the
41 Dining Lodge and Entrance.

Figure 3-29. CCC stone retaining wall near the Dining Lodge (HS-422). (Mundus Bishop 2016)

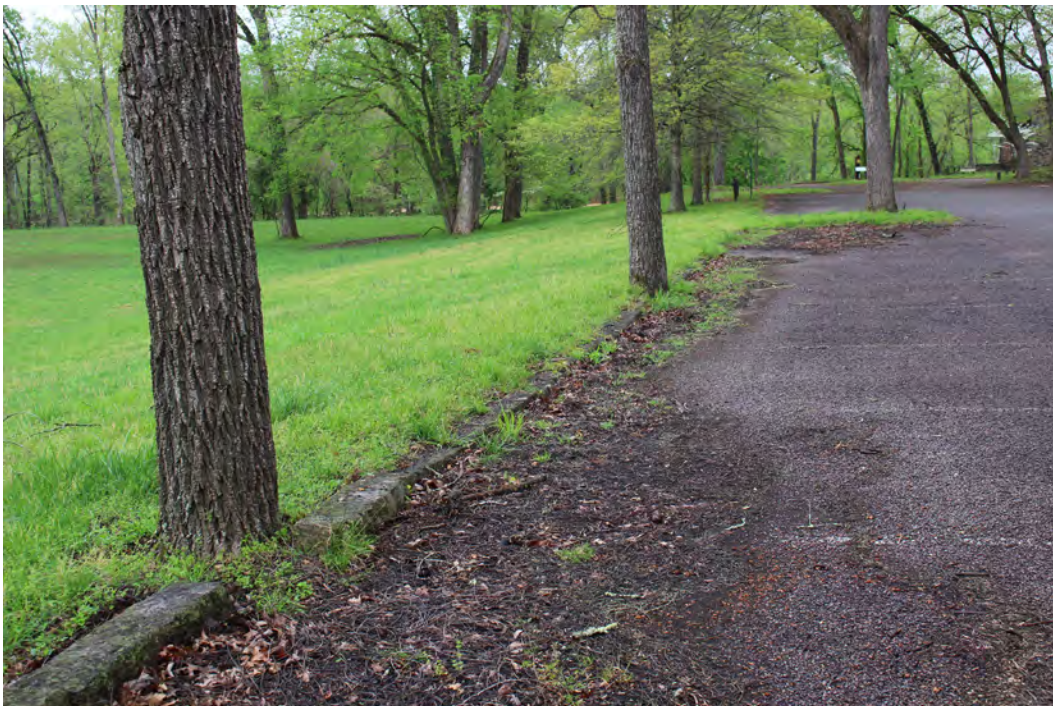
Figure 3-30. The CCC stone retaining curb at the Main Parking Area (HS-714) is in fair to poor condition. (Mundus Bishop 2016)
