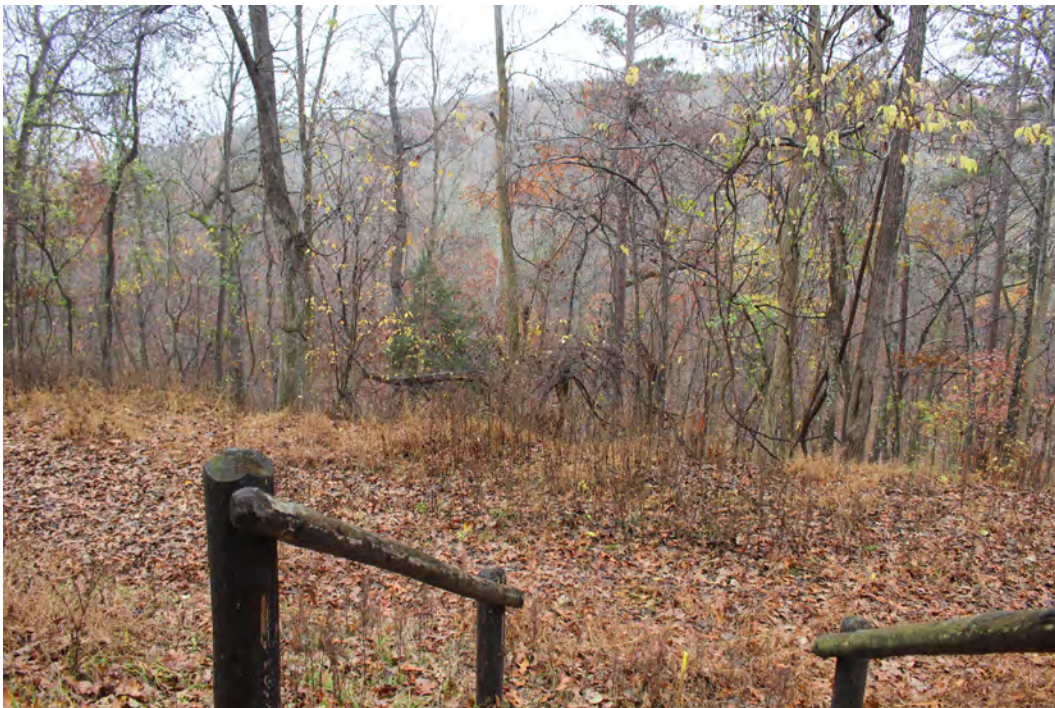
42 The vegetation patterns generally remain
43 similar to the period of significance. However,
44 the native forest has become more dense
45 and now encroaches into previously open
46 areas, and many CCC plantings have been

Figure 3-50. The vegetation today remains similar to the period of significance, however the native forest is more dense and encroaches into previously open areas. (Mundus Bishop 2015)

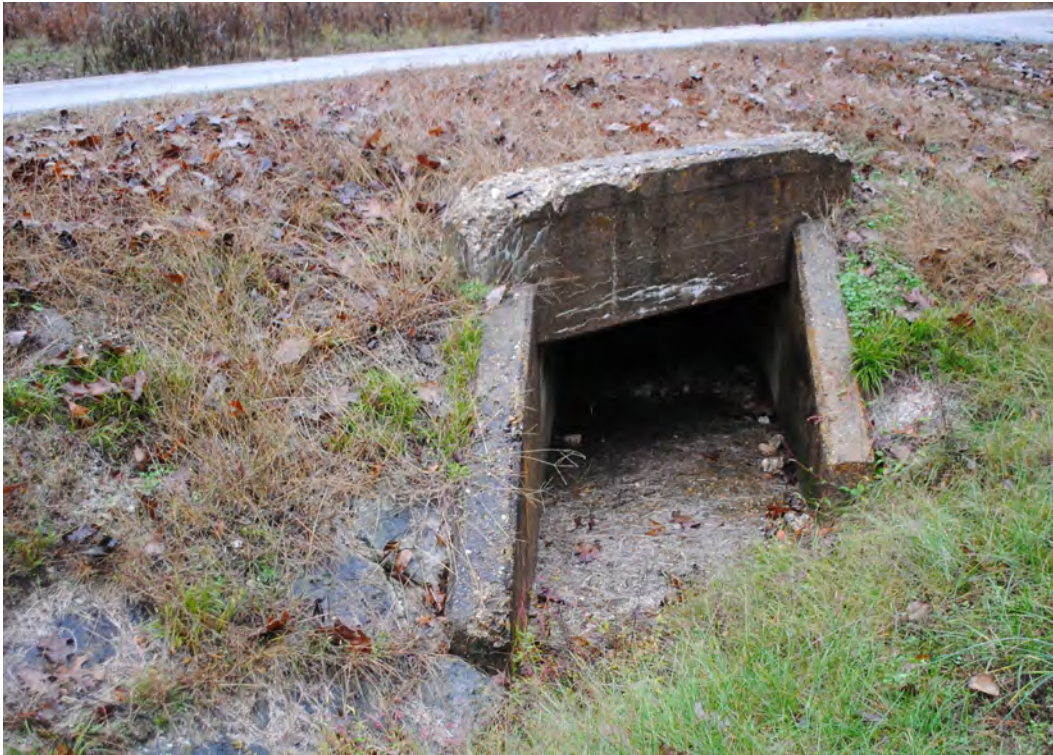
Figure 3-51. The stone and concrete culvert extends under Peavine Road / State Highway 103. (Mundus Bishop 2015)

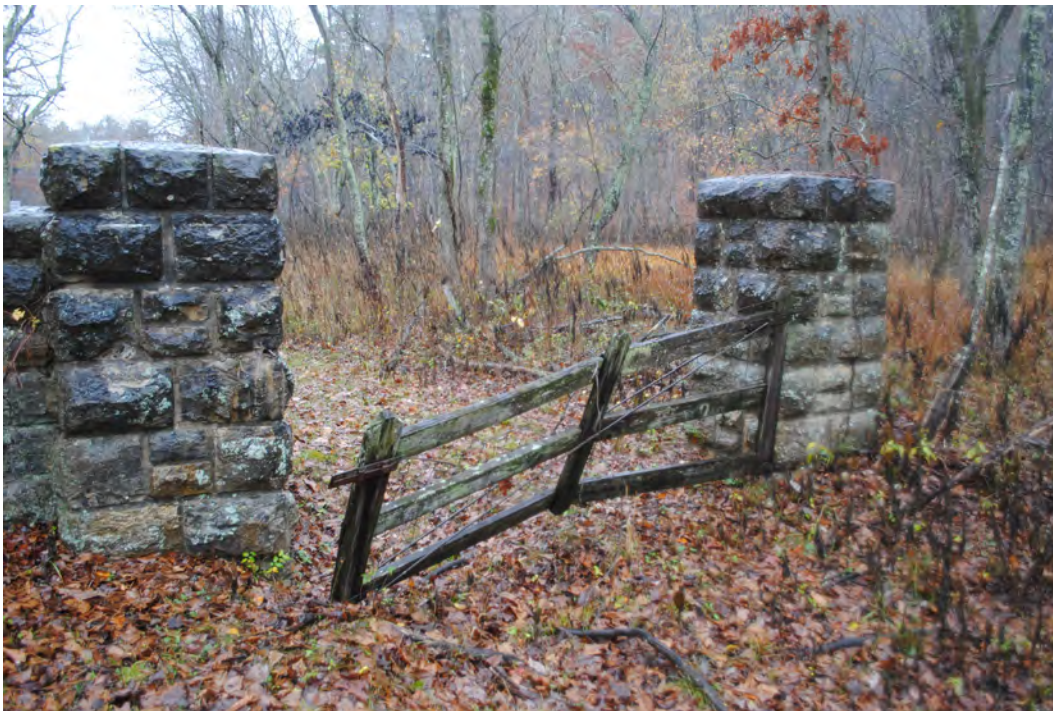
Figure 3-52. The wood gate near the Entrance Building (HS-432) is in poor condition and the remnant road is difficult to discern. (Mundus Bishop 2015)

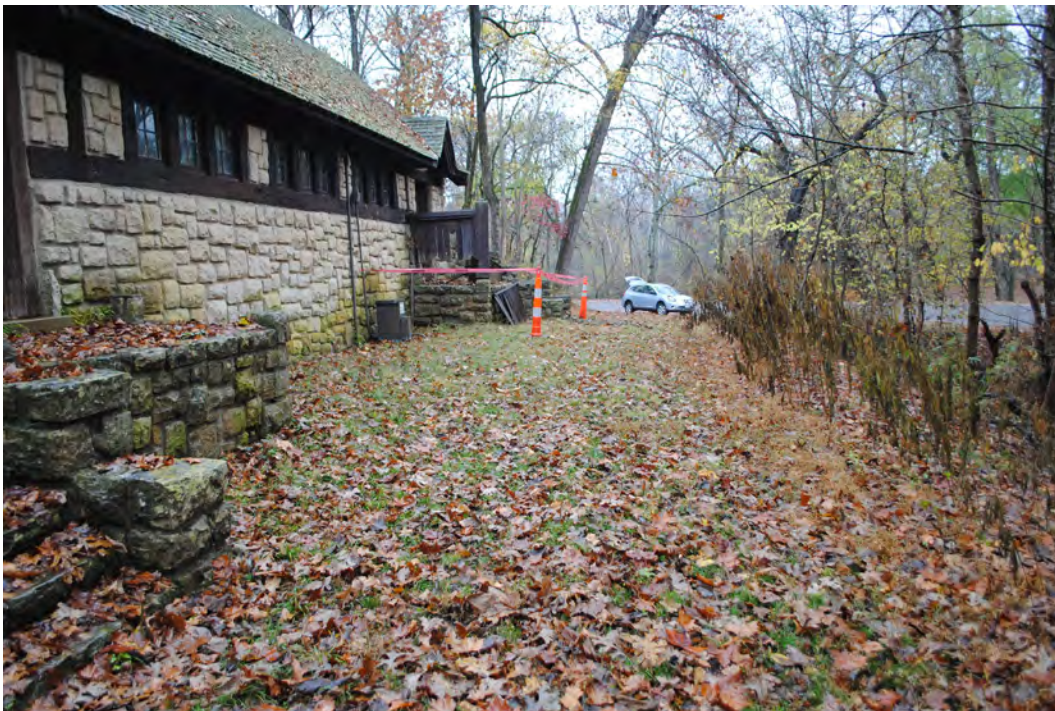
Figure 3-62. Latrine (476). (Mundus Bishop 2015)

Latrine (HS-423) (1935)	Single story gabled building with gable dormers over the two entrances. Half-timber framing with irregular course cut stone infill. Four light sash windows on continuous wood sill, with concrete floor.	Poor	Contributing

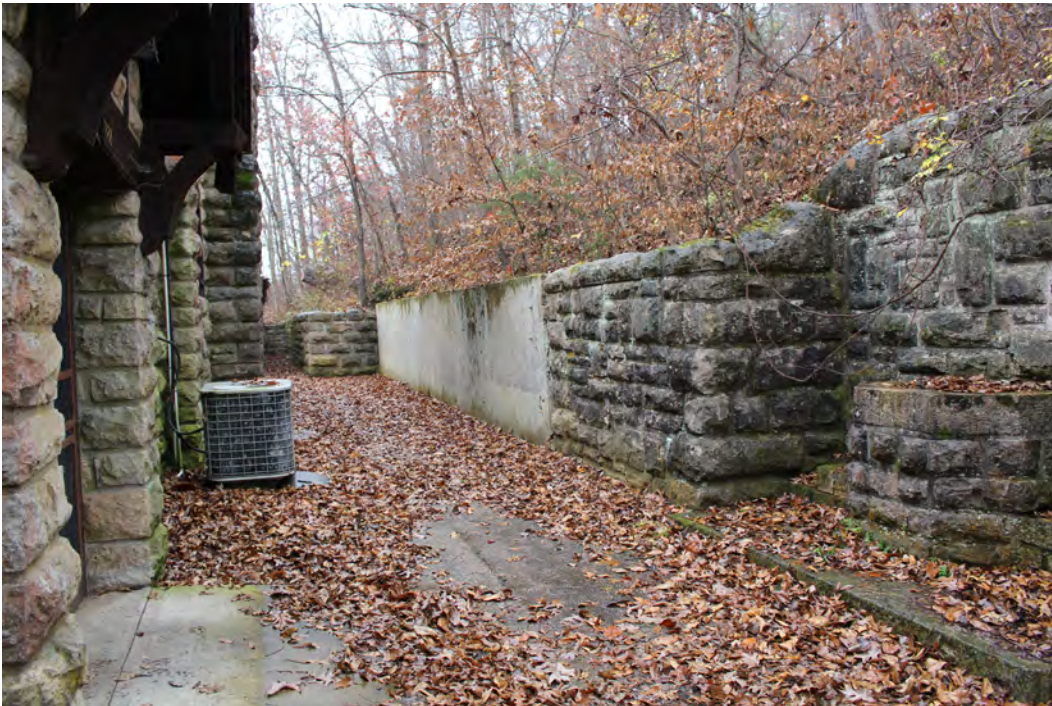
Figure 3-73. Dining Lodge Retaining Wall and Fountain (HS-422A). (Mundus Bishop 2015)

Dining Lodge			
Feature	Description	Condition	"Contributing / Non-Contributing"
Retaining Wall and Abutments (HS-423A) (between 1934 and 1936)	Large cut stones dry laid against the sides of a creek that flows in front of the Latrine (HS-423). The stone ledges are set into banks in long continuous courses with tight joints.	Fair	Contributing
Flagpole		Good	Contributing
Pedestrian Light		Good	Non-contributing
Low Level Lighting	Uplighting and small bollards occur at front entrance	Very Poor	Unknown
Wood Posts	One post at service drive		Non-contributing
Propane Tank	Silver tank on concrete pad with fence enclosure of wood slats, and gate on one end.	Unknown	Non-contributing
Electrical Transformer	Standard green box, set at curve of drop-off at Dining Lodge.	Unknown	Non-contributing
Wood Footbridge		Good	Non-contributing
Latrine			
Feature	Description	Condition	"Contributing / Non-Contributing"
Retaining Wall and Abutments (HS-423A) (between 1934 and 1936)	Large cut stones dry laid against the sides of a creek that flows in front of the Latrine (HS-423). The stone ledges are set into banks in long continuous courses with tight joints.	Fair	Contributing
