LADDER CREEK TANK – TCRA PHASE 1 SUMMARY

City Light is removing burned debris and impacted soil from the area immediately surrounding the Ladder Creek Settling Tank outside Newhalem, WA under a CERCLA Time Critical Removal Action (TCRA). This memorandum summarizes Phase 1 of the TCRA activities.

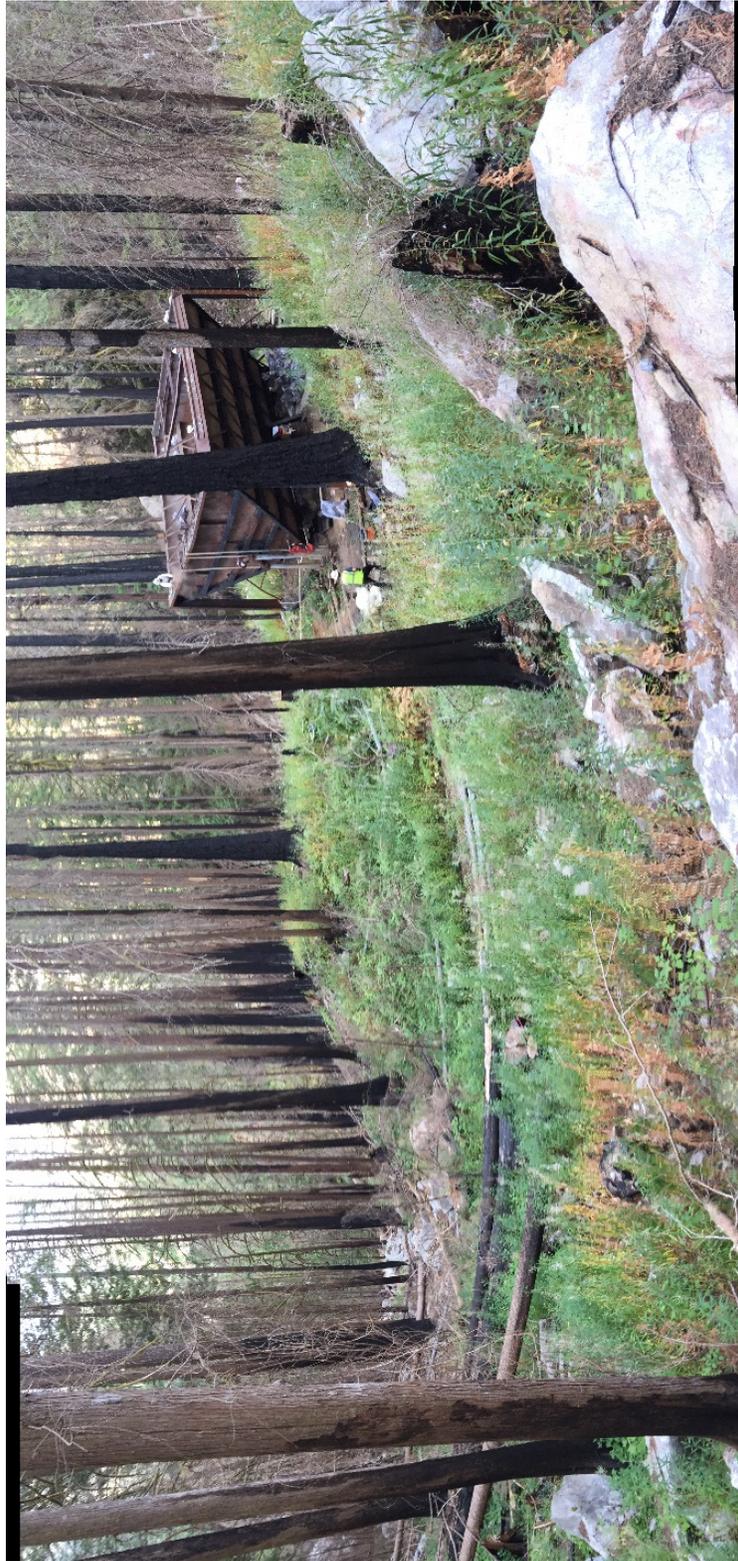
City Light and its contractor mobilized to the tank site on Monday 8/28. Due to the remote location, all materials were hand-carried to the site via the rugged foot trail. Over the course of the week the contents of the tank were removed and the tank interior was pressure washed clean. Figures 1, 2 and 3 show cleaning activities in progress. Contents included primarily sediment left in the tank from when it was operated to settle out sediments in water diverted from Ladder Creek, organic material including leaves and pine needles, and branches. These materials were placed in plastic bags and lowered to the ground where they were stockpiled in a staging area under the tank (Figure 4).

Figure 1 - Ladder Creek Settling Tank Panorama

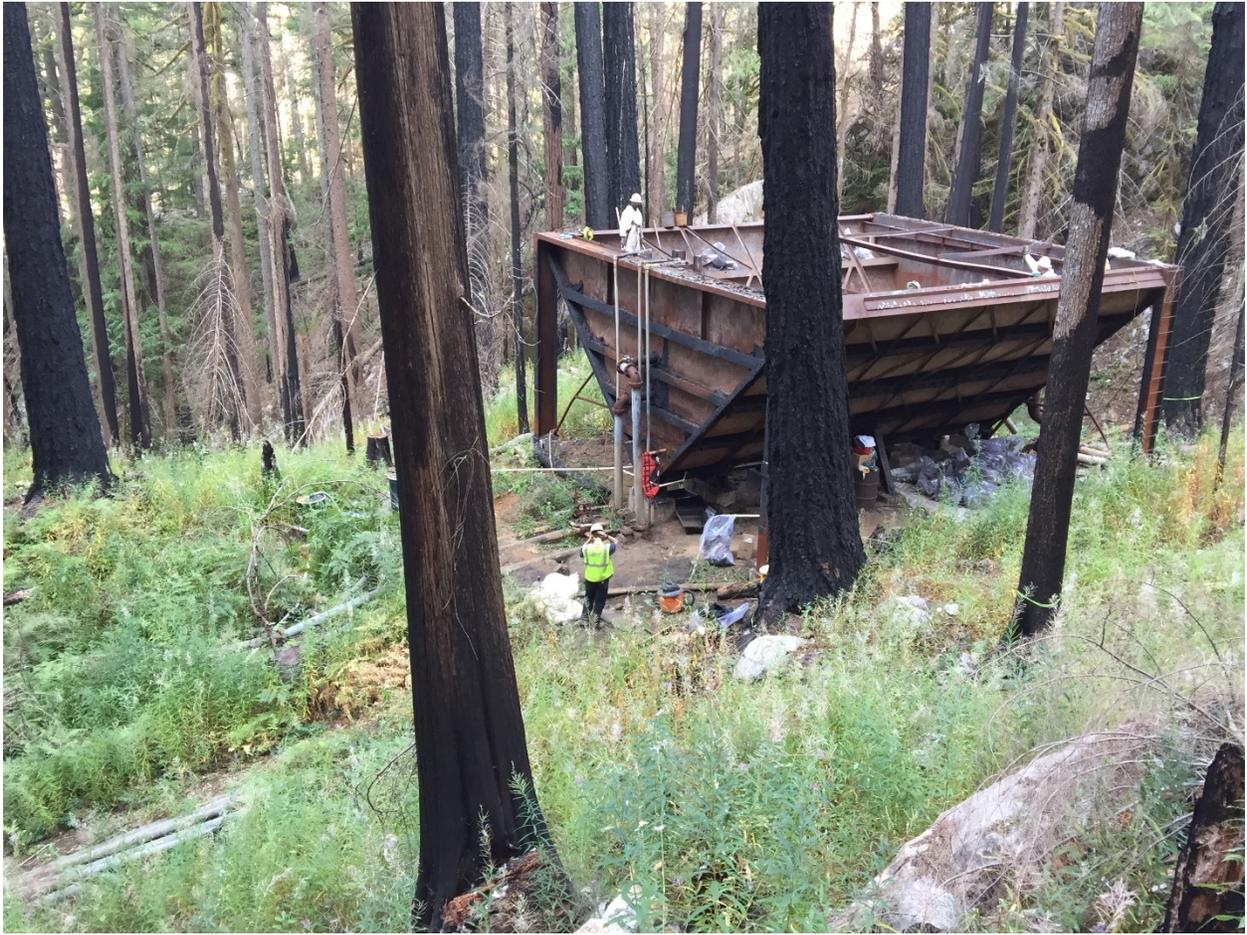
Figure 2 - Ladder Creek Settling Tank; Tank Cleaning Activities #1

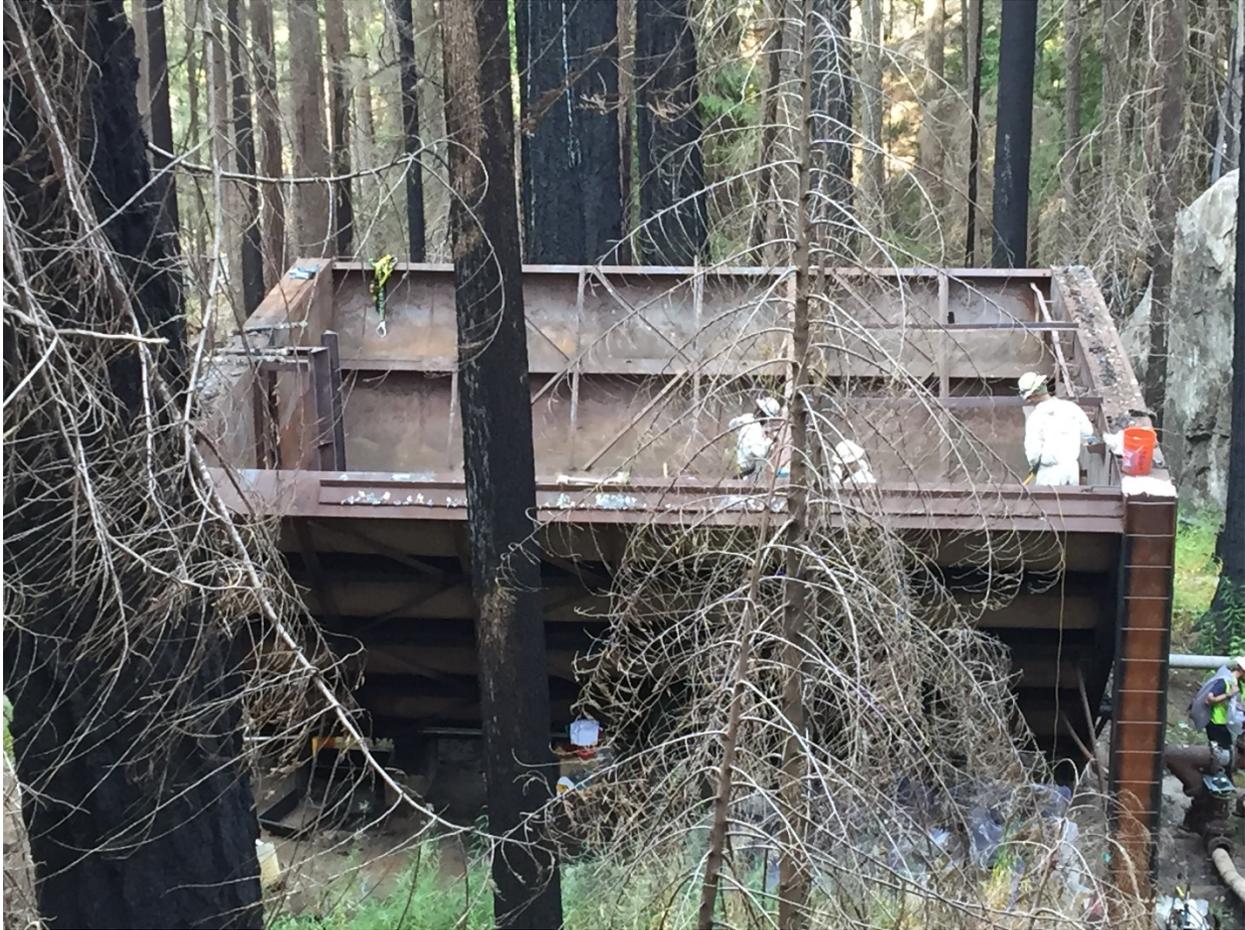
Figure 3 - Ladder Creek Settling Tank; Tank Cleaning Activities #2

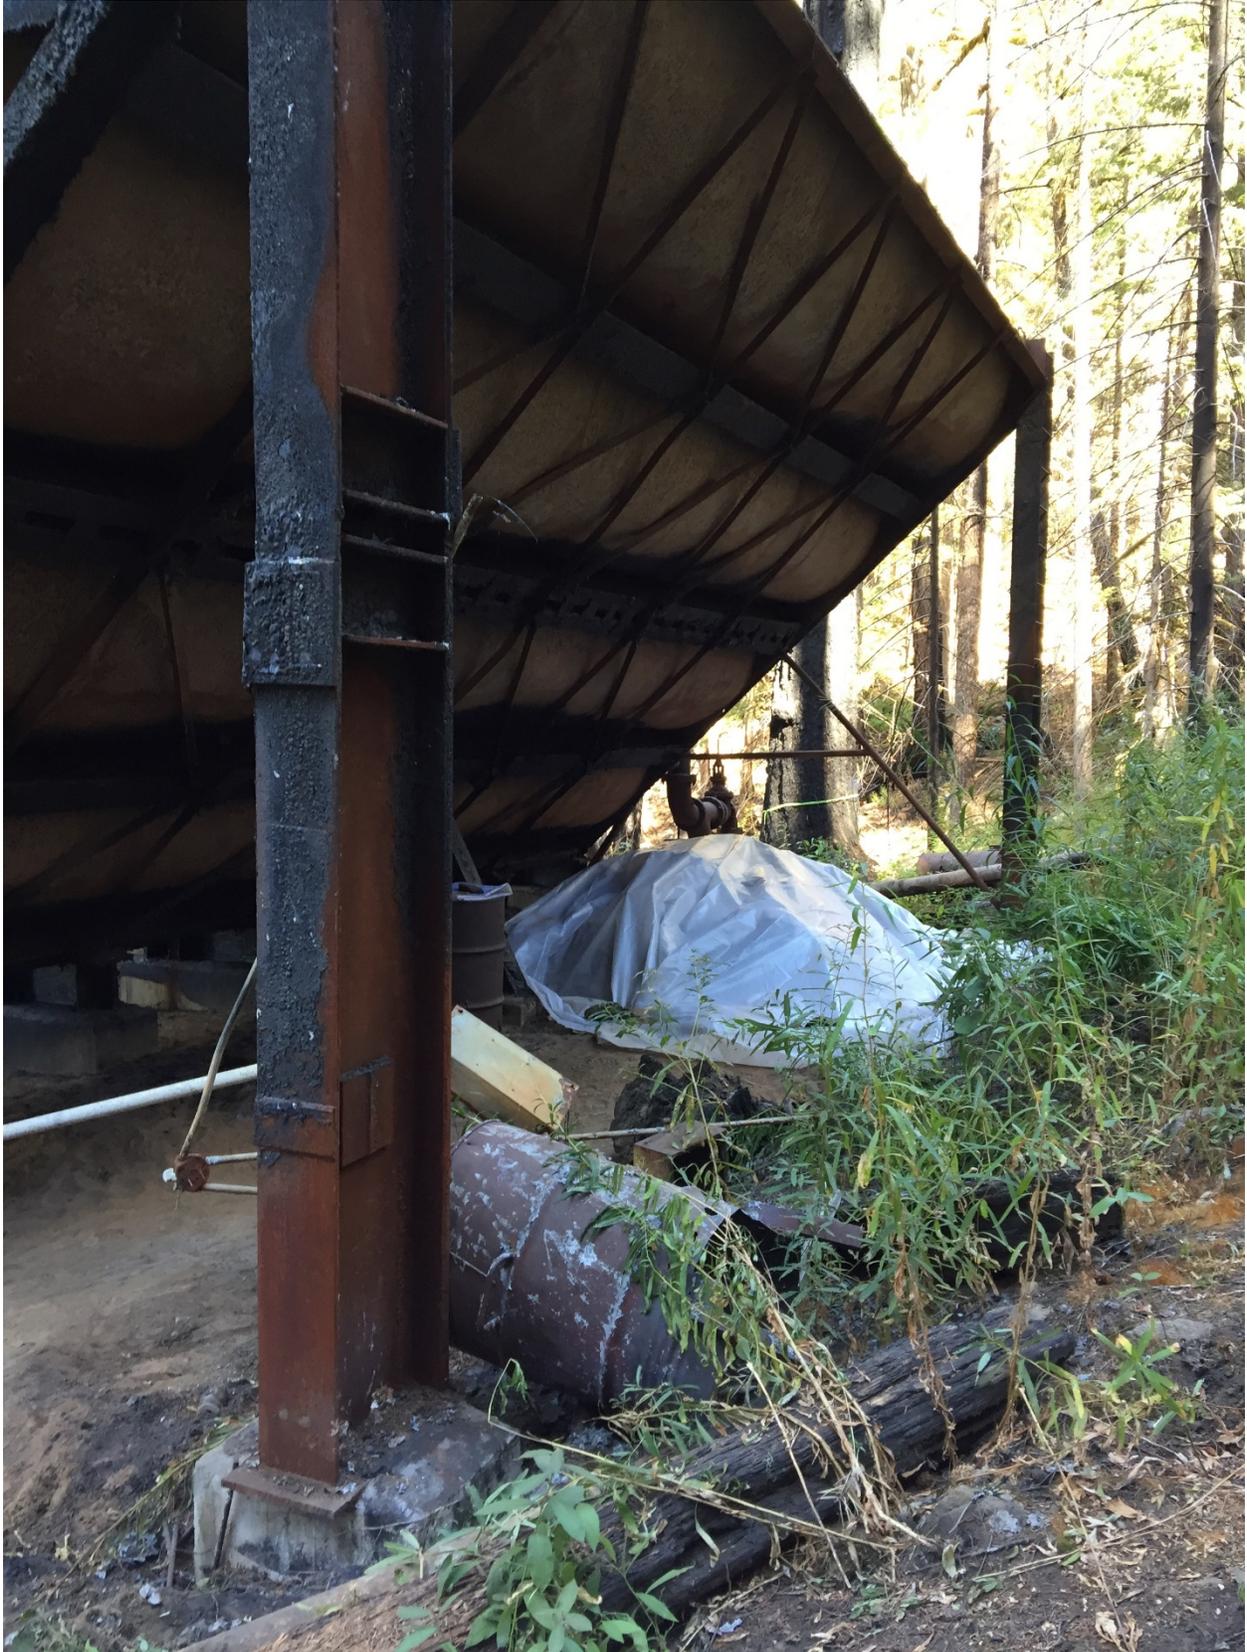
All equipment used for cleaning the tank was de-mobilized from the site on September 1, and materials removed from the tank were staged in a stockpile for the winter. Materials remaining at the tank location include the covered stockpile of debris removed from the tank and the GAC drums. These materials will be flown out during Phase 3 of the TCRA.

Figure 4 - Ladder Creek Settling Tank; Materials From Inside Tank Staged for Winter

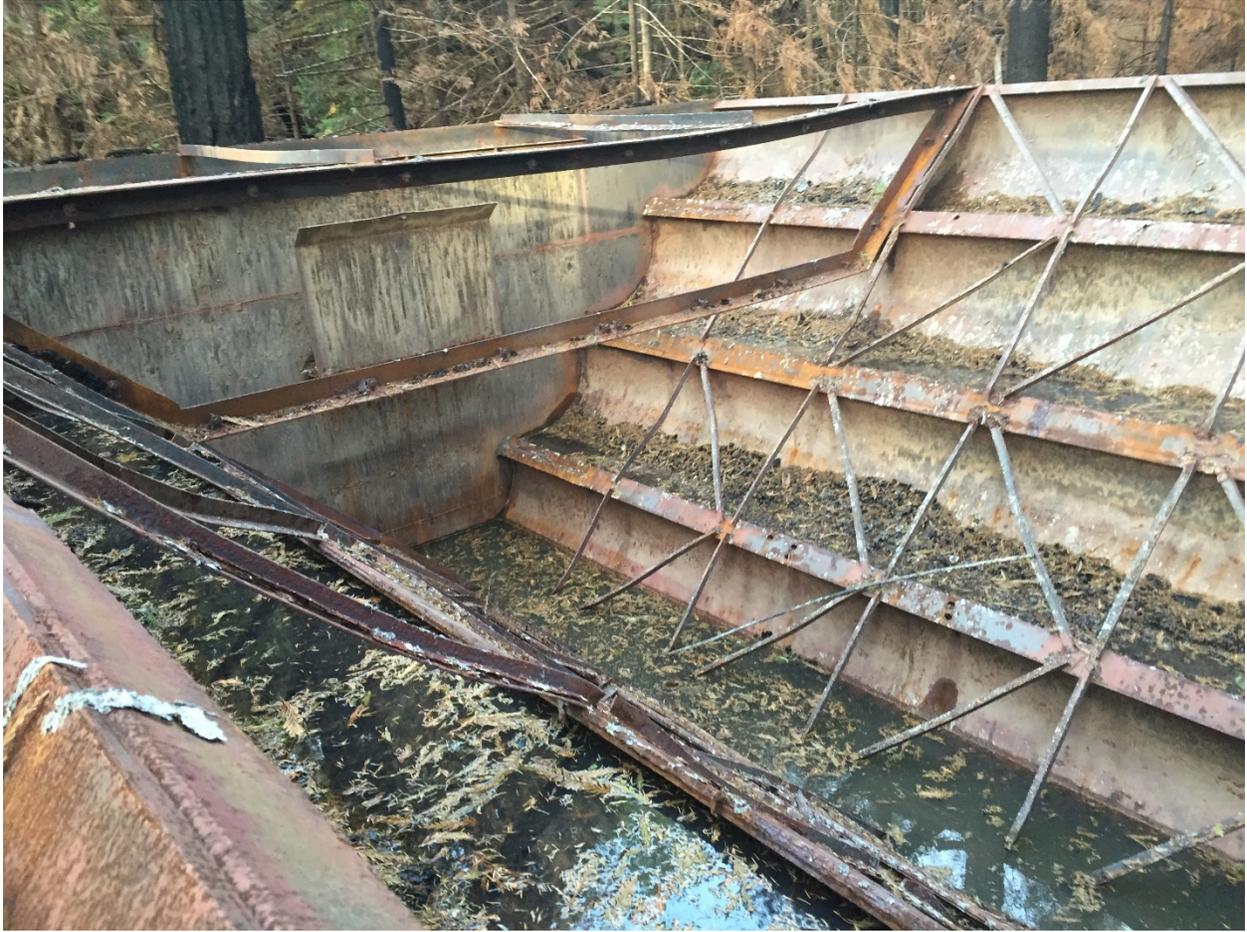
No metals were detected in the sample, indicating residues were successfully removed from the tank interior. Figure 5 (2015) and 6 show the tank interior before and after cleaning.

Figure 5 - Ladder Creek Settling Tank; Tank Interior in 2015, Before Cleaning

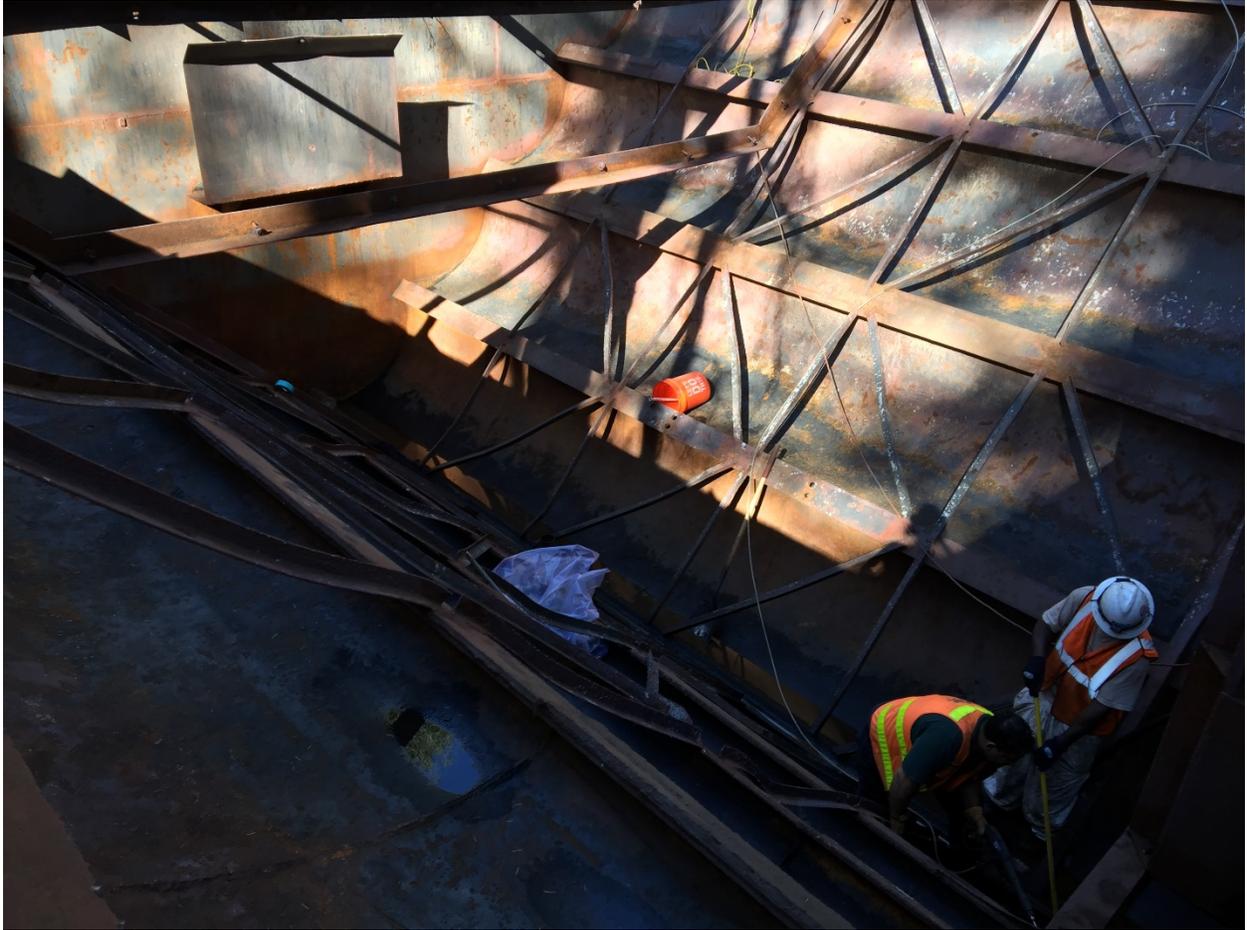
Figure 6 - Ladder Creek Settling Tank; Tank Interior After Cleaning

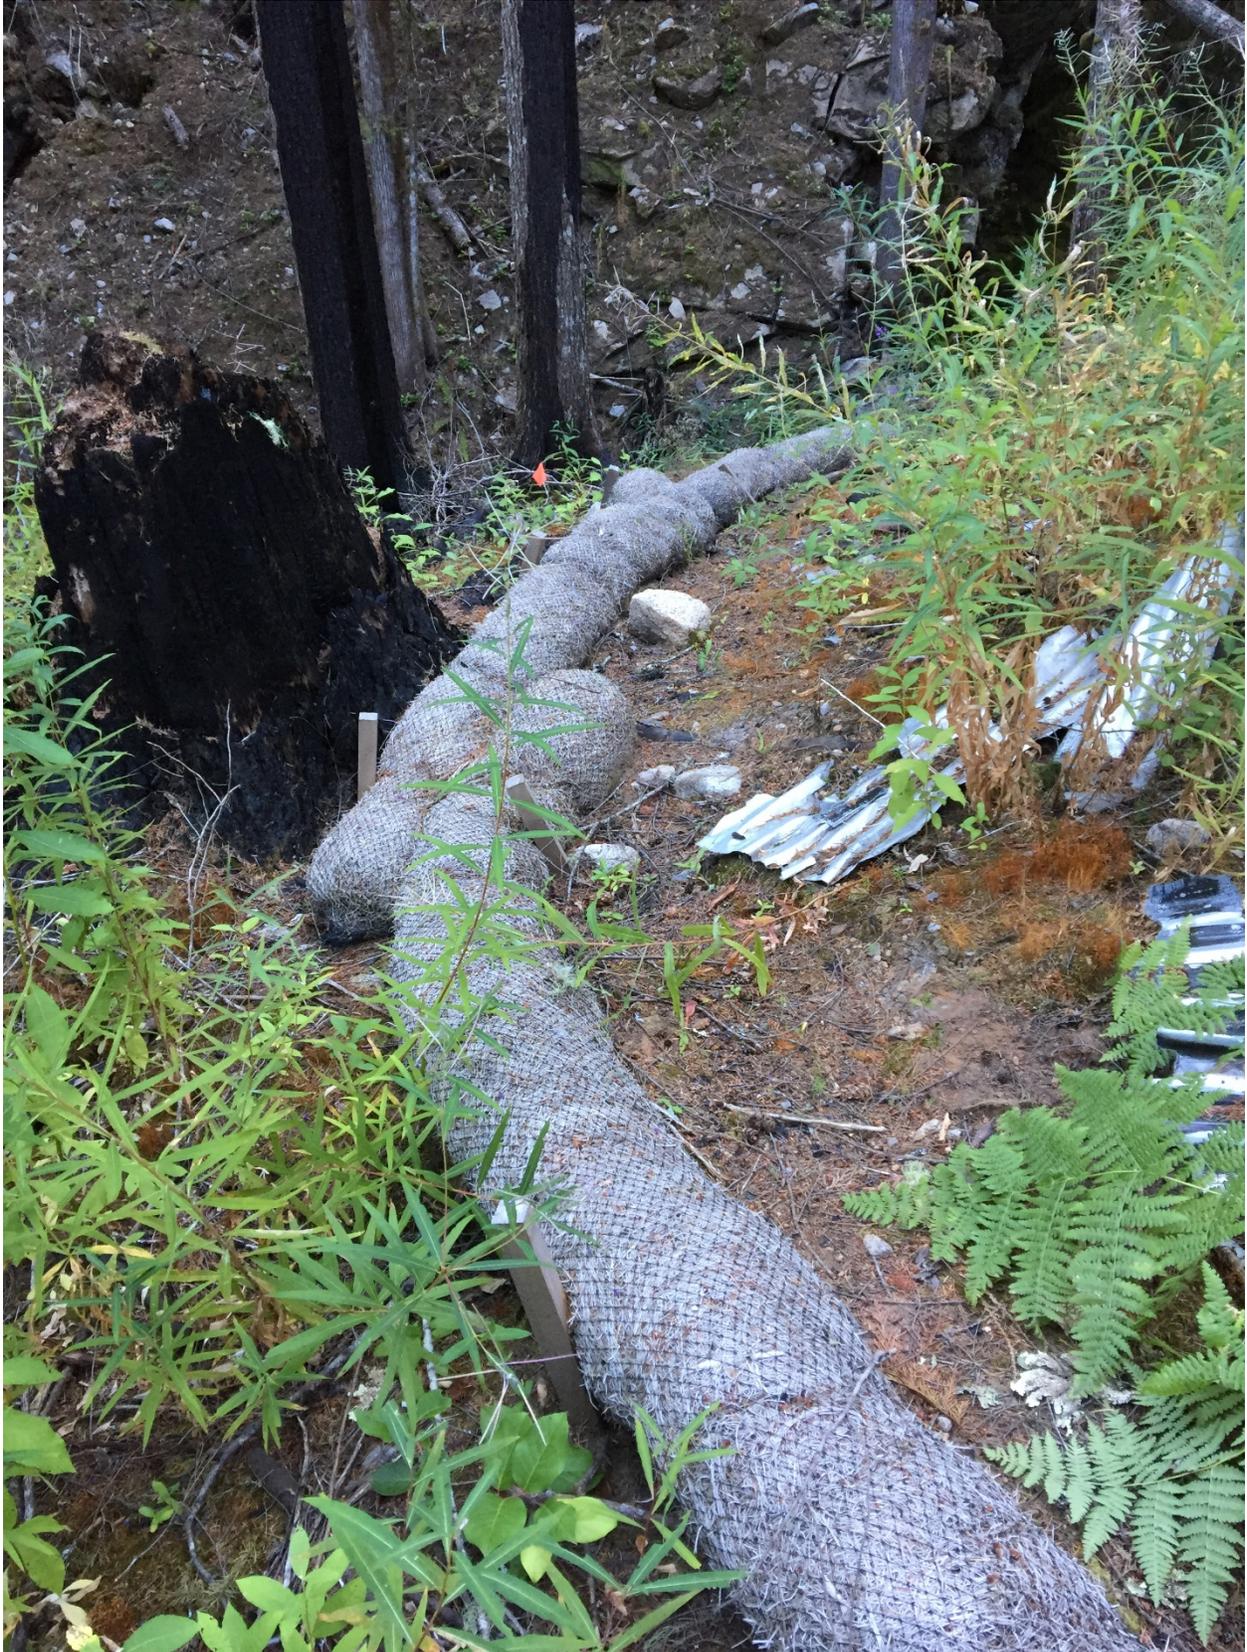
Erosion and Sedimentation Control - Coir logs were installed around the tank in fall 2015 to control erosion and sedimentation after the fire. The coir logs were checked and monitored during the Phase 1 activities. At completion of the Phase 1, three new coir logs were installed to supplement the existing ones. Figures 7, 8 and 9 show the current condition of the coir logs around the site.

Figure 7 - Ladder Creek Settling Tank; Erosion Control in Place #1

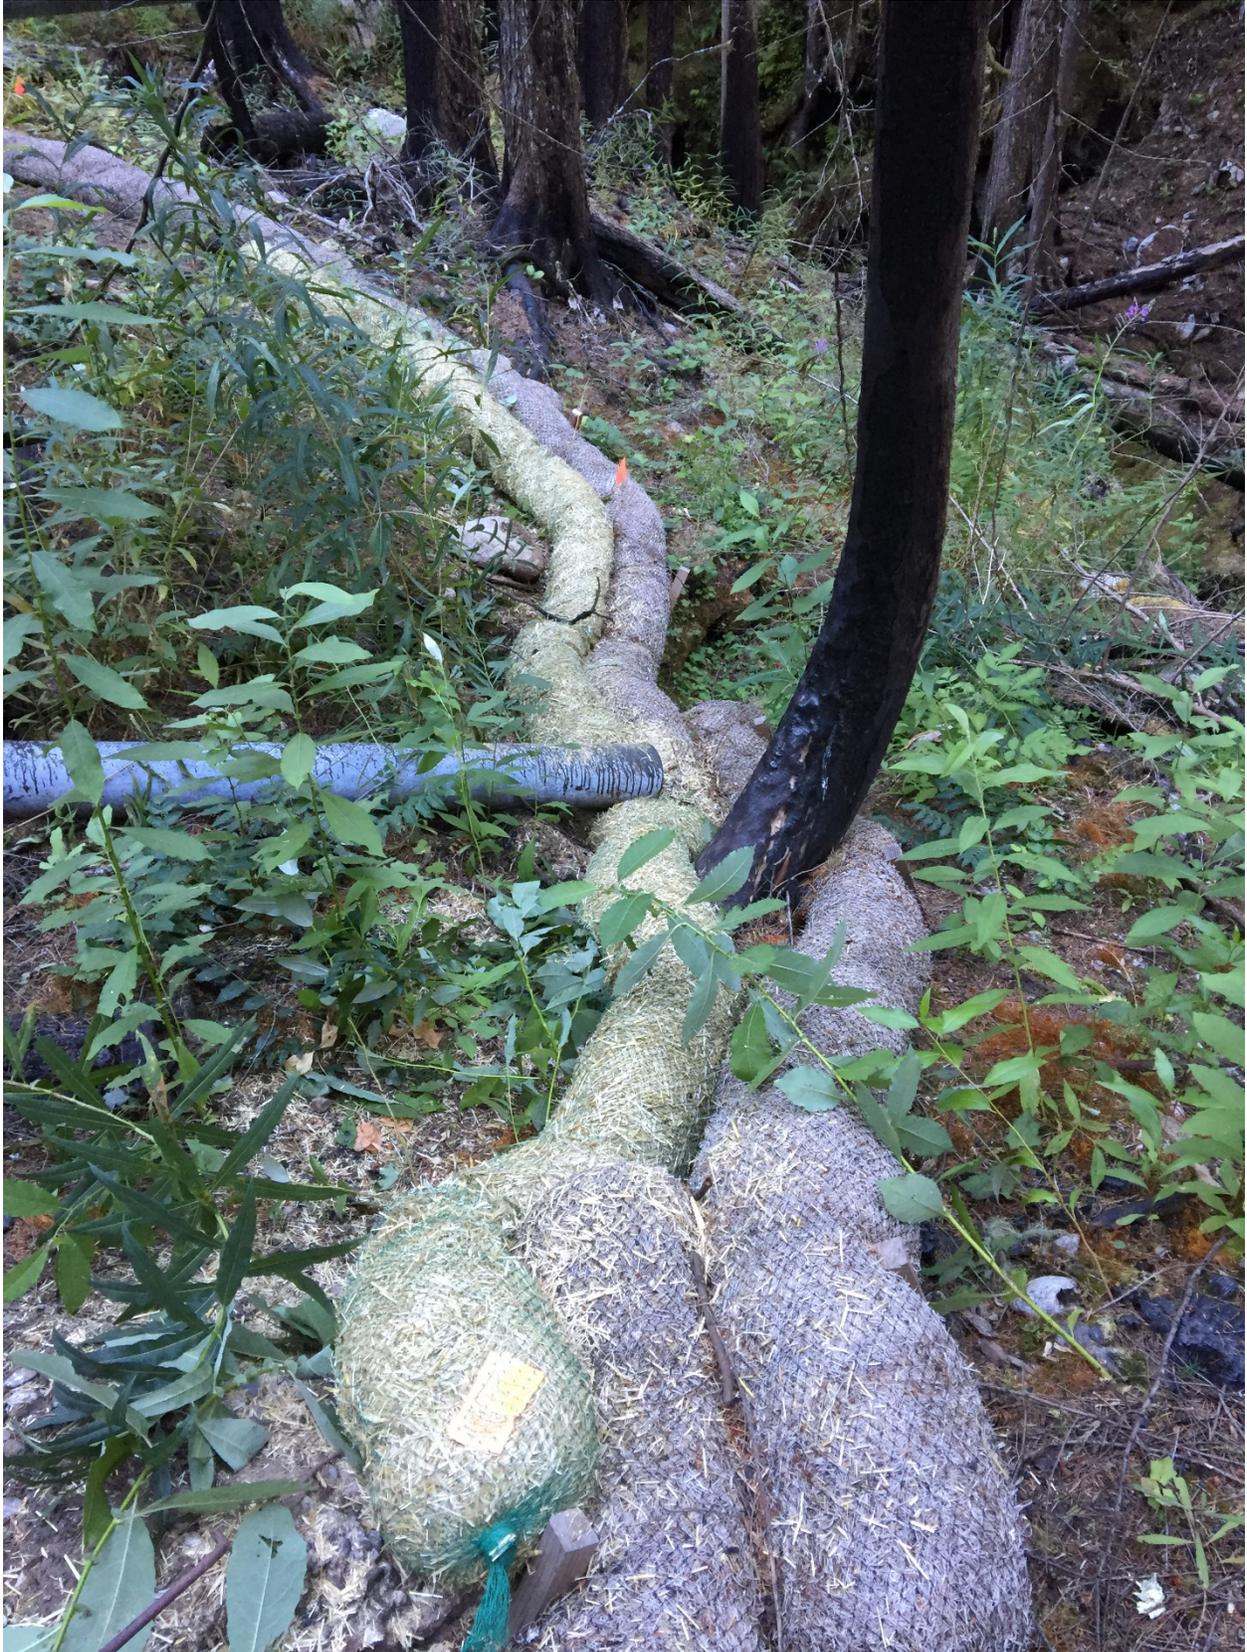
Figure 8 - Ladder Creek Settling Tank; Erosion Control in Place #2

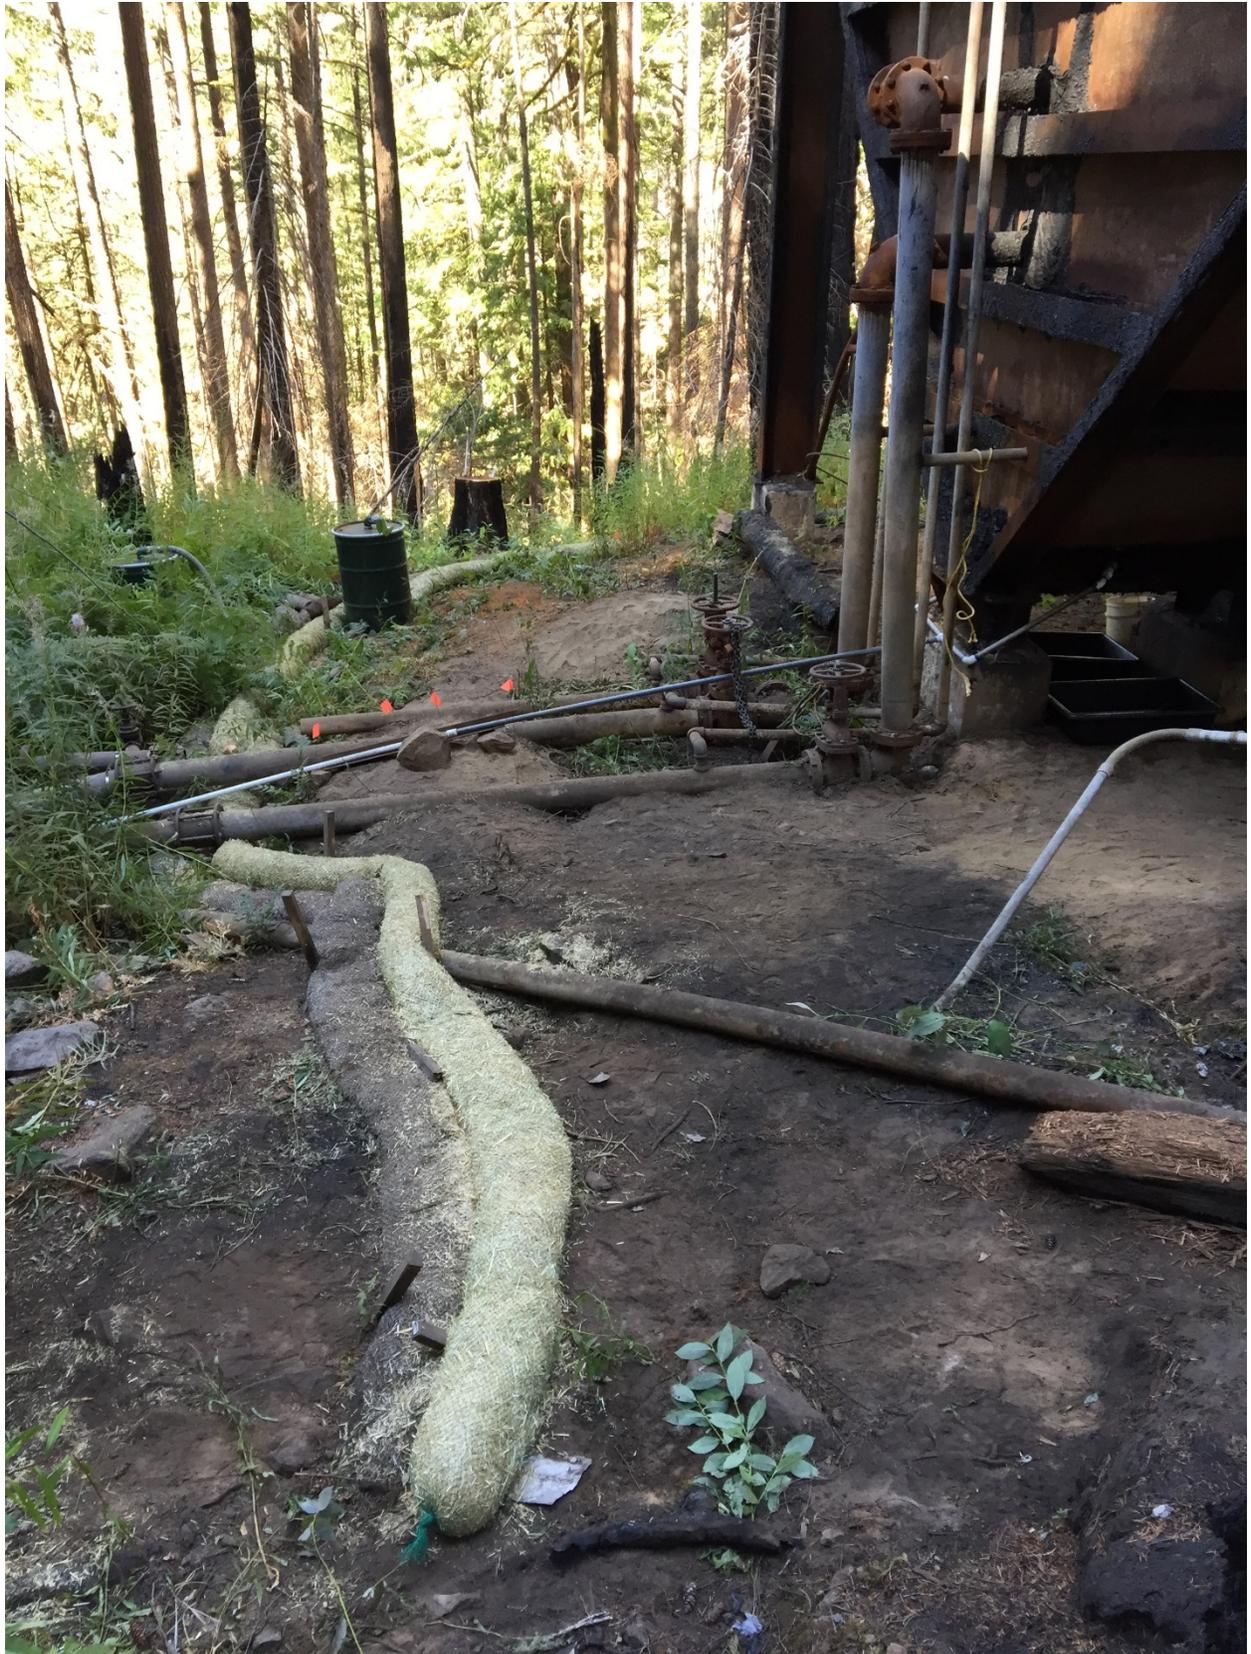
Figure 9 - Ladder Creek Settling Tank; Erosion Control in Place #3

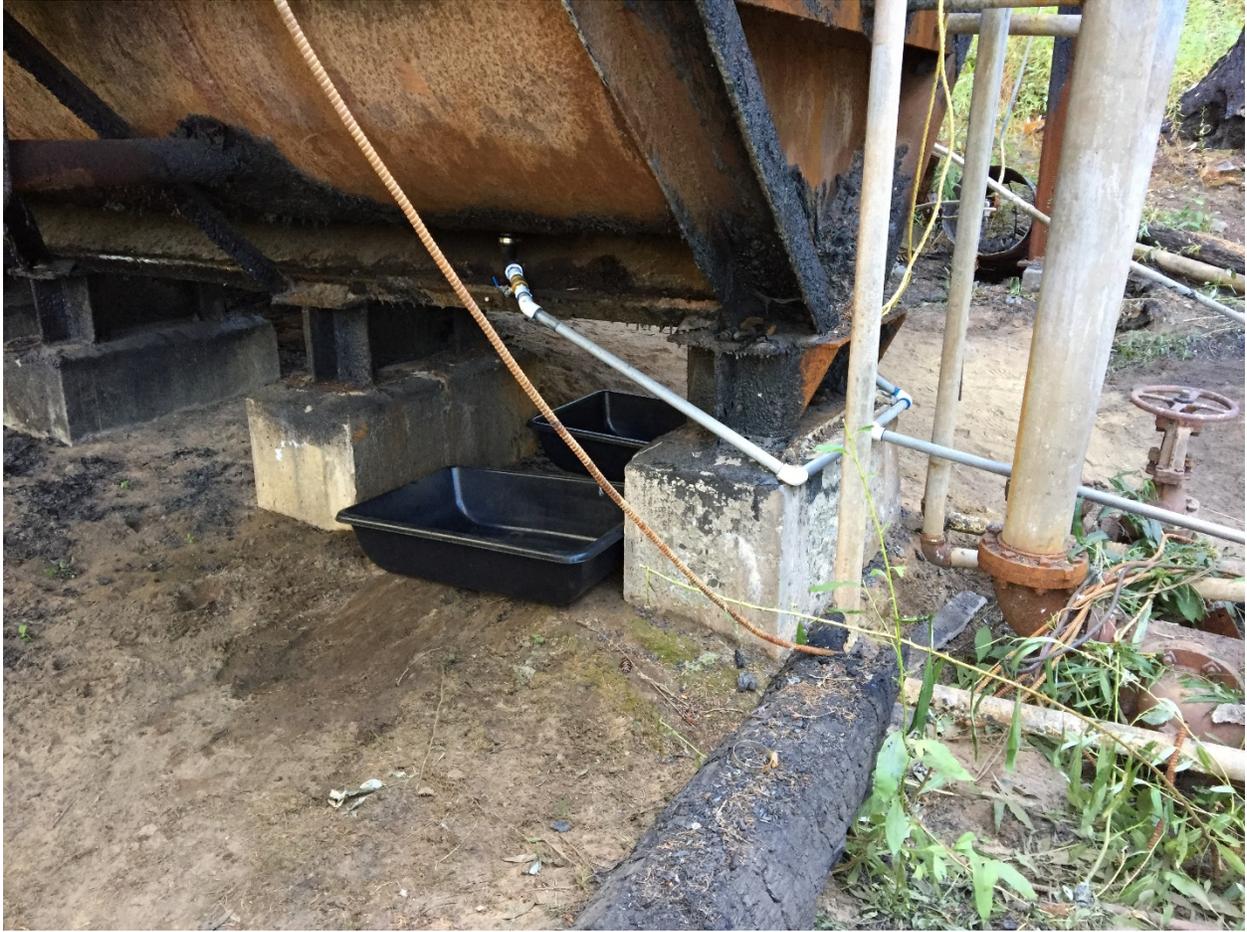
Settling Tank - After completion of the tank cleaning, the GAC drum filtration system was disconnected and new piping was put in place conveying water from inside the tank to the distribution/manifold piping at the ground surface approximately 30 feet south of the tank. Water accumulating in the tank discharges to the ground via this system. Figures 9 and 10 show the new line in place at the tank discharge port. All piping that had been in contact with the tank discharge up-line from the filtration system was removed and staged for disposal. City Light does not currently plan to modify the current condition of the settling tank.

Figure 10 - Ladder Creek Settling Tank; Discharge Apparatus After Tank Cleaning
