APPENDIX A
PHOTO LOG OF HISTORIC FEATURES OF THE
SCENIC LOOP DRIVE HISTORIC DISTRICT

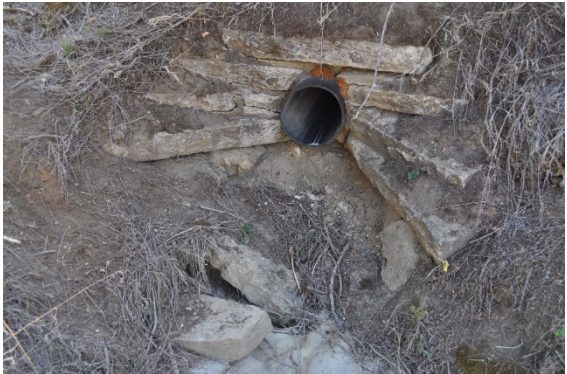
Resource Name	Plastic pipe culvert

Architectural Feature No.	10	
Field No.	THRO LR14	
Location	MM 25.95	
Date(s) of Construction	1936	
Action	Heavily damaged surrounding slope, particularly erosion below outlet. Headwall will not be preserved. Install a pipe rundown in this location, out falling well below the existing rundown.
