CHAPTER 3: CULTURAL LANDSCAPE REPORT

MICHIGAN ISLAND EXISTING CONDITIONS

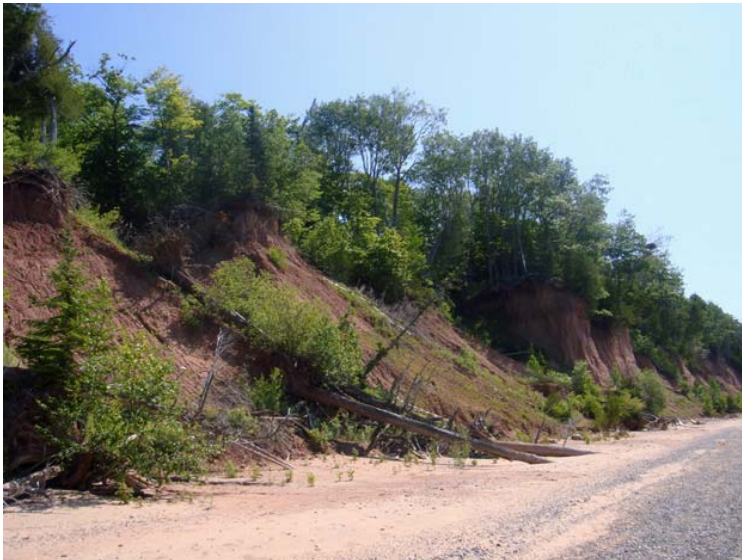
Existing Condition. The light station grounds on Michigan Island are located on a bluff, rising approximately 60' above Lake Superior. The overall island topography consists of a landscape of gently rolling, forested hills ending in steep banks that slope down to rocky or sandy beaches. The light station grounds are primarily flat with several small drainages leading from the interior of the island to the bluff edge and shoreline. The embankment slope is highly erodible but stable. The shoreline adjacent to the light station is primarily a narrow rocky cobble beach east of the boat dock with sand beaches to the west fluctuating in width. The topography of the light station and reservation is in good condition.

Site Image MI-31: Bluff along lake edge, east of dock, 2009 (Source: MBD DSC00585.JPG)

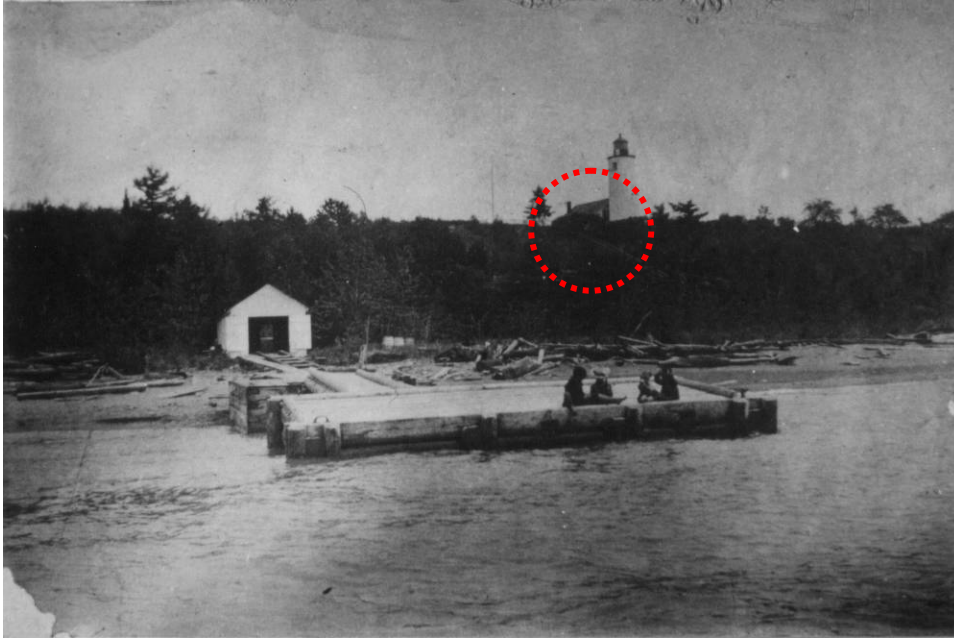
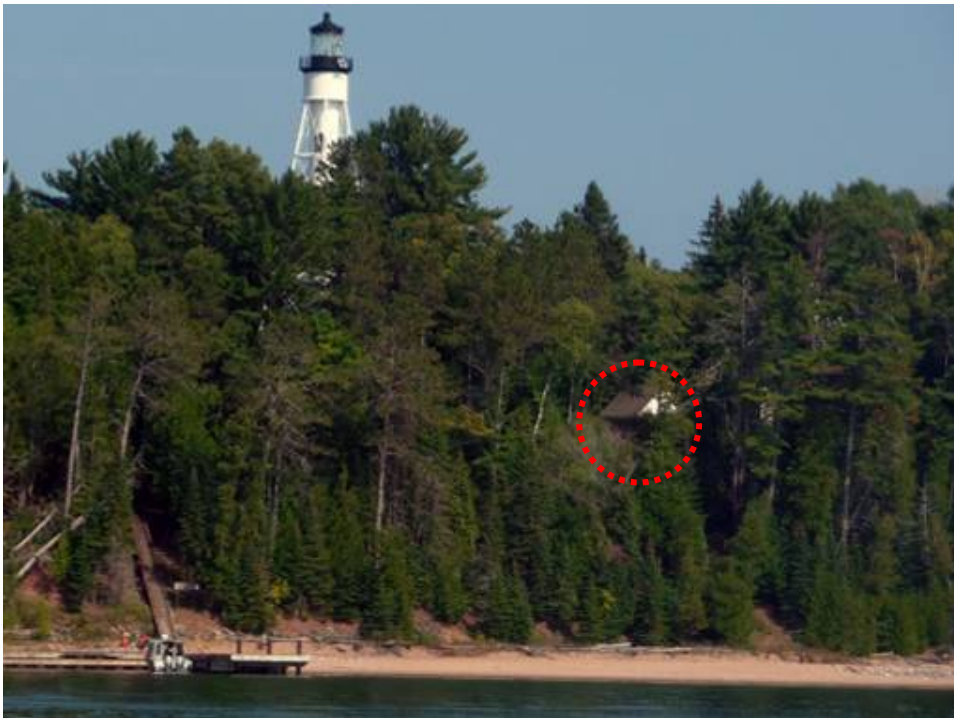
Existing Condition. Notable views to Michigan Island include those of the Light Tower and Old Michigan Island Lighthouse from passing ships and pleasure boats on Lake Superior. Notable views from the island include those to the south over Lake Superior from the Light Station grounds, and vistas from the top of the Light Tower and Old Michigan Island Lighthouse across the island and outward over the water. Selective clearing projects have been undertaken to open vistas to and from the light station. Views and vistas are generally in poor condition.

5 *Site Image MI-33: View from water to Old Michigan Island Lighthouse (and Light Tower) showing growth of forest; top, c. 1904 (Source: NPS APIS Archives); below, c. 2009 (Source: MBD P1010811.jpg)*

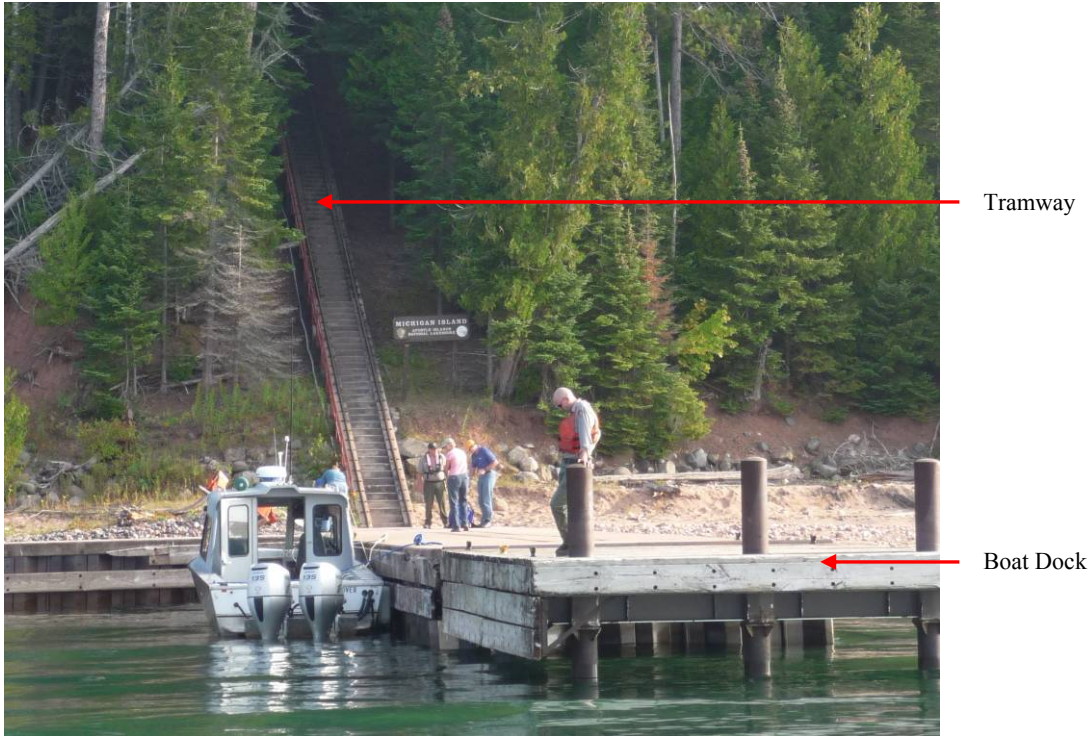
Existing Condition. The concrete boat dock extends from the shore in an 'L' shape to the south (140') and west (70') of the shore. The existing dock was constructed in 1987 and was modified in 1993. It is a steel sheet pile structure infilled with stone rubble and capped with a concrete deck. The top of the boat dock has tram rails set into the surface, which are connected to the inclined tramway. Due to the nature and location of the boat dock, this dock and its predecessors have frequently been damaged or destroyed by the harsh wave and ice action of Lake Superior. The boat dock is in good condition but has functionality issues related to sedimentation and water depth.

2
3 Site Image MI-36: Boat dock and tramway, 2009 (Source: MBD P1010680.jpg)
4

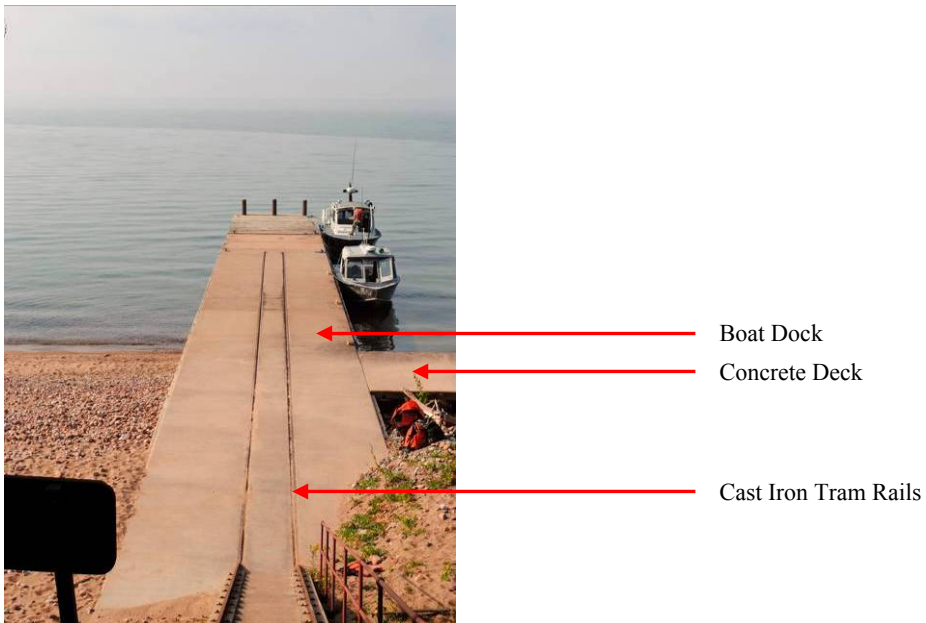
5
6 Site Image MI-37: Boat dock, 2009 (Source: MBD DSC_0036.jpg)
7

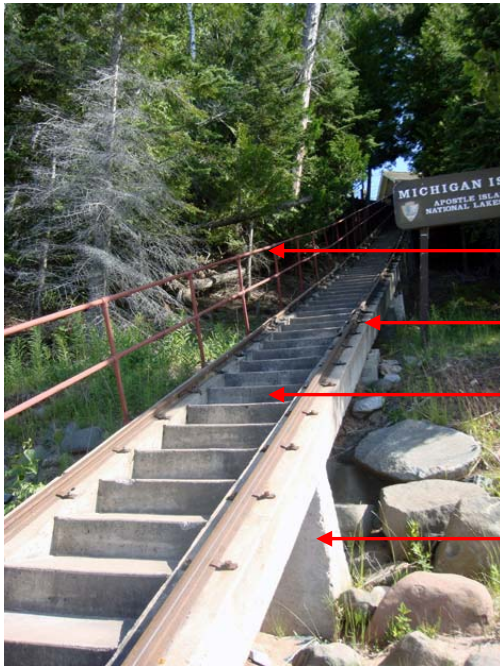
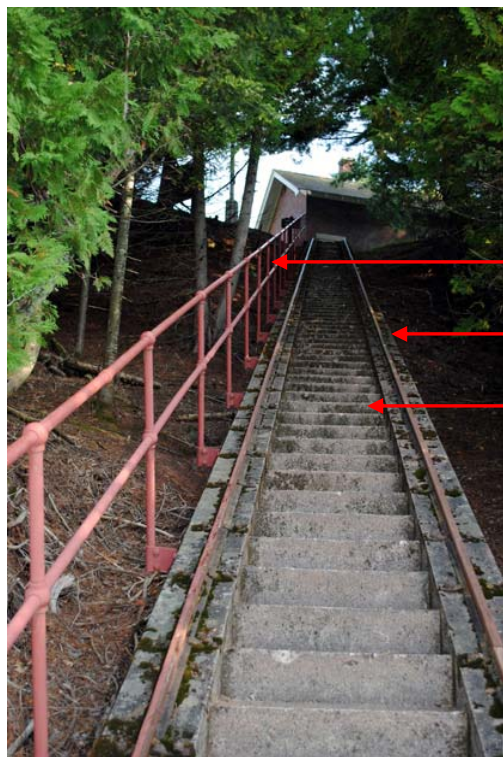
The tramway is in good condition and retains all of its original elements of the upper portion including: concrete footings and stairs, steel handrail, and cast iron tram rails.

Site Image MI-39: Upper section of tramway, 2009 (Source: MBD DSC_0037.jpg)

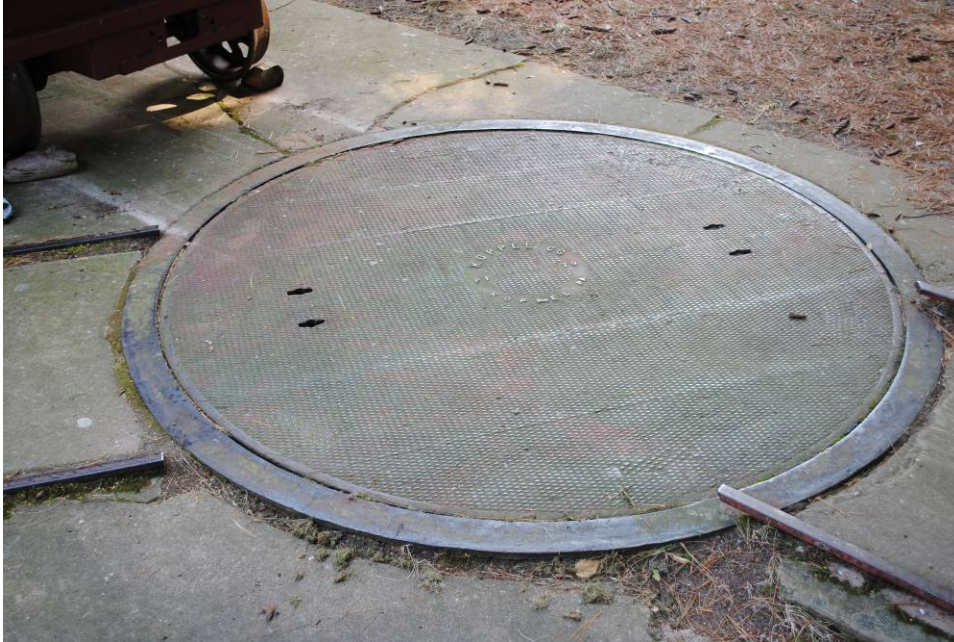
Existing Condition. At the top of the tramway is a manufactured steel turntable used to turn carts and connect them to the tram tracks that extend into the light station grounds. The turntable is 5' in diameter and is covered with a large cast iron plate stamped "KOPPEL CO PF 79, KOPPEL, PA." The turntable is currently locked in one position, nonfunctional, and in poor operating condition.

Site Image MI-42: Tram turntable, 2009 (Source: MBD DSC00599.JPG)

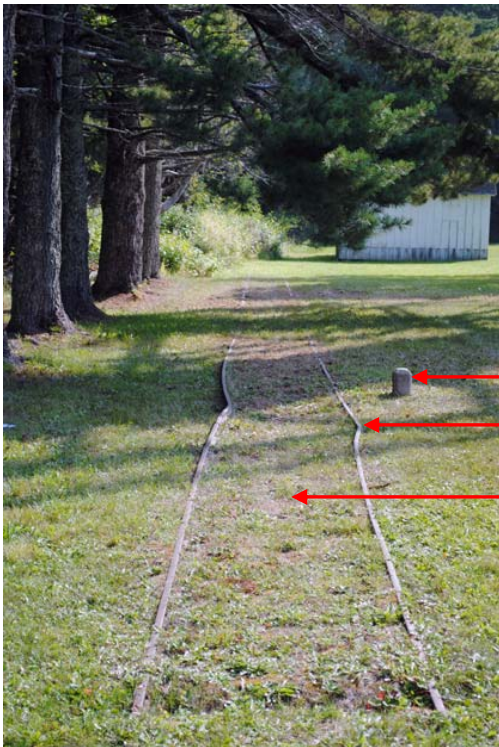
Existing Condition. The tram tracks lead from the Power House tramway turntable north past the Keepers Quarters, then turn to the east along the row of pine trees, before turning south and connecting to the Shed behind the Old Michigan Island Lighthouse. The tracks are cast iron 25-pound rails, spaced 36" on center matching the tramway and secured to timbers set in gravel. The tracks are a system and are intact and remain in place, although portions of the rails have been damaged and bent and a great portion of the tracks have excessive soil and vegetation between the rails. The wooden timbers beneath the tracks are extant but are generally in poor condition. Overall the tram tracks are in fair to poor condition.

Area of Damaged Rail

Encroaching Vegetation

Site Image MI-43: Tram tracks, 2009 (Source: MBD DSC_0054.jpg)

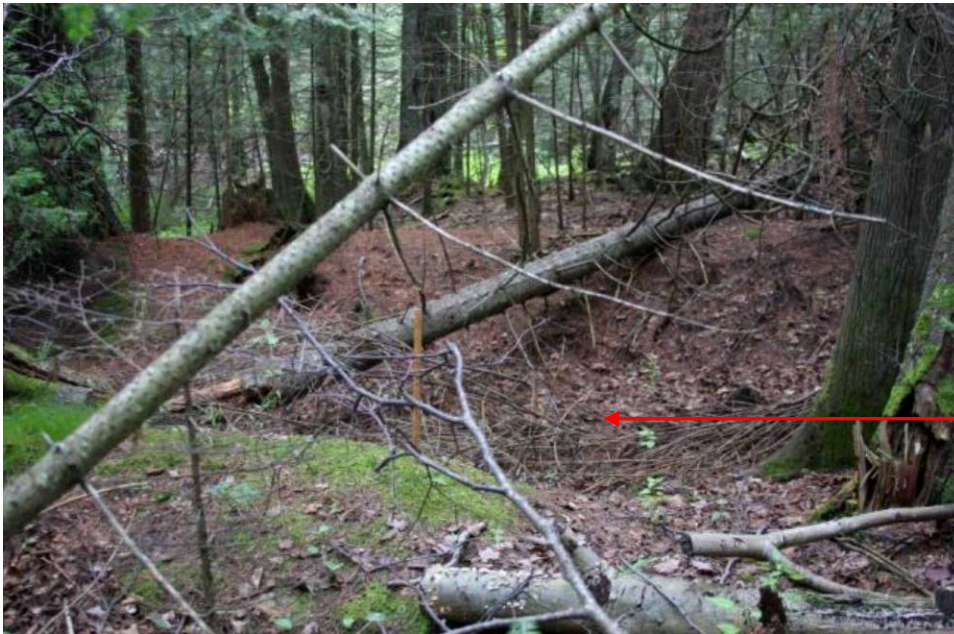
Existing Condition. The root cellar at the Michigan Island Light Station was located approximately 100' north of the Privy on the east side of the station. It is nonextant; however, there is evidence of its location in the form of a 10' x 14' rectangular depression in the ground where it once existed. The depression is bordered by four earth mounds, approximately 2' to 4' high.

Site Image MI-44: Root cellar depression 100' north of historic Privy, 2010 (Source: Rubin Stenseng, Michigan Island Light Station Summer 2010 Volunteer)
