Small Scale Features

Small Scale Feature Photographs

1 ***Vegetation Diagram and Photographs***

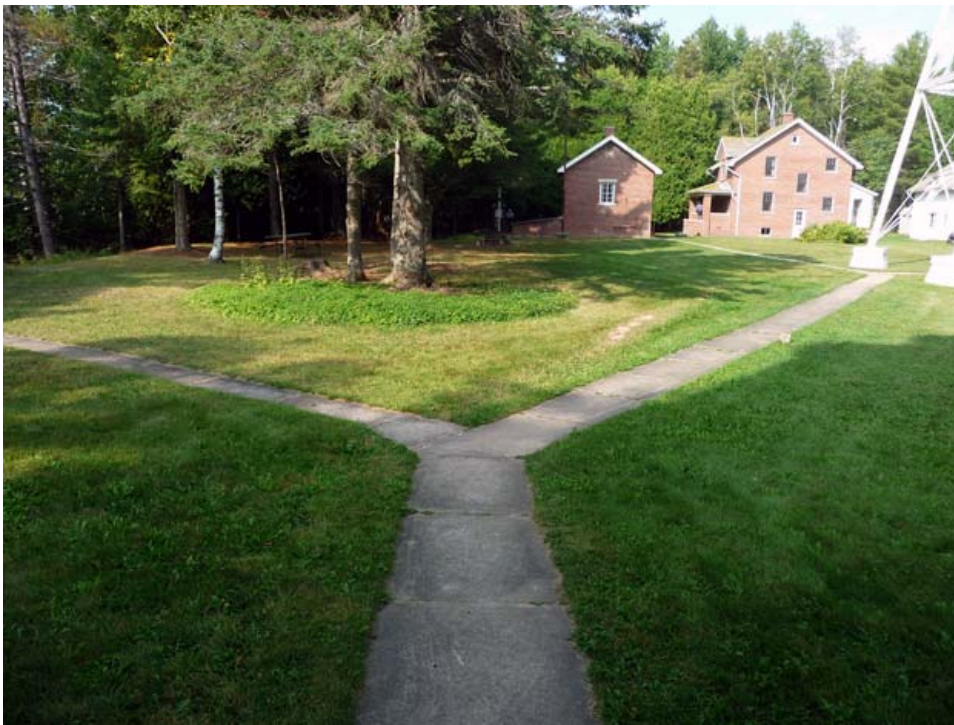
Existing Condition. The concrete walks on the grounds were installed during the Early Light Tower period (1929–1938) many of them following the previous layout of wood planks as was typical of the Apostle Islands. Typical to several of the Apostle Islands light stations, the walks appear to be constructed of precast units 2.5' × 4' × 4" thick with some small units also installed. The units have a fine aggregate finish and tooled edges. Historic photographs indicate that the concrete units may have been placed on top of the ground surface rather than excavated and placed. Other portions of the concrete walks appear to have been poured in place to infill odd shapes and address building edges. Overall the concrete walks are in good condition with only a few slabs requiring replacement due to excessive cracking.

Site Image MI-47: Concrete walks – walk to left once led to former wooden staircase down bank, 2009 (Source: MBD P1010741.JPG)

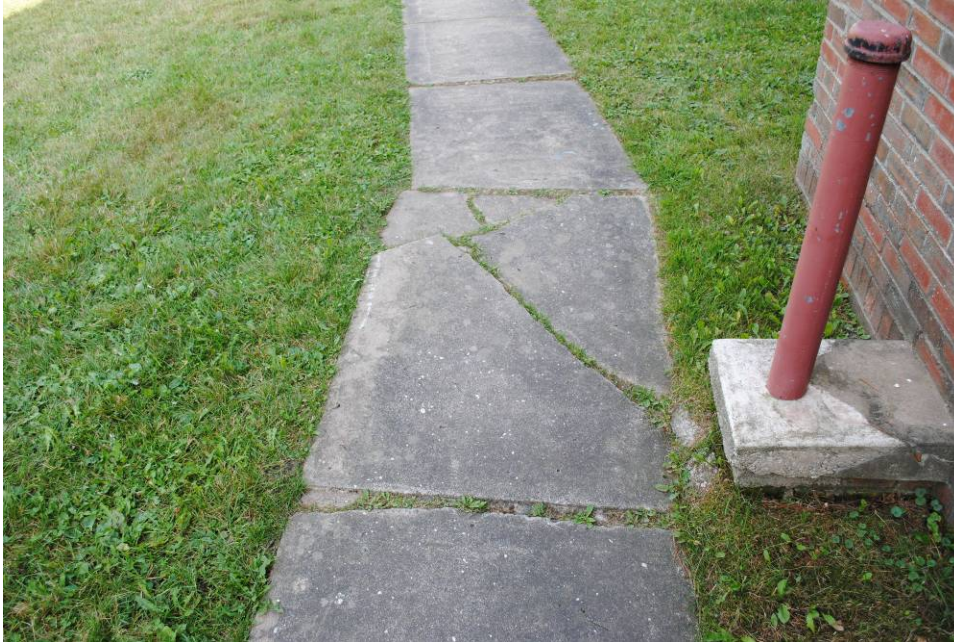
Site Image MI-48: Broken section of concrete walk north of Power House, 2009 (Source: MBD DSC_0108.JPG)

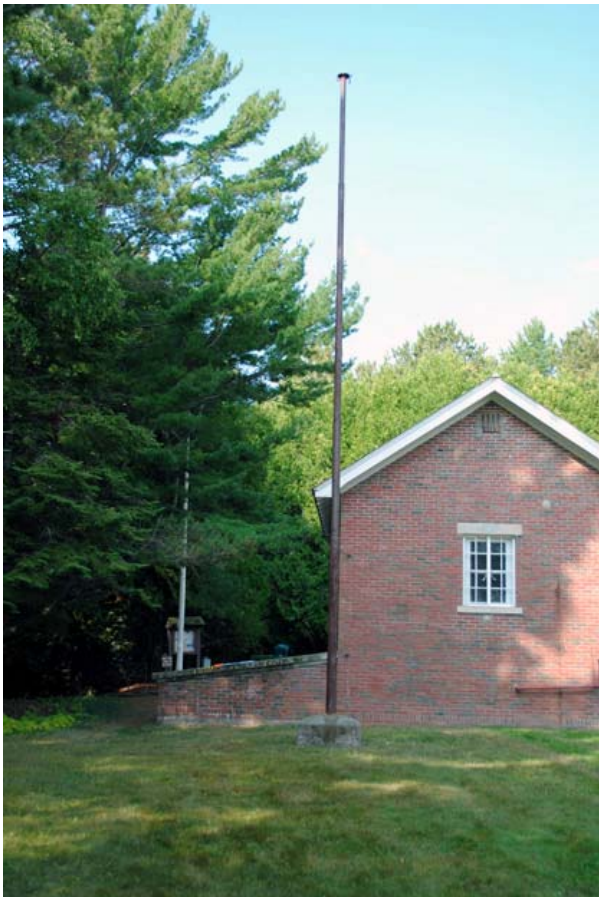
Site Image MI-49: Radio antenna pole – south, 2009 (Source: MBD DSC_0050.jpg)

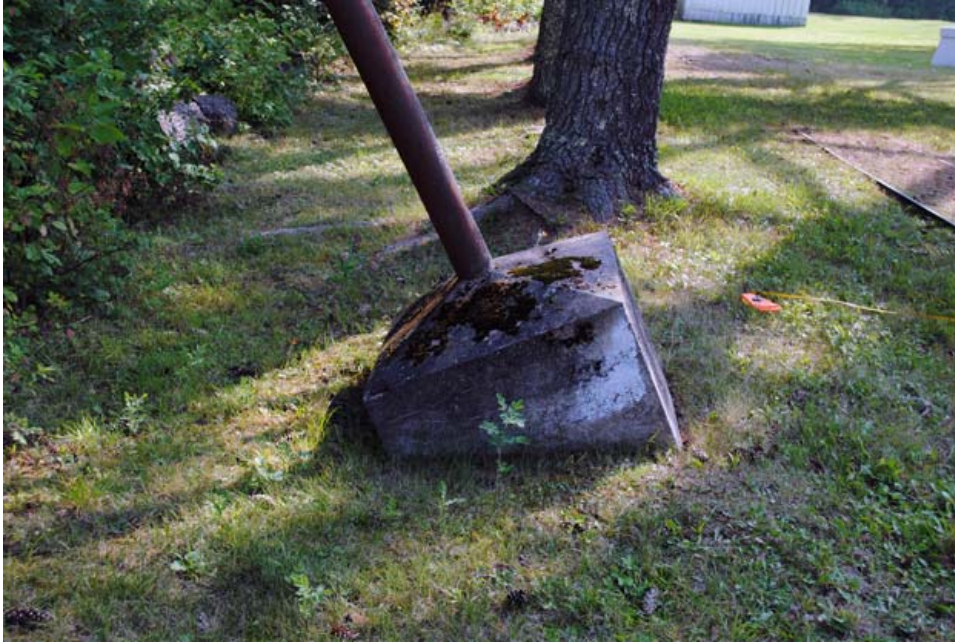
Existing Condition. The radio antenna poles (north and south) were features that were originally installed between 1929 and 1931 along with the many other technological advances (Light Tower, Power House, and tramway) related to improvements in navigational aid. An annotated 1928 drawing at the APIS Archives indicates that one or both of the poles were moved from their original locations once if not twice. They are currently located just east of the Power House, and another directly north from the first, north of the tram tracks. They are cast iron poles, with a height of approximately 40', and identical concrete bases, approximately 18" tall, with a 36"×36" width. Radio Antenna Pole – South is in good condition. Radio Antenna Pole – North is in fair condition, the foundation needs to be reset as the pole is leaning to the north.

Site Image MI-50: Radio antenna pole – north (possibly relocated), 2009 (Source: MBD DSC_0052.jpg)

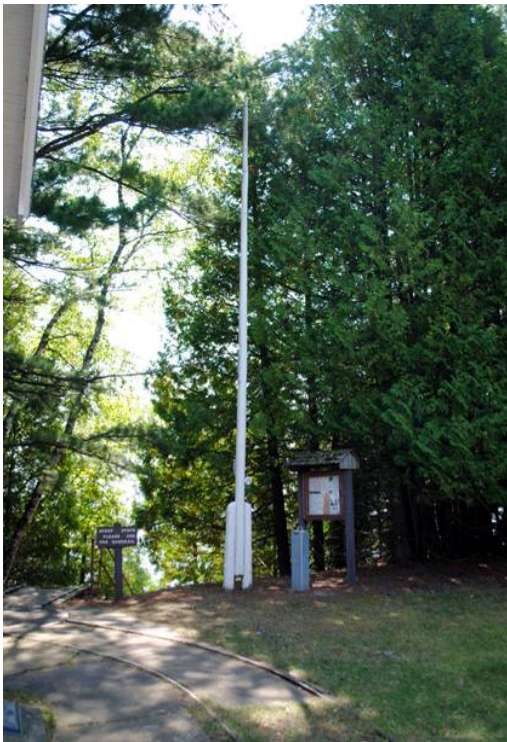
Existing Condition. The flagpole is at the top of the tramway, just south of the Keepers Quarters. The flagpole is constructed of a single wood pole, approximately 25' high mounted between two smaller base posts, with through bolt connections. The entire structure is painted white with a concrete footing. The flagpole was installed during the Light Tower period and is in good condition.

Site Image MI-51: Flagpole, 2009 (Source: MBD DSC_0088.jpg)

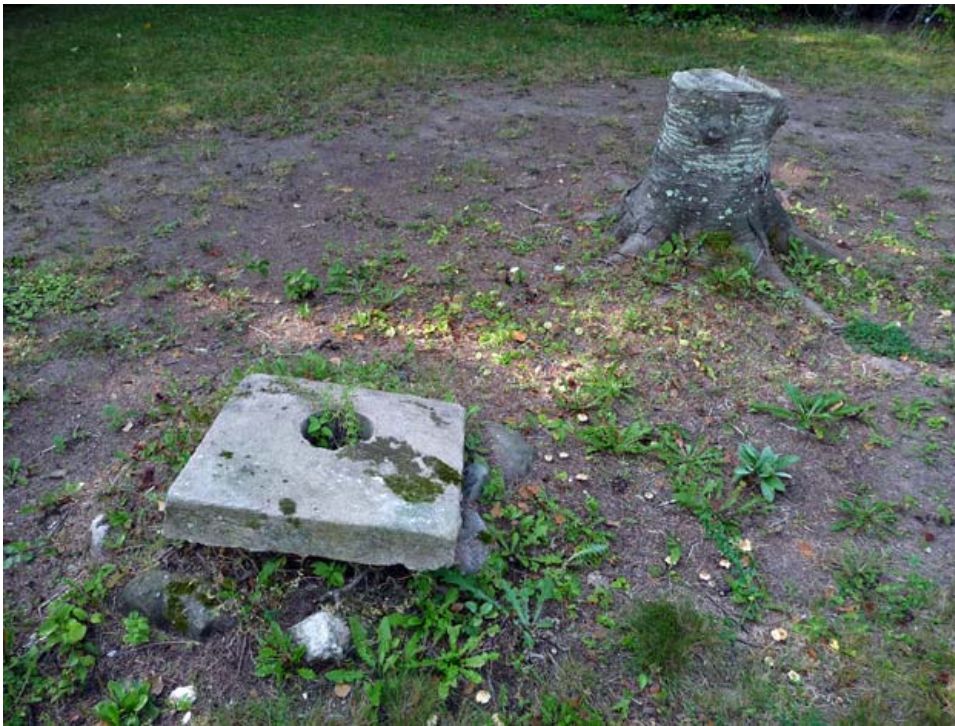
Originally another flagpole existed southwest of the Old Michigan Island Lighthouse. This pole is no longer extant except for a remnant concrete collar, approximately 18" square. Historic photographs indicate that the first flagpole had a metal pole painted white.

Site Image MI-53: Concrete footing – base for original flagpole, 2009 (Source: MBD P1010738.JPG)

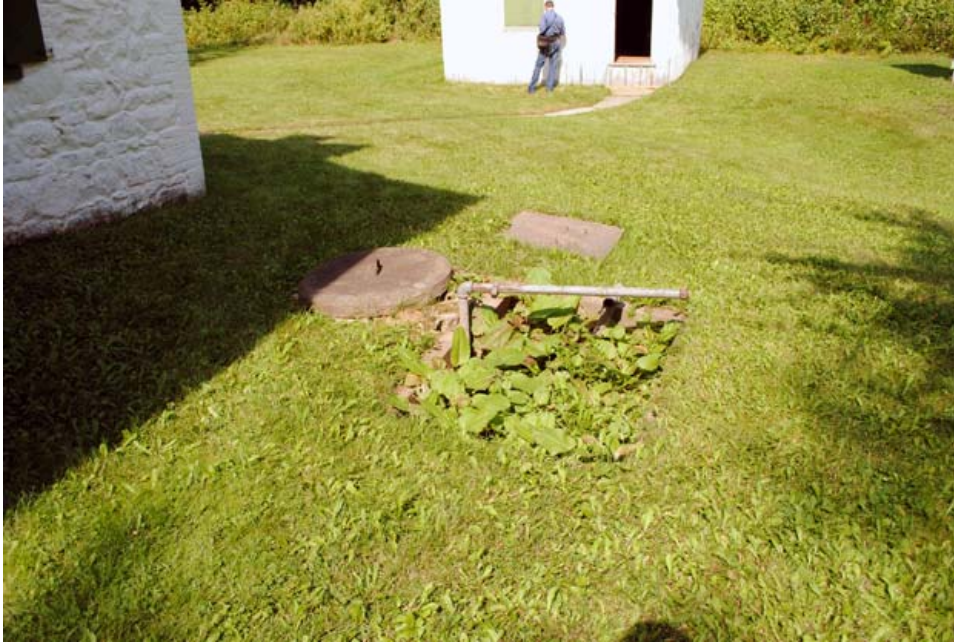
Site Image MI-54: Lighthouse cistern (left) and well basin (right), 2009 (Source: MBD DSC_0060.jpg)

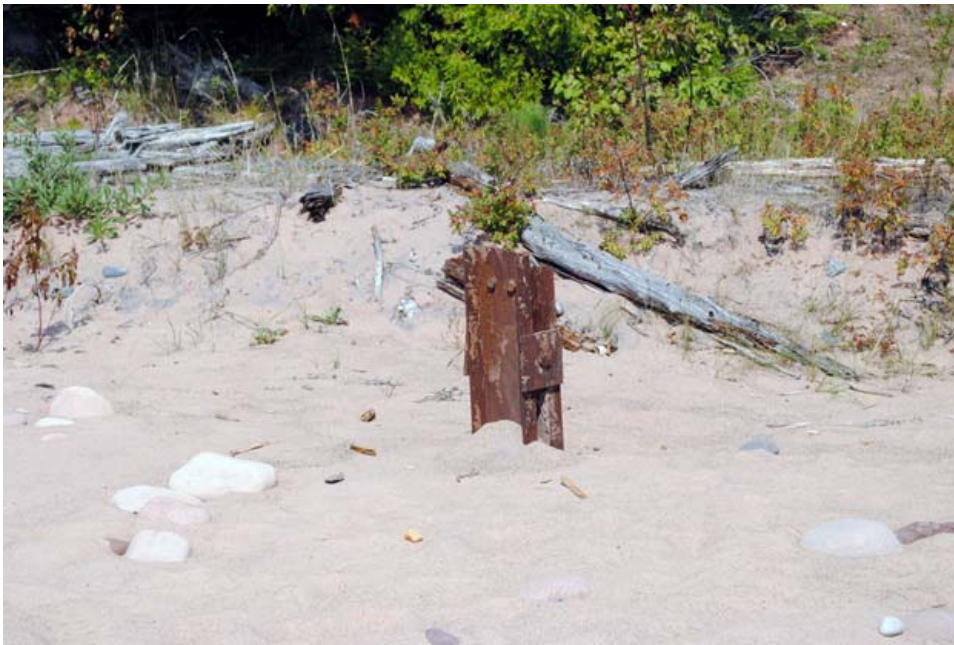
Steel Piling (unknown date)	MI-55	Buried steel piling on beach – possible location of former boat dock or boathouse	Poor	Contributing; Steel Piling is from the period of significance.
Park Sign (1970–2009)	MI-56	Wooden Michigan Island park sign	Good	Noncontributing – contemporary
Interpretive Sign (1970–2009)	MI-57	Wooden park sign with a brief history of Michigan Island	Fair	Noncontributing – contemporary
Trail Sign (1970–2009)	MI-58	Aluminum trail sign on wood post - showing trail location and distance	Good	Noncontributing – contemporary Compatible
Information Kiosk (1970–2009)	MI-59	Wood sign/kiosk	Good	Noncontributing – contemporary

Site Image MI-55: Steel piling, 2009 (Source: MBD DSC_0084.jpg)

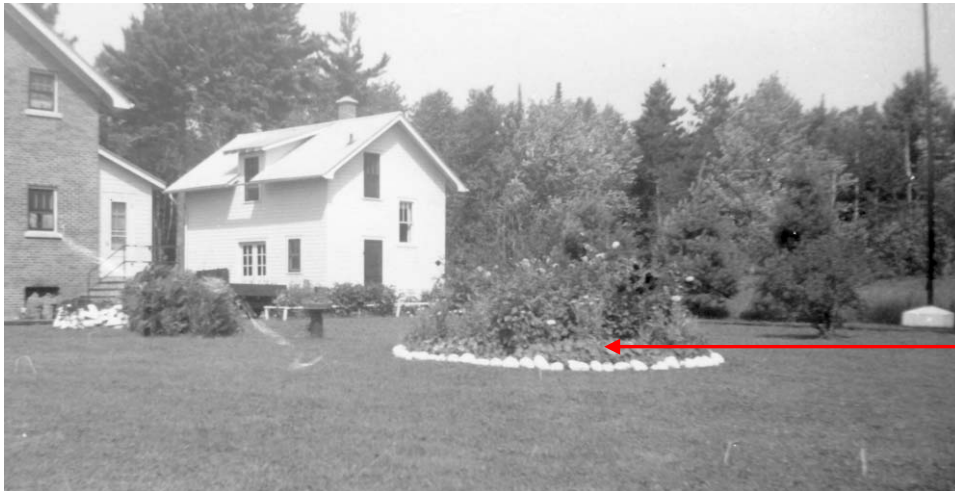
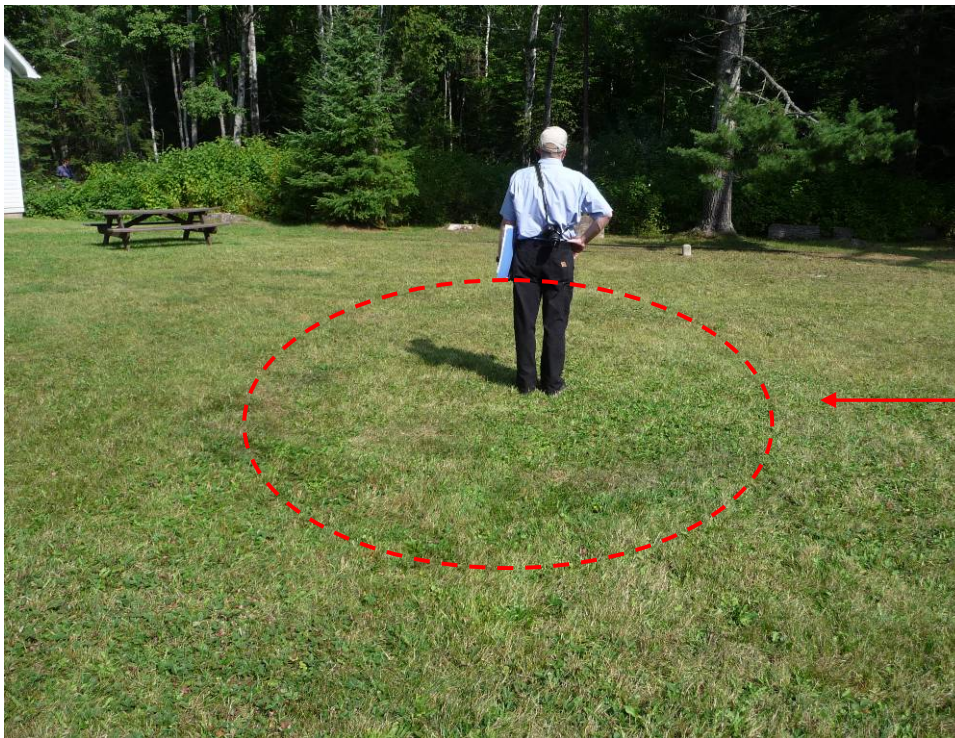
22 The Lanes created many stone planters and used stone edging around planting beds on the light station
23 grounds. While most of the planters have been removed, a circular depression exists today where a stone-
24 edged planter once was between the Light Tower and the fern bed.

Site Image MI-69: Circular depression in area of stone edged planter; top, c. 1930; bottom, 2009; (Source: MBD P1010785.jpg)

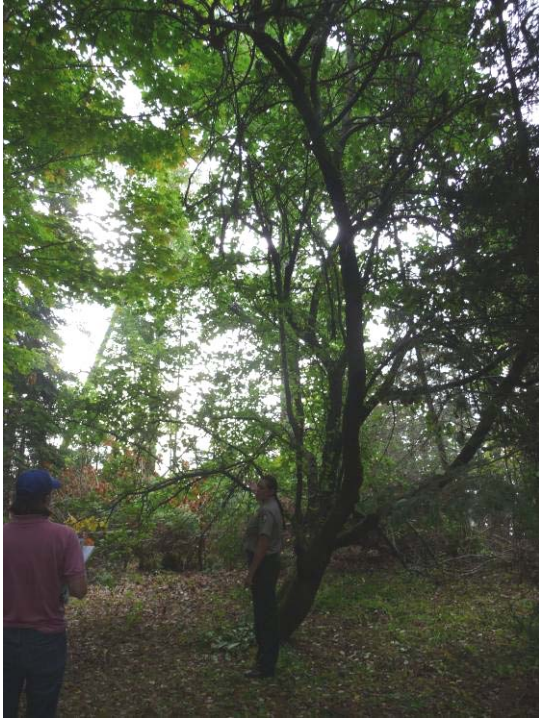
Site Image MI-70: Orchard planting; remnant apple tree southeast of Old Lighthouse, 2009 (Source: MBD P1010687.jpg)

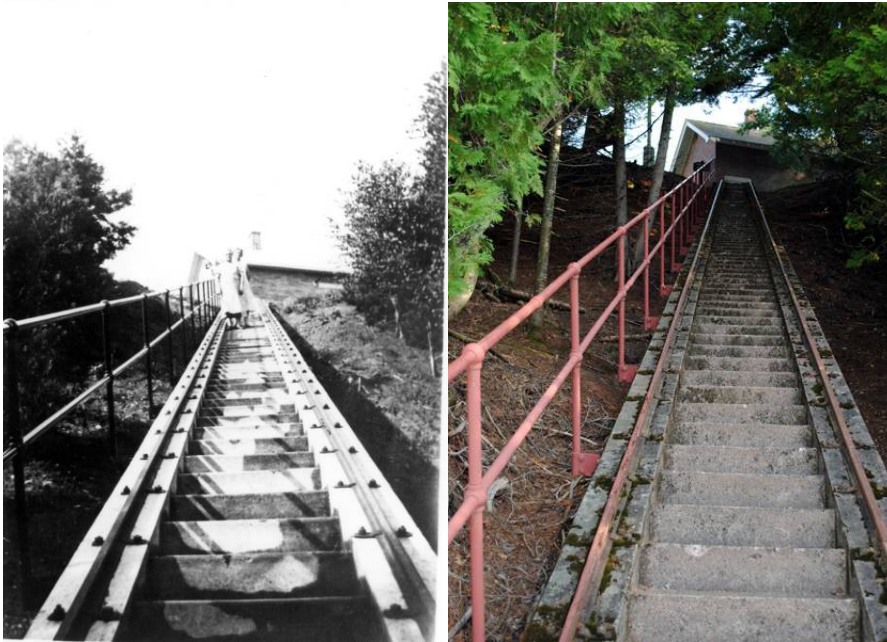
Site Image MI-74: Vegetation along tramway; left, c. 1930; right, 2009; (Source: MBD DSC0037.jpg)

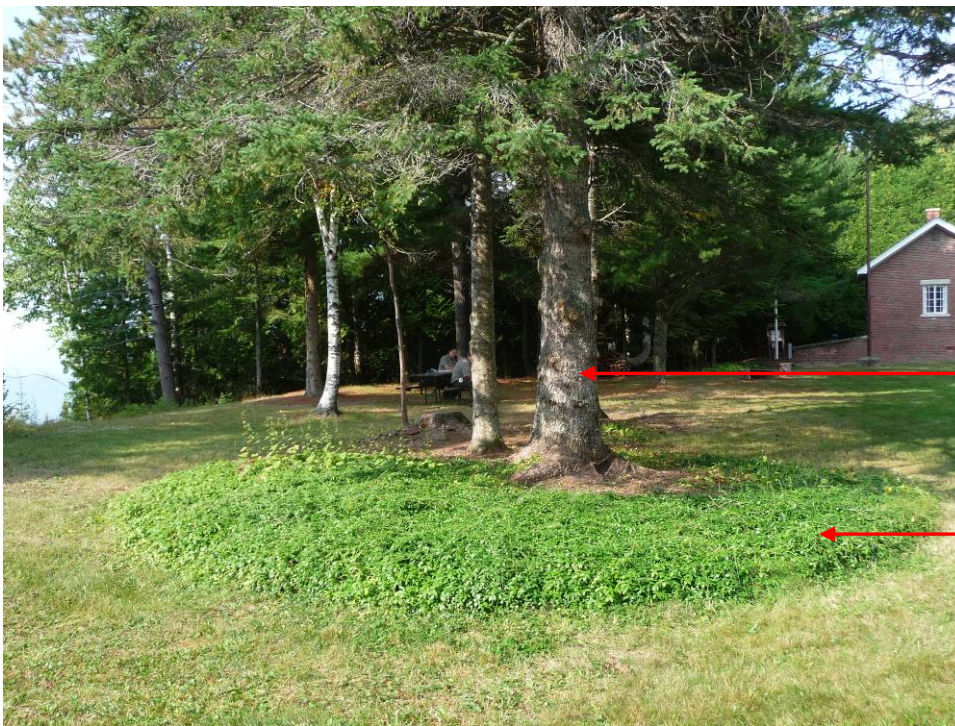
Site Image MI-75: Vinca/Periwinkle plantings at light station grounds, 2009 (Source: MBD P1010757.jpg)

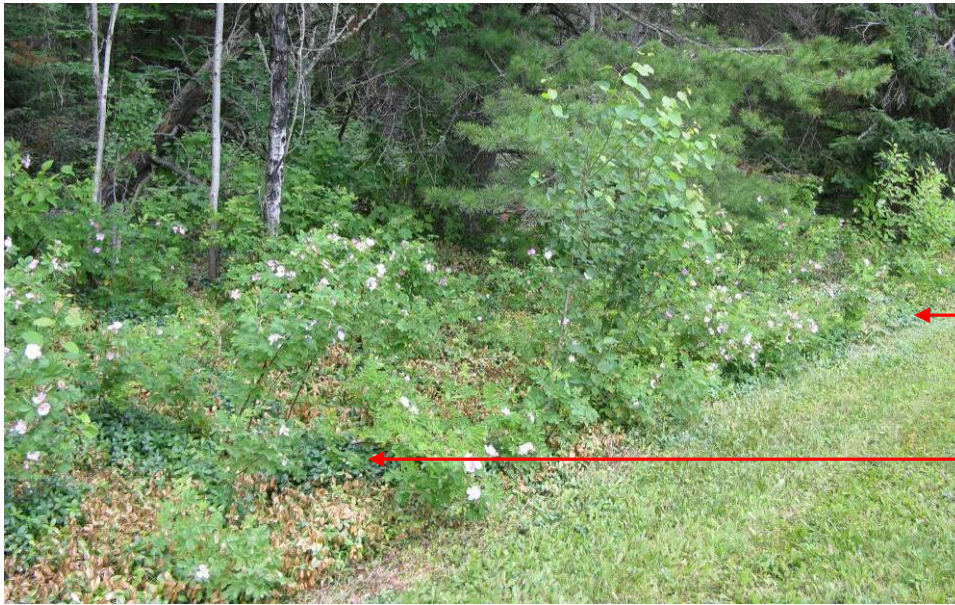
Some domestic plantings, primarily Periwinkle (*Vinca minor*), have been introduced to the island and have encroached into the forest area. Periwinkle, considered an invasive plant species, was planted during the period of significance and is extant in a planting bed beneath the contributing pine tree west of the Old Michigan Island Lighthouse. Periwinkle is also extant in the forest adjacent to the grounds and is spreading into the surrounding forest.

Site Image MI-76: Invasive Vinca/Periwinkle growing north of Old Lighthouse on edge of current woods, 2009 (Source: Susan Mackreth Cherry Trees a 2009.JPG)

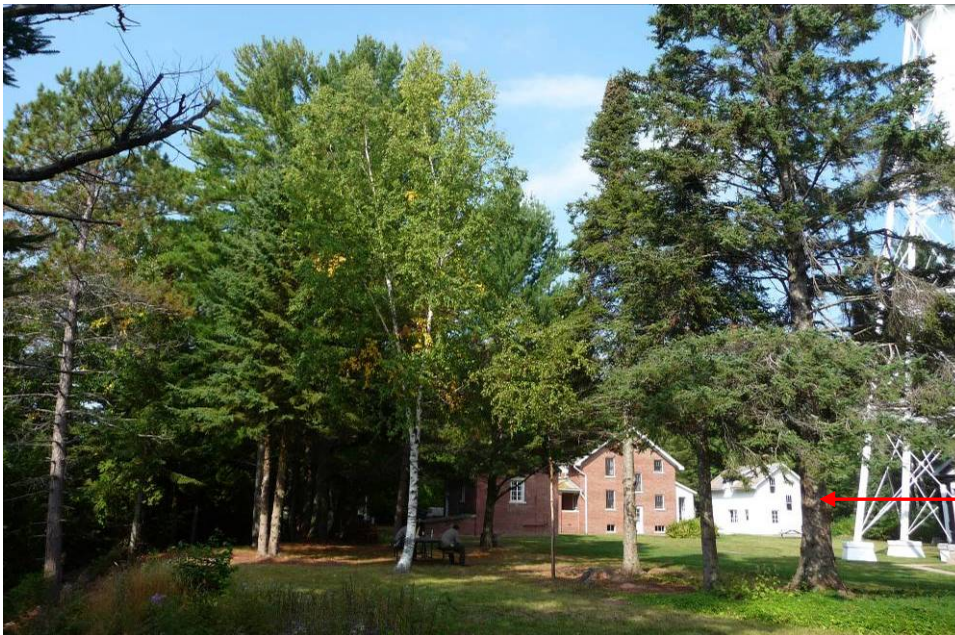
Site Image MI-79: Cluster of trees between Power House and Old Michigan Island Lighthouse (Noncontributing); pine tree (Site Image MI-78) at right of image is contributing, 2009 (Source: MBD P1010766.JPG)
