## OLD MICHIGAN ISLAND LIGHTHOUSE

### Chronology of Alterations and Use

1 *Old Michigan Island Lighthouse Photographs, 2009*

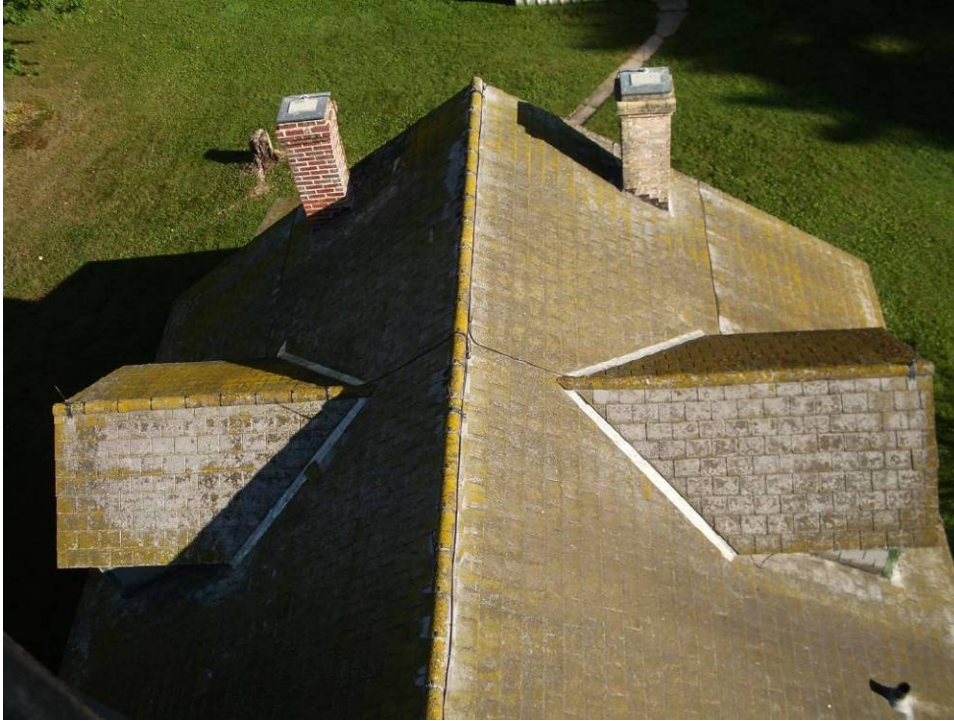
MI-OLH-06: Dormers, roof, and chimneys from the Tower, looking north (Source: A&A IMGP2761)

27 There are two original brick chimneys flanking either side of the ridge of the main gable. The east chimney  
 28 may have had a parge coating applied at the time as it is a whitish color versus the clear red brick coloration  
 29 of the west chimney. There are bricks located in the west second floor bedroom near the west chimney that  
 30 suggest recent masonry work. A cap of galvanized sheet metal and what appears to be one of the composite  
 31 replacement roof shingles have been installed at both chimneys (MI-OLH-06).

The chimneys are in good condition. Newer repointing work appears to have been performed on the west chimney but the upper course of the east chimney needs repointing. There are two types of brick at the west chimney, which may be due to recent repair work.

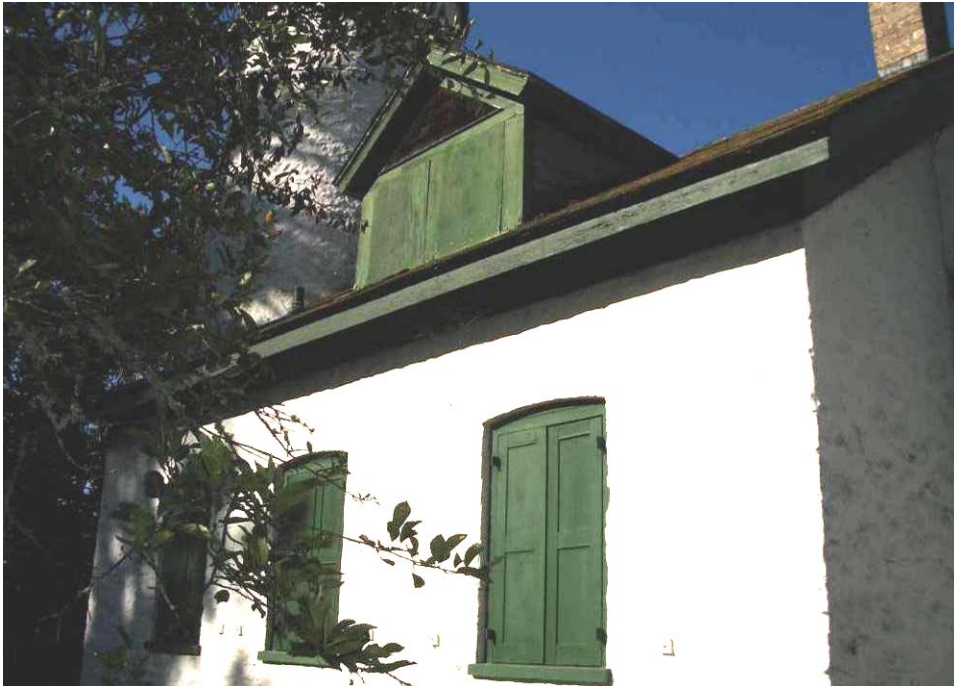
MI-OLH-07: East dormer, trim, chimney, and shutters (Source: A&A IMGP2764)

Overall, the dormers are in fair condition. The wood wall shingles are cupping badly while the asbestos wall shingles are performing well. The north side of the east dormer has moss growth and there is newer white caulking also at the east dormer. There is a hornet's nest at the eave of the west dormer.

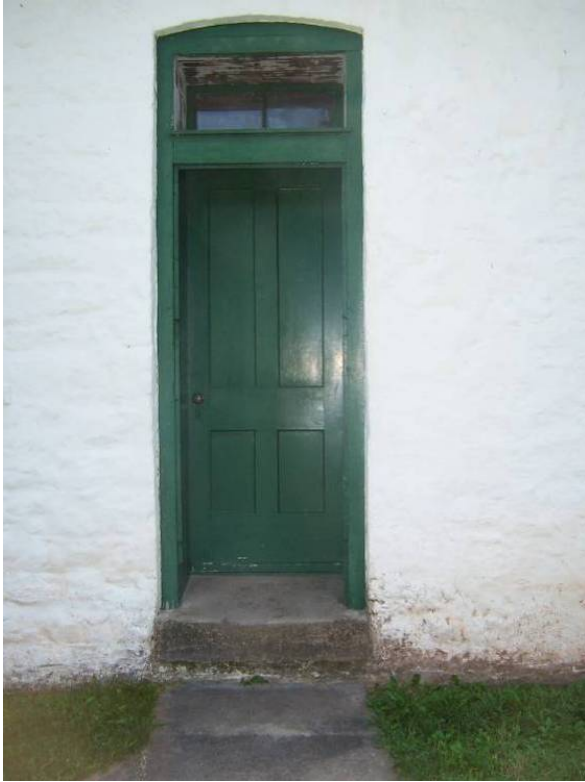
1  
2 *MI-OLH-12: West entry door (primary) (Source: A&A 102\_9512)*  
3

**Main Entry Door.** This door is in good condition with the exception of the hardware. The knob is loose and the deadbolt sluggish. The skeleton key is missing and the hinges are rusted. Also, the paint is peeling on the interior face of the door.

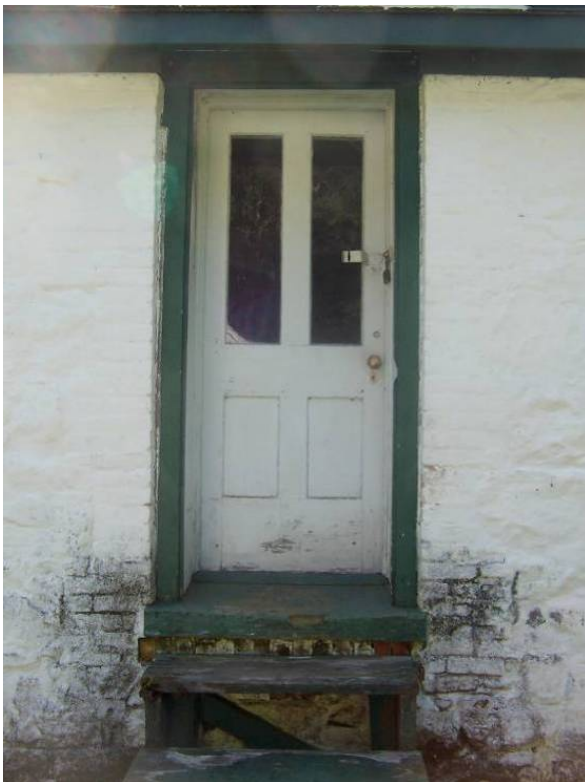
4  
5 *MI-OLH-13: North entry door (kitchen entrance) (Source: A&A 102\_9511)*

**Kitchen Entry Door.** The door is in fair condition with peeling paint, rusted hardware and knobs, and the door barely latches. There is a divot out of the front face of the sill, a crack in the glass pane, and the wood steps have no railing, are steep (8½"x 11"), and are rotting.

31 **Exterior North (Kitchen) Stairs.** These exterior stairs are in fair condition as the wood stairs are starting  
32 to rot in places and the paint is peeling. This is most likely due to the roof draining onto these stairs. There  
33 is no handrail.

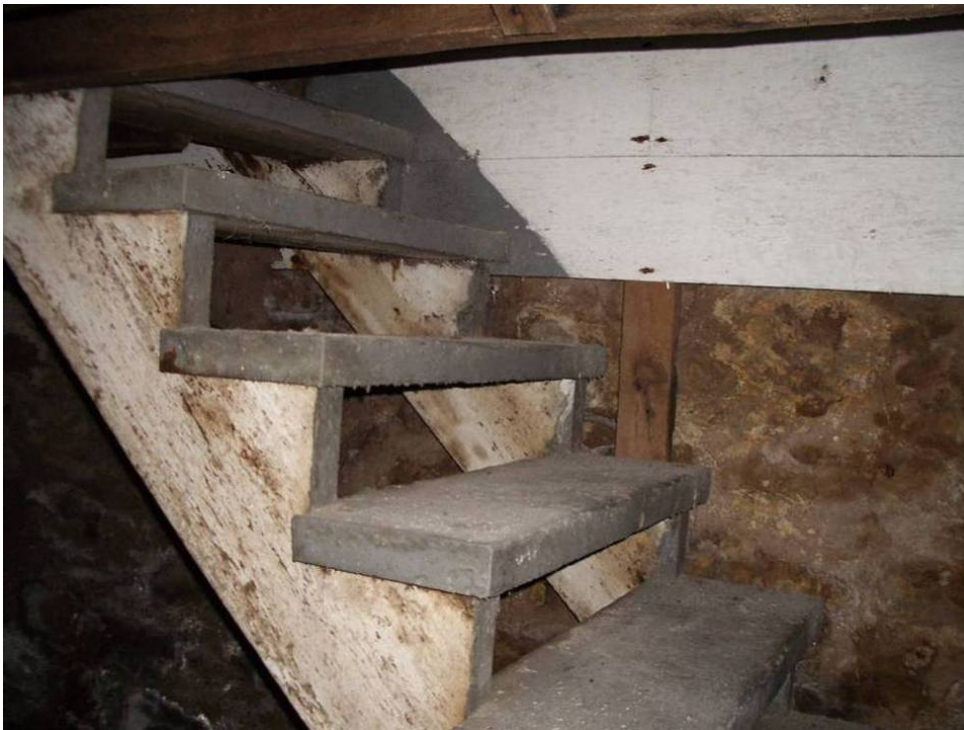
MI-OLH-15: Basement stair (Source: A&A IMGP2818)

35 **First Floor to Basement Stairs.** These stairs are in fair condition as they are heavily worn, especially in  
36 the centers, and do not have a handrail.

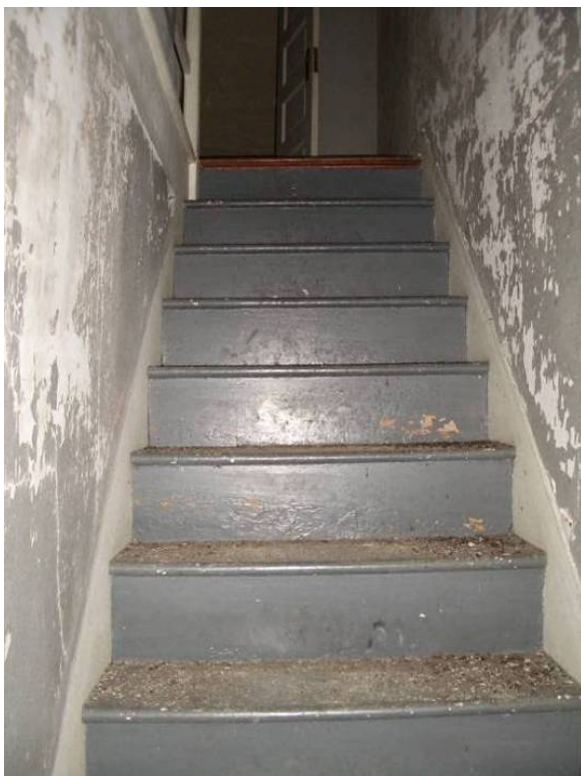
4  
5 MI-OLH-27: First floor to second floor stairs, east view (Source: A&A IMGP2806)

38 **First Floor to Second Floor Stairs.** These stairs are in fair condition as the stair walls have badly peeling  
39 paint and a handrail needs to be added to the rest of the stairs.

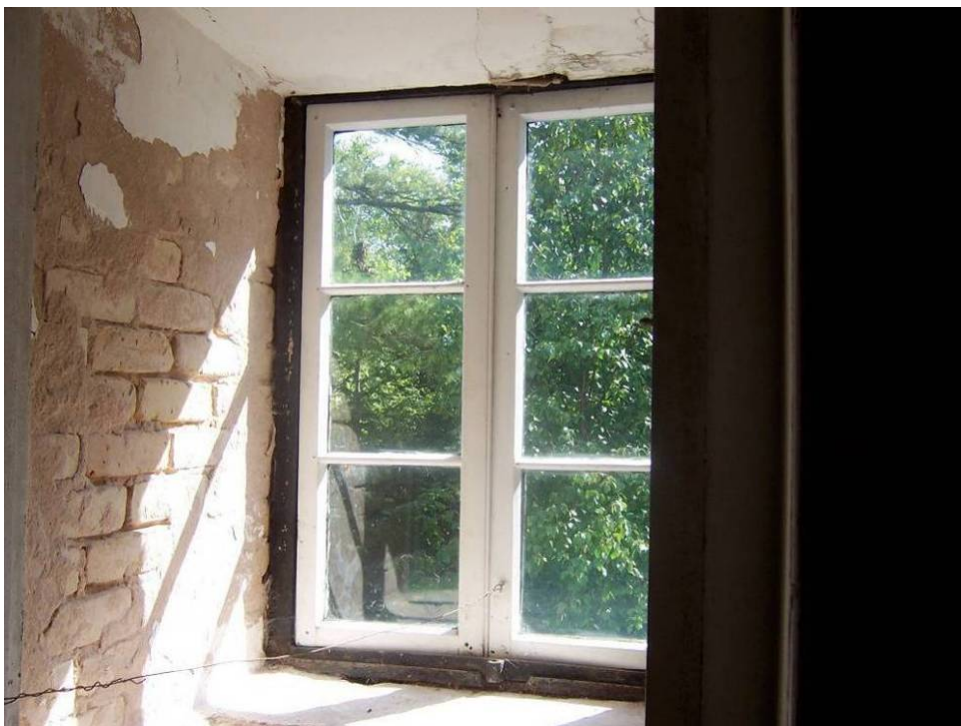
1  
2 *MI-OLH-34: Tower window 1 (Source: A&A 102\_9527)*  
3

**Two Leaf, Three-Lite Casements.** These windows are located in the Lighthouse Tower and have metal frames with wood sash. This window type appears to have replacement sash with reused original panes (where available). The sash has a simple beveled profile at the muntins. The interior trim and frame is painted. The typical dimension for a pair is 2’2” by 3’0”. (A paint sample from the window was taken and reveals multiple layers of whitewash, like the tower walls) (MI-OLH-34).

**Two Leaf, Three-Lite Casements.** These windows are in fair condition as their throw bolt hardware is missing, the metal frames are rusted at the interior, and the interior trim paint is badly alligatored. All glazing is in fair condition as it is gapped in some areas.

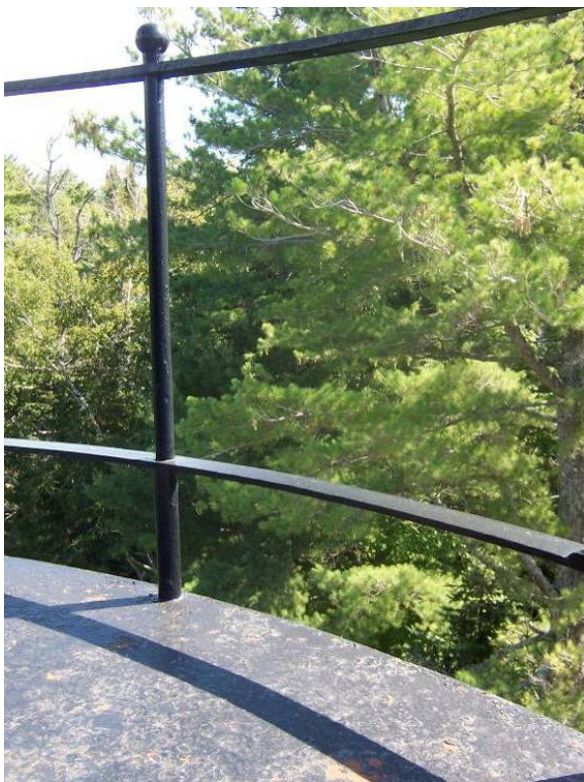
MI-OLH-42: Lantern walkway railing (Source: A&A 100\_9647)

The Lighthouse Tower walk, railing, roof, and finial are in fair condition. The walkway paint is peeling and the underlying metal is rusted. The caulk is missing at the horizontal walk joints, but the caulk at the base of the wall and deck has held up well. The ball of the finial has a previous crack and there is one  $\pm\frac{3}{8}$ " diameter rusted through hole at the northeast quadrant.
