## SECOND TOWER

## General Condition Assessment

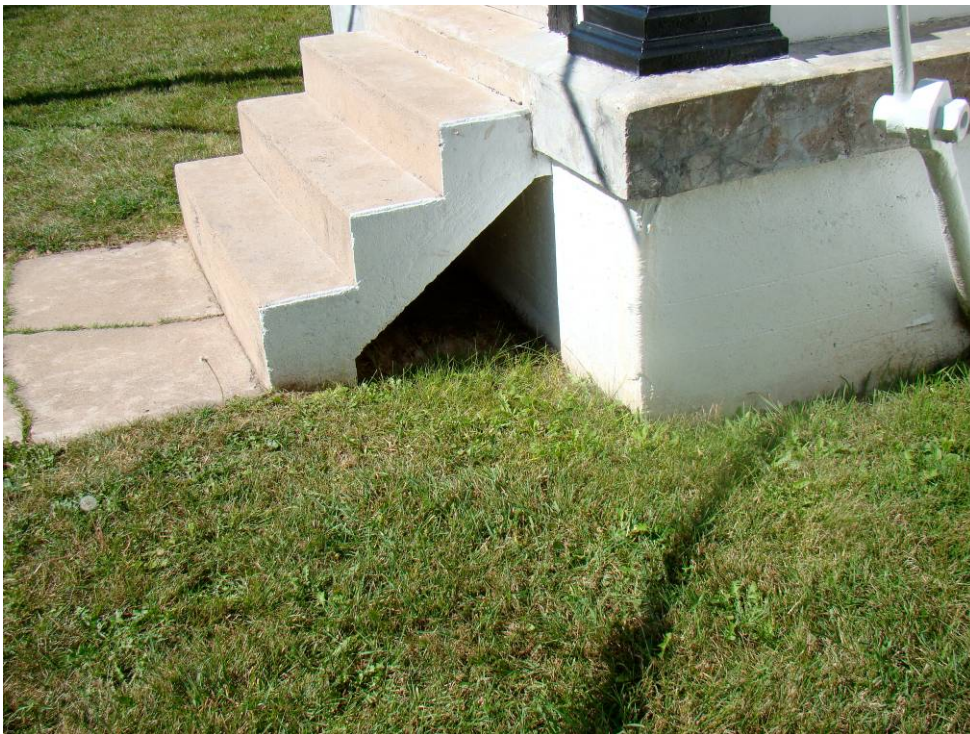
The building is currently not accessible due to the 3’0” wide door and the 2’7” elevation change from grade to the finished floor (MI-ST-08).

MI-ST-08: Entry stair, east elevation (Source: A&A DSC00823)

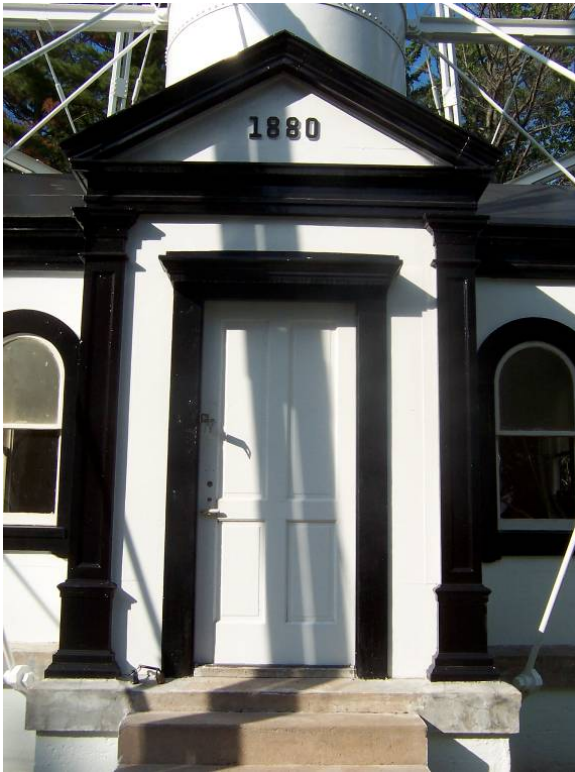
**Entry to Building and Tower.** This door is in fair condition as the bottom rail is loose and the base of the exterior trim is rotted and weathered. The hardware for the door is in poor condition as the knob is missing.

- 1
- 2 *MI-ST-09: South entry (primary) door (Source: A&A 102\_9572)*
- 3

Repair damaged entry door bottom rail and base of trim with epoxy stabilization. Scrape, sand, and repaint. Replace the missing knob with finish to match original. Add a security gate at the base of the tower stair.

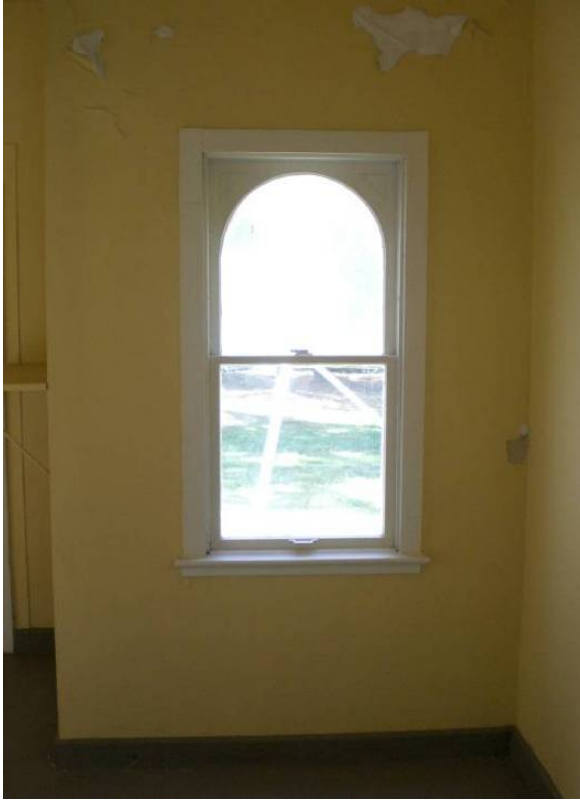
The window trim and frame (cast parts) are in good condition with minor rusting at joints and connections. The wood sash are in good condition but are no longer operable. The Plexiglas product is inconsistent with the historic character of the windows. Moreover, the sash may be retrofits based on the evidence of the pins at joints and the router marks.

MI-ST-11: Typical window, interior face (Source: A&A CIMG3596-A)

Replace Plexiglas with glass at sash. Verify/provide operability to all sash to facilitate ventilation. Repair cast components that have minor rust and repaint. Investigate replacing one lower sash of a north window with a secure louver to enhance ventilation.

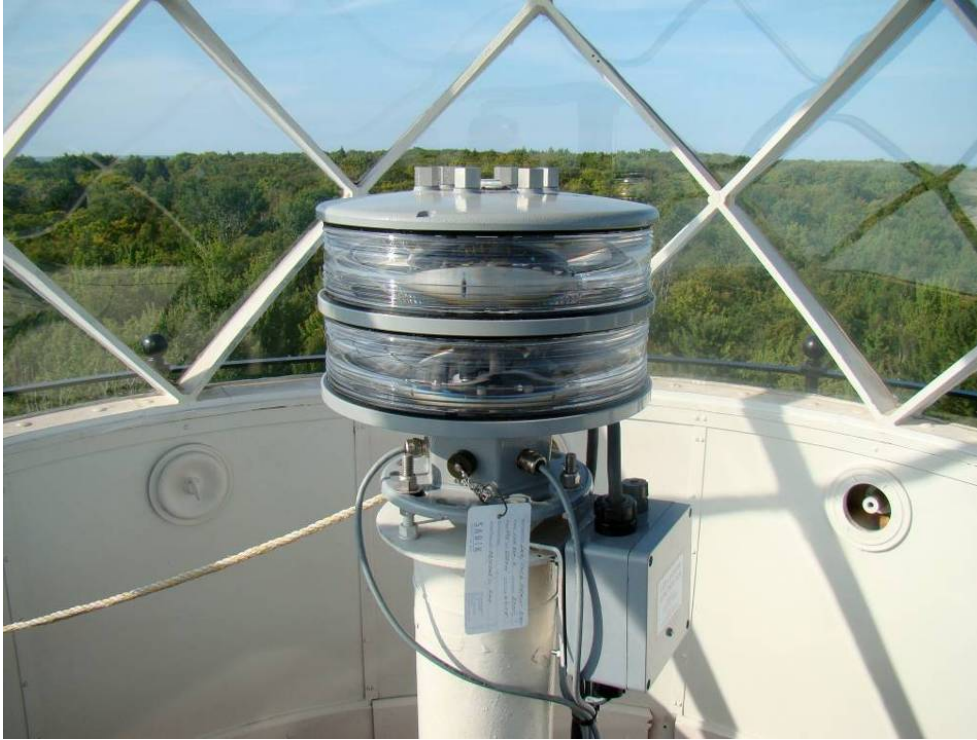
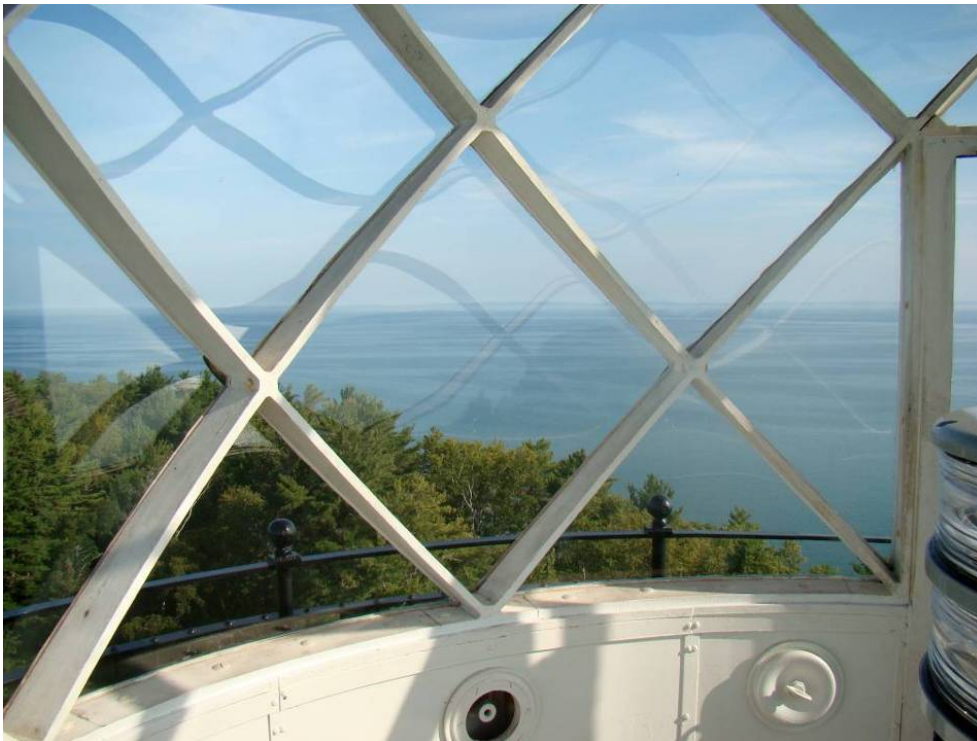
The paint is in good condition but the glazing has a few cracks at the corners. The silicone is also in good condition. Two of the brass intake caps are missing, six of the caps are painted shut, and all chains and cords are missing for the exhaust vent system. Overall, the lantern is in good condition.

MI-ST-18: Lantern (Source: A&A 100\_9633)

MI-ST-19: Lantern, looking southeast (Source: A&A DSC00619)

Provide two new brass intake vent cap controls and repair six which are painted shut. Verify operation of all ventilation components. Repair select areas with cracks at glazing.

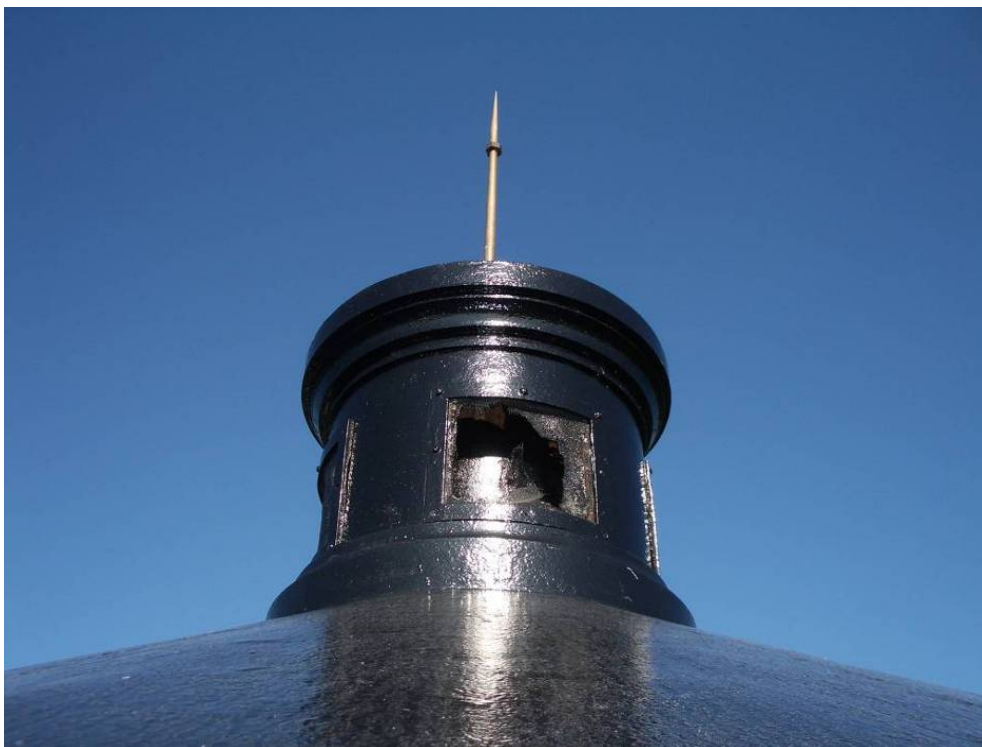
The tower roof is cast iron segments with a vent ball finial at the center. There are three screens at the finial vent that have been torn out. The roof of the tower base consists of painted cast iron panels, though the original drawings call for cast iron roof panels. The cornice of the base is 24-gauge galvanized iron, painted (MI-ST-22).

1  
2 *MI-ST-22: Lantern roof (Source: A&A IMGP2769)*  
3

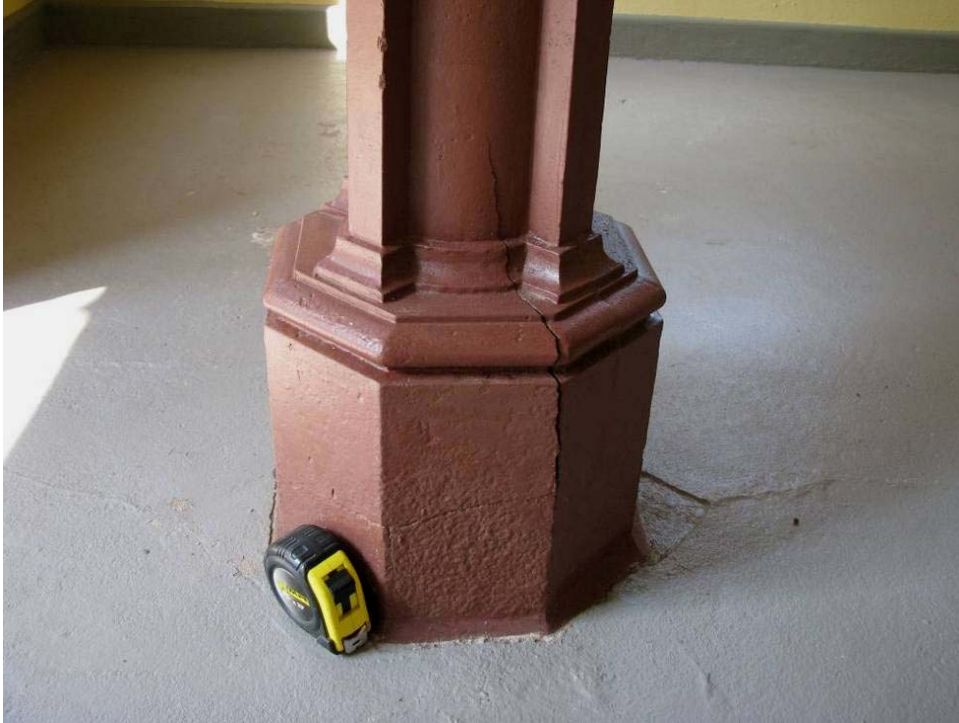
The walls of the center cylinder, tower base, watch room, and lantern are in good condition with the exception of the cast iron column bases in the tower base. Two of the column bases are cracked and further investigation is needed (MI-ST-26 and 27).

MI-ST-26: Crack in column base (Source: Martin/Martin)

The two cracked column bases should be investigated further to determine if the cracks are structurally significant.

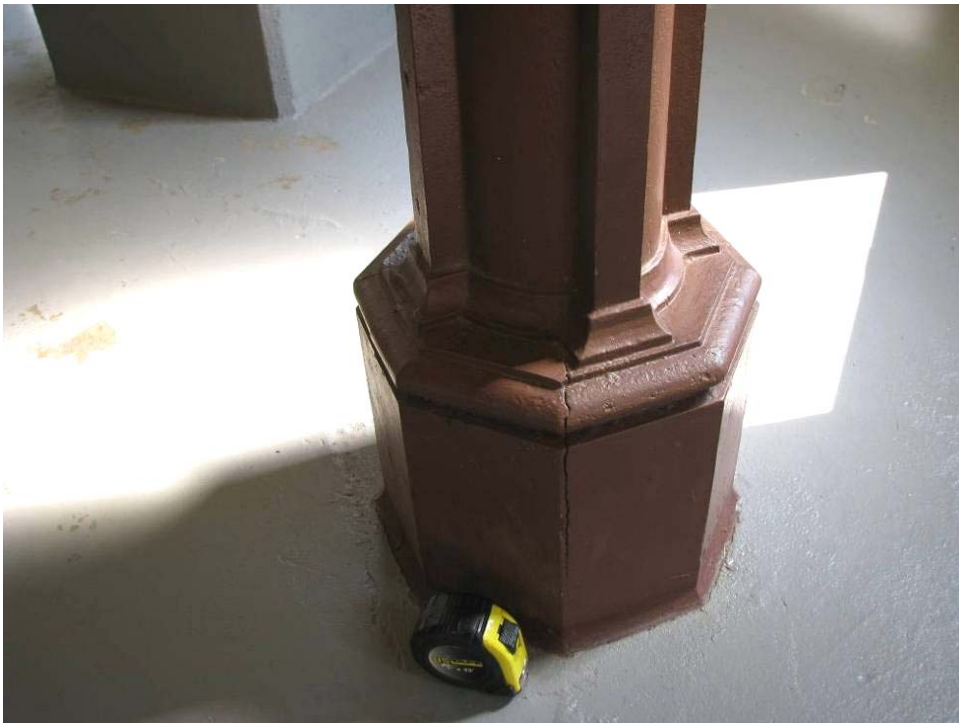
MI-ST-27: Crack in column base (Source: Martin/Martin)
