KEEPERS QUARTERS

The following section is a discipline-by-discipline, component-by-component condition assessment of the building. Refer to Volume I, Chapter 2: Methodology for definitions of the condition ratings.

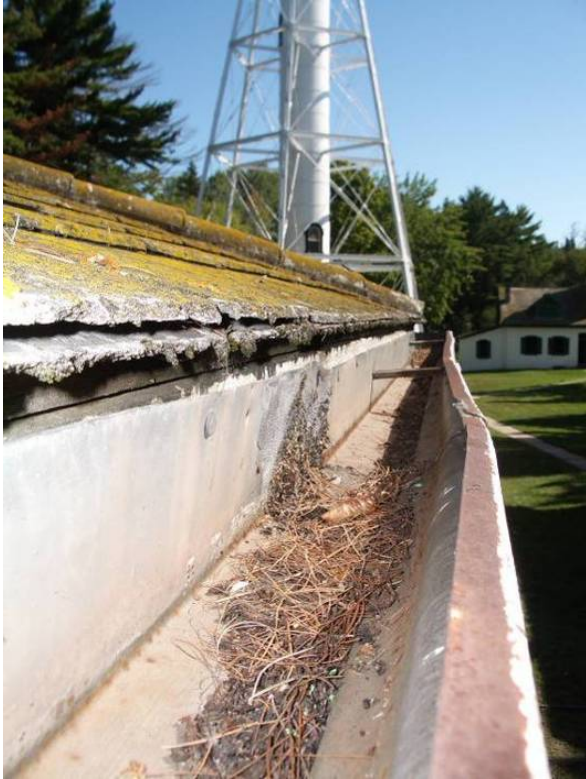
MI-KQ-06: East gutter and roof detail (Source: A&A IMGP2804)

3 Overall, the gutters and downspouts are in poor condition. The gutters have failure at joints, and the areas
4 that have rusted through have resultant damage to masonry and trim. There is also a gutter missing at the
5 eastern portion of the north elevation. The underdrain system's condition is unknown, but it is suspect.

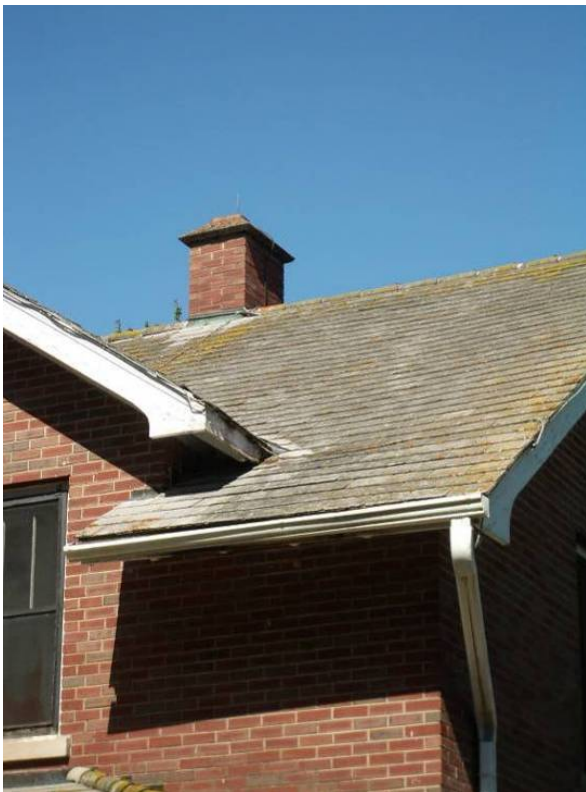
MI-KQ-07: South roof, trim, gutter, and chimney detail (Source: A&A IMGP2826)

The roofing is in poor condition. It appears to be nearing its end of serviceable life and yellow algae exists pervasively. The eave and associated trim is in fair condition with several areas of damage and peeling paint.

10 The chimney is in good condition.

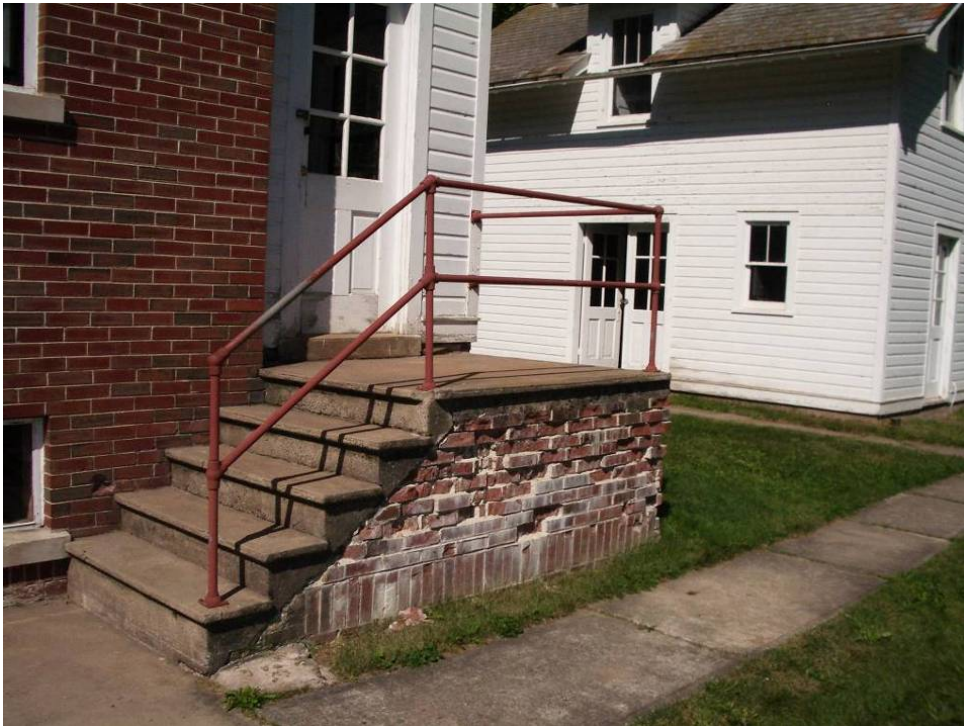
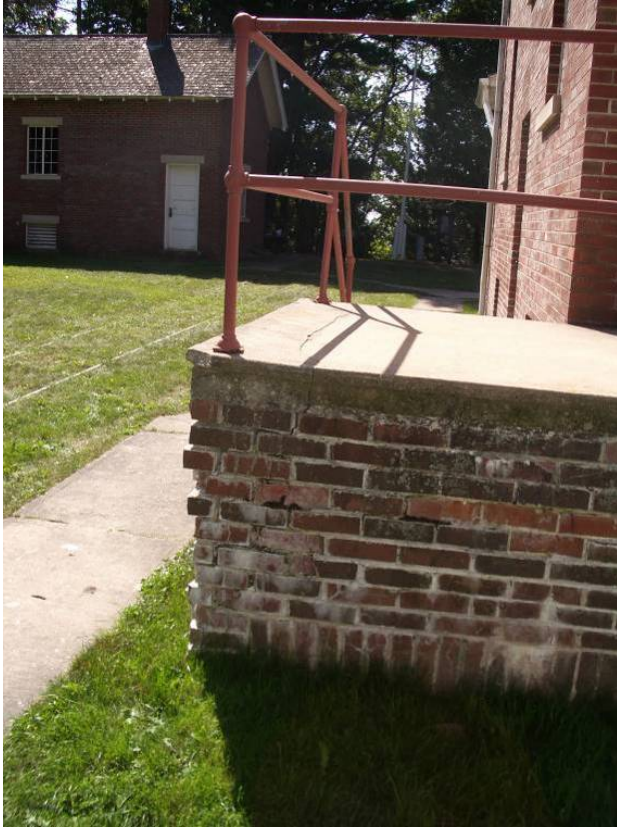
5
6 **Exterior East (Kitchen Entry) Stairs.** This concrete stair and railing are in poor condition as the brick
7 base of the stairs is deteriorating. The mortar is too hard, and as a result, is disintegrating and the bricks are
8 loosening and falling out. There is also a horizontal crack in the concrete landing that is associated with the
9 brick foundation failing.

The exterior walls are in good condition with the exception of the masonry walls under the landing at the back door which are in poor condition. The walls at the landing are severely deteriorated. The concrete landing slab has cracked and is in fair condition. The damage to the bricks at the landing needs further investigation (MI-KQ-51 and 52). The framing of the interior walls could not be observed, thus their condition is unknown. No obvious signs of structural damage were observed.

MI-KQ-11: East porch (Source: A&A IMGP2797-A)

MI-KQ-12: East porch detail, north elevation (Source: A&A IMGP2798)

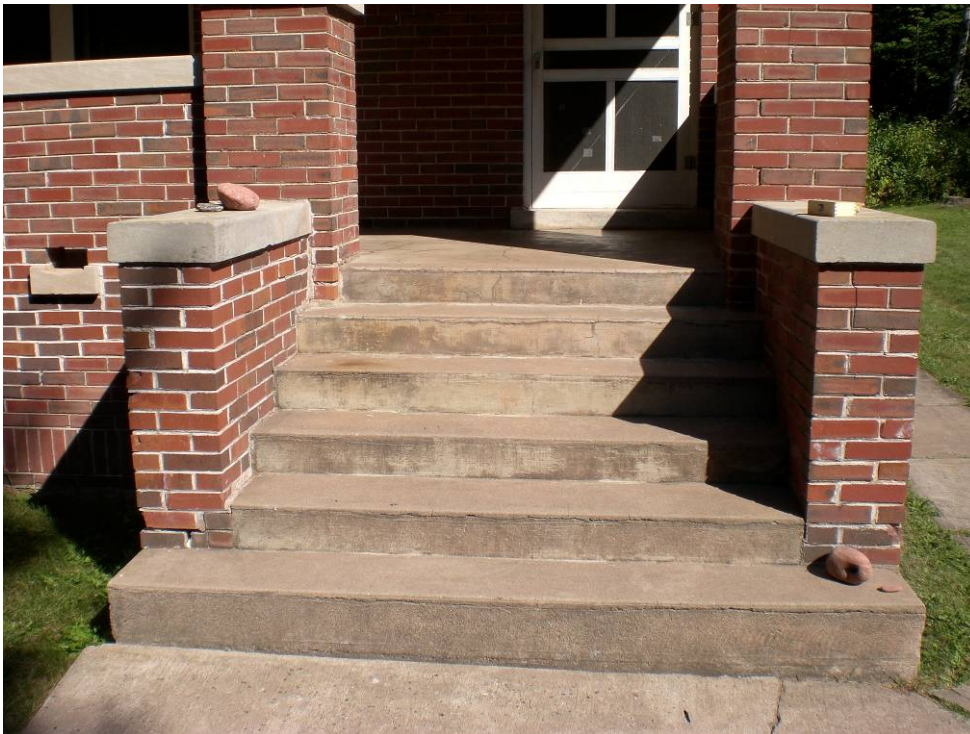
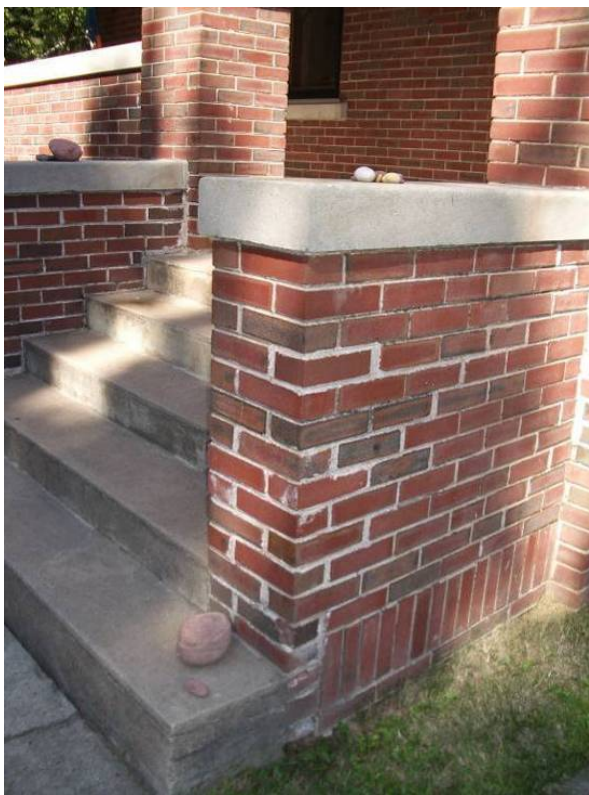
48 The porch is generally in good condition but there is cracking at the porch topping slab. The south wall's
49 masonry shows signs of previous repair, possibly due to the slope of the porch floor and its built-in drains.

MI-KQ-13: Front porch detail (Source: A&A CIMG3644)

MI-KQ-14: Front porch detail, looking west (Source: A&A IMGP2795)

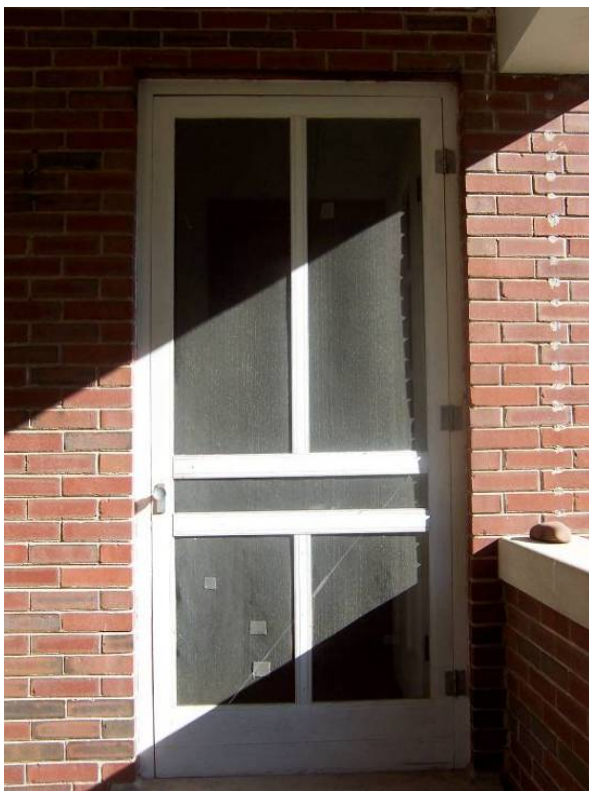
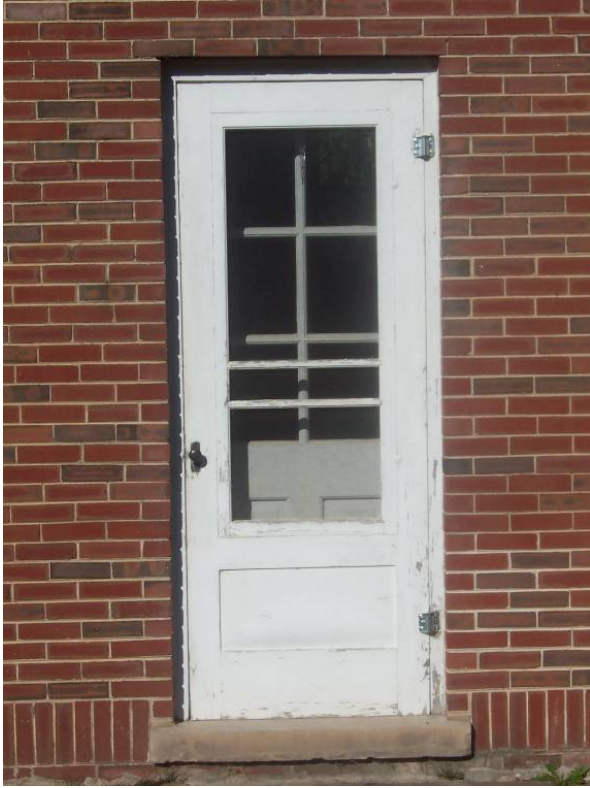
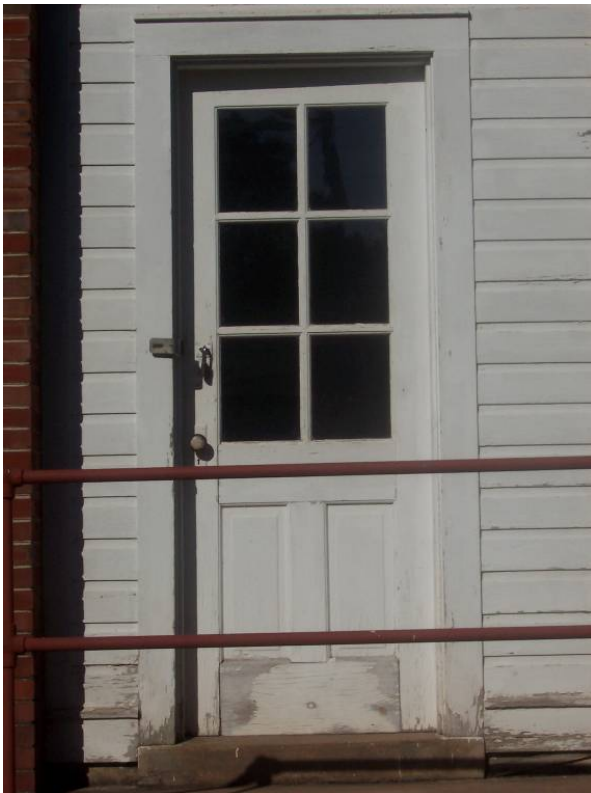
32 **Basement Entry, Main Entry, and Kitchen Entry Doors.** These doors are in fair condition as they have
33 peeling paint and the lower rails for the basement and kitchen entry doors are deteriorating from rain and
34 sun exposure.

36 **Screen Doors for Basement Entry, Main Entry, and Kitchen Entry Doors.** These doors are in good
37 condition besides minor peeling paint.

MI-KQ-15: South entry (primary) screen door (Source: A&A 100_9594)

MI-KQ-16: East entry screen and wood doors (Source: A&A 100_9606)

MI-KQ-17: North entry wood door (Source: A&A 100_9607)

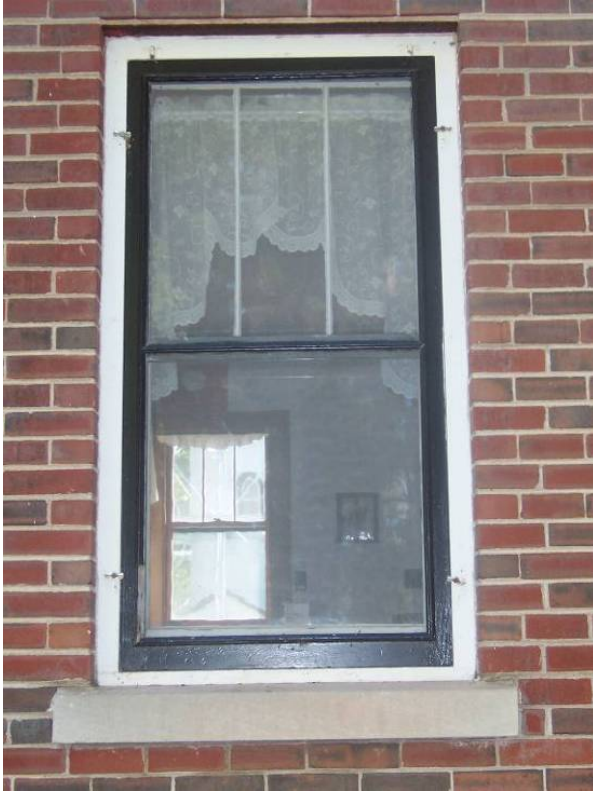
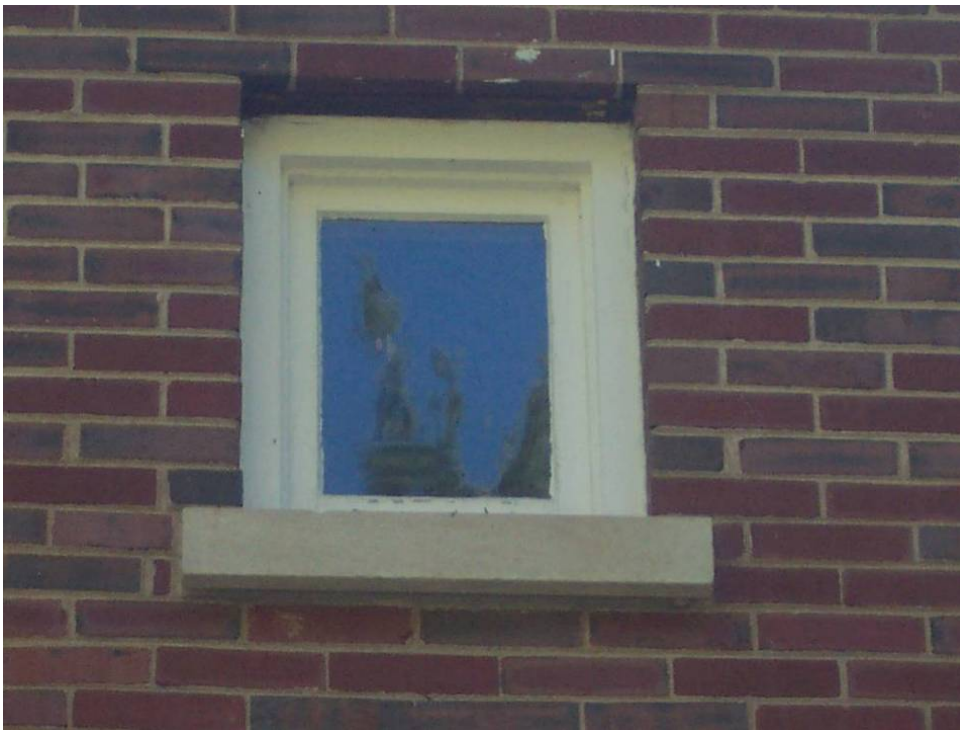
24 The typical double hung windows have some cracked and missing glazing putty, a few cracked panes, paint
25 peeling on the exterior, and alligatored interior trim varnish. A few of the screens are missing screen stops
26 and there are two patched screen areas. Overall, however, the windows in this building are in good
27 condition.

MI-KQ-18: Typical exterior window (Source: A&A 100_9596)

MI-KQ-19: Attic window (Source: A&A 100_9598)

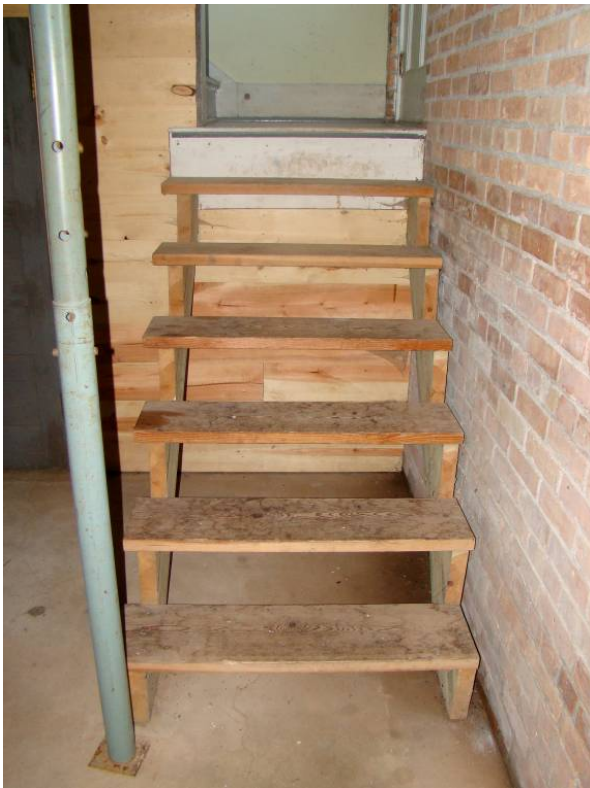
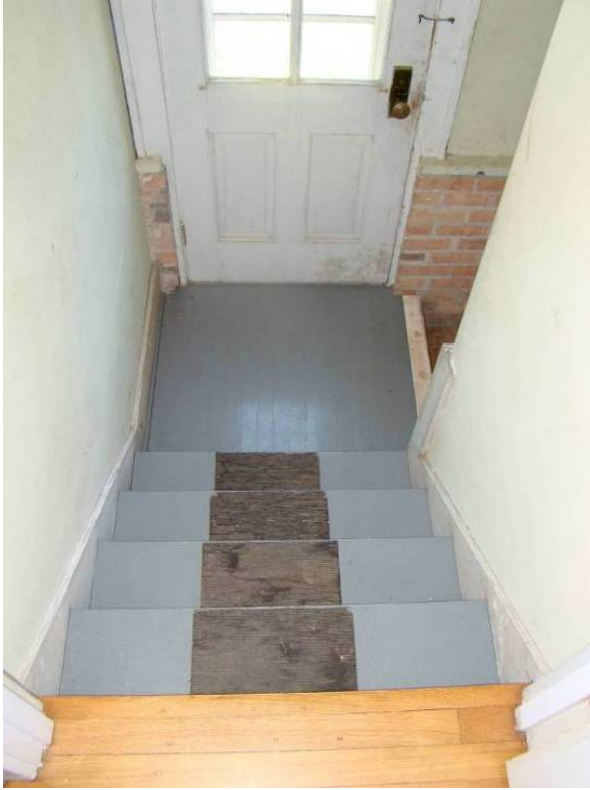
10
11 **Basement to First Floor Stairs.** These stairs are overall in good condition but neither flight has handrails.

MI-KQ-21: Basement stairs (Source: A&A DSC00841)

1
2 *MI-KQ-22: Stairs from basement entry to kitchen (Source: A&A DSC00844)*
3

4. Add code compliant handrails at the stairs	Adding a modern element may be visually disruptive.	Design a guardrail that blends well with the historic fabric.	- Improves visitor and staff safety

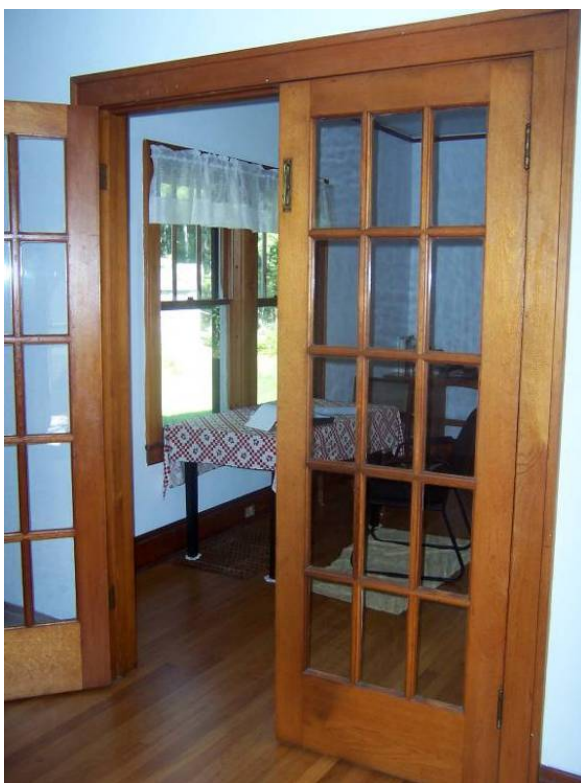
MI-KQ-27: Living room double doors into dining room (Source: A&A 100_9616)

Living Room to Dining Room Double Doors. This set of doors is in good condition with the exception of the alligatored varnish.

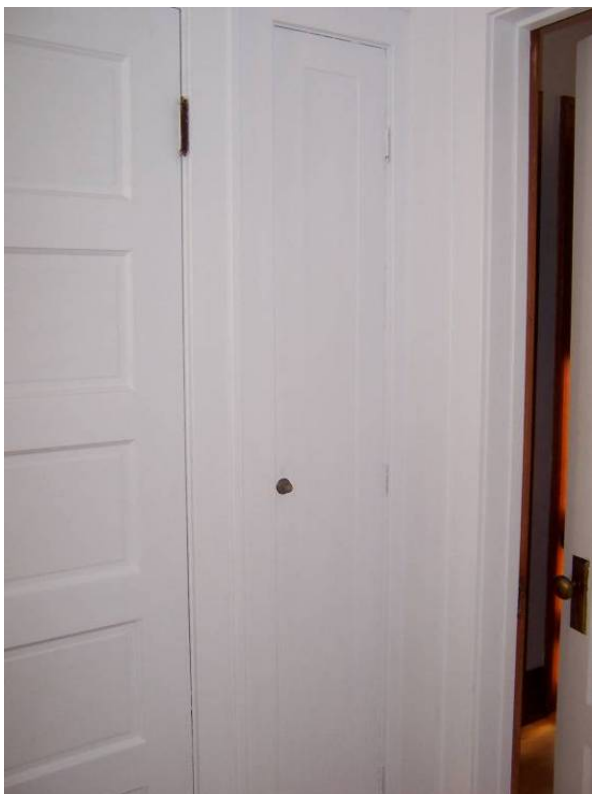
MI-KQ-31: Kitchen broom closet door, east wall (Source: A&A 100_9611)

Broom Closet Door. This door is in good condition.

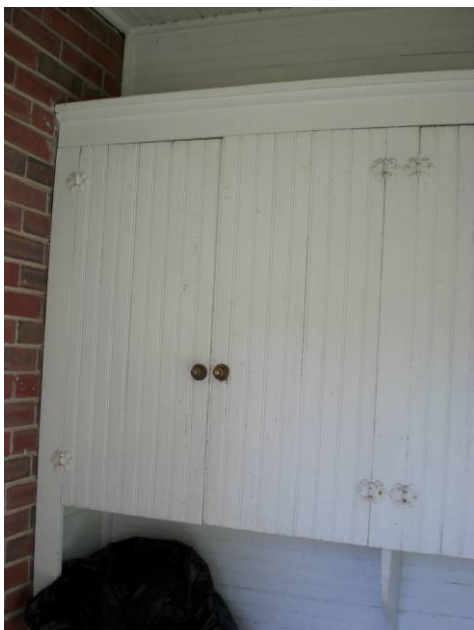
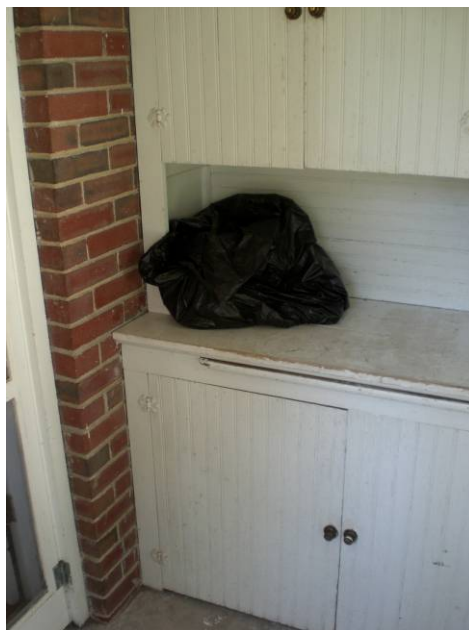
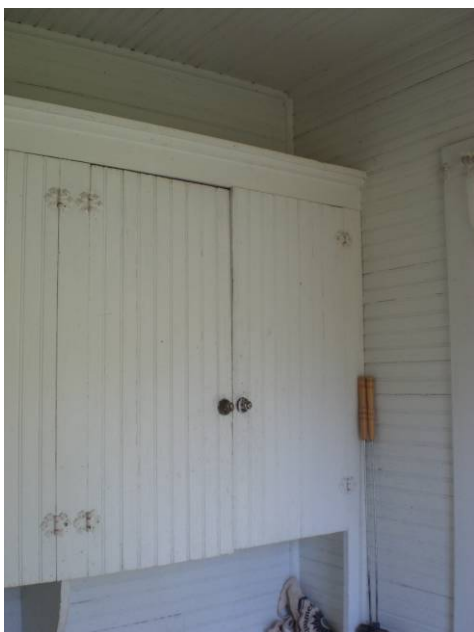
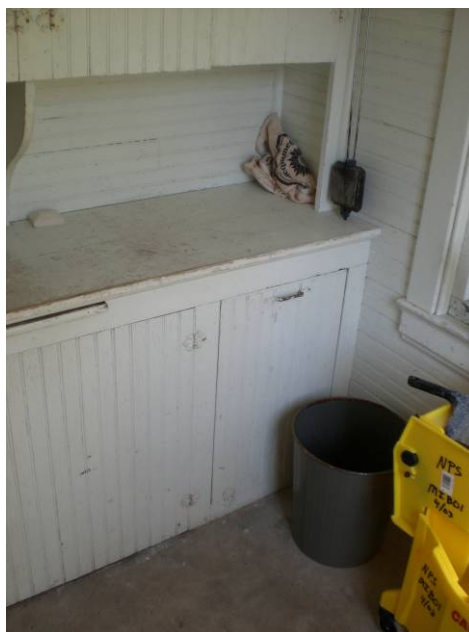
19 In general, the casework is in good condition. The registers are in good condition. The kitchen entry's
20 cabinet is in fair condition as the paint is peeling badly and cracking, the hinges are rusted, and upper
21 cabinets' doors are misaligned.

MI-KQ-34 and 35: Kitchen entry wood cabinet, south side (Source: A&A CIMG3733 and CIMG3732)

MI-KQ-36 and 37: Kitchen entry wood cabinet, north side (Source: A&A CIMG3734 and CIMG3735)

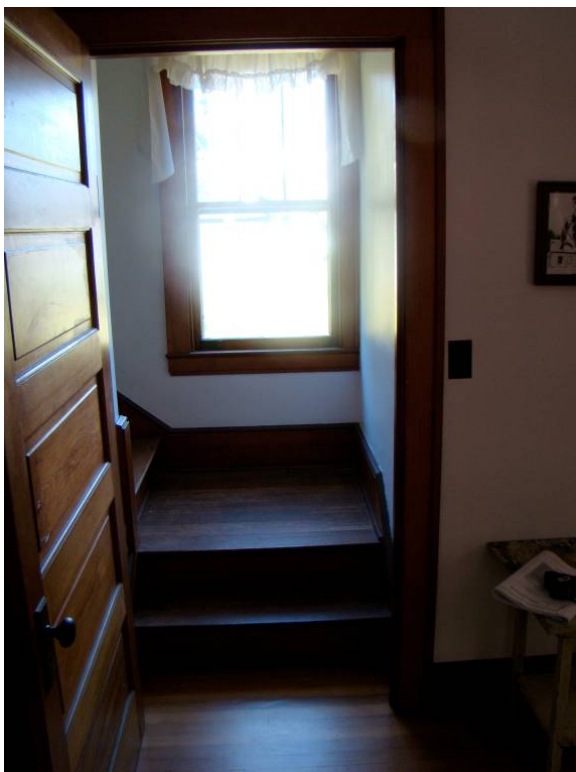
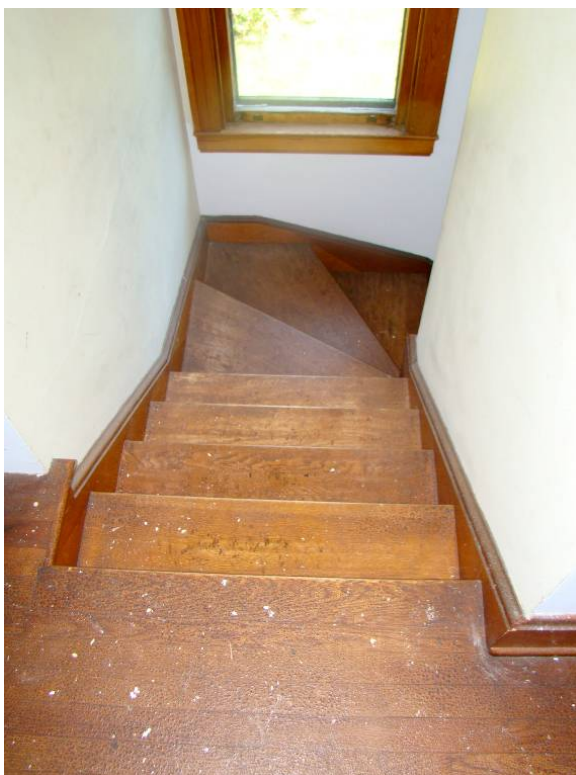
12
13 **First Floor to Second Floor Stairs.** These stairs are in good condition although there are no handrails and
14 the finish is badly alligatored.

1
2 *MI-KQ-38: Stairs from living room to second floor (Source: A&A DSC00830)*
3

4
5 *MI-KQ-39: Stairs from living room to second floor (Source: A&A DSC00835)*

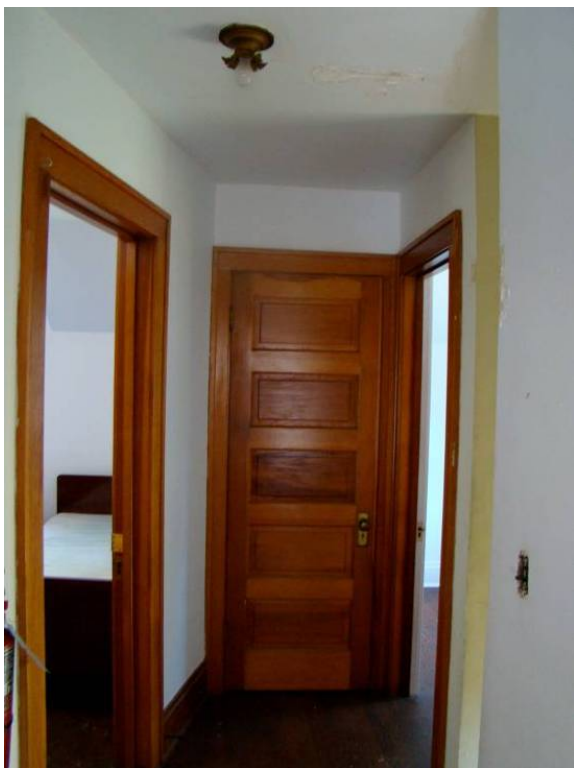
1
2 *MI-KQ-40: Second floor hall, north elevation (Source: A&A DSC00717)*
3

Overall, the original plaster ceiling finishes are in good condition with limited instances of cracks and peeling paint. The second floor hall and stairway have poor ceiling finishes, however, as these areas have heavy peeling, cracking, and obvious moisture issues. The southwest bedroom has a crack in the plaster running east to west with evident repair work. There is also a section of plaster missing at the southwest corner of the sloped roof line where sealant was applied in 2008 to cover the lath (S. Mackreth's recollection as volunteer's supervisor). The kitchen entry's ceiling finish of beadboard is in fair condition with some board separation.

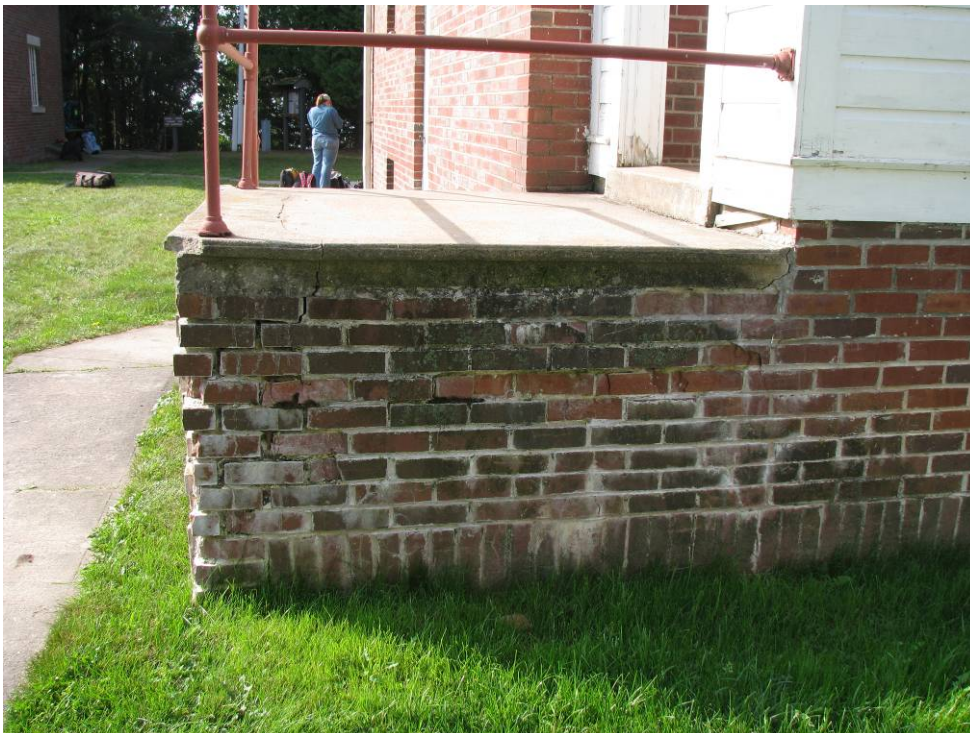
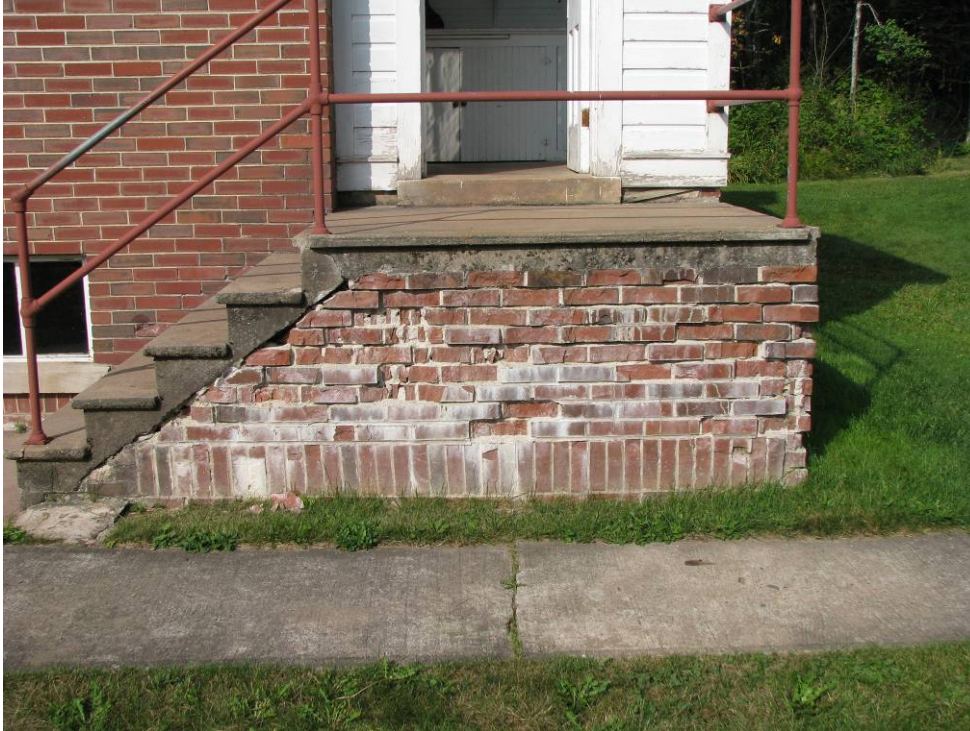
Structurally, the Keepers Quarters is in good condition. The brick masonry below the landing at the back door needs further attention. The roof needs to be strengthened to support the required snow load.

MI-KQ-51: Masonry wall deterioration (Source: Martin/Martin)

MI-KQ-52: Masonry wall deterioration (Source: Martin/Martin)
