ASSISTANT KEEPERS QUARTERS AND WORKSHOP

Chronology of Alterations and Use

CHAPTER 4: HISTORIC STRUCTURE REPORT

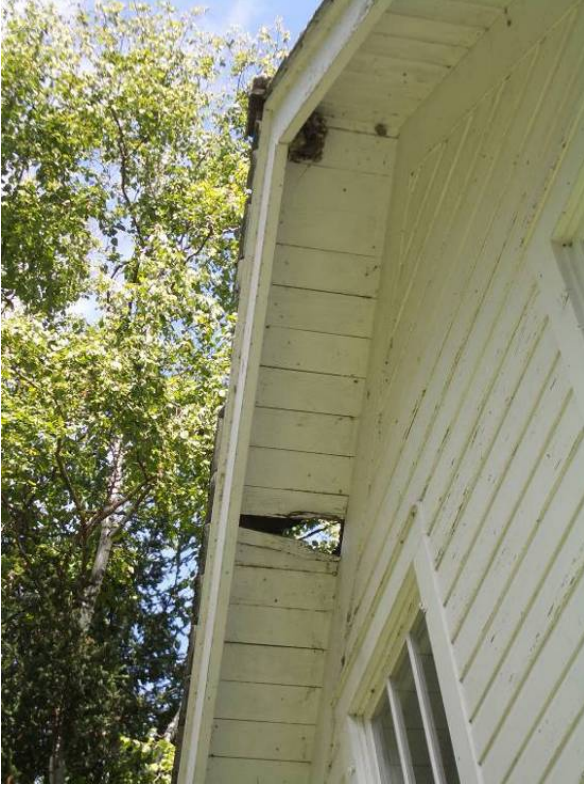
MI-AKQ-07: West eave, trim, and roof (Source: A&A IMGP2832)

The existing roofing is asbestos roof shingles 9" wide × 7" exposure. There is a hole in the roof (northwest), perhaps due to a tree fall. The ridge trim is missing at the west end (likely due to the same damages that caused the hole at the roof) and has been repaired with wood. There does not appear to be any extant flashing. The roof appears to be original to the structure as it is consistent with the notes on the original construction drawings (MI-AKQ-07). The eave consists of exposed rafter tails and tongue and

The roof shingles are in poor condition and at the end of their serviceable life.

Remove the existing asbestos shingle roof and replace with an asphalt shingle roof of 9” wide × 7” high exposure to match the dimensions of the 1927–1929 era. Repair the hole in the roof substrate at the eave. Verify/provide proper underlayment and flashings at all eaves, rakes, valleys and intersections. Scrape, sand, and repaint the wood trim at the eave, exposed rafter tails, exposed underside of the roof sheathing, fascia, and frieze using the paint analysis to guide the color selection.

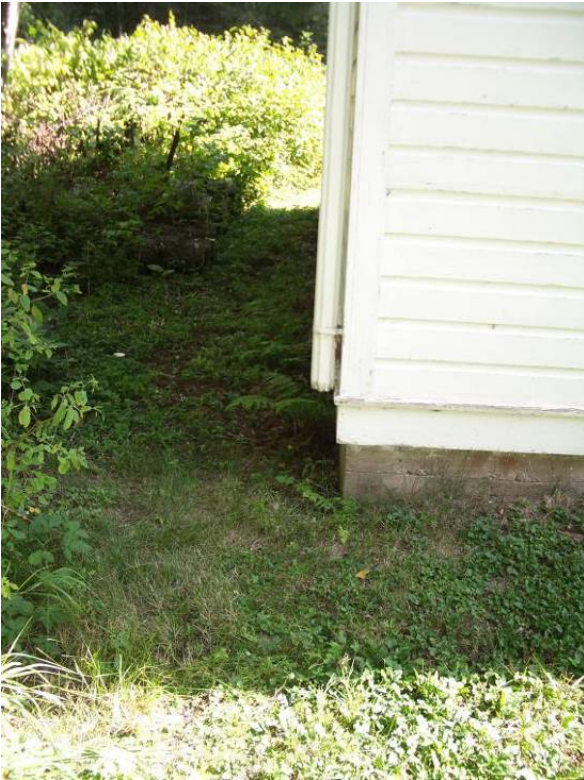
MI-AKQ-08: Northwest corner downspout and foundation (Source: A&A IMGP2833)

There is a half-round gutter hung with wire ties to the roof. The downspouts are fluted, 3" diameter round shape. There is no underdrain system on this building. The original construction plans do not show the gutters and downspouts, so it is not known if they are original to the building. They are seen in photos as early as 1935 (MI-AKQ-08 and 09).

The gutters and downspouts are in poor condition. There is no underdrain system. The gutters are rusted and have paint peeling.

Replace the existing ½ round gutters in kind. Reuse the existing fluted downspouts and provide extensions to direct water away from the foundation. Add splash stones at each downspout. Coordinate gutter replacement with roofing work to allow for proper attachment of gutters.

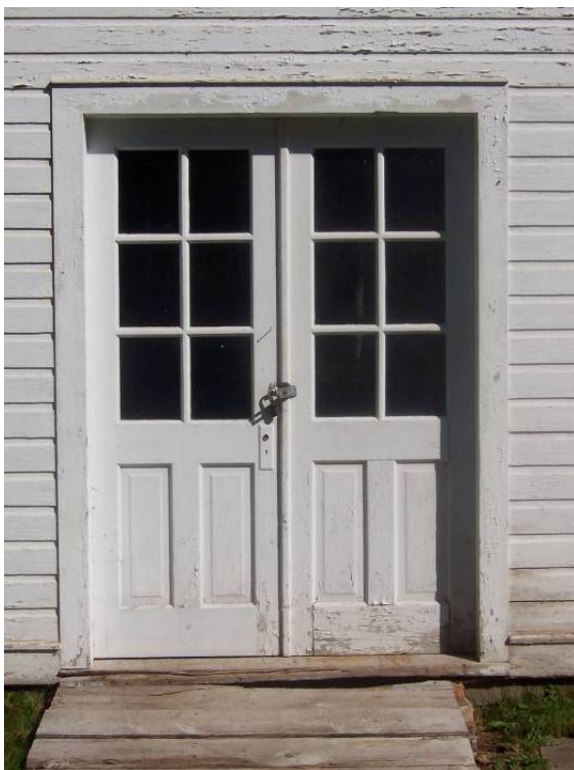
1
2 *MI-AKQ-11: South entry (primary) doors (Source: A&A 100_9622)*
3

20 These doors are in fair condition as they have peeling paint, missing door hardware, gapped and brittle
21 glazing compound, and a broken wood sill on the south doors.

9 Repair broken wood sill on the south doors and replace failing glazing compound where needed. Scrape,
10 sand, and repaint the doors. Repair existing hardware as required to allow smooth operation.
11
12

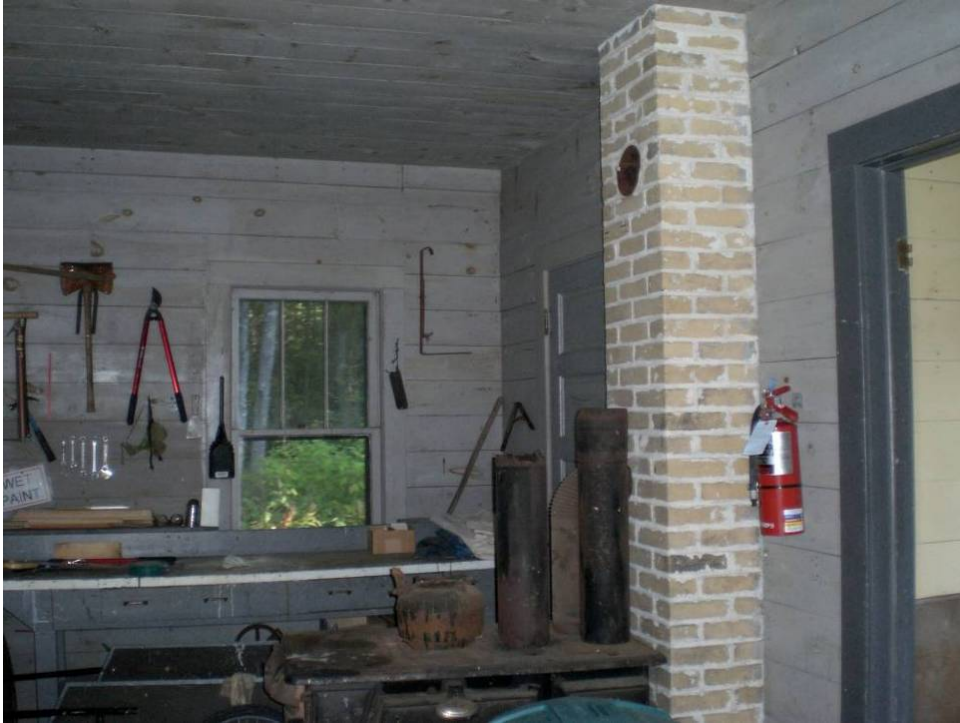
MI-AKQ-15: Storage room, looking northeast (Source: A&A CIMG3444)

The chimney is exposed on the interior and is blond brick. The exterior portion of the chimney is red brick with a sloped cast concrete cap and clay flue. The chimney has a metal clean-out on the first floor. The chimney is 1'4¼" wide and 1'1" deep from its western face to the wall (MI-AKQ-15).

3 This chimney is in good condition. The chimney appears to have been recently repointed at the interior.

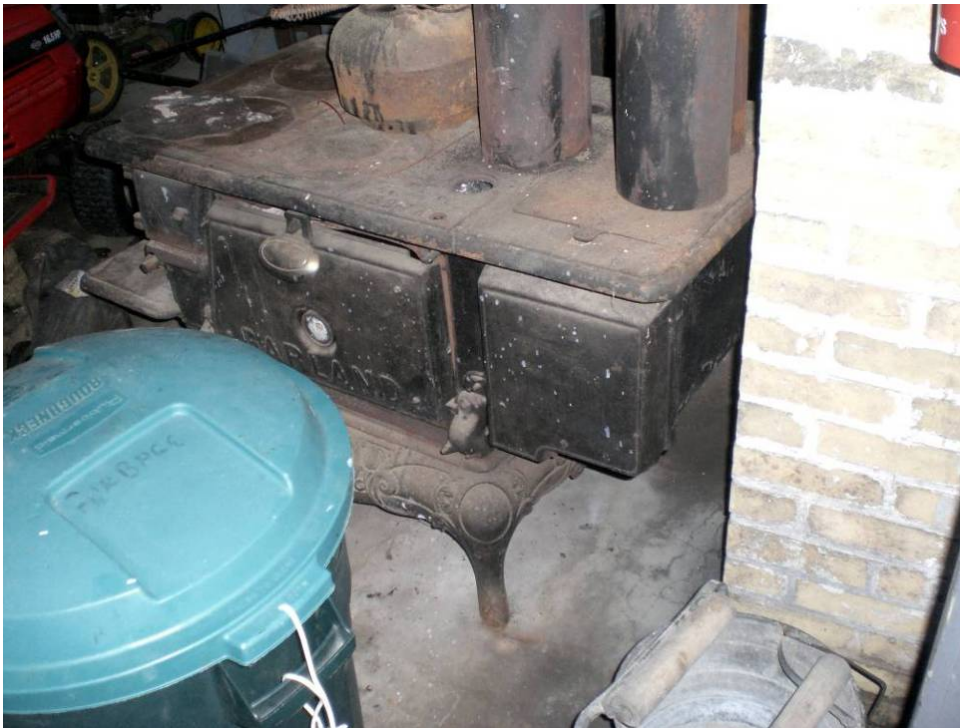
MI-AKQ-16: Stove at chimney (Source: A&A CIMG3450)

There are no active heating or ventilation systems remaining in the building. The cast iron wood stove located on the first floor is in poor condition.

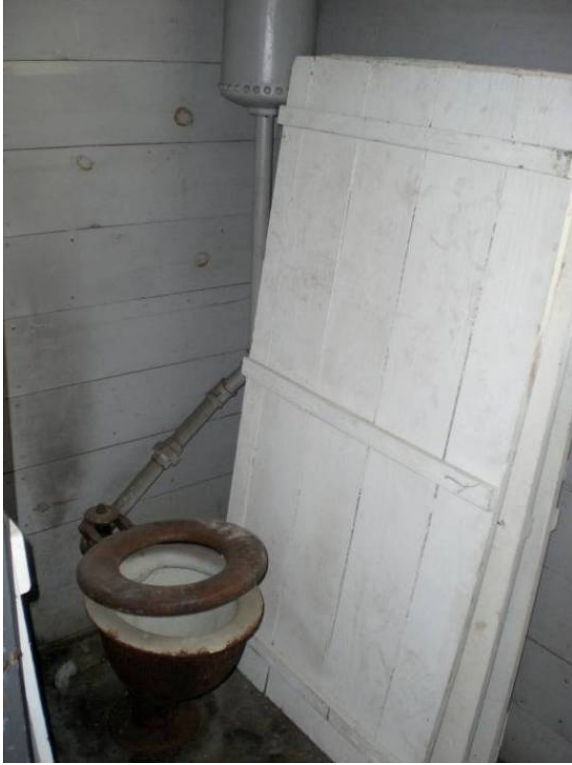
MI-AKQ-17: Water closet, looking east (Source: A&A CIMG3486)

The toilet on the first floor is still in place, although not functional and in poor condition. The second floor sink has been removed.

The existing plumbing fixtures and plumbing piping are no longer functional. It is recommended that the plumbing piping be removed or capped. The clay sewer pipe serving the building should be capped below grade.

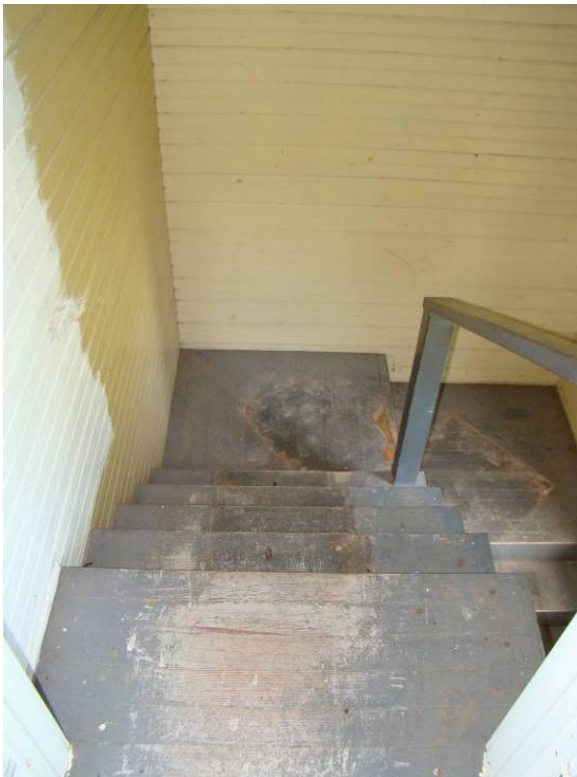
MI-AKQ-18: Stairs to second floor living quarters, looking down (Source: A&A DSC00846)

First Floor to Second Floor Stairs. These stairs are painted wood with rubber tread mat glue residues remaining. There are nine risers to the landing and then five more risers. The riser height is 8" and the treads are 10" deep and 3'2" wide. There is a simple wood board railing, painted, on the upper set of stairs after the landing. The rail is 4" × 1½" and the distance from the nosing to the rail is 3'0" on center. These stairs are original to the building (MI-AKQ-18).

First Floor to Second Floor Stairs. These stairs are in fair condition as the upper set of stairs has an inadequate 2x4 wood railing and the bottom portion of the stairs has no railing. Also, the glue adhesive remains from the rubber tread mats and there are water stains on the landing.

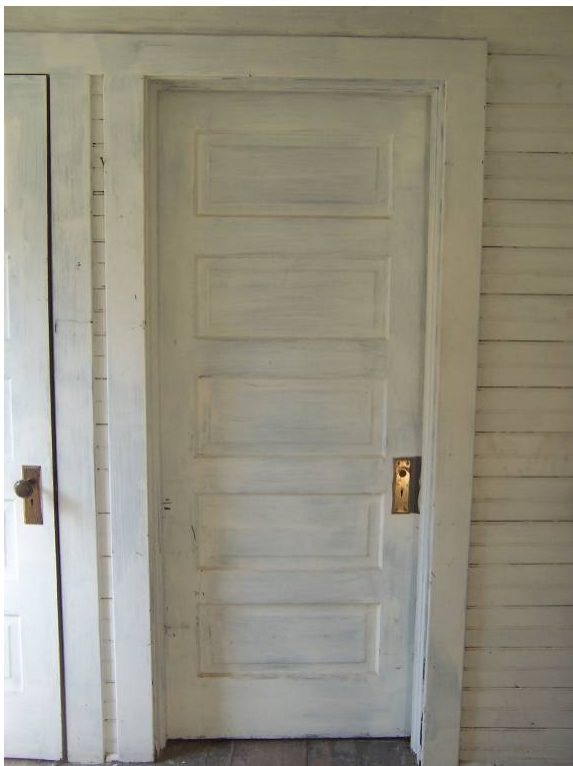
MI-AKQ-20: Living room door to bedroom (Source: A&A 100_9621)

These original doors are five panel, wood doors with raised panels and are painted. The wood trim matches the interior window trim. Each door has knob hardware with mortise plates on both faces and two hinges. The typical door dimension for this type of door on the first floor is 2'8" × 7'0" × 1¼" and on the second floor is 2'0" to 2'8" × 6'8" × 1¼" (MI-AKQ-20).

31 These doors are in fair condition as most of their knobs are missing on the second floor doors and are loose
32 on the first floor doors.

21 Scrape, sand, and repaint interior doors where needed. Replace missing knobs with finish to match original
22 and tighten existing hardware to allow smooth operation.
23
24

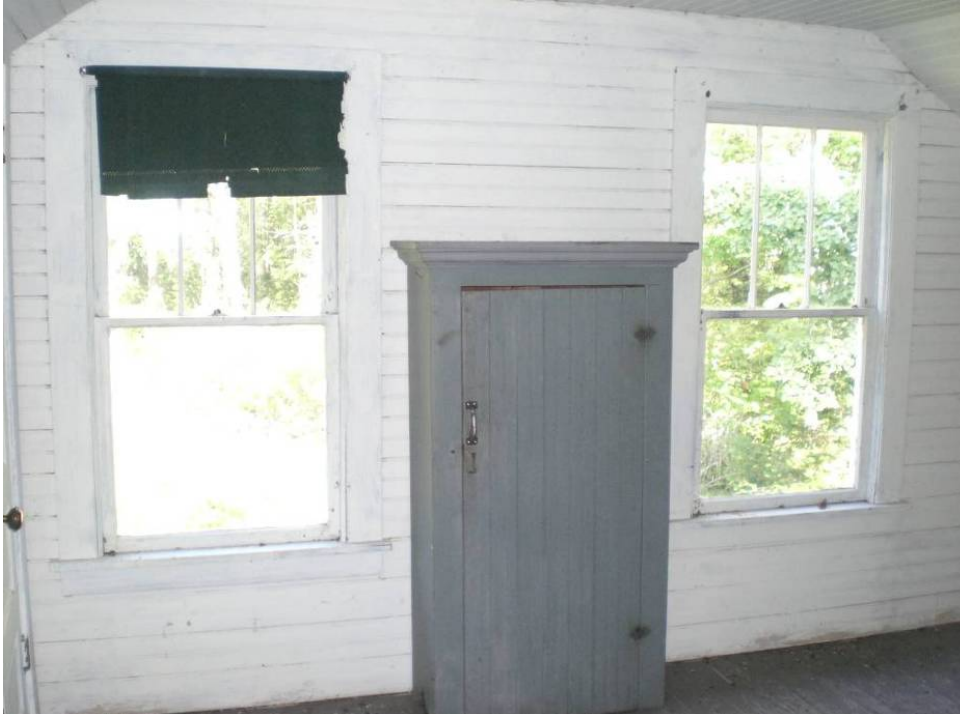
MI-AKQ-21: Bedroom, west elevation (Source: A&A CIMG3520)

All but one window in the building are three-over-one (one window is two-over-one), double hung. Each window has a thumb turn latch, no lift hardware, sash cord and pulleys intact, and extant roller shade hanger hardware. The interior trim is ¾" × 4½" painted wood with a rounded edge, a sill and a skirt. The muntins have an inset, rounded profile. The exterior trim is 1" × 4½" painted white with a simple 2x sill. One window has a two-lite screen, painted black, and held in place with spring clips at the perimeter. The typical dimensions for these windows are 2'10" × 5'7" with the façade window slightly shorter. These windows are original (MI-AKQ-21).

13 These windows are generally in fair condition as there is peeling paint, loose and missing glazing putty, a
14 few windows sealed shut by paint, a torn screen, and a broken screen stop. Some screens are also missing
15 although screen hardware is extant.

3 Repair select windows with missing glazing putty and paint-sealed sashes. Replace missing screens.
4 Scrape, sand, and repaint exterior and interior of windows and frames.
5
6

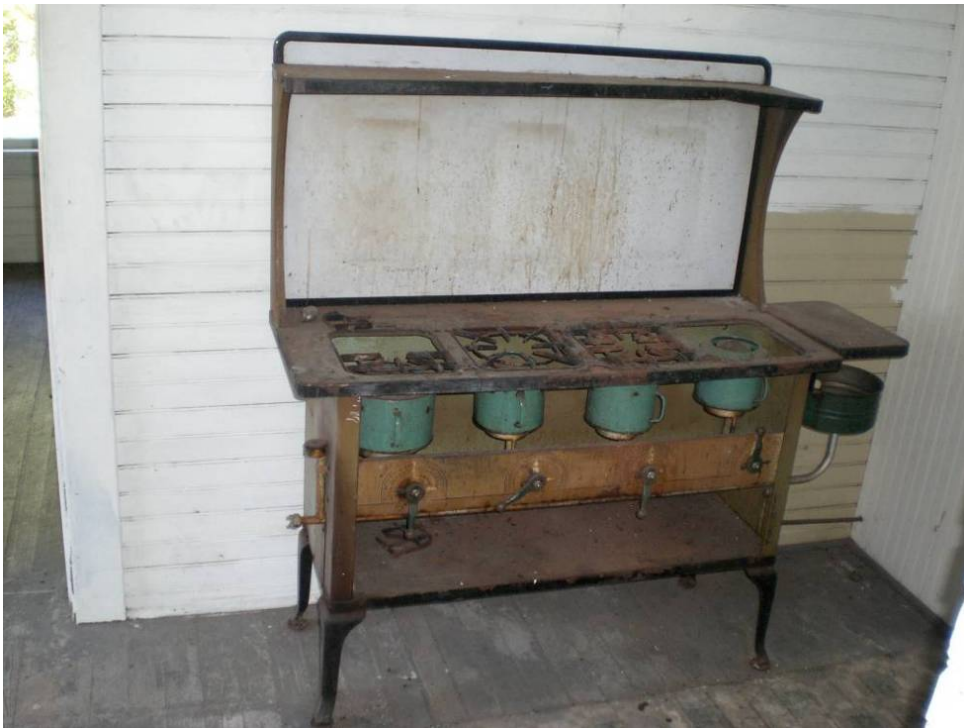
MI-AKQ-26: Kitchen stove with coffee pot burners (Source: A&A CIMG3556)

In general, the Michigan Island Assistant Keepers Quarters and Workshop is in good condition on the exterior with the exception of the hole in the roof at the northwest area and fair condition on the interior. The original interior finishes are in fair condition with some separation of beadboard paneling and water stains and possible damage in the kitchen. The original windows and doors are also in fair condition, as is the historic casework. The kitchen has a metal range with coffee pots used as burners (MI-AKQ-26).

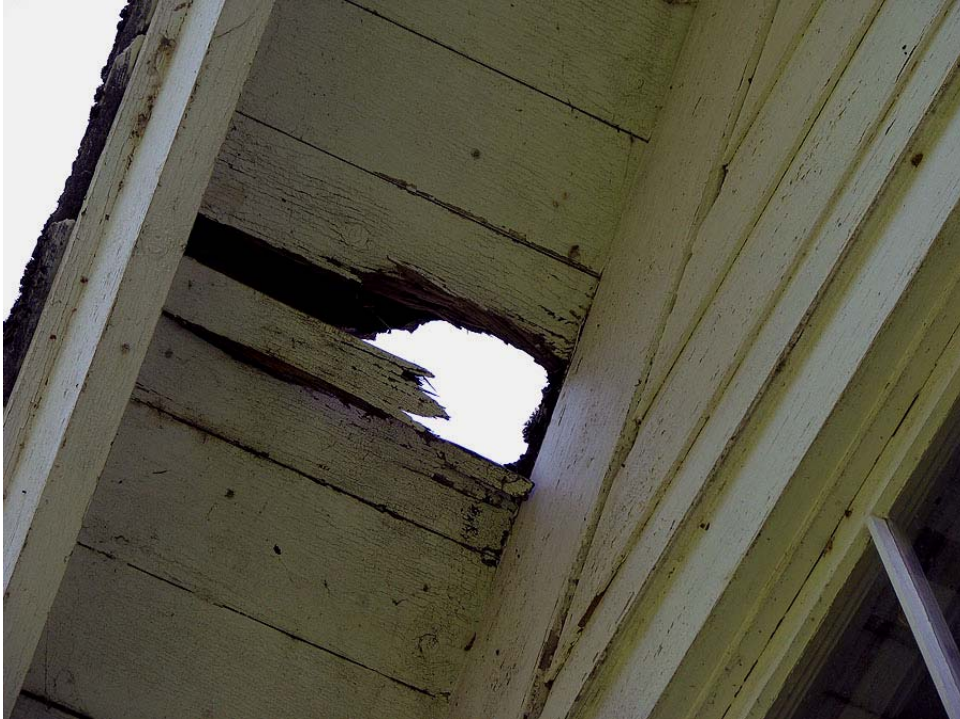
MI-AKQ-28: Roof damage detail (Source: Martin/Martin)

There is currently a hole in the roof in the northwest section and there are no active mechanical systems in the building.

The roof framing could not be observed, thus its condition is unknown. No obvious signs of distress or damage were observed with the exception of a small hole in the roof from falling tree branches (MI-AKQ-28).

The roof should be repaired where it has been damaged.
