## SHED

## CHAPTER 4: HISTORIC STRUCTURE REPORT

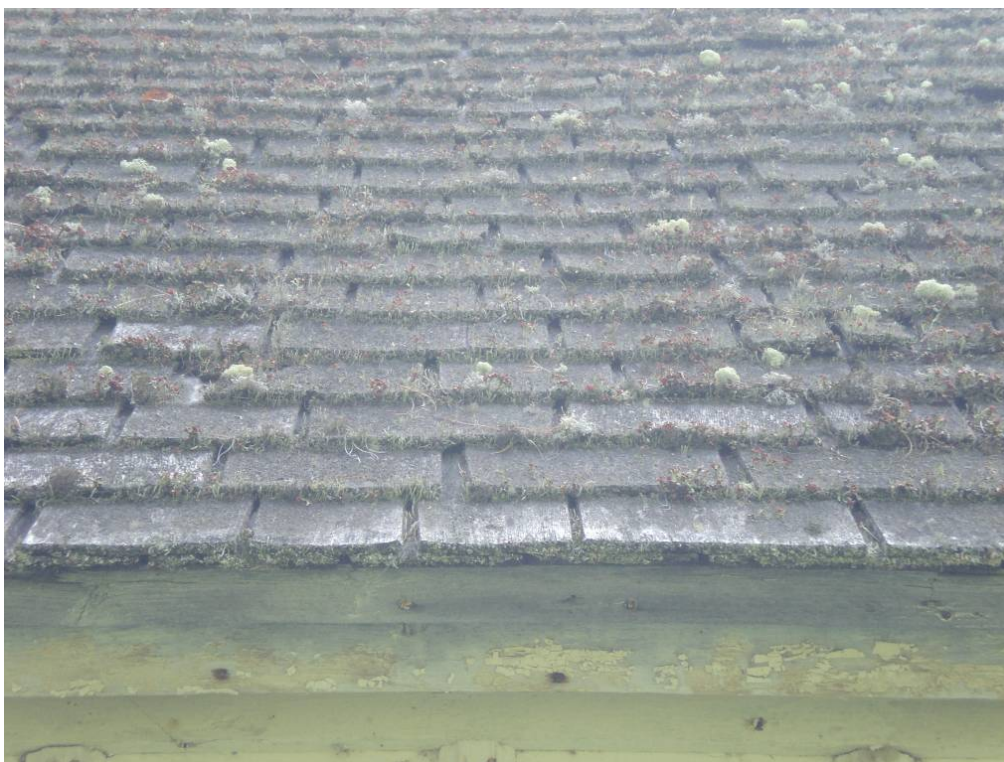
The existing wood shingles with moss growth are in poor condition.

MI-S-07: Detail of roofing shingles (Source: A&A CIMG3255)

Remove existing wood shingle roof and replace in kind matching exposure. Verify/ provide proper flashings and replace any damaged open sheathing as needed in course of reroofing.

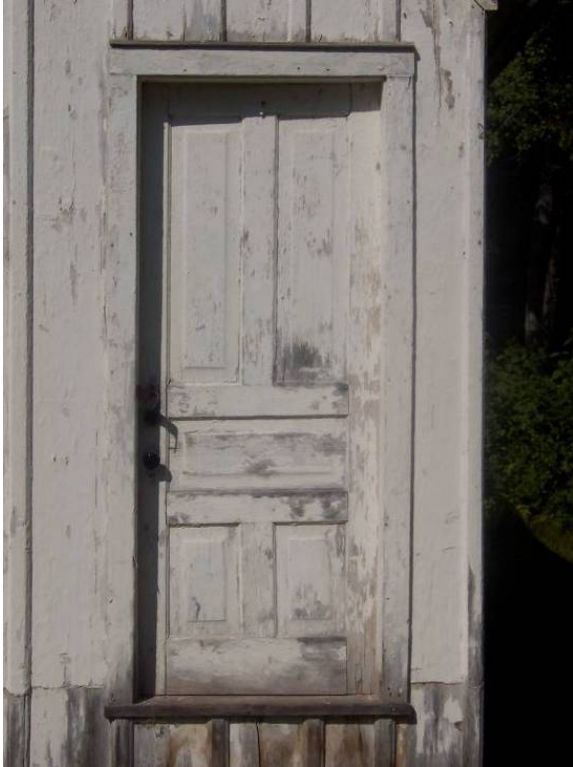
3 **Main (South) Entry.** This main door is in fair to poor condition as the hinge-side stile and the bottom rail  
4 are broken, the paint is alligatored and peeling, and the knob is loose.

1  
2 *MI-S-08: South elevation entry (primary) door (Source: A&A CIMG3248)*  
3

Repair broken stiles and rails and epoxy stabilize areas of rotting wood components. Scrape, sand, and repaint doors. Repair existing hardware as required to allow smooth operation. Investigate the installation of a Plexiglas (or similar product) panel at the south entry for visitor viewing.

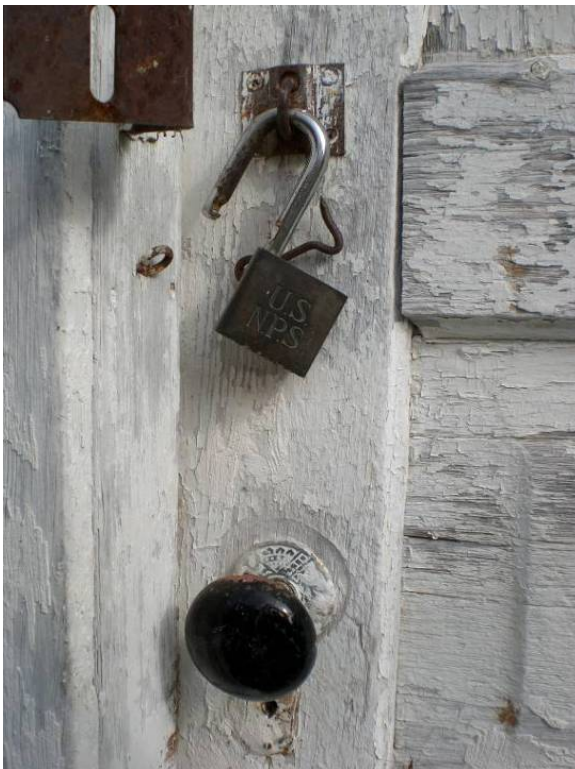
4  
5 *MI-S-09: South elevation door, detail of lockset (Source: A&A CIMG3269)*

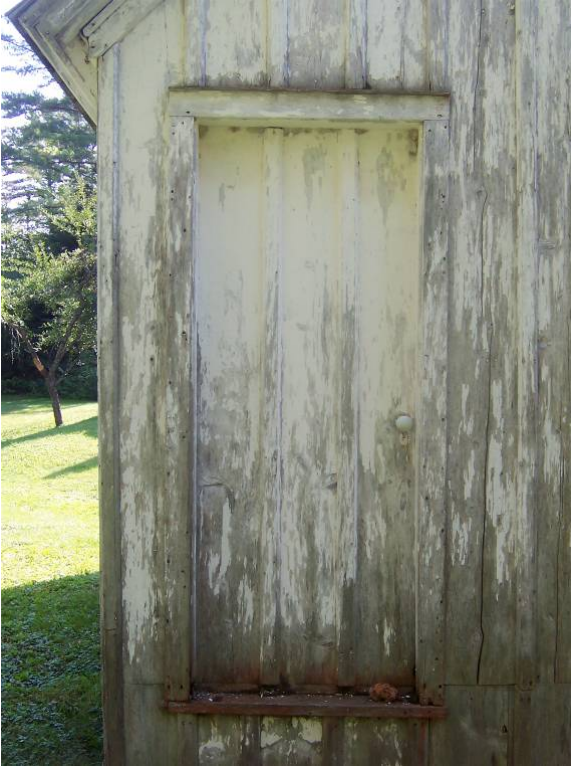
5  
6 **Rear (North) Door.** This door is in fair condition as the frame is rotting at the base, the knob is loose and  
7 rusted, and the paint is peeling.

MI-S-10: North elevation entry door (Source: A&A CIMG3250)

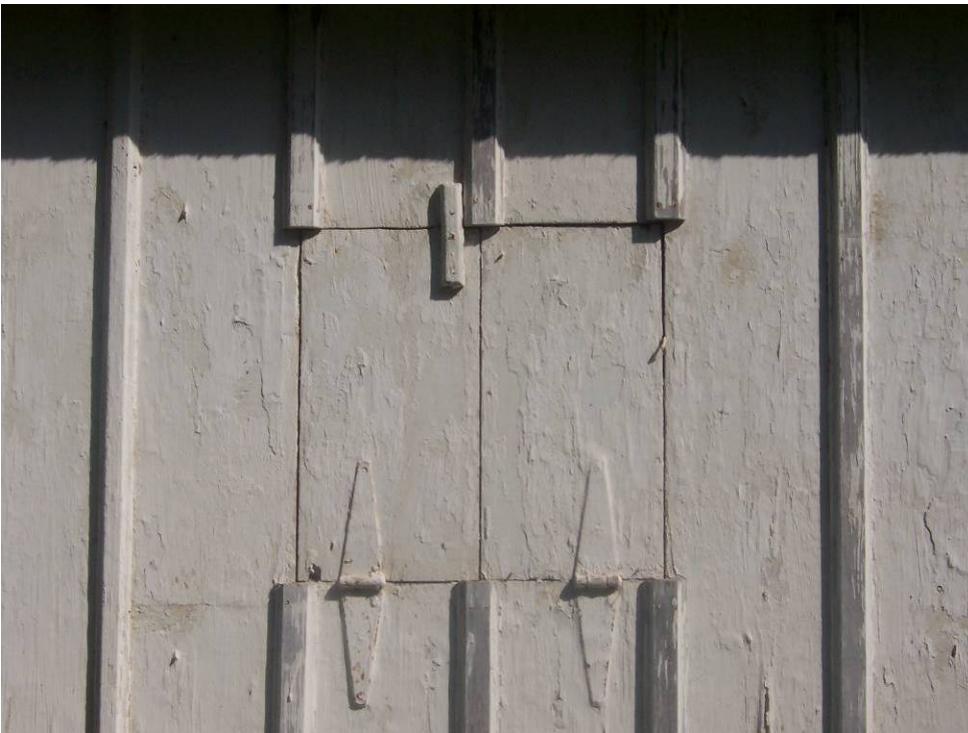
**Side (West) Elevation Hatch.** The hatch is in good condition, though it is inoperable.

MI-S-11: West elevation hatch opening (currently inoperable) (Source: A&A CIMG3246)

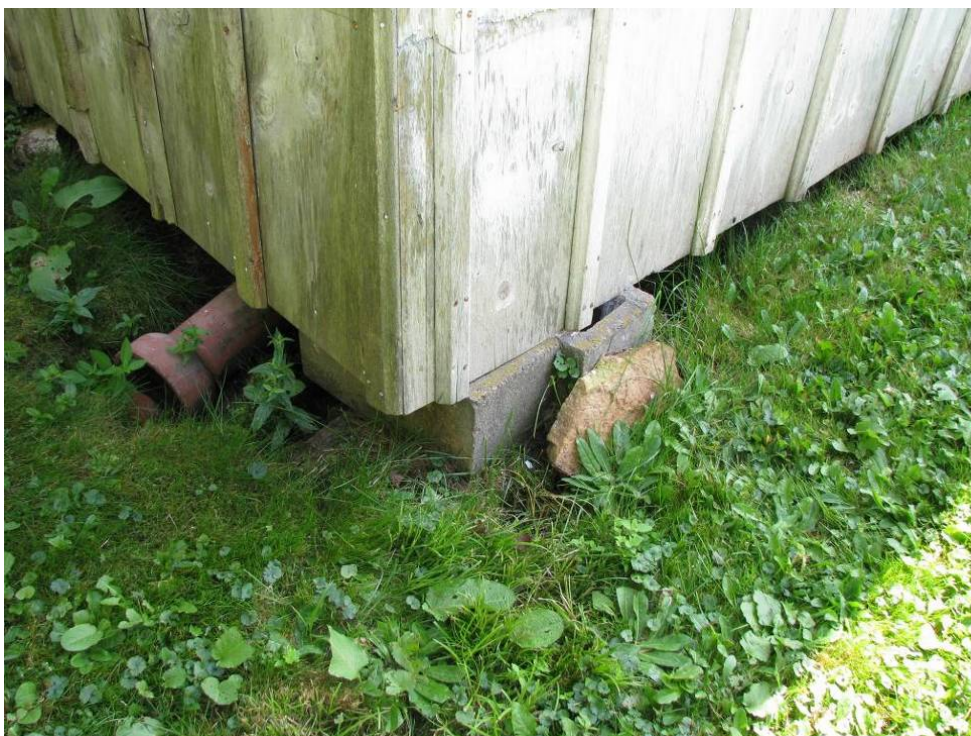
47 The foundation is in poor condition. The accessible portions of the foundation are concrete masonry blocks.  
48 In some locations, the floor framing rests directly on the ground. There are no connections between the  
49 floor framing and the blocks (MI-S-17). The wood beams that support the floor framing could not be  
50 observed, thus their condition is unknown.

*MI-S-17: Foundation blocks (Source: Martin/Martin)*

A new foundation in compliance with the IEBC and NPS requirements should be provided for the support of the shed.

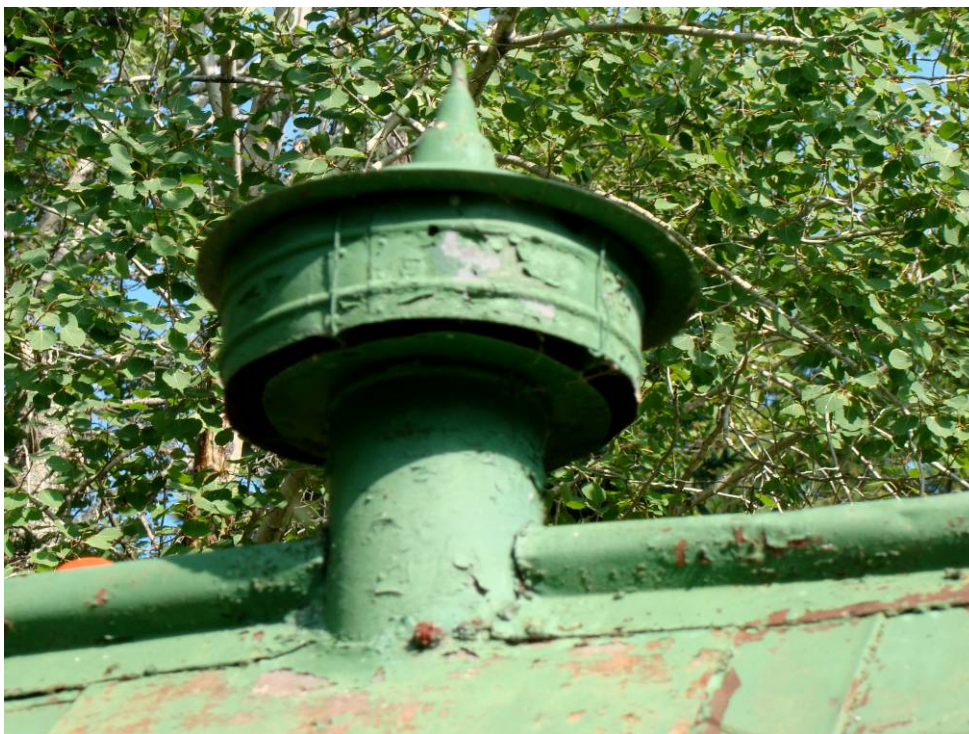
The gravity vent on the roof of the Privy is in fair condition. The Privy vault vent at grade is in poor condition.

MI-P-06: North roof vent (Source: A&A DSC00597)

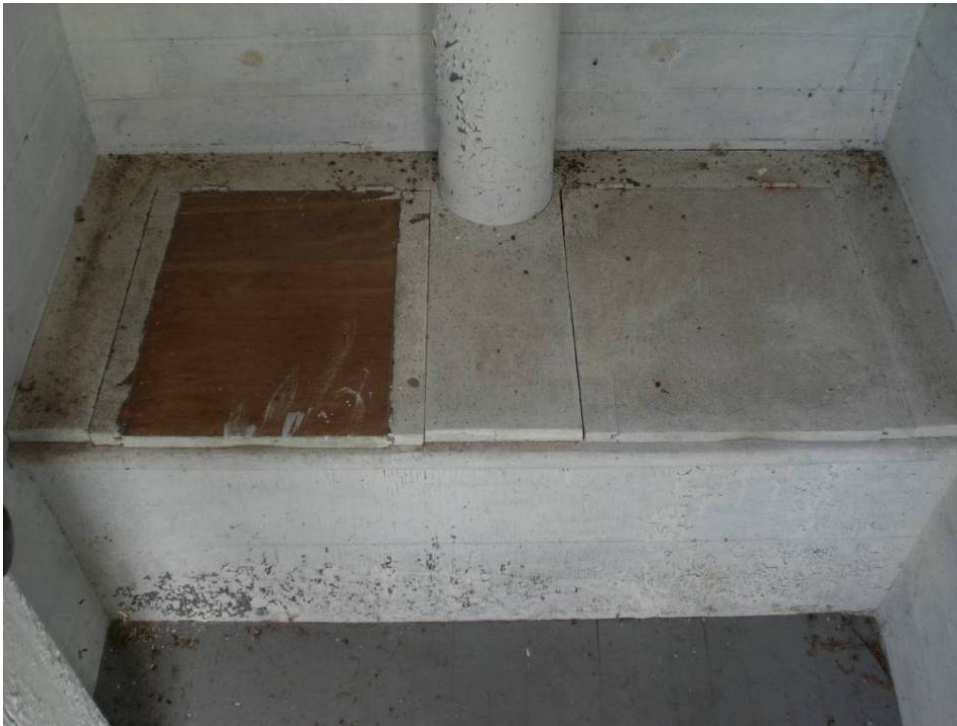
24 The two-seater is in fair condition with peeling paint, missing paint, and rusty hinges. The vent pipe is also  
25 in fair condition with badly peeling paint.

1  
2 MI-P-08: Seat detail (Source: A&A CIMG3287)  
3

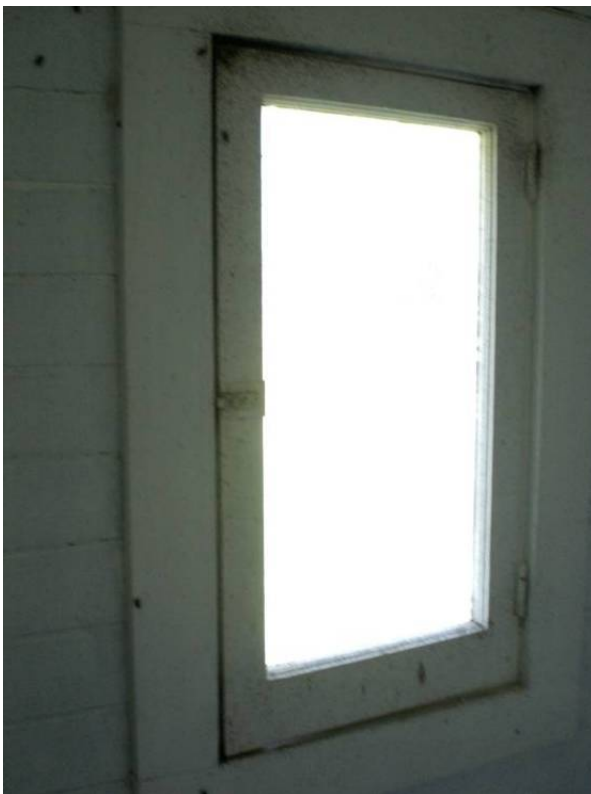
This window is in good condition with peeling paint.

4  
5 MI-P-09: Window (Source: A&A CIMG3278)

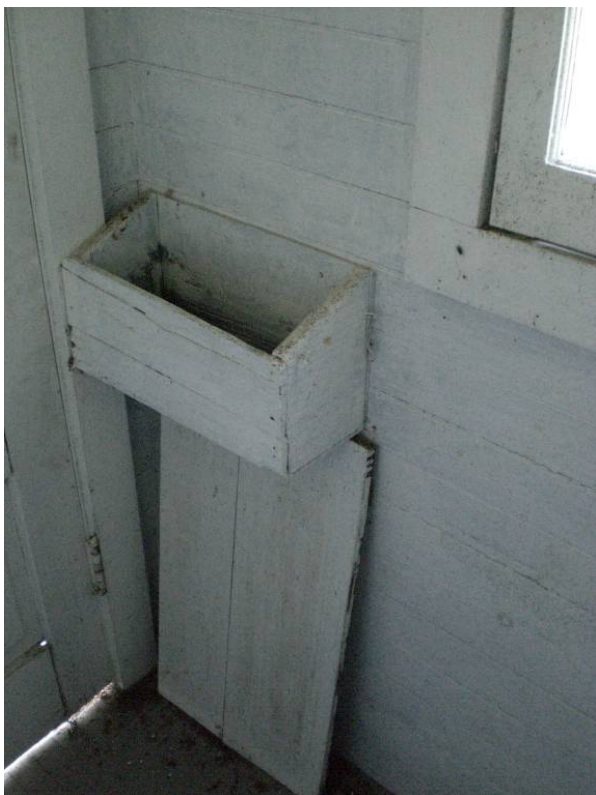
27 The small wood basket is in fair condition as it is warped and has peeling paint.

MI-P-10: Window and built-in box (Source: A&A CIMG3282)

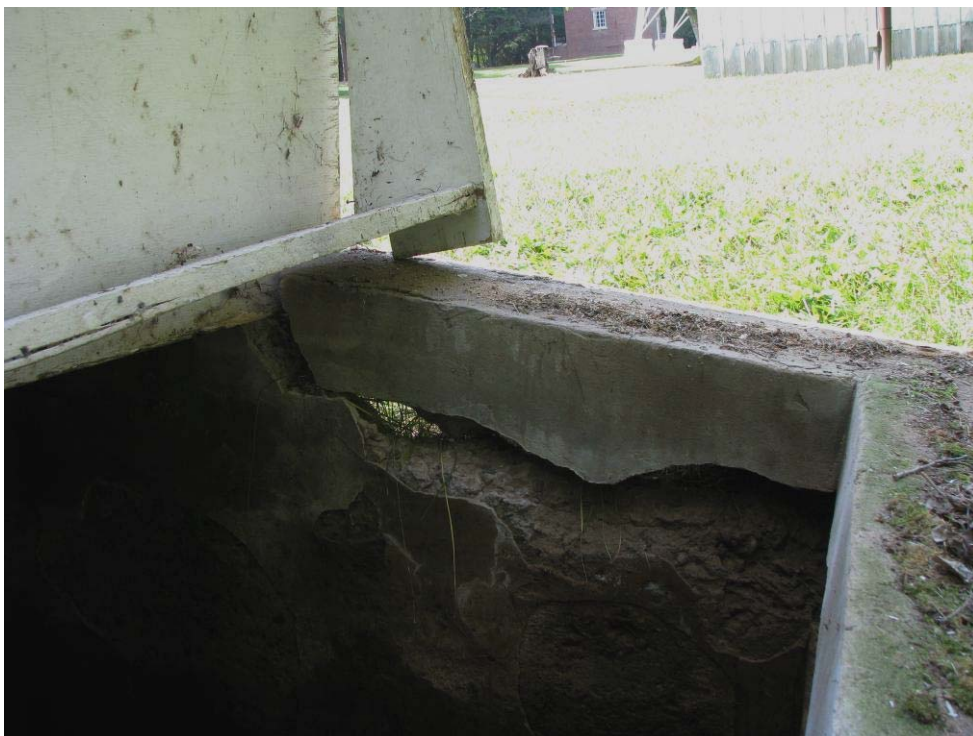
38 The walls of the concrete vault at the rear of the Privy are in poor condition. The original concrete has  
39 freeze/thaw deterioration and previous repairs to the tops of the walls are failing. The original concrete is  
40 continuing to deteriorate below the repair (MI-P-11). The footings at the front of the Privy are in poor  
41 condition. They have been undermined and are rotating out from under the Privy (MI-P-12).

MI-P-11: Concrete wall deterioration (Source: Martin/Martin)

The walls of the concrete vault should be repaired or replaced. The spot footings should be replaced with new footings that bear at the same elevation as the concrete vault.

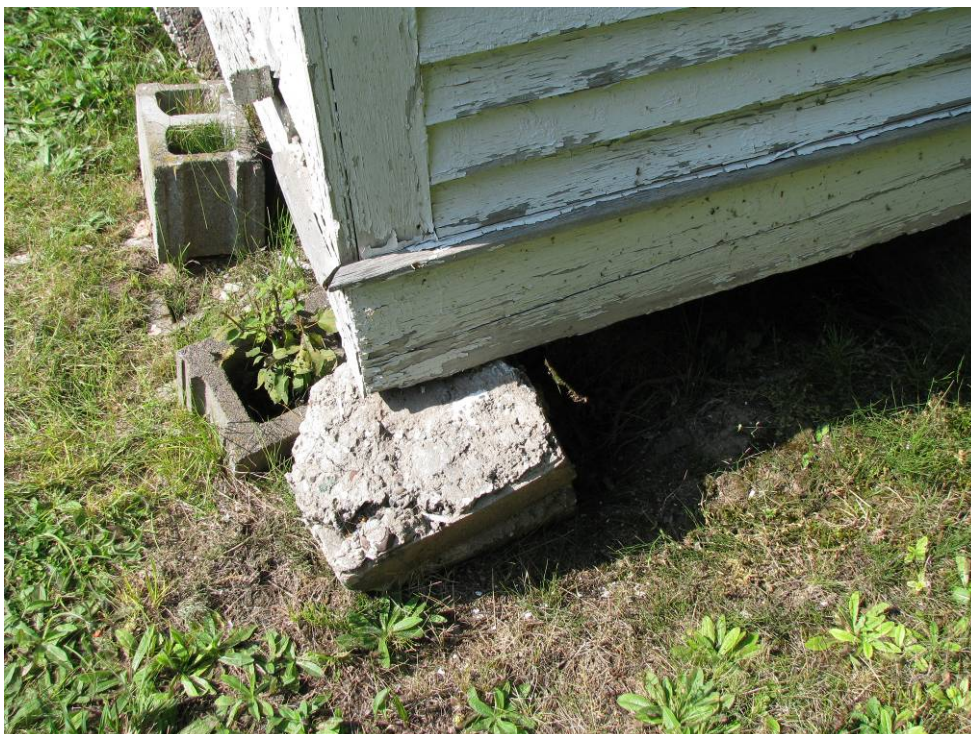
MI-P-12: Footing rotation (Source: Martin/Martin)
