CULTURAL LANDSCAPE REPORT • HISTORIC STRUCTURE REPORT

APOSTLE ISLANDS NATIONAL LAKESHORE
LIGHT STATIONS OF MICHIGAN ISLAND, OUTER ISLAND, DEVILS ISLAND,
LONG ISLAND AND SAND ISLAND
VOLUME III

100% DRAFT
MARCH 2011

VOLUME III OF VI: OUTER ISLAND CLR/HSR

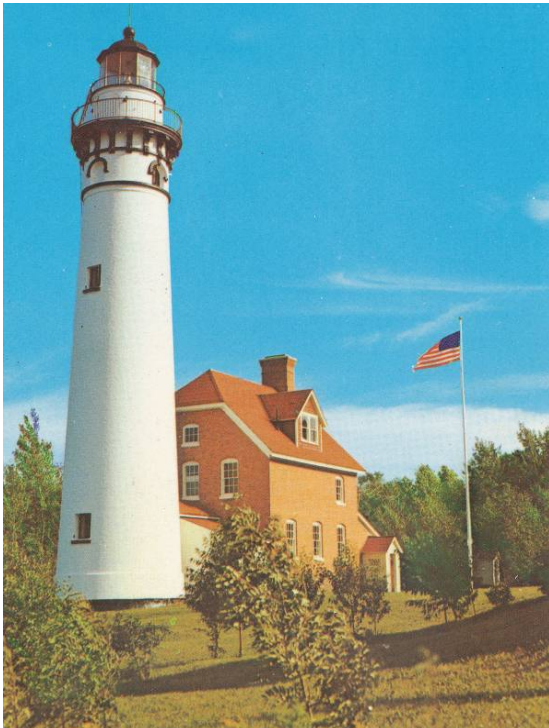
Site Image OI-22: Outer Island Tower, Keepers Quarters, flagpole, and Privy. Note encroaching vegetation in foreground, c. 1974 (Source: NPS APIS Archives)

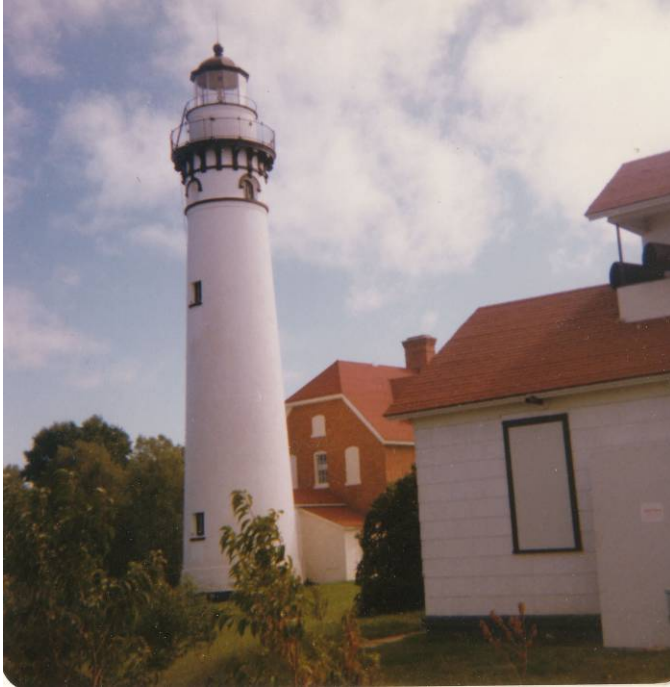
1
2 Site Image OI-23: Outer Island Tower, Keepers Quarters, and Fog Signal Building. Note encroaching vegetation in
3 foreground and behind Tower and Keepers Quarters, c. 1977 (Source: NPS APIS Archives)
4

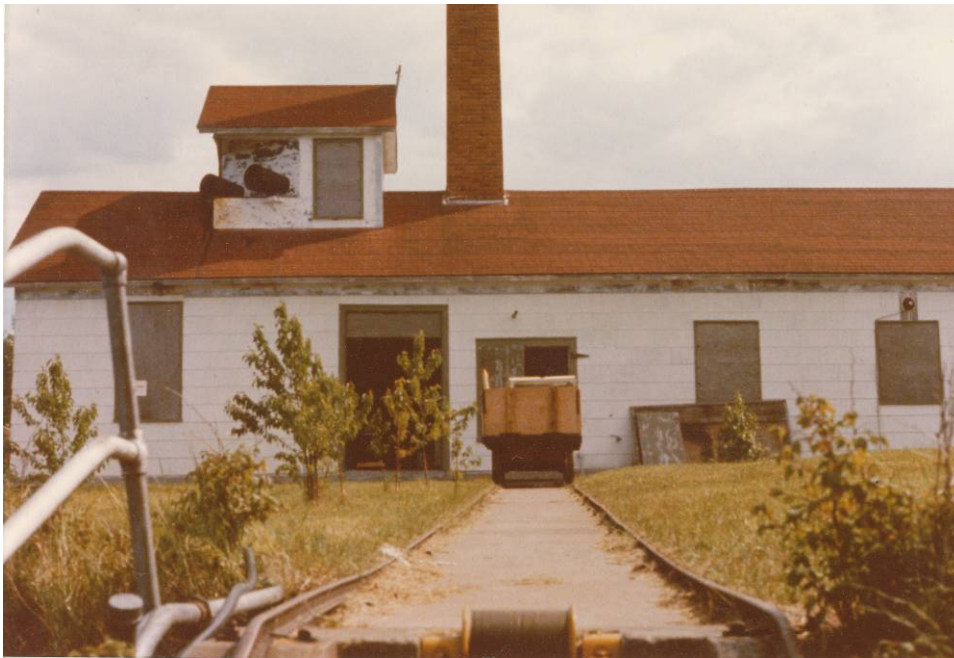
5
6 Site Image OI-24: Outer Island Fog Signal Building. Note encroaching vegetation in foreground, c. 1977 (Source: NPS
7 APIS Archives)

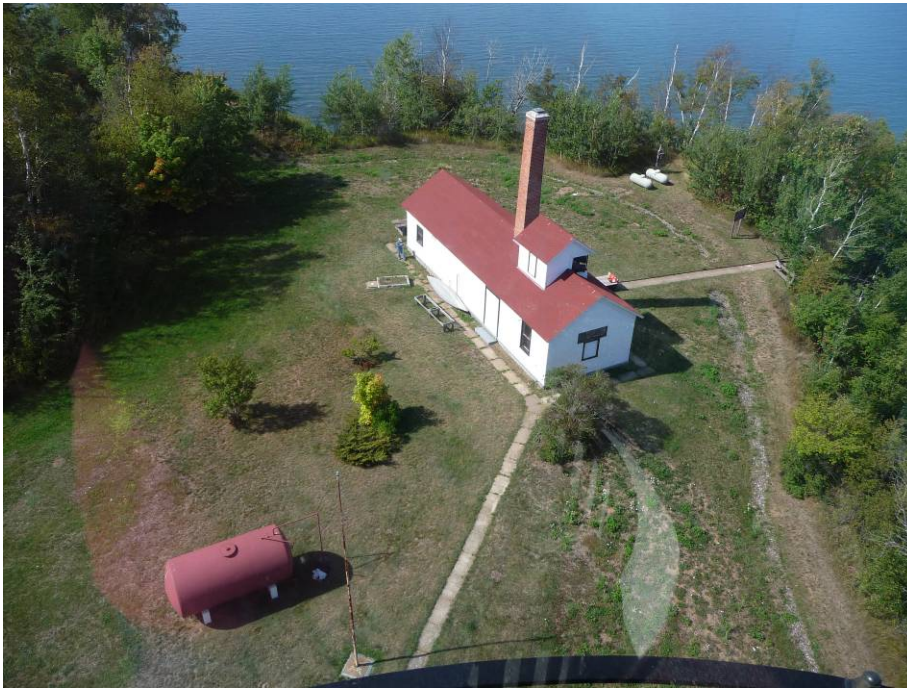
Site Image OI-27: Light station grounds from Light Tower, looking west to Fog Signal Building. Note the vegetation on the embankment, 2009 (Source: MBD P1010887.jpg)

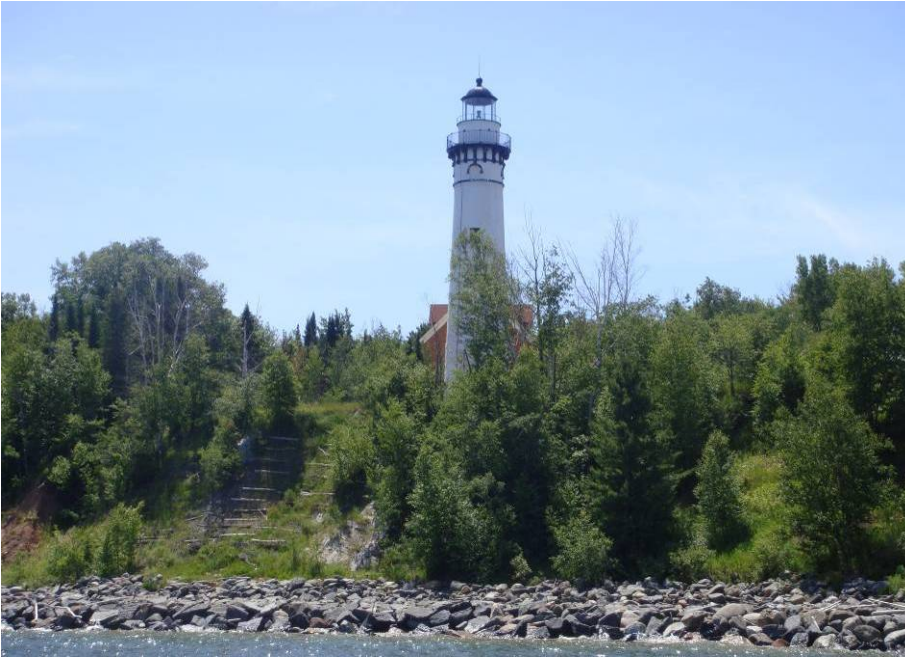
The topography of the reservation and light station grounds is a contributing feature. The erosion control work has diminished the integrity of the cultural landscape.

2
3 *Site Image OI-29: Banks and shoreline with erosion control and stone revetment looking east from the dock, 2009 (Source:*
4 *MBD DSC00606.JPG)*

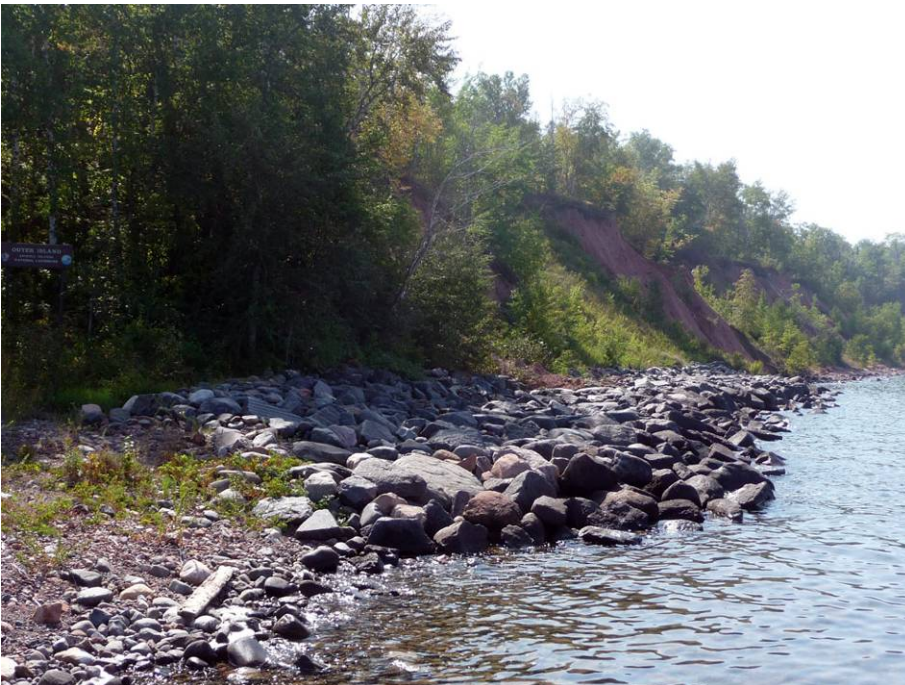
6
7 *Site Image OI-30: Banks and shoreline with erosion control and stone revetment looking west from the dock, 2009 (Source:*
8 *MBD P1010839.JPG)*

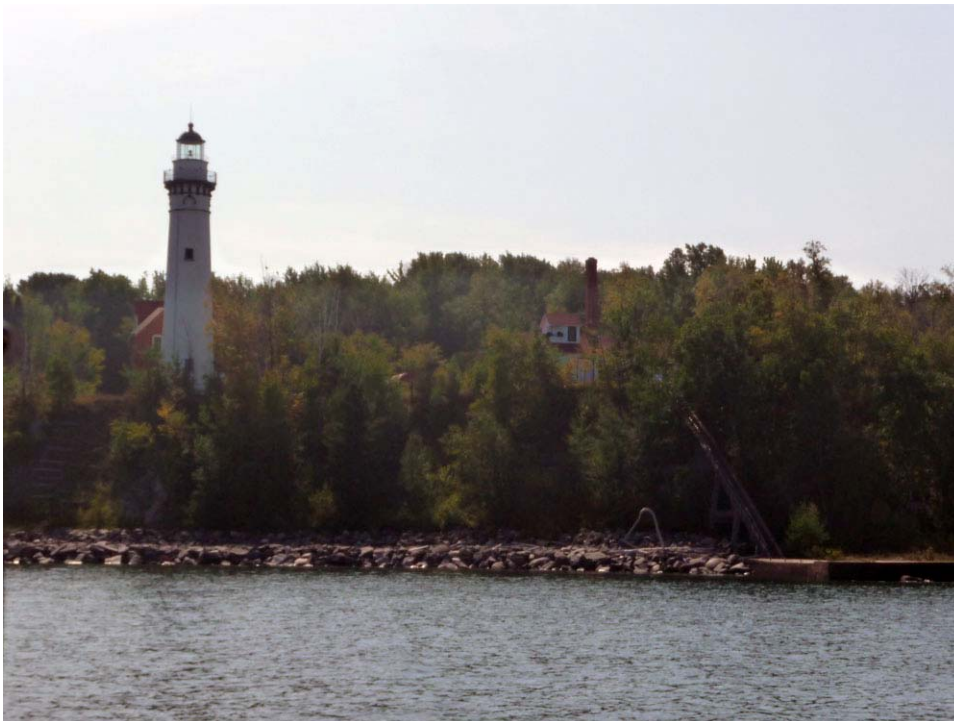
Site Image OI-33: View to Tower from Lake Superior; above, 1891 (Source: NPS APIS Archives); below, current view obscured by encroaching vegetation, 2009 (Source: MBD P1010831.JPG)

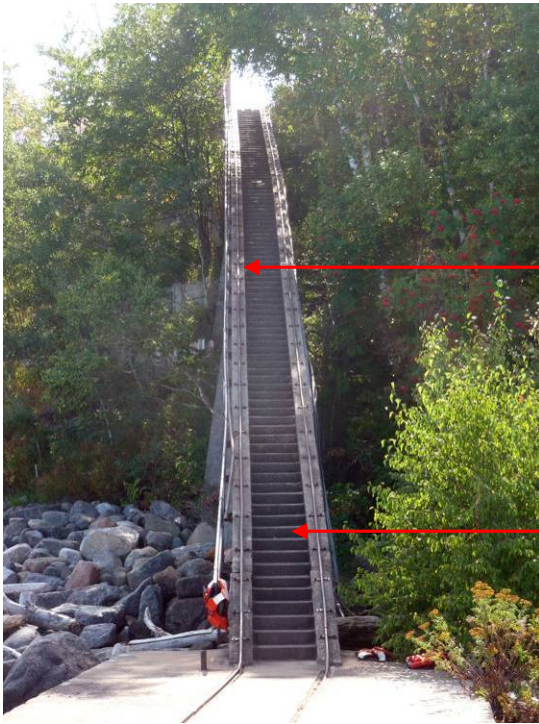
The tramway is in good condition and retains all of its original elements including: concrete structural supports with footings and stairs, steel handrail, and cast iron tram rails.

Site Image OI-41: Tramway viewed from the north, 2009 (Source: MBD P1010865.JPG)
