Small Scale Features

| TITLE OF PROJECT CULTURAL LANDSCAPE REPORT | |
| TITLE OF DRAWING EXISTING CONDITIONS | |

| UNITED STATES DEPARTMENT OF THE INTERIOR | | OUTER ISLAND LIGHT STATION | |

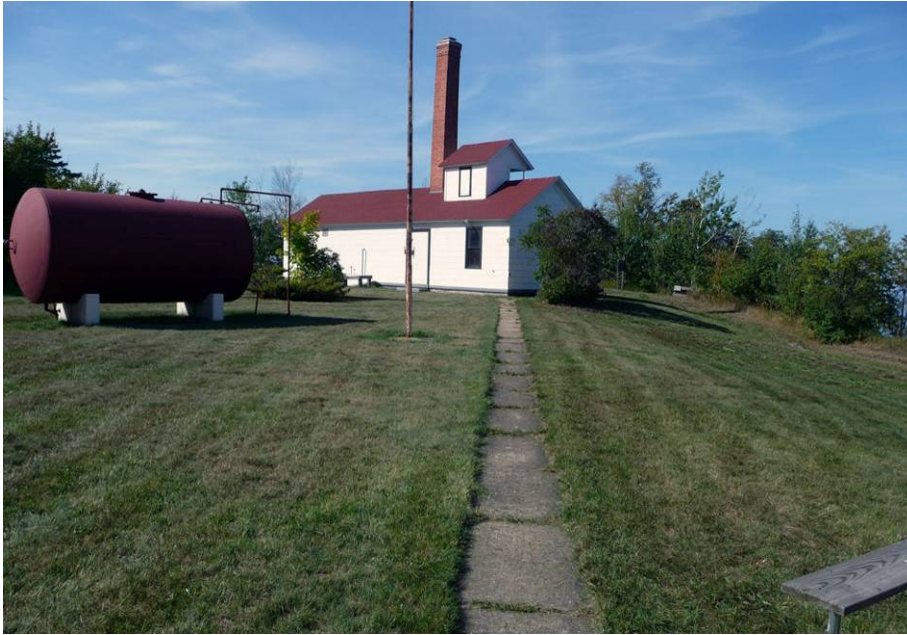
Existing Condition. The concrete walks on the grounds were installed during the Light Station period (1901–1938) many of them following the previous layout of wood planks as was typical of the Apostle Islands. Typical to several of the Apostle Islands light stations, the walks appear to be constructed of precast units 2.5'×4'×4" thick with some small units also installed. The units have a fine aggregate finish and tooled edges. Historic photographs indicate that the concrete units may have been placed on top of the ground surface rather than excavated and placed. This practice is also found at other Apostle Island light stations. Other portions of the concrete walks appear to have been poured in place to infill odd shapes and address building edges. Overall the concrete walks are in good condition with only a few slabs requiring replacement due to excessive cracking. Vegetation has encroached, in places, into the joints between slabs.

| Feature | Site Image # | Description | Condition | Contributing? /Rationale |
|--|---|---|---|--|
| Concrete Walks (1901-1938) | OI-45 | 2 – 2.5' x 4' concrete panels. Vegetation encroaching on many panels. | Fair | Contributing; See text |

2
3 *Site Image OI-45: Concrete sidewalk viewed from west side of the Keepers Quarters northwest to Fog Signal Building. Fuel*
4 *tank and second flagpole at left and center, 2009 (Source: MBD P1010949.JPG)*
5

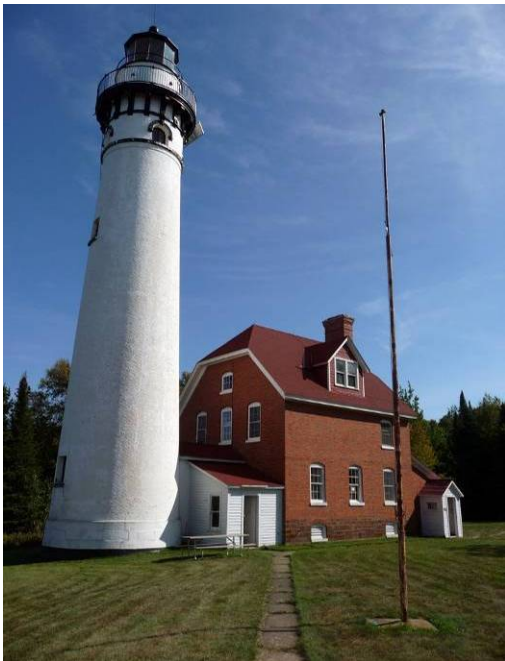
The second flagpole is located centrally between the Fog Signal Building and the Tower and Keepers Quarters along the west side of the concrete walk. The second flagpole dates to the Coast Guard Period (1939-1960) and is notable for the compass rose engraved on its square concrete footing which is 3'x3'.

The pole is steel and stands approximately 30' high. It appears that it was painted white, but now is heavily rusted. The flagpole is in good condition.

6
7 *Site Image OI-46: Second flagpole in foreground at right of image. Outer Light Tower and Keepers Quarters viewed from*
8 *the northwest, 2009 (Source: MBD P1010934.JPG)*
9

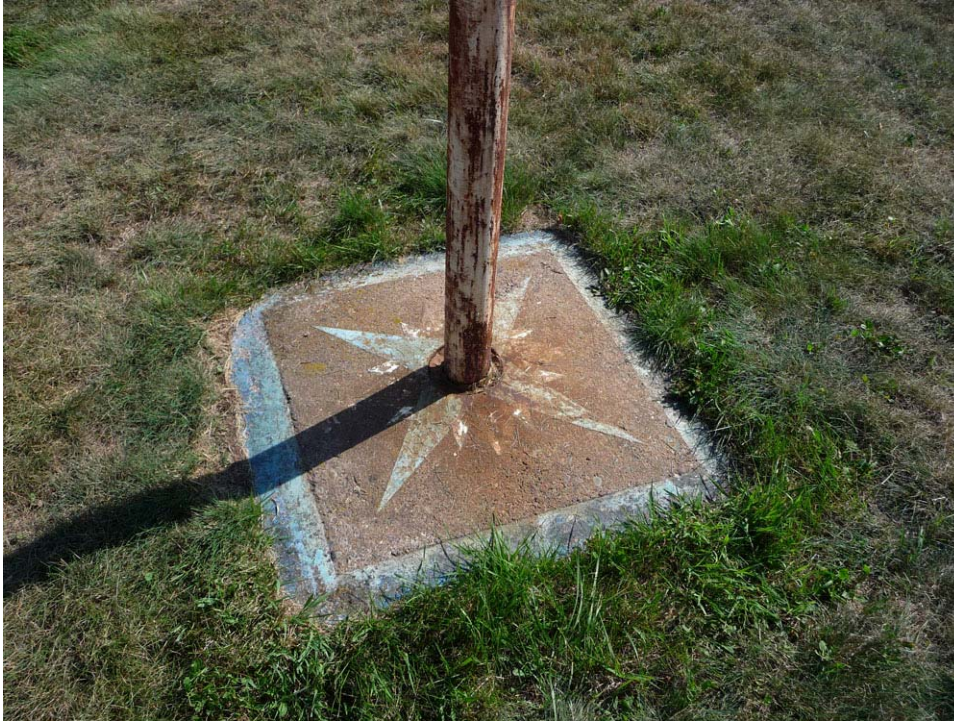
| Feature | Site Image # | Description | Condition | Contributing? /Rationale |
|--|---|---|---|--|
| Second Flagpole (1939-1960) | OI-45, OI-46, OI-47 | 3' x 3' decorative base with metal pole located between Tower and Fog Signal Building. Rust evident. | Fair | Contributing; See text |

Site Image OI-47: Second flagpole base and compass rose, 2009 (Source: MBD P1010935.JPG)

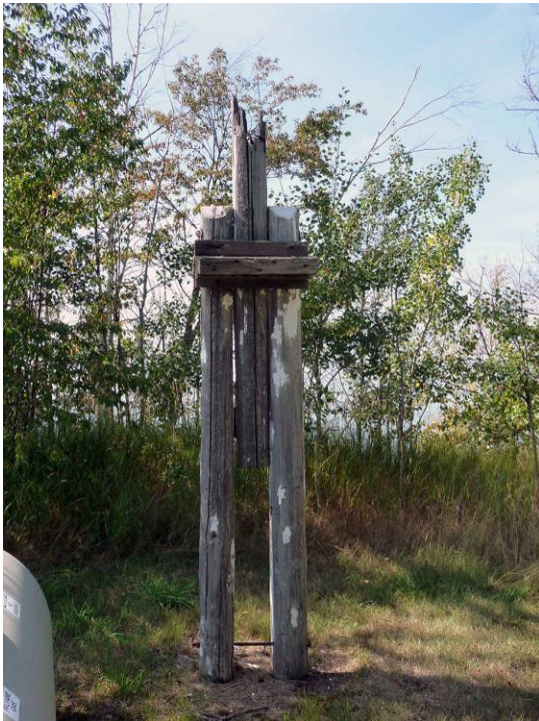
Existing Condition. There are two flagpoles on the light station grounds, the original flagpole and the second flagpole. The original flagpole is near the top of the tramway, approximately 45' west of the light station's main entrance. Historic photographs indicated flagpoles have been located in this area but have been removed or lost due to harsh climatic conditions on the bluff edge. The extant original flagpole remains from the Light Station period (1901-1938) and is constructed of a single wood mast pole, mounted between two shorter wood base columns, with through bolt connections. The center pole is broken, and stands approximately 10' tall. The two columns are approximately 8" in diameter and mounted in a concrete footing. The original flagpole is in poor condition.

| Feature | Site Image # | Description | Condition | Contributing? /Rationale |
|--|---|---|---|--|
| Original Flagpole (1901-1938) | OI-48 | Wood flagpole northwest of Propane Tanks. | Poor | Contributing; See text |

Site Image OI-48: Original flagpole, 2009 (Source: MBD P1010916.JPG)

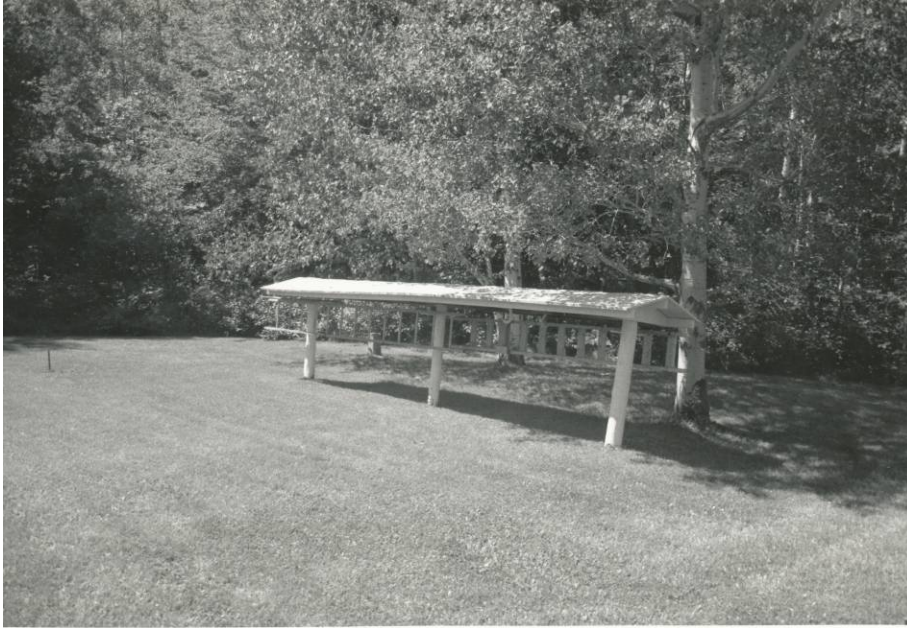
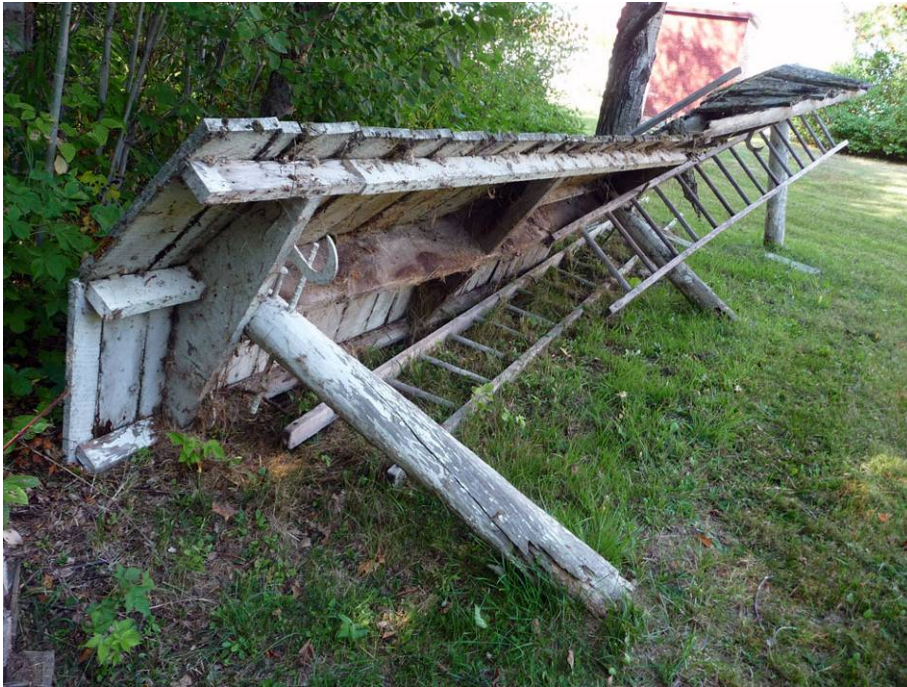
Existing Condition. The wooden ladder stand is located approximately 60' south of the Oil Storage. It is approximately 30' long and 5' wide. The ladder stand has three wood posts and a triangular roof made of wood panels approximately 30"x6". The feature has remnant white paint, two remnant ladders, and is in collapsed and poor condition.

| Feature | Site Image # | Description | Condition | Contributing? /Rationale |
|--|---|---|---|--|
| Ladder Stand (c. 1939) | OI-50 | 20' x 5' collapsed wood structure south of Oil Storage c. 1939 | Poor | Contributing; See text |

Site Image OI-50: Collapsed ladder stand (c. 1939), above: c. 1980 (Source: NPS APIS Archives); below: c. 2009 (Source: MBD P1010984.JPG)

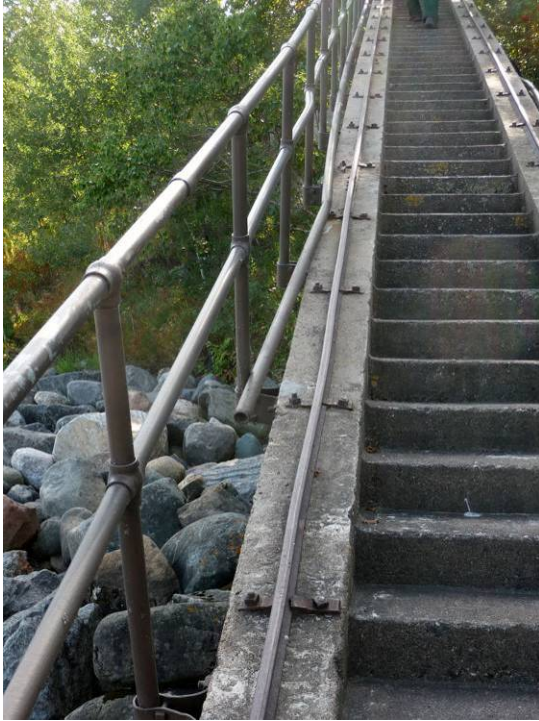
| Feature | Site Image # | Description | Condition | Contributing? /Rationale |
|--|---|---|---|--|
| Tramway Guard Railing (1934) | OI-51 | Steel pipe railing attached to the east side of the tramway. | Fair | Contributing |

Site Image OI-51: Concrete tramway pipe railing, 2009 (Source: MBD P1010867.JPG)

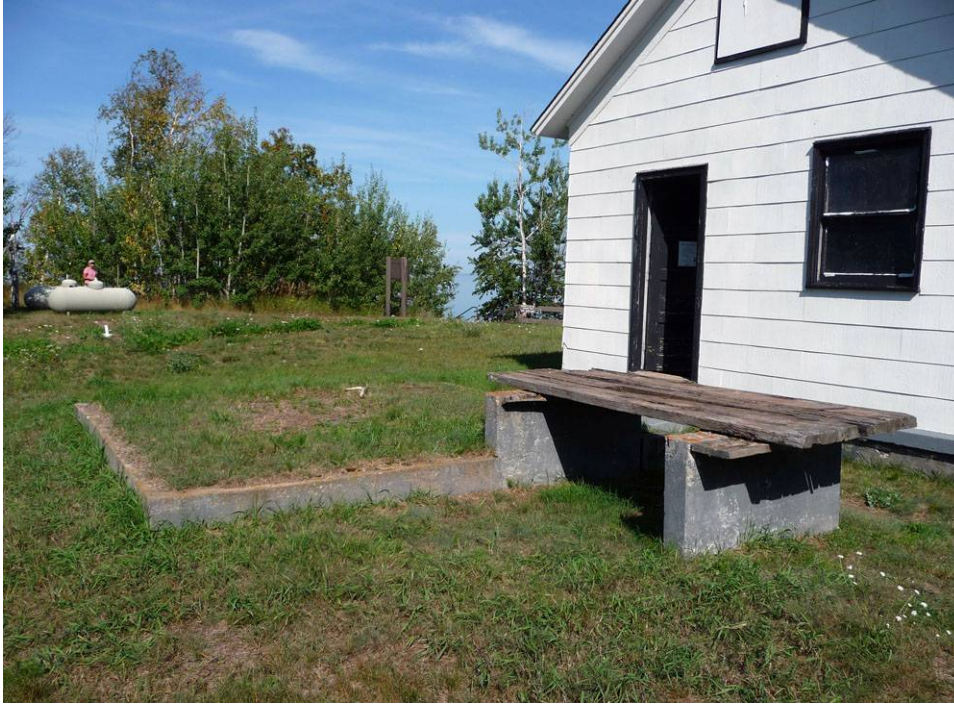
| Feature | Site Image # | Description | Condition | Contributing? /Rationale |
|--|---|---|---|--|
| Concrete Foundation and Wall (1901-1938) | OI-57 | 12' x 12' concrete foundation, 1' tall, 6" wide and (2) 2.5' tall, 6' long, 1' wide walls west of Fog Signal Building. Wood planks sit atop the walls. Historic photographs indicate this area was used for chopped wood and oil storage. | Concrete: Good Wood: Poor | Contributing; Historic photographs indicate this area was present during the Light Station period and modified during the Coast Guard Period |

Site Image OI-57: Concrete foundation and wall, 2009 (Source: MBD P1010925.JPG)

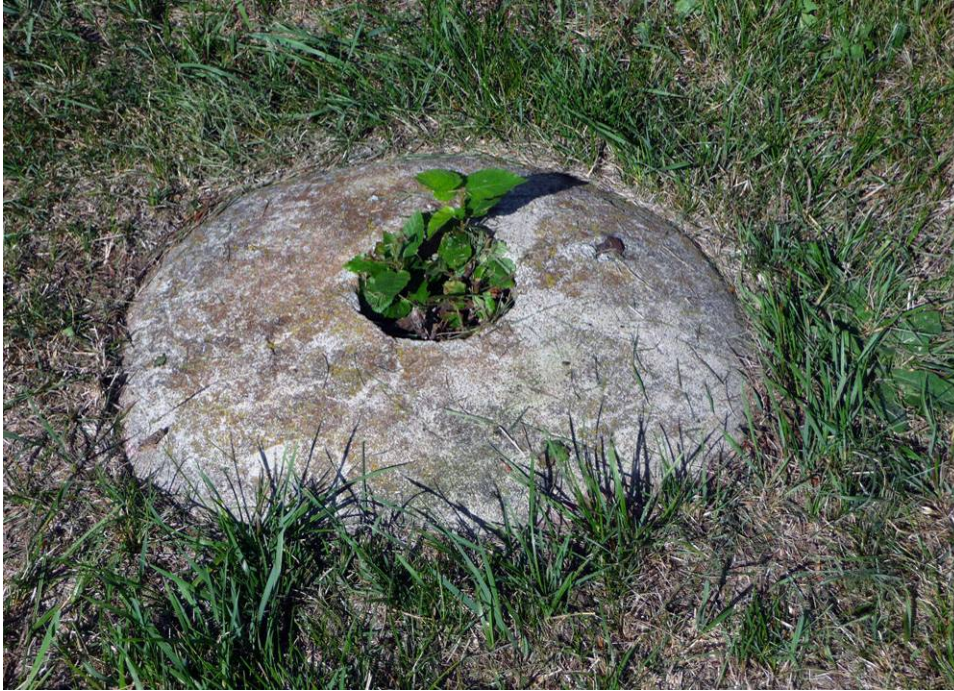
| Feature | Site Image # | Description | Condition | Contributing? /Rationale |
|---|---|--|---|--|
| Concrete Footing (date unknown) | OI-60, OI-63 | Circular concrete footing with 2' diameter. | Good | Noncontributing, safety hazard |

Site Image OI-63: Concrete footing, 2009 (Source: MBD P1010962.JPG)

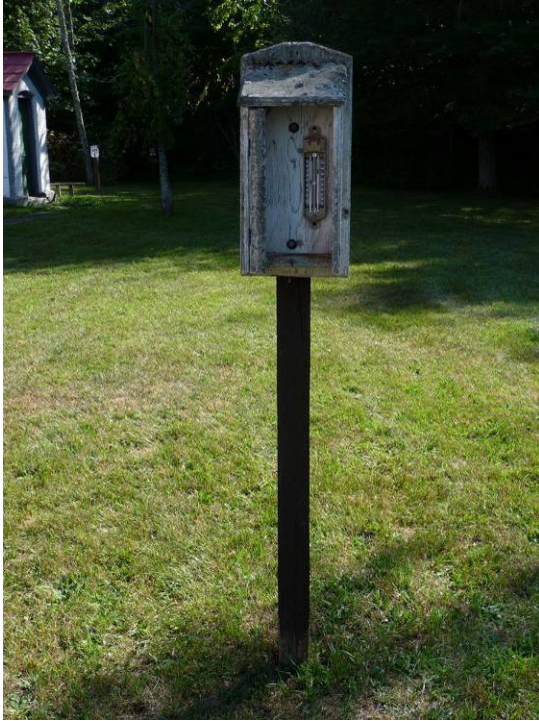
| Feature | Site Image # | Description | Condition | Contributing? /Rationale |
|---|---|--|---|--|
| Weather Gauge (1970 - present) | OI-67 | 5'9" tall painted wood post with thermometer north of fire pit. | Poor | Noncontributing, Noncompatible |

Site Image OI-67: Weather gauge, 2009 (Source: MBD P1010972.JPG)

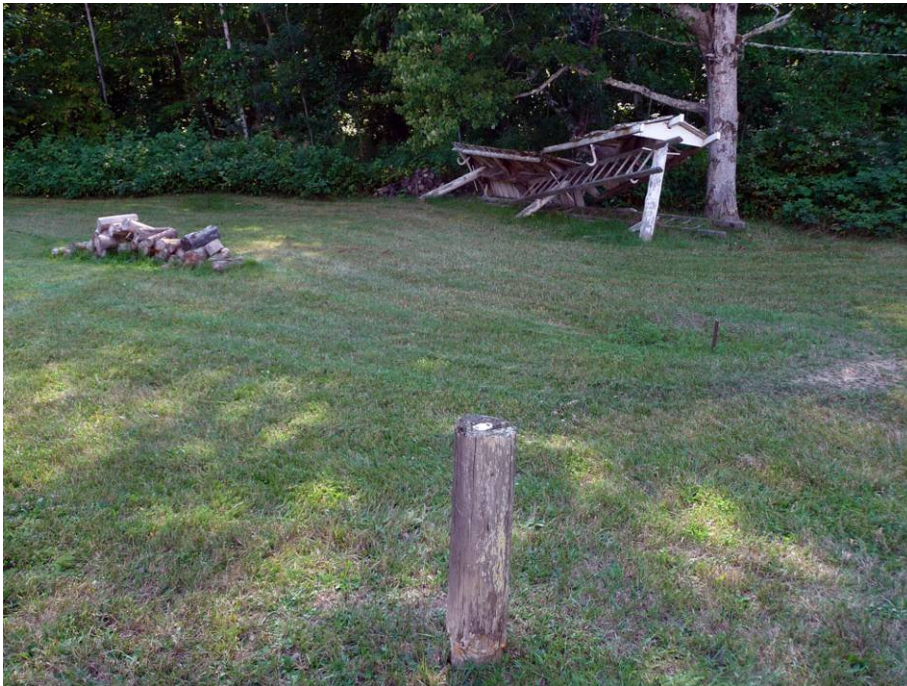
| Feature | Site Image # | Description | Condition | Contributing? /Rationale |
|---|---|--|---|--|
| Remnant Post (date unknown) | OI-68 | 2'4" tall wood post west of weather gauge | Poor | Noncontributing, Noncompatible |

Site Image OI-68: Remnant post in foreground and collapsed ladder stand in background, 2009 (Source: MBD P1010974.JPG)

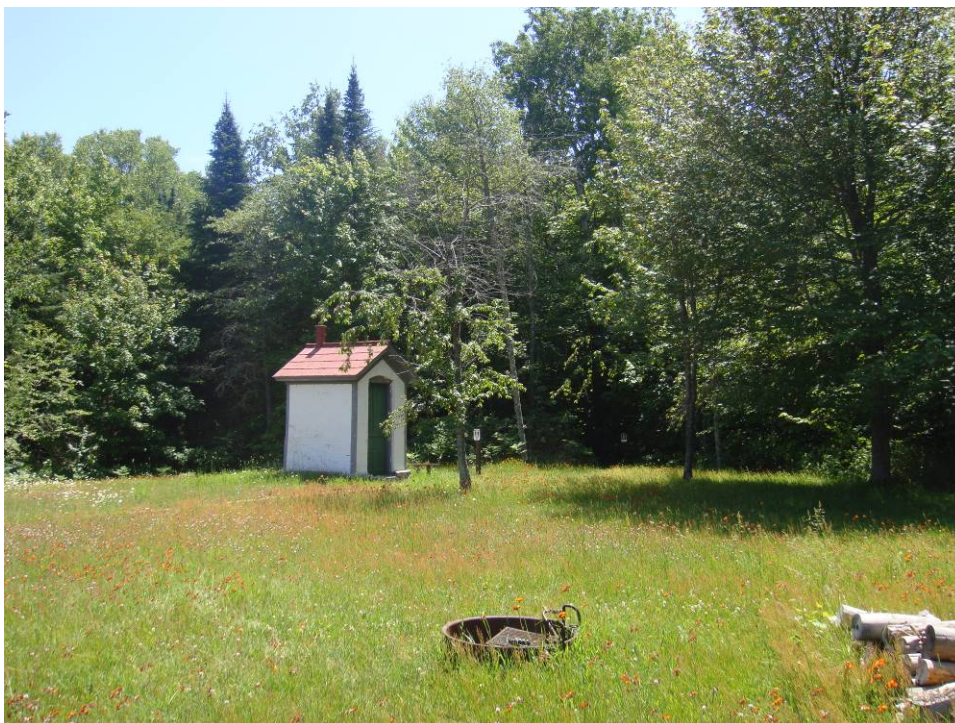
The trees at the south end of the site, near the Privy, appear to be encroaching forest vegetation. These trees are noncontributing features, but compatible, as they do not interrupt the views between the light station grounds and Lake Superior.

| Feature | Site Image # | Description | Condition | Contributing? /Rationale |
|---|---|---|---|---|
| Trees near Privy | OI-74 | White birch, dogwood, and poplar, encroaching forest | Fair to Poor | Noncontributing, Compatible |

Site Image OI-74: Encroaching forest near Privy, 2009 (Source: MBD DSC00620.JPG)
