1 **OUTER ISLAND TOWER**

2 **Chronology of Alterations and Use**

1 *Outer Island Tower Photographs, 2009*

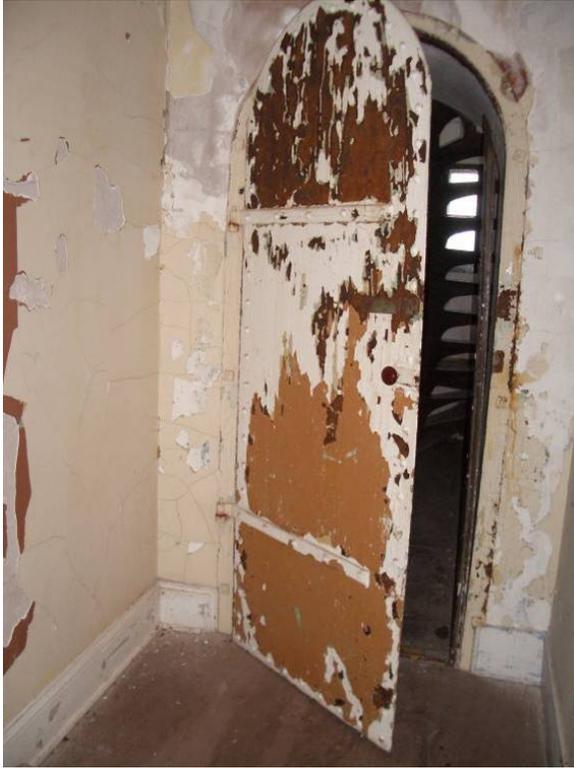
13 There are no remaining doors in the interior of the Tower. There was originally a door at the service level
 14 where one hinge remains. The opening size is 1'9" wide x 5'6 1/2" high. There is a door located at the
 15 Tower base between the hyphen to the Quarters and the Tower that is made of metal plate, painted, and is
 16 original to the building. The door has strap hinges and ceramic knobs. There is metal trim on both wall
 17 faces. The dimensions for the door are 3'0" x 7'9". (OI-T-02)

49 The Tower base door made of metal is in fair condition as it and its door frame have rust and badly peeling
50 paint.

OI-T-02: Door from quarters to Tower (Source: A&A IMG3236)

43 Remove existing paint and remove and patch rust areas and recoat. Coordinate with overall ventilation
44 enhancements. Study effects of allowing door to remain open to promote ventilation from basement to the
45 Tower. Investigate adding a security gate at the base of the stair or adjacent to the Tower door.
46
47

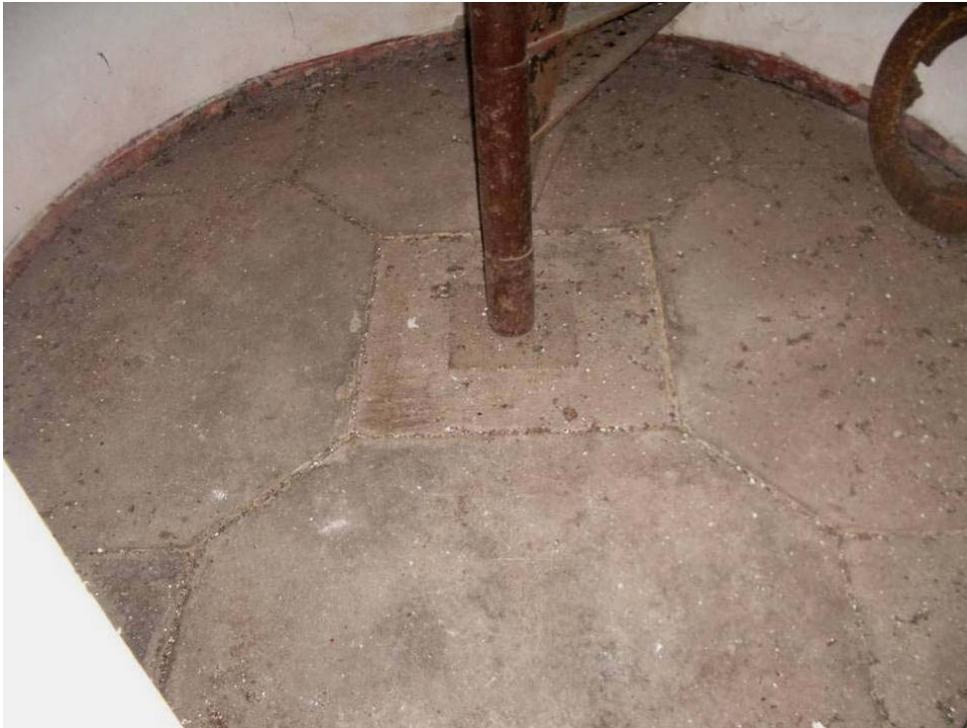
8 The floor at the entry is made of concrete slabs with a concrete square slab in the center with a metal plate
9 anchoring the spiral staircases center pole. (OI-T-03)

31 The concrete floor is in good condition.

OI-T-03: Tower floor and stair base (Source: A&A IMG3234)

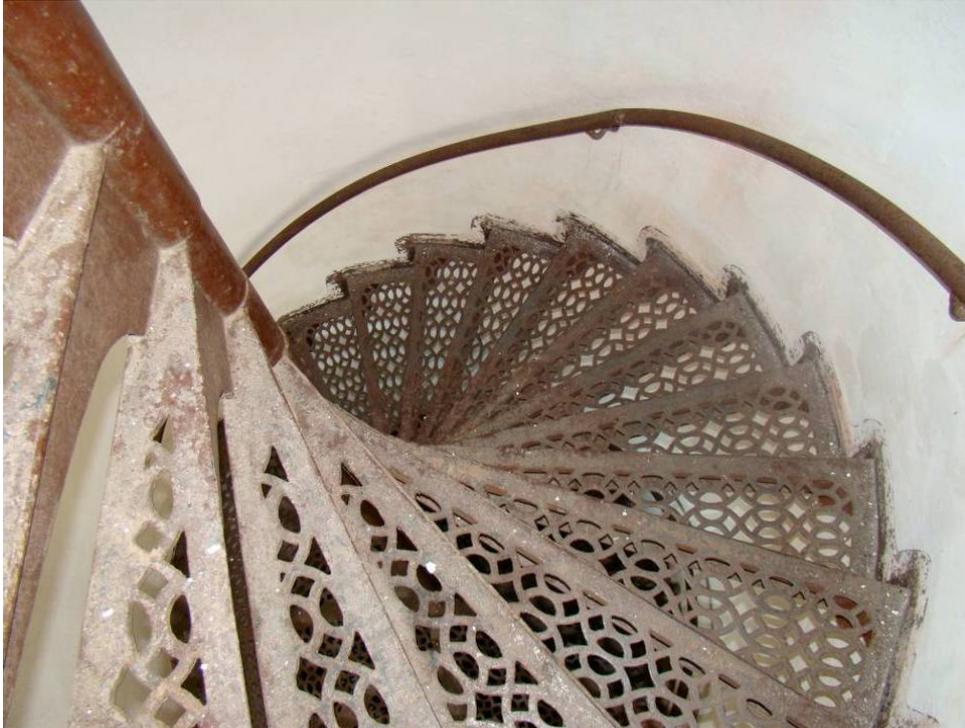
13 This spiral staircase is cast iron. There are 30 treads from the base to the first landing (1/2 of circle shape),
14 24 treads from the first landing to the second landing (1/2 of circle shape), another 24 treads from the
15 second landing to the third landing (5/8 of circle shape), and finally 16 treads from the third landing to the
16 top floor. The top floor has a hatch to the lantern level. The top of the stairs railing is 2’0” above the nosing
17 and has a 2” diameter. There are no railings at the landings or leading to the hatch. The stair risers are 8”,
18 the tread overhang is 1/2”, and the tread depth goes from 1 1/2” to 12 1/2” with a width of 3’10”. (OI-T-04)

36 This spiral staircase is in good condition with some rusting and peeling paint. The railings are also in good
37 condition with some rusting. There are no railings at the landings or near the hatch door.

OI-T-04: Tower stairs and railing (Source: A&A DSC01567)

30 Remove existing paint, remove and patch areas of rust and repaint. Add code compliant handrails at the
31 landings and near the hatch door that match existing railings.
32
33
34 *Architecture – Passageway*
35 Priority: *Low*
36 No recommendations at this time.
37
38
39 *Architecture – Accessibility*
40 Priority: *Low*
41 Provide program access through interpretive exhibits and waysides at the Visitor Center.
42
43
44 ***Treatment Recommendations -- Structural***
45 *Structural – Foundation*
46 Priority: *Low*
47 No recommendations at this time.
48
49
50 *Structural – Floor Framing*
51 Priority: *Low*

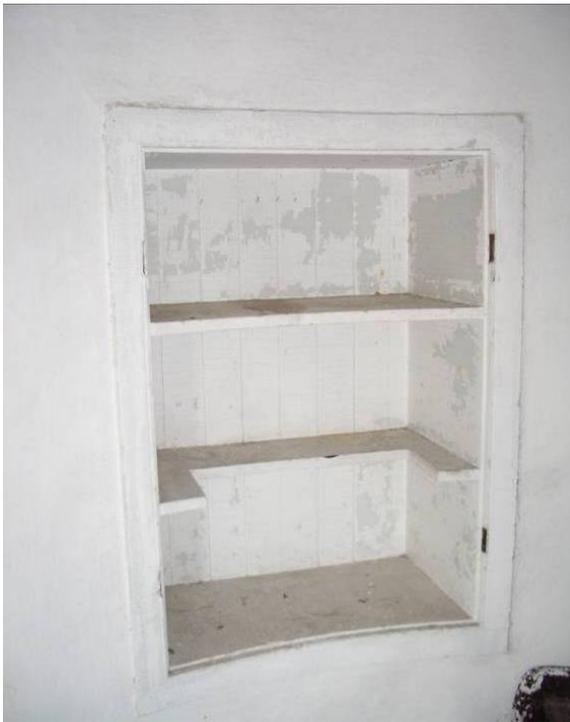
OI-T-07: Tower wood cabinet with missing door (Source: A&A IMGP3230)

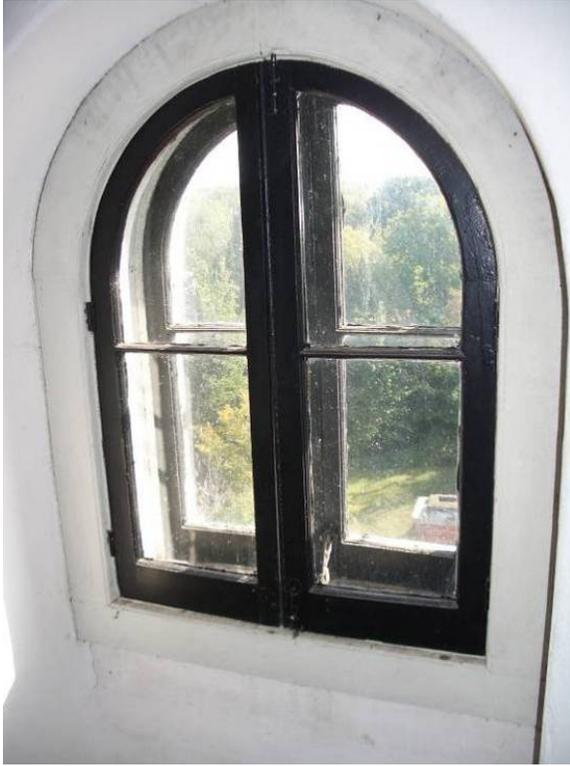
4
 5 **Arched Window.** This type of window is a two-leaf, two-lite casement, with an arched top, and a matching
 6 storm window. There are two of these windows located at the top landing. The interior trim for each
 7 window is the same simple 1x as the rectangular windows, but arched at the top, following the profile of
 8 the window opening. The dimensions of each casement pair is 2'4" x 3'1 1/2". Both windows are painted
 9 and are original to the Tower. (OI-T-08)

43
44 **Arched Window.** This type of window is in good condition.

OI-T-08: Tower arched window (Source: A&A IMG3227)

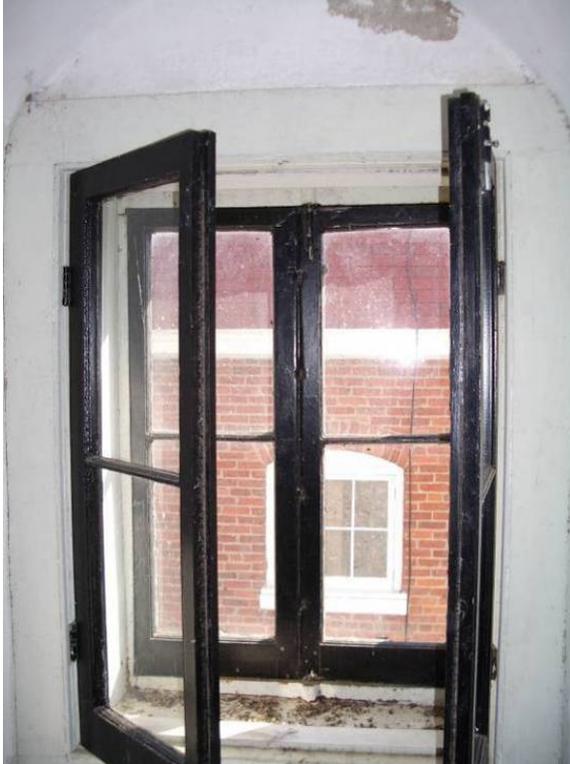
1 at the second-to-the-top landing does not have a storm set, but the other two windows of this type are
 2 complete. The interior trim for each window is simple wood 1x, painted. The dimension of each casement
 3 pair is 2'2" x 3'1 1/2". All windows are painted and original to the Tower. (OI-T-09)

41 **Rectangular Window.** This type of window is in good condition except that one of the three windows has
42 a missing storm window.

OI-T-09: Tower rectangular window (Source: A&A IMG3232)

37 Reconstruct the missing storm window from one of the rectangular windows to match the existing storms.
38 Verify/provide operability to all lower sash to facilitate ventilation.
39
40

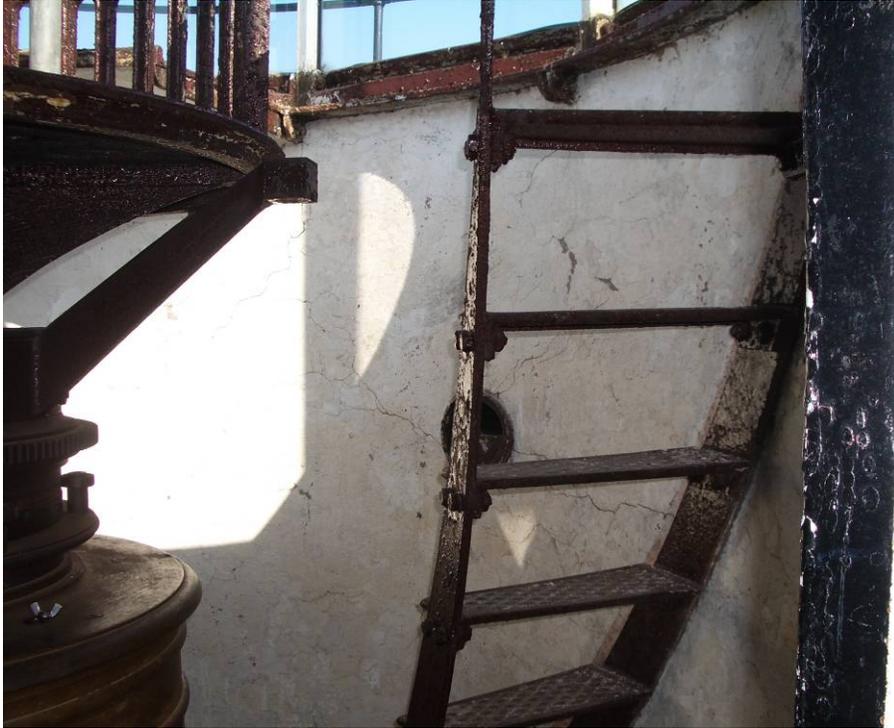
39 The lantern is a decagonal glass and metal structure with diamond plate cast iron decking continued from
 40 the lantern level deck. The rectangular glazing is stamped "AGC 279J -1975 CFR 1201 CII 218U ASI 84."
 41 (OI-T-11, 12 and 13)

15 The lantern has nonhistoric glazing with failing seals and frame system. The paint is peeling on the
16 remainder of the interior elements.

OI-T-11: Lantern with ladder to access lantern walkway (Source: A&A IMGP3210)

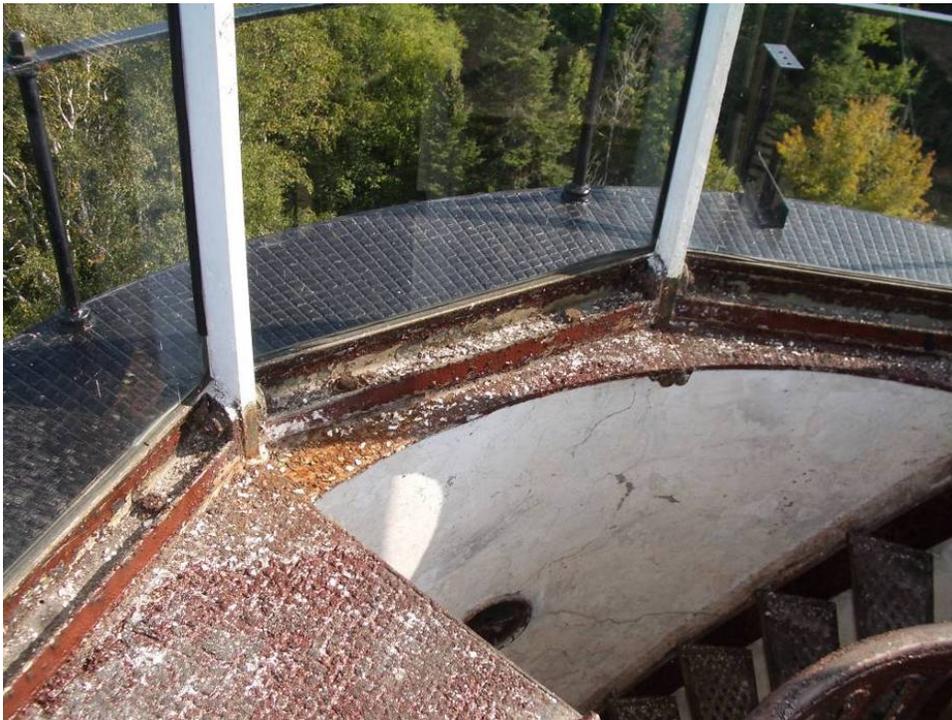
OI-T-12: Lantern floor hatch and ladder (Source: A&A IMGP3221)

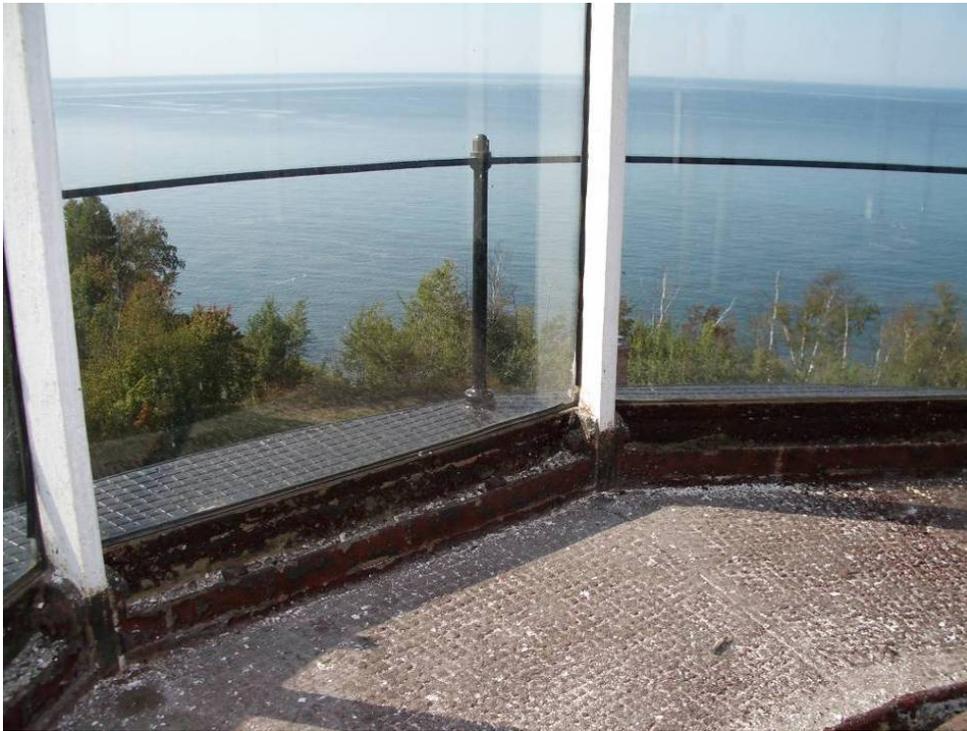
OI-T-13: Lantern glazing and upper interior and exterior walkway and railing (Source: A&A IMGP3214)

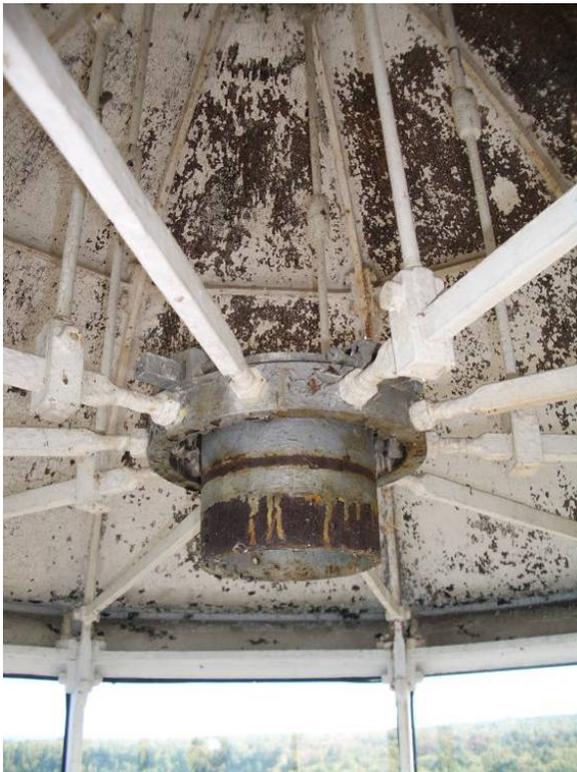
45 The ceiling finish for the lantern is the underside of the cast iron decagonal roof. The ceiling has painted
 46 metal cross-bracing and structural members along the roof line. (OI-T-14)

21 The ceiling finish for the lantern is in fair condition as there is rusting and peeling paint.

OI-T-14: Lantern ceiling (Source: A&A IMGP3220)

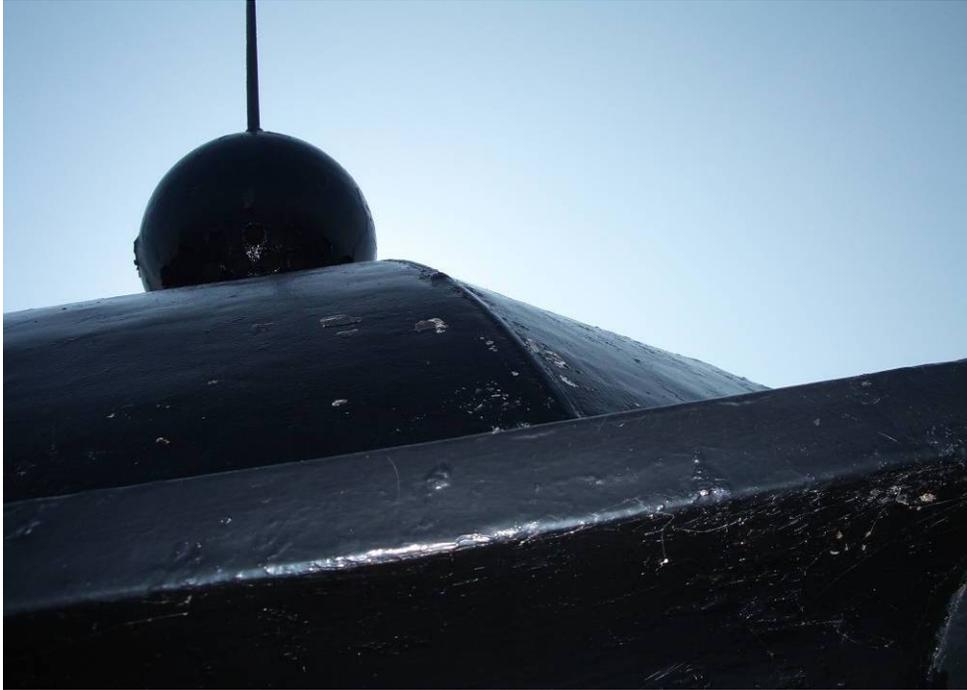
The roof consists of painted cast iron panels bolted together with an orb-shaped venting finial at the center. The roof system includes five 1" cast iron roof drains. (OI-T-15)

27 The roof appears to be in fair condition though small patches of rust are evident.

OI-T-15: Lantern roof (Source: A&A IMG3200)

24 Patch and prep areas of rust. Prime and repaint entire roof.
25
26
27

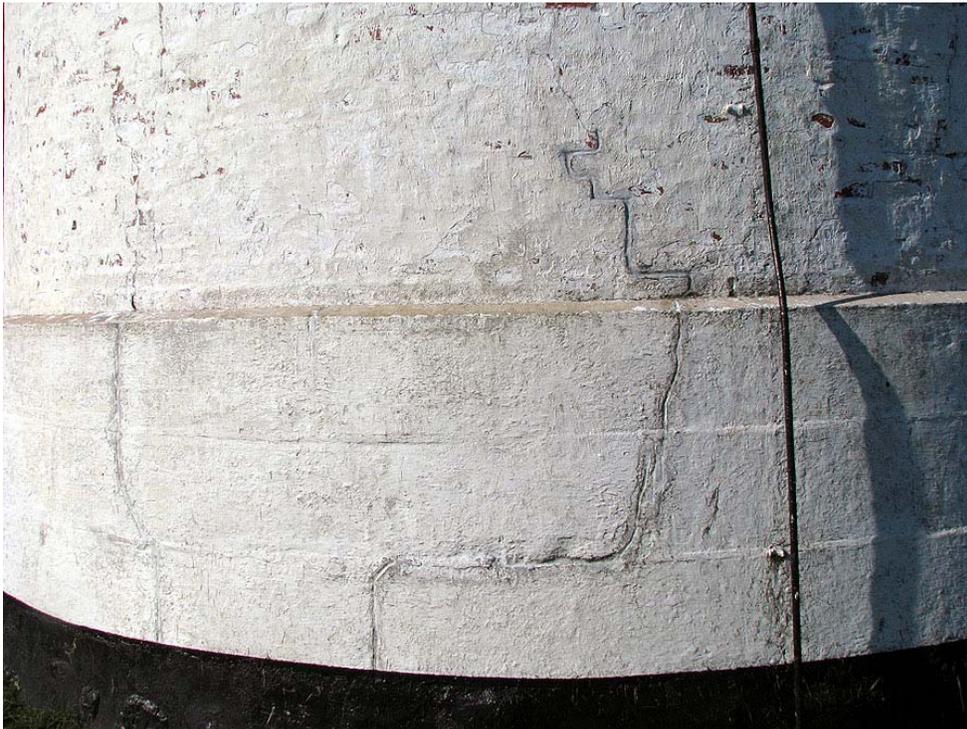
48 The visible portion of the foundation is in good condition. Sub-vertical cracks in the masonry are not
49 structural and may be due to brick growth, the tendency of fired clay bricks to expand as they age, or
50 differential thermal movement between the brick and the stone (OI-T-16).

OI-T-16: Foundation and wall cracks (Source: Martin/Martin)

11 No recommendations at this time. (Architects' note: Due to the disparity of opinion of the condition of the
12 walls between the Structural Engineer and APIS staff, it is suggested to install crack and vibration monitors
13 to further assess the existing cracks to determine if they are active.)
