1 **KEEPERS QUARTERS**

2 **Chronology of Alterations and Use**

General Condition Assessment

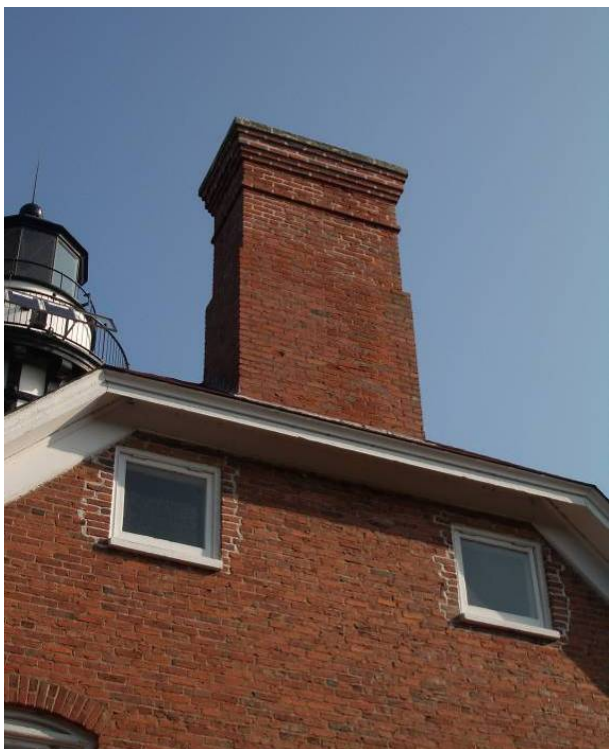
11 The chimney has several spalled bricks and is in fair condition.

OI-KQ-06: Chimney detail, south elevation (Source: A&A IMGP3100)

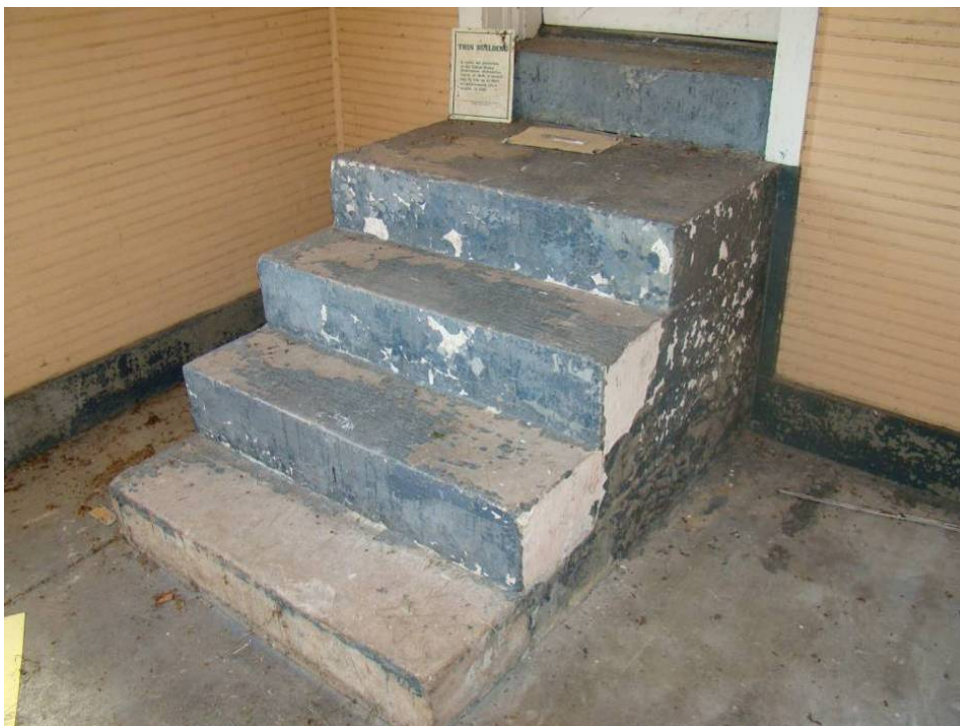
Secondary Entrance Stairs. These concrete stairs have badly peeling paint and no handrails. Overall, the stairs are in fair condition. (OI-KQ-22)

1
2
3
OI-KQ-22: Secondary entrance, looking east (Source: A&A CIMG4535)

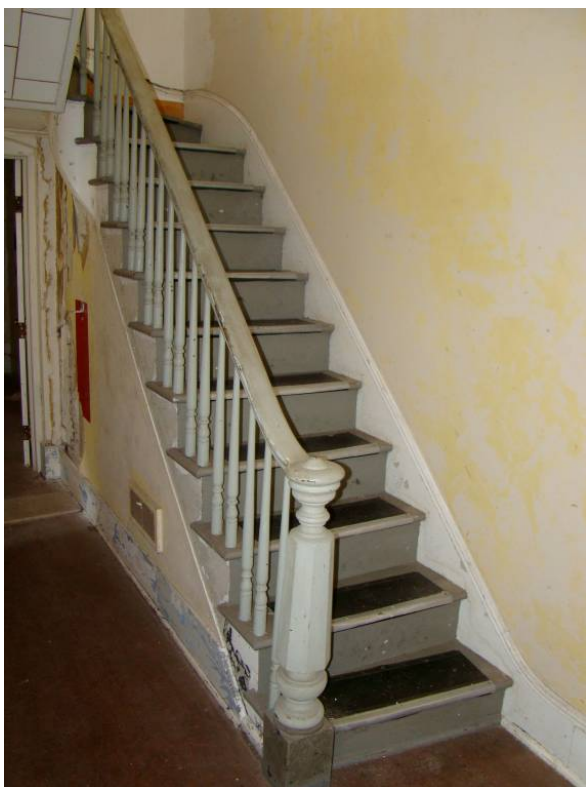
First Floor to Second Floor Stairs. These wood stairs have peeling paint, chipped wood nosings, and worn and cockeyed rubber grips. The balustrade also has peeling paint and chips in the balusters. Overall, the stairs and balustrades are in fair condition. (OI-KQ-23)

4
5
OI-KQ-23: Stair to second floor hall, looking north (Source: A&A DSC01550)

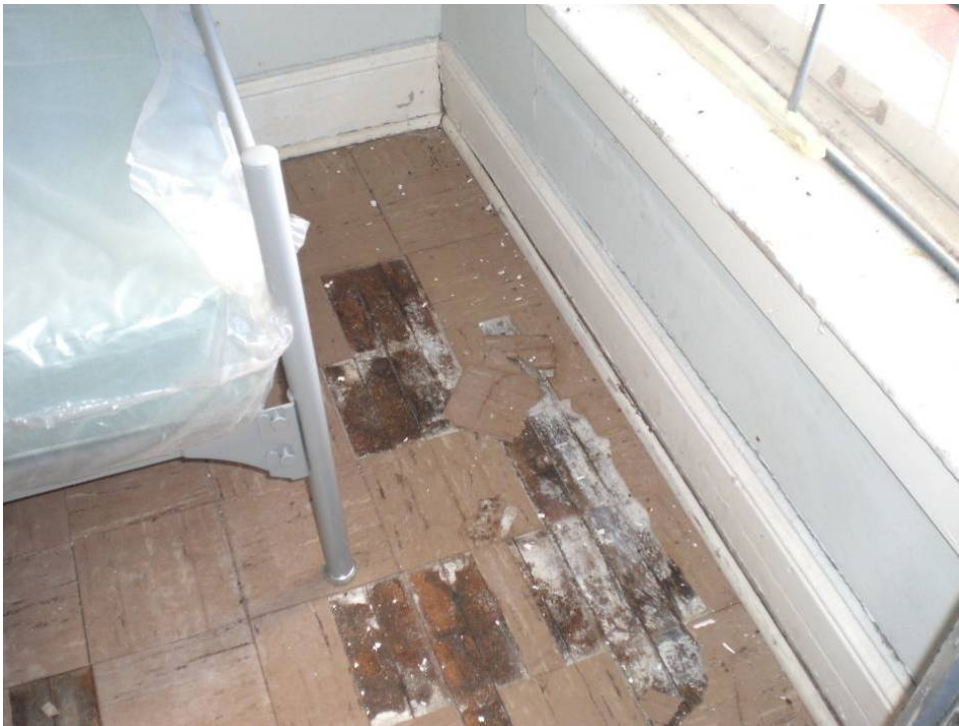
The resilient flooring in the second floor hall and second floor bedrooms (four bedrooms, three closets) is in fair condition as there are water stains and obvious patches in the resilient flooring. The visible wood in the northeast bedroom is in poor condition as there are water stains on the boards and what appears to be water damage at the northwest corner. (OI-KQ-25)

4
5 OI-KQ-25: Northeast second floor bedroom floor and base trim (Source: A&A CIMG4598)

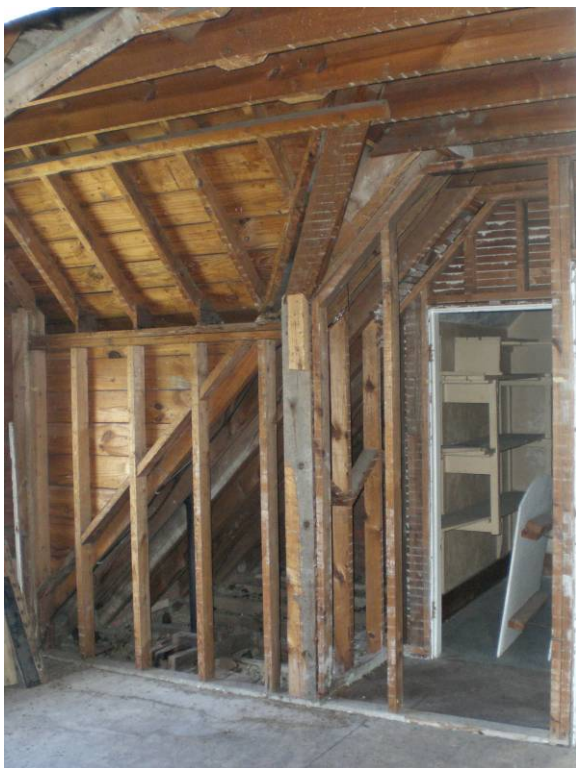
Attic. The attic has the exposed roof structure of joists, beams, and wood sheathing. However, there are nail holes on the joists and beams from where lath once was attached (there are stains from the plaster keys on the lath). (OI-KQ-30 and 31)

1
2
3
OI-KQ-30: Northwest view of attic space (Source: A&A CIMG4656)

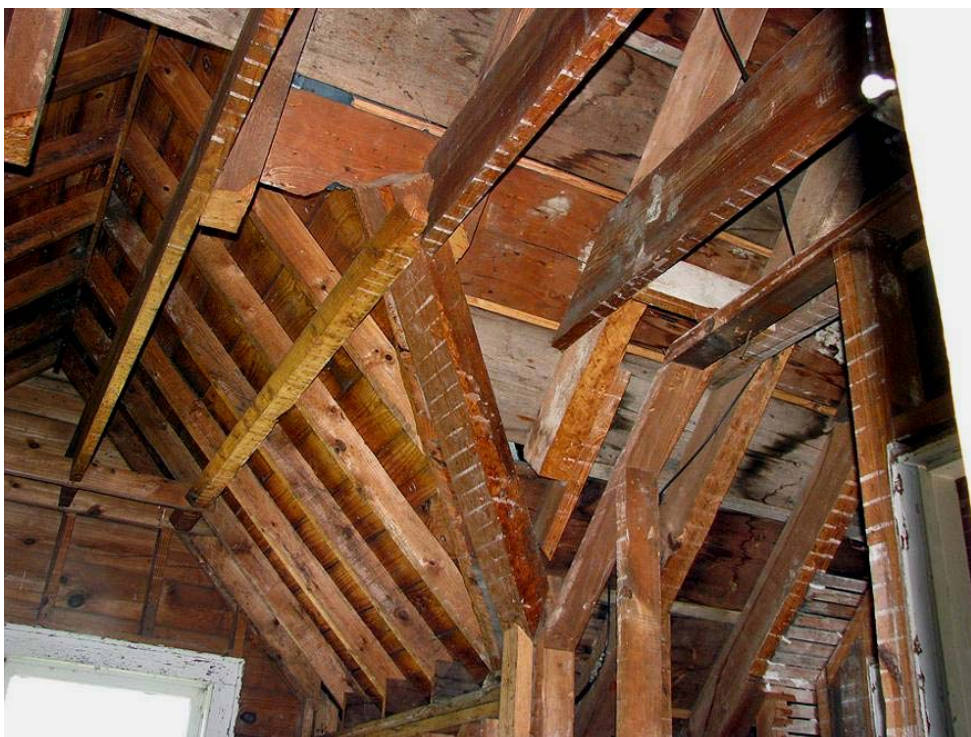
4
5
OI-KQ-31: Dormer framing in attic (Source: Martin/Martin)

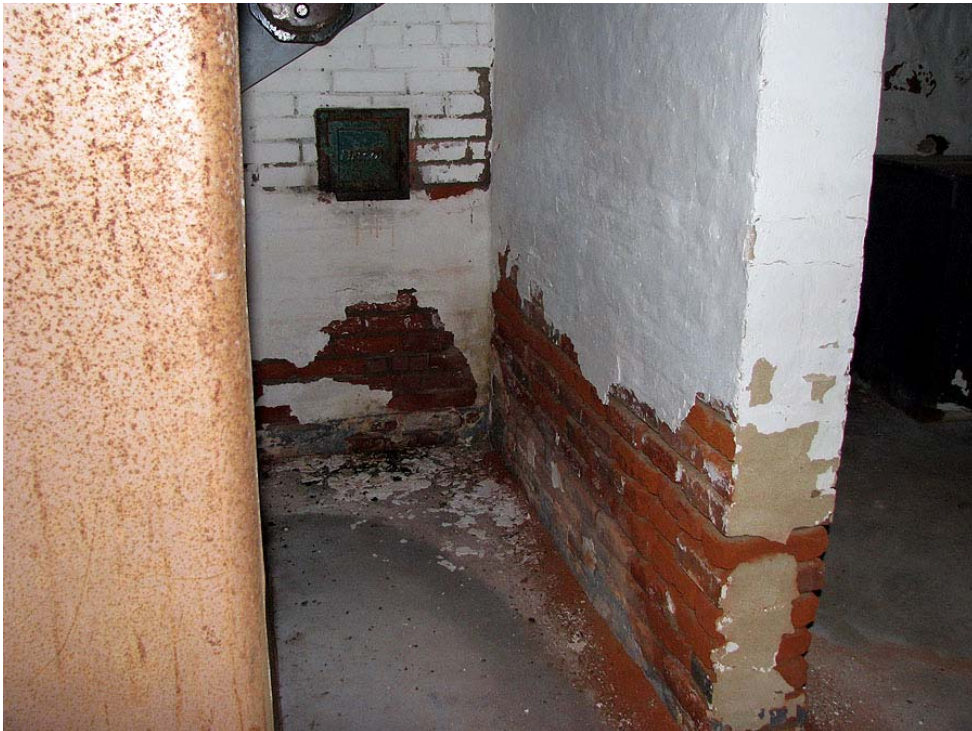
01-KQ-33: Deteriorated masonry wall in basement (Source: Martin/Martin)

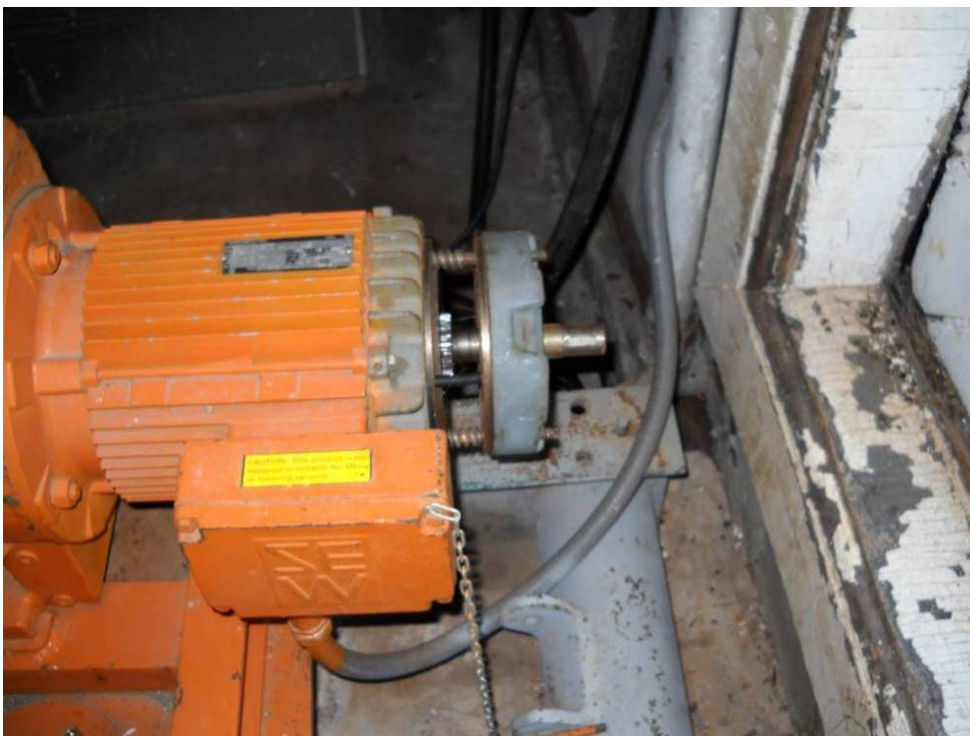
OI-FSB-17: Tram hoist winch, clutch is disassembled and awaiting parts (Source: RMH)
