OIL STORAGE

Chronology of Alterations and Use

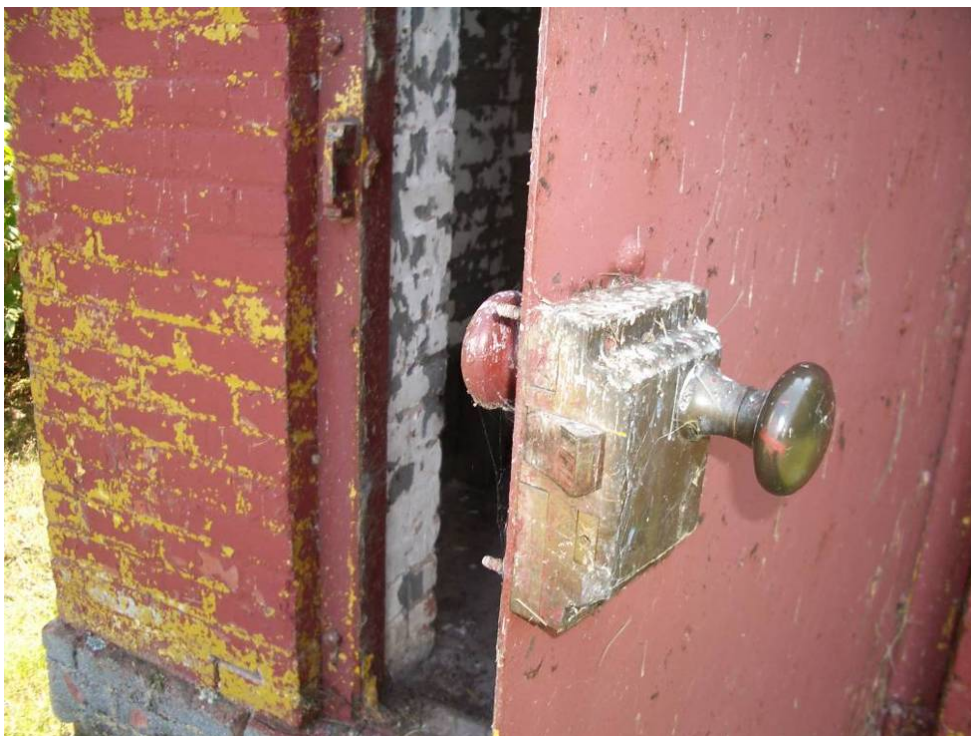
OI-OS-05: North entry door hardware (Source: A&A IMGP3169)

The exterior door is made of steel, has an original lockset, and has two strap hinges. It is 2'7" x 6'10 1/2" and is original to the building. (OI-OS-05) There is a painted stone sill at the door.

This steel door is in good condition as there is only minor paint peeling. The sill is cracked.

Repaint steel door. Epoxy repair the crack at the sill.

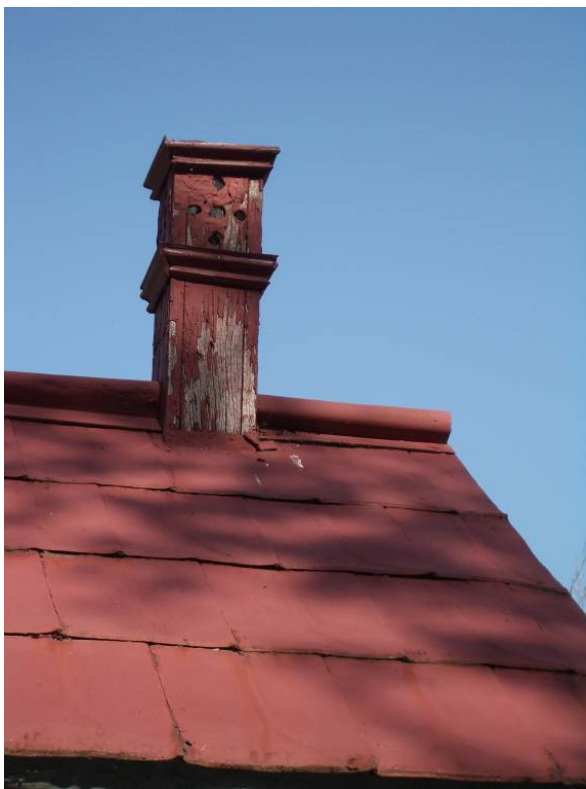
OI-P-06: Roof and vent details, south elevation (Source: A&A IMGP3163)

The roof is in fair condition as there is missing trim at the ridge cap and the peeling paint has revealed rust on the metal shingles. The wood elements are in fair condition as they have badly peeling paint. The wood vent with peeling paint shows deteriorated wood.

The original decorative gravity vent on the roof is in poor condition as it needs conservation work.

Replace the missing trim at the ridge cap and any rusted metal shingles in-kind. Scrape, sand and repaint metal shingles and wood elements at eave and rake. Scrape and sand the vent. Epoxy stabilize the wood members and prep and repaint.
