**CULTURAL LANDSCAPE REPORT • HISTORIC STRUCTURE REPORT**

**APOSTLE ISLANDS NATIONAL LAKESHORE**  
LIGHT STATIONS OF MICHIGAN ISLAND, OUTER ISLAND, DEVILS ISLAND,  
LONG ISLAND AND SAND ISLAND  
**VOLUME IV**

100% DRAFT  
MARCH 2011

**VOLUME IV OF VI: DEVILS ISLAND CLR/HSR**

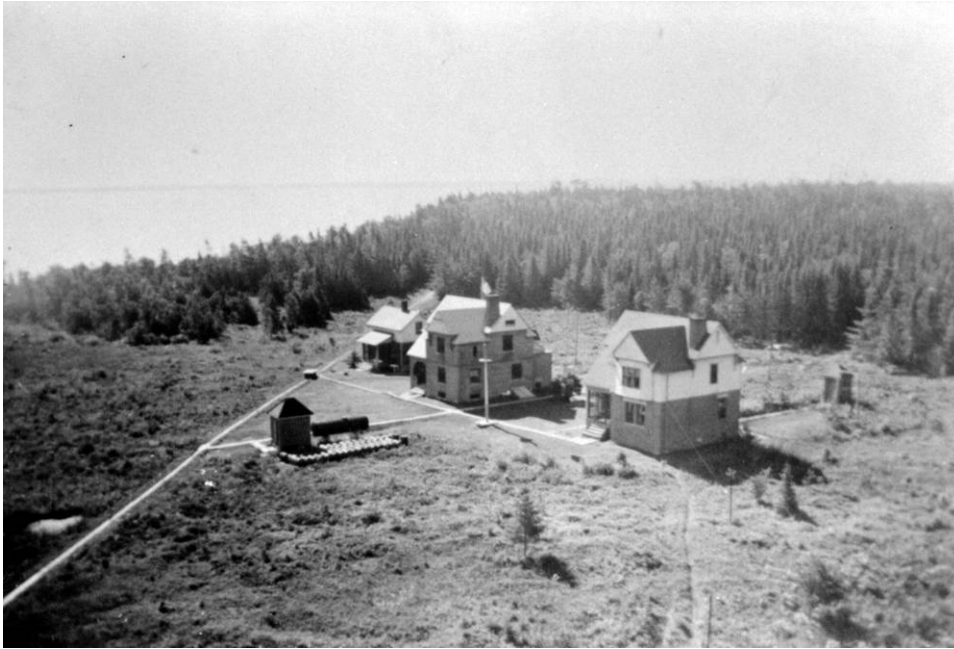
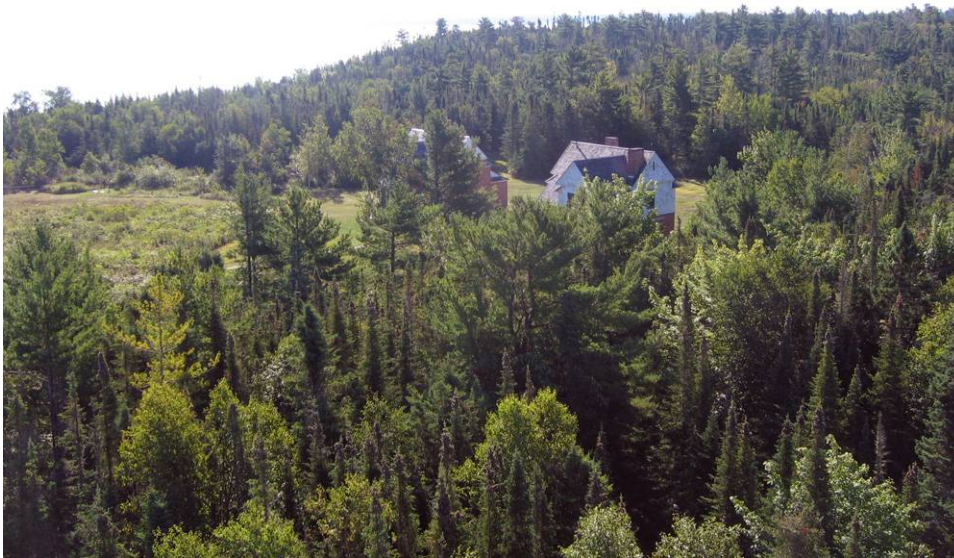
Site Image DI-20: View from the Light Tower showing the cleared area at the Keepers Quarters; top, c. 1940 (Source: NPS APIS Archives); below (2009) (Source: MBD Devils 040.jpg)

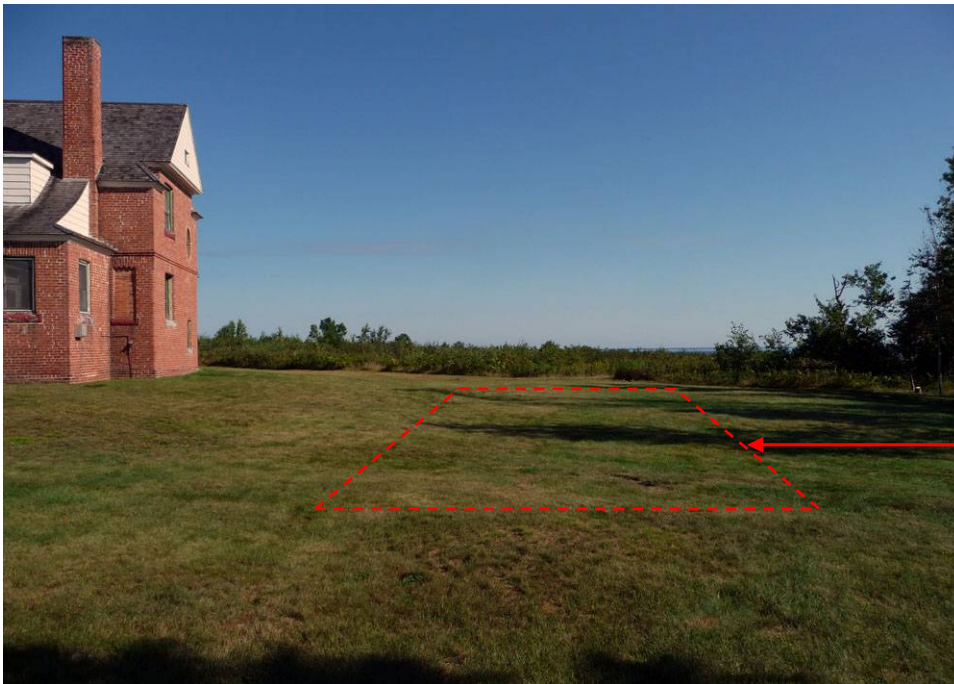
Location of Nonextant  
Assistant Keepers Quarters  
and Associated Barn

Site Image DI-23: Shallow depression marking the nonextant Assistant Keepers Quarters and associated barn, 2009 (Source: MBD P1020058.JPG)
