## Circulation/Accessibility

### *Devils Island Circulation*

Apostle Islands National Lakeshore CLR/HSR

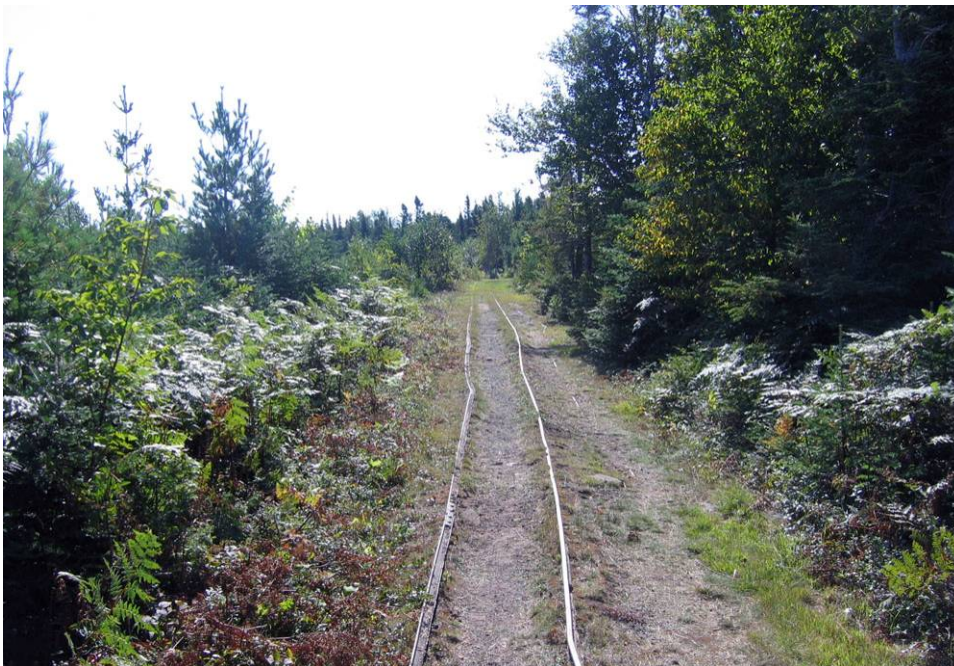
The primary transit of materials on site historically was accomplished using the tram tracks that cross the light station grounds from north to south linking the Fog Signal Building, Keepers Quarters and Tramway Engine Building. The tracks are in fair to poor condition and are not fully functional.

5  
6    *Site Image DI-29: Tram tracks between Fog Signal Building and Keepers Quarters, 2009 (Source: MBD Devils 072.jpg)*

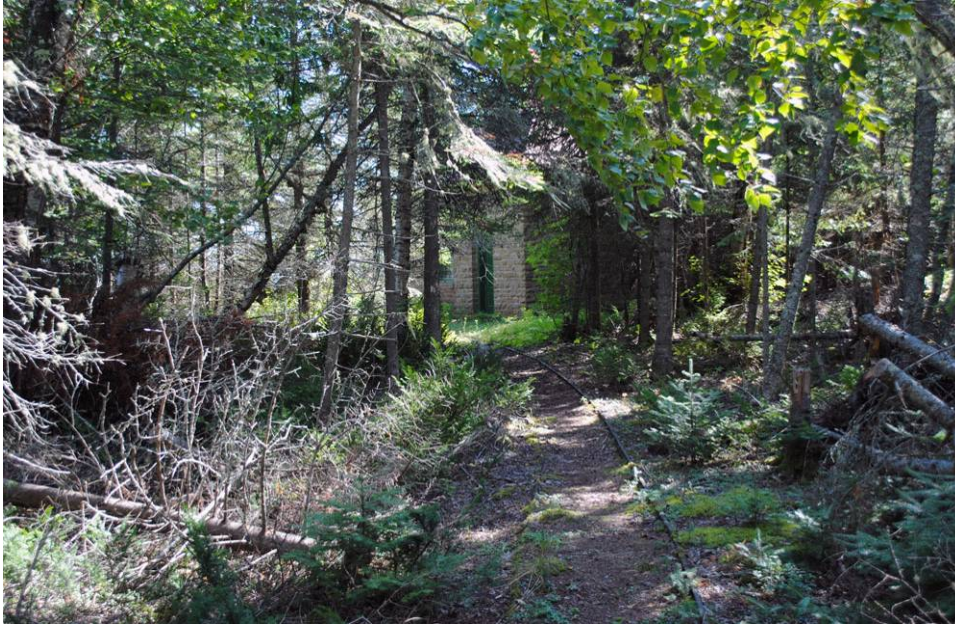
Site Image DI-30: Tram tracks at Tramway Engine Building, note extent of forest encroachment, 2009 (Source: MBD DSC\_0006.JPG)

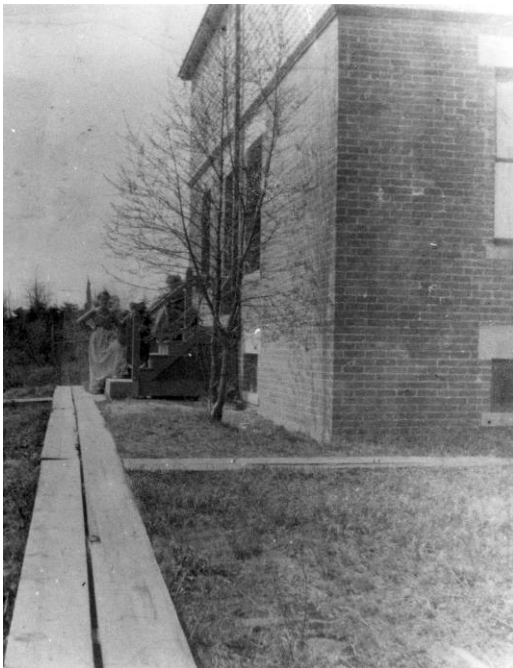
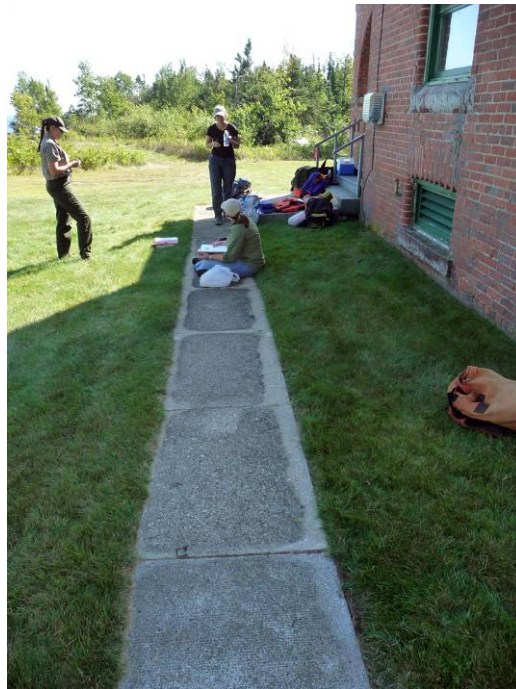
Site Image DI-31: Left - wood plank walk at Assistant Keepers Quarters, c. 1908 (Source: NPS APIS Archives); Right - concrete walk at Keepers Quarters, 2009 (Source: MBD Devils 021.jpg)

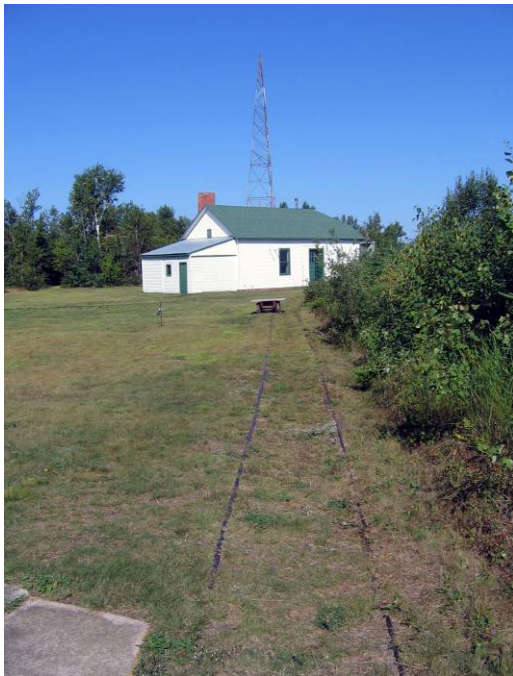
**Existing Condition.** The tram tracks on the light station run the length of the grounds (approximately 1600 linear feet) following a straight line that parallels the shoreline of the island and connect the Fog Signal Building to the Tramway Engine House. The tracks are cast iron 25 pound rails, spaced 36" on center and secured to timber and log ties set in a base material. The tracks as a system are intact and remain in place but are nonfunctional. The condition of the tram tracks is poor as the timbers beneath are rotted, the area between the tracks has become filled with soil and vegetation and portions of the rails have been damaged and bent. Overall the tram tracks are in poor condition.

6 *Site Image DI-33: Tram tracks near Fog Signal Building with radio beacon tower in background, 2009 (Source: MBD Devils*  
 7 *066.jpg)*

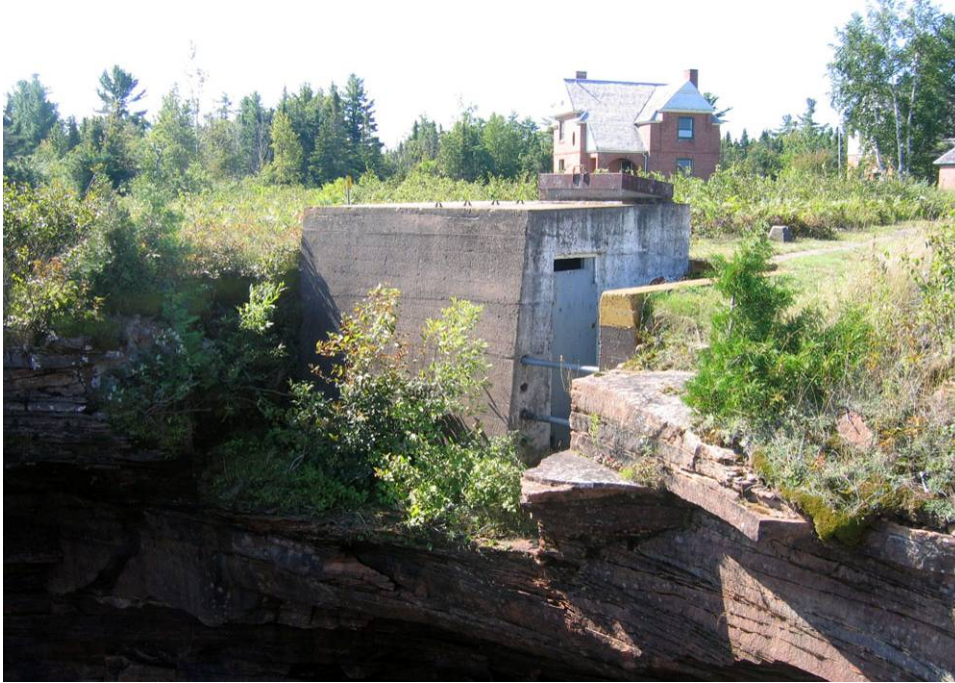
**Existing Condition.** The pump house is located directly northeast of the Keepers Quarters, and is built into the edge of the shoreline cliff, overhanging open water below. It is a board formed, cast-in-place, concrete structure, approximately 10'x10' in size, with a concrete stairway leading down to an access door on its north facade. The pump house has a square hatch with a metal cover on the roof. The stairway is in fair condition but lacks handrails and the guardrails along the cliff edge are not code compliant. The pump house is in poor condition and is nonfunctional.

Site Image DI-34: Pump house at cliff edge, 2009 (Source: MBD Devils 085.jpg)

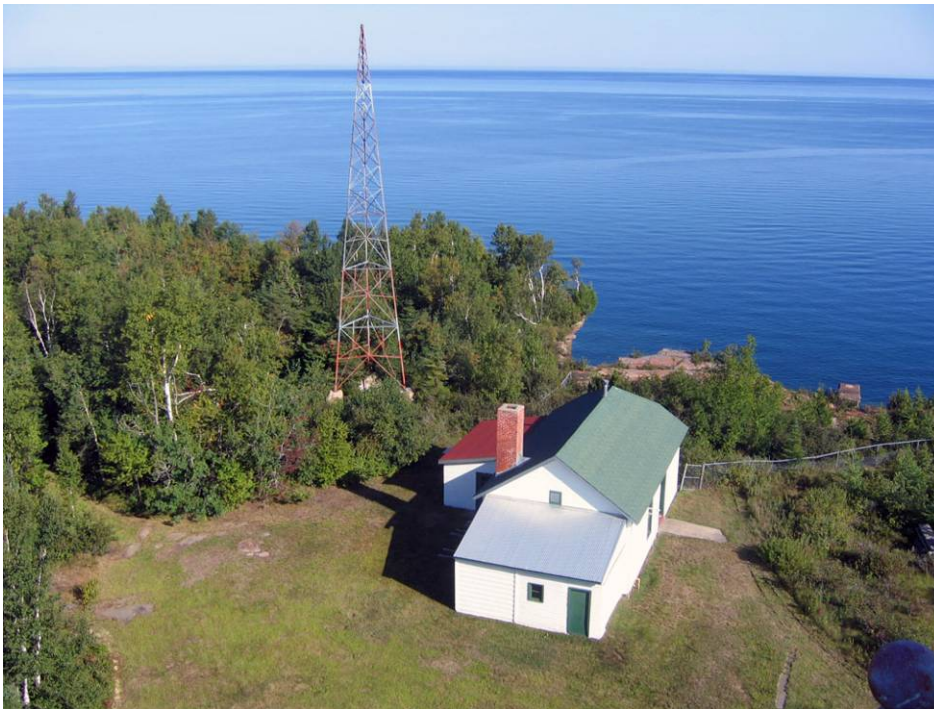
**Existing Condition.** The radio beacon tower is located directly west of the Fog Signal Building. The tower is a tripod shape, approximately 80' tall, constructed of a painted steel frame set on three concrete footings. The structural portions of the tower are in good condition although the tower no longer transmits signals.

Site Image DI-35: Radio beacon tower near Fog Signal Building, 2009 (Source: MBD Devils 041.jpg)

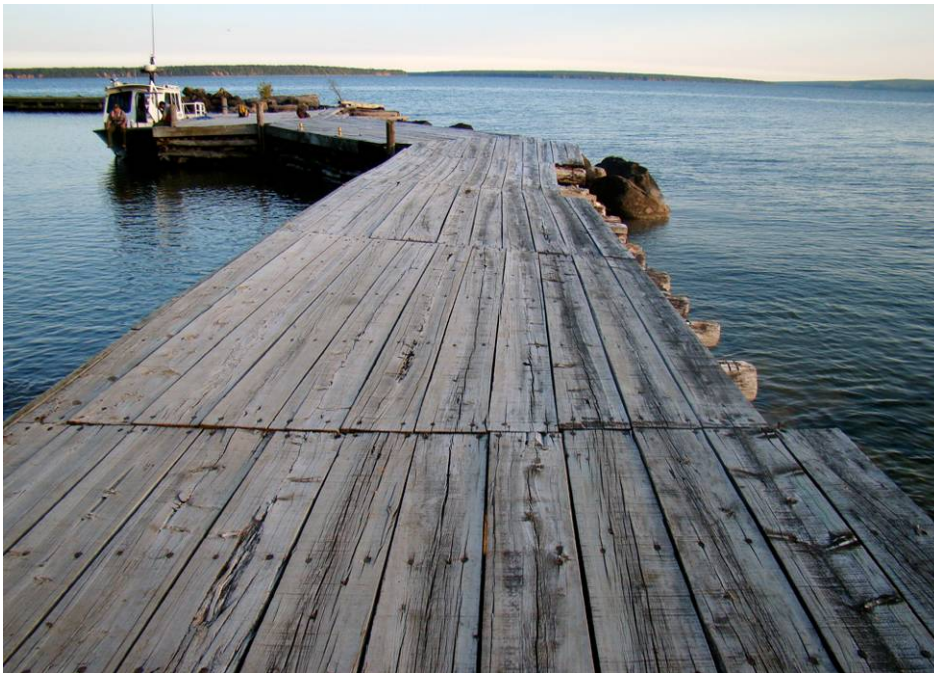
**Existing Condition.** The boat dock is constructed of timber frame cribbing with a stone rubble infill and wood plank decking. The dock is approximately 120' in length by 15' wide and in conjunction with the stone jetty forms a small sheltered harbor. The dock is weather-battered with damage to the timber cribbing and wood decking readily apparent. The boat dock is in fair to poor condition.

Site Image DI-37: Boat dock at Boathouse site – south end of Devils Island; jetty in background, 2009 (Source: A&A Devils 041.jpg)

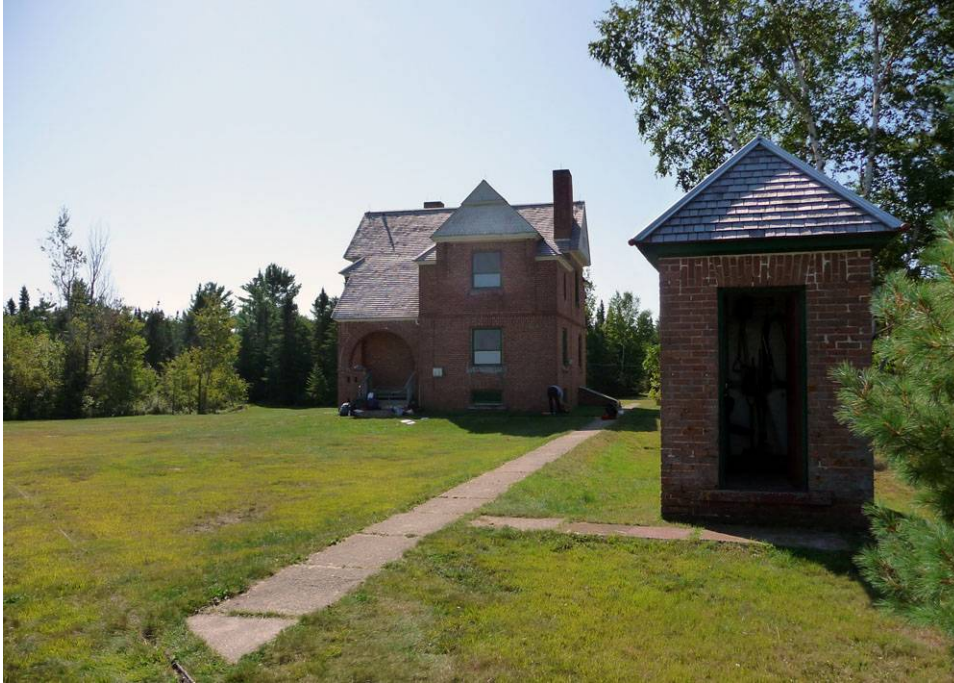
**Existing Condition.** Typical to several of the Apostle Islands light stations, the concrete walks appear to be constructed of precast units 2.5'×4'×4" thick with some smaller units also installed. The walk sections have a fine aggregate finish and tooled edges. Historic photographs indicate that the concrete units were placed on top of the ground surface rather than excavated and placed. Other portions of the concrete walks appear to have been poured in place to infill odd shapes and address building edges. Overall the concrete walks are in good condition with only a few slabs requiring replacement due to severe cracking.

2  
3 Site Image DI-38: Concrete walk at Keepers Quarters – precast slab construction, 2009 (Source: MBD P1020148.JPG)  
4

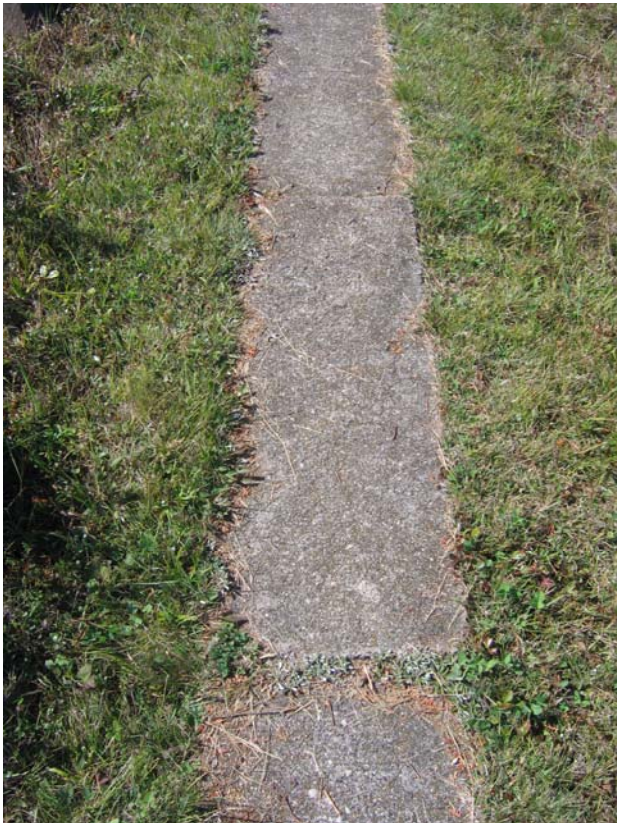
5  
6 Site Image DI-39: Concrete walk to Pump House – precast slab construction, 2009 (Source: MBD Devils 088.jpg)

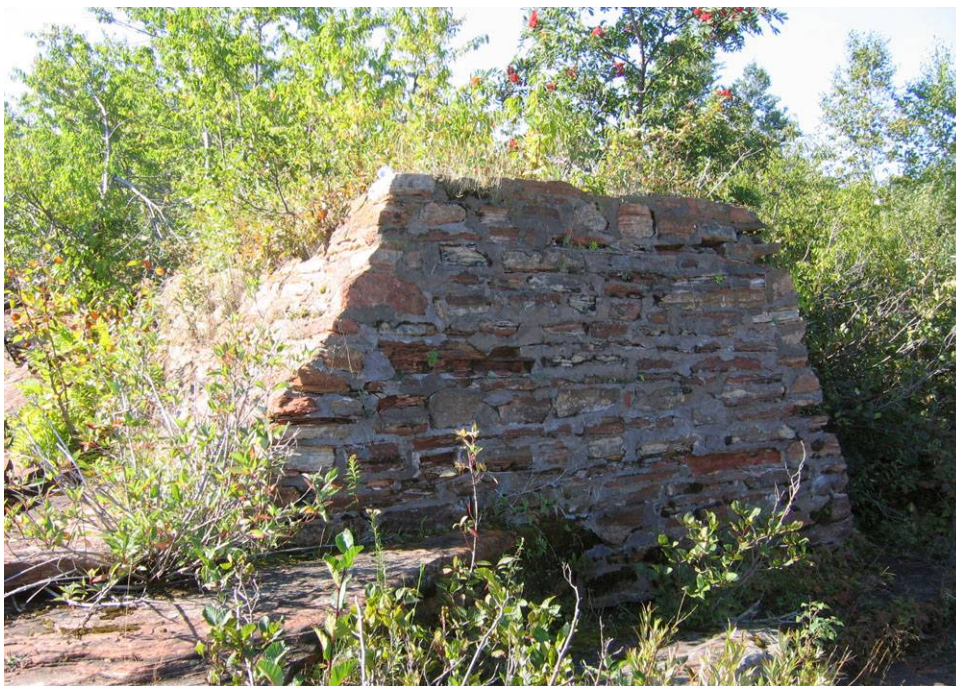
**Existing Condition.** The stone masonry tram terminal is located at the northwest end of the tram tracks. The trapezoidal shaped raised platform is approximately 24'×8'×5' wide and the terminal is constructed directly on the exposed bedrock of the site. The tram tracks have been removed from the top of the terminal and brush vegetation has encroached at the base and top of the structure. The tram terminal is in fair condition.

Site Image DI-40: Tram terminal, 2009 (Source: MBD Devils 050.jpg)

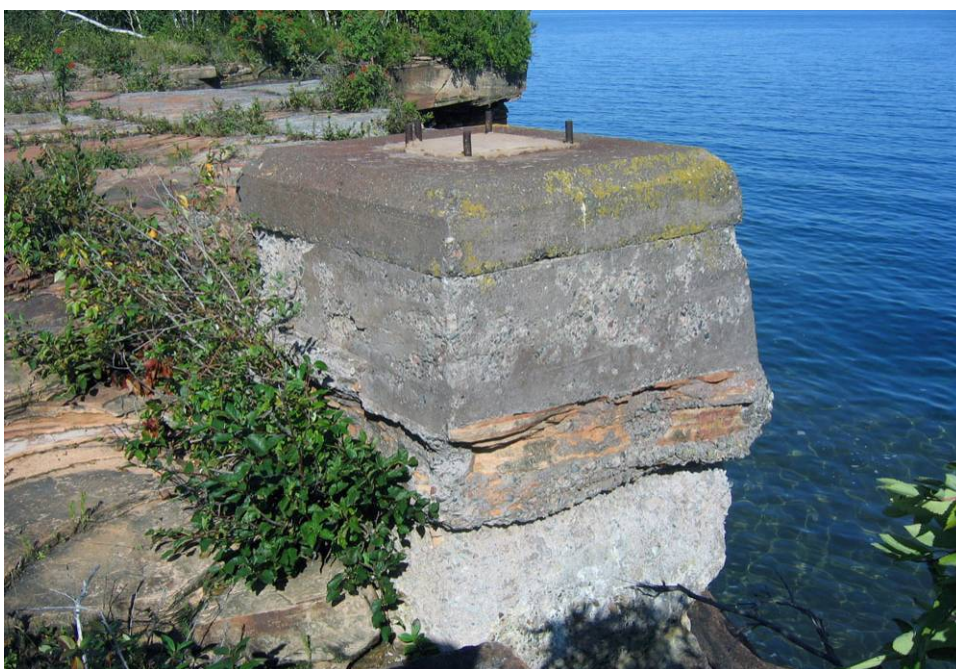
**Existing Condition.** Four extant, concrete footings remain from the nonextant derrick assembly near the Fog Signal Building. The footings are cast-in-place, concrete with stone masonry and steel rod/bolt imbeds. The footings vary in size but are approximately 3'×3'×3'. The footings are in fair condition; however two of the footings have tipped over and are in danger of falling into the water.

Site Image DI-41: Derrick footing, 2009 (Source: MBD Devils 060.jpg)

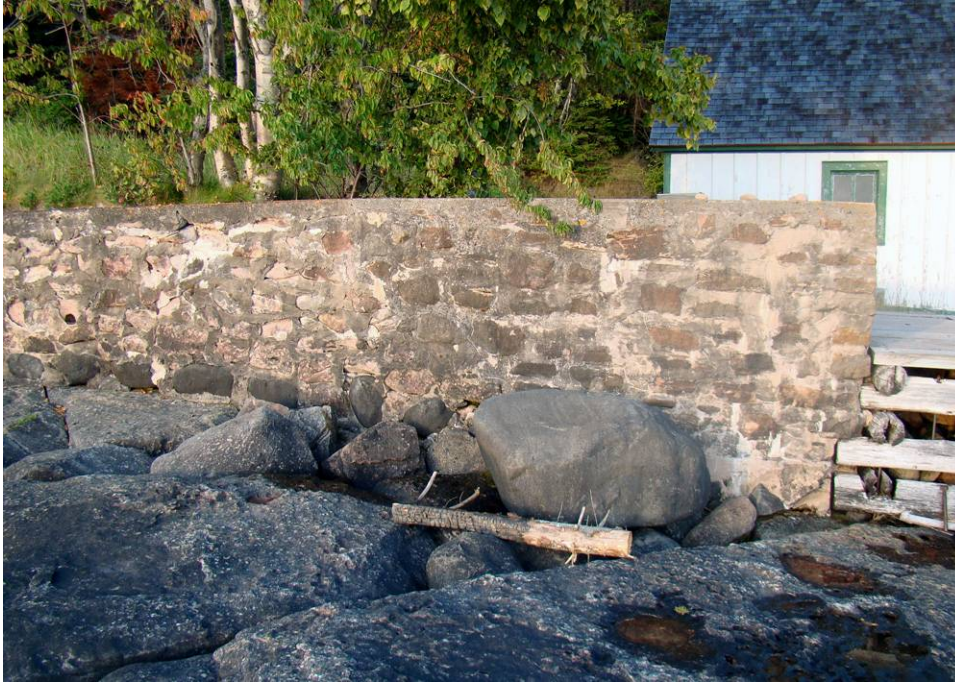
**Existing Condition.** A stone masonry wall is located adjacent to the Boathouse and boat dock. The trapezoidal shaped wall is approximately 20'×2'× 4' and constructed of native stone, hand placed and mortared. The wall is in good condition.

Site Image DI-42: Stone wall at Boathouse, 2009 (Source: A&A DSC01075.jpg)

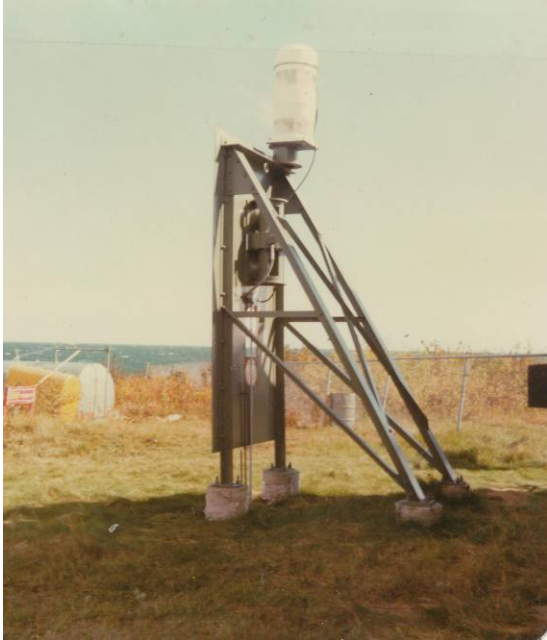
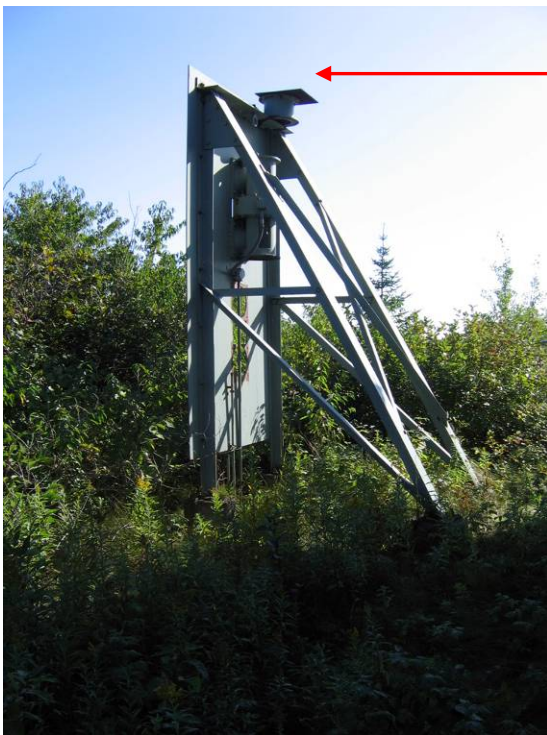
*Site Image DI-50: Fog Signal Frame; top (1977) (Source: NPS APIS Archives); bottom (2009) Fog signal frame with fog signal removed, note extent of forest encroachment (Source: MBD Devils 045.jpg)*
