LIGHT STATION TOWER

CHAPTER 4: HISTORIC STRUCTURE REPORT

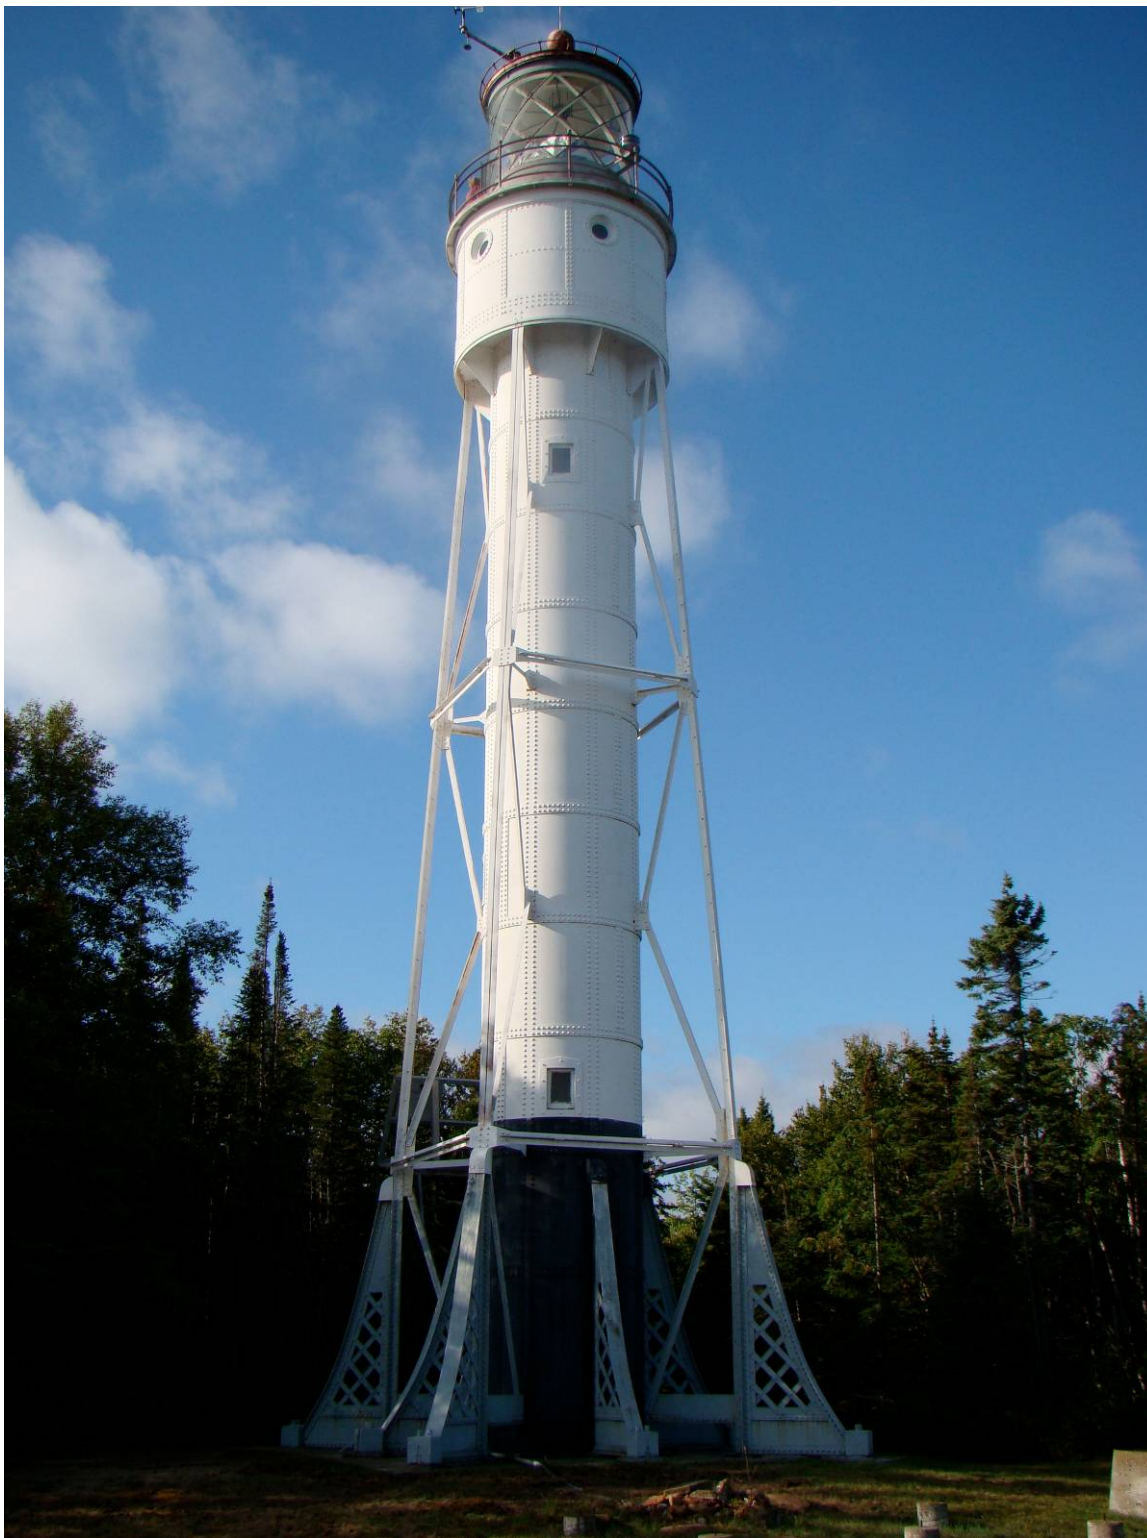
2
3 *DI-LS-01: North elevation, 2009 (Source: A&A DSC00867)*

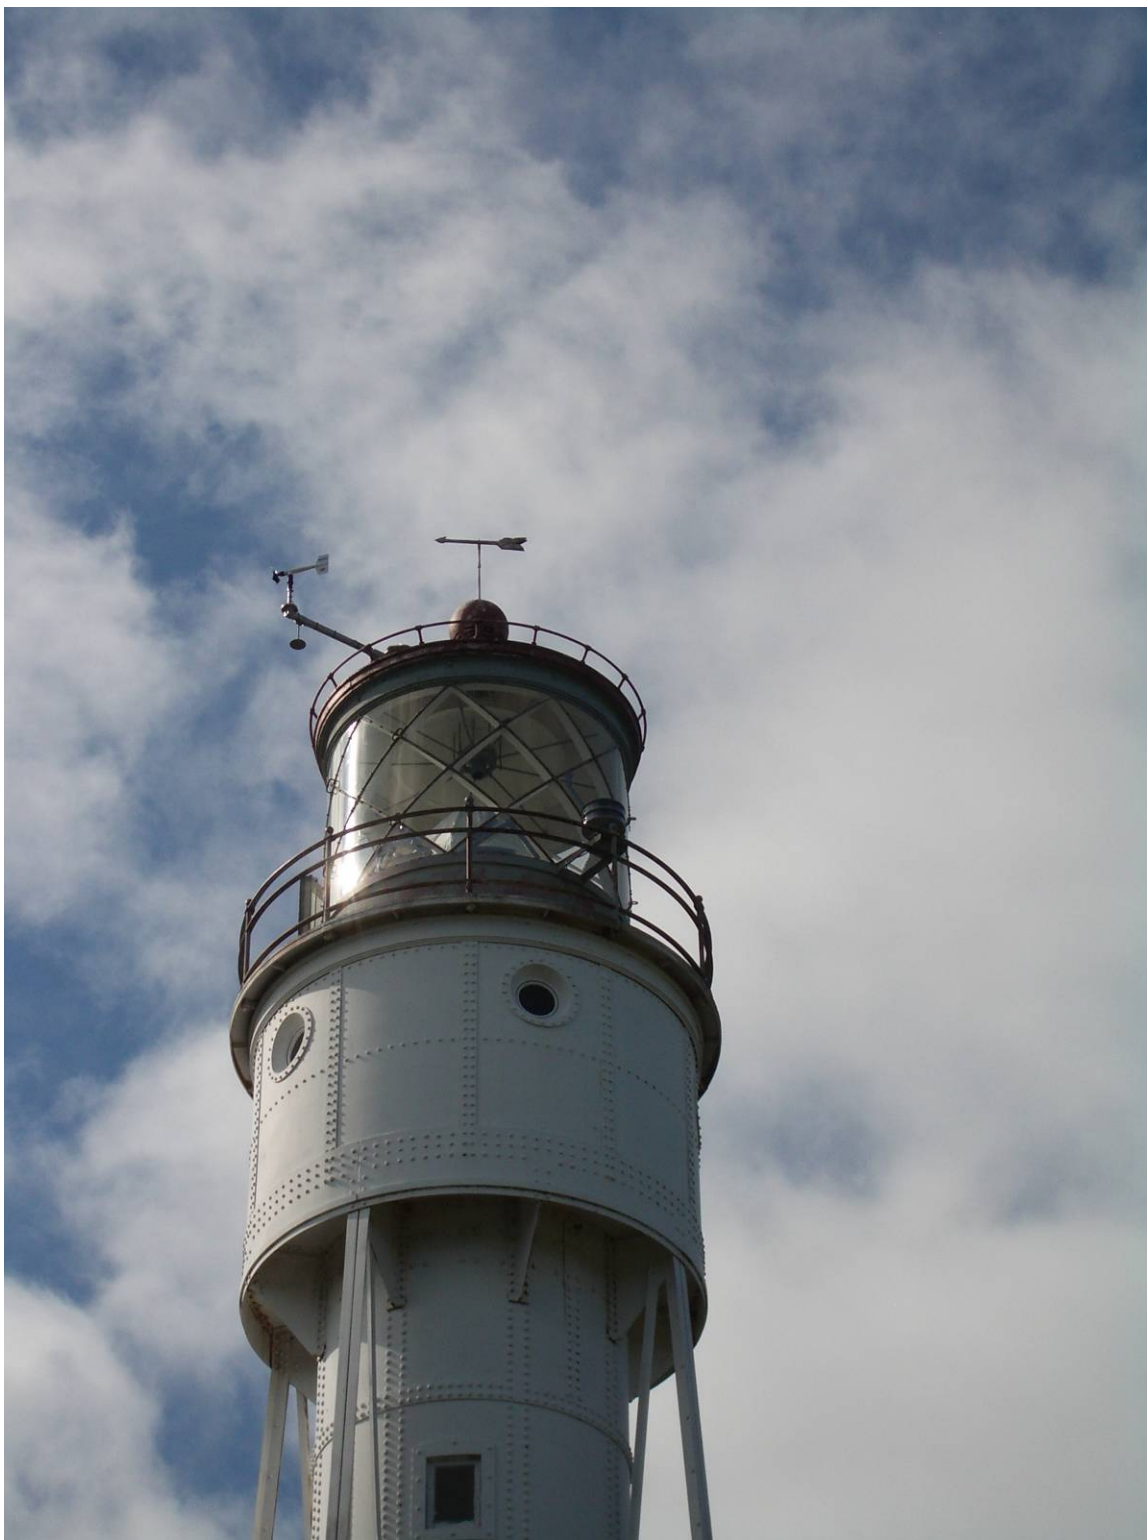
DI-LS-02: Lantern, 2009 (Source: A&A IMGP2878)

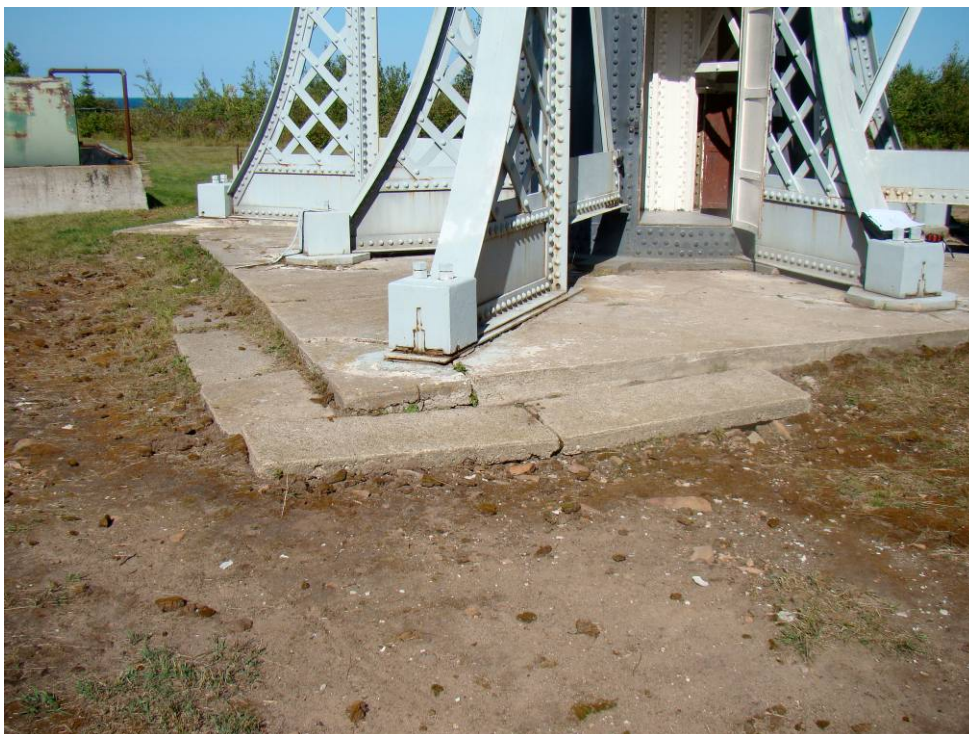
DI-LS-03: Entry and foundation (Source: A&A DSC00945)

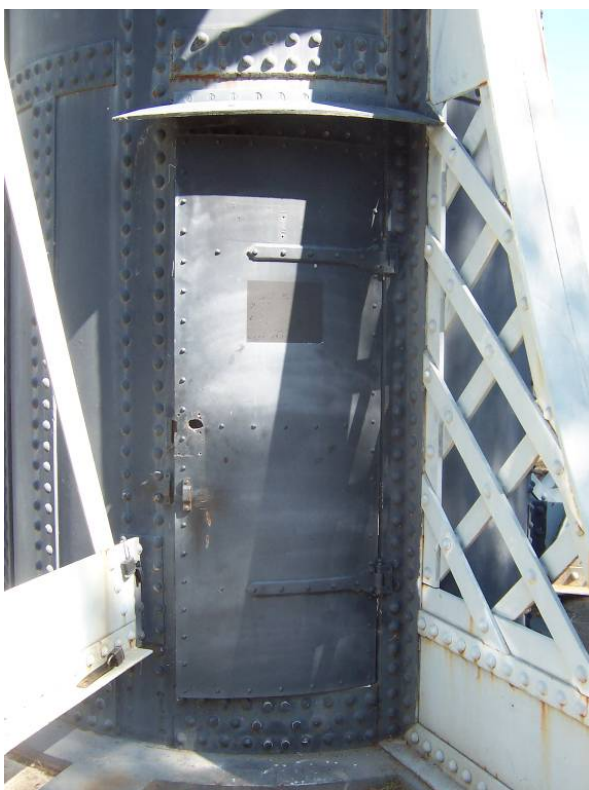
Entry Door at Base of Tower. This door is made of 1/8" metal plate with rivets, painted gray. The dimensions are 2'-4" x 6'-2" x 3/8" frame with 1/8" plate. (DI-LS-04 and 05)

Entry Door at Base of Tower. This door has minor paint deterioration, minor rust and is missing mortise hardware.

DI-LS-04: Entry door (Source: A&A 100_9715)

Install missing hardware in-kind at the entry door at the base of the Tower and remove the rust from the cast components. Repaint all doors. Verify operation of all ventilation components.

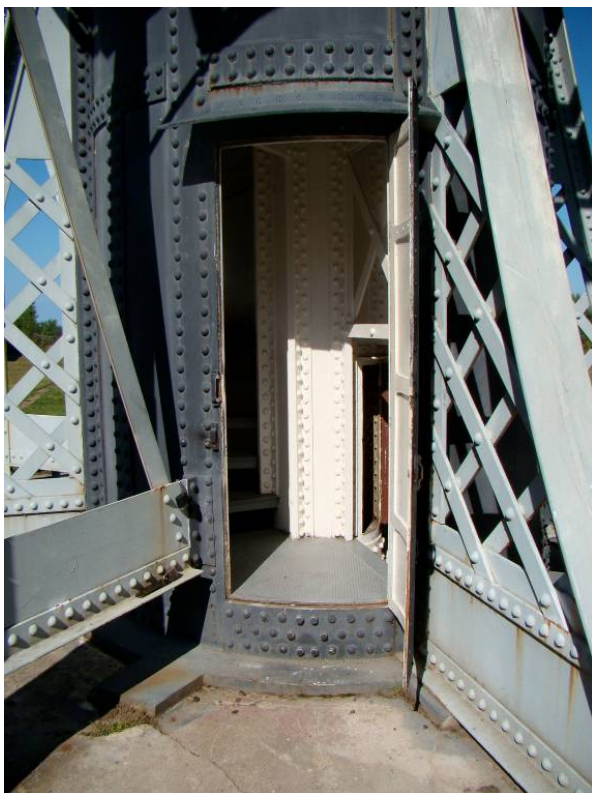
DI-LS-05: Entry (Source: A&A DSC00948)

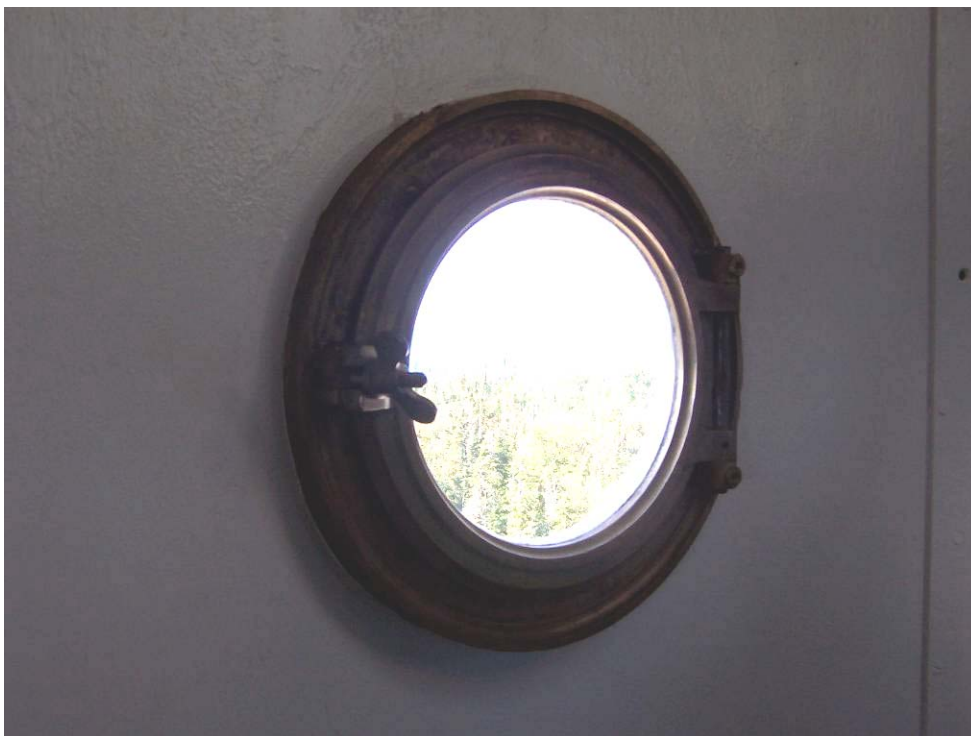
Five “Port-hole” Style Windows. These windows are brass-framed on the interior and are 1’-3” in diameter. They are original to the structure. (DI-LS-06)

Five “Port-hole” Style Windows. These windows are in good condition.

DI-LS-06: Porthole style window (Source: A&A 100_9711)

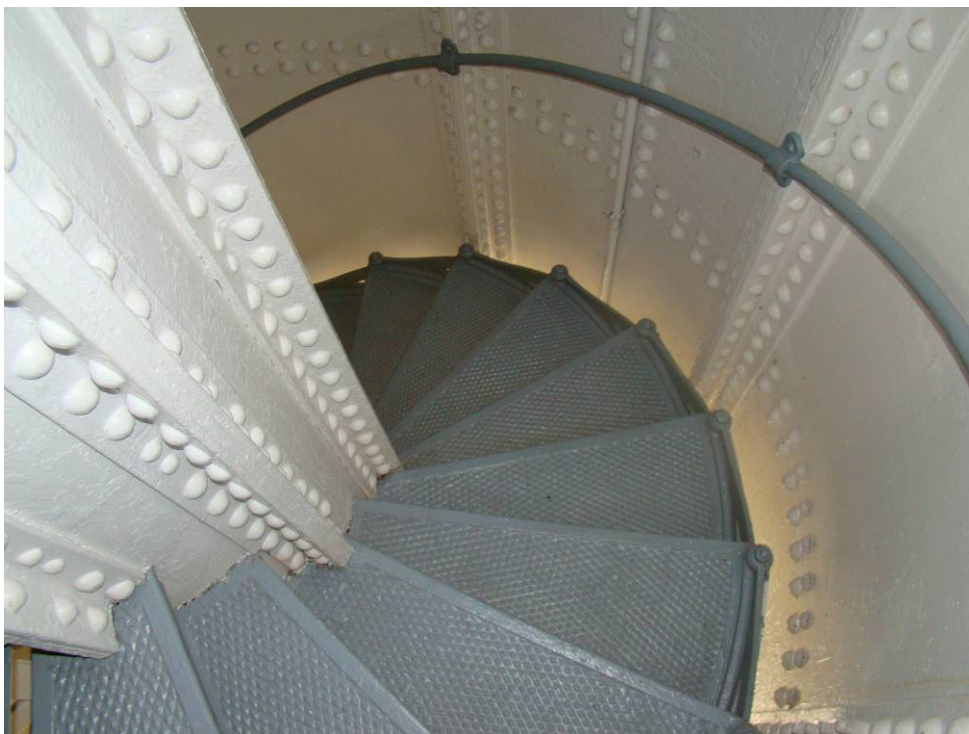
The spiral staircase is cast iron, painted gray. There are 75 treads leading to a door at the watch room landing, another eleven treads leading to the landing, and finally a ladder with eight rungs leading to the lantern level. The metal railing is 3'8" above the stair nosing and is 1" in diameter. The ladder railing is 2' above the treads and has a 1" diameter. The stair risers are 8" and the tread depth widens from 3 1/2" to 6". (DI-LS-07 and 09)

This spiral staircase is in good condition.

1
2 *DI-LS-07: Stair, looking down (Source: A&A DSC00853)*
3

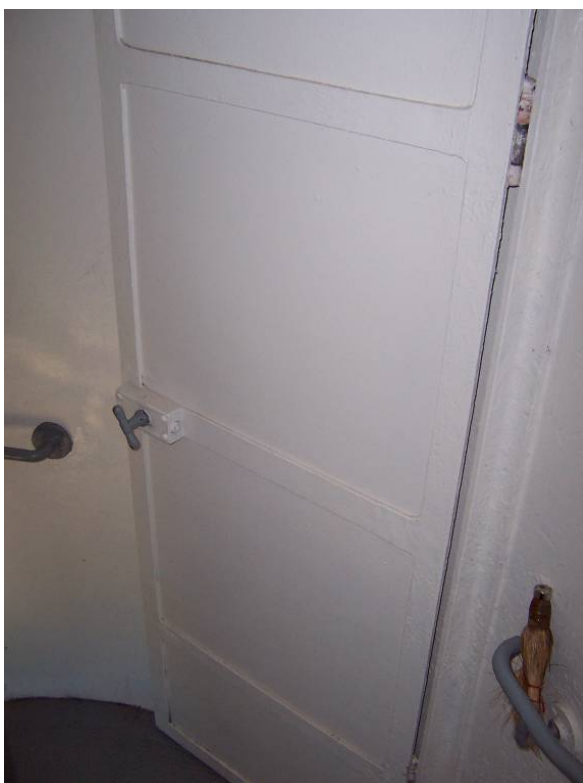
Door to Watch Room. This door is plate metal with a turn lever and is painted white. The dimensions for the door are 2'-5" x 6'-7" x 3/8". (DI-LS-08)

Door at Watch Level. This door has minor paint deterioration and minor rust.

4
5 *DI-LS-08: Door to watch room (Source: A&A 100_9712)*

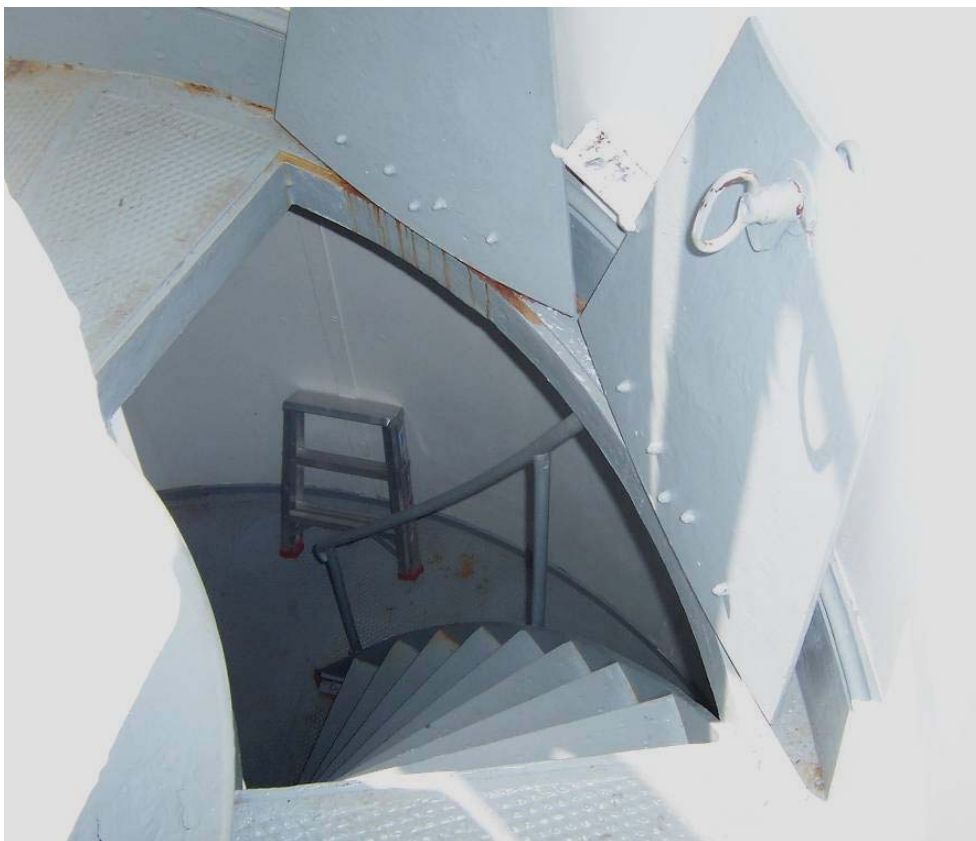
Hatch Door at Lantern. This hatch door is composed of two, pie-shaped, metal plate sections with wall mounted catches and heavy-duty brass hinges. The dimension for each section is 1'-9" x 2'-6". (DI-LS-09)

Hatch Door at Lantern. This pair of doors has minor paint deterioration.

DI-LS-09: Stair and hatch from service level to lantern (Source: A&A 100_9708)

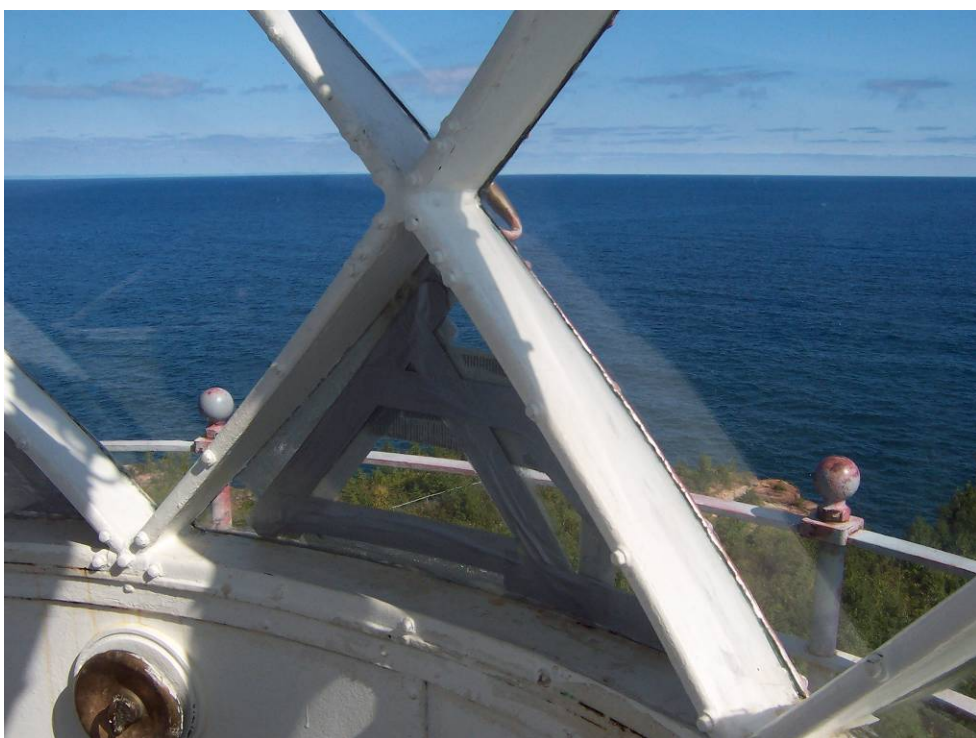
Cast iron walls rise 3'-2 1/2" from the finished floor and are secured with screwed connections. The exterior panels are cast iron. Five 6 1/2" diameter intake vents in the walls are controlled by brass caps that open as they are turned. There is no evidence of any upper vents at the exterior wall. Glazing is 6'-0" high curved segments with curved brass cross members, 1" x 4", bolted together, forming a lattice 2'-0 1/2" on center. The glazing is unmarked and it is believed to have been replaced multiple times (this is consistent with the replacement glazing located in a closet in the second floor of the Assistant Keepers Quarters). Silicone sealant secures the interior. The glazing is held in-place with 1" wide heavy-duty brass stops at the exterior. The brass is bolted to the lattice frame at 6" on center. Brass handles are mounted onto the stops. A shallow, cone-shaped metal deflector, with a +/- 8" diameter vent hole at the center, is suspended +/- 18" below the roof. The lantern door is 2'-6" x 5'-5" x 4" with three heavy cast iron hinges. A cross brace was added at some point to the center panel. The entire assembly (with the exception of the glazing and the cross brace) is original to the structure and is painted. (DI-LS-10, 11 and 12)

The lantern glazing was repaired in 2009. Paint is peeling from the lattice structure at the exterior and the lower level of the interior. Rust stains indicate that wind-driven rain or condensation has probably entered the base of the lattice structure and rusted the steel plates. One handle is missing and some screws on the exterior have been sheared off. The intake vents at the lantern level are no longer operational due to caulking.

DI-LS-10: Lantern and glazing (Source: A&A 100_9701)

Remove astragals and clean by mechanical methods; remove glass panes; clean lantern frame by mechanical methods, vacuum putty; apply butyl tape to lantern frame; install new glass panes; apply a top layer of butyl tape; install astragals and seal using a wet silicone caulk; replace sheared and damaged fasteners; pressure test the lantern using water; replace Plexiglas indoors with cured glass pane; and, realign door and frame to allow proper operation and fit.

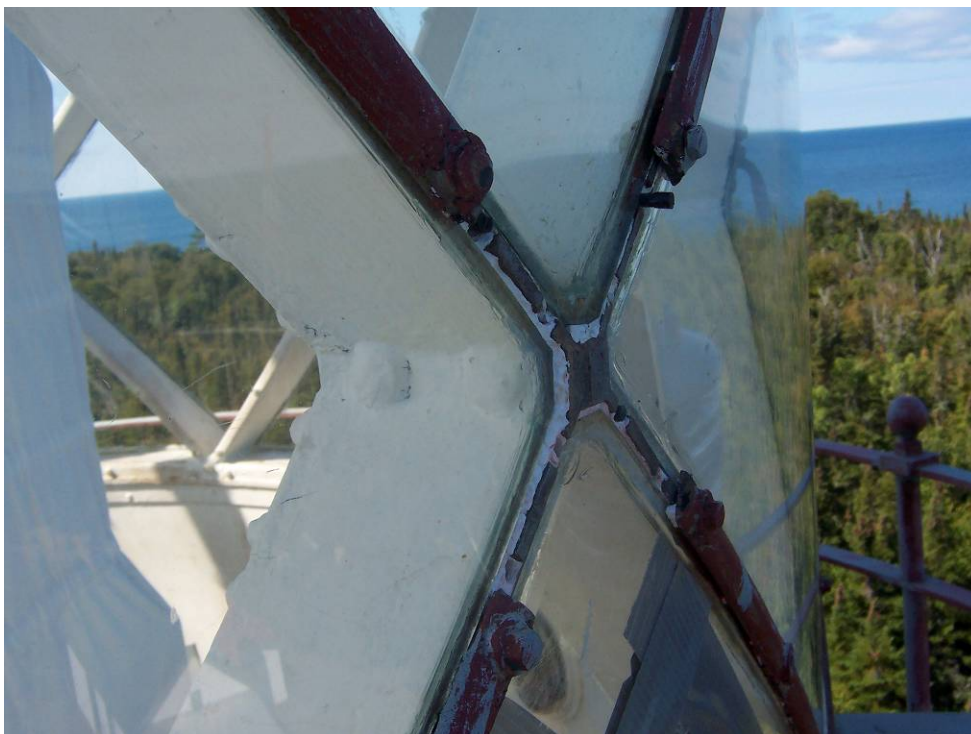
DI-LS-11: Glazing detail (Source: A&A 100_9706)

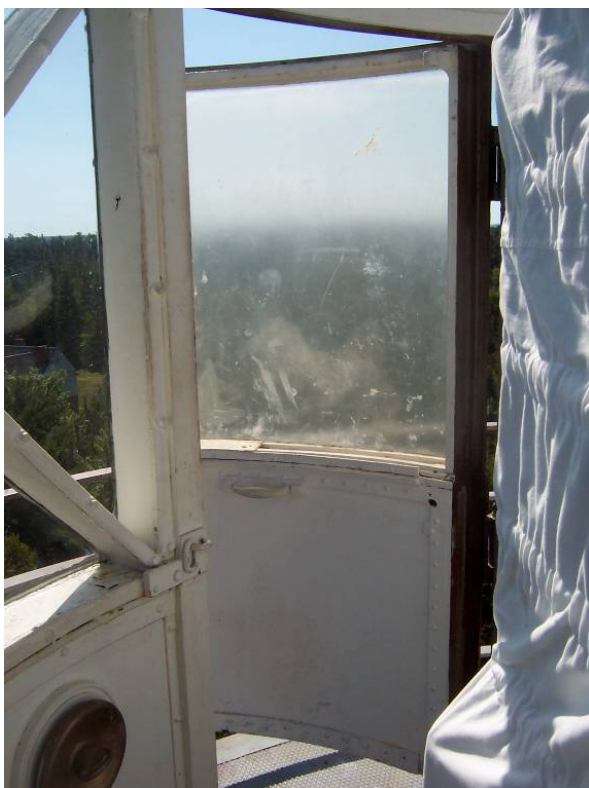
DI-LS-12: Lantern door (Source: A&A 100_9705)

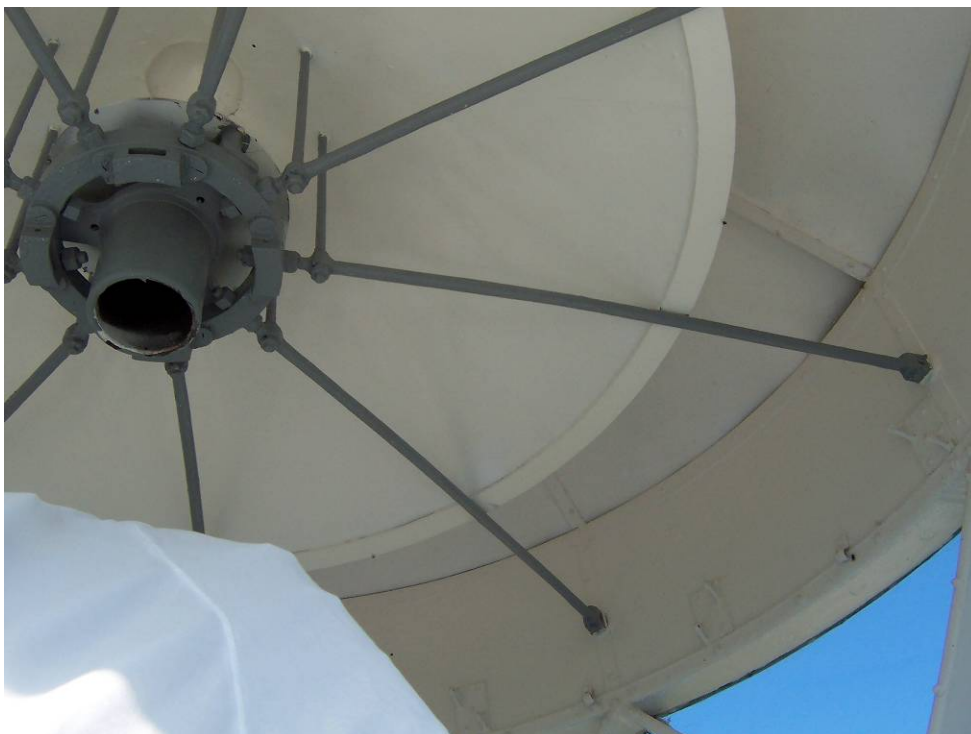
The ceiling finish is sheet metal, painted white with a screened in center to allow ventilation to the exterior ball finial. (DI-LS-13)

The sheet metal ceiling is in good condition though it has pulled away in several locations. This does not appear to be reflective of exterior issues but perhaps is due to the Fresnel lens reinstallation.

DI-LS-13: Lantern ceiling (Source: A&A 100_9702)

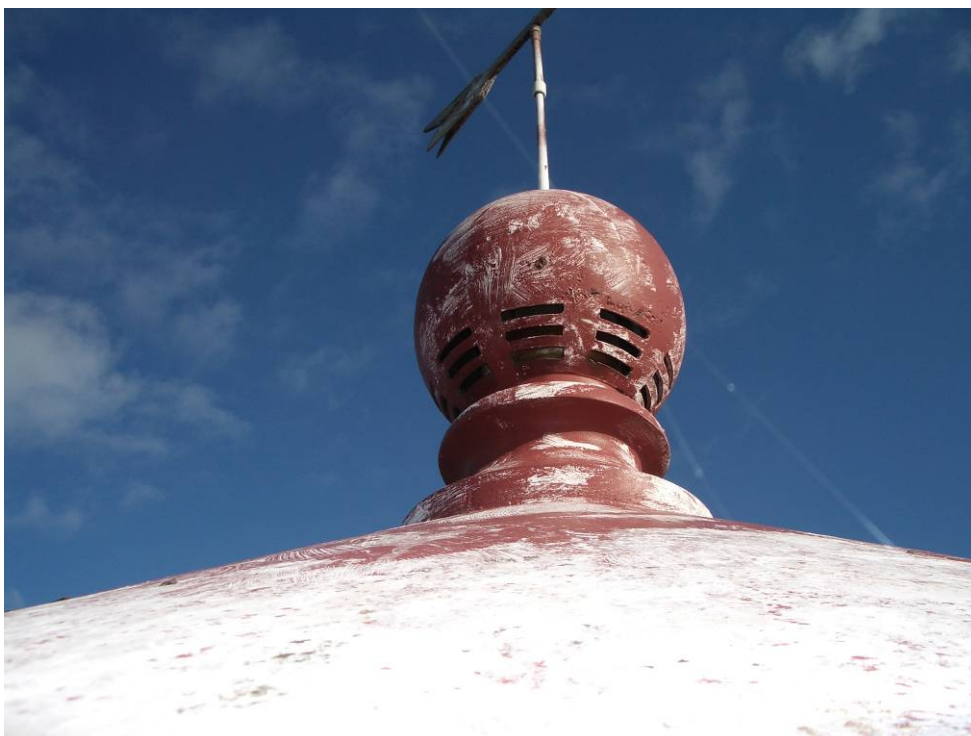
The roof is composed of cast iron panels painted red with a ball ventilator at the center with a weather vane. Access to the roof was difficult; assessment relies on photo documentation. (DI-LS-14 and 15)

The cast iron roof is in good condition with the exception of peeling paint.

DI-LS-14: Lantern roof (Source: A&A IMGP2862)

Scrape and prep areas of rust and repaint the roof. Clean the dirt and debris blocking the ball ventilator.

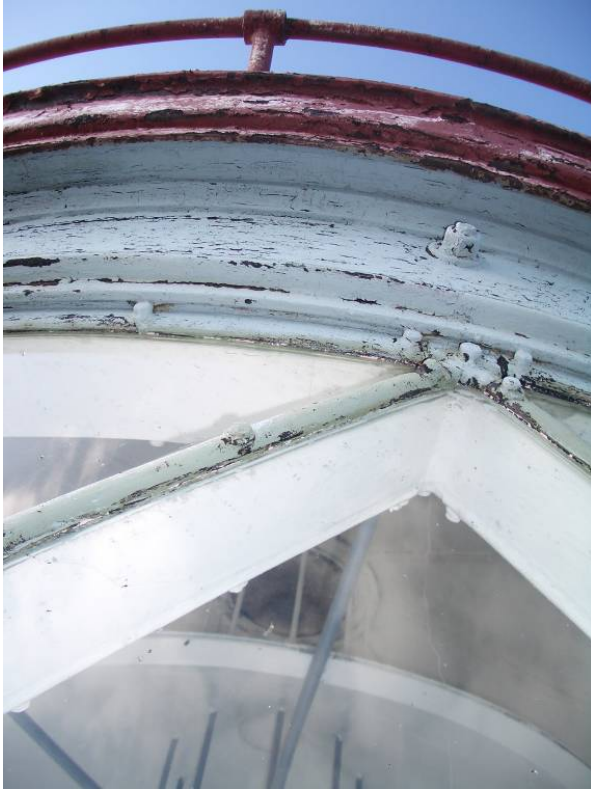
DI-LS-15: Lantern roof, glazing and trim detail (Source: A&A IMGP2875)

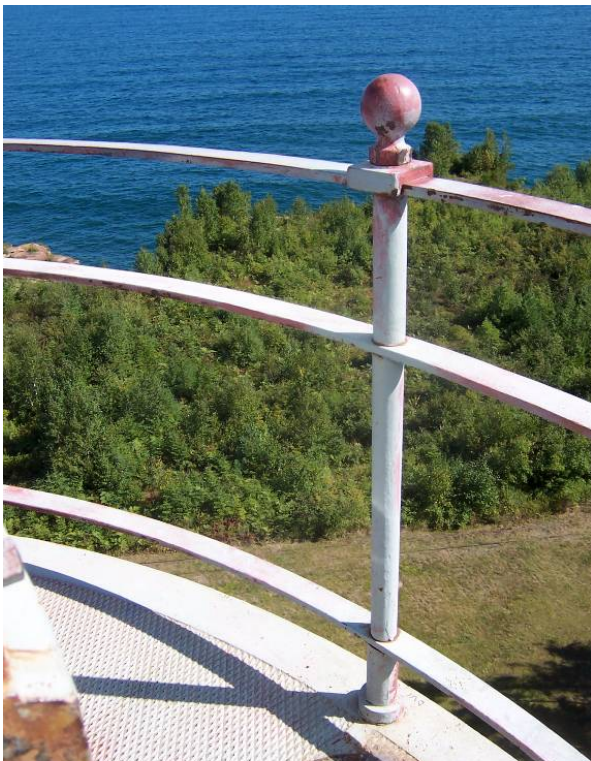
There is a diamond plate deck that is 2'-4" wide. Metal rails are located at 7", 2'-3", and 3'-0". The rails are 1/2" x 2" bar stock. Metal posts are 1 5/8" diameter with ball finials at 4'-0" on center. All metal is painted and original to the structure. (DI-LS-16)

The metal decking, rails, and posts are in fair condition with red paint appearing beneath the most recent white paint layer.

DI-LS-16: Lantern walkway and railing (Source: A&A 100_9704)

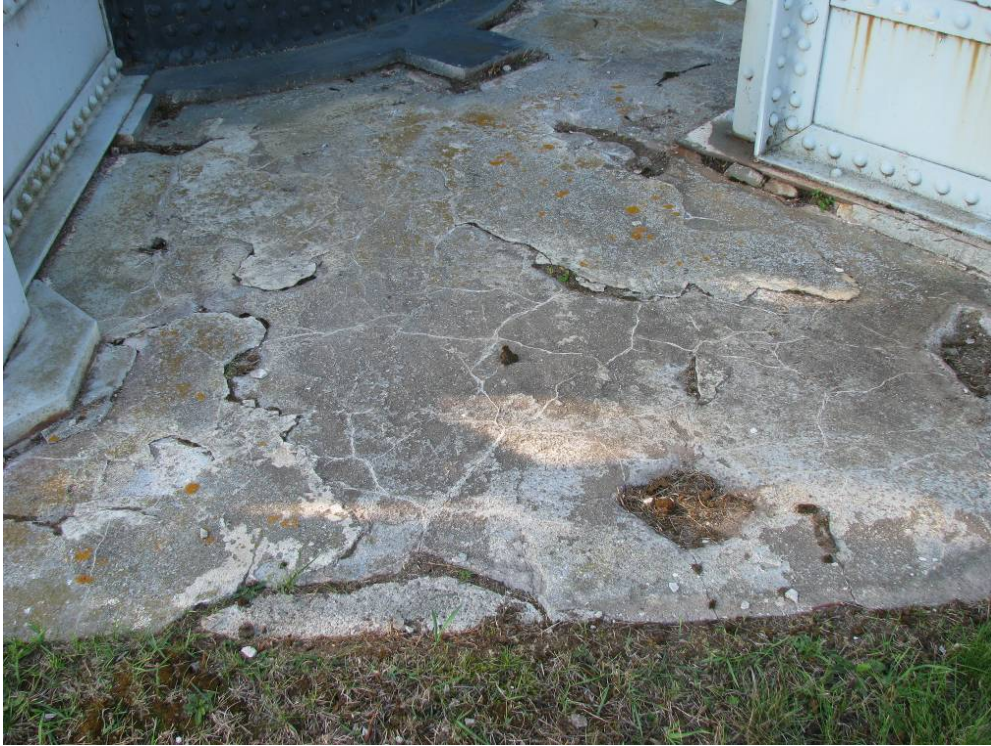
The visible portion of the foundation is in poor condition. The top surface of the mat is heavily cracked and the surface has started to deteriorate (DI-LS-17 and 18).

19 Lateral stability of the Tower is fair. Cracking of the mat foundation could be affecting the performance of
20 the exterior braces.

DI-LS-17: Severe cracking of mat foundation (Source: Martin/Martin)

Surface cracking of the mat foundation indicates that the concrete mat may be deteriorating. The cracking may also be leading to corrosion or loss of uplift capacity of the anchor bolts. The condition of the concrete and the anchor bolts should be evaluated further.

Lateral stability of the Tower should be evaluated further due to the cracking of the mat foundation.

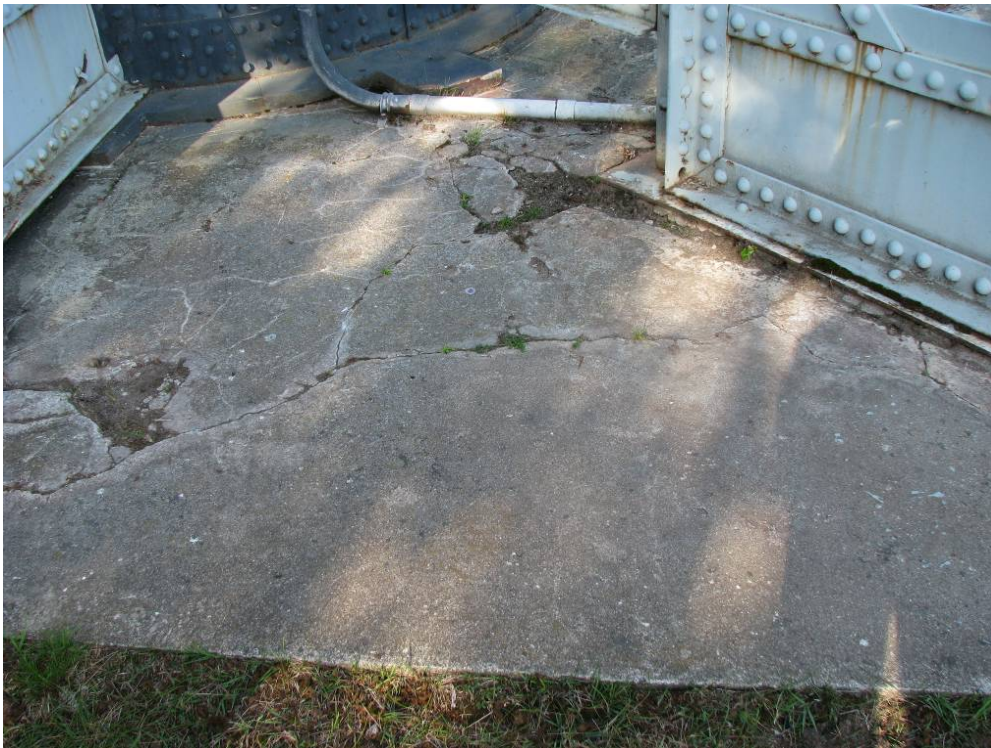
DI-LS-18: Cracking of mat foundation (Source: Martin/Martin)
