## KEEPERS QUARTERS

#### *Significant Alterations / Current condition*

## General Condition Assessment

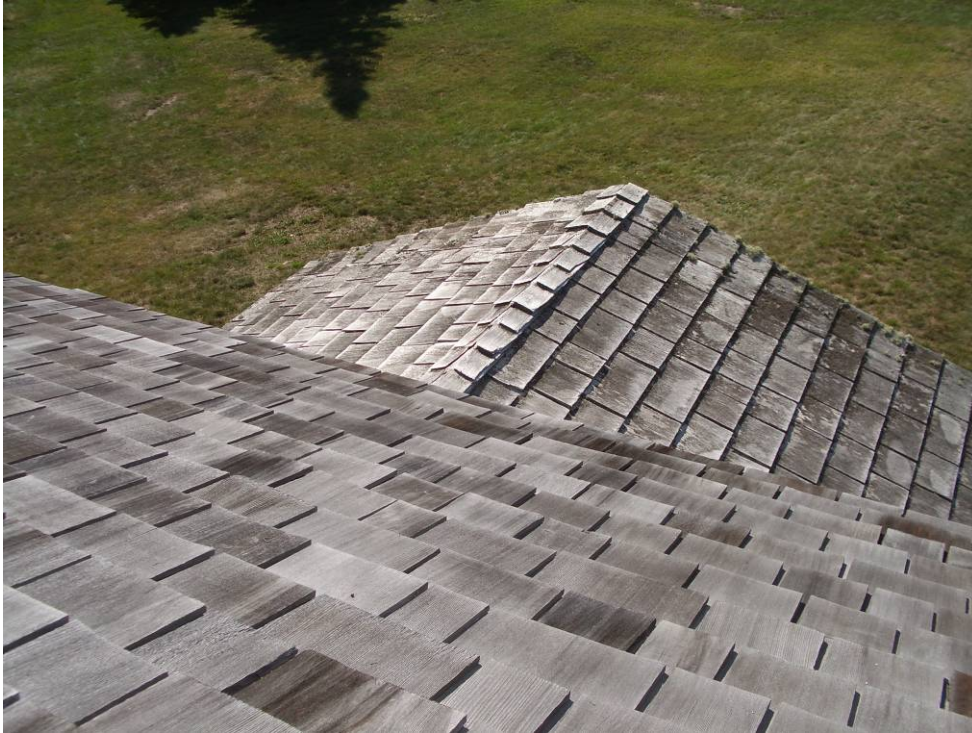
The main roof is in good condition. The south entry roof, which has the older cedar shingles, is in fair condition as it has moss growth and is weathered. The eaves, overall, appear to be in good condition with several areas of patching repair evident. The tie offs on the roof should not be used for life safety anchors until they can be certified as meeting OSHA requirements.

DI-KQ-05: South elevation roof shingles (Source: A&A IMGP2884)

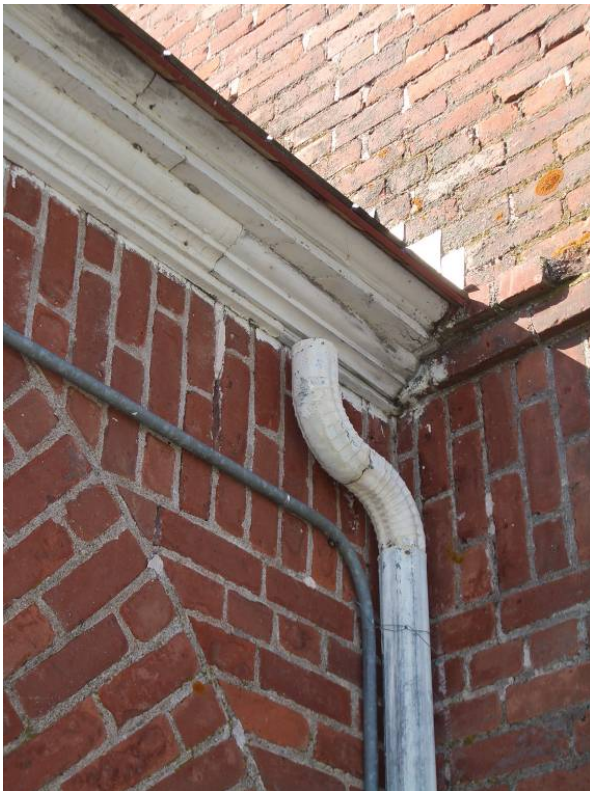
3 The sole remaining downspout is in poor condition as there is no existing gutter in situ.

DI-KQ-06: Downspout at north elevation porch (Source: A&A IMGP2887)

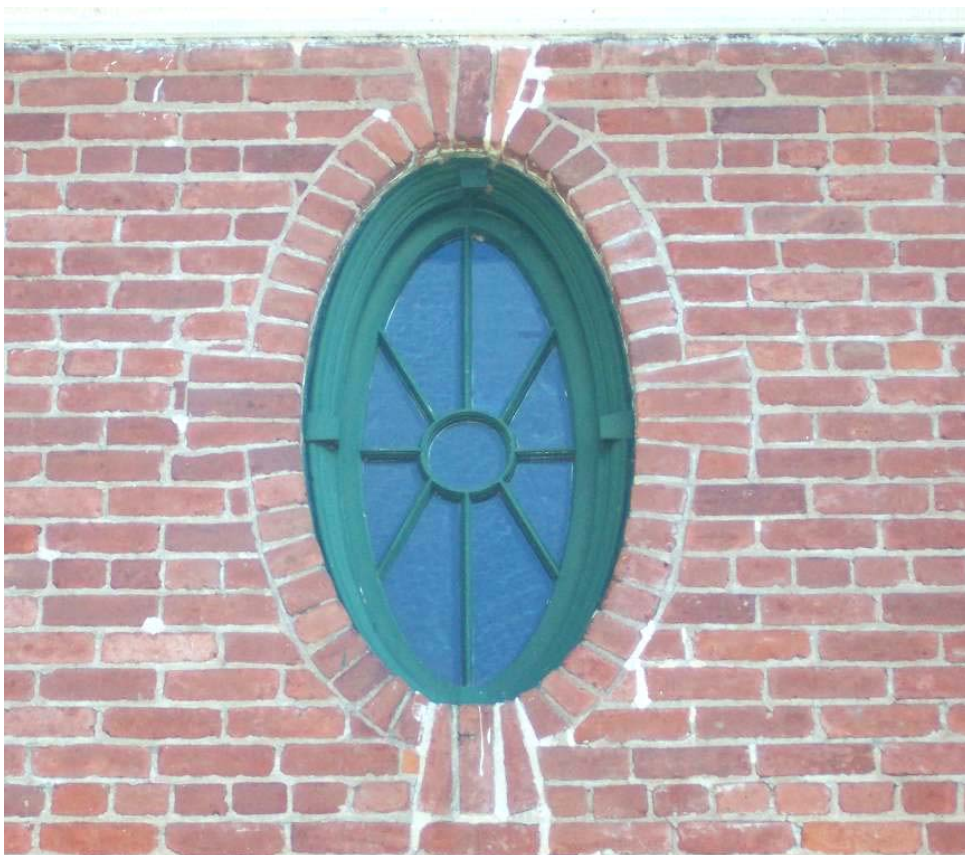
38 **Oval Windows.** There are two fixed, multi-lite oval windows located on the second floor. The oval  
 39 window on the east side of the building was replaced, or possibly reconstructed, in 1991 (from note on  
 40 HABS drawing). (DI-KQ-09, 28 and 31) Prior to its replacement, the window was rectangular, though  
 41 originally oval per historic photos. (Historic Images DI-01 and 06)

24 **Oval Windows.** The windows both have duct tape surrounding their frames and deterioration of members  
25 at joints. Original interior trim has been removed. They are in poor condition.

DI-KQ-09: Oval window detail, east elevation (Source: A&A 100\_9718)

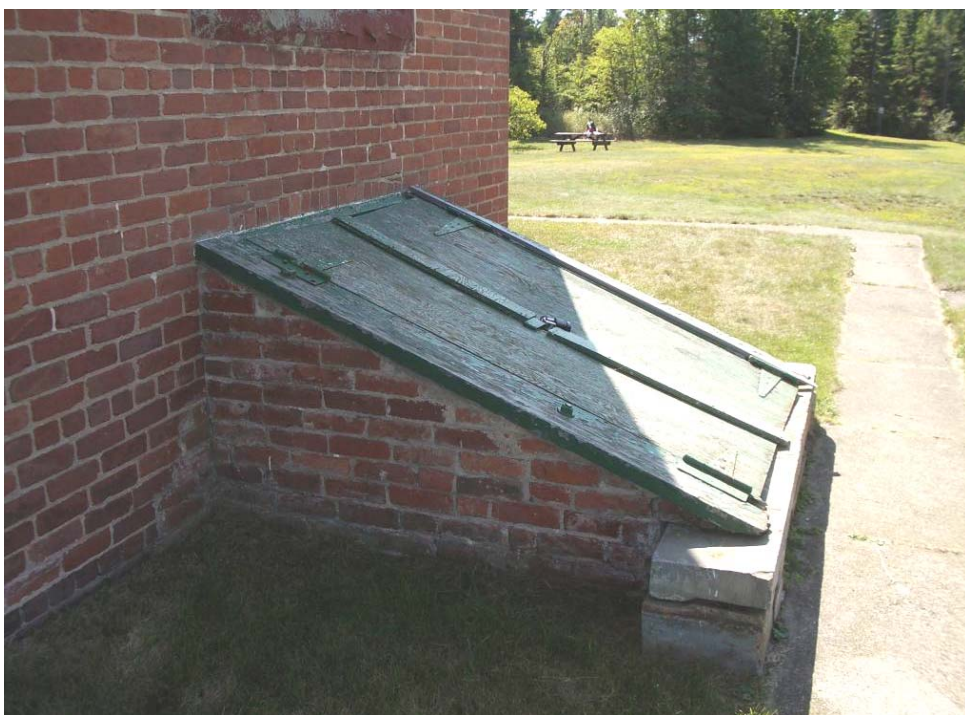
The side walls of the hatch are red brick and are separate from the house walls (not toothed into the original wall). The door frame is a stone ledge, the frame itself is wood (painted), and the double hatch doors are plywood (also painted). From original drawings and historic photos, the hatch location is original to the building, though the wood elements have been replaced through the years. (DI-KQ-10)

The basement hatch is in fair condition as the previous pointing is evident on the side walls (different color mortar) and the wood hatch frame is rotted at the bottom.

DI-KQ-10: West hatch doors and foundation (Source: A&A IMGP2892)

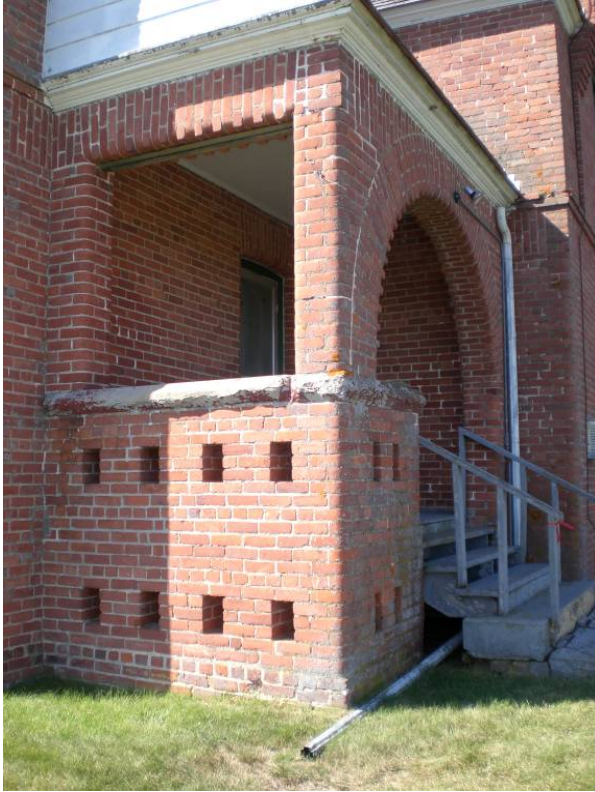
This porch has a wood floor with tongue and groove decking with a ¼” round base shoe at the brick wall junction (both floor and trim painted blue-gray). The floor does not appear to be original as the joist pockets, which can be seen and the level of the previous porch, may have been higher as indicated by the paint line. The porch was once screened-in. The wood stairs are contemporary and made of 2x12 treads, riser height between 4 ¼” and 7 ¾”, and a loose 2x4 wood handrail. The porch’s brick knee wall is capped with painted brownstone. Underneath the porch is a black membrane attached to the exterior masonry wall. Sand and previous roofing debris has collected in the space. (DI-KQ-11 and 12)

The porch is in overall good condition, the newer wood floor is in fair condition, and the stair and railing are in poor condition because they do not meet modern safety codes.

DI-KQ-11: Main entry porch and stair, looking southwest (Source: A&A CIMG3707)

3. Add code compliant guardrail and handrail at porch and stair	Modern code upgrade could be visually disruptive to the historic integrity of the building.	Design a guardrail and handrail as discretely as possible.	- Improves safety for visitors and staff

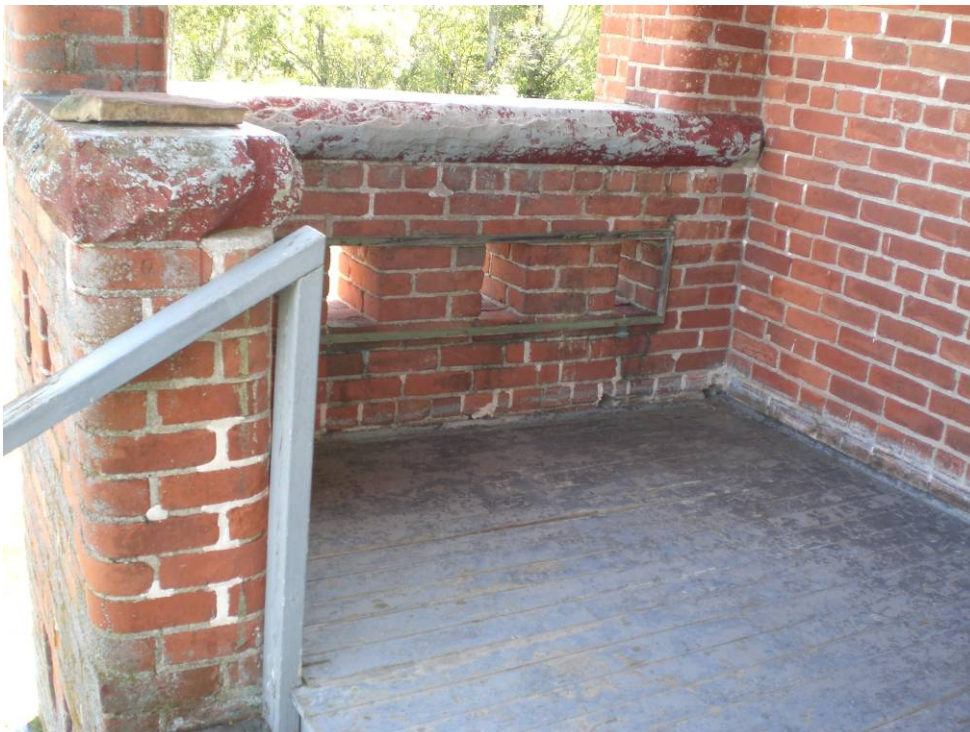
DI-KQ-12: Porch floor and walls, looking southwest (Source: A&A CIMG3709)

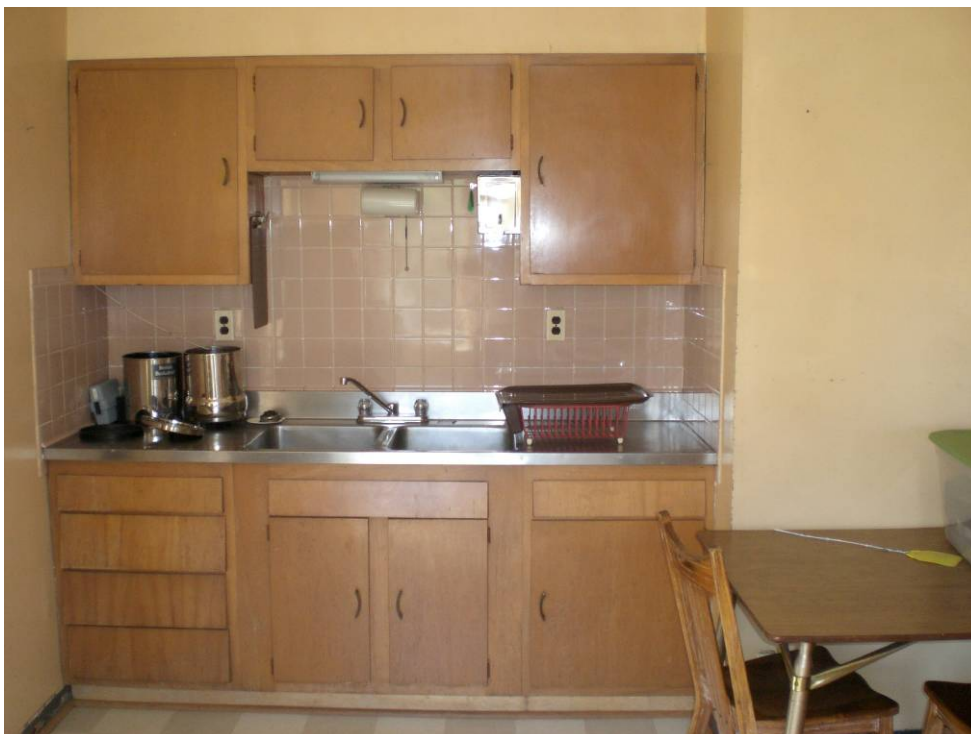
**Kitchen.** The kitchen has two sections of built-in nonhistoric base and wall cabinets along the west and north walls. The west wall's cabinets have a stainless steel countertop, while the north wall has a laminate countertop. (DI-KQ-21)

The kitchen's two sections of built-in nonhistoric base and wall cabinets are both in good condition. The first floor bedroom's closet hook racks and built-in shelving are in good condition. The second floor hall's built-in attic ladder located on the south wall is in good condition.

DI-KQ-21: Kitchen cabinets, west elevation (Source: A&A CIMG3734)

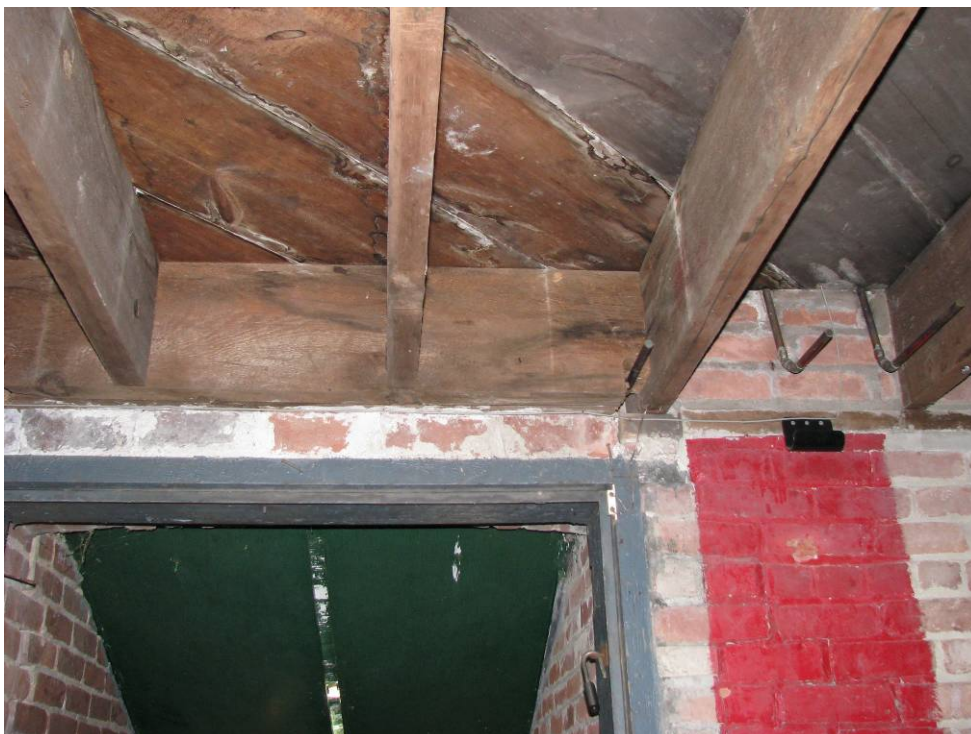
The framing for the first floor is in fair condition. Floor joists that are headed off above doors and windows are not properly supported. (DI-KQ-33) The middle of a triple 2x10 beam below the entry has been cut out and pipe columns have been installed each side of the cutout. The floor joists above the cutout are unsupported and the pipes are crushing into the beam. (DI-KQ-34) One floor joist has been damaged. (DI-KQ-35) Floor joists are unsupported on either side of an opening in an interior wall at the cistern. (DI-KQ-36)

DI-KQ-33: Joist header above hatch doors (Source: Martin/Martin)

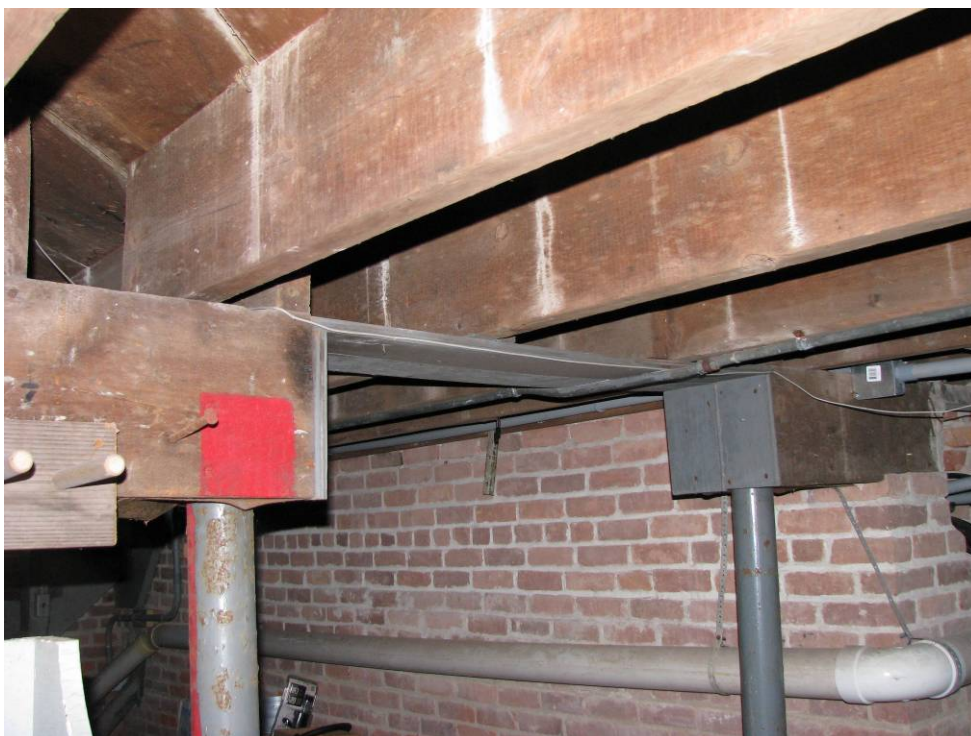
The exterior walls are in good condition. The interior walls could not be observed, thus their condition is unknown. Wall finishes on the first and second floors were cracked above the first floor beam that had been cut.

DI-KQ-34: Cut out (3) 2x10 beam (Source: Martin/Martin)

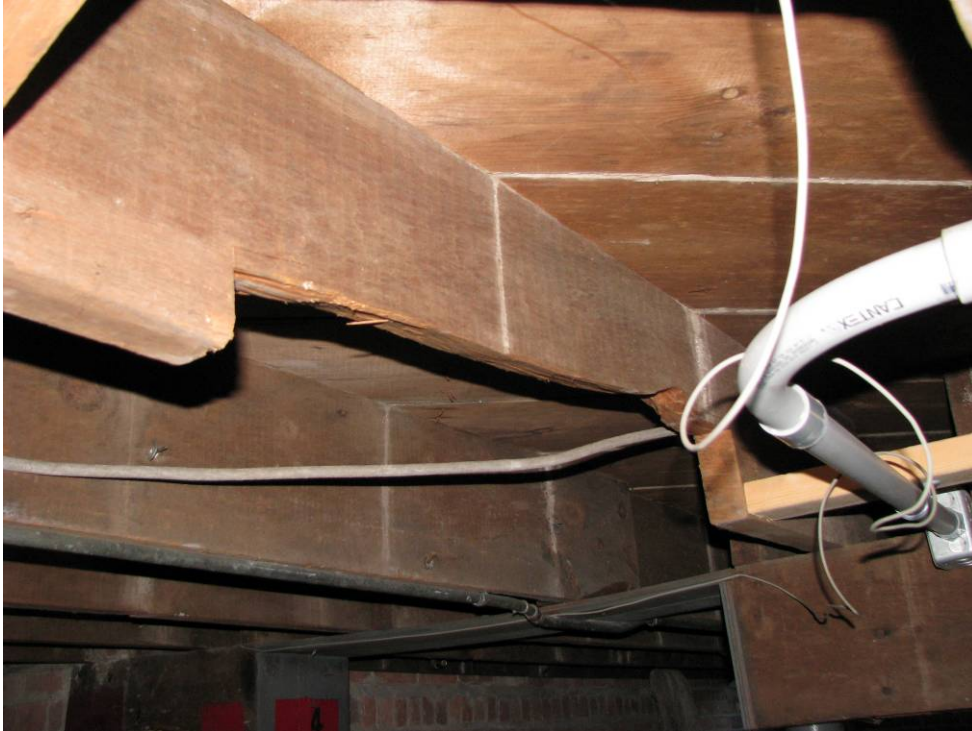
DI-KQ-35: Damaged floor joist (Source: Martin/Martin)

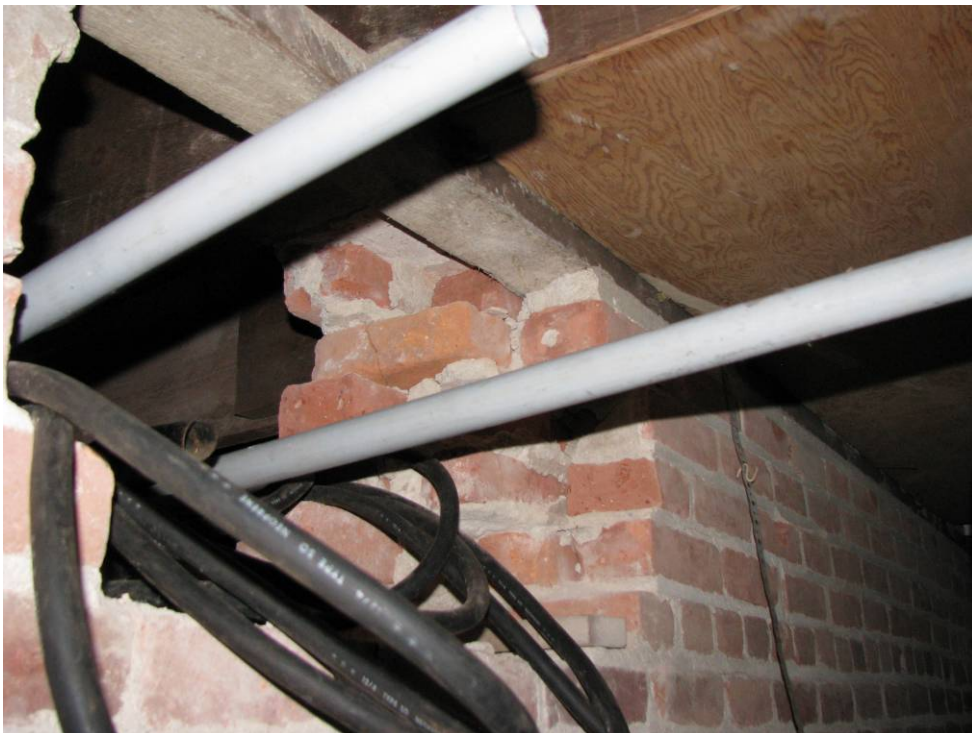
DI-KQ-36: No joist support at cistern (Source: Martin/Martin)

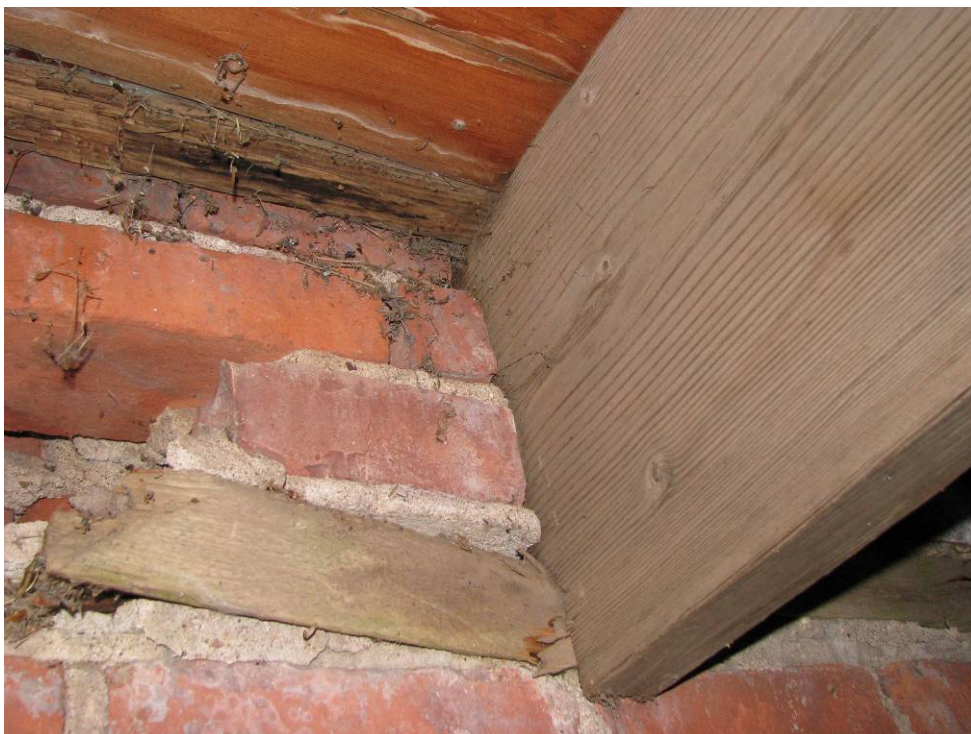
Framing for the front porch is in poor condition. The east ends of the joists are rotten. The east edge of the tongue and groove decking is also rotten. (DI-KQ-37)

DI-KQ-37: Deterioration at front porch (Source: Martin/Martin)
