1 ASSISTANT KEEPERS QUARTERS

General Condition Assessment

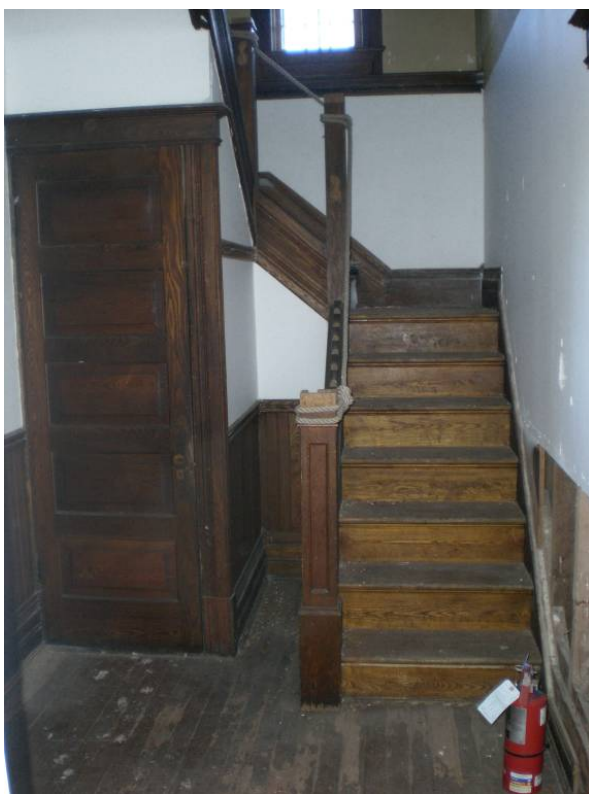
DI-AKQ-16: Stairs to second floor, east elevation, looking up (Source: A&A CIMG3845)

First Floor to Second Floor Stairs. These stairs are stained wood with only the newels remaining in the balustrade. A rope is acting as the handrail. There are seven risers (8" high) to a landing and then another eight risers. The treads are 10 3/4" deep with a 1" nosing. The stairs and newels are original to the building. (DI-AKQ-16)

3
4 **First Floor to Second Floor Stairs.** These stairs are missing most of the balustrade, only the newel posts
5 remain. Stain is faded and worn. Overall, the stairs are in poor condition.

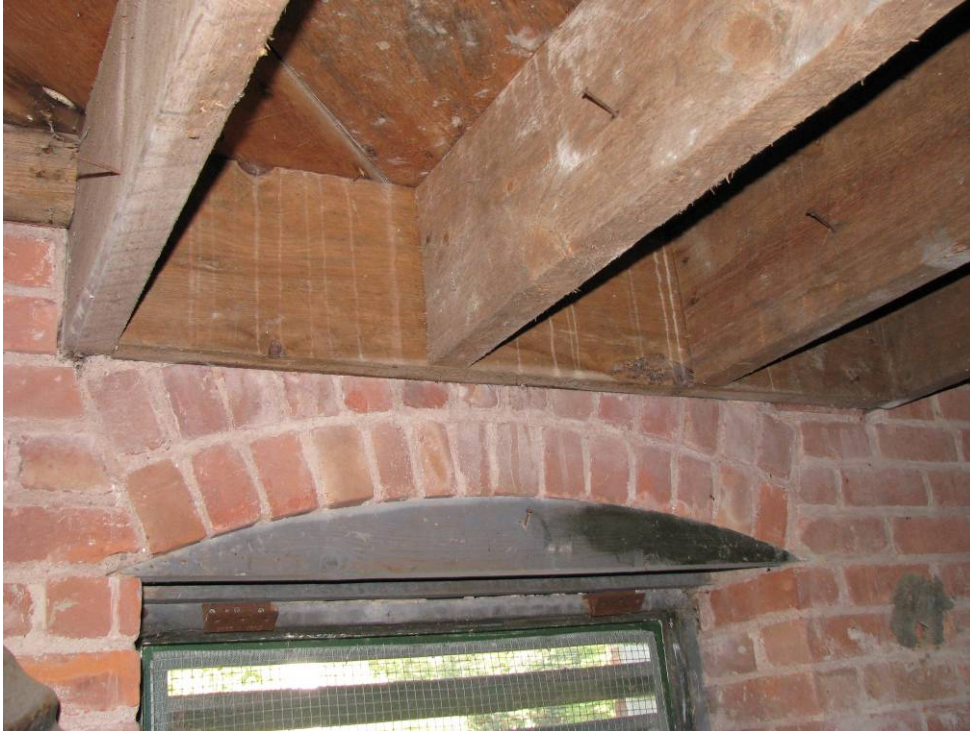
27 The basement floor is in good condition. The framing for the first floor is in fair condition. Floor joists that
28 are headered off above doors and windows are not properly supported (DI-AKQ-31). One floor joist has
29 been cut for plumbing work and another joist is damaged (DI-AKQ-32). The base of four posts that support
30 the stair and first floor are rotten. (DI-AKQ-33)

DI-AKQ-31: Joist header above basement window (Source: Martin/Martin)

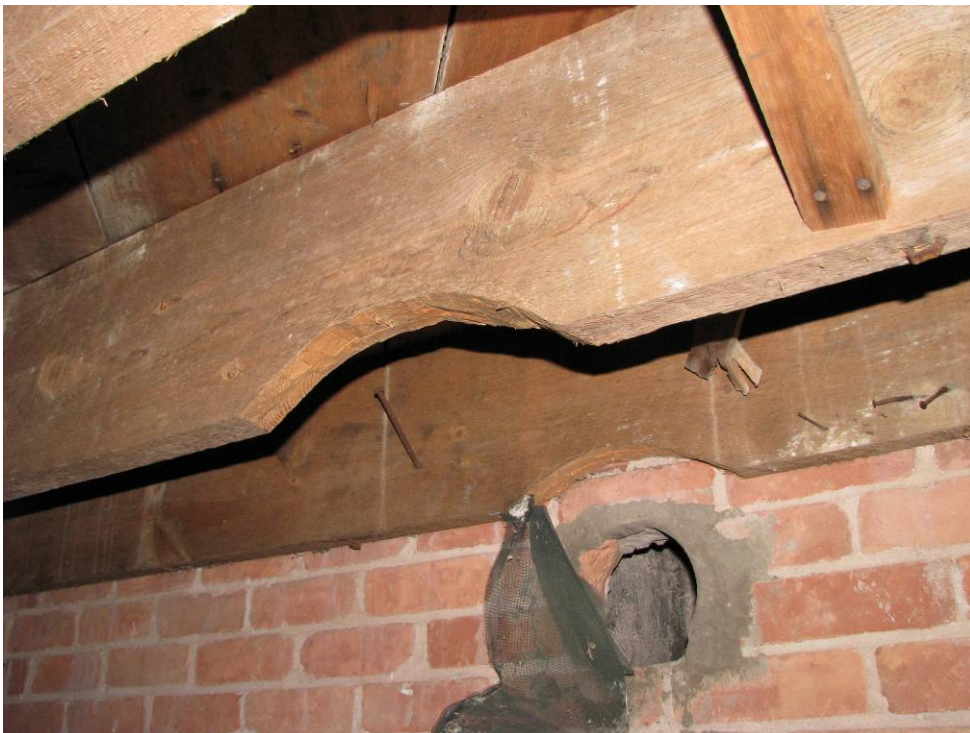
DI-AKQ-32: Damaged floor joist (Source: Martin/Martin)

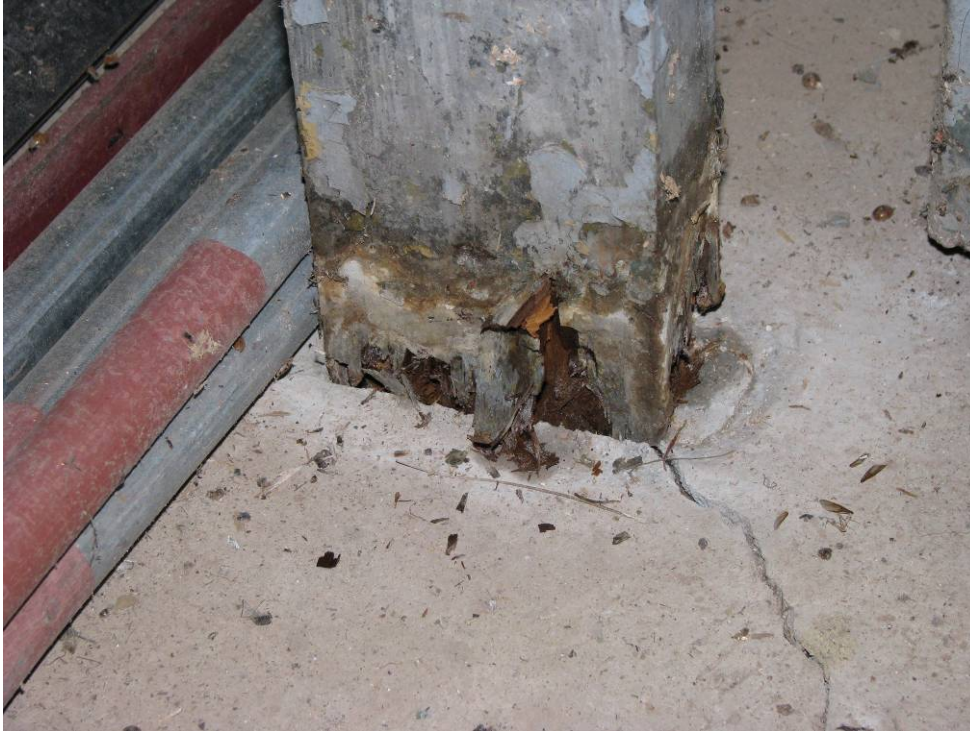
DI-AKQ-33: Deterioration at base of post at basement (Source: Martin/Martin)

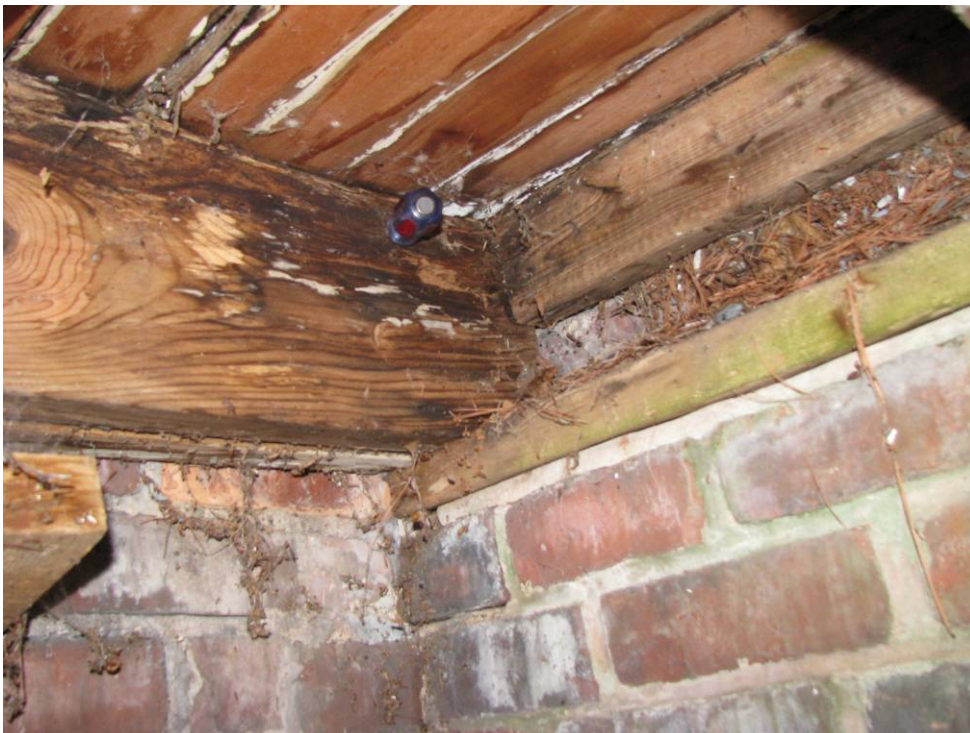
31
32 Framing for the front porch is in poor condition. The east ends of the joists are rotten. The east edge of the
33 tongue and groove decking is also rotten (DI-AKQ-34).

DI-AKQ-34: Deterioration at front porch (Source: Martin/Martin)

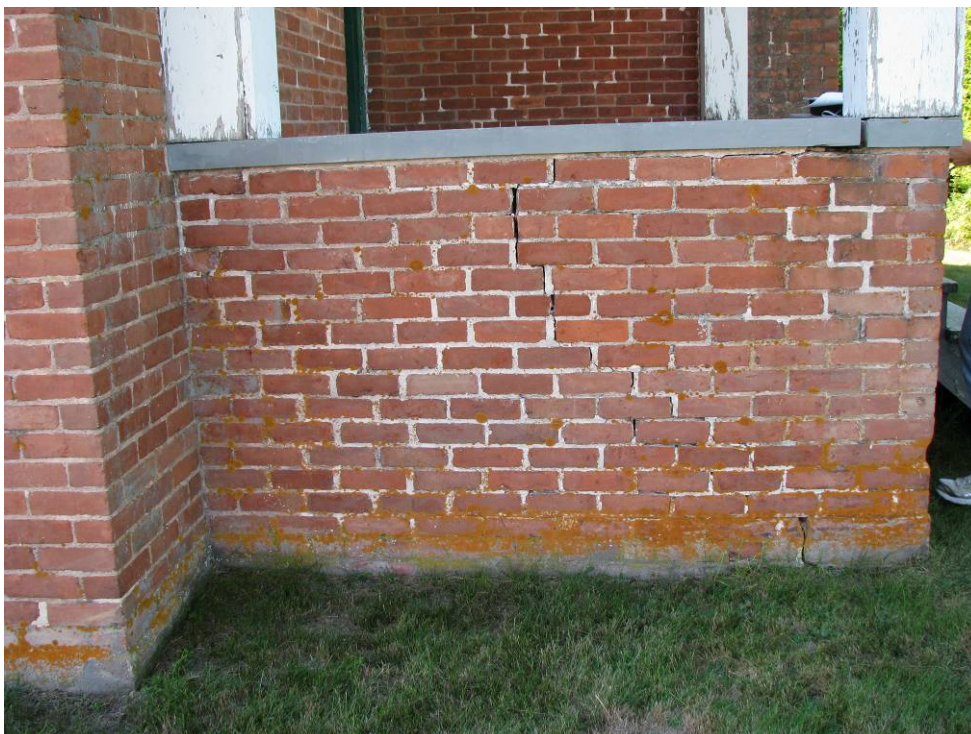
The exterior masonry walls are in fair condition. There are numerous cracks in the north and east walls of the front porch that indicate settlement of the foundation (DI-AKQ-35 and 36). The framing of the interior walls, where it was accessible, is in good condition. The condition of the remainder of the walls is unknown. No obvious signs of distress or damage were observed.

DI-AKQ-35: Cracked masonry at front porch (Source: Martin/Martin)

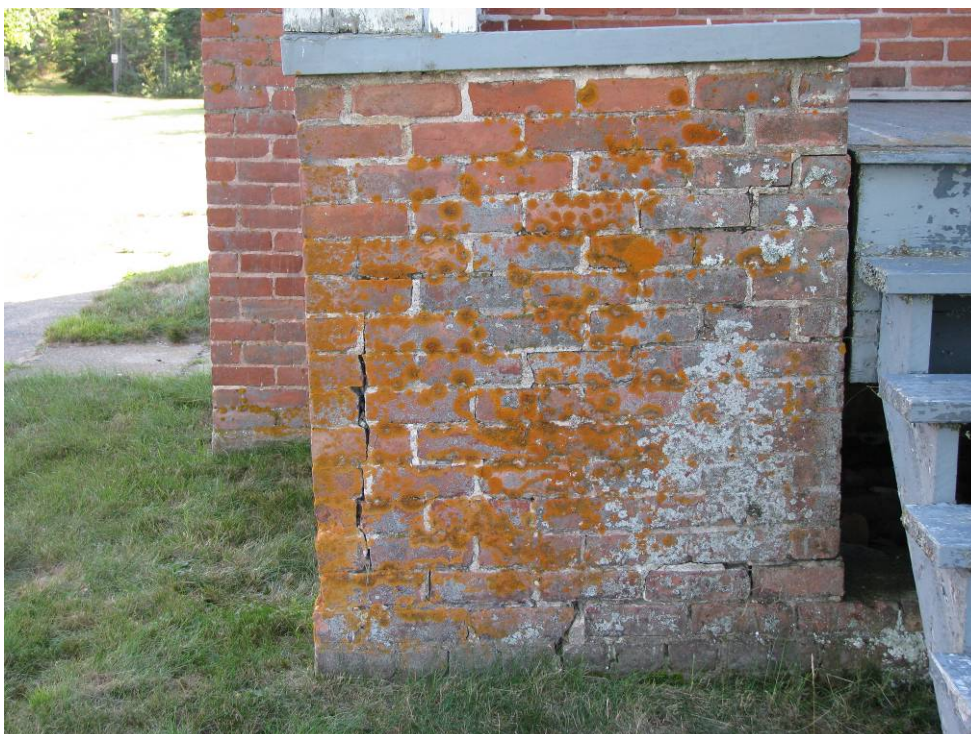
DI-AKQ-36: Cracked masonry at front porch (Source: Martin/Martin)

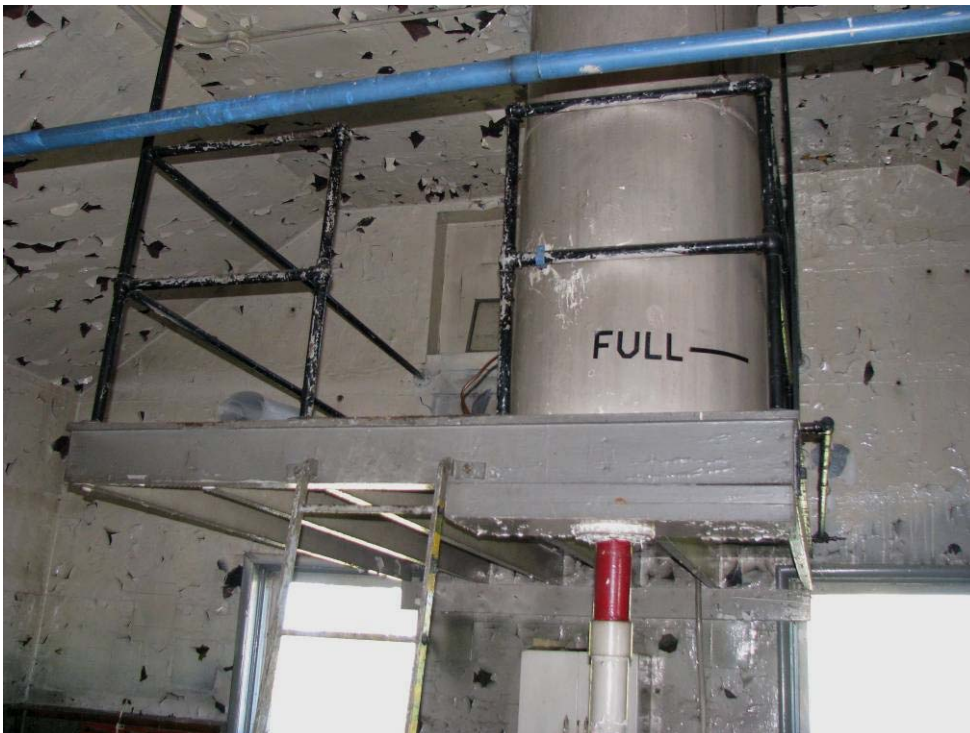
DI-FSB-21: Offset column at loft header beam (Source: Martin/Martin)

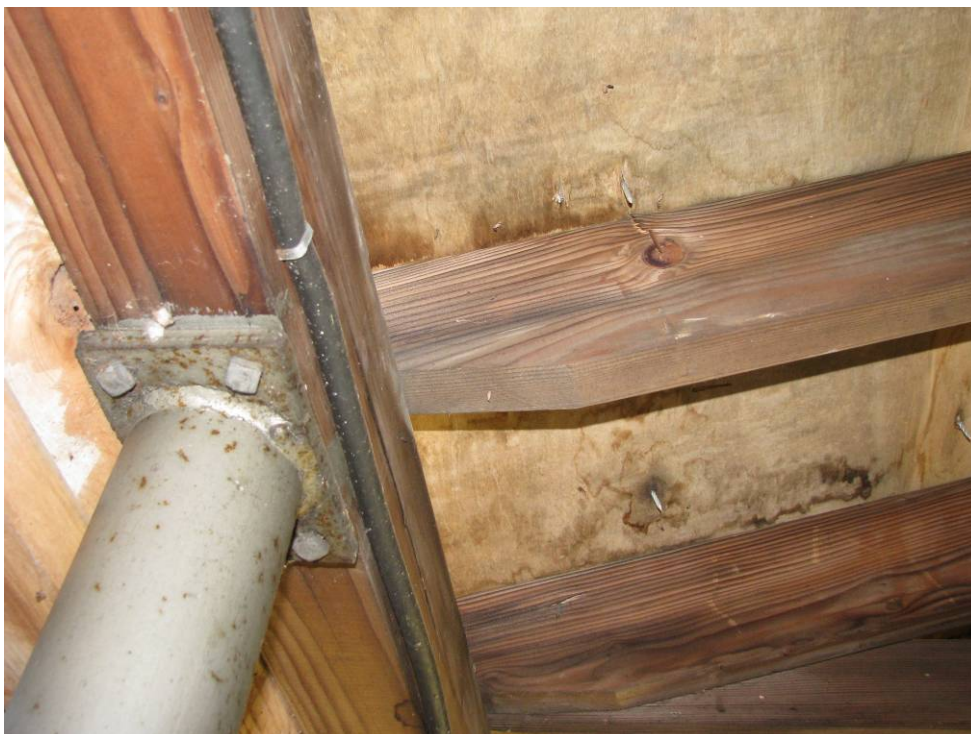
DI-FSB-22: Notched joist at eave (Source: Martin/Martin)

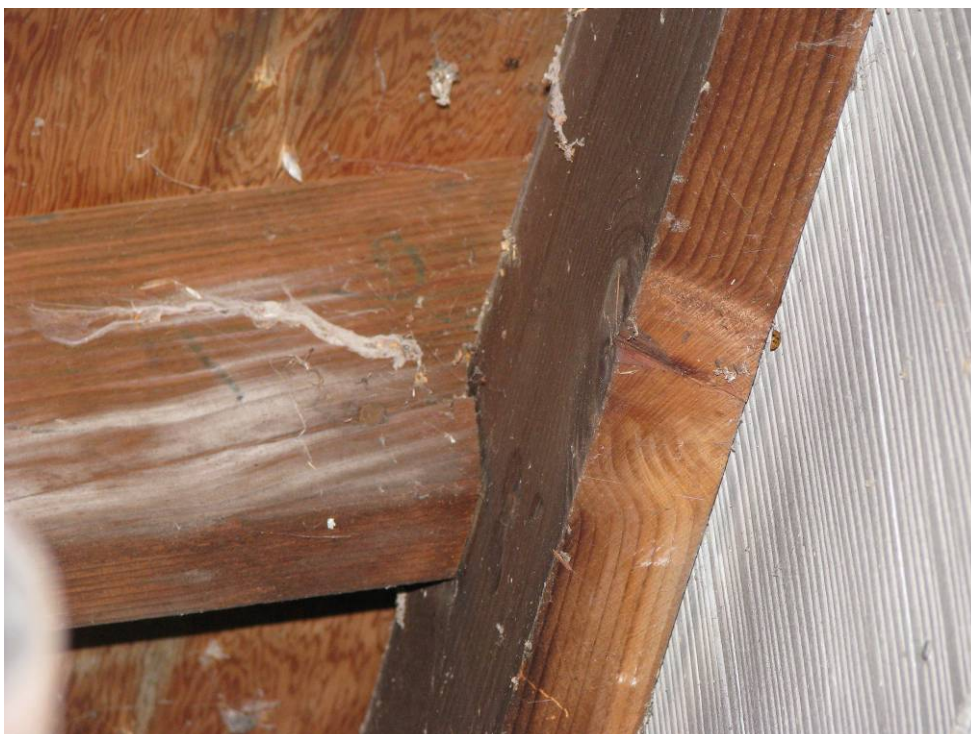
DI-FSB-23: Notched joist at rafter bearing (Source: Martin/Martin)

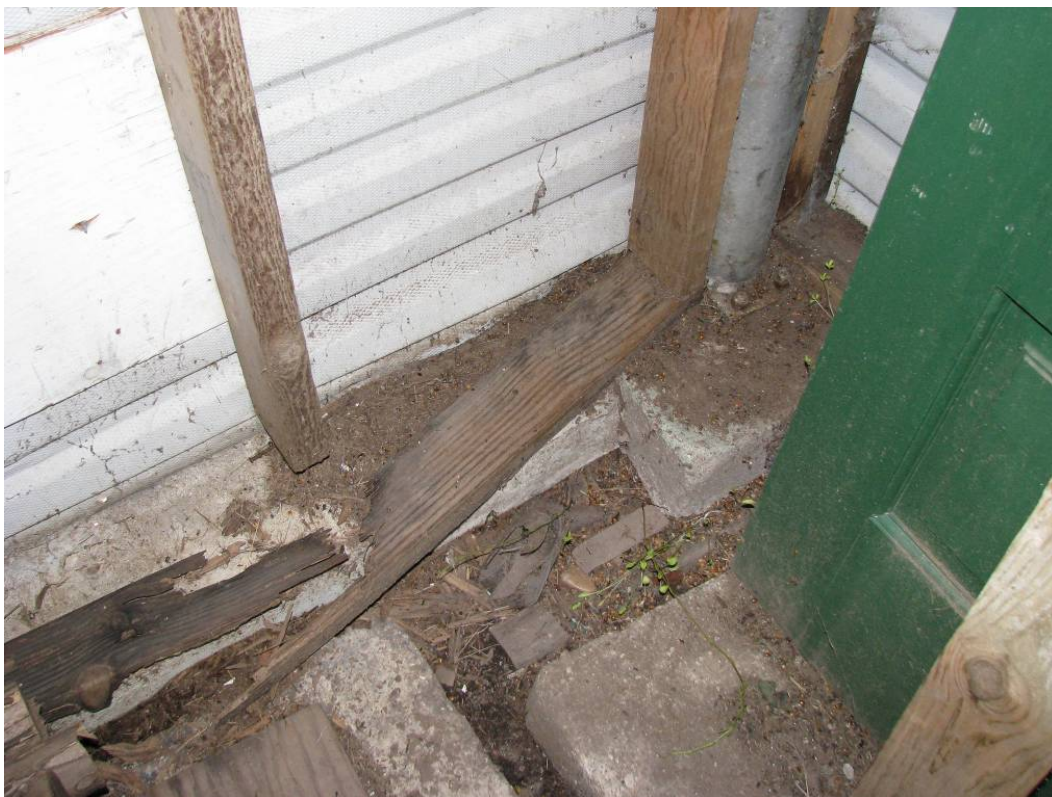
DI-FSB-24: Deteriorated sill plate (Source: Martin/Martin)
