OIL HOUSE #1

Chronology of Alterations and Use

1 ***Oil House #1 Photographs, 2009***

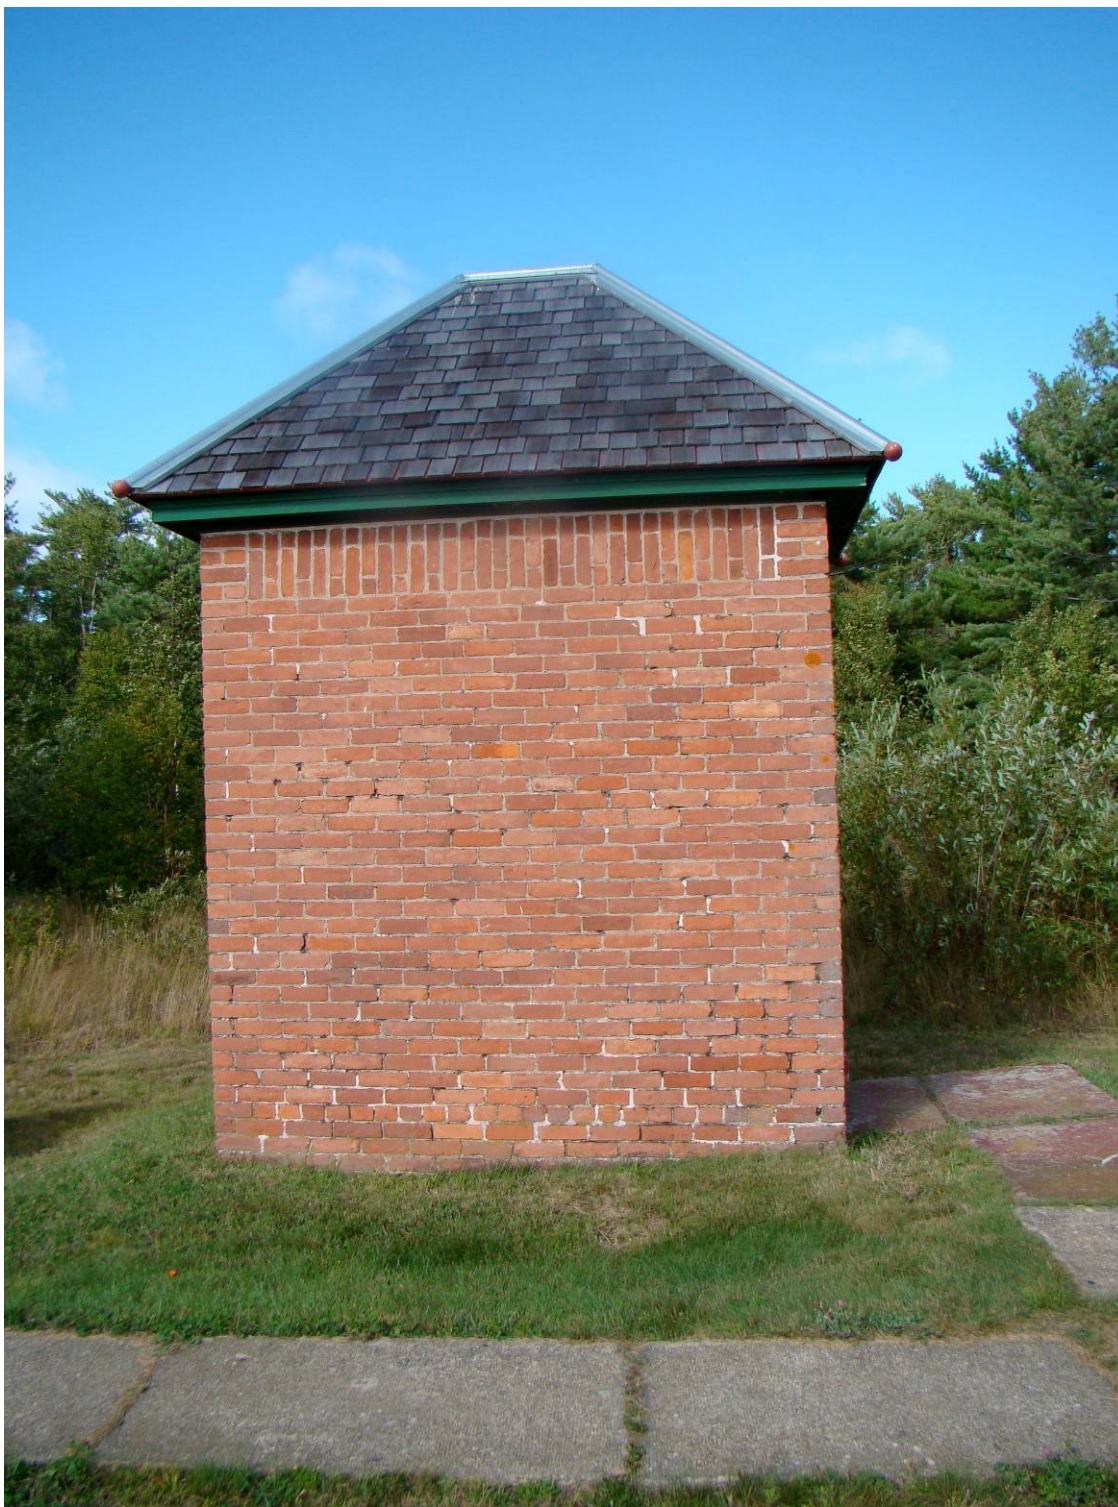
2
3 *DI-OH1-01: North elevation, 2009 (Source: A&A DSC00874)*

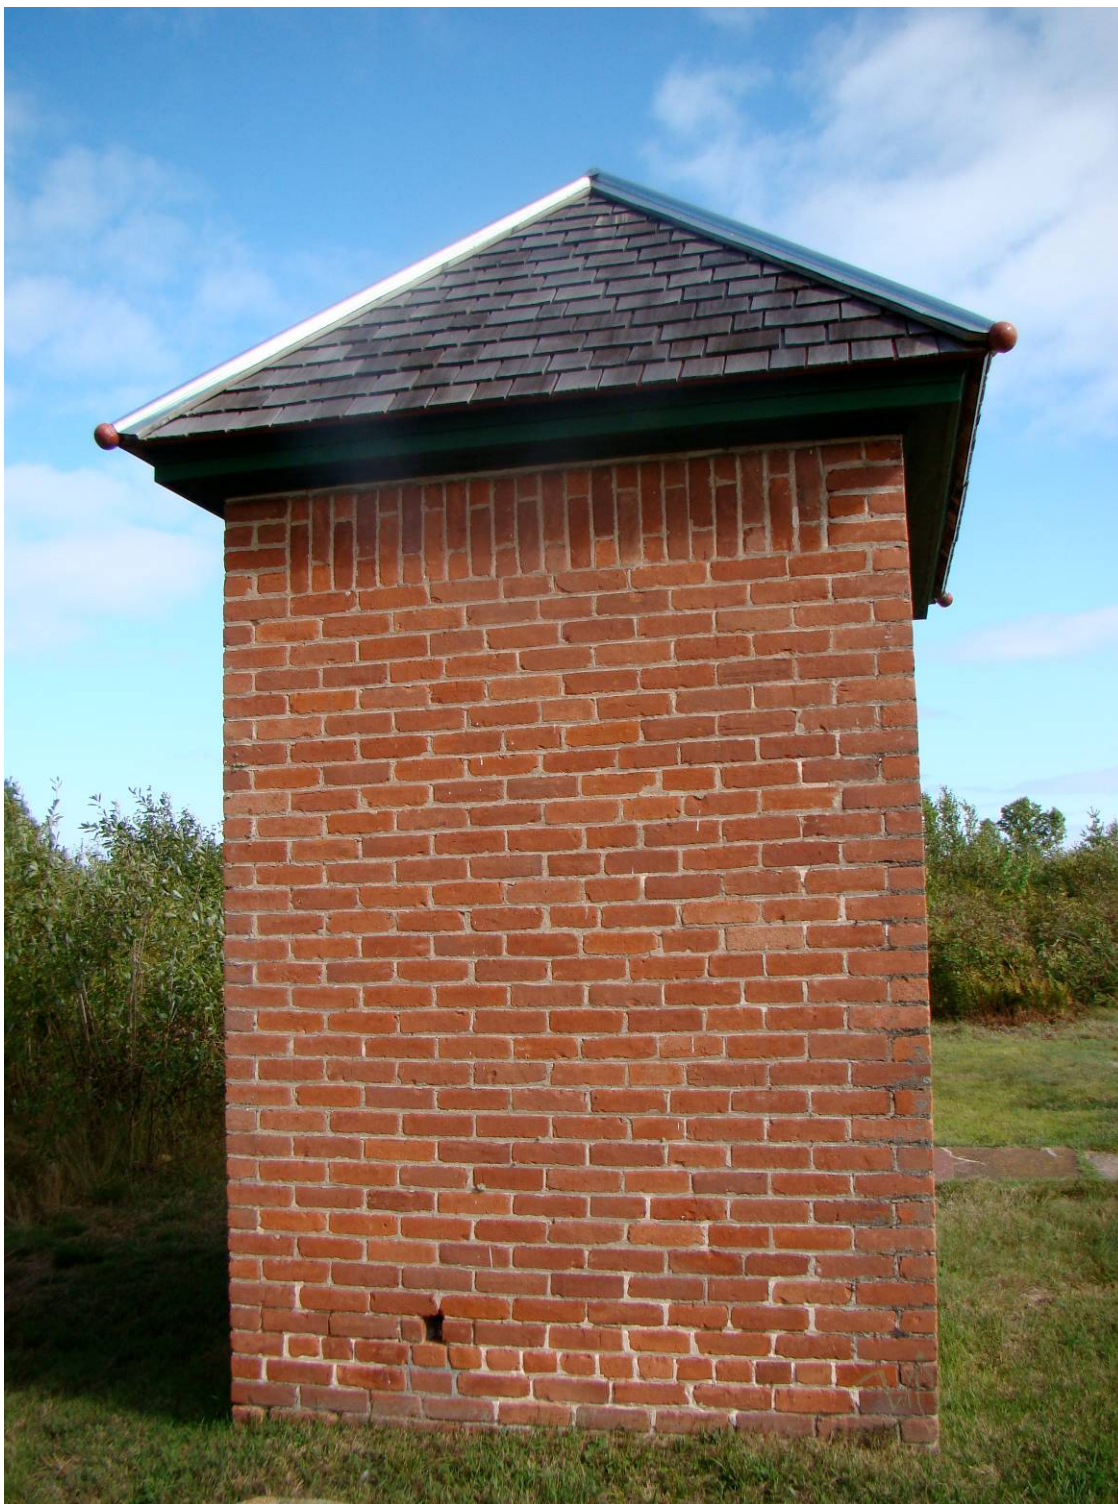
DI-OH1-02: East elevation, 2009 (Source: A&A DSC00875)

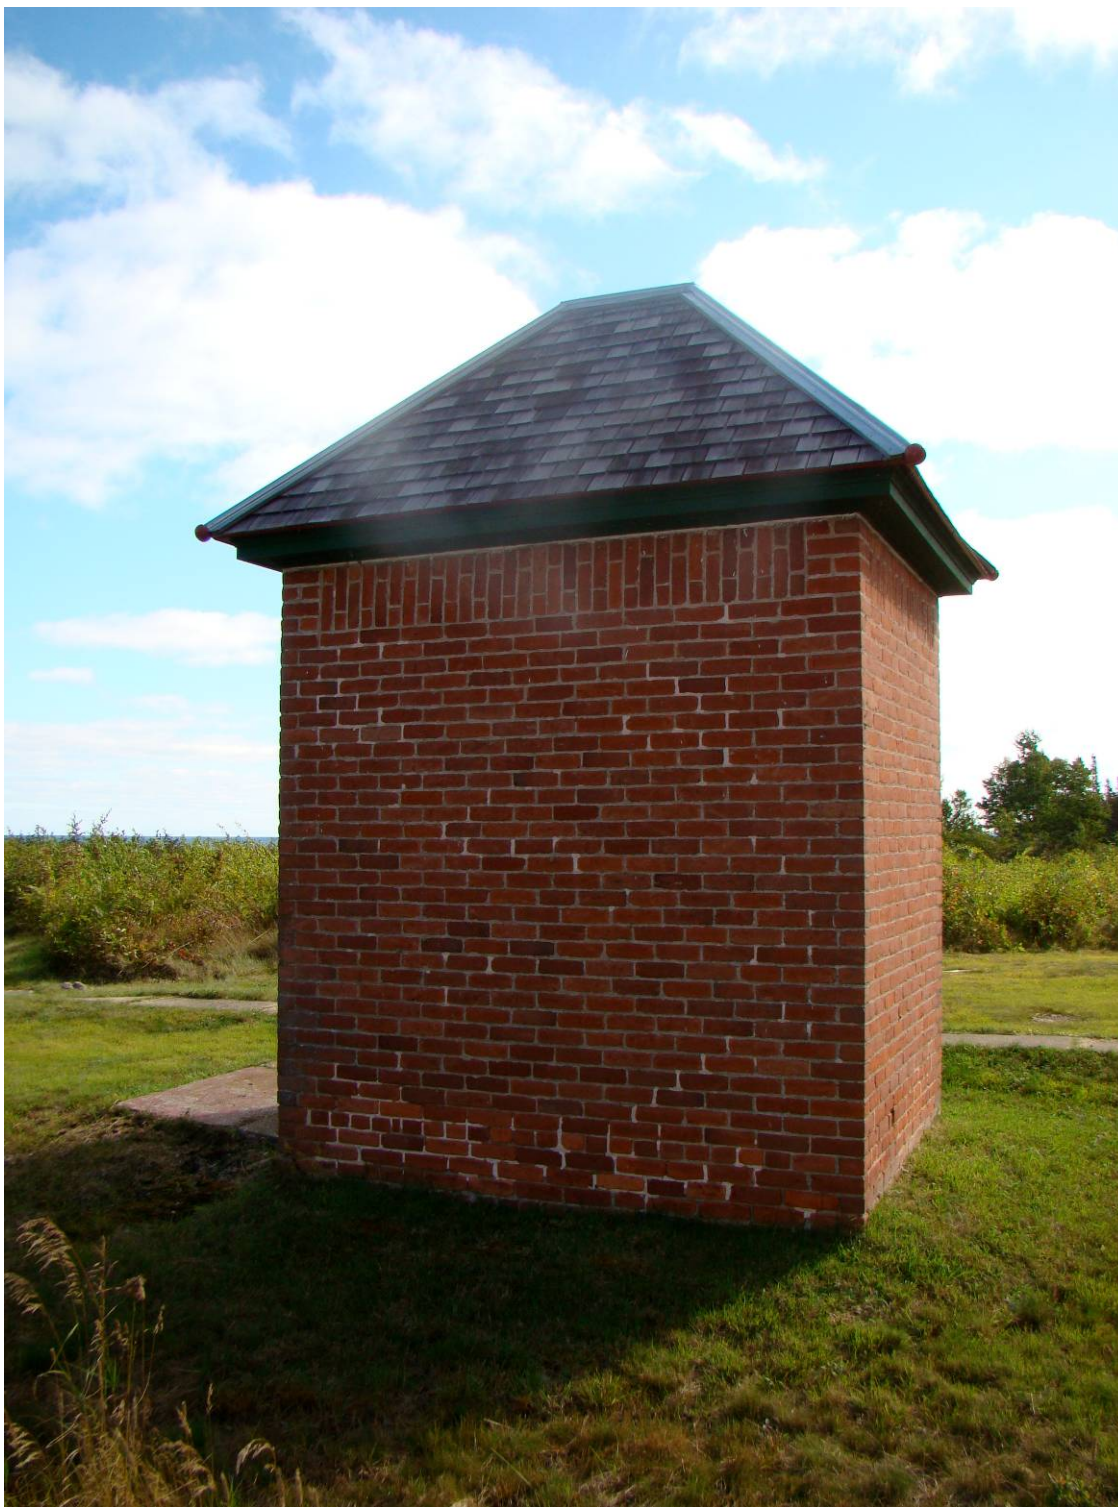
DI-OH1-03: South elevation, 2009 (Source: A&A DSC00876)

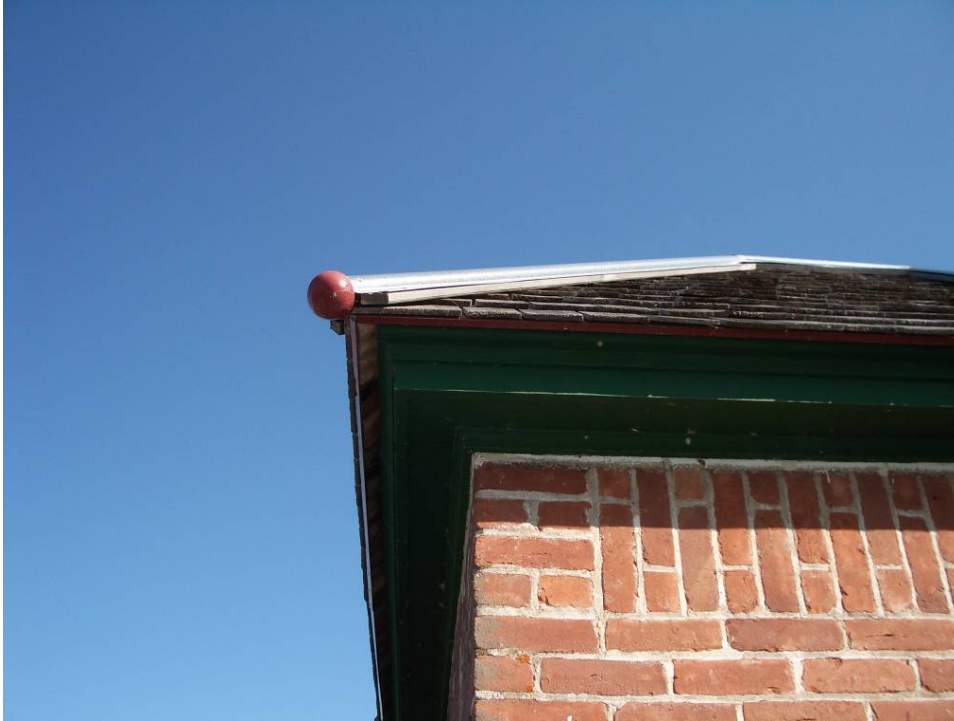
This roof and eave are in good condition.

DI-OH1-05: Roof, trim and wall detail (Source: A&A IMGP2919)

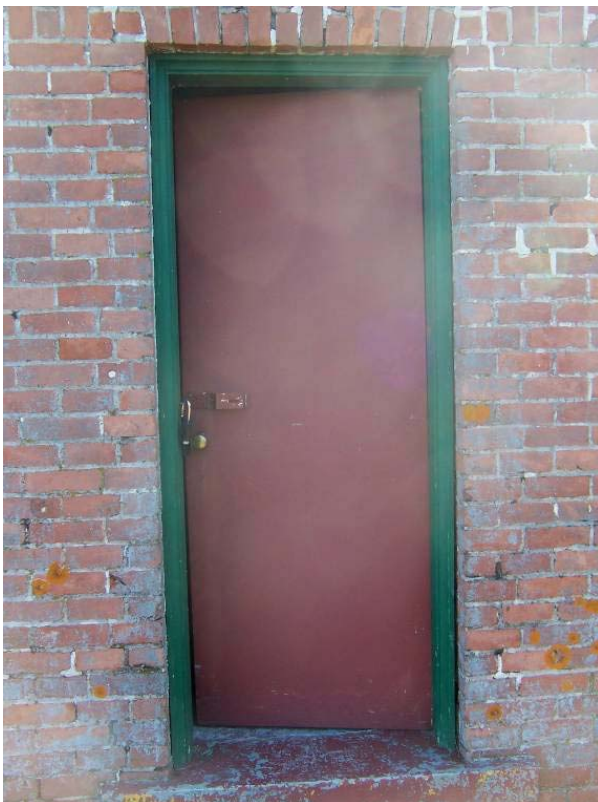
The entry door is a contemporary wood, flush, hollow-core door with two hinges and contemporary hardware. (DI-OH1-06)

The entry door is in fair condition as the frame of the door is beginning to separate from the masonry near the bottom hinge.

DI-OH1-06: North elevation entry door (Source: A&A 100_9779)

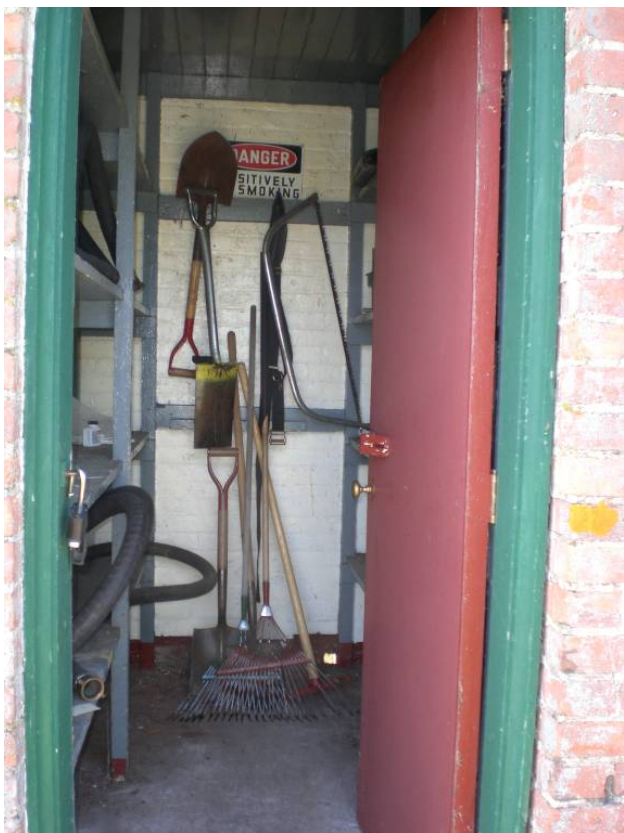
DI-OH1-07: South view into interior (Source: A&A CIMG3670)

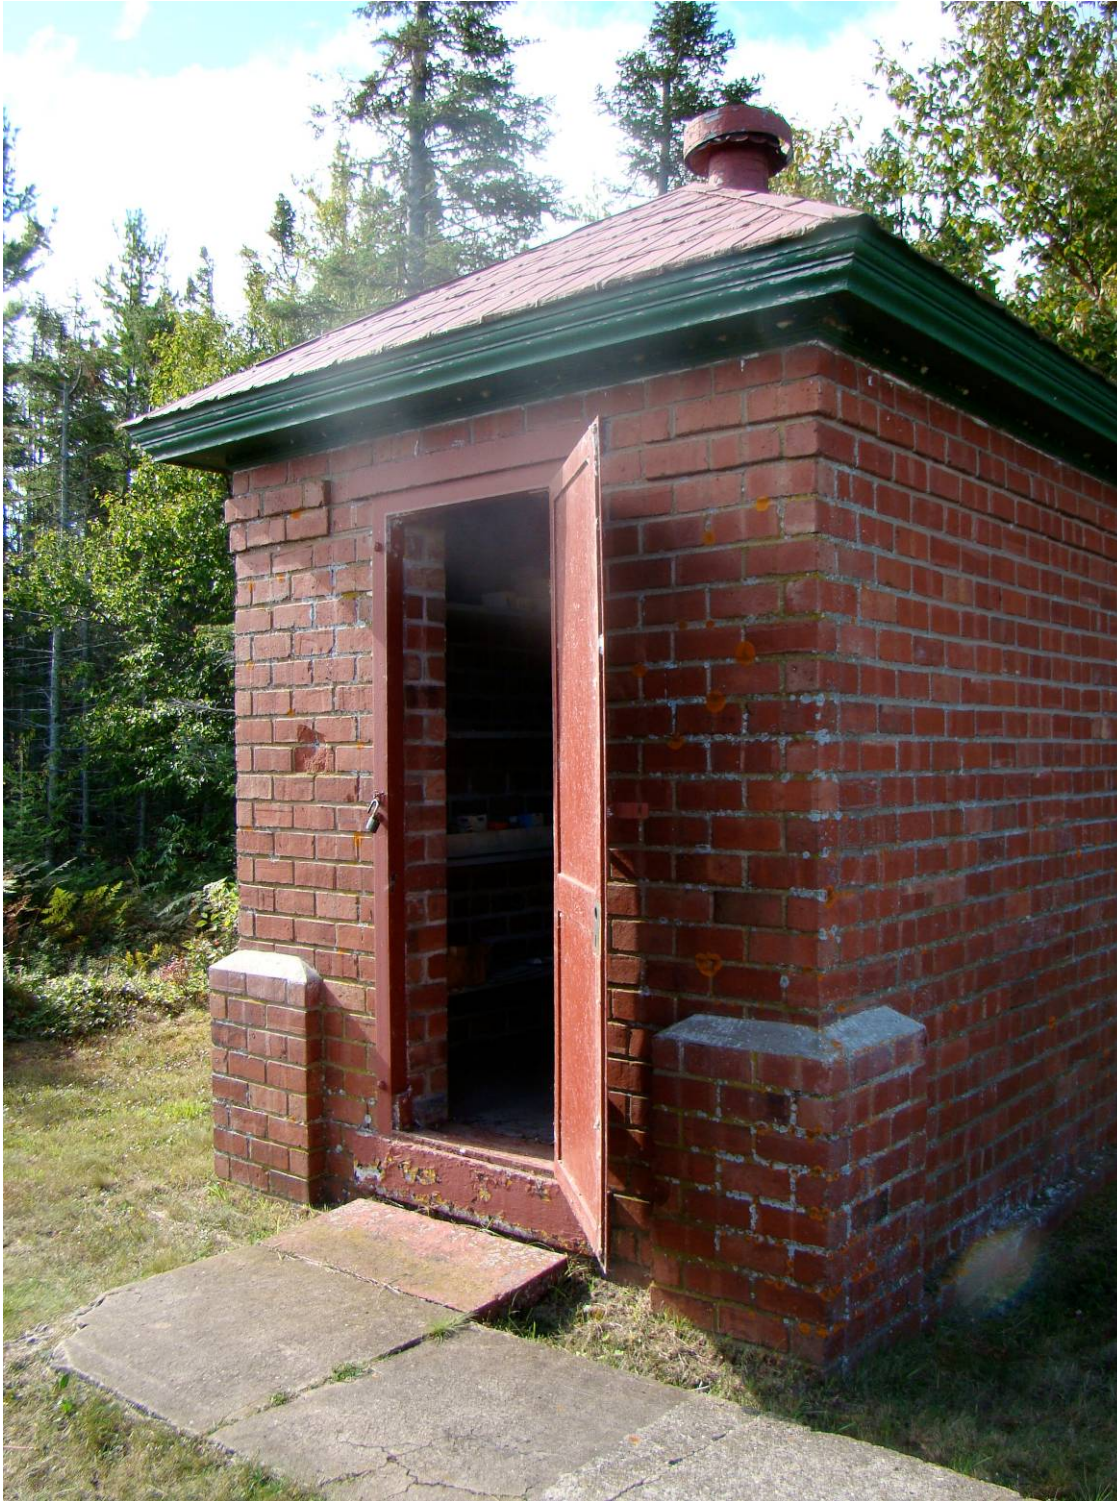
2
3 *DI-OH2-01: Northeast elevation, 2009 (Source: A&A DSC00872)*

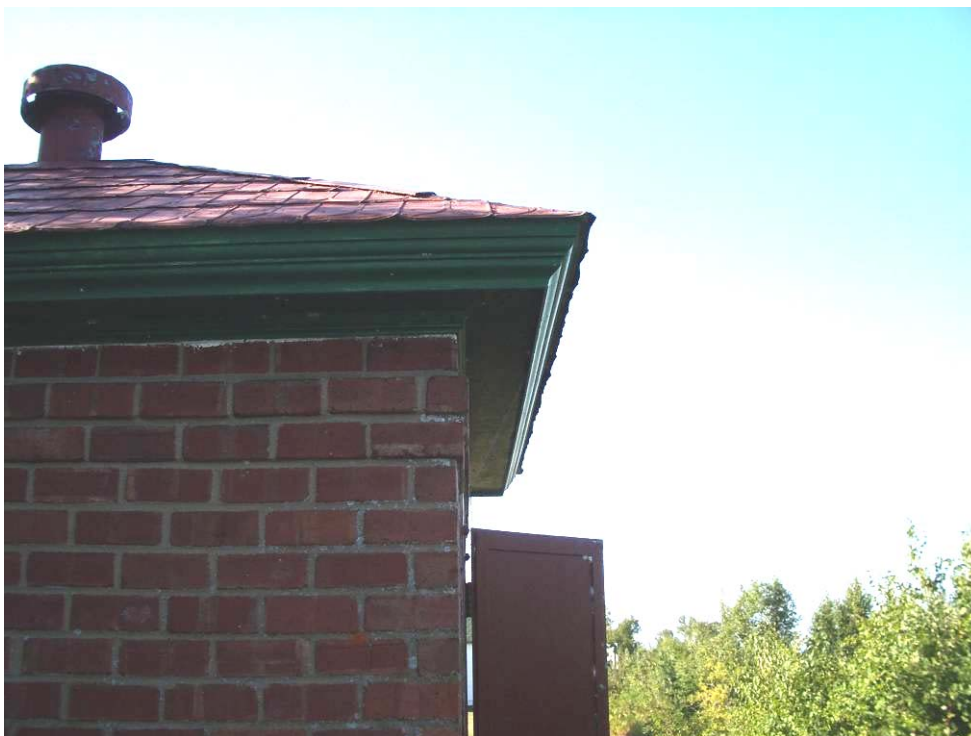
This roof is in fair condition as one portion of the ridge cap is missing (on the northeast corner), but was located on the ground near the structure. Also, paint is peeling in some areas and signs of rust are visible under the paint. The eave and trim is in good condition.

A circular metal roof vent is in fair condition, but the vent opening has been sealed off inside the building making the vent nonfunctional.

DI-OH2-04: Trim, roof and roof vent (Source: A&A IMGP2922)

Remove the existing metal shingles. Verify that the substrate is sound, replace as needed if not. Install a new prefinished metal shingle to match the existing including a hipped ridge cap trim.

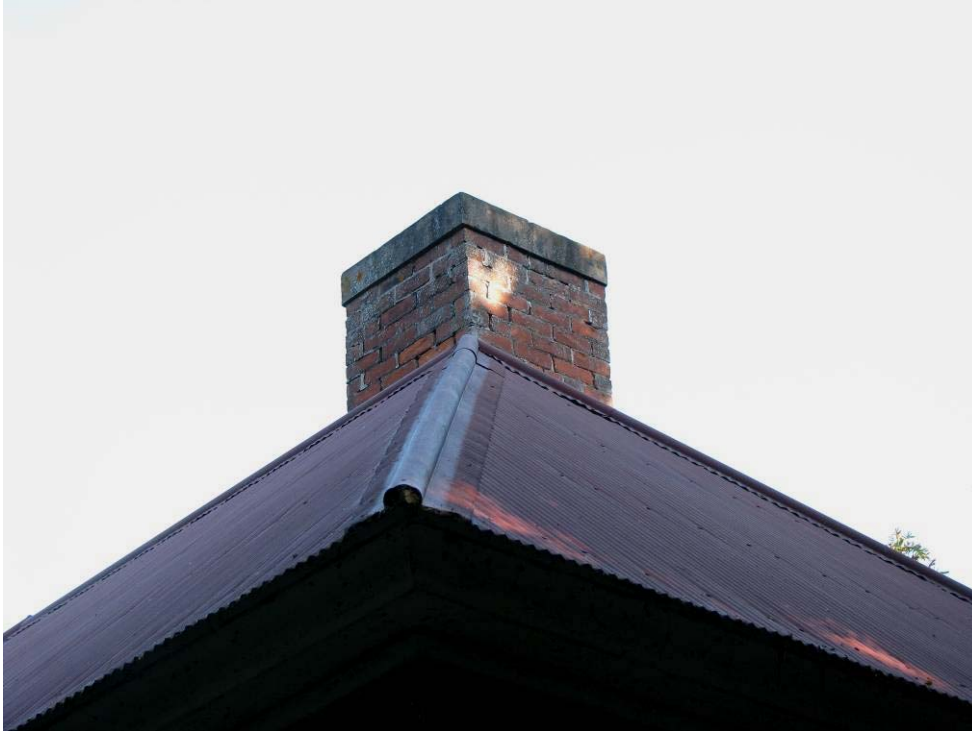
The chimney is in fair condition as the upper portion of the chimney is in need of repointing and there are two cracks in the concrete cap that appear to be stress fractures.

DI-TEB-05: Roof and chimney detail (Source: Martin/Martin Devils Island 16 Sep 09 375.jpg)

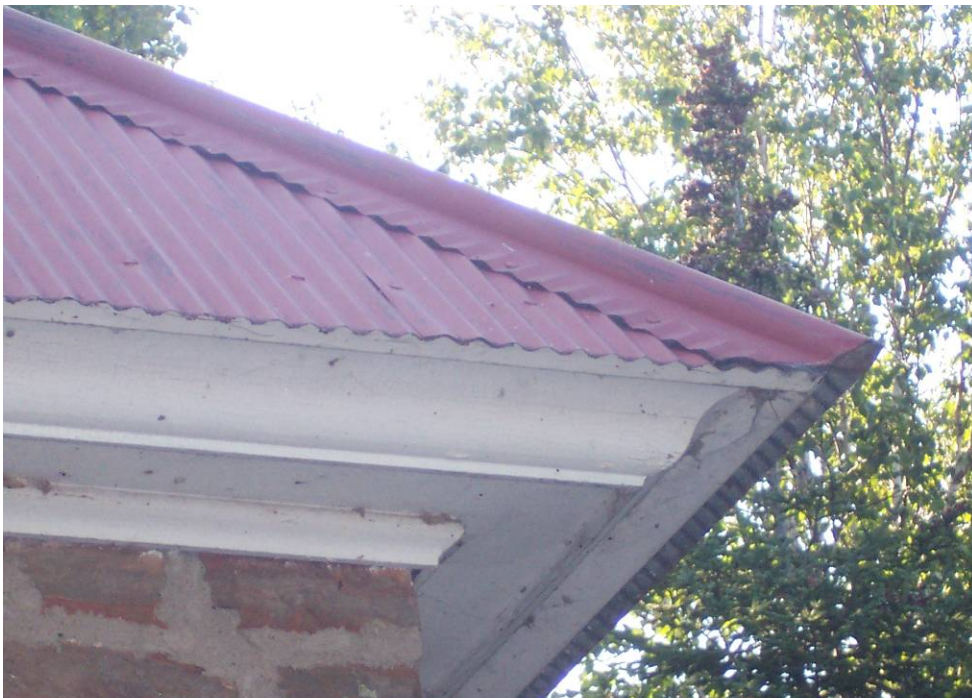
The roofing is in good condition as it is well fastened. The soffits and overhangs have weathered and alligatored paint, but are overall in good condition.

DI-TEB-06: Eave detail (Source: A&A 100_9762)

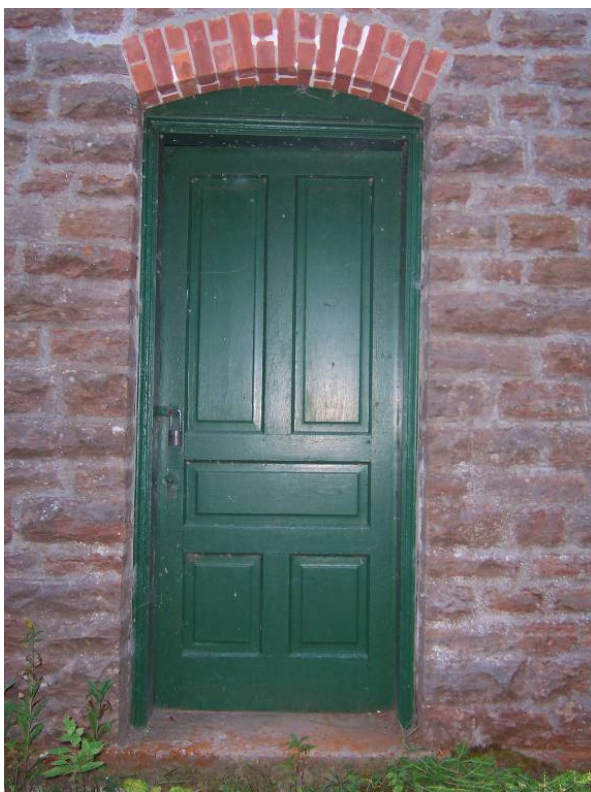
The entry door is missing its knob hardware and the interior and exterior paint is peeling.

DI-TEB-08: Northeast entry door (Source: A&A 100_9759)

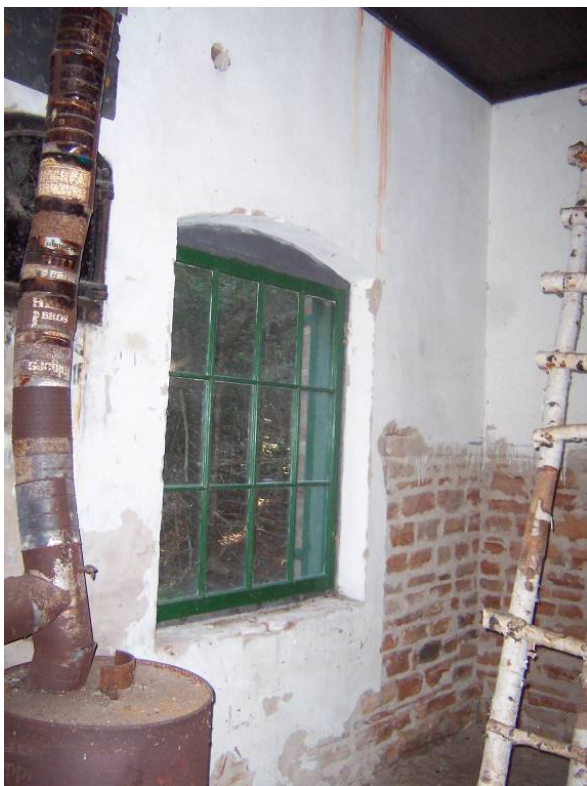
Fixed Lite Window. The two windows of the building are in fair condition. Their wood sills are rotting and their glazing compounds are failing.

DI-TEB-11: Window, looking northwest (Source: A&A 100_9766)
