BOATHOUSE

Chronology of Alterations and Use

1 *Boathouse Photographs, 2009*

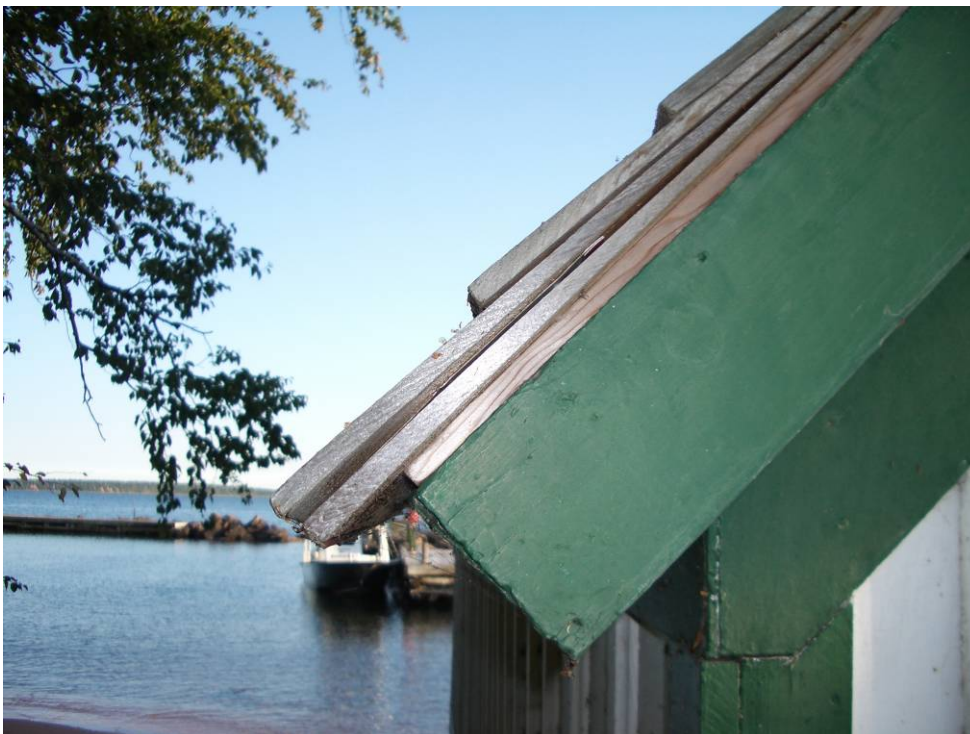
DI-BH-08: North elevation trim and roof detail (Source: A&A IMGP2951)

The exterior trim consists of the base trim (has no slope) and the 1x4 corner boards. All the trim is wood and is painted. (DI-BH-08)

The trim is in good condition.

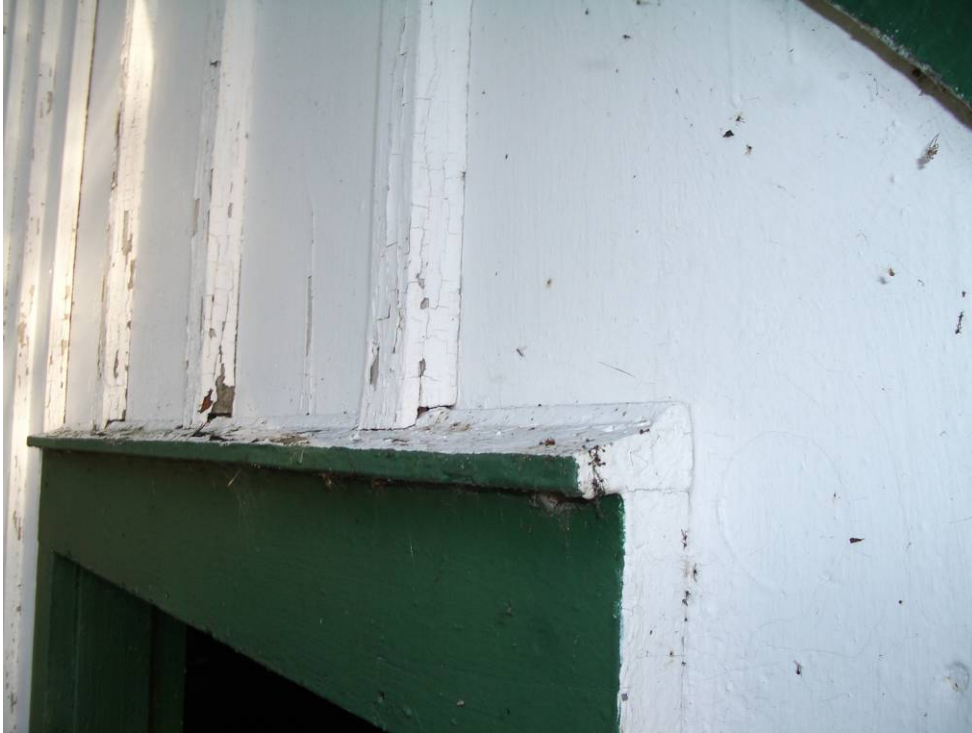
DI-BH-09: North elevation entry door trim detail (Source: A&A IMGP2955)

Entry Door. This door is made of vertical tongue and groove wood planks, 3 ½” wide with bead, and is original to the building. The door has two strap hinges and a spring-loaded handle. There is a wood sill and the exterior trim is 1 1/8” x 4 ½”, painted. The door is 2’7 ½” x 6’8” x ¾”. A paint sample taken at the exterior door trim shows an impressive number of paint layers, especially for an exterior sample. The oldest layer of paint is gray and the wood beneath is heavily weathered. A sample from the eave trim indicates that its oldest layer of paint was the same shade of gray. (DI-BH-09 and 13)

Entry Door. The base of the door panel is rotting away and the base of the exterior trim is rotted and split off. Overall, the door is in poor condition.

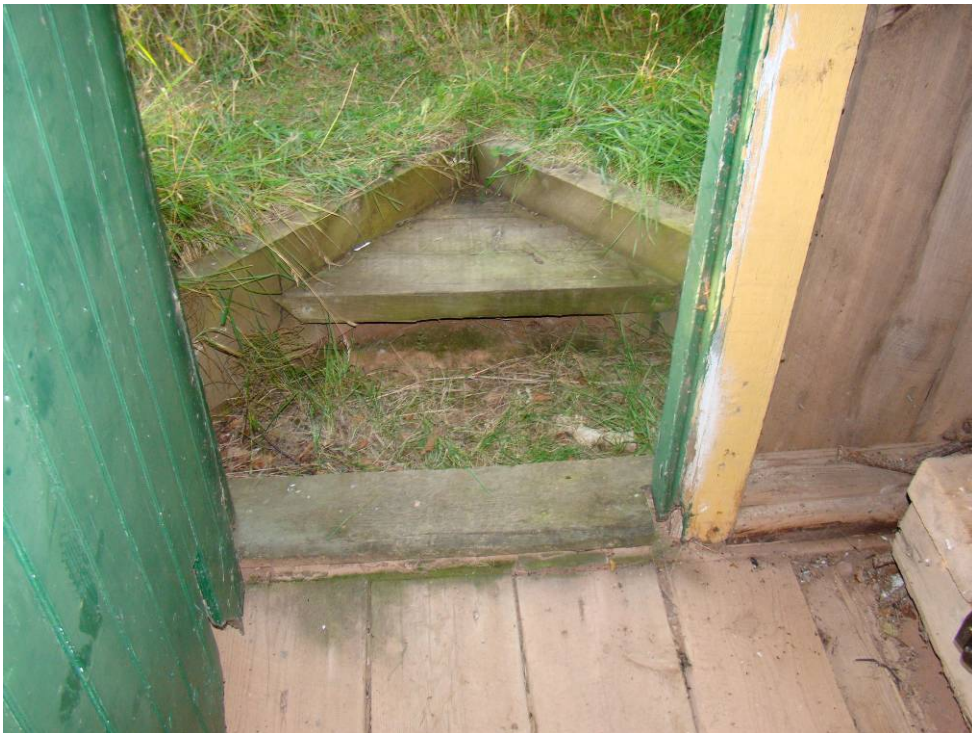
DI-BH-10: Entry door stair detail (Source: A&A DSC01062)

Exterior Stairs to Entry Door. These stairs, while in good condition, do not meet code/functional needs without a wider landing.

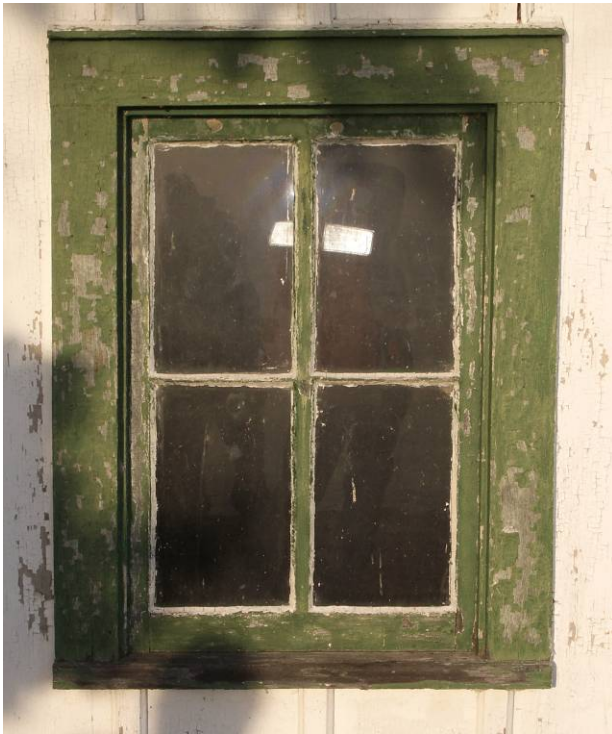
DI-BH-11: West elevation window, exterior (Source: A&A IMGP2954-A)

The window in this building is a two- over two-lite, fixed sash, original to the building. It is located on the west side of the building. The sash is painted on both the interior and exterior faces. The exterior trim is 1 1/8" x 4 ½". The window is 2'1" x 3' 1". A paint sample taken at the exterior window trim indicates nine layers of paint, either dark green or white, with extremely weathered wood beneath. (DI-BH-11)

The window is in fair condition as the glazing compound is brittle and failing and the sill is weathered.

Epoxy stabilize the sill. Remove the glazing compound and replace. Scrape, sand and paint.

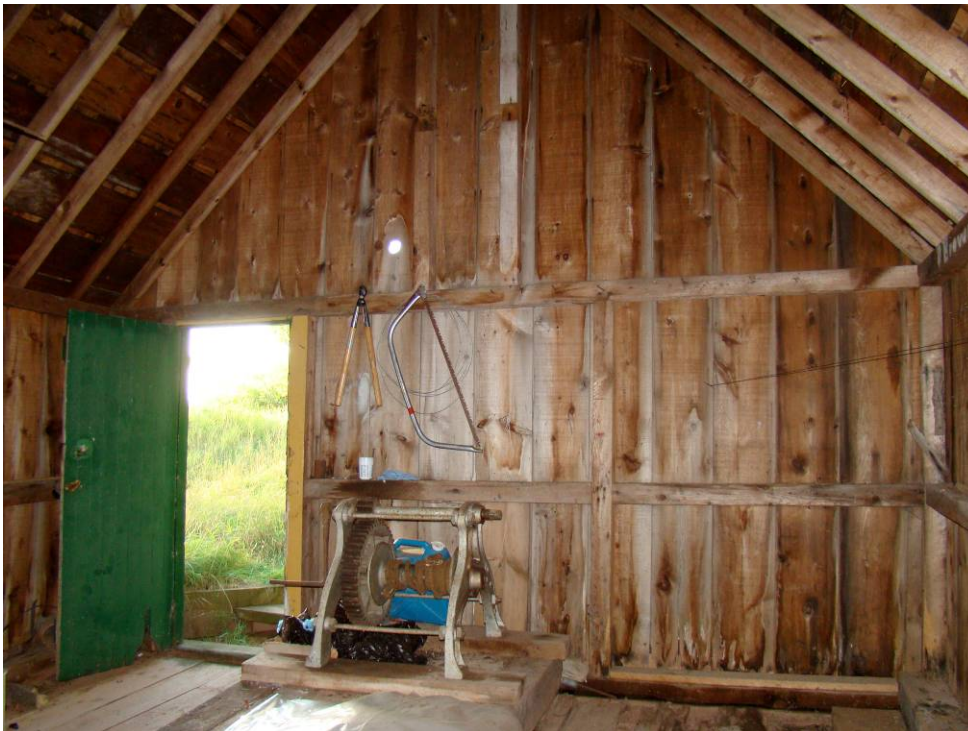
DI-BH-12: Entry door and hoisting mechanism, north elevation (Source: A&A DSC01053)

The cast iron hand operated gear winch at the north end of the building is in poor condition with considerable rust damage.

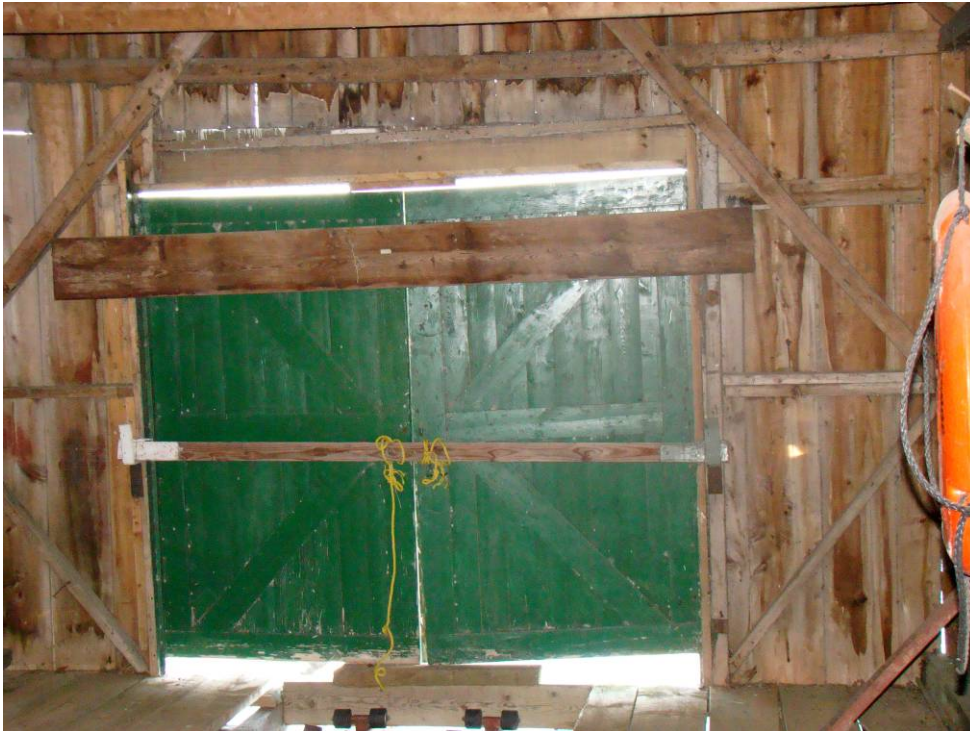
DI-BH-14: Boathouse door, interior (Source: A&A DSC01046)

Boat Doors. This set of doors has badly peeling paint and the bases of the doors are weathering. These doors are also in poor condition.

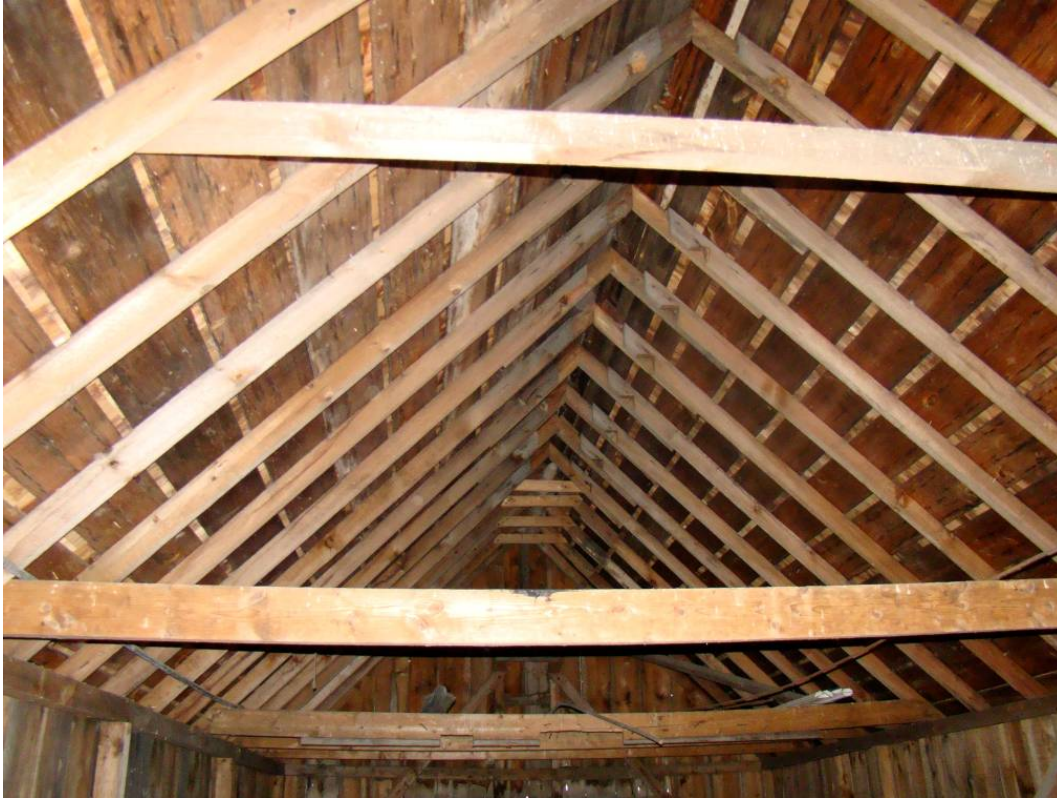
DI-BH-15: Roof framing, looking south (Source: A&A DSC01051)

The Boathouse was reroofed in 2006 with 5" exposure cedar shingles. The current roof has a prefinished red metal drip edge flashing at the starter course that extends 7" up the roof. The sheathing is spaced. Tie-off rings were installed at the ridge, though they do not appear to meet OSHA requirements, and there is a wood ridge cap. There is 1x6 frieze board and 1 x 4 ½" fascia at the gables and eaves. (DI-BH-15)

The roof framing is in fair condition. There did not appear to be enough collar ties to keep the walls from spreading out.

Lateral load resisting system of the building should be investigated further and if needed, replaced with construction that will meet IBC and NPS requirements.
