EXISTING CONDITION ASSESSMENT AND LANDSCAPE ANALYSIS

The existing condition assessment and landscape analysis for the Long Island Light Station are presented in this section. The light station reservation and the three individual sites within it are documented as one entity through the landscape characteristics that together comprise its cultural landscape. The presentation of the existing condition assessment and analysis is organized by landscape characteristics - spatial organization, topography, views and vistas, and circulation/accessibility; and identifies those buildings, structures, small scale features and vegetation that contribute to the cultural landscape of the light station. An overview of the CLR methodology is presented in Volume I, Chapter 2: Methodology.

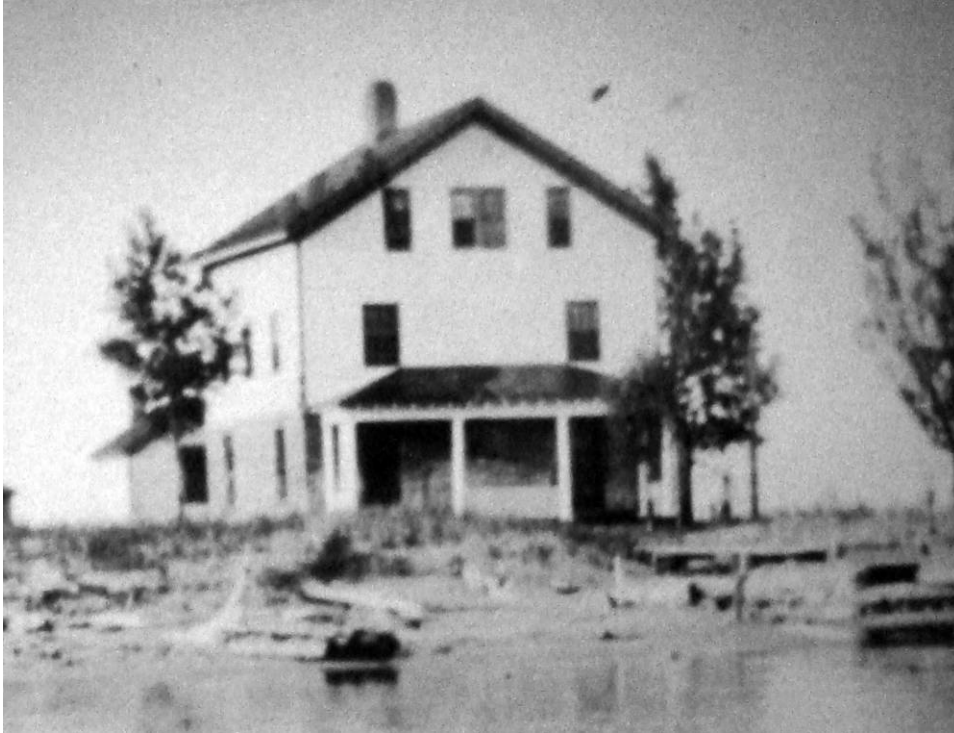
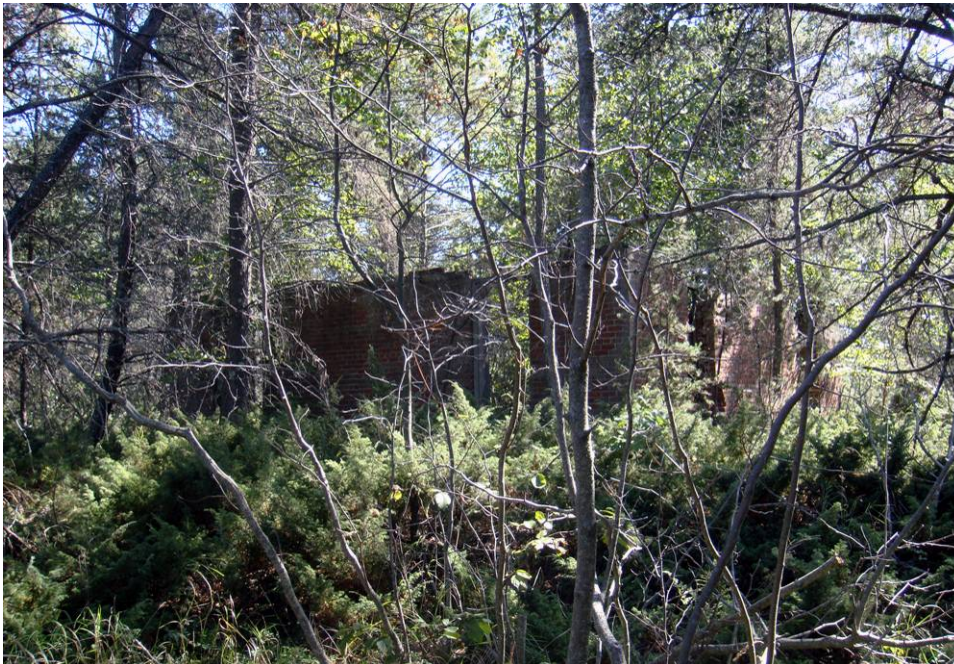
The Original LaPointe Lighthouse site is embedded in a pine and oak forest with rolling topography. The grounds are approximately 400' from the Lake Superior shoreline. The extant features are arranged around the ruin of the Original LaPointe Lighthouse, forming a loose geometric ring of structures. The grounds are heavily forested and no cleared area is extant. The spatial organization of the Original LaPointe Lighthouse site is in poor condition.

10
11 The spatial organization of the Original LaPointe Lighthouse site has been diminished primarily due to the
12 encroachment of the forest and complete loss of cleared area around the lighthouse ruin. Due to the
13 dynamic nature of Long Island, the north shoreline is further away from the site than during the early
14 historic periods. Historic maps and photographs indicate that the shoreline was between 50' to 150' from
15 the Original LaPointe Lighthouse. Today the shoreline is approximately 400' from the lighthouse ruin and
16 no longer visible from the site. In addition, the loss of structures (privies and kitchens) and small scale
17 features (concrete walks) that defined the site has diminished the spatial organization of the grounds.

Site Image LI-24: View of Original LaPointe Lighthouse showing diminished spatial organization by encroaching vegetation; top, c. 1920 (Source: NPS APIS Archives); below, 2009 (Source: MBD DSC01285.jpg)

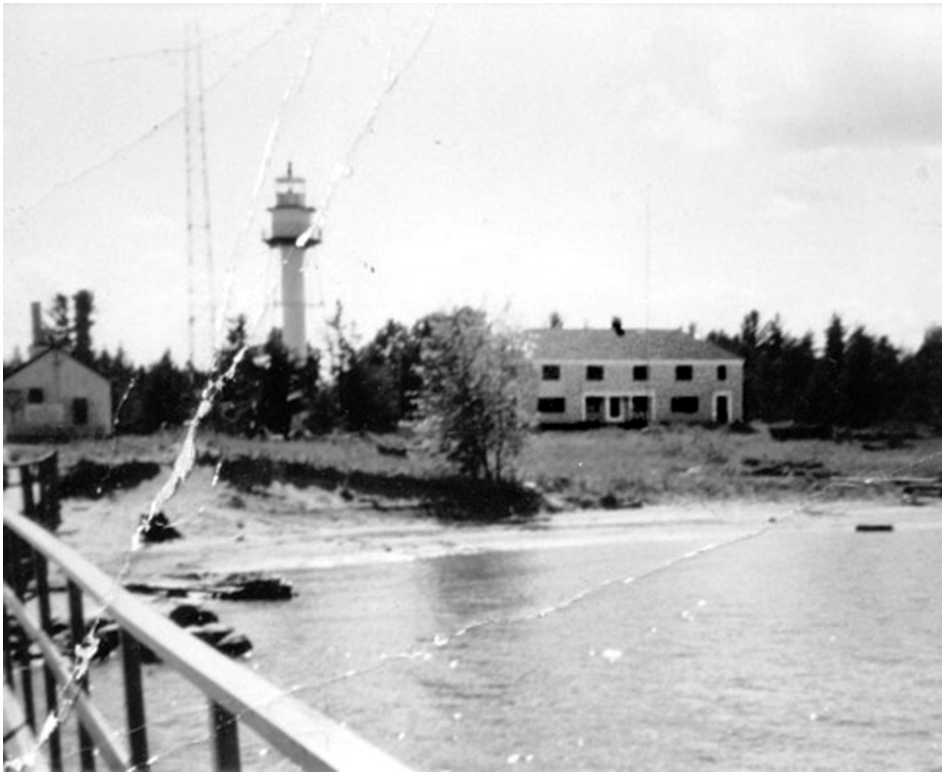
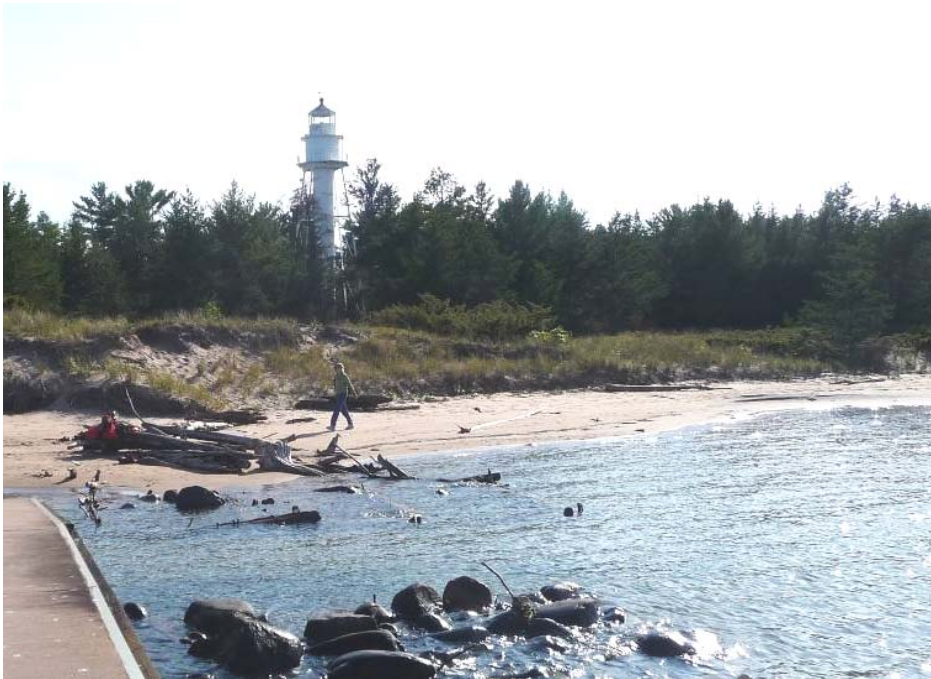
The LaPointe grounds are arranged around its central focus, the 67' tall LaPointe Light Tower. Buildings, structures and small scale features are located in a loose radial pattern around the tower. Concrete walks and boardwalks extend from the tower and connect to each other in an organized but asymmetrical pattern. Most of the features are in a cleared area around the tower and fog signal building foundation. The overall feeling is one of enclosure as the site is surrounded by the encroaching pine forest. The spatial organization of the LaPointe site is in poor condition.

The LaPointe site retains the organization of buildings, structures, and small scale features from the period of significance, but has been degraded by the loss of the cleared area of the grounds. During the period of significance the cleared area extended around all of the structures, small scale features, and buildings. Today, much of the grounds are covered with forest vegetation, obscuring the structures and features to the

1 south of the tower and the site is no longer open to the Lake Superior shoreline. (Site Image LI-24, LI -25)
2 Once the island no longer operated as a manned light station with a light keeper, the forest vegetation was
3 not cleared regularly. During the period of significance, approximately nine acres at the LaPointe site were
4 open and clear of trees. The cleared area has been reduced by about five acres due to forest encroachment
5 and the shifting shoreline of Lake Michigan.

Site Image LI-25: View of LaPointe grounds from Lake Superior showing diminished spatial organization; top, c. 1969 (Source: NPS APIS Archives); below, 2009 (Source: MBD P1020369.jpg)

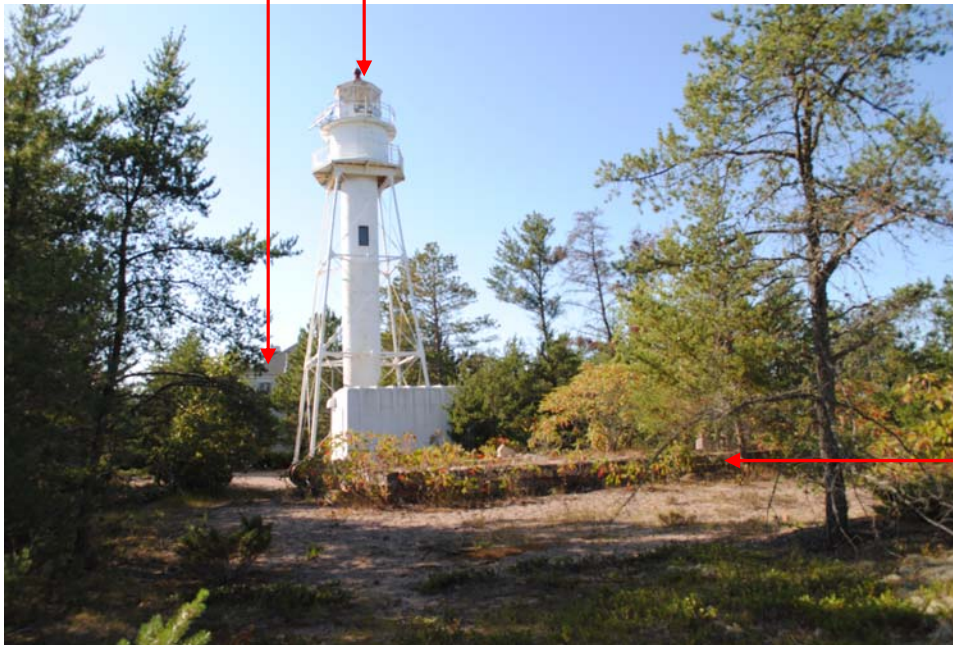
6
7 The area from the buildings to the north shoreline has decreased at the LaPointe site as the shoreline has
8 shifted. The encroachment of forest vegetation and the loss of the Fog Signal Building, Radio Tower, and
9 Radio Beacon have diminished the integrity of the LaPointe site.

Site Image LI-26: View of LaPointe grounds from east showing diminished spatial organization by encroaching forest vegetation, 2009 (Source: MBD DSC_0180.JPG)

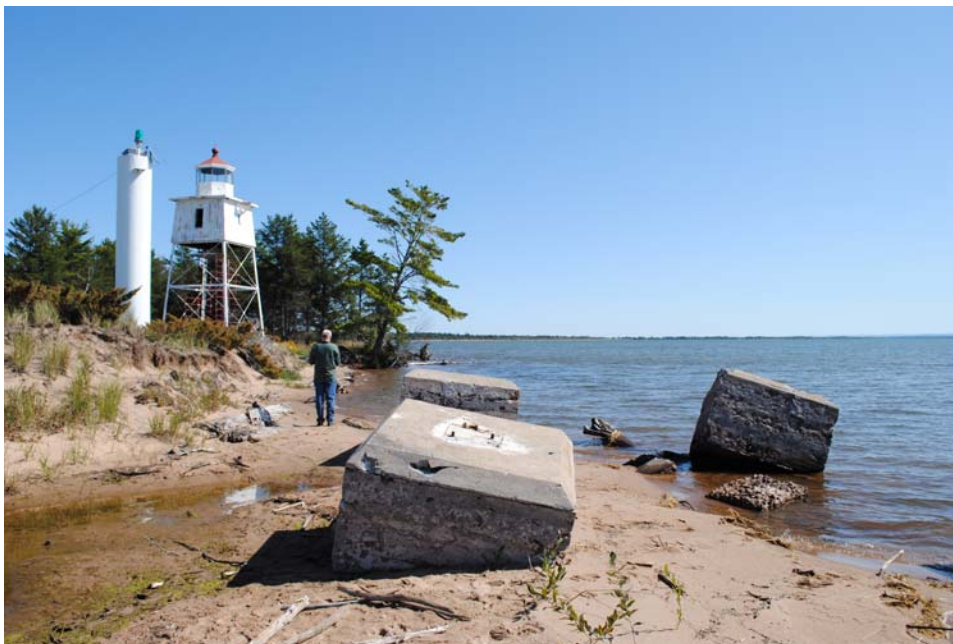
Site Image LI-27: View of Chequamegon Point grounds from west showing original concrete footings for Chequamegon Point Light Tower, Chequamegon Point Light Tower, and USCG Culvert Tower, 2009 (Source: MBD DSC_0022.JPG)

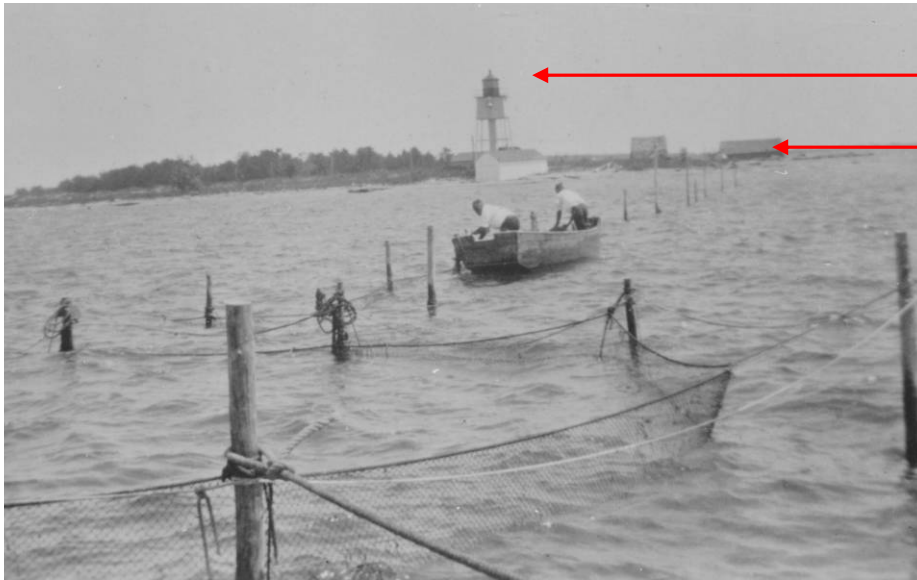
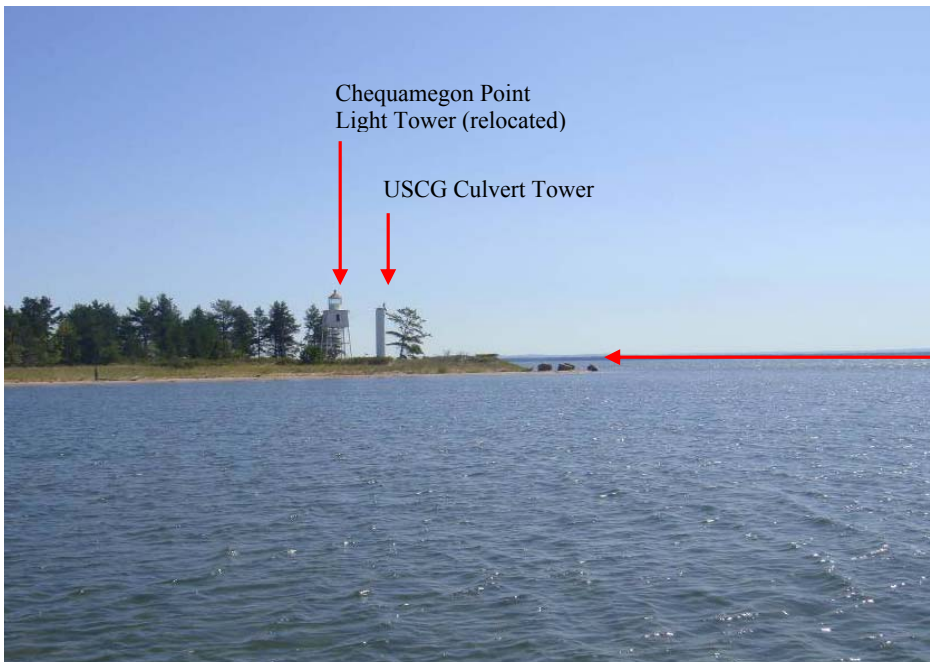
18
19 The spatial organization of the Chequamegon Point site has been diminished by the loss of structures
20 (boathouse), the relocation of the Chequamegon Point Light Tower, the addition of the USCG Culvert
21 Tower and the encroachment of the surrounding forest.
22

Site Image LI-28: View of Chequamegon Point showing diminished spatial organization and encroaching forest vegetation. Three nonextant structures visible in top image; top, c. Light Tower Period (Source: NPS APIS Archives); below, 2009 (Source: MBD DSC01260.jpg)

A historic photograph (Site Image LI-28) shows three structures on the shoreline at Chequamegon Point. No remnant materials were found related to these structures.

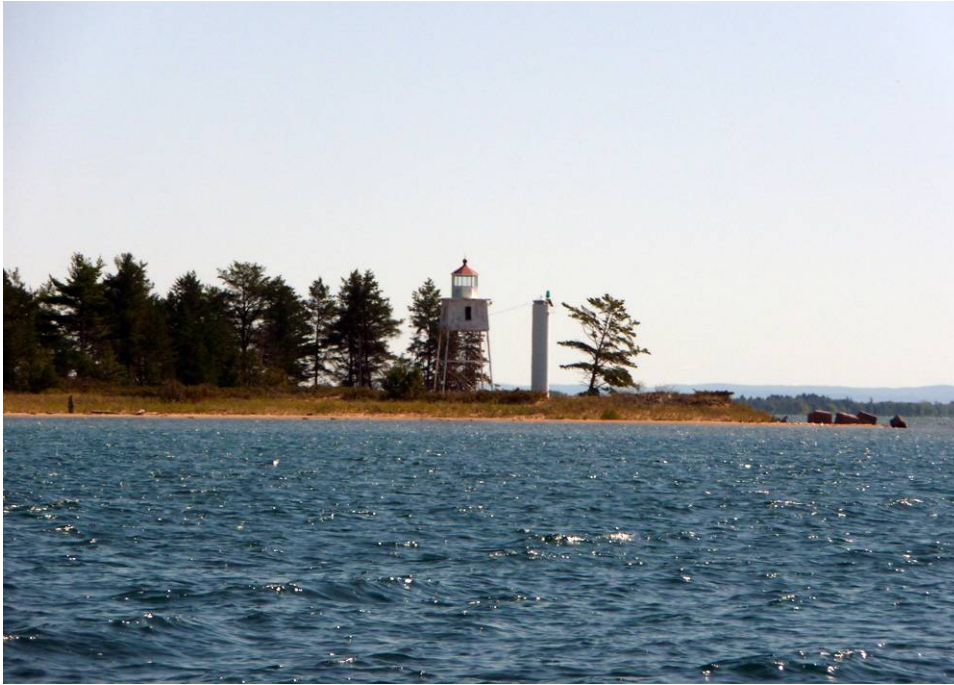
Views to Chequamegon Point from Lake Superior and Chequamegon Bay remain much as they have been since the late 1890s. These are important views of historic navigational aids.

2
3 *Site Image LI-32: View to Chequamegon Point from Lake Superior, with extant concrete footings visible on beach, 2009*
4 *(Source: MBD P1020330.JPG)*

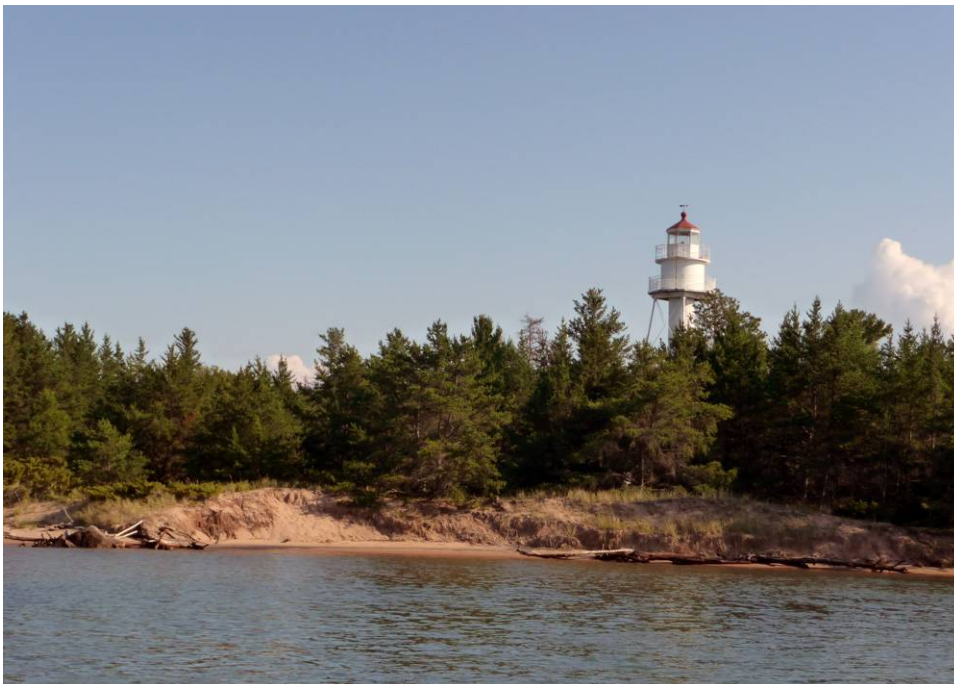
At the LaPointe site, views from Lake Superior to the Triplex and LaPointe Light Tower are greatly obscured by vegetation. Historic photographs indicate that the Triplex was clearly visible from the water and boat dock until 1965. Today, the Triplex is not visible from Lake Superior due to encroaching forest vegetation. The LaPointe Light Tower remains visible above the trees. Views from the LaPointe Light Tower over Lake Superior, adjacent islands, and over Long Island remain intact due to the height of the tower. However, neither the Chequamegon Point Light Tower nor the Original LaPointe Lighthouse are visible today from the LaPointe Light Tower. Night sky views from Long Island looking toward Madeleine Island are diminishing as more development and light occurs on Madeleine Island.

6
7 *Site Image LI-33: View to LaPointe Light Tower from Lake Superior, note encroaching vegetation, 2009 (Source: MBD*
8 *P1020372.JPG)*

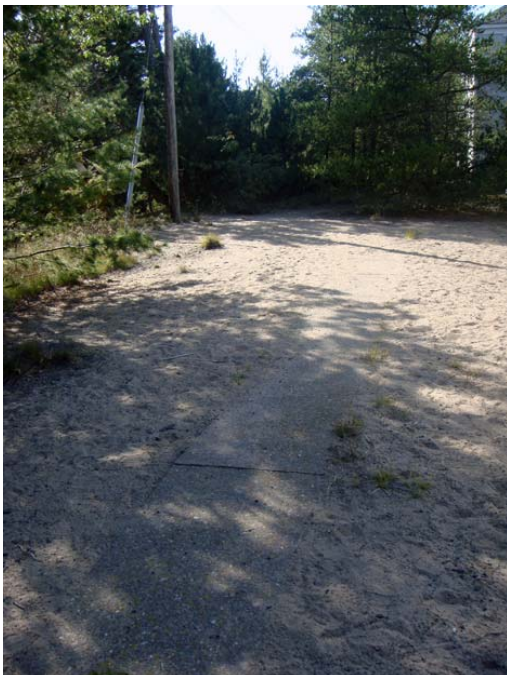
5
6 *Site Image LI-37: Extant concrete walk at the LaPointe site, 2009 (Source: MBD DSC01349.JPG)*

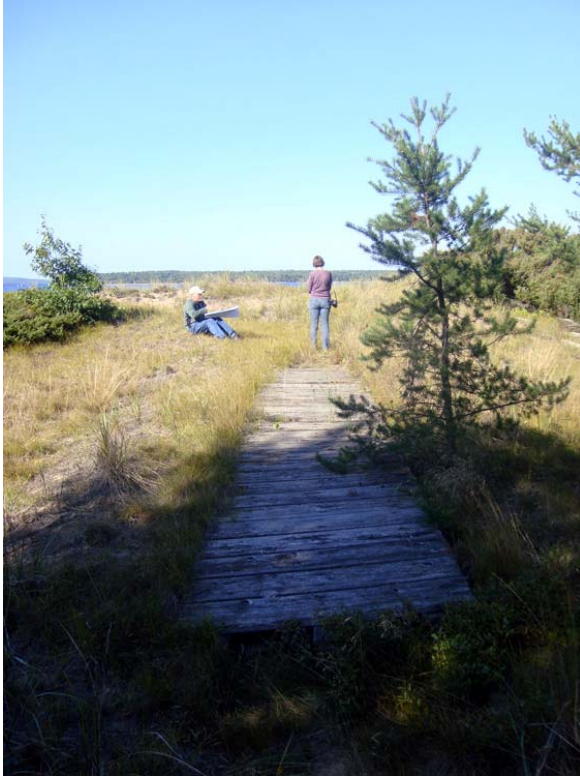
Site Image LI-38: Extant remnants of the boardwalk at the LaPointe site leading from the Fog Signal Building foundation to the shore, 2009 (Source: MBD DSC01372.JPG)

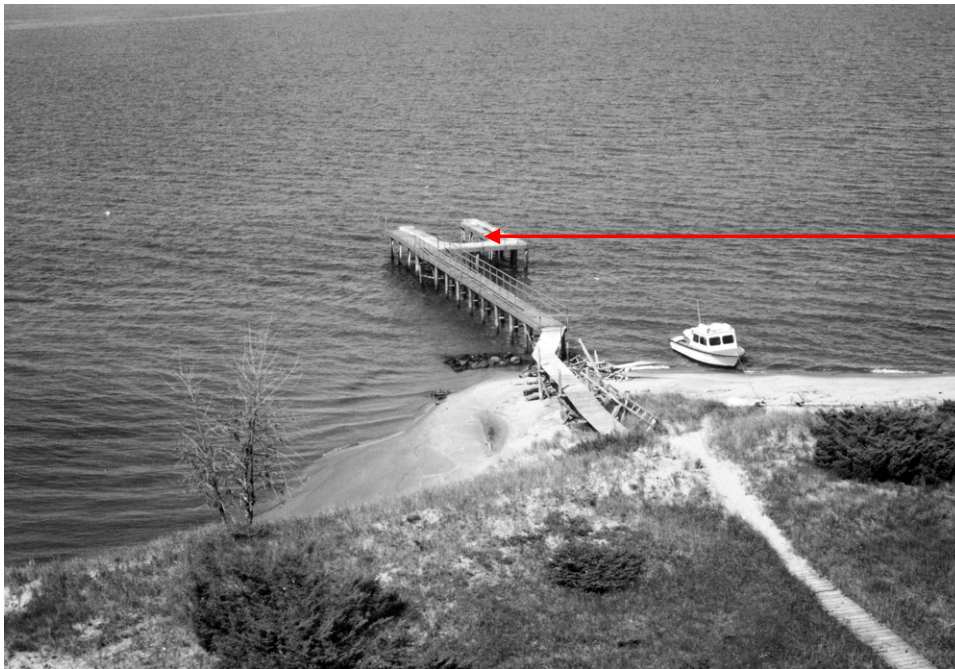
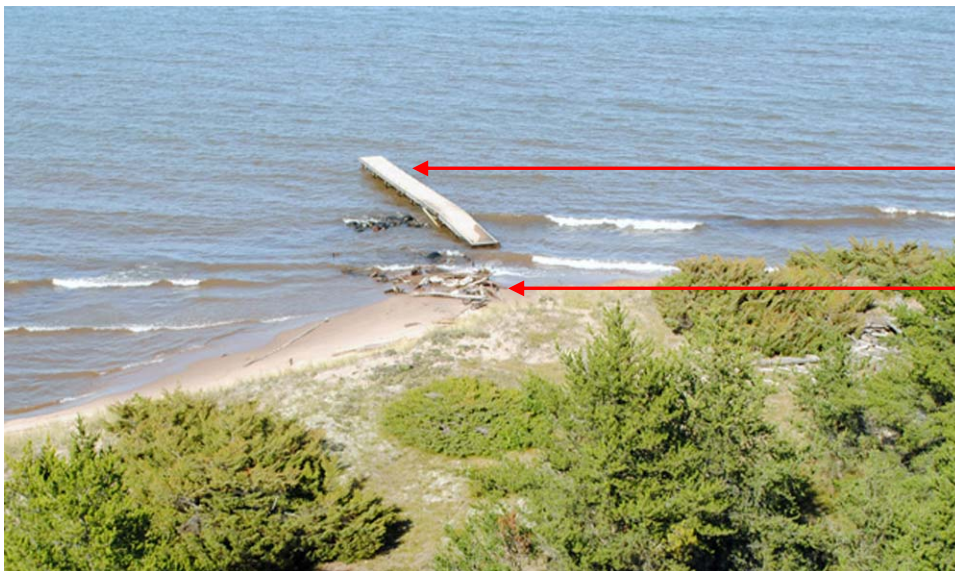
Existing Condition. A boat dock is located on the Lake Superior shoreline directly north the LaPointe Light Tower. The dock is approximately 80' long and 8' wide and is built of steel pipe framing with a concrete deck. In 2009, the south end of the dock was approximately 15' from the shoreline. Due to the nature and location of the boat dock, this dock and its predecessors have frequently been damaged or destroyed by the harsh wave and ice action of Lake Superior. The dock is used for landing small boats by visitors and park staff. The dock is in fair condition but has functionality issues related to the fluctuation of the depth of water adjacent to the dock.

Site Image LI-40: Boat dock at LaPointe as viewed from LaPointe Light Tower; top, 1987; below, 2009 (Source: MBD DSC_0150.JPG)

Boat dock planning work is currently under study by the NPS under separate but related projects, including the Great Lakes Restoration Initiative.

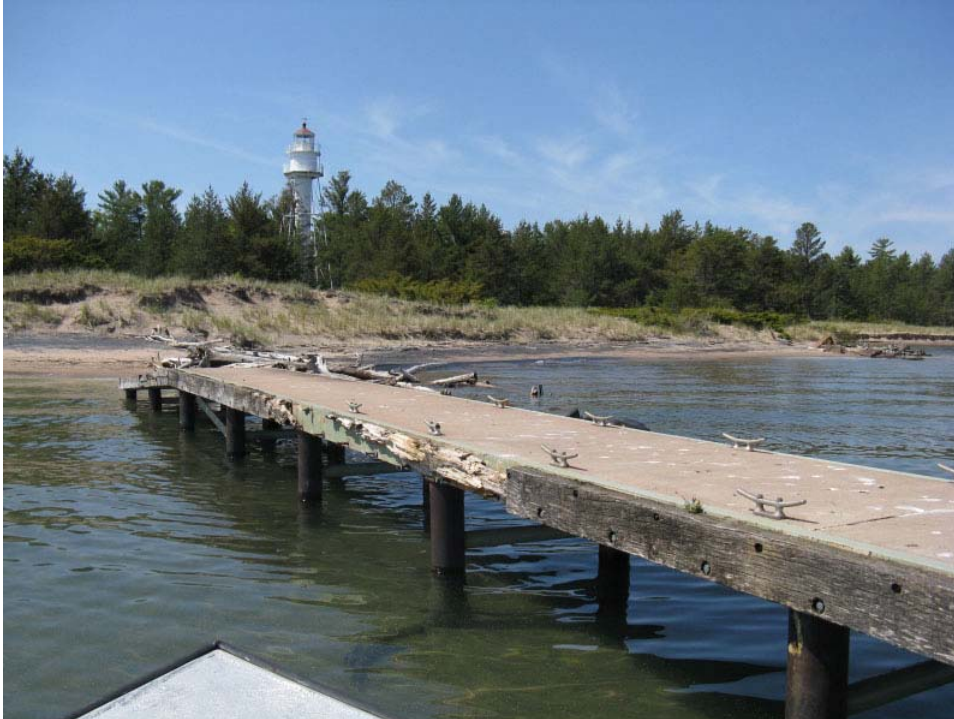
Site Image LI-41: Boat dock at LaPointe, 2009 (Source: APIS LaPointe Boat Dock.JPG)

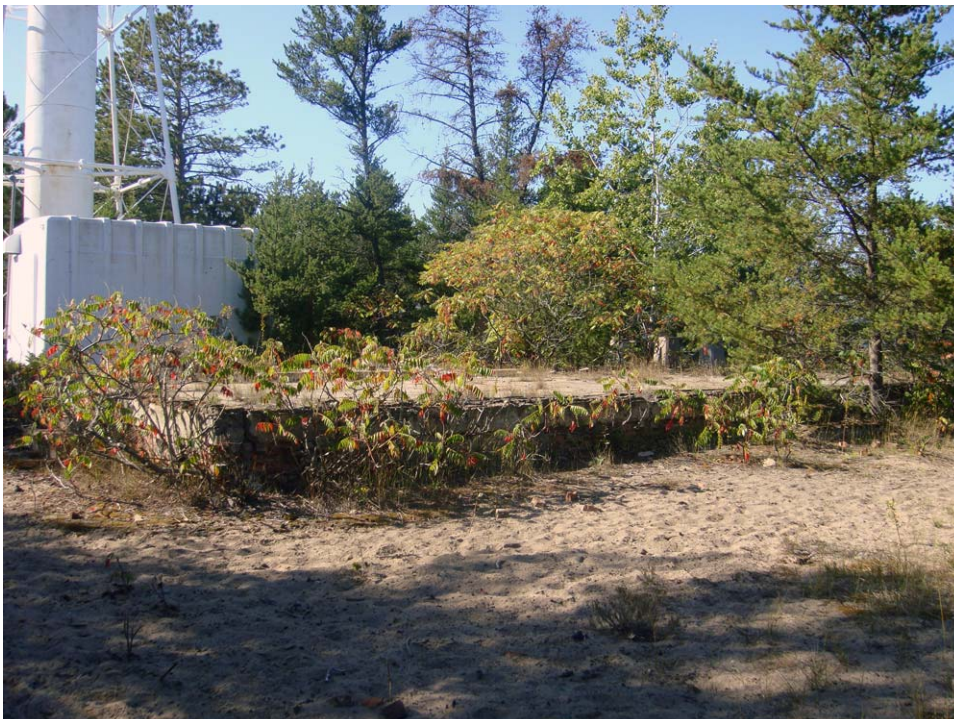
Existing Condition. The Fog Signal Building foundation is a brick and concrete foundation approximately 40' by 25' and elevated 24" above adjacent grade. The foundation includes steps on the east, south, and

west sides up to the finish floor elevation and remnants of the brick chimney. The foundation is in fair condition as a remnant structure.

Site Image LI-42: Fog Signal Building foundation, 2009 (Source: MBD DSC01356.JPG)

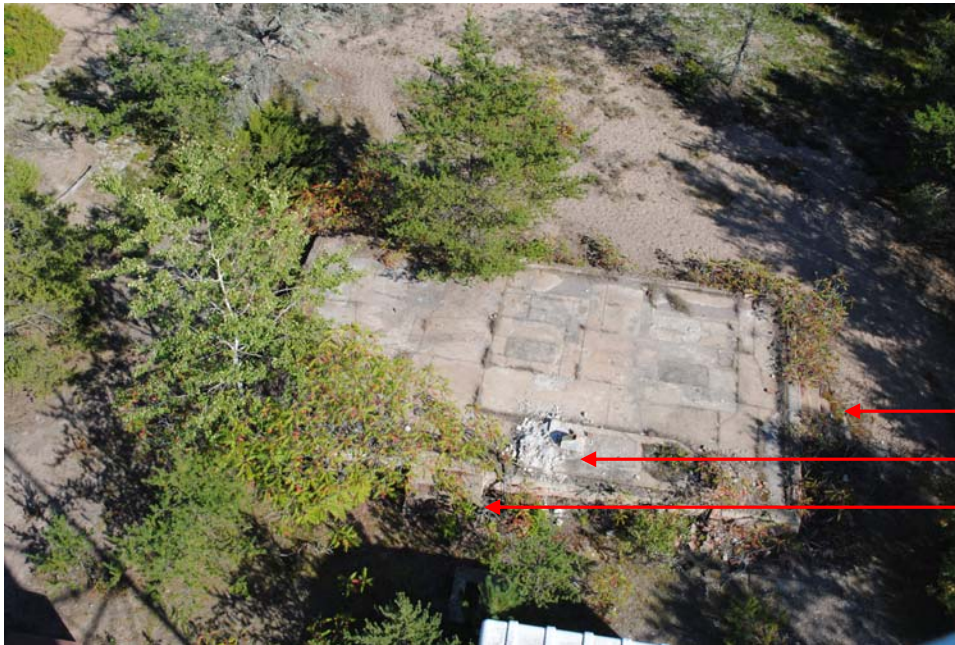
Site Image LI-43: Fog Signal Building foundation as viewed from LaPointe Light Tower, 2009 (Source: MBD DSC_0152.JPG)

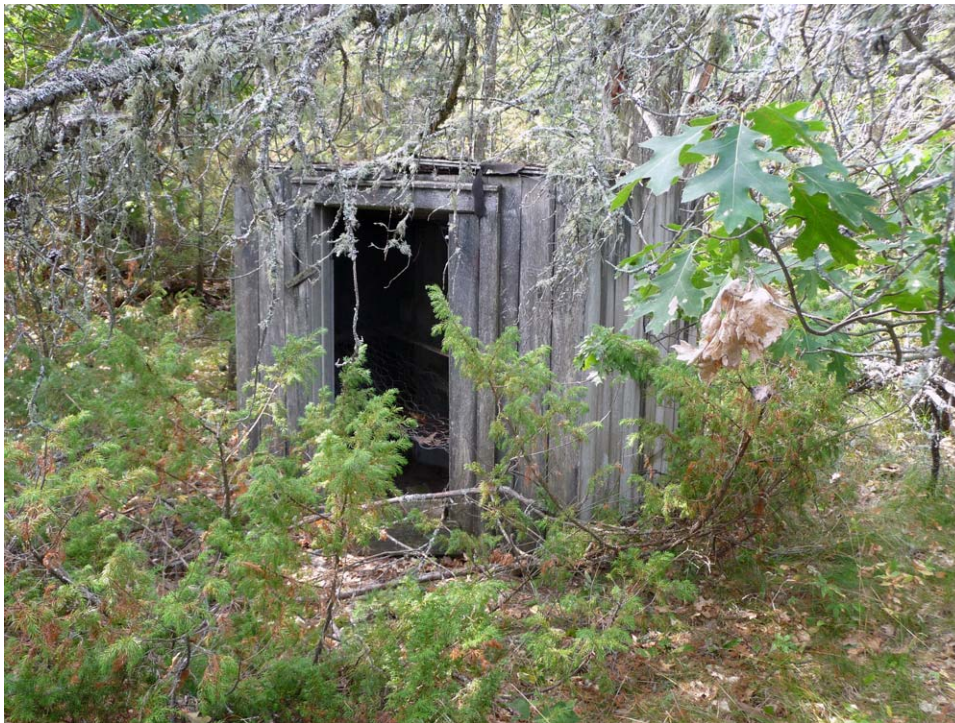
Existing Condition. A small wood framed shed is located in the forested area to the southeast of the Light Tower. The shed is approximately 10'×10' in size with wooden vertical siding and a corrugated metal roof. The shed is in poor condition.

Site Image LI-44: Wooden shed, 2009 (Source: MBD P1020349.JPG)

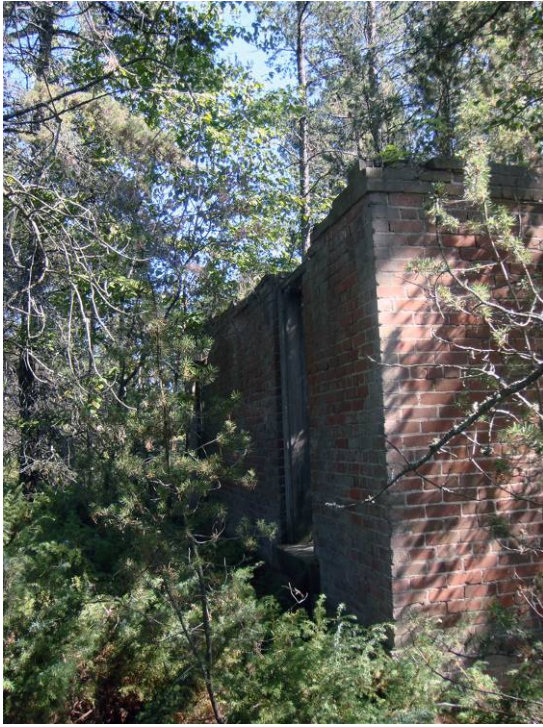
Existing Condition. The brick, first floor foundation of the Original LaPointe Lighthouse (and former Keepers Quarters) is presently in ruin. Brick walls vary in decay from a full height of about 10' to approximately window height (3' +/-). Stone lintels are present in most windows and a concrete foundation for the kitchen and back porch exists. The interior walls have remnants of lath and plaster wall finishes. The footprint of the ruin is approximately 45' x 30'. Bricks found in the area are marked 'SB Co'. No extant portions of the second floor wood construction remain. The ruin is located in a thickly vegetated scrub forest with forest growth both surrounding it and within the footprint of the ruin. The Original LaPointe Lighthouse ruin is in poor condition.

2
3 Site Image LI-46: Original LaPointe Lighthouse ruin, 2009 (Source: MBD IMG_9419.JPG)
4

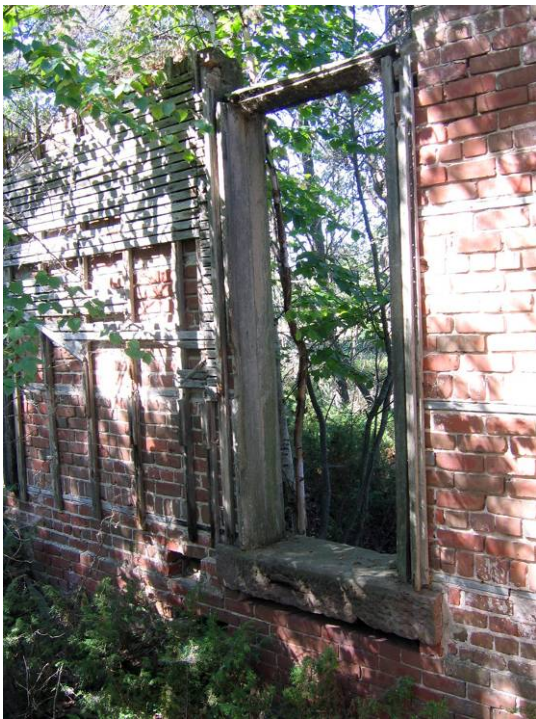
5
6 Site Image LI-47: Original LaPointe Lighthouse ruin, 2009 (Source: MBD DSC01300-nw.JPG)
7

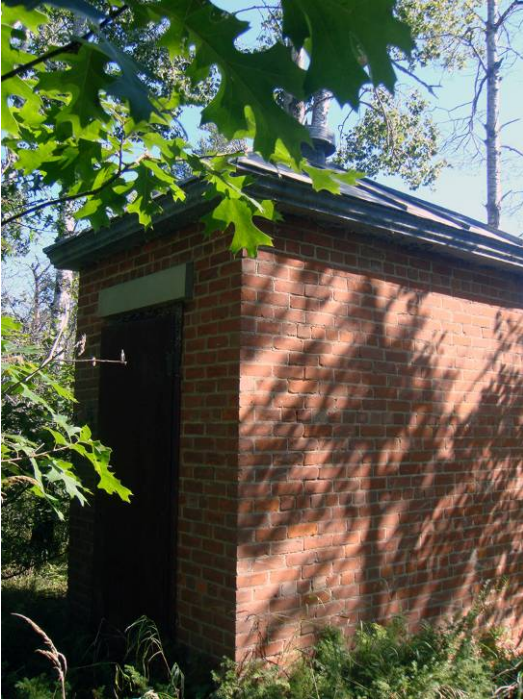
Existing Condition. The Oil Building is located approximately 80' south of the Original LaPointe Lighthouse ruin. The building is brick masonry construction, approximately 8' x 6', with a steel door (nonlocking), metal roofing and stone lintels. The exterior of the building is intact with the roofing, masonry and steel door in place. The interior of the building is in poor condition as the floor is in disrepair. In general the Oil Building is in good condition.

Site Image LI-48: Oil Building, 2009 (Source: MBD DSC01306.JPG)

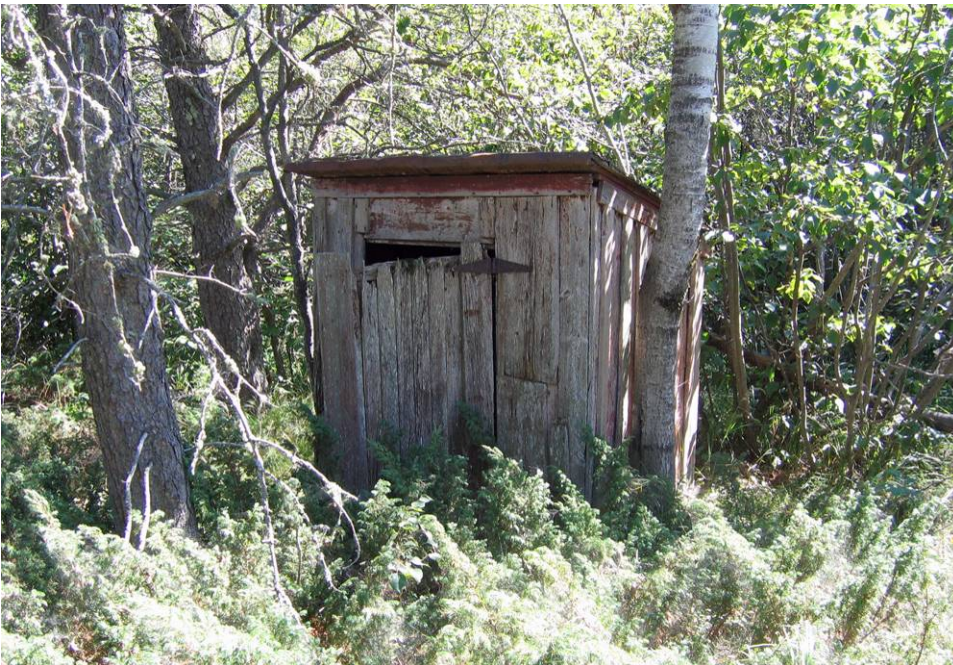
Existing Condition. The privy is located in the forested area to the southeast of the Original LaPointe Lighthouse ruin. The privy is approximately 10' x 15' in size with vertical, wooden siding and a corrugated metal roof. The privy is intact but in poor condition.

Site Image LI-49: Privy, 2009 (Source: MBD DSC01306.JPG)

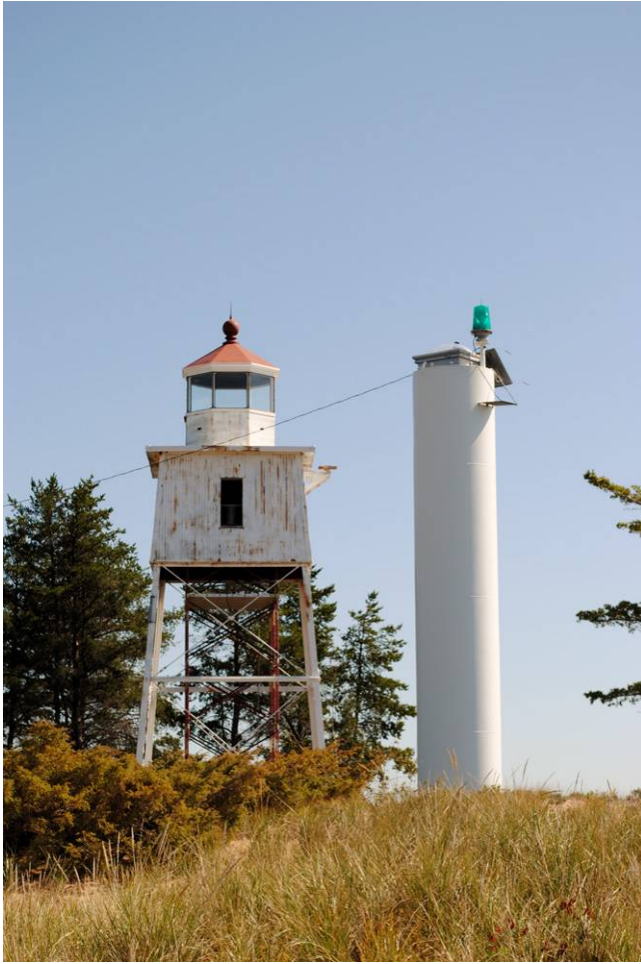
Existing Condition. The USCG Culvert Tower is a steel light tower approximately 45' in height located approximately 60' west of the Chequamegon Point Light Tower. Electricity to the tower is provided via the overhead electric line from the LaPointe site.

2
3 *Site Image LI-50: Chequamegon Point Light Tower (left) and USCG Culvert Tower (right), 2009 (Source: MBD*
4 *DSC_0057.JPG)*
5
