Small Scale Features

LaPointe Site

LONG ISLAND LIGHT STATION CLR TREATMENT

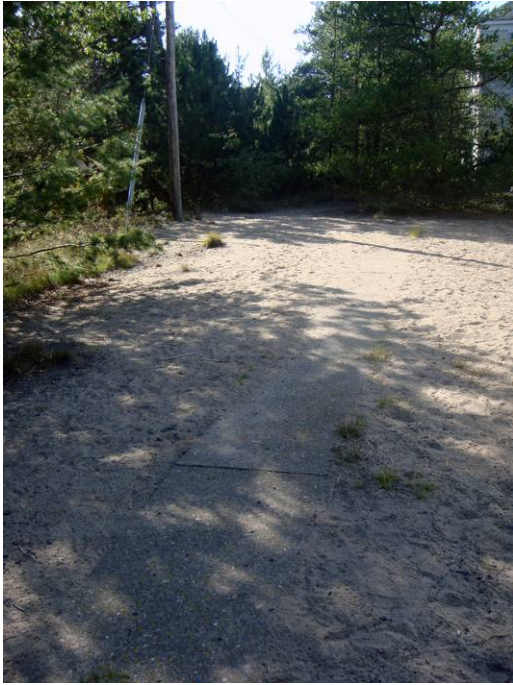
Existing Condition. Similar to several of the Apostle Islands light stations, the concrete walks appear to be constructed of precast units 2.5'×4'×4" thick with some smaller units also installed. The units have a fine aggregate finish and tooled edges. Other portions of the concrete walks appear to have been poured in place to infill odd shapes and address building edges. The shifting sands of Long Island have covered many of the walks. Additional walks may be uncovered with further investigation. Overall the concrete walks are in good condition with only a few slabs showing significant cracking and sloughing along the edges.

2
3 Site Image LI-51: Concrete walk south of LaPointe Light Tower, 2009 (Source: MBD DSC01349.JPG)

Concrete walks exist at all three sites. Repair and maintain all concrete walks in the current, historic locations. Repair includes the removal and replacement of isolated, severely cracked sections. Replacement of damaged sections shall be completed with precast units matching the dimensions of the existing concrete slabs, poured and finished prior to installation. The mix, aggregate size and finish of the replacement sections should match the historic material. Maintenance includes vegetation removal and minor leveling to eliminate trip hazards. At each site, use noninvasive methods to locate any walks that have been buried by sand but can be easily uncovered.

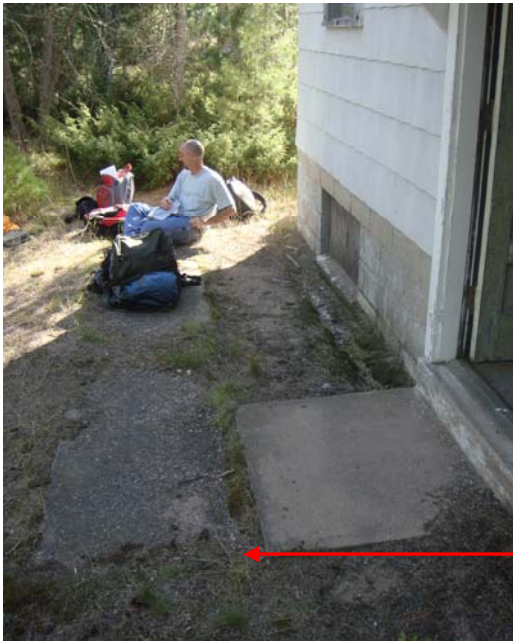
Area of Damaged Concrete

5
6 Site Image LI-52: Concrete walk east of Triplex, 2009 (Source: MBD DSC01343.JPG)

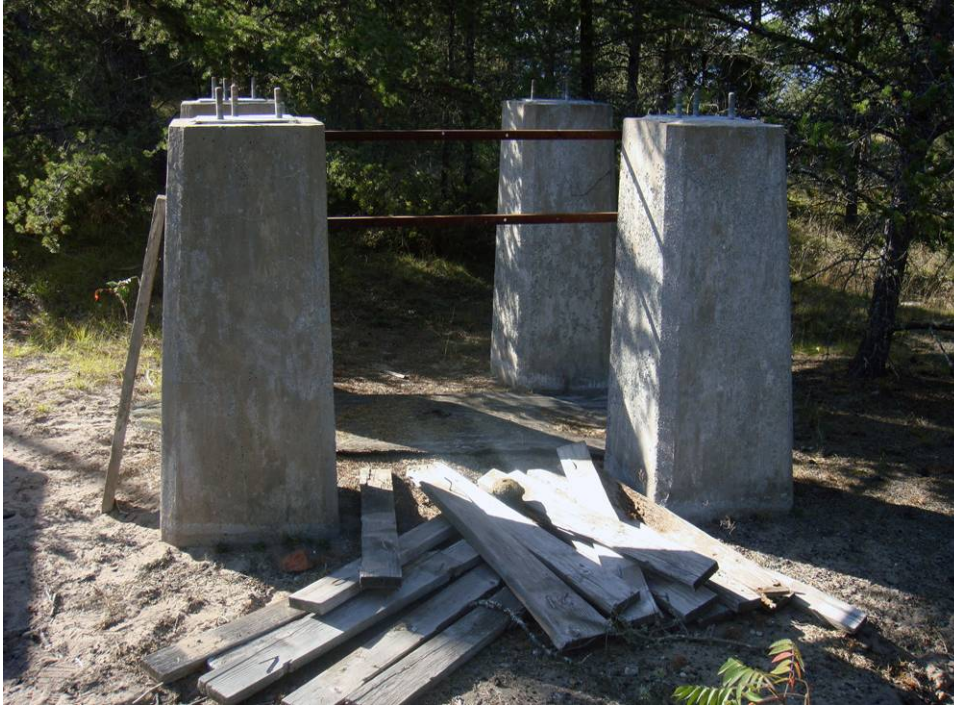
Concrete Footings – A include four footings spaced at 6' on center in a square pattern, each with a 2' square base, narrowing to 1.5' square at the top at 4' above grade. The vertical edges have a 1" chamfer. The top of each footing has galvanized mounting bolts and base plates. Concrete Footings – A are in good condition.

Site Image LI-53: Concrete footings (A) for nonextant steel frame radio tower northeast of LaPointe Light Tower, 2009 (Source: MBD P1020343.JPG)

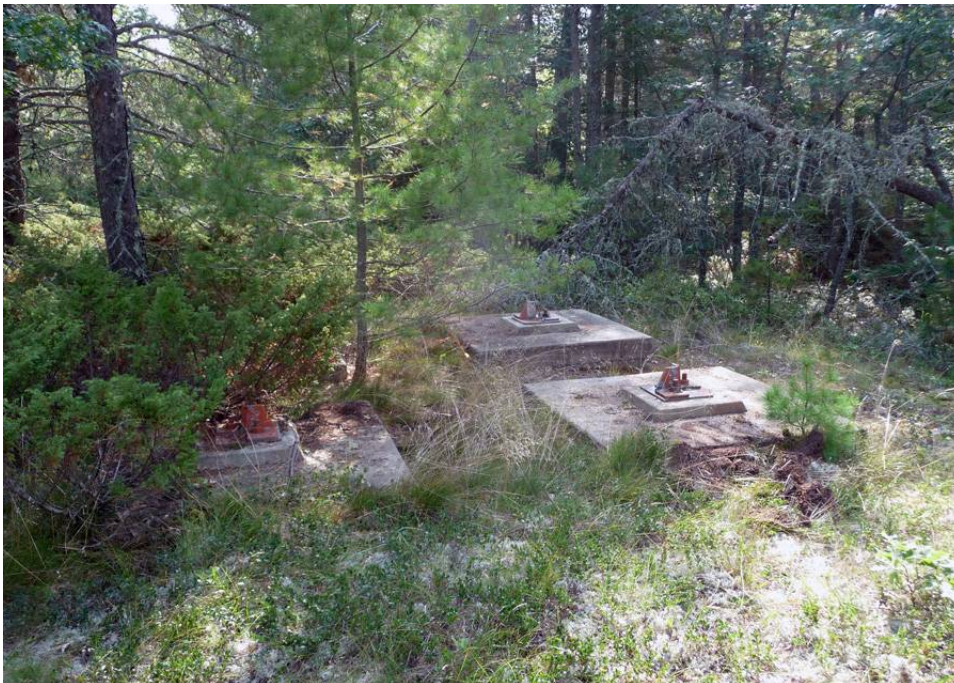
Concrete Footings – B include four footings with 4' × 4' square bases, spaced at 8' on center in a square pattern. The footings rise approximately 3-4" above adjacent grade and each have a 12" × 12" centered concrete platform with a metal support. Concrete Footings – B are in fair condition.

Site Image LI-54: Concrete footings (B) for nonextant radio beacon tower, 2009 (Source: MBD DSC01408.JPG)

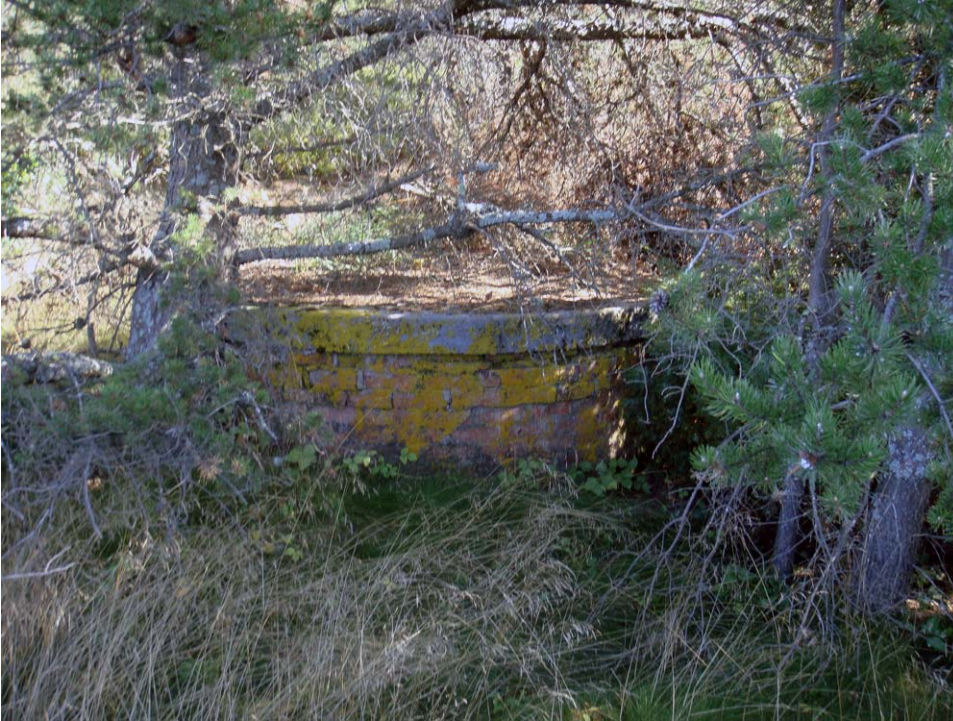
Existing Condition. The cistern is located approximately 75' north of the Fog Signal Building foundation and is surrounded by encroaching vegetation. It is 8' in diameter, 2' above grade, and is brick with a concrete cap. Depth of the cistern is unknown. The cistern is in good condition.

Site Image LI-55: Concrete and brick cistern, 2009 (Source: MBD DSC01401.JPG)

- Remove vegetation adjacent to the cistern;
- Repair mortar joints and make minor masonry repair to the cistern (new mortar to match existing);
- Alter the concrete top to allow for a compatible, lockable cover;
- Retain all galvanized water supply piping in place.

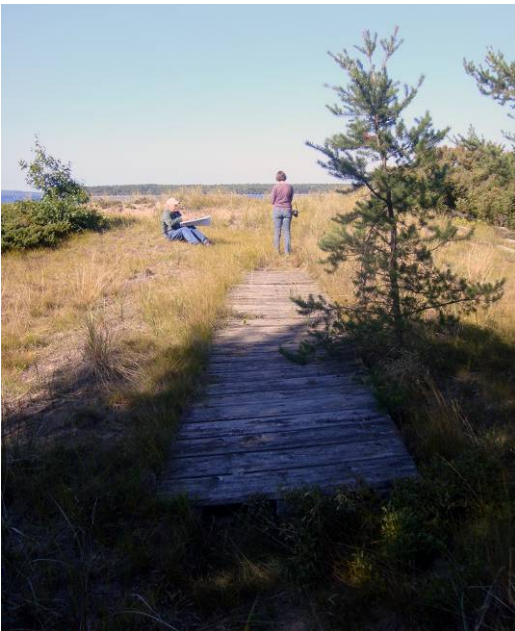
Existing Condition. The remnant boardwalk is located approximately 100' north of the Fog Signal Building foundation. The boardwalk is constructed with milled wood planking and is 4' wide and approximately 40' in length. The boardwalk is in poor condition.

Site Image LI-56: Remnant of wooden boardwalk between Fog Signal Building foundation and water, 2009 (Source: MBD DSC01372.JPG)

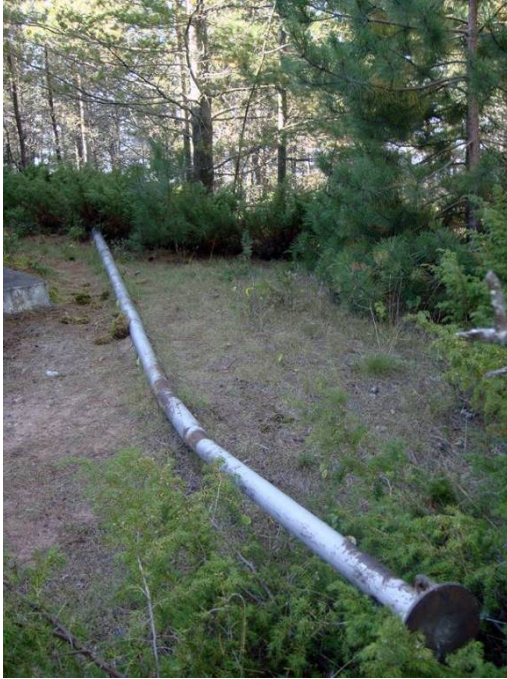
Site Image LI-57: Flagpole on north side of Triplex Building, 2009 (Source: MBD DSC01340.JPG)

Repair flagpole, by straightening if feasible, or cutting and reattaching with a sleeve, Repaint the pole, replace hardware and halyard and reset the pole on the extant concrete base.

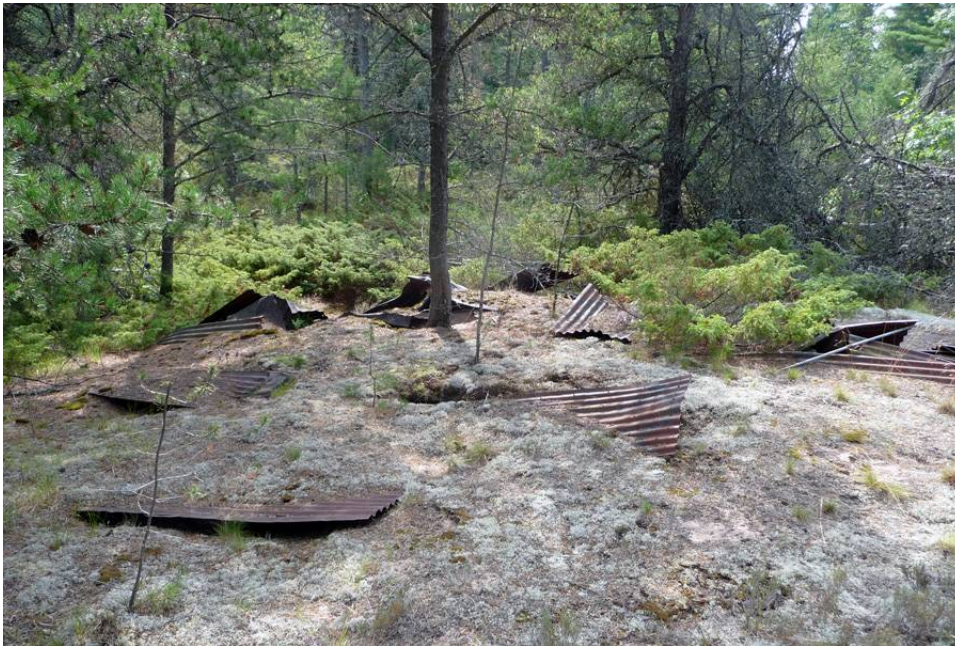
Site Image LI-58: Rubble pile west of Fog Signal Building foundation, 2009 (Source: MBD P1020347.JPG)

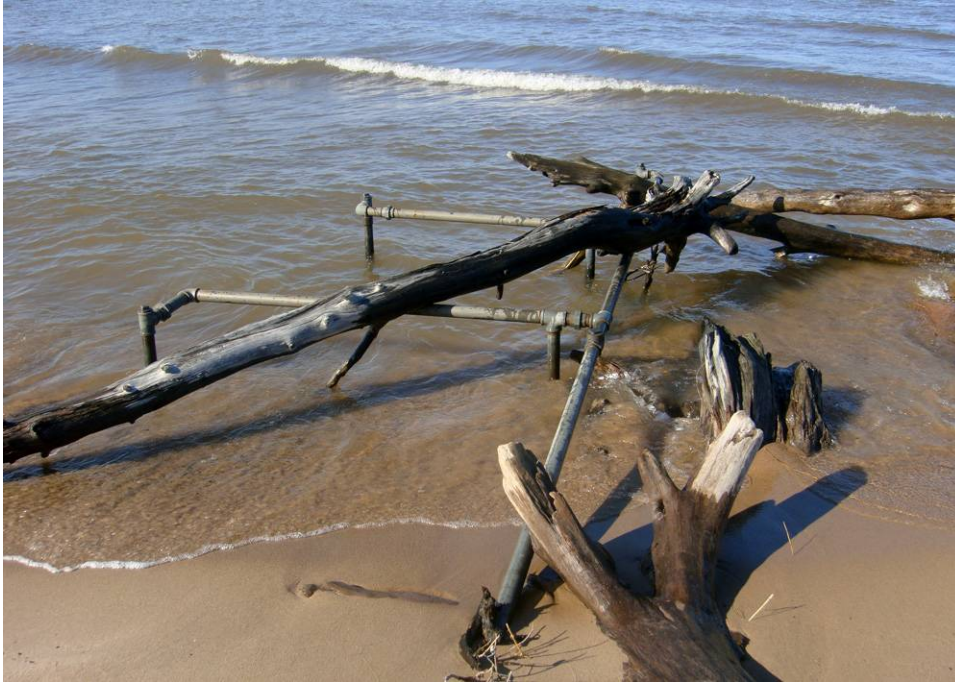
Site Image LI-59: Pipe crib at edge of water, 2009 (Source: MBD DSC01397.JPG)

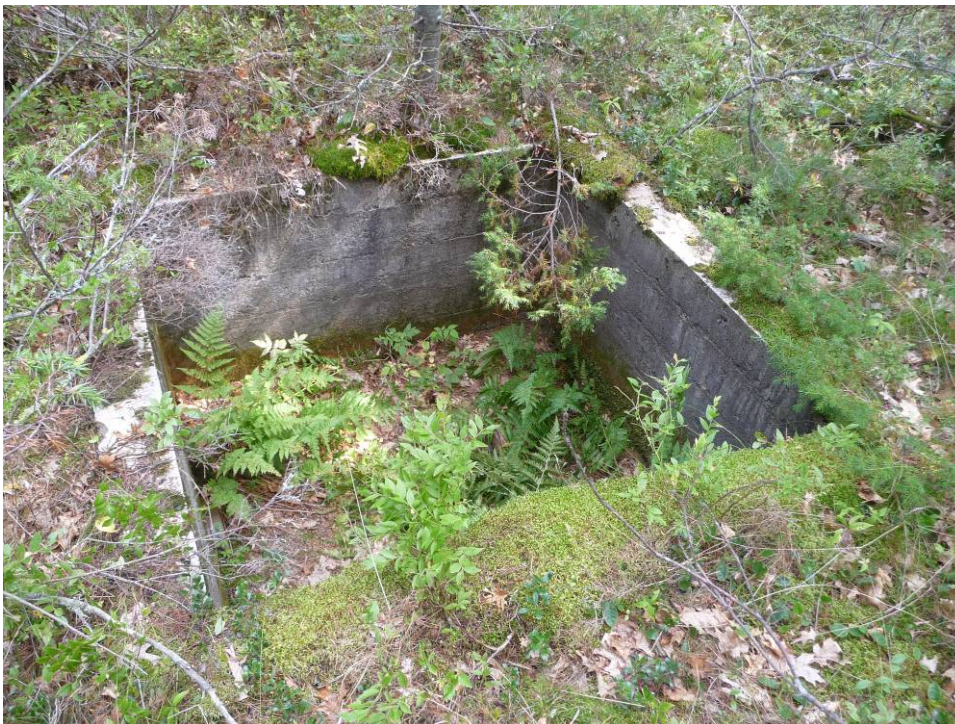
Site Image LI-60: Septic bed, 2009 (Source: MBD P1020344.JPG)

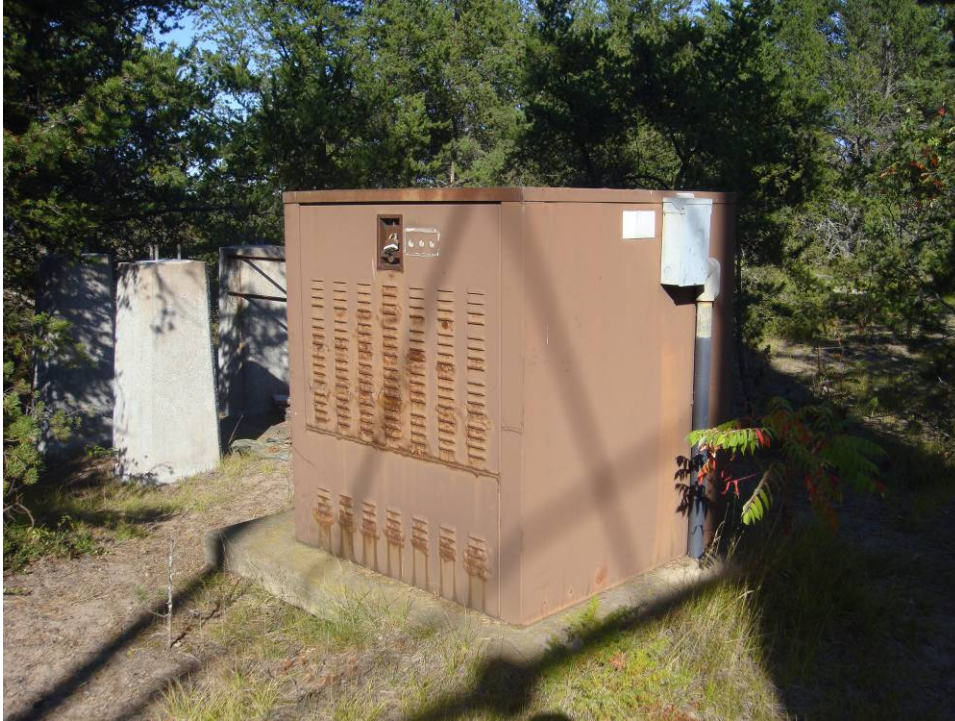
Site Image LI-61: Utility box, 2009 (Source: MBD DSC01411.JPG)

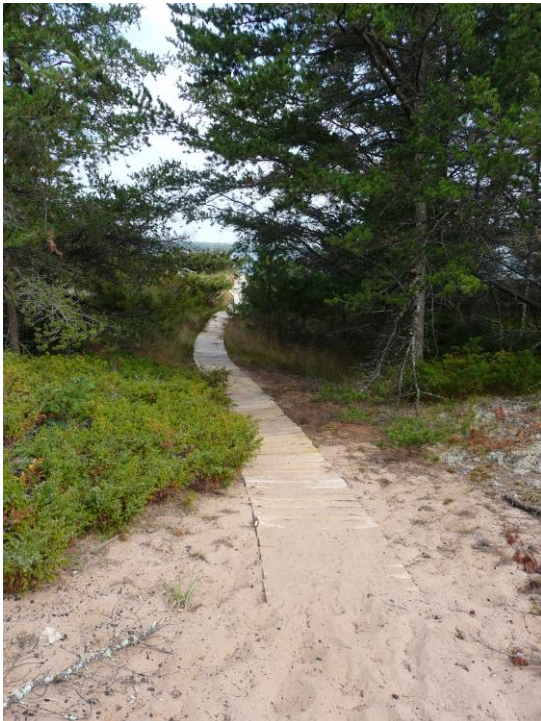
Site Image LI-62: Floating boardwalk, 2009 (Source: MBD P1020345.JPG)

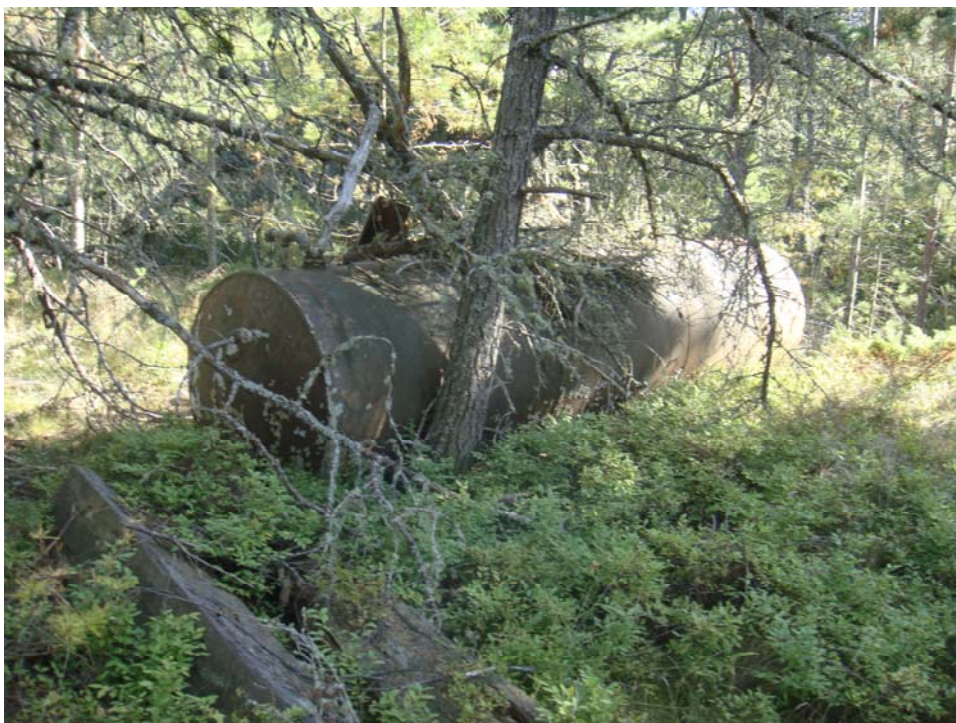
Site Image LI-63: Fuel tank, 2009 (Source: MBD DSC01354.JPG)

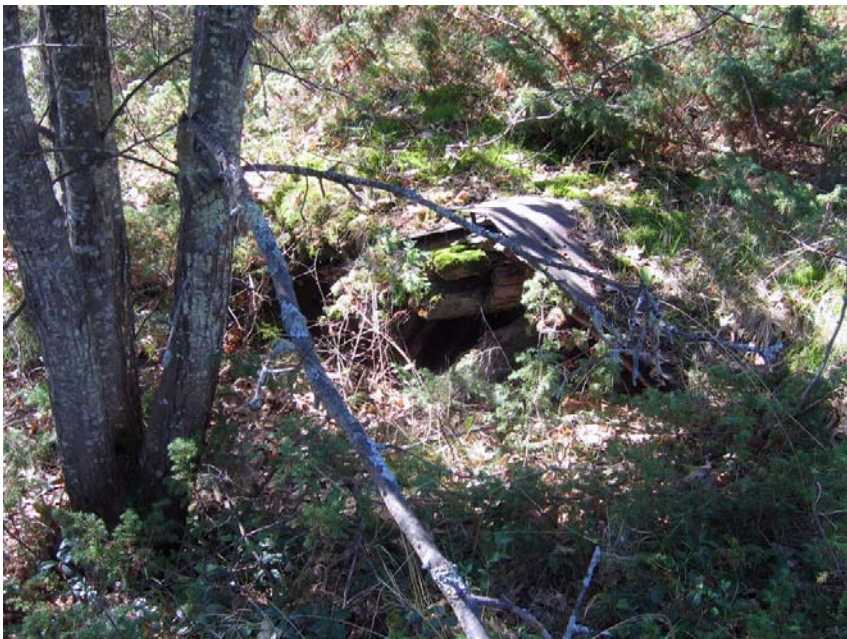
Analysis. The portions of concrete walks are similar to the precast units found at the LaPointe site and on other light stations in the Apostle Islands. The root cellar is collapsed and buried but provides insight into the operation of the light station and the lives of the keepers and their families. The extant small scale features Original LaPointe Lighthouse site are contributing features. Field investigations for the CLR were limited and it was noted in the 1988 archeological survey of Long Island that this site may be a productive site if further archeological investigations are to occur.

Site Image LI-64: Root cellar east of Original LaPointe Lighthouse ruin, 2009 (Source: MBD IMG_9424.JPG)

Protect the root cellar by removing any vegetation that may be damaging buried portions of the structure and directing water away from structure. Provide additional noninvasive site investigations to determine extent and condition of buried structure.

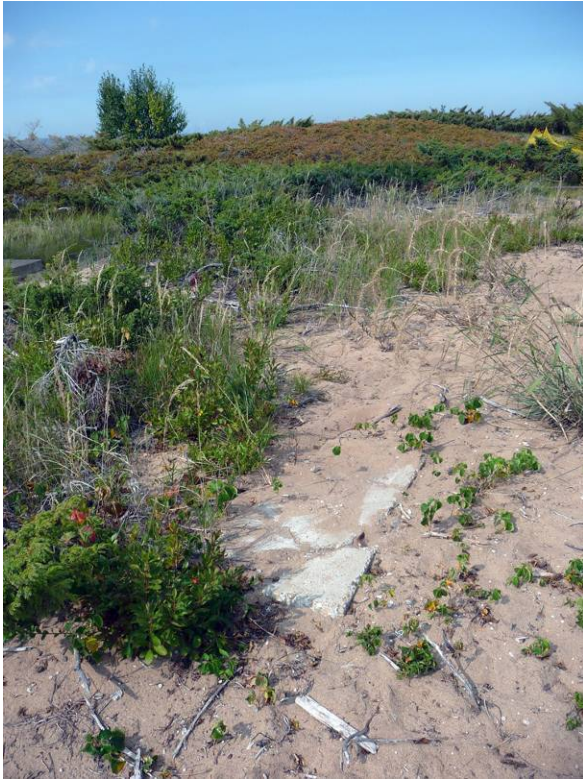
2
3 Site Image LI-65: Concrete walk at Chequamegon Point, 2009 (Source: MBD DSC01349.JPG)

Treatment measures at the Chequamegon Point grounds are limited to reestablishing the corridor for the connecting path between the sites and maintaining existing concrete walks found on the site.

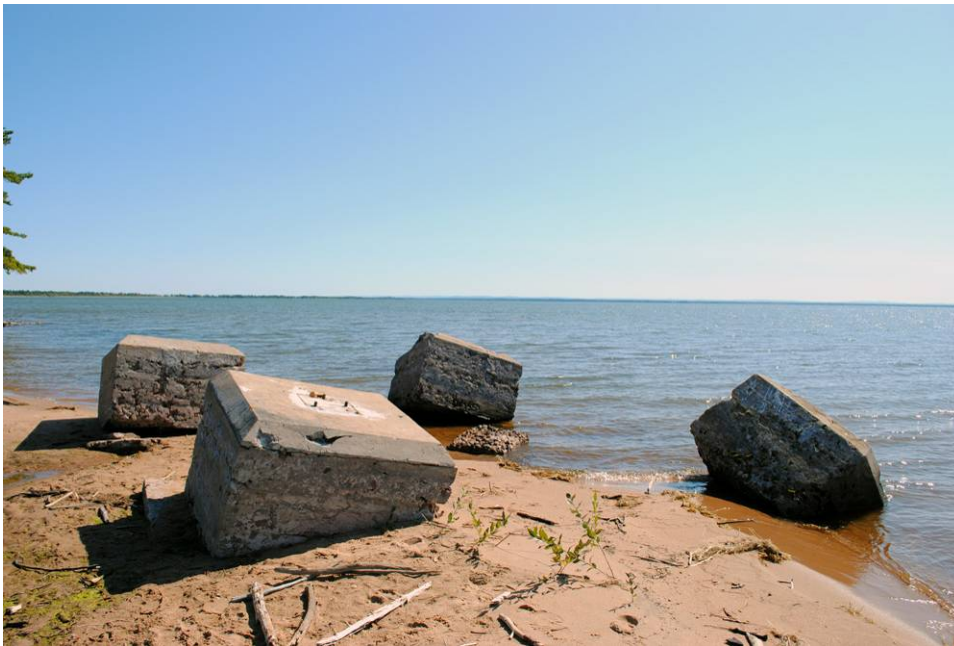
5
6 Site Image LI-66: Concrete footings remain from the former location of the Chequamegon Point Light Tower, 2009 (Source:
7 MBD DSC_0021.JPG)

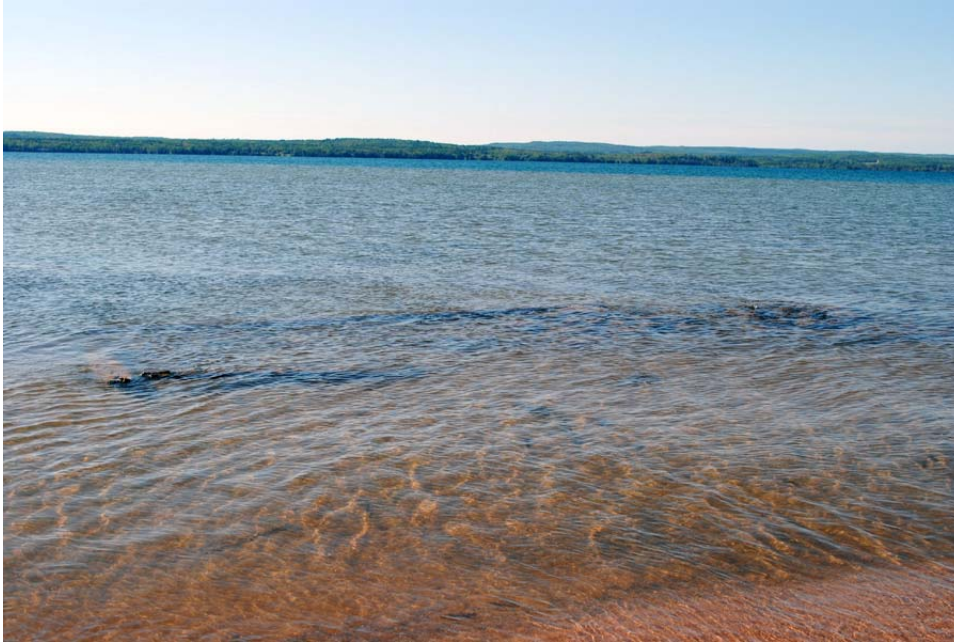
Site Image LI-67: Rubble landing crib remnants at Chequamegon Point, 2009 (Source: MBD DSC_0049.JPG)

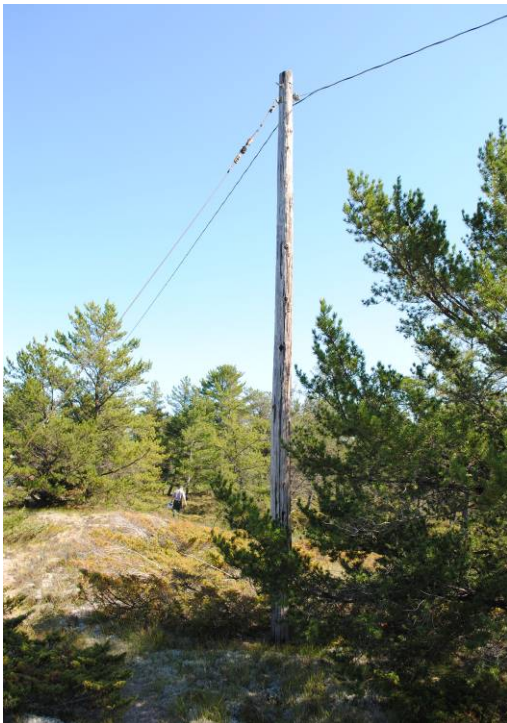
Site Image LI-68: Typical power pole for electric line, 2009 (Source: MBD DSC_0088.JPG)

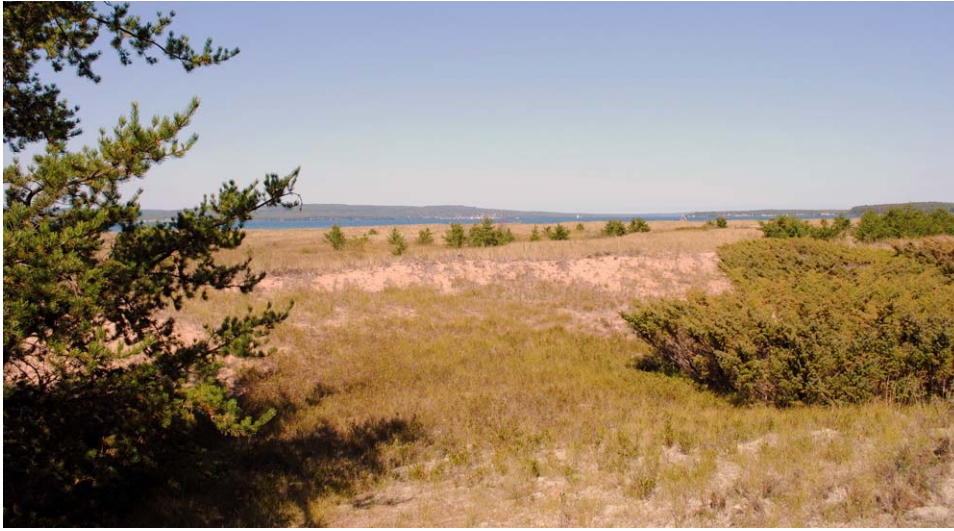
2
3 Site Image LI-73: Typical low dune vegetation on Long Island, 2009 (Source: MBD DSC_0073.JPG)
4

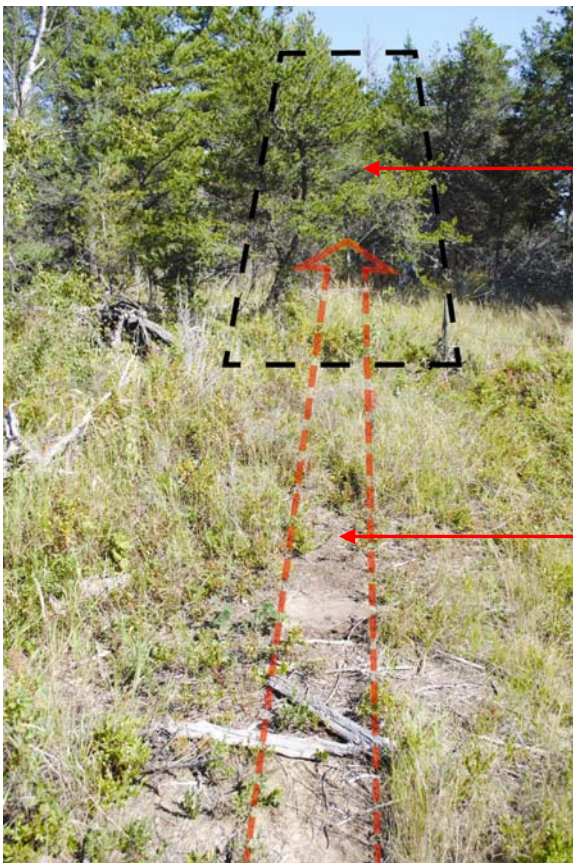
5
6 Site Image LI-74: Reestablish the cleared corridor between the three sites and uncover extant concrete walks, 2009 (Source:
7 MBD DSC_0068_ANNOTATED.JPG)
8
9

24 Further investigation should be undertaken to locate the concrete walk connecting the three sites. It is
25 possible, although no formal documentation exists, that a portion of the walk remain in place, nonvisible,
26 buried beneath the sand.
