# LAPOINTE LIGHT TOWER

## Chronology of Alterations and Use

1 **LaPointe Light Tower Photographs, 2009**

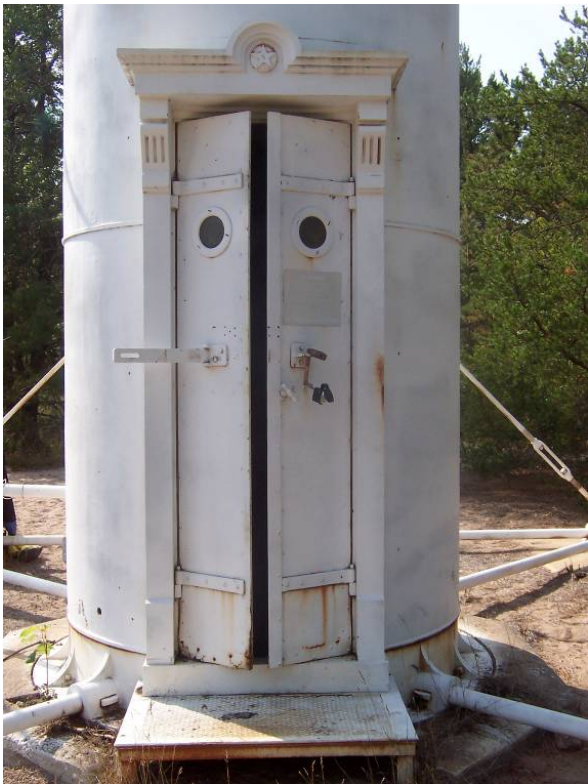
LI-LT-04: North entry door (Source: A&A 100\_9810)

**Entry Doors.** The bases of these entry doors are rusted. Overall, they are in fair condition.

Remove rust and patch as necessary to maintain surface integrity. Prepare and repaint all doors. Repair hinges, latches and levers to ensure smooth operation. Operable doors will be required if the public is to access the Tower and will facilitate ventilation and mitigate moisture issues of the Tower's interior.

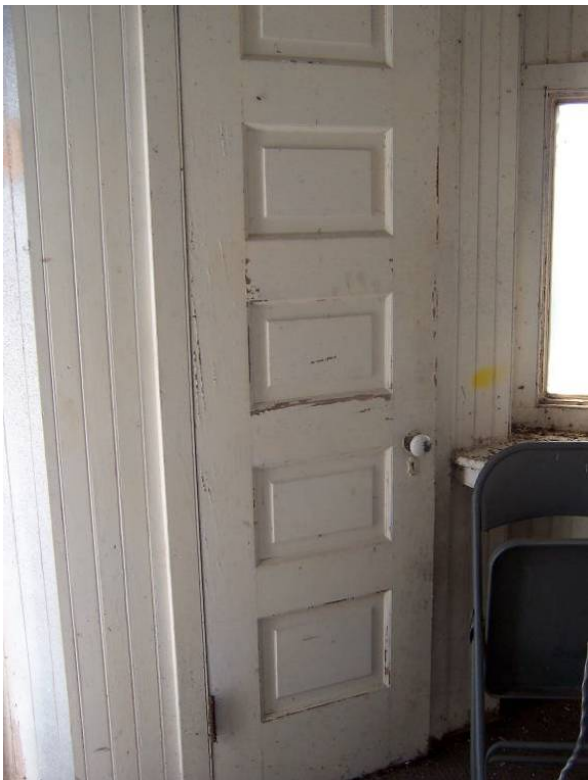
*LI-LT-08: Watch room storage door (Source: A&A 100\_9806)*

**Watch Room Storage Door.** This door is in fair condition as the paint is peeling, the hinges are rusting, and the knob operates sluggishly.

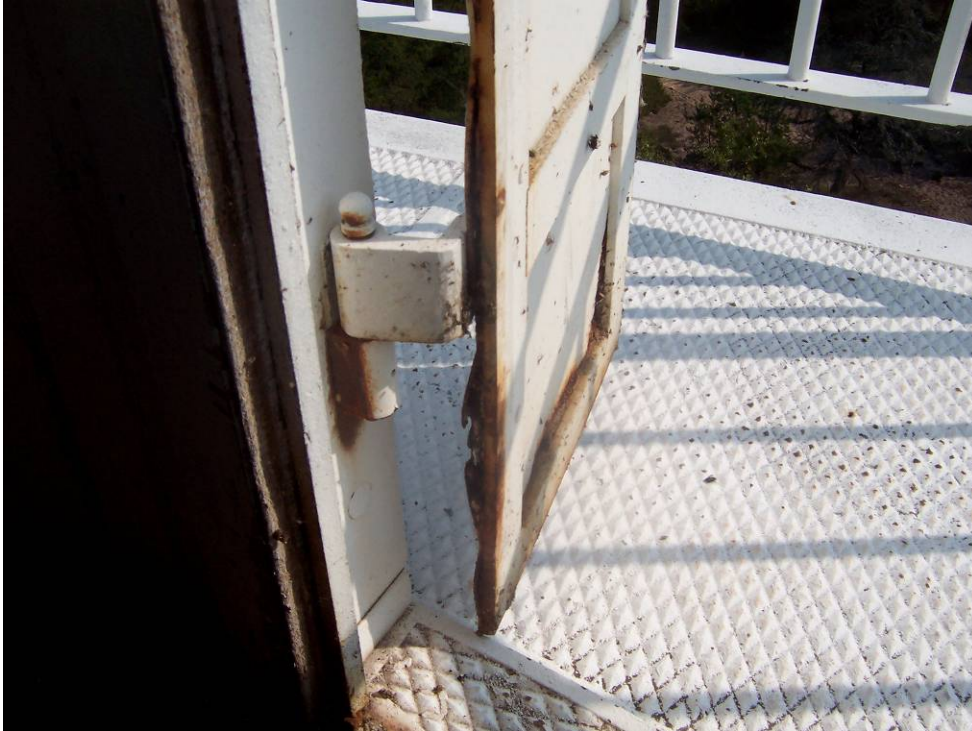
LI-LT-09: Watch walk access door, walkway and railing (Source: A&A 100\_9808)

**Watch Walk Access Doors.** These doors are rusted, the lever does not throw the top and bottom throw bolts, and the hinges are sluggish.

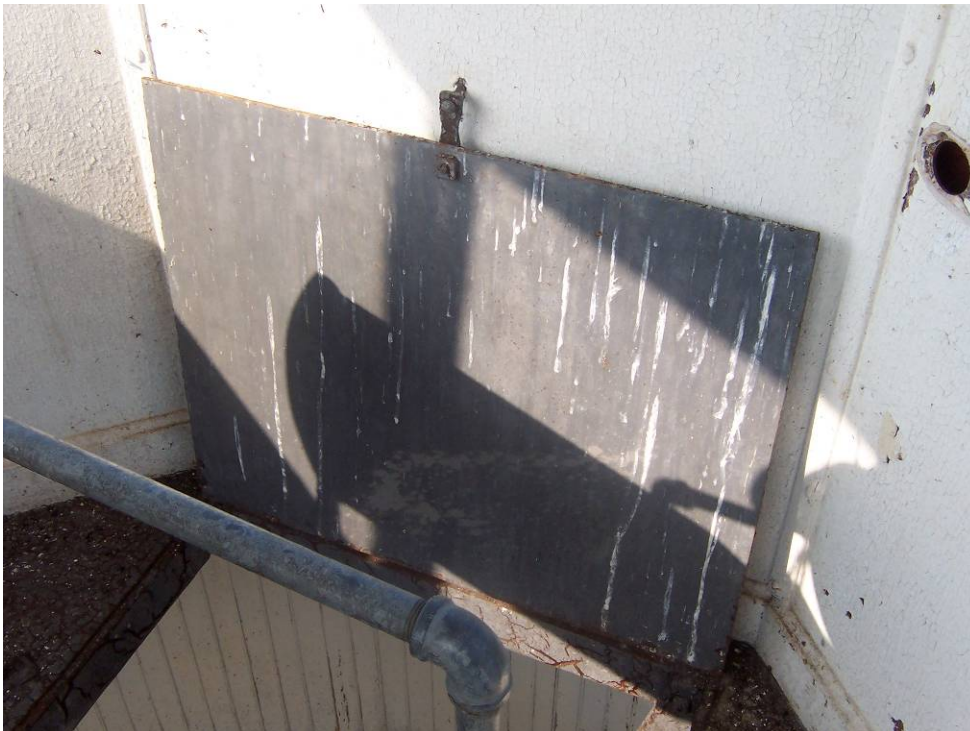
LI-LT-12: Lantern hatch (Source: A&A 100\_9801)

**Hatch Door to Lantern Level.** This hatch opening is in poor condition as the top portion is rusting and very deteriorated.

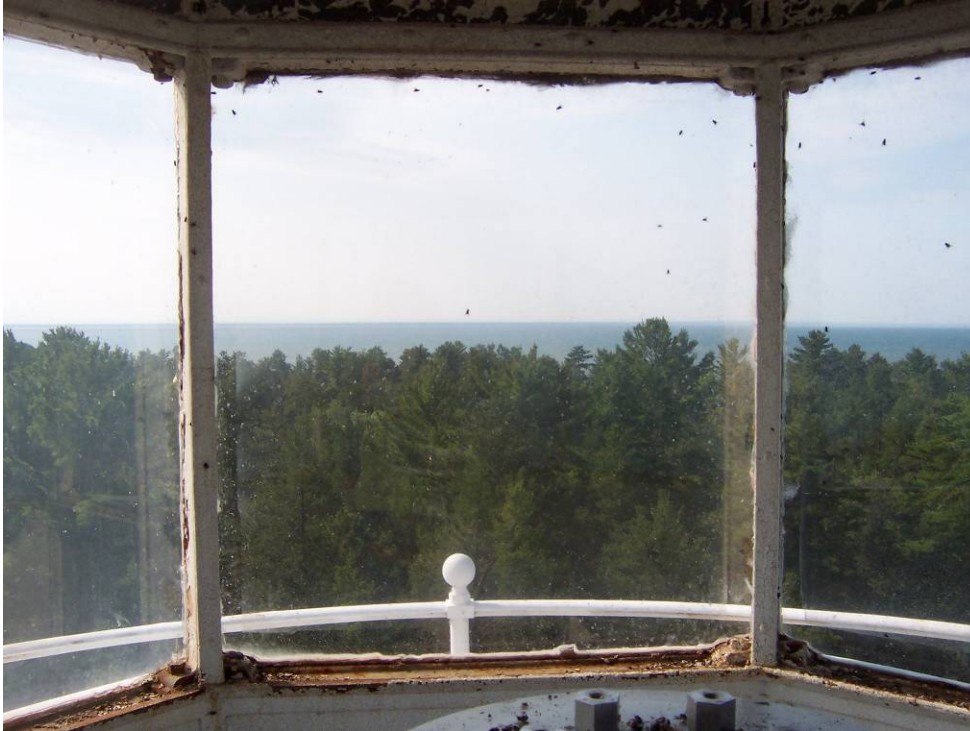
LI-LT-13: Lantern glazing (Source: A&A 100\_9800)

The lantern members are in fair condition as there is alligatored and peeling paint, all cast iron members are rusting, one pane of glass is cracked, and there is a bullet hole. The glazing seals are loose and damaged.

Scrape, prep and repaint all cast members. Replace cracked and otherwise damaged panes. Verify tight seals for all lantern glazing. Verify proper operation of all ventilation components.

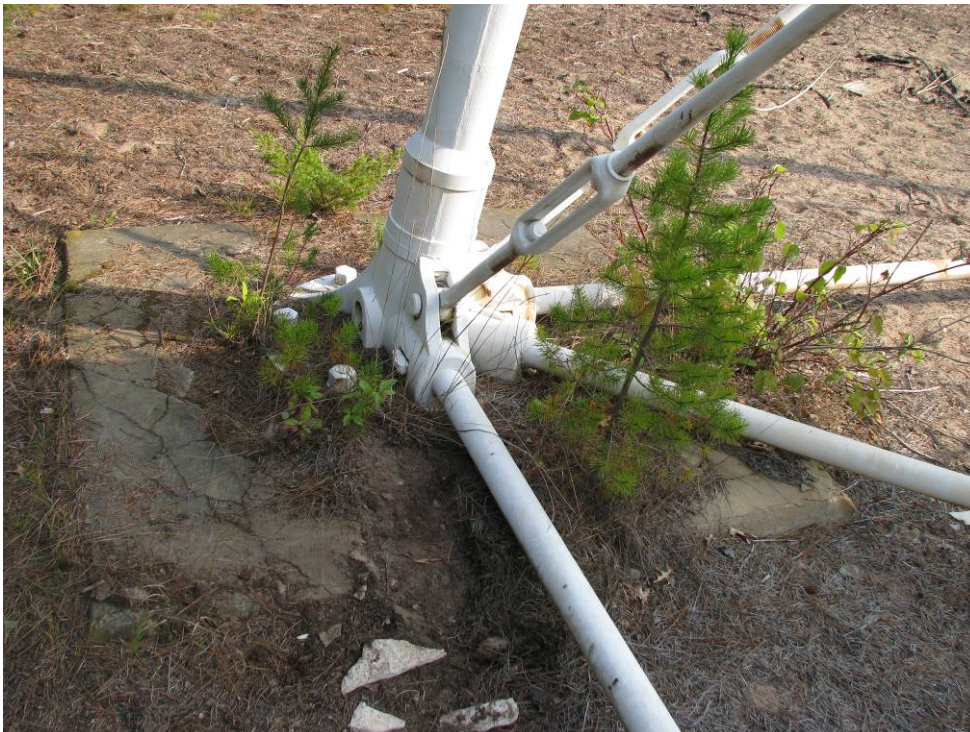
The visible portions of the concrete footings are in poor condition. The footings are severely cracked and several have surface deterioration and vegetation growing in the cracks (LI-LT-20 and 21).

LI-LT-20: Deteriorated footing (Source: Martin/Martin)

Surface cracking of the footings indicates that the concrete mat may be deteriorating. The cracking may also be leading to corrosion or loss of uplift capacity of the anchor bolts. The condition of the concrete and the anchor bolts should be evaluated further.

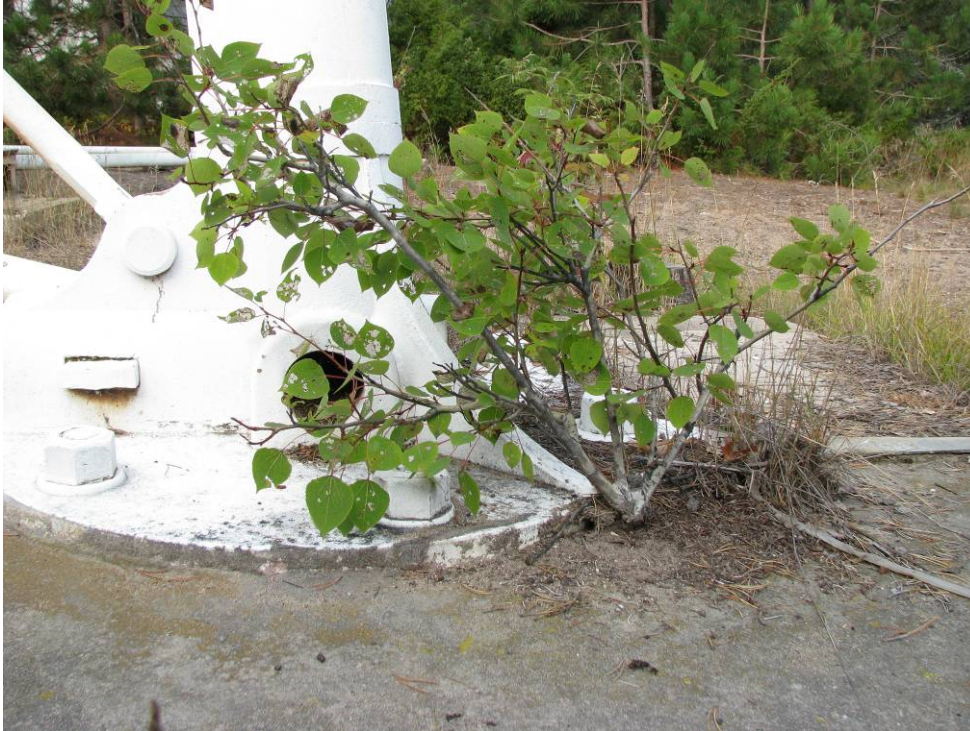
LI-LT-21: Deteriorated footing (Source: Martin/Martin)

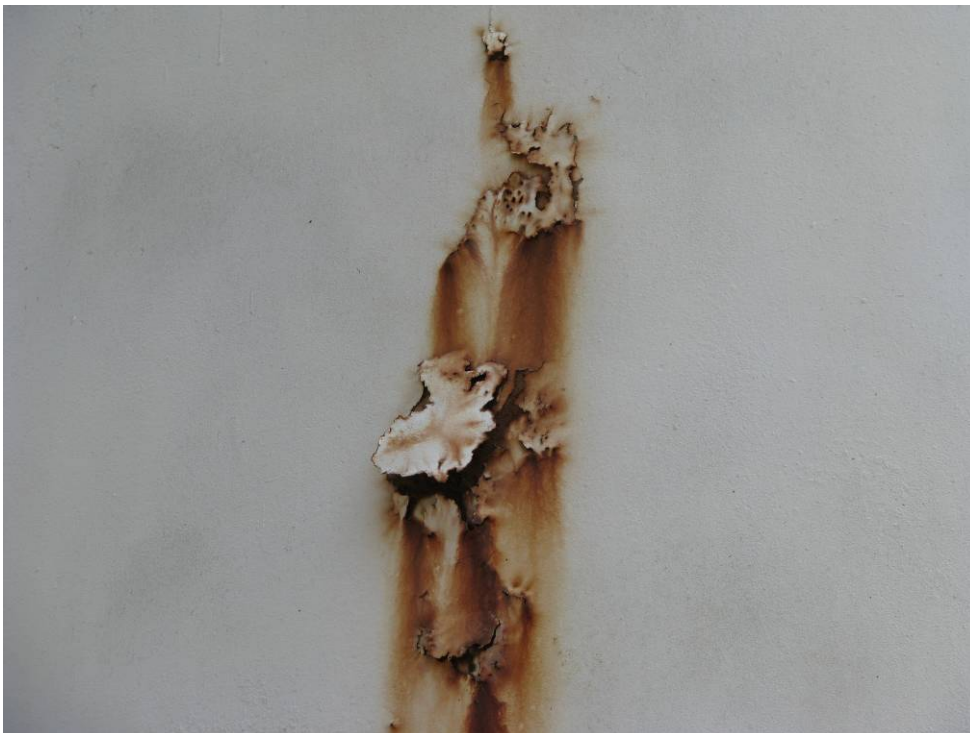
The walls of the center cylinder and watch room are in good condition. However, small areas of delamination were observed (LI-LT-22 and 23). The walls of the lantern are in good condition.

LI-LT-22: Surface delamination (Source: Martin/Martin)

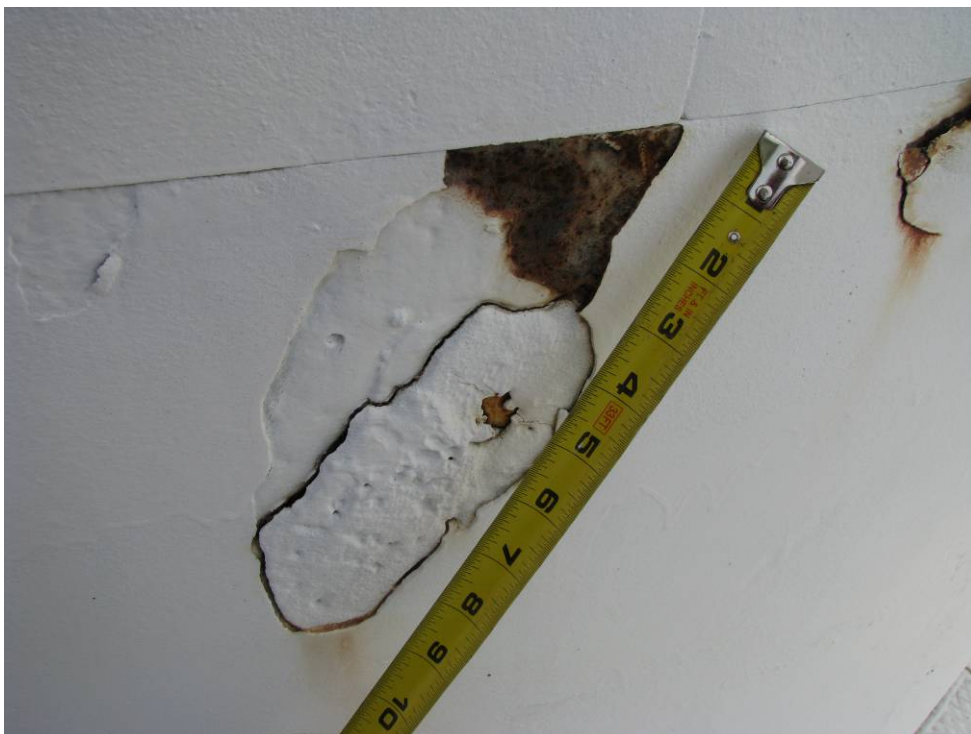
LI-LT-23: Surface delamination (Source: Martin/Martin)

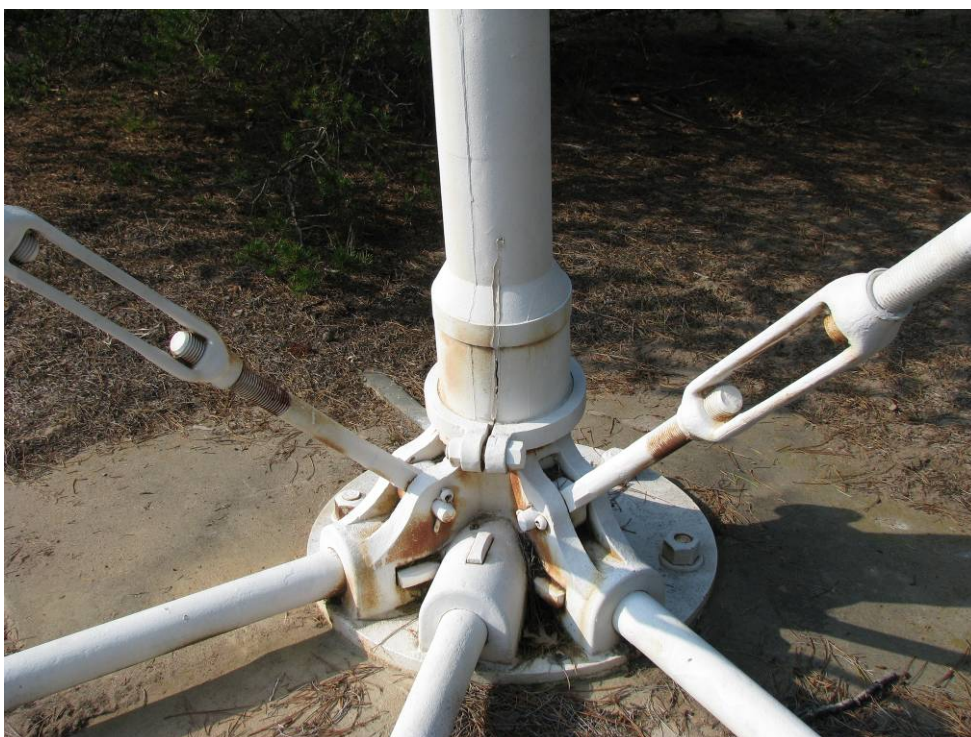
The exterior braces are in fair condition. Cracks were observed in the belled ends of several of the leg segments. The cause of the cracks could not be determined. The cracks could be due to corrosion of the braces, corrosion of hidden structural elements within the belled ends or binding of the joined elements due to differential movement. Some of the cracks had been drilled to relieve the stresses at the tip of the crack (LI-LT-24 and 25).

LI-LT-24: Cracked brace (Source: Martin/Martin)

The cracks in the belled ends of several of the leg segments should be investigated further.

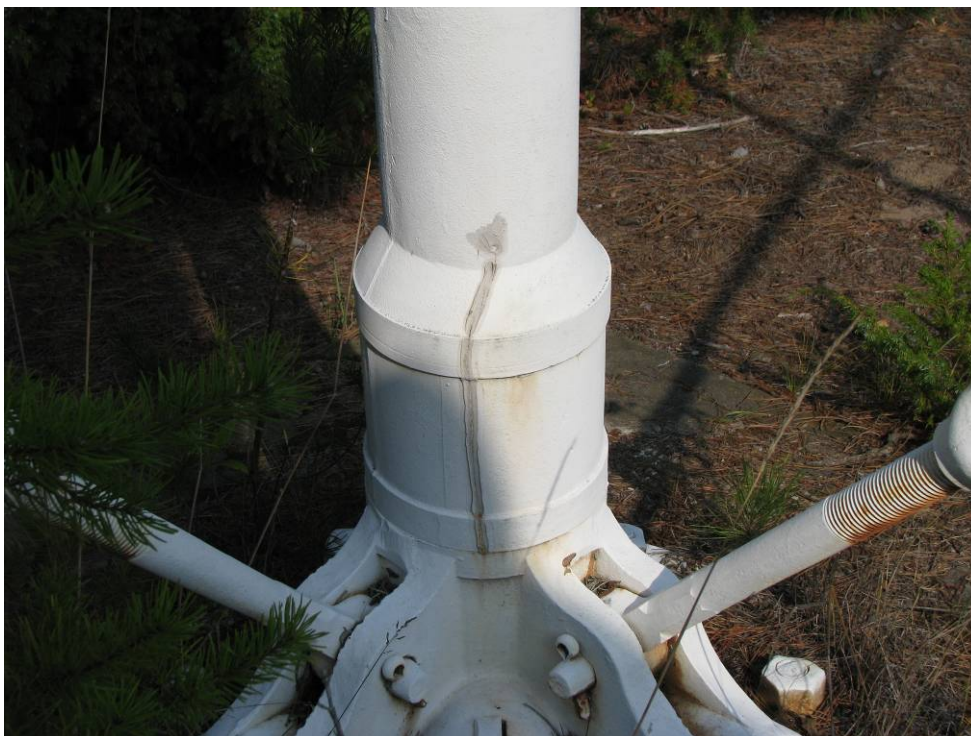
*LI-LT-25: Cracked brace (Source: Martin/Martin)*
