TRIPLEX

Chronology of Alterations and Use

1 *Triplex Photographs, 2009*

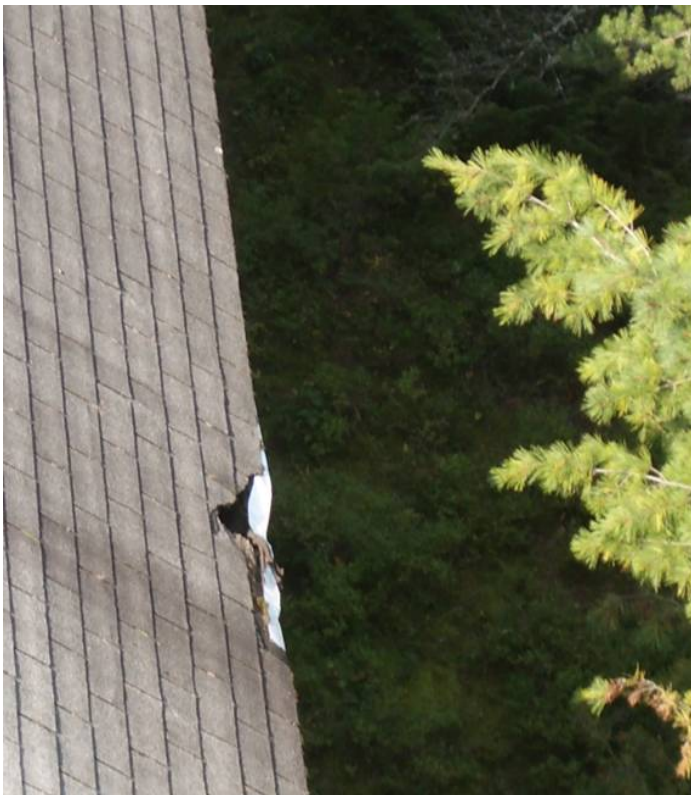
LI-TX-07: Roof damage at southeastern portion (Source: A&A IMGP2987)

The roof is overall in fair condition. There is a hole at the eave/soffit on the north side, though it has yet to translate to finish damage on the interior. There is damage on the interior from roof leaks but the damage appears to have occurred prior to this new roof. This roofing is nearing the end of its serviceable life. (LI-TX-07)

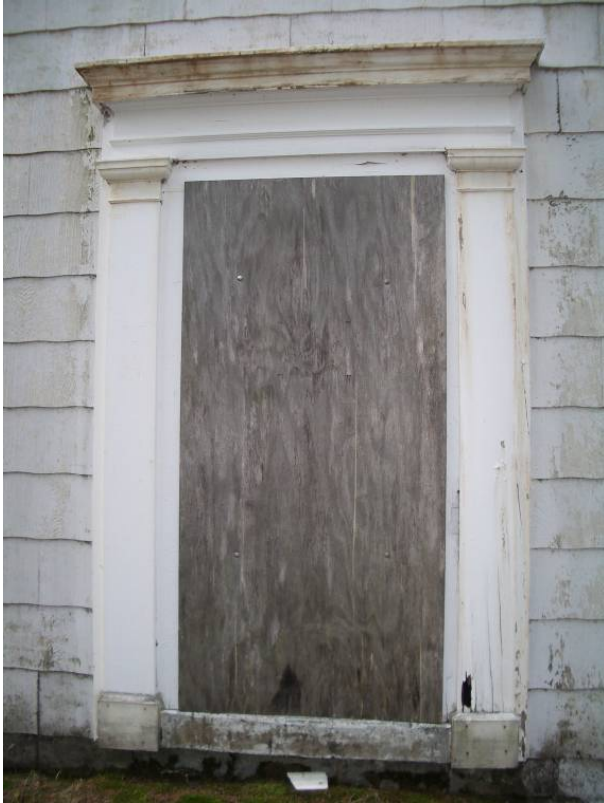
LI-TX-08: East unit's main entry door (Source: A&A IMGP2976)

44 The exterior trim is overall in fair condition. The cornice trim is generally in good condition with the
45 exception of the hole at the north elevation's east end. The drip edge trim appears to be rusting and staining
46 the trim below as it is in poor condition. (LI-TX-08)

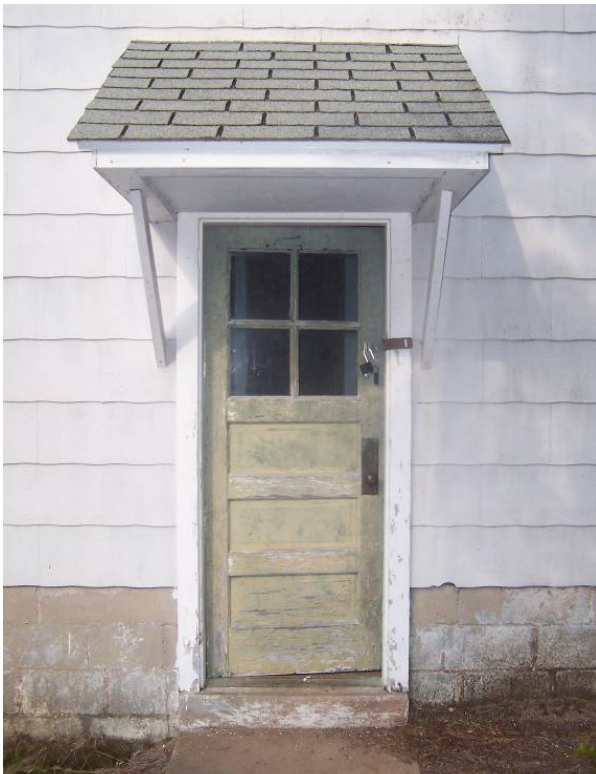
LI-TX-09: East unit's kitchen entry door and overhang (Source: A&A 100_9784)

3 All three shed overhangs appear to be in good condition, though paint is peeling in some areas. (LI-TX-09)

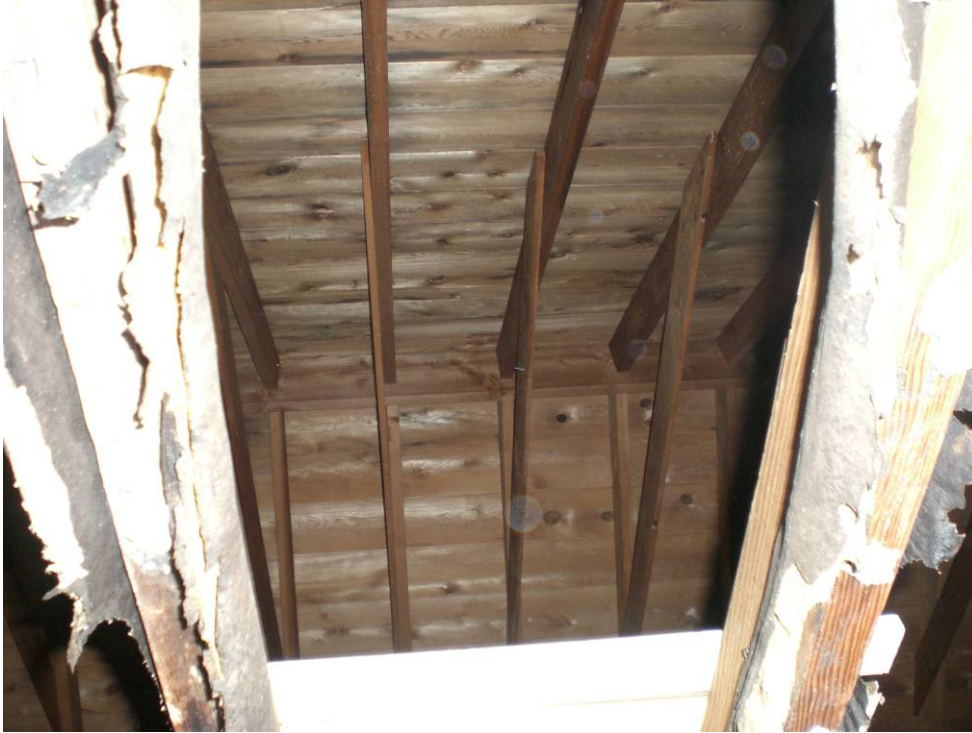
LI-TX-20: East unit's northeast bedroom, attic view through fallen ceiling (Source: A&A CIMG4022)

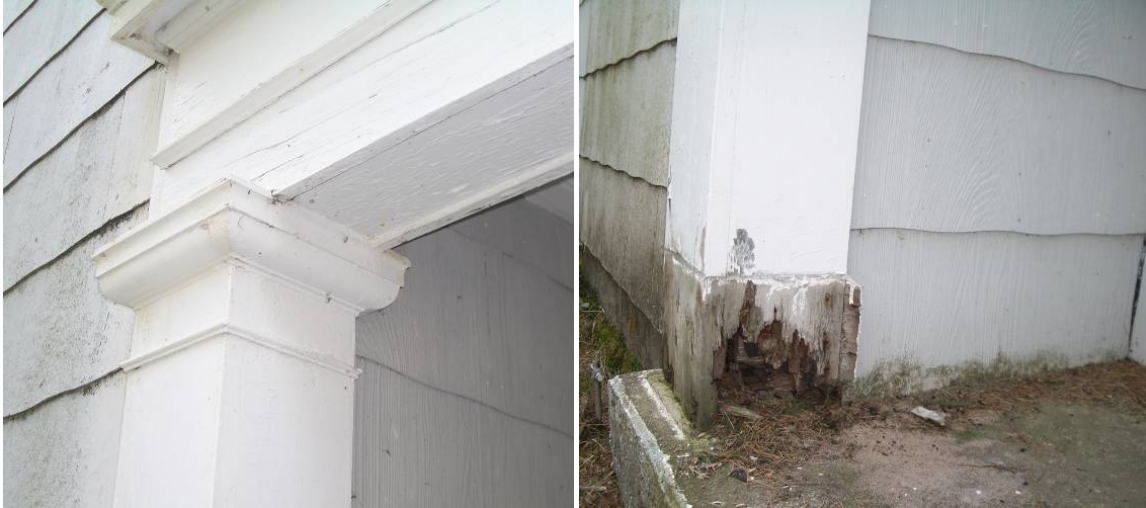
LI-TX-24 and 25: West column capital and base of portico (Source: A&A IMGP2983 and IMGP2980)

51 The bases' 1x built-up trim of the center two columns has been replaced, as evidenced by the different
52 direction of joints, and the ogee bead trim is missing. The base of the far east column is rotted through,

exposing the rotted conditions at the wall framing. The porch's soffit and beam appear to be in fair condition with peeling paint. The concrete stoop is in good condition. The door trim around the center door is in good condition by nature of being further protected by the porch. (LI-TX-24 and 25)

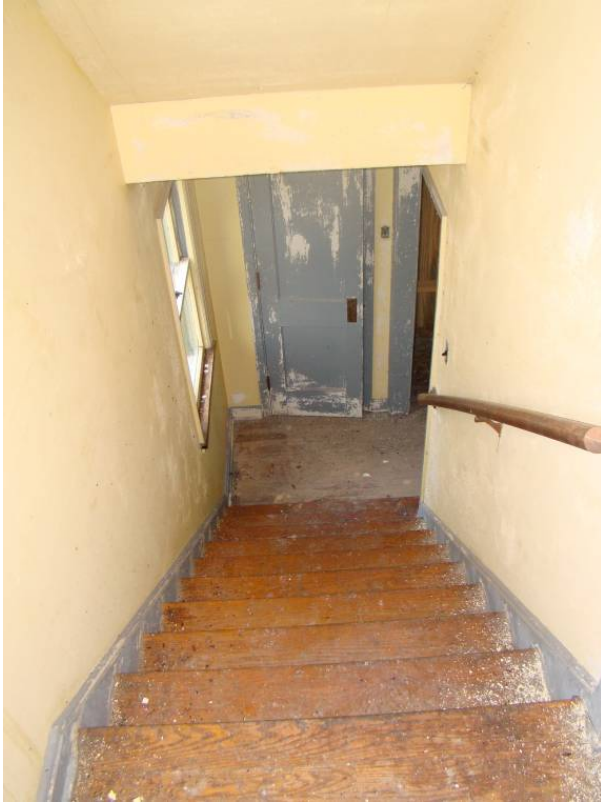
LI-TX-39: West unit stair to second floor (Source: A&A DSC01136)

Second Floor to First Floor Stairs. These stairs are wood with painted risers and stained treads. There are ten risers to a landing (3'8" wide x 3'4" long) and then four more risers at 9" high. The treads are 3'4 ¾" wide and 10 ½" deep with a 1 ½" nosing overhang. The wood handrail has a 2 ¼" diameter and from the nosing to the center of the handrail is 2'6 ½". These stairs and handrail are original to the building. (LI-TX-39)

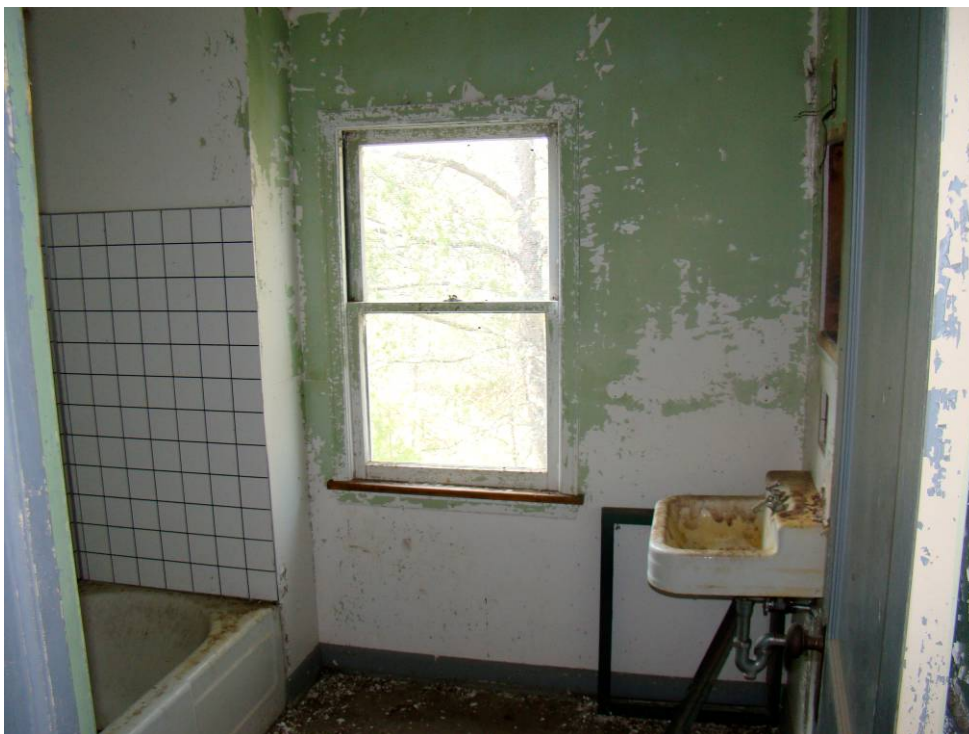
LI-TX-43: West unit bath, looking north (Source: A&A DSC01183)

Unit C, West Unit. The basement's wood and concrete block wall finishes are in fair condition. There appears to be some water infiltration along the south, east, and north walls. Overall, the basement is very damp and has a high moisture content. The entry has a large patch of missing gypsum board under the triple window. The framing and wood sheathing are visible and show signs of water damage. The front door is also boarded-up. (LI-TX-38) The kitchen is in poor condition with visible mold between layers of paint. The parlor also has visible mold along the gypsum board seam. The second floor hall has alligatored paint at the western corner. The three bedrooms have blistering paint. The closets tend to have accelerated poor conditions of the rooms they are associated with. The second floor bath's gypsum board is in poor condition with blistering paint. The FRP wainscot is in fair condition. (LI-TX-43)

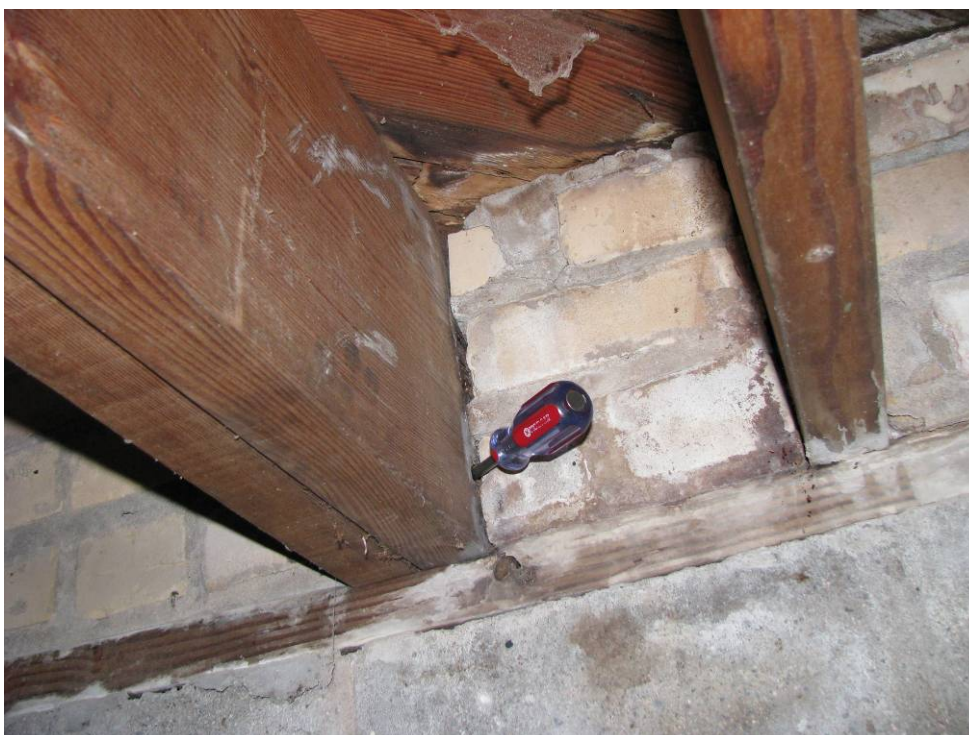
LI-TX-44: Deteriorated floor joist (Source: Martin/Martin)

Structurally, the Triplex is in fair condition. Deteriorated flooring and joists need to be repaired and the basement needs to be dried out to reduce moisture content of the first floor framing. The roof framing needs to be strengthened to carry the required snow load.

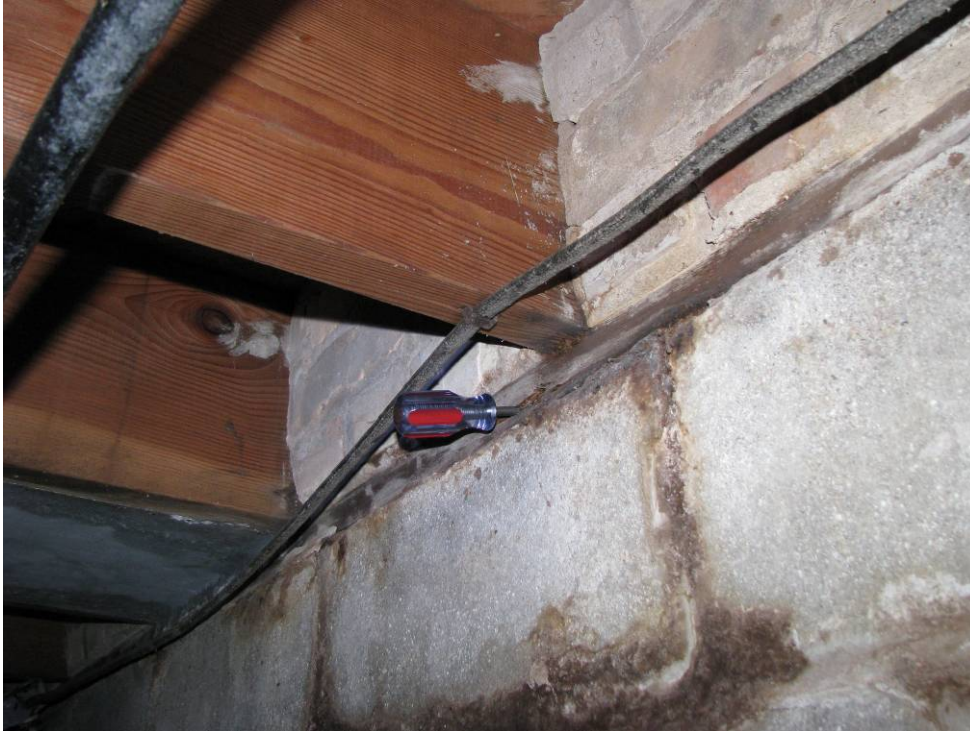
LI-TX-45: Deteriorated sill plate (Source: Martin/Martin)

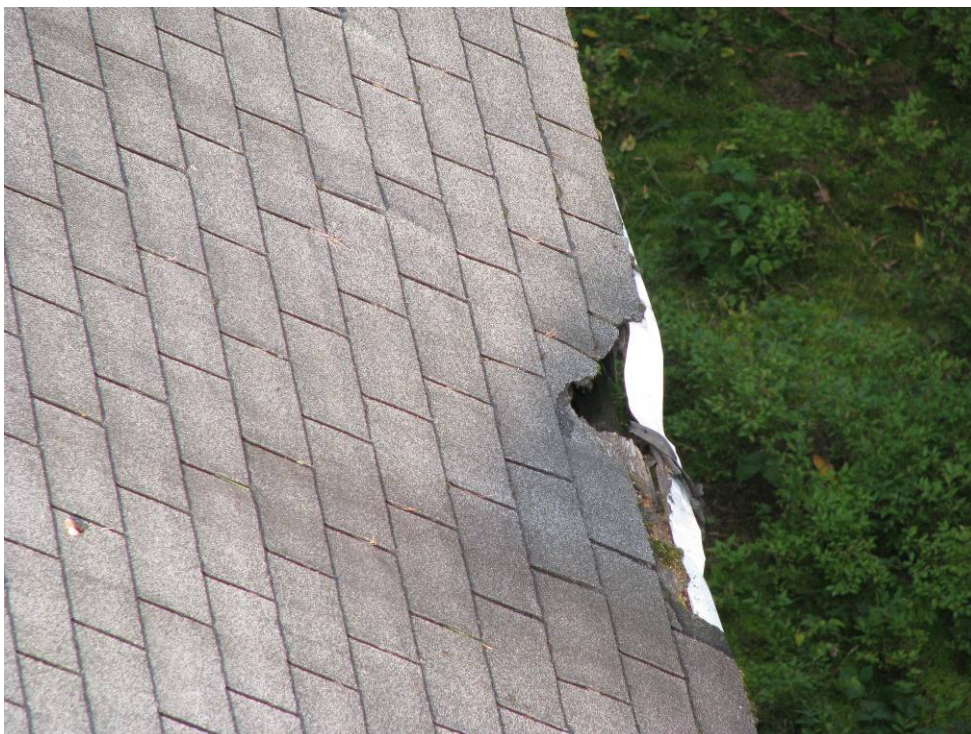
LI-TX-47: Damage at roof eave (Source: Martin/Martin)

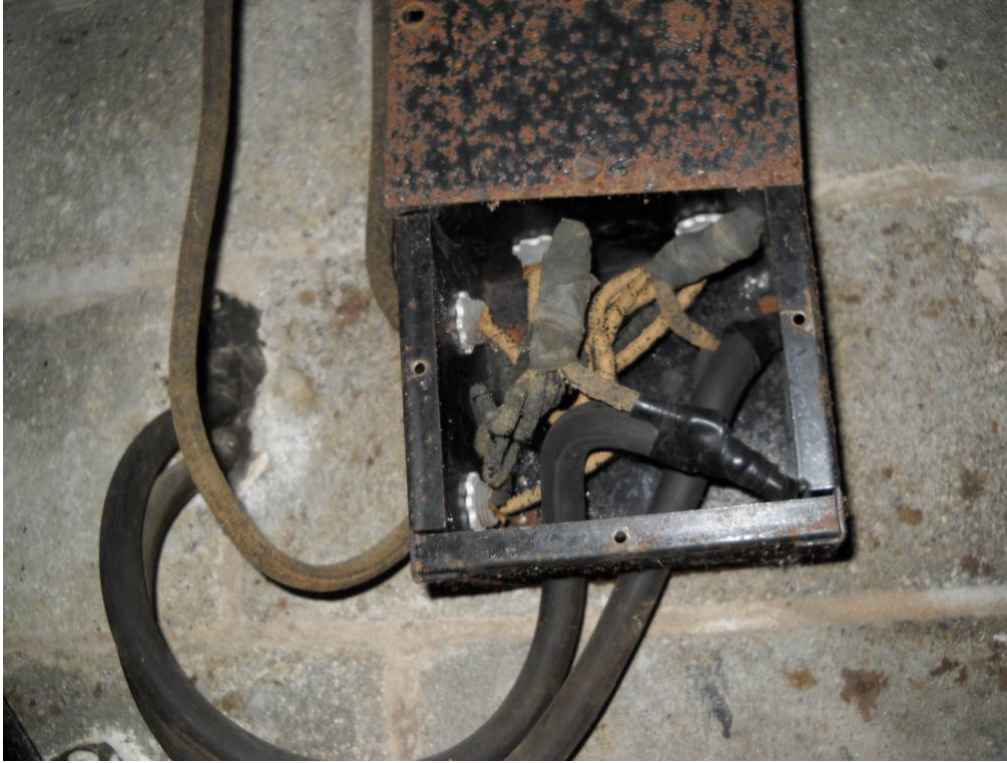
Electrically, the existing systems are over 70 years old, are in poor condition, and are well beyond their useful life expectancy. In addition, the installation no longer meets current National Electrical Code requirements.

LI-TX-49: Service entrance, power for all three units connected through small (approx. #6AWG) conductors (Source: RMH)
