# **OIL BUILDING**

## **Chronology of Alterations and Use**

The following section is a discipline-by-discipline, component-by-component condition assessment of the building. Refer to Volume I, Chapter 2: Methodology for definitions of the condition ratings.

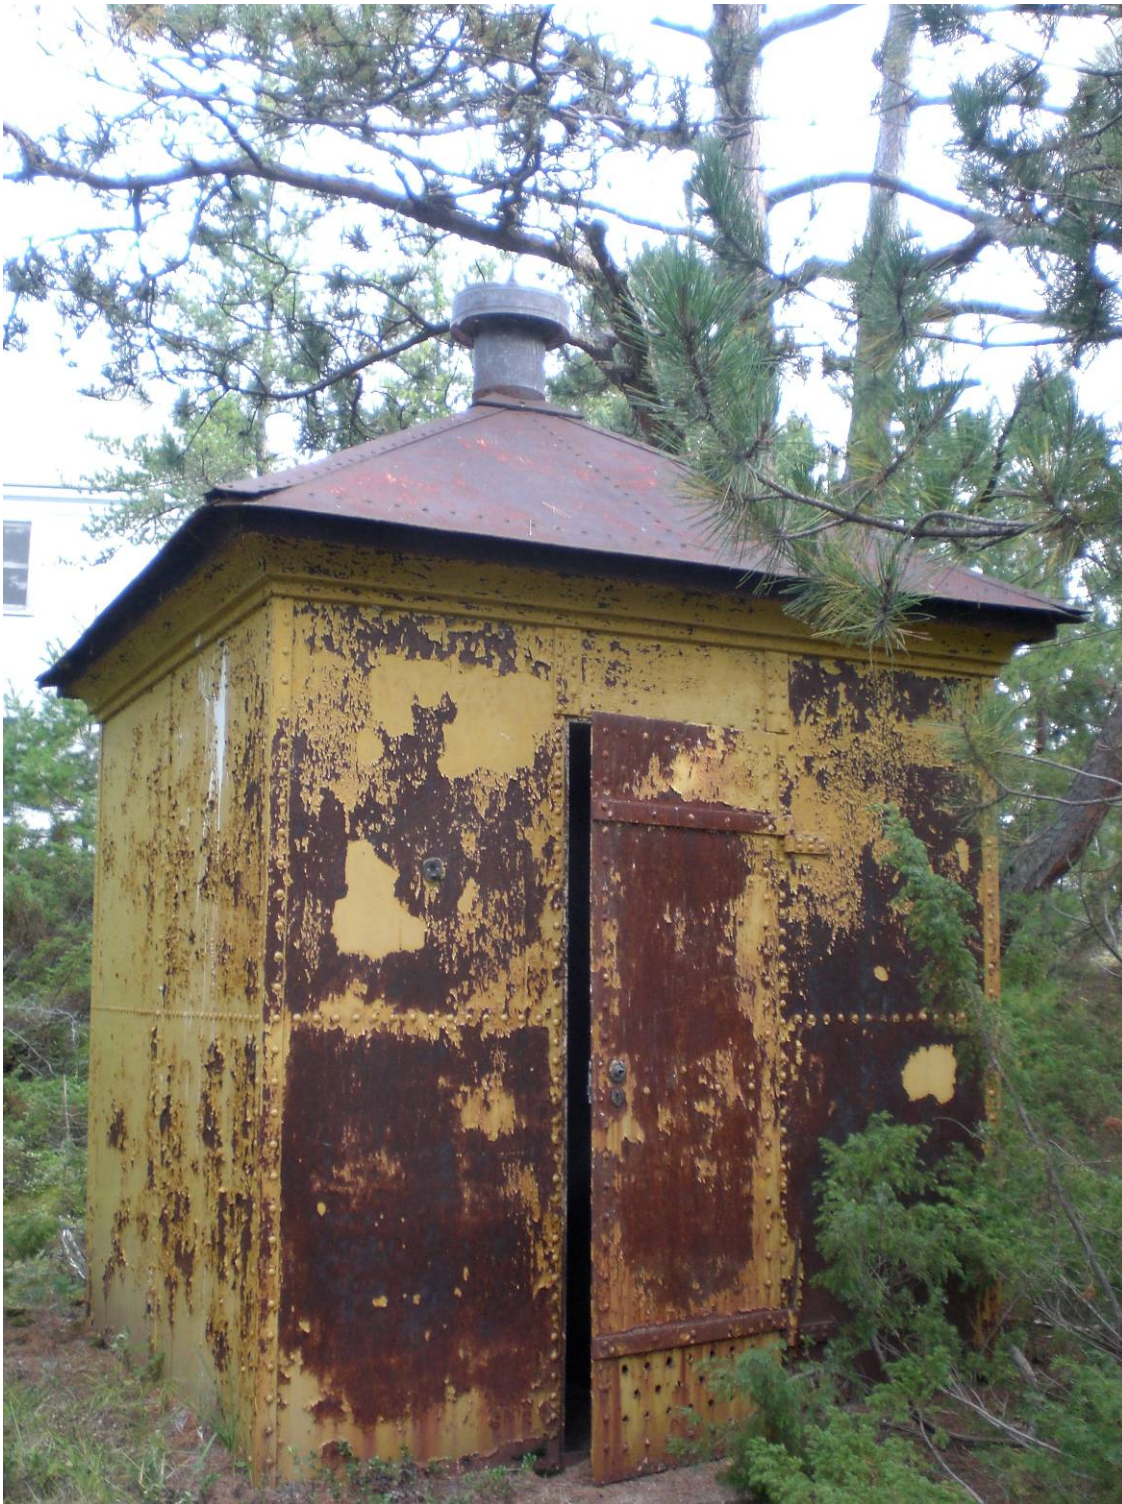
2  
3 *LI-OB-01: South elevation, 2009 (Source: A&A CIMG3930)*

The sheet metal is in fair condition as the yellow paint is peeling and a large amount of surface rust is visible.

Scrape, patch and prepare areas of rust and repaint the walls.

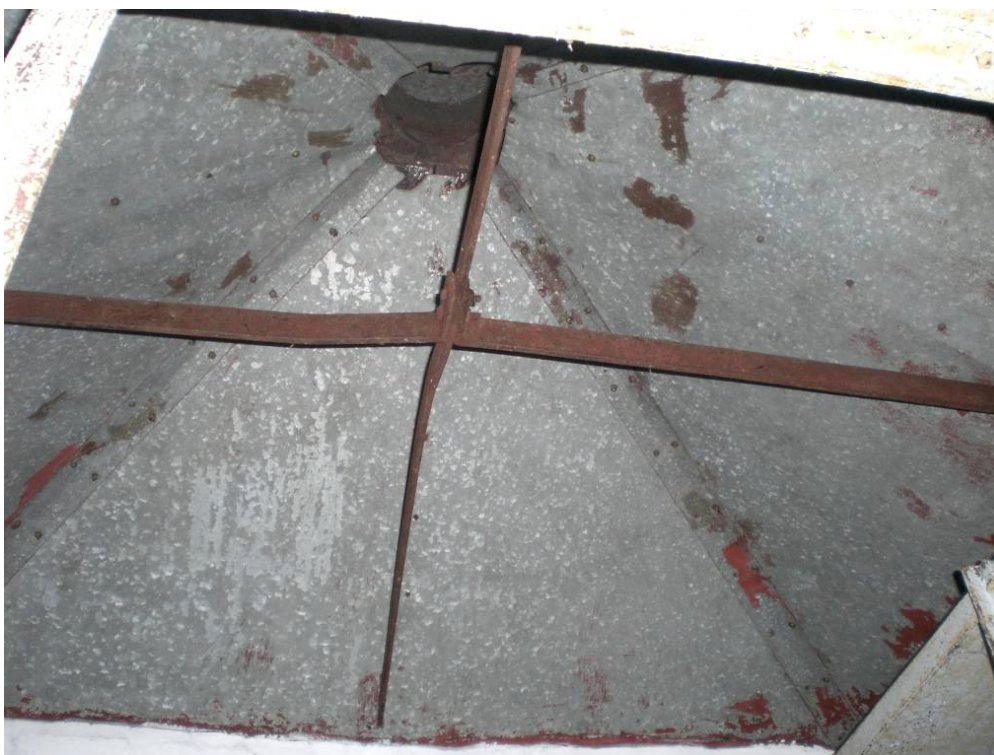
LI-OB-06: Sheet metal ceiling (Source: A&A IMGP3002)

The ceiling is sheet metal attached to the pyramidal roof structure. The roof framing has metal cross-bracing. (LI-OB-06)

The sheet metal roof is in good condition but the cross-bracing is rusting.

No recommendations at this time other than to monitor the rust on the cross bracing.

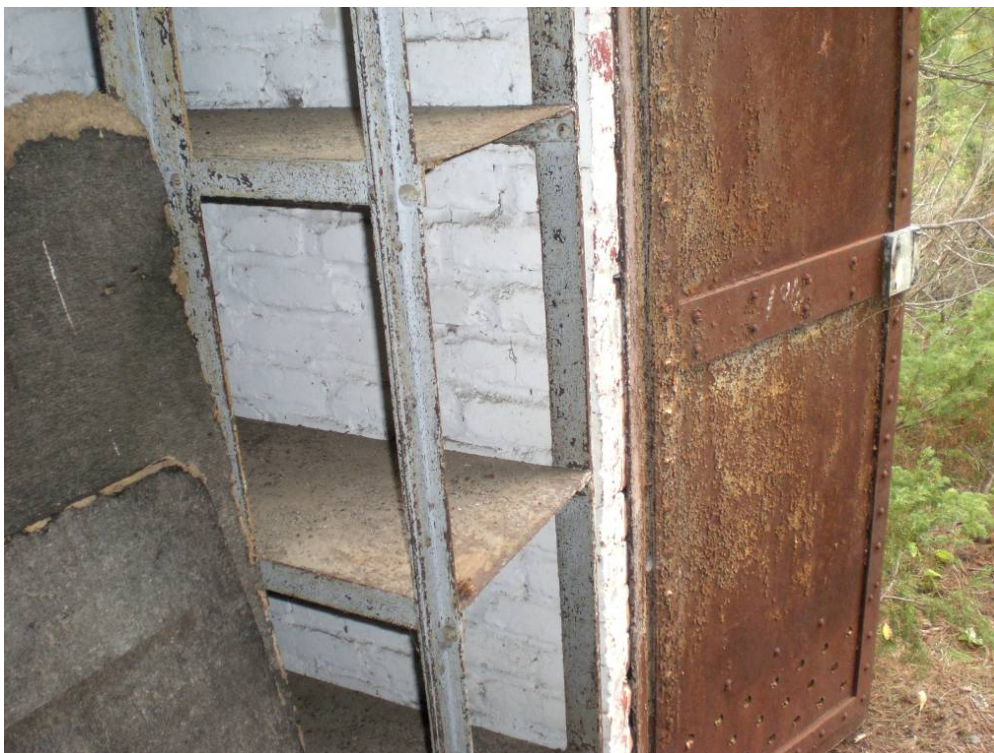
*LI-OB-07: Door and brick interior walls, looking south (Source: A&A CIMG3923)*

The original entry door is plate steel with heavy strap hinges, mortise lock, and is painted yellow. The door is 2'3" x 6'6" x 3/8" frame with a 1/8" plate. (LI-BO-01 and 07)

The door is badly rusted on the surface, is missing one hinge pin, no longer has its original hardware, and has badly peeling paint.

The painted brick is in good condition, but there is some spalling at the floor level, which indicates moisture may be trapped between the masonry and the sheet metal siding.

Scrape, patch and prepare areas of rust and repaint the door. Replace the missing hinge pin and knob/lock mechanism. Without replacing the hardware, this building remains open to possible damage and vandalism.

Repaint the masonry walls to make more water-tight. Monitor the moisture issues and spalling at the base of the interior of the wall. Providing a path for any trapped moisture to escape between the masonry and sheet metal siding and/or introducing a flashing component between the brick and concrete slab to prevent moisture wicking up into the brick wall should both be explored for future mitigation.
