## EXISTING CONDITION ASSESSMENT AND LANDSCAPE ANALYSIS

The existing condition assessment and landscape analysis for the Sand Island Light Station are presented in this section. The light station reservation and grounds are documented as one entity through those landscape characteristics that together comprise its cultural landscape. The presentation of the existing conditions assessment and analysis is organized by landscape characteristics - spatial organization, topography, views and vistas, and circulation. The landscape analysis identifies those buildings, structures, small scale features and vegetation that contribute to the significance and integrity of the cultural landscape of the light station. An overview of the CLR methodology is presented in Volume I, Chapter 2: Methodology.

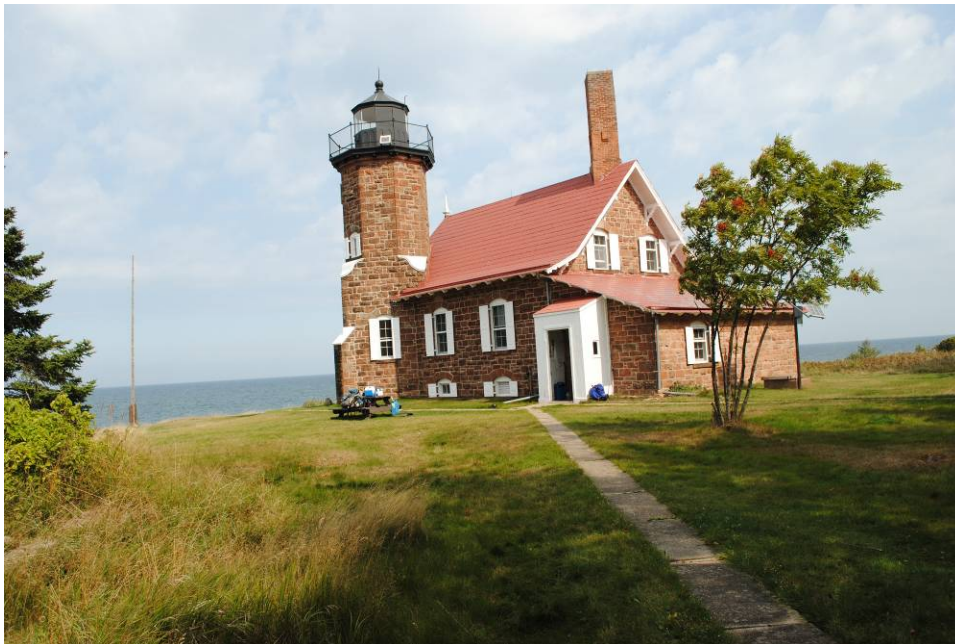
Nonextant Garden Area

Concrete Walk to  
Nonextant Tool Shed

2  
3 *Site Image SI-24: Arrangement of Privy and Oil Building to the south of the Light Station Quarters with path to a nonextant*  
4 *Tool Shed, 2009 (Source: MBD P1020414.JPG)*

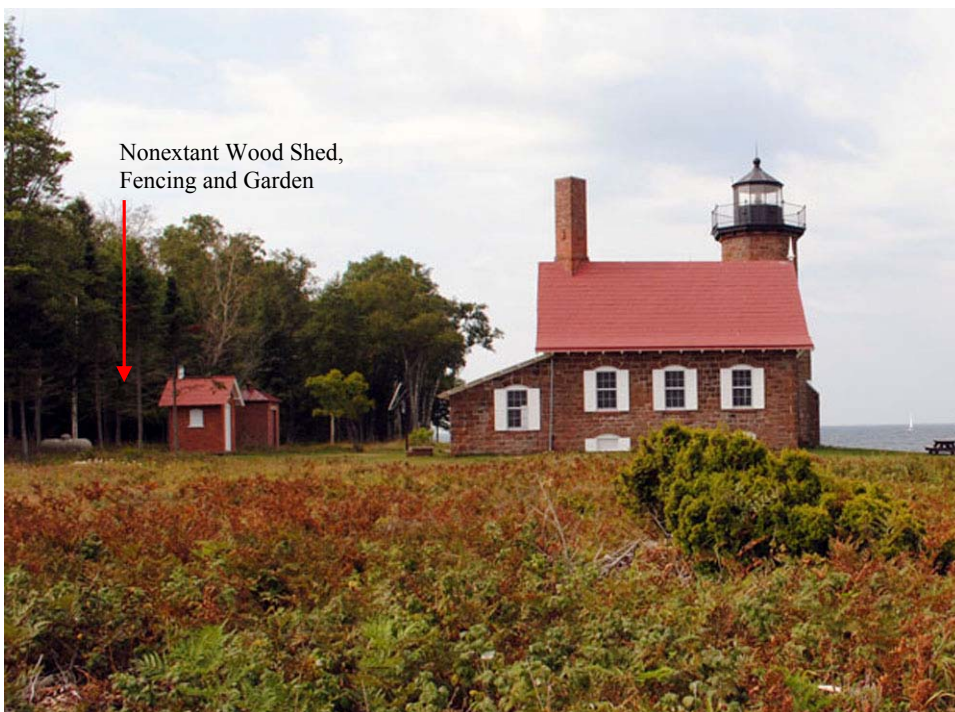
Spatial composition is an important contributing feature and the encroachment of the forest and loss of buildings and structures has diminished the integrity of this feature and the light station.

*Site Image SI-26: View of Light Station from the east – note reduction in cleared area to left and growth of forest; top, c. 1913 (Source: NPS APIS Archives); below, 2009 (Source: MBD DSC\_0250.JPG)*

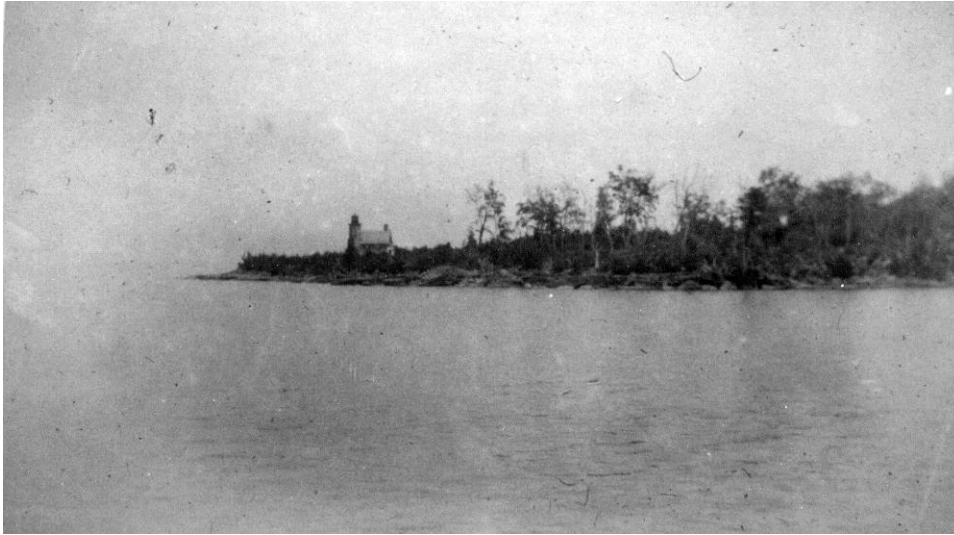
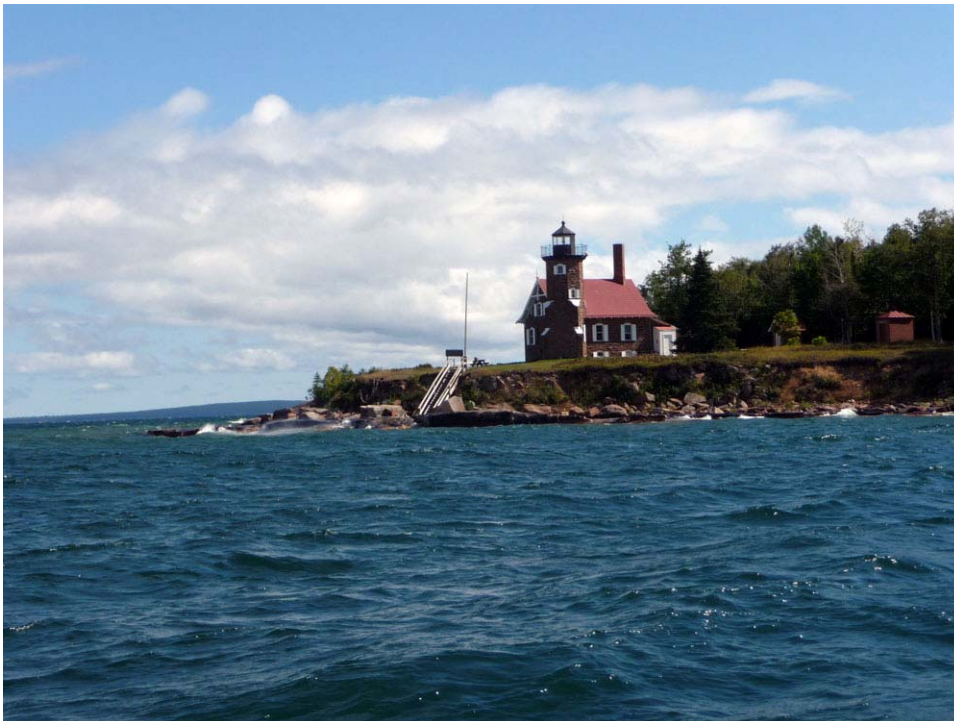
*Site Image SI-30: View of Light Station Quarters from Lake Superior; top, c. 1891 (Source: NPS APIS Archives); below, 2009 (Source: MBD P1020458.JPG)*

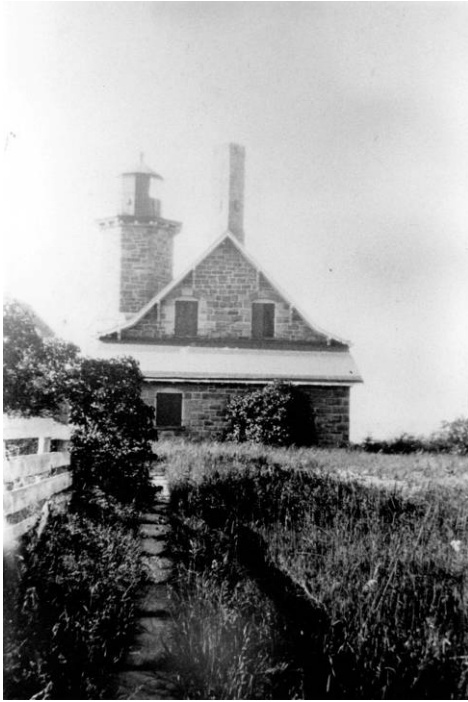
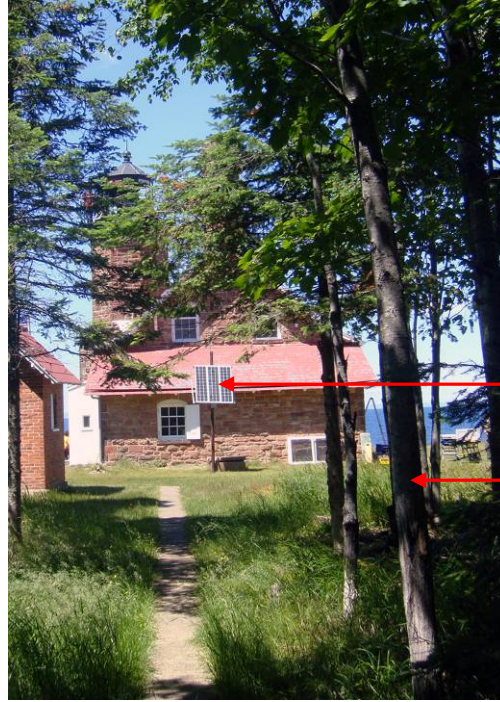
Note Solar Panel and  
Battery Unit Obscuring  
Southern View

Note Vegetation Blocking  
Southern View

Site Image SI-31: View to Light Station Quarters from the south; top, c. 1920 (Source: NPS APIS Archives); below, 2009 (Source: MBD DSC00708.JPG)

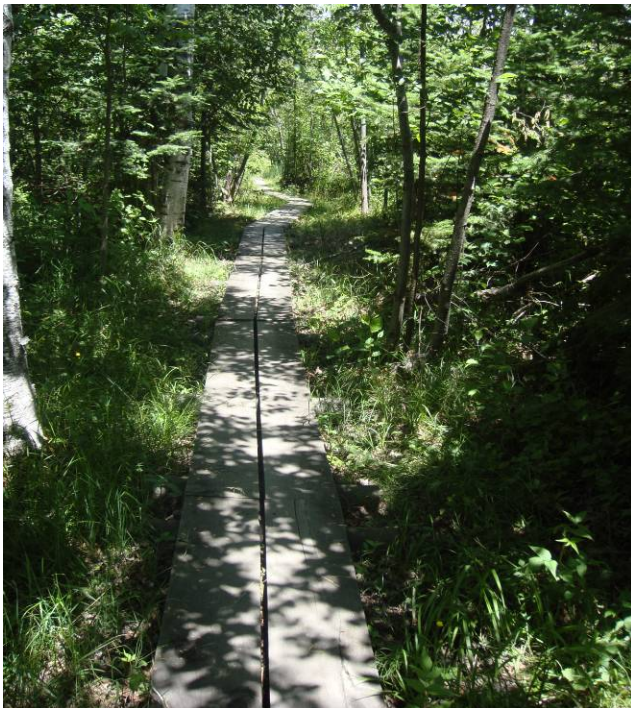
Concrete walks connect the features of the light station grounds, including the Light Station Quarters, Oil Building, and Privy. One leads southeast from the Privy approximately 85 feet to the area of the nonextant Tool Shed. The trail, from the East Bay Landing Dock connects to the concrete walk via a wood plank walk (Site Image SI-34).

Site Image SI-34: Wood plank walk section of trail corridor between the Light Station and East Bay Landing Dock, 2009 (Source: MBD DSC00698.JPG)

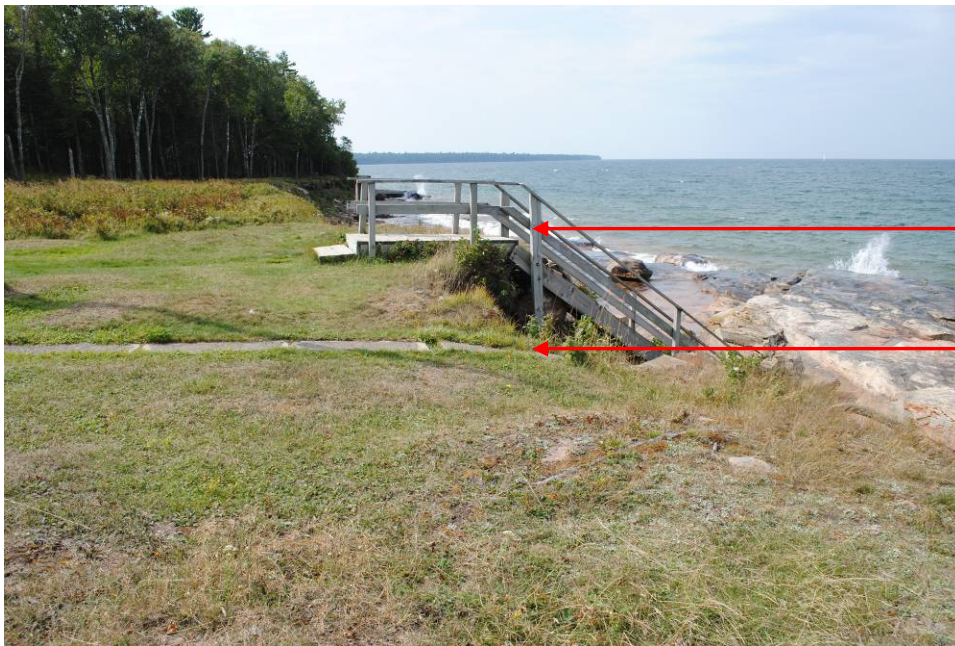
Wooden Staircase

Concrete Walk

Site Image SI-38: Wooden staircase at north landing offset from historic concrete walk, 2009 (Source: MBD DSC\_0263.JPG)

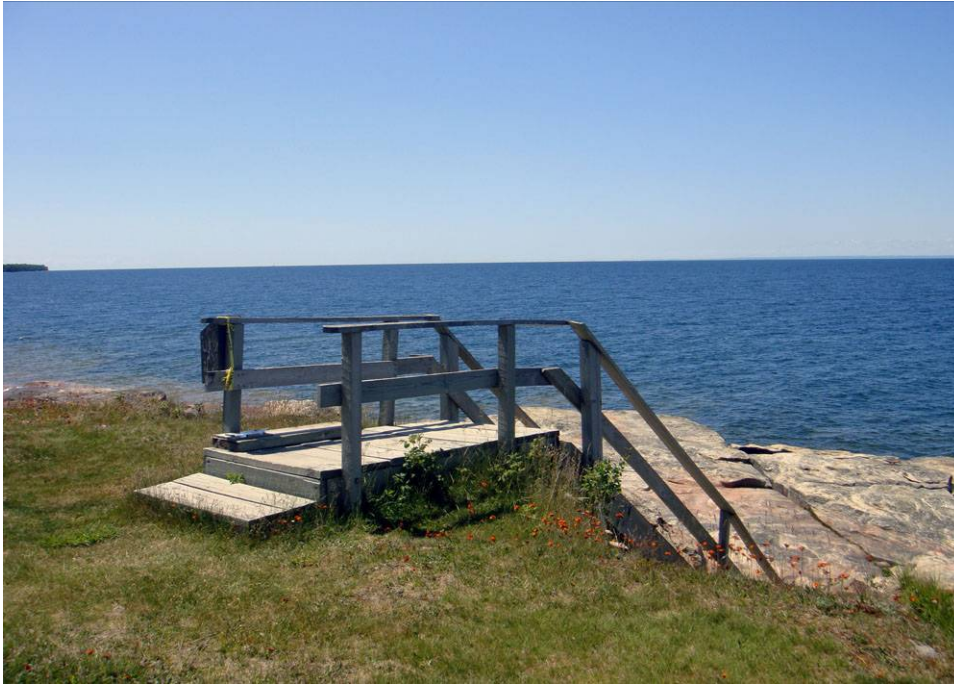
**Existing Condition.** A wooden stairway connects the light station grounds to a natural rock outcrop (approximately 18' high) used as a boat landing. The stairway is built of dimension lumber, is 4' wide with railing on both sides, and approximately 3' high. There is a 1' x 4' step on the light station grounds leading up to a 6' x 4' landing. There are 22 steps leading from the landing to the rocky ledge. The bottom step appears to be a historic 2.5' x 4' precast concrete slab laid on the rocky ledge surface. The alignment of the stairway is offset from the historic concrete walks above by approximately 20'. The stairway is showing signs of disrepair and is in poor condition.

The stairway is from the NPS period and is a noncontributing, noncompatible feature that diminishes the integrity of the light station.

2  
3 Site Image SI-39: View of the wooden stairway at the North Landing, 2009 (Source: MBD DSC00711.JPG)  
4

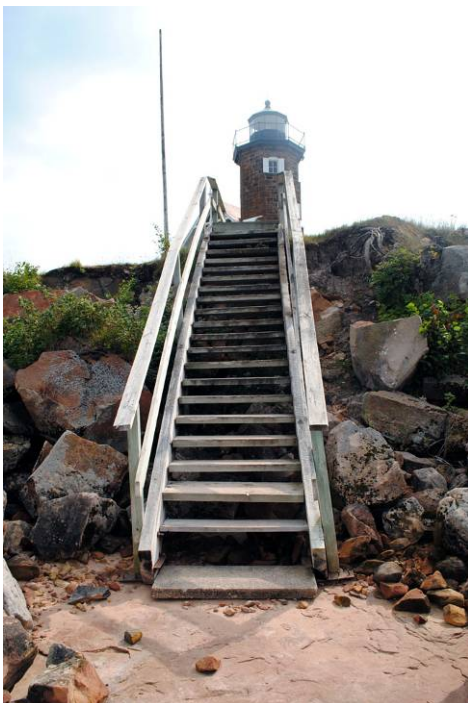
5  
6 Site Image SI-40: View of the stairway from the North Landing, 2009 (Source: MBD DSC\_0274.JPG)  
7

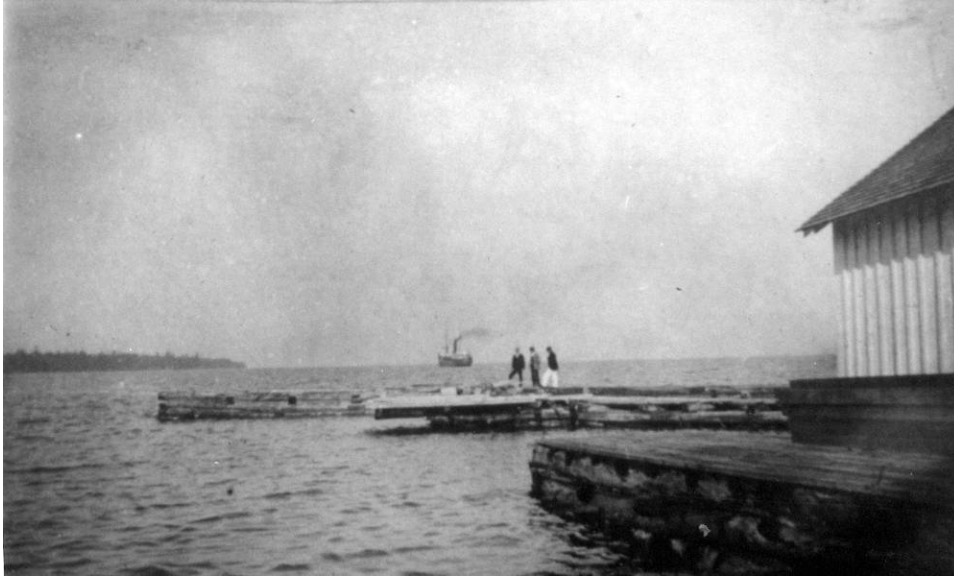
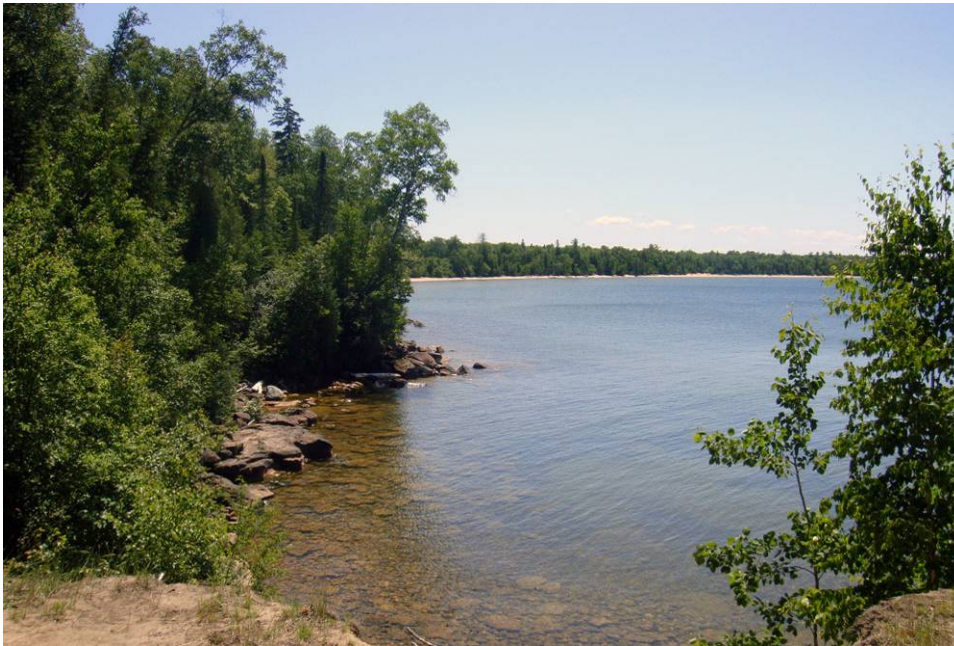
**Existing Condition.** No readily visible features of the Boathouse exist. Remnant materials from the Landing Cribs exist under the water.

*Site Image SI-41: Former Boathouse area; top (c. 1904) (Source: NPS APIS Archives); below (2009) (Source: MBD DSC00705.JPG)*

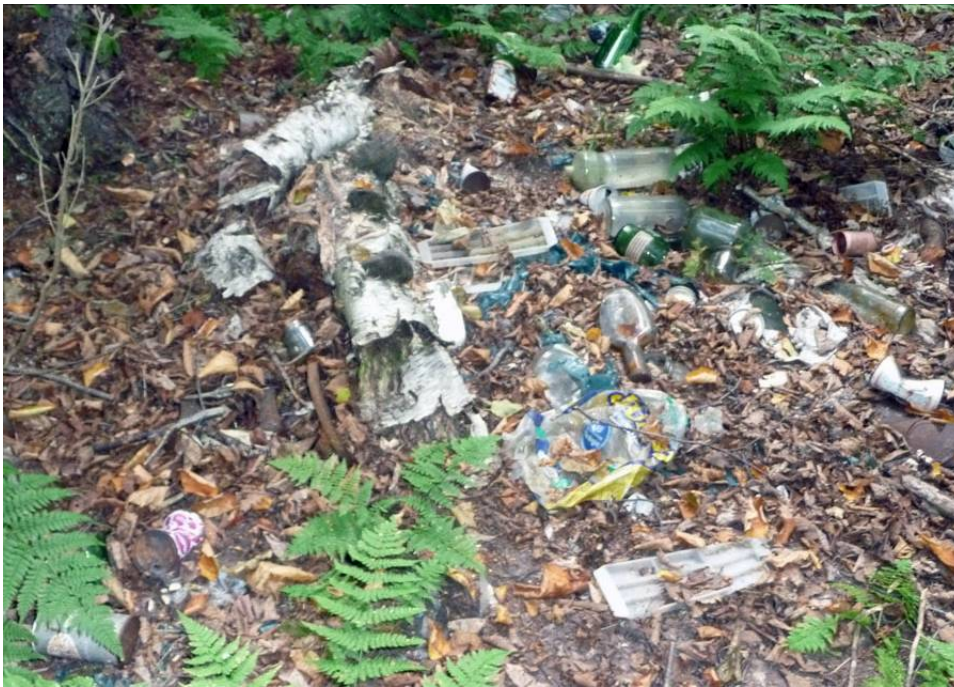
**Existing Condition.** Three dump sites and a site containing brick rubble exist in the forest vegetation in the area surrounding the Sand Island Light Station. The sites were located at varying distances from the light station, one as close as 60 feet away and another as far as 220 feet. The sites contain various materials. Dump Site 1 is primarily glass bottles and soda cans, Dump Site 2 consists of what appears to be fuel containers, and Dump Site 3 has remnant wood panels and other materials, possibly remnants of a building interior.

Site Image SI-45: Dump site No. 1, 2009 (Source: MBD P1020382.JPG)

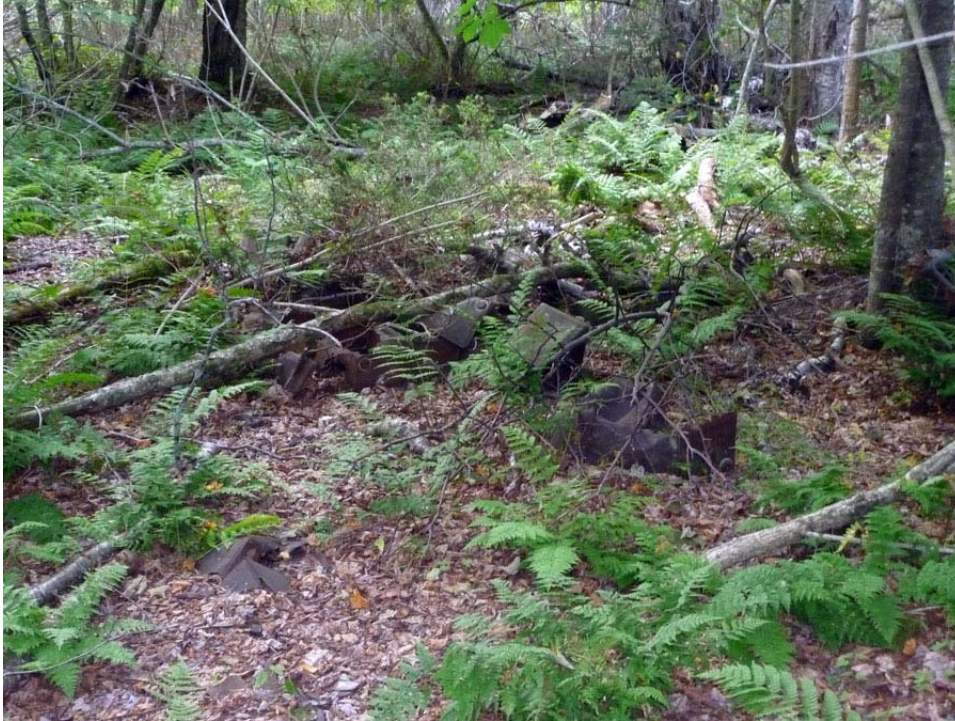
Site Image SI-46: Dump site No. 2, 2009 (Source: MBD P1020387.JPG)

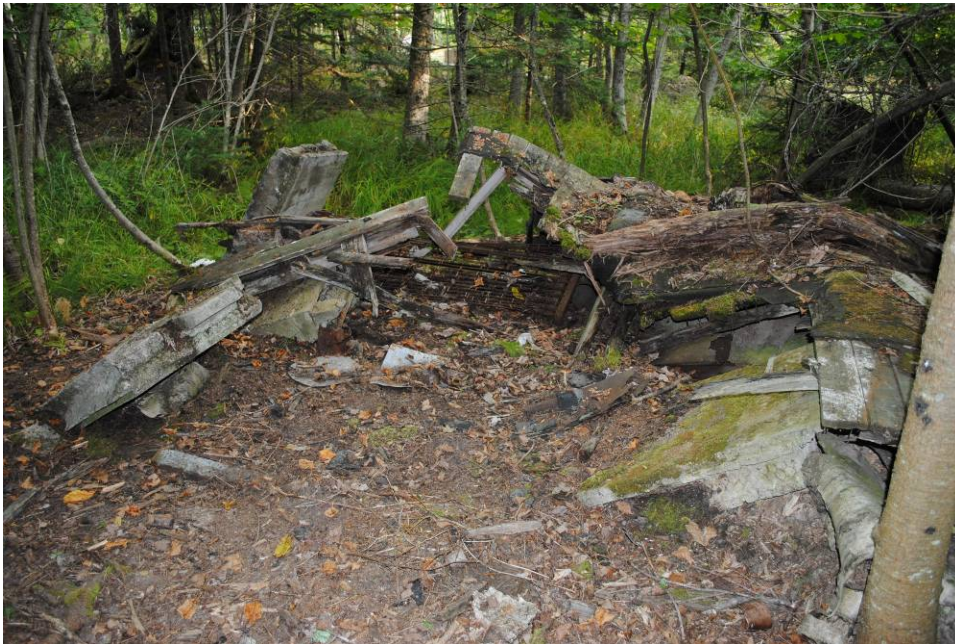
Site Image SI-47: Dump site No. 3, 2009 (Source: MBD DSC\_0227.JPG)

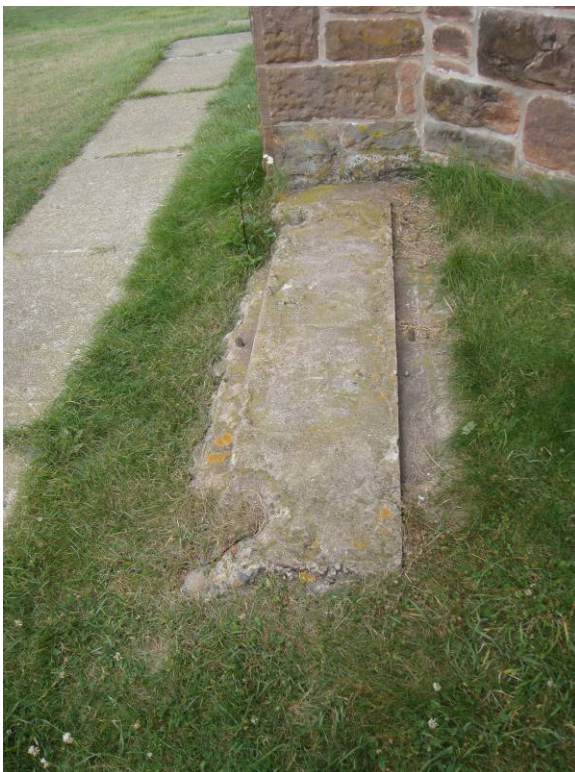
Concrete Foundation (1881 - 1969)	SI-49	Concrete foundation, immediately south of Light Tower at Light Station Quarters. Approximately 30" x 6". Use unknown, appears to be from the period of significance	Fair	Contributing
Sign (1970 – 2009)	SI-50	NPS wooden interpretive sign	Fair	Noncontributing – contemporary; Compatible
Trail Sign (1970 – 2009)		NPS trail sign	Good	Noncontributing – contemporary Compatible
Fire Pit (1970 – 2009)	SI-51	Steel fire pit – located away from Light Station Quarters	Good	Noncontributing – contemporary; Compatible
Flagpole (1970 – 2009)	SI-52	Wooden flagpole similar in design to flagpoles at Michigan and Outer. As it is not pictured in any of the historic photographs, it appears that it is an NPS addition.	Good	Noncontributing – contemporary; Compatible
Modern Fiberglass Battery Storage Unit (1970 – 2009)	SI-53	Fiberglass battery storage unit at rear of Light Station Quarters	Fair	Noncontributing – contemporary; Compatible

Site Image SI-49: Concrete Foundation south of Light Tower at Light Station Quarters, 2009 (Source: MBD DSC01439.jpg)

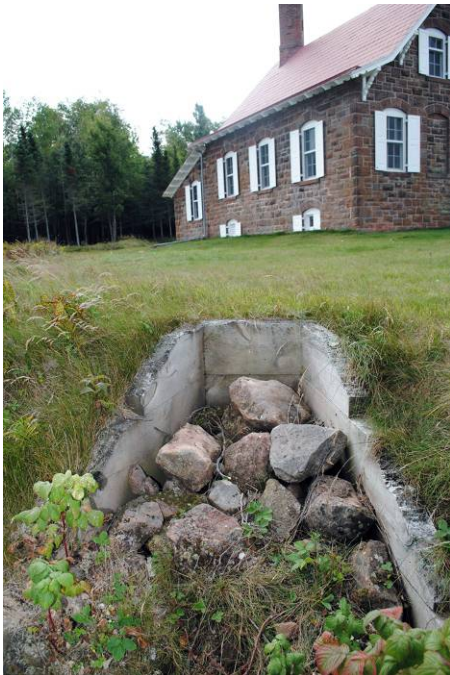
Bench	SI-54	Wooden, rough cut log bench	Fair	Noncontributing – contemporary; Compatible
Wood Headwall (c.	SI-55	Wood headwall for drain	Good	Noncontributing –

Site Image SI-55: Wood headwall for drainage pipe, 2009 (Source: DSC\_0259.JPG)
