1 **Table SI-2: Vegetation**

1 *Vegetation Photographs*

SAND ISLAND CLR TREATMENT

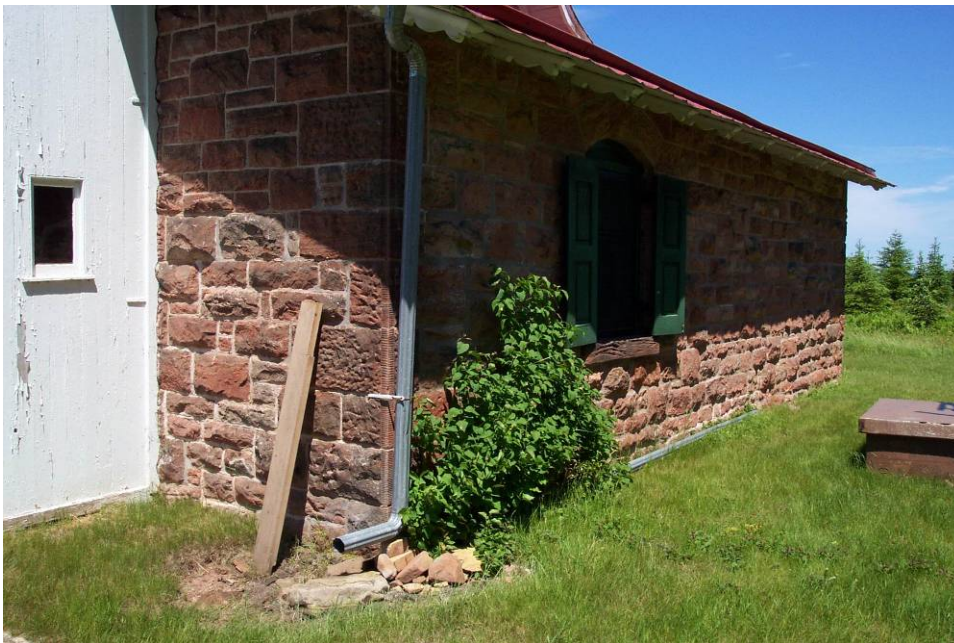
5
6 *Site Image SI-59: Purple lilac at southwest corner of Light Station Quarters, 2005 (Source: Photo courtesy of Susan*
7 *Mackreth)*

The light station grounds historically contained several types of domestic tree and shrub plantings that were planted and maintained by the lighthouse keepers and their families. This treatment measure includes restoring missing lilac (*Syringa sp.*) plantings near the Light Station Quarters, and the removal of noncontributing trees in cleared area of the light station.

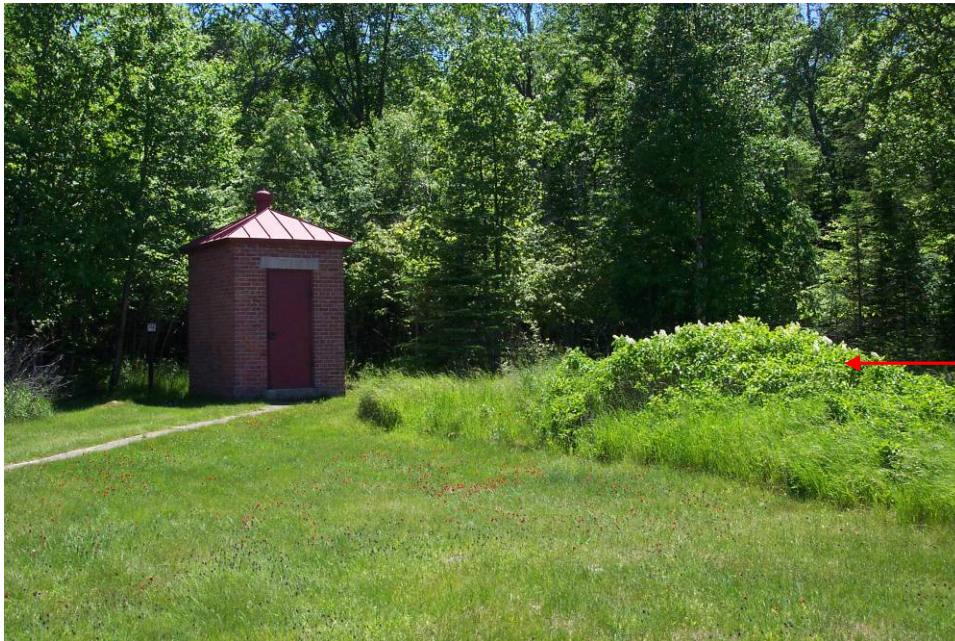
White Lilac

Site Image SI-60: White lilac at northwest of Oil Building, 2005 (Source: Photo courtesy of Susan Mackreth)

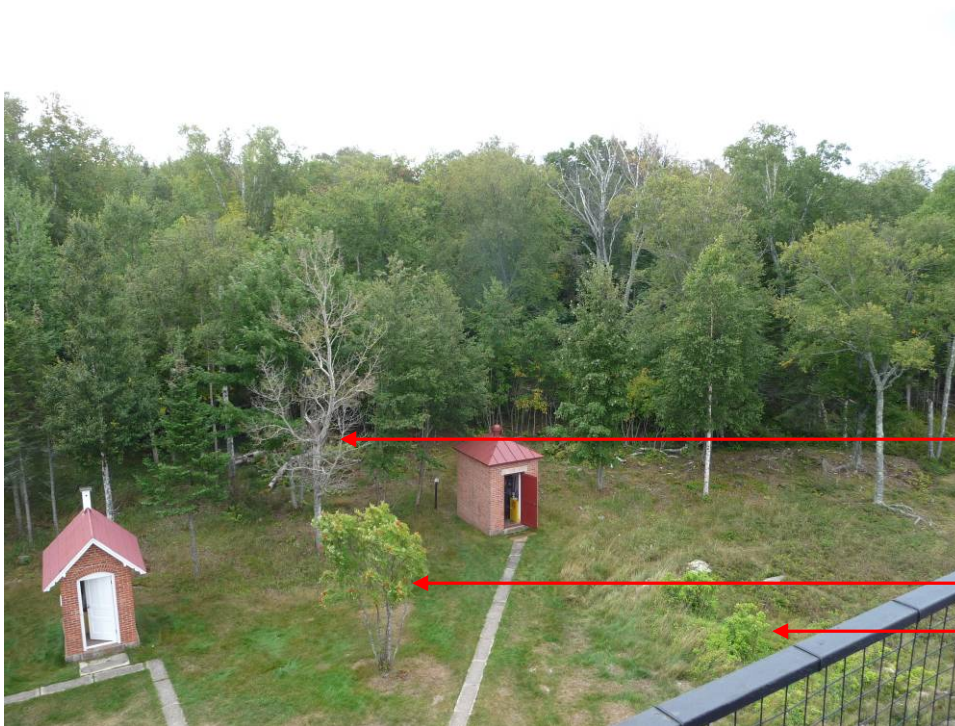
Site Image SI-61: Mountain Ash, deciduous tree and white lilac viewed from Light Station Quarters Tower looking southwest, 2009 (Source: MBD P1020418.JPG)

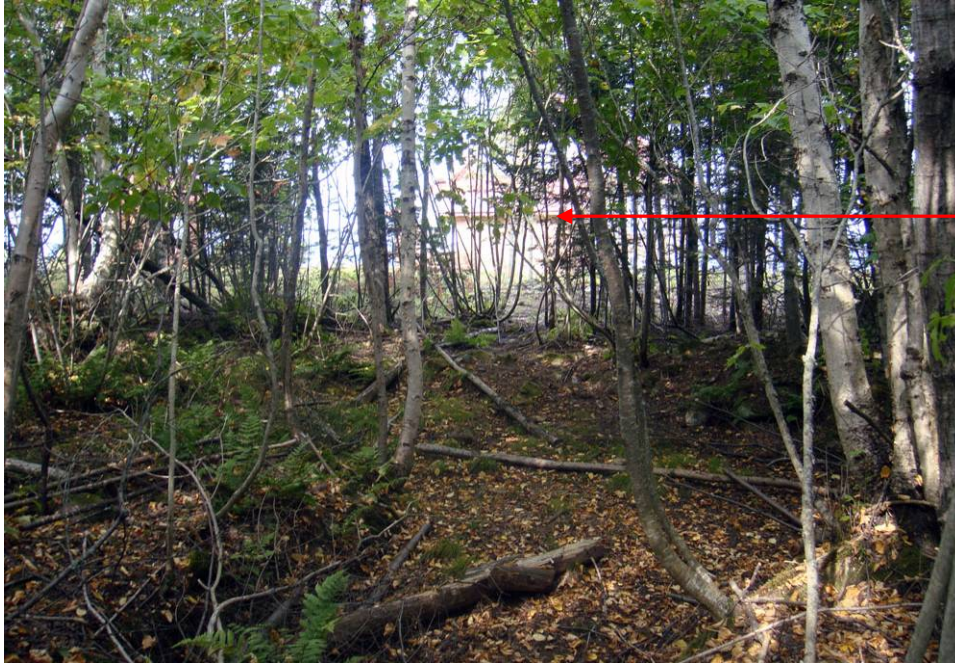
Analysis: Reservation. Historic drawings and photographs indicate that a larger cleared area existed on the north edge of the reservation than that which exists today. The cleared area has continued to reduce from approximately 3.7 acres at the end of the period of significance to approximately 1.8 acres in 2009. During the Light Station period the light station grounds were maintained as low vegetation. The original larger clearing provided the necessary openness to allow for the light to be seen from Lake Superior. The clearing also provided a protected area south of the Light Station Quarters for livestock and a garden. The area south of the Light Station Quarters was maintained as an open clearing and contained a fenced garden area and two sheds. Today, the majority of this clearing has been filled by encroaching forest and the garden area is nonextant. Clearing work done during the NPS period has reduced the amount of forest encroachment from its peak in the 1960s. Brush piles remain from this work. The cleared area of the light station is a contributing feature. The relationship between the extent of the cleared area and forest vegetation on the reservation has changed since the period of significance. Vegetation in the former boathouse area has also encroached into the historic clearing at that location. The extensive encroachment of forest vegetation diminishes the integrity of the light station.

Site Image SI-62: Forest encroachment into former garden area, 2009 (Source: MBD DSC01436.JPG)

The cleared area south of the Light Station Quarters will be restored to a condition that represents the period of significance. The existing cleared lawn area will be moderately expanded into non-extant garden area to the south of the Sand Island Lighthouse. The measure includes clearing of forest trees, shrubs and ground covers. Lawn grasses and a garden will be established in the newly cleared area.

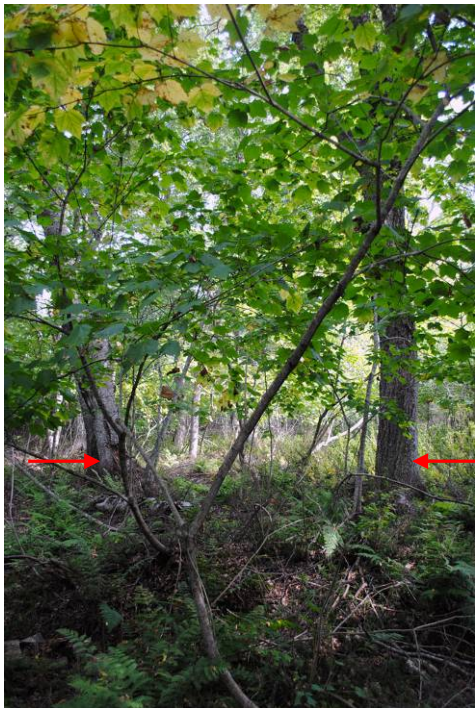
Site Image SI-63: Older trees at historic clearing line, 2009 (Source: MBD DSC_0299.JPG)

As previously presented under Spatial Organization the cleared area of the light station reservation and immediate light station grounds has been substantially reduced from the period of significance. This action includes the removal of forest vegetation (approximately 1 acre) that has encroached into the historic cleared area of the light station, specifically the historically cleared area south of the Light Station Quarters. Further discussion on means and methods of clearing are discussed in Volume I, Chapter 5: Management Issues. Maintain newly cleared areas as meadow vegetation at a 12"- 24" height by mowing on a regular basis.

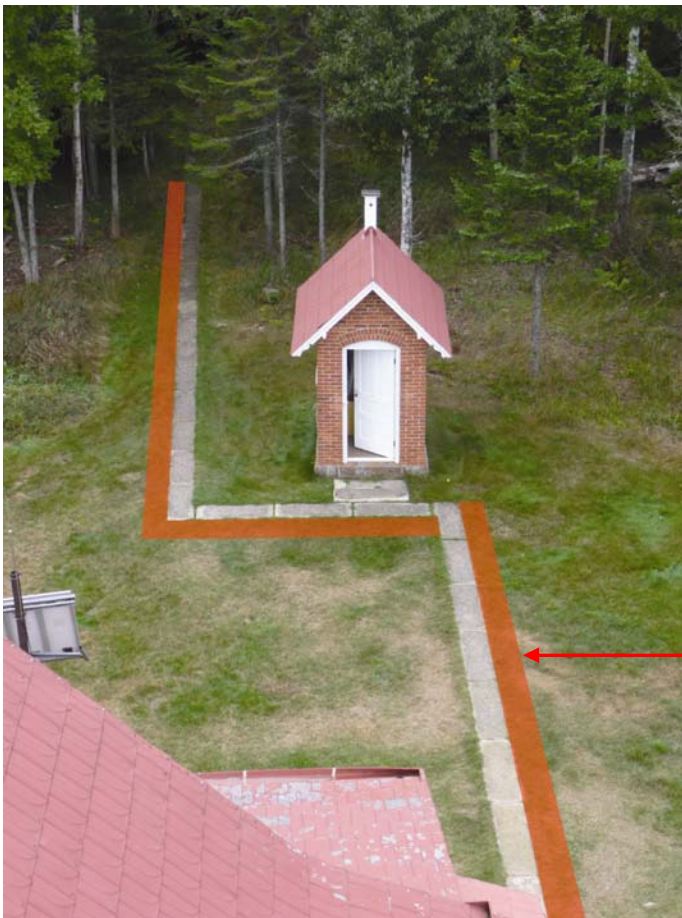
6
7 Site Image SI-67: ABAAS Option - Widen walks by retaining existing historic walks in place and installing new precast
8 concrete material to achieve an accessible width. (Source: MBD P1020420_annotated.JPG)

- Provide an outdoor accessible route (minimum 36" width) to a new accessible NPS restroom (location to be determined by the Park Service)
- Provide an accessible entrance to the west entry of the Light Station Quarters (see HSR)
- Widen concrete walks on the light station to minimum width of 36" in the areas indicated on the drawings. Widening shall be accomplished by adding new, precast concrete stones (18" wide), installed adjacent to the historic material. New materials shall match existing materials in form, texture and color.
