CHAPTER 4: HISTORIC STRUCTURE REPORT

SAND ISLAND INTRODUCTION

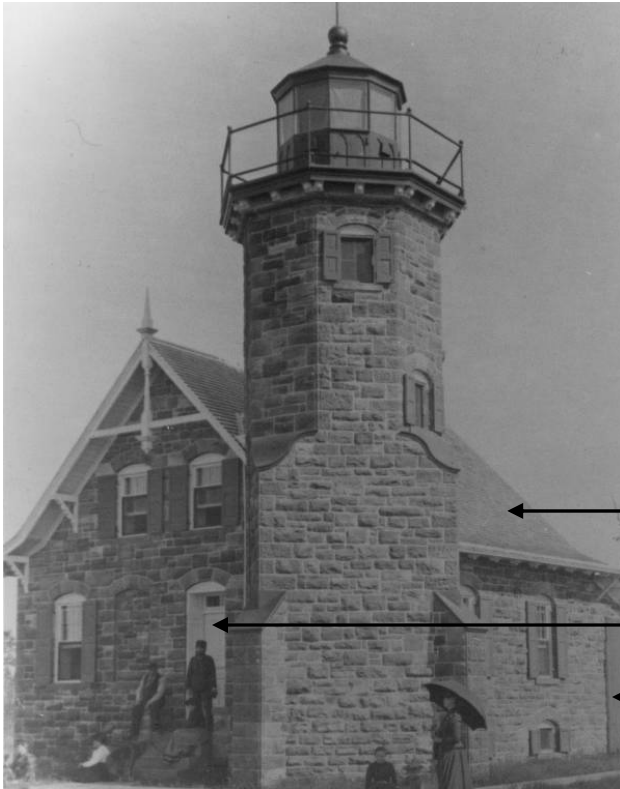
Apparent Wood Shingle
Roofing

No Screen Door

Kitchen Vestibule Visible

Historic Image SI-01: Keepers Quarters, looking southeast, 1890 (Source: NPS APIS Archives)

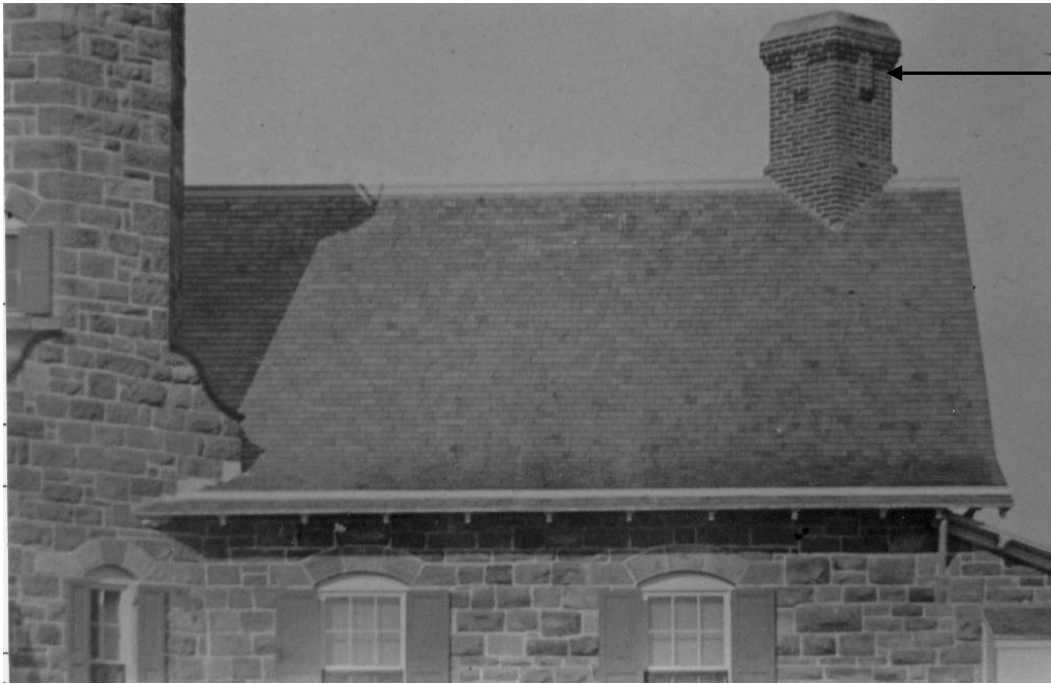
Brick
Chimney
with Stone
Cap

Historic Image SI-02: West elevation of the Keepers Quarters and chimney, c. 1900 (Source: NPS APIS Archives)

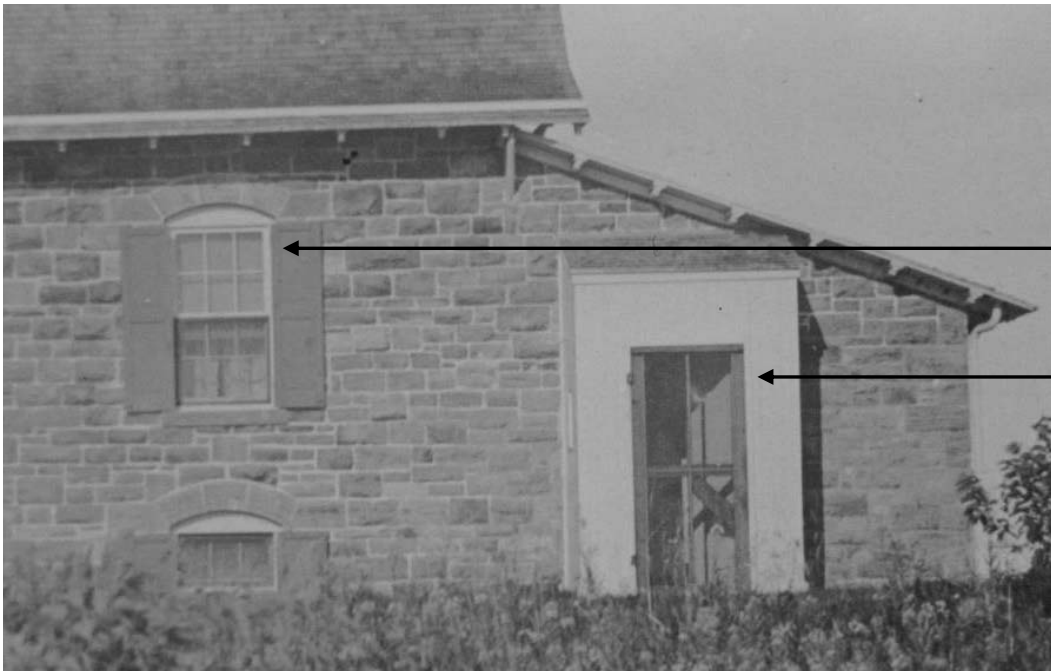
Shutters
Painted Dark
Color

Kitchen
Vestibule
with Screen
Door

Historic Image SI-03: West elevation of the Keepers Quarters kitchen vestibule, c. 1900 (Source: NPS APIS Archives)

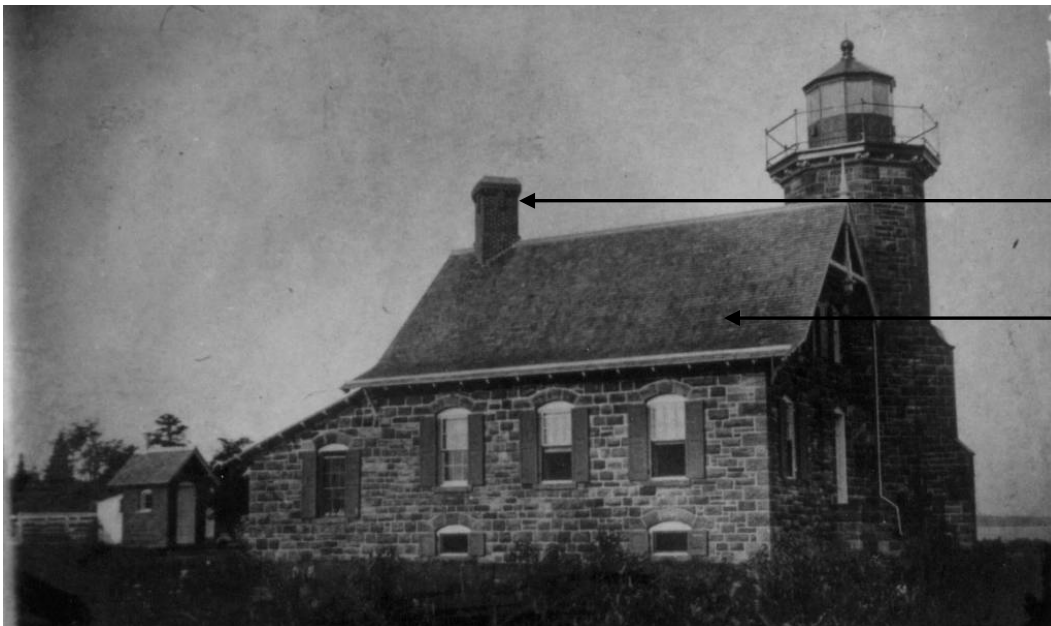
Chimney
Cap

Wood
Shingles

Historic Image SI-05: East elevation of the Keepers Quarters, 1904 (Source: NPS APIS Archives)

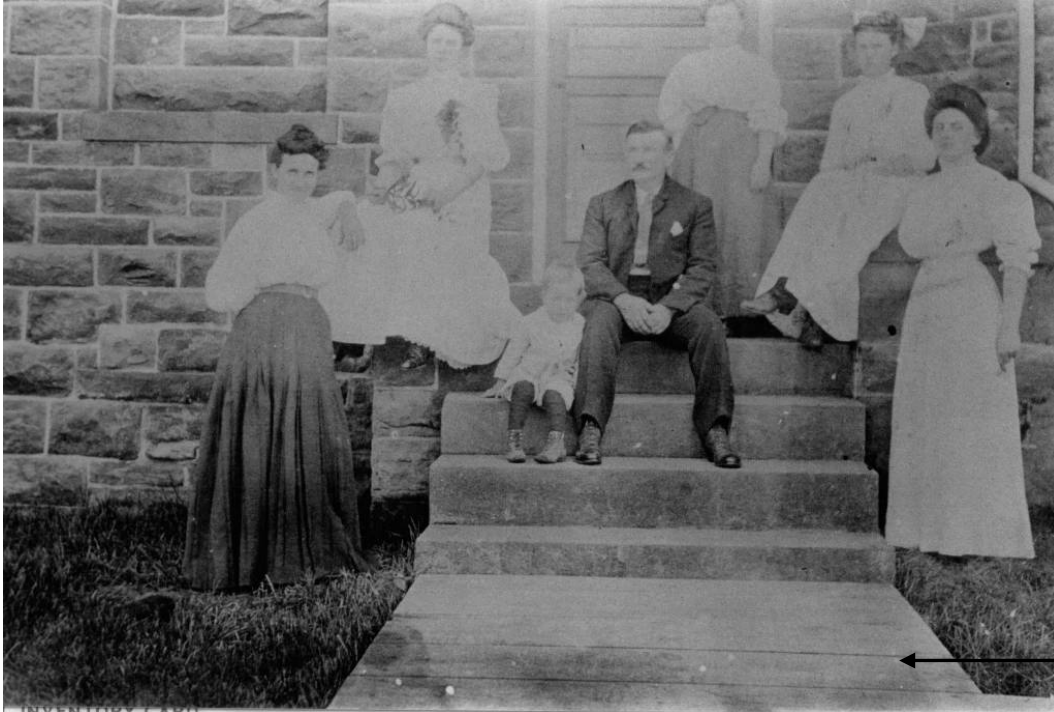
Wood
Boardwalk

Historic Image SI-06: Main entry, 1905-1909 (Source: NPS APIS Archives)

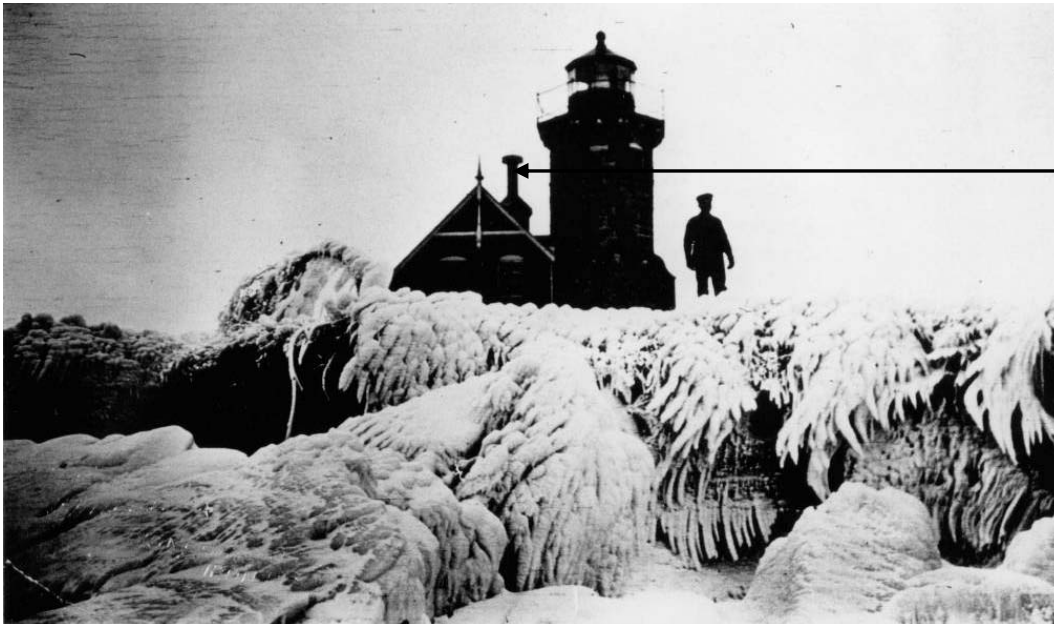
Sheet
Metal Flue for
Extending
Chimney

Historic Image SI-07: Keepers Quarters, looking southeast from the lake, 1909 (Source: NPS APIS Archives)

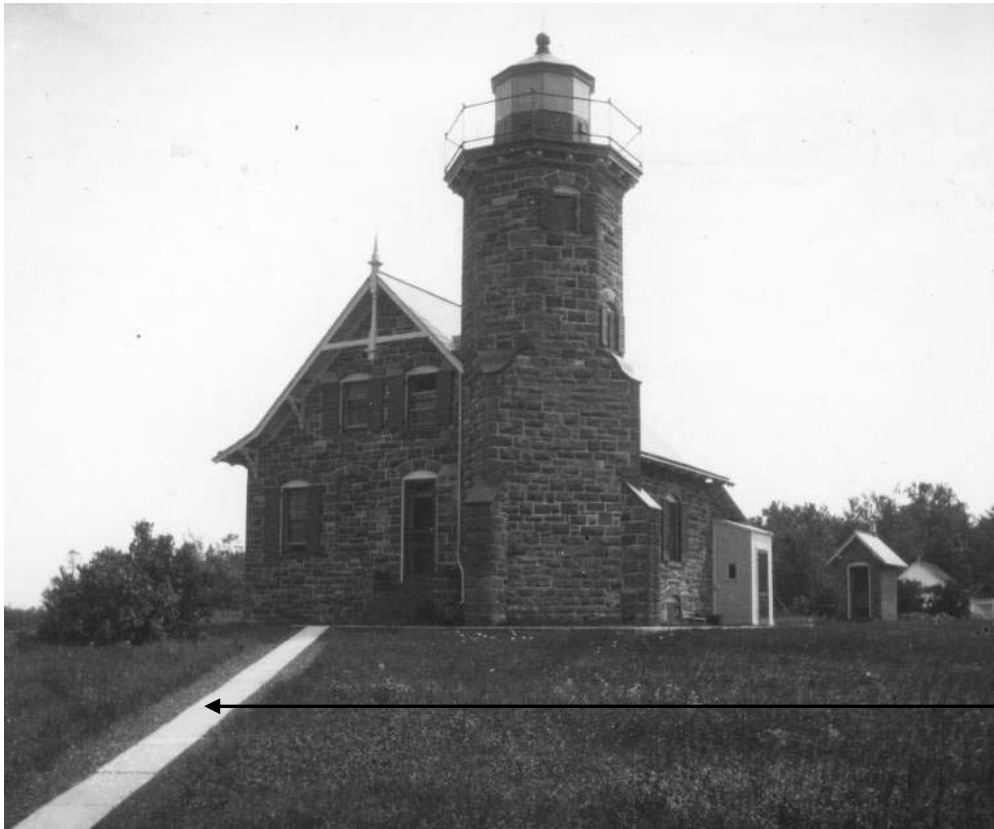
Concrete
Walkway

Historic Image SI-08: Keepers Quarters and Privy, looking southeast, post 1911 (Source: NPS APIS Archives)

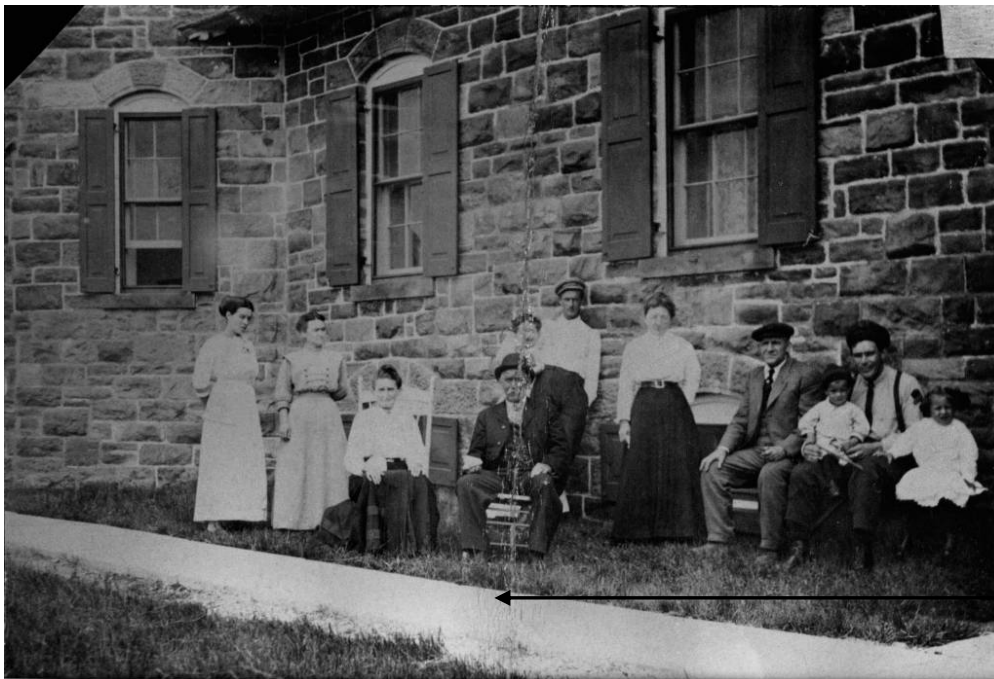
Concrete
Walkway

Historic Image SI-09: West elevation of the Keepers Quarters, 1911 (Source: NPS APIS Archives)
