1 ***Sand Island Light Station Quarters Photographs, 2009***

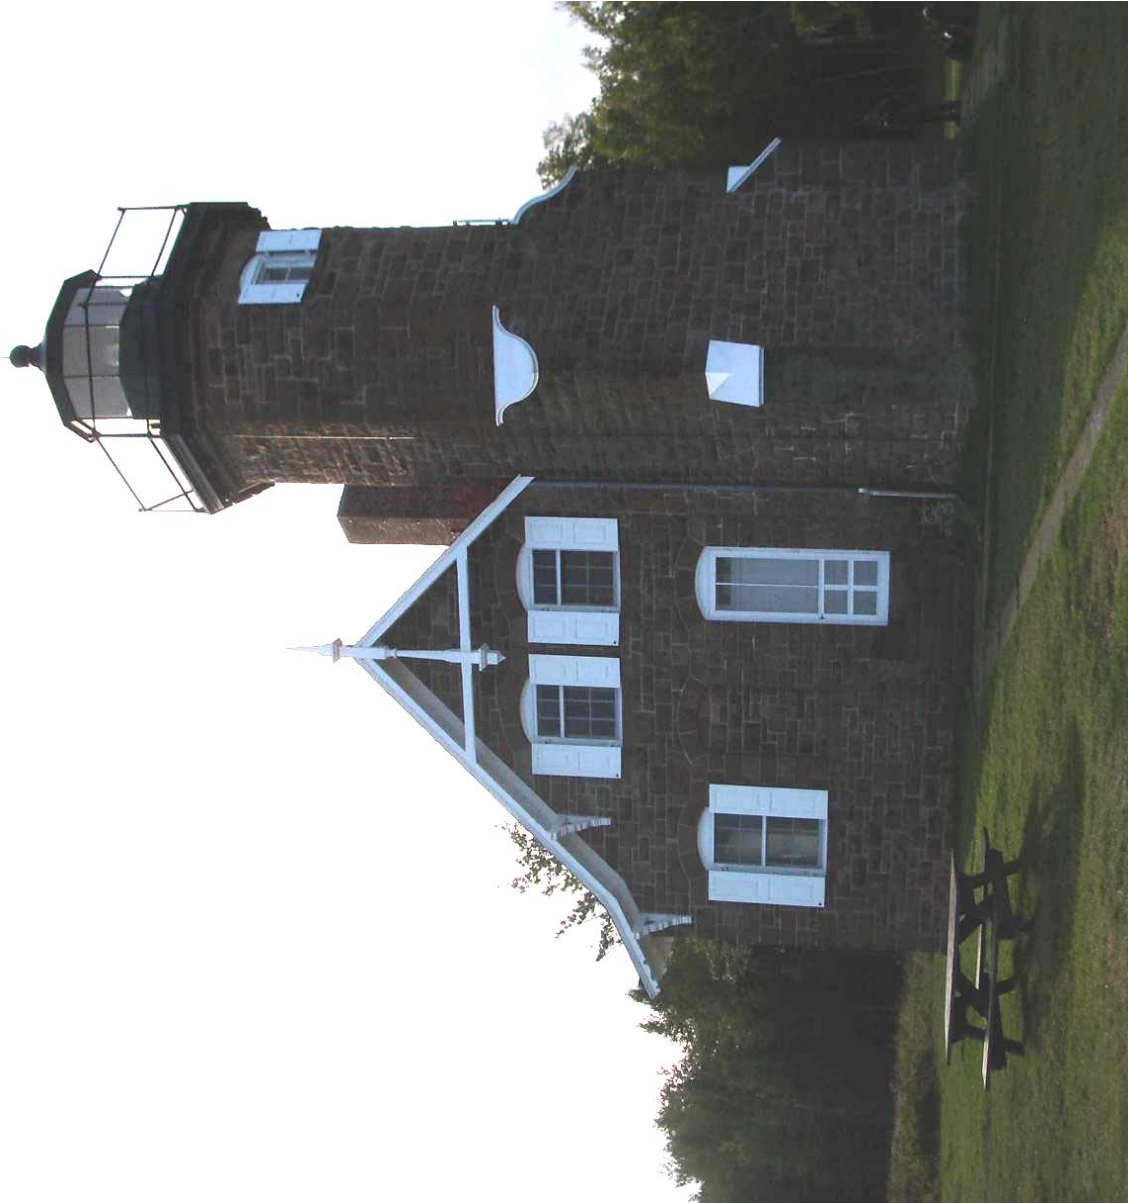
SI-LSQ-01: North elevation, 2009 (Source: A&A DSC01353)

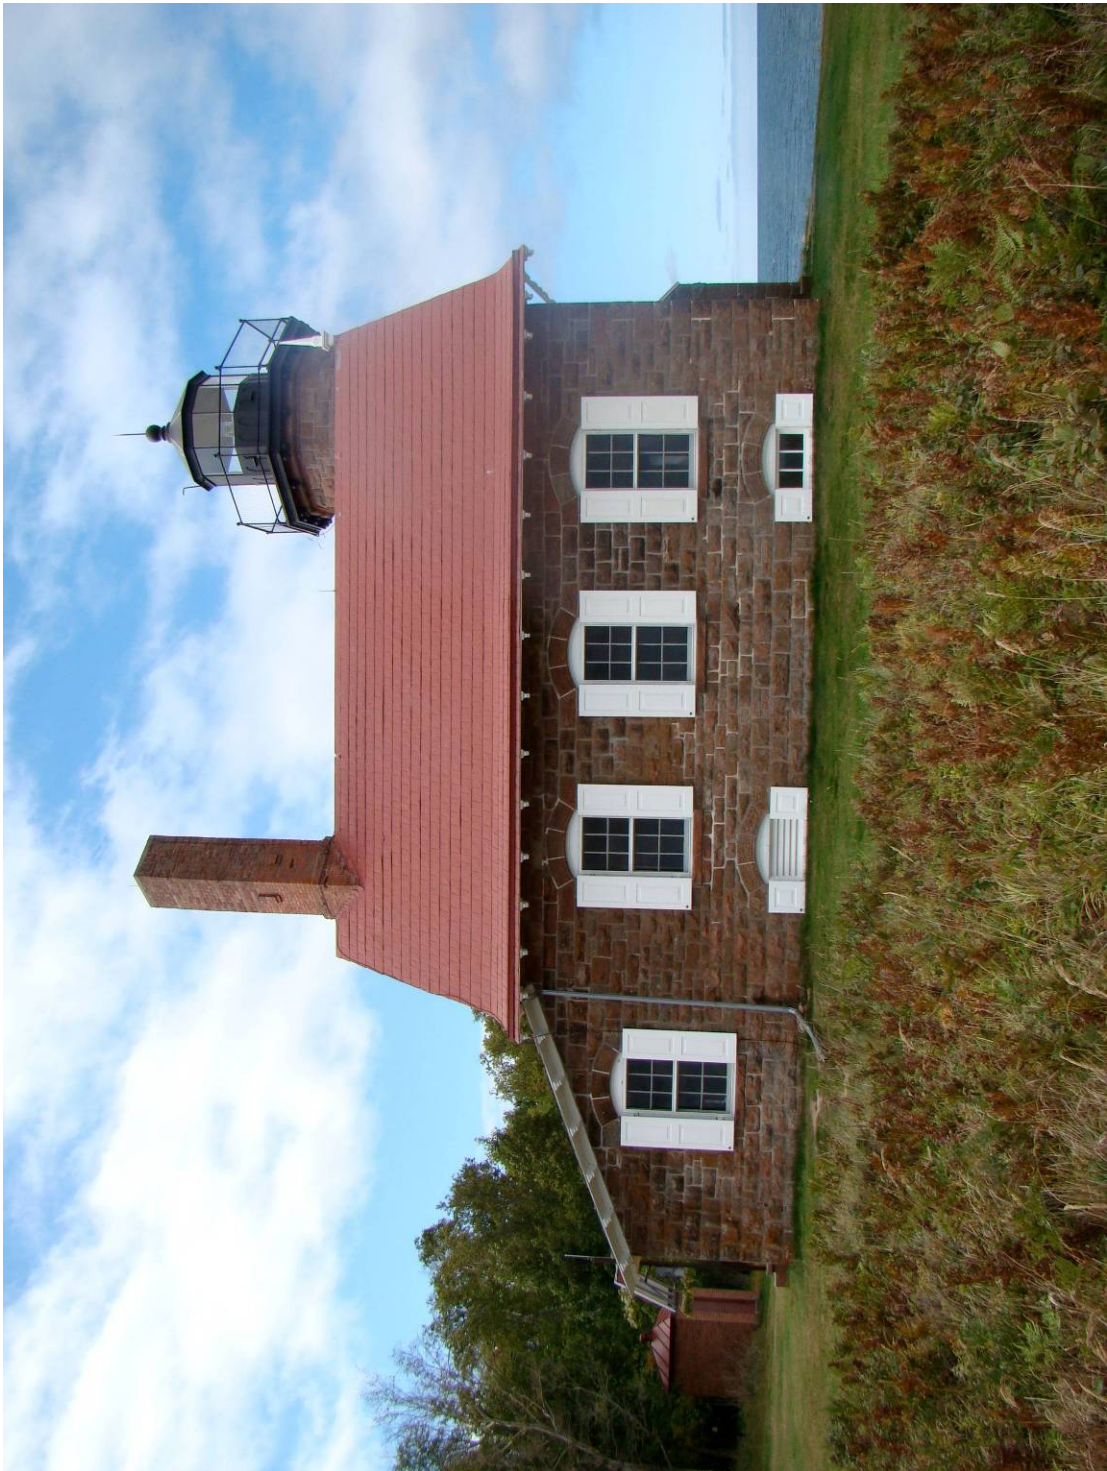
SI-LSQ-02: East elevation, 2009 (Source: A&A DSC01342)

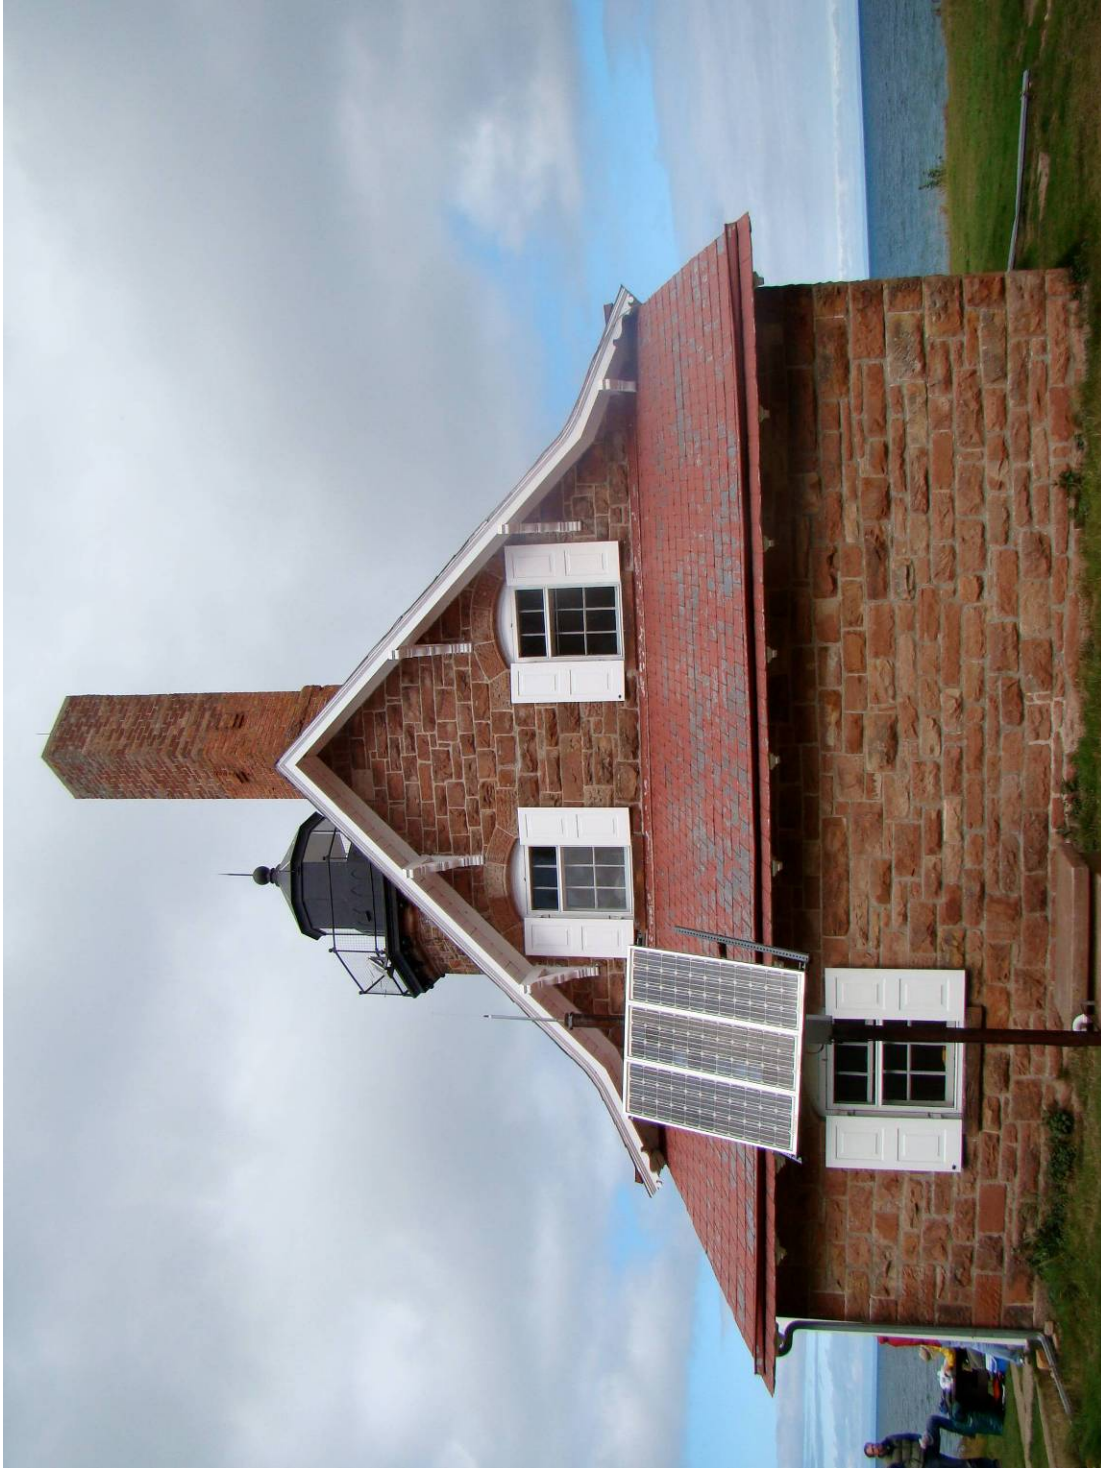
SI-LSQ-03: South elevation, 2009 (Source: A&A DSC01343)

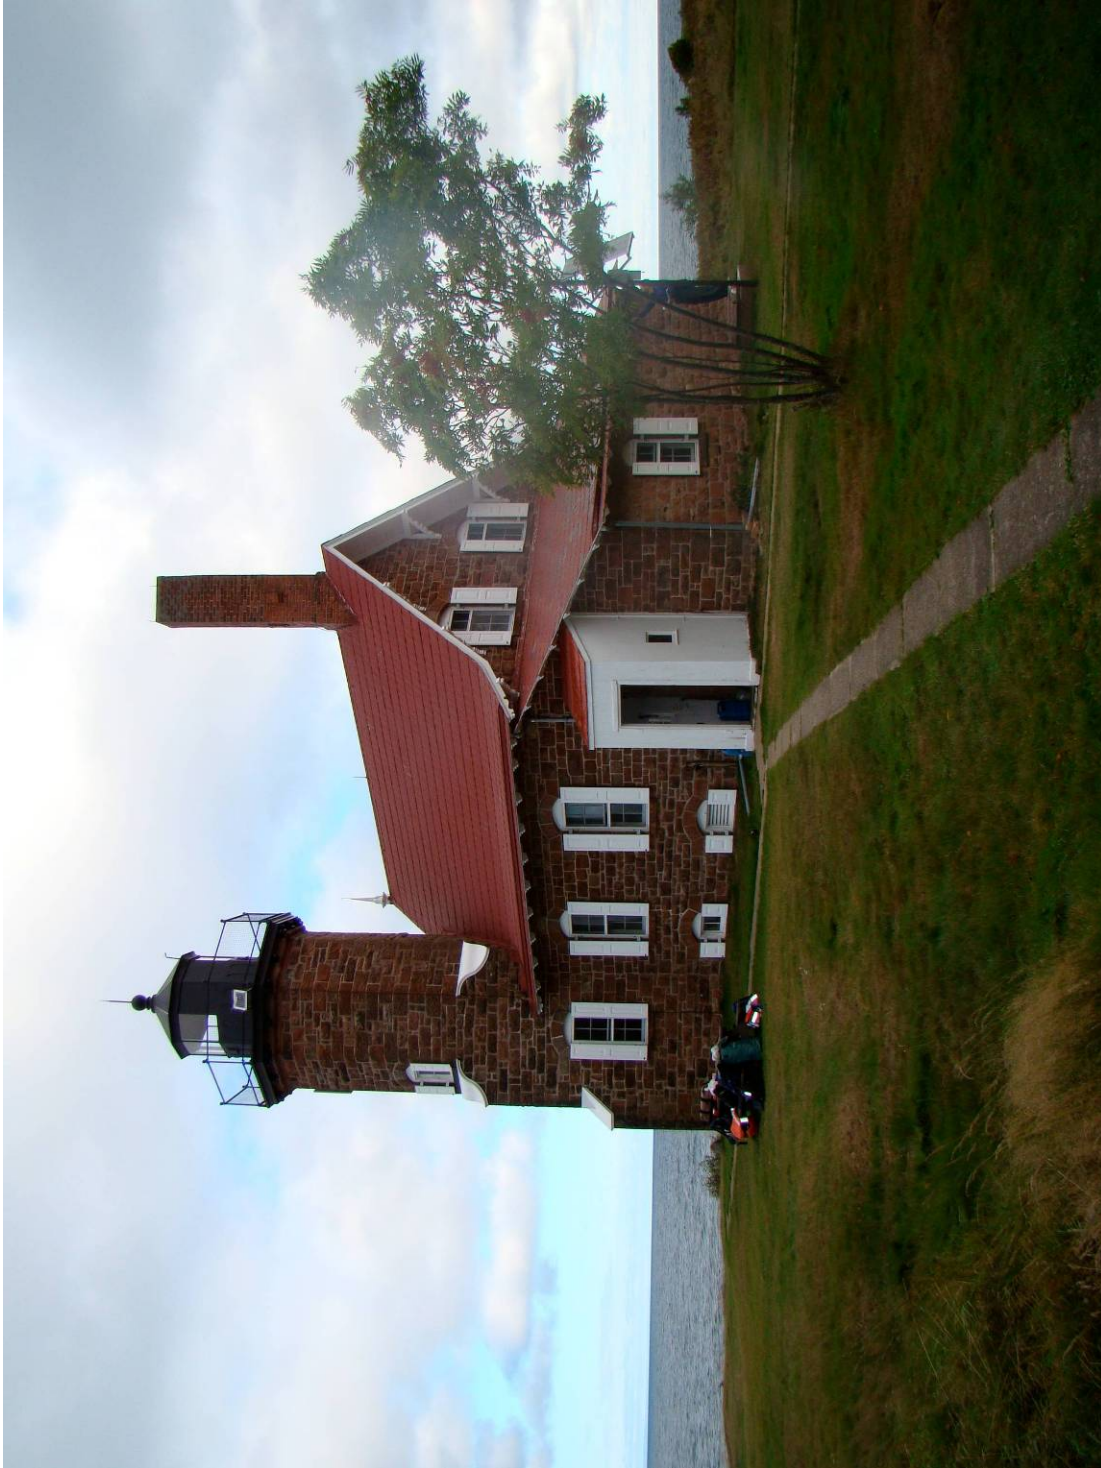
SI-LSQ-04: West elevation, 2009 (Source: A&A DSC01264)

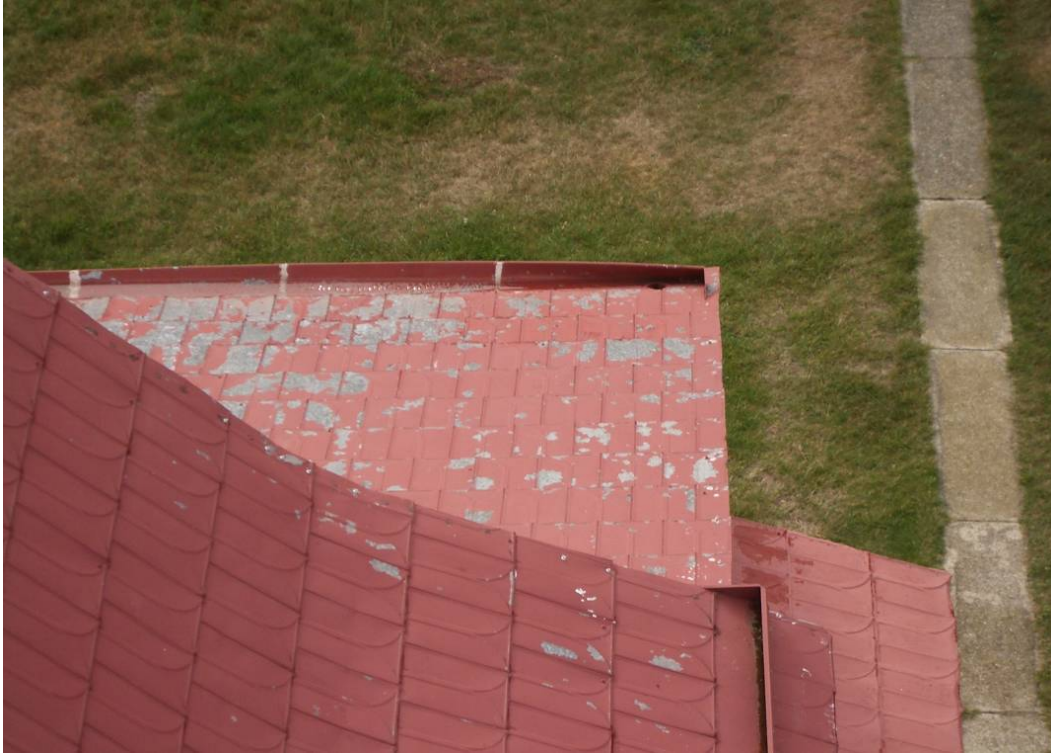
SI-LSQ-05: Roof shingles, view from Tower to south shed roof (Source: A&A IMGP3047)

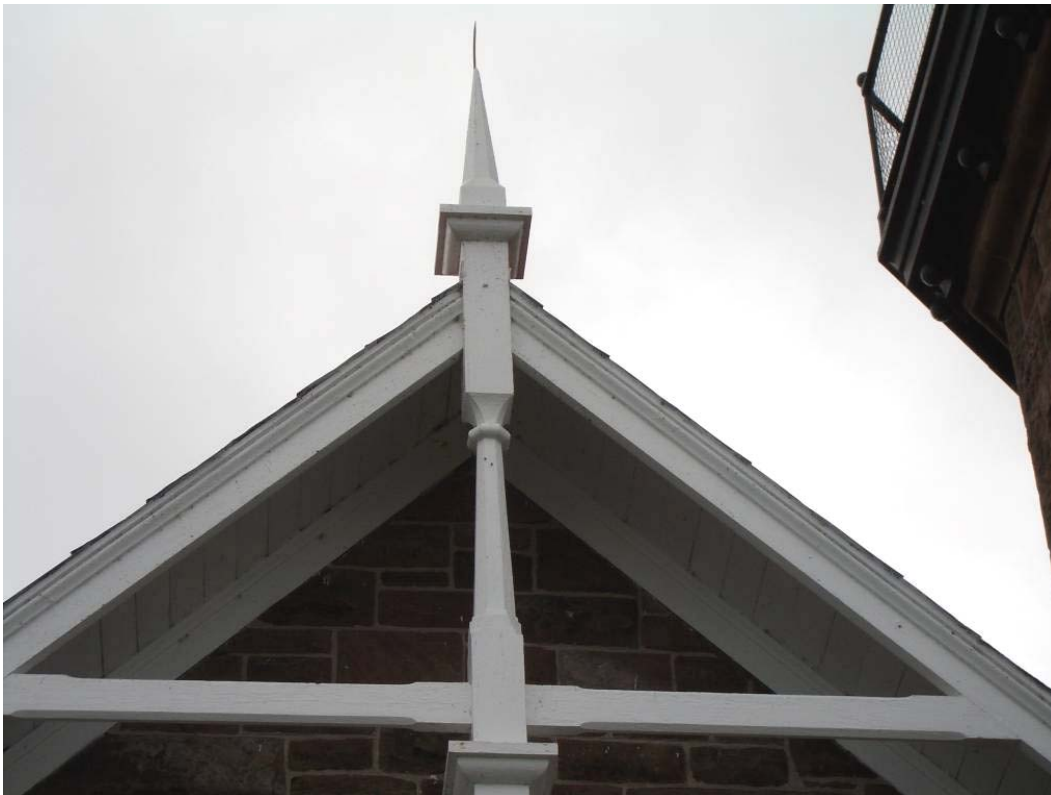
SI-LSQ-06: Roof finial and trim, north elevation (Source: A&A IMGP3067)

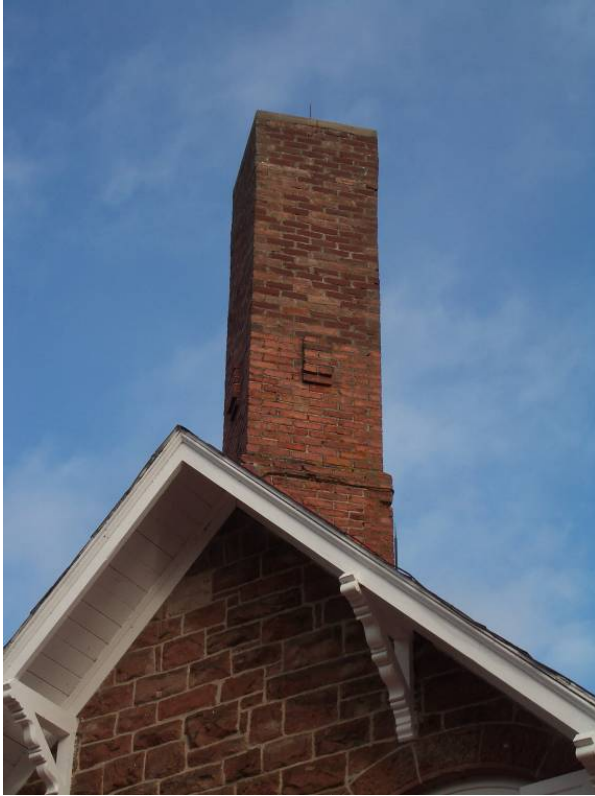
SI-LSQ-07: Trim, wall, and chimney detail, south elevation (Source: A&A IMGP3036)

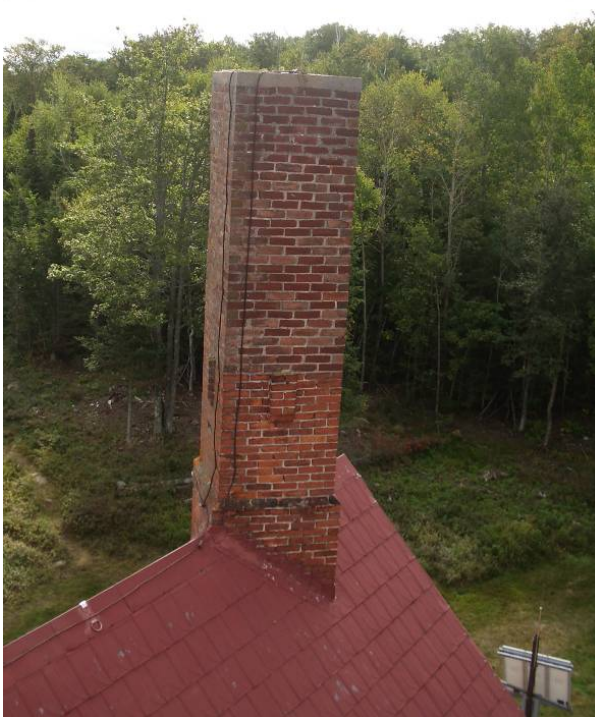
SI-LSQ-08: Chimney and roof detail, looking south from Tower (Source: A&A IMGP3049)

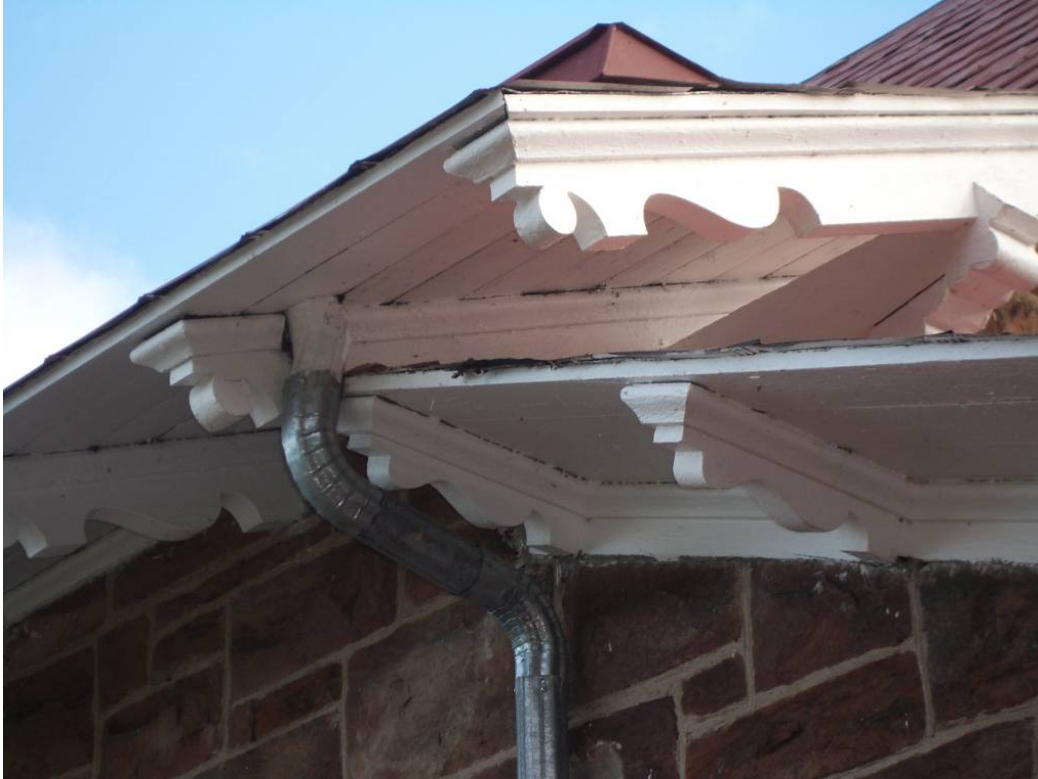
SI-LSQ-09: Trim and downspout detail, west elevation (Source: A&A IMGP3041)

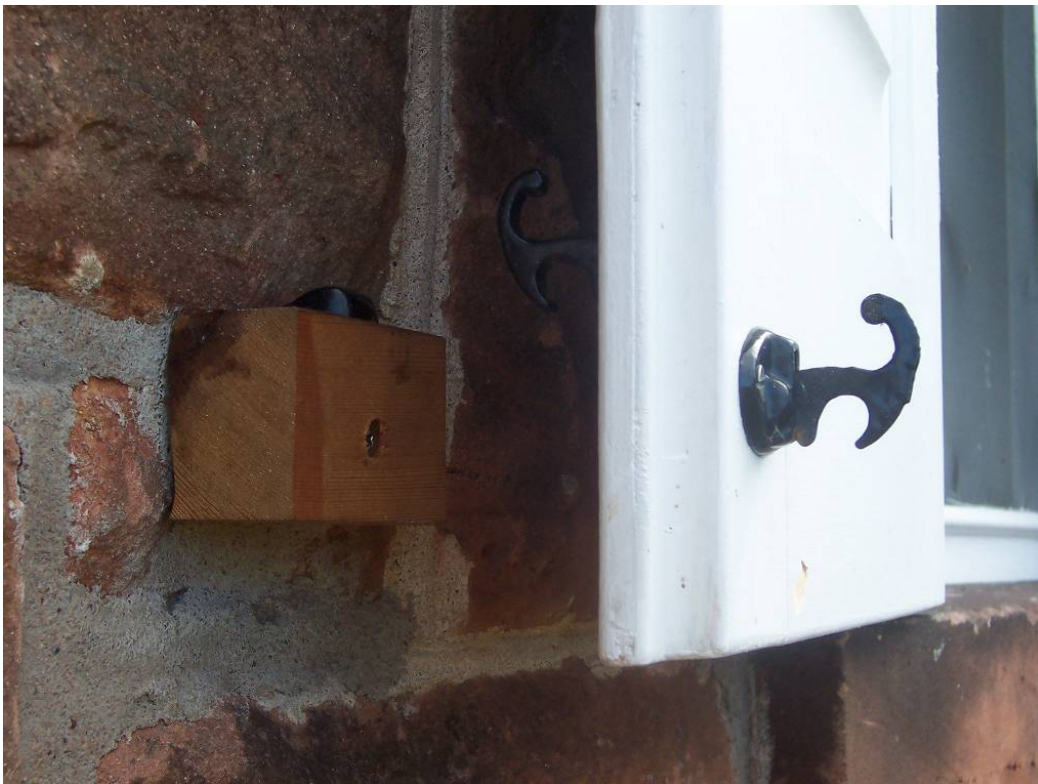
SI-LSQ-10: Window shutter hardware (Source: A&A 100_9865)

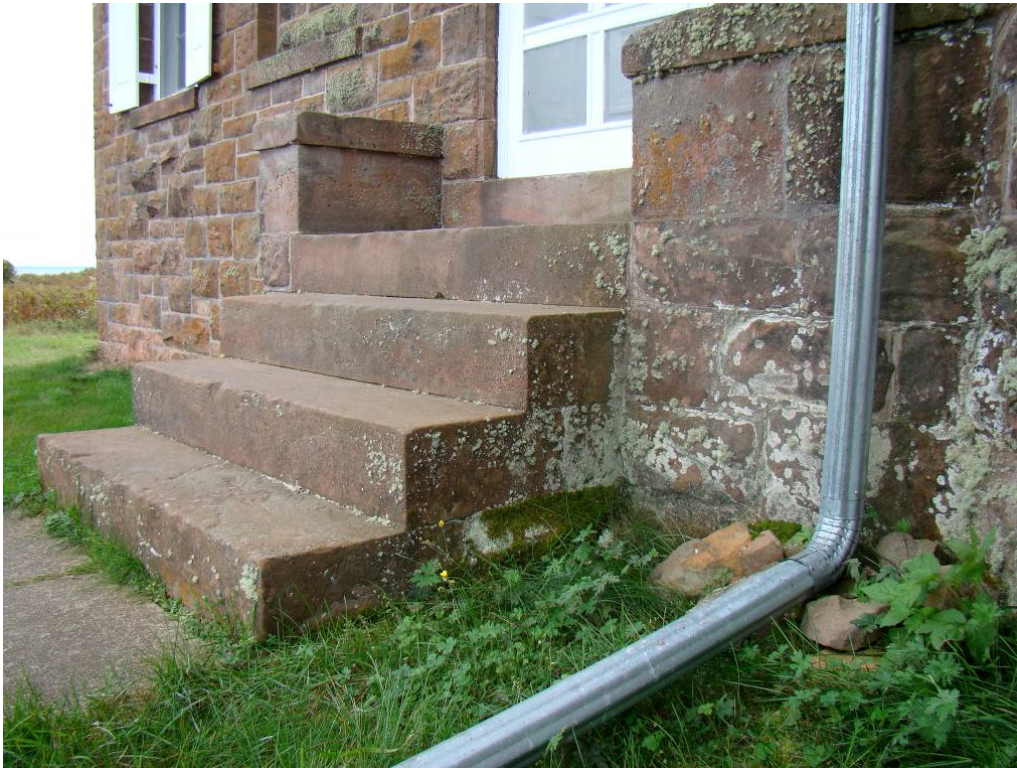
SI-LSQ-11: Entry stairs and downspout, north elevation (Source: A&A DSC01301)

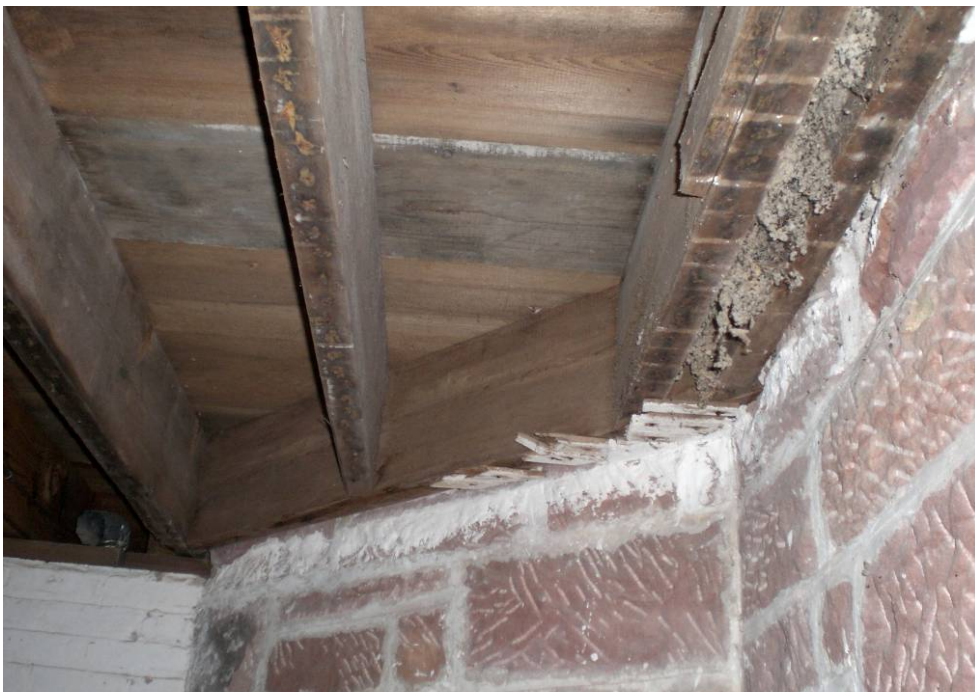
SI-LSQ-16: Basement cellar ceiling and remnants of lath and plaster, looking east (Source: A&A CIMG4320)

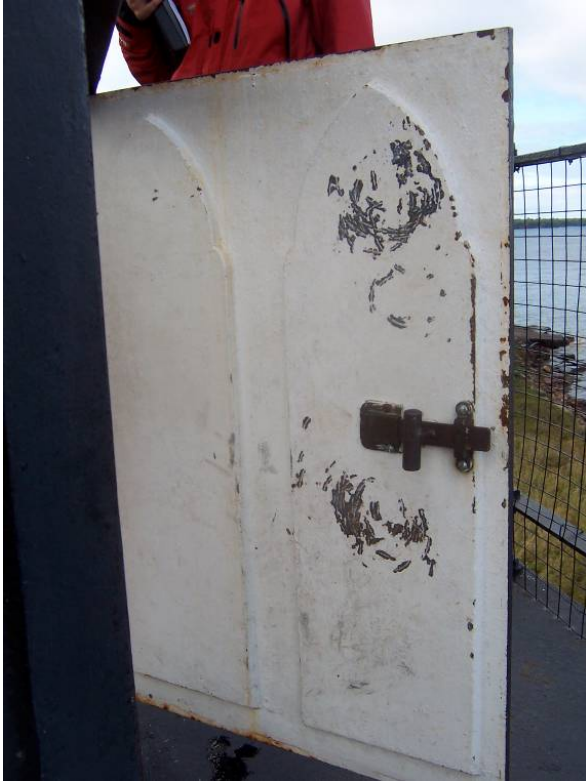
SI-LSQ-35: Lantern door to walkway with circular imprints (Source: A&A 100_9836)

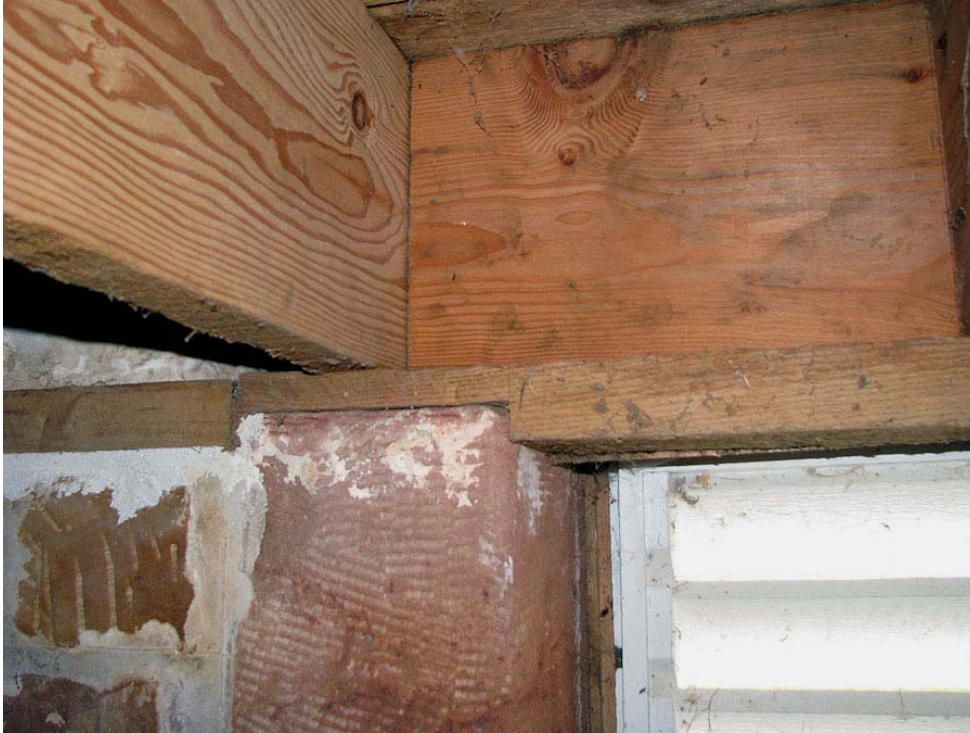
SI-LSQ-37: Joist header above window at basement (Source: Martin/Martin)

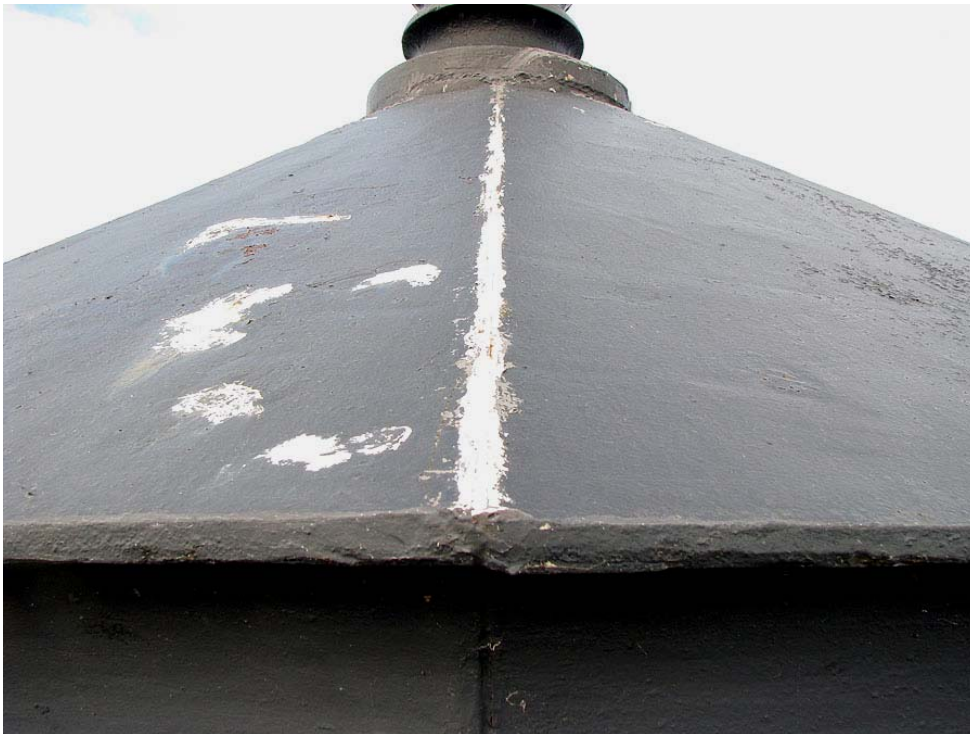
SI-LSQ-38: Sealed joints in roof (Source: Martin/Martin)

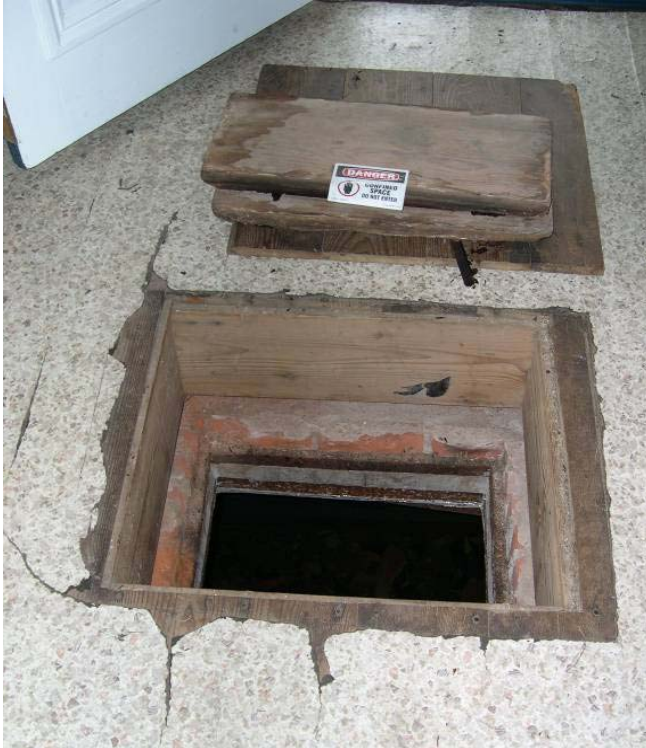
SI-LSQ-39: Cistern opening in summer kitchen floor (Source: Martin/Martin)

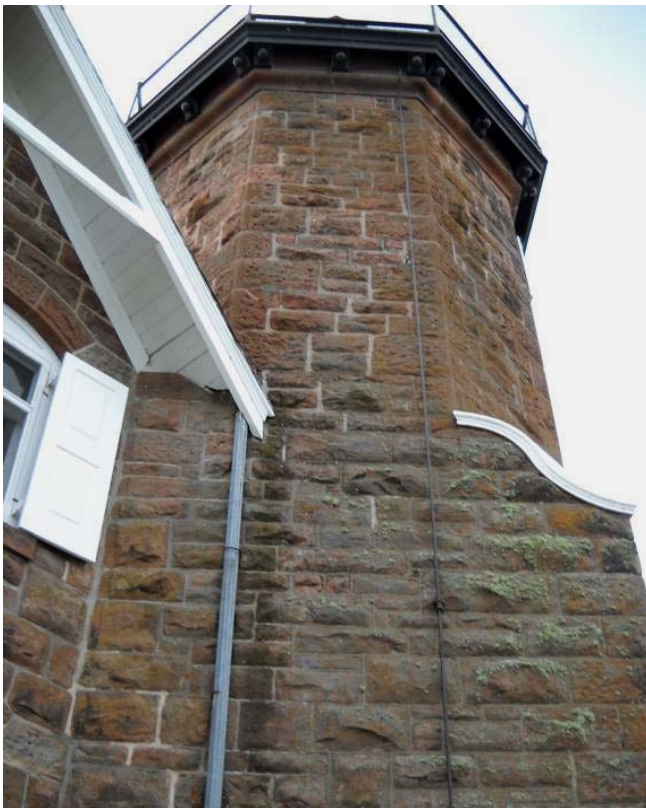
SI-LSQ-40: Lightning protection, historic grounding conductor with insulator (Source: RMH)
