## **OIL BUILDING**

### **Chronology of Alterations and Use**

1 ***Oil Building Photographs, 2009***

1 ***Privy Photographs, 2009***

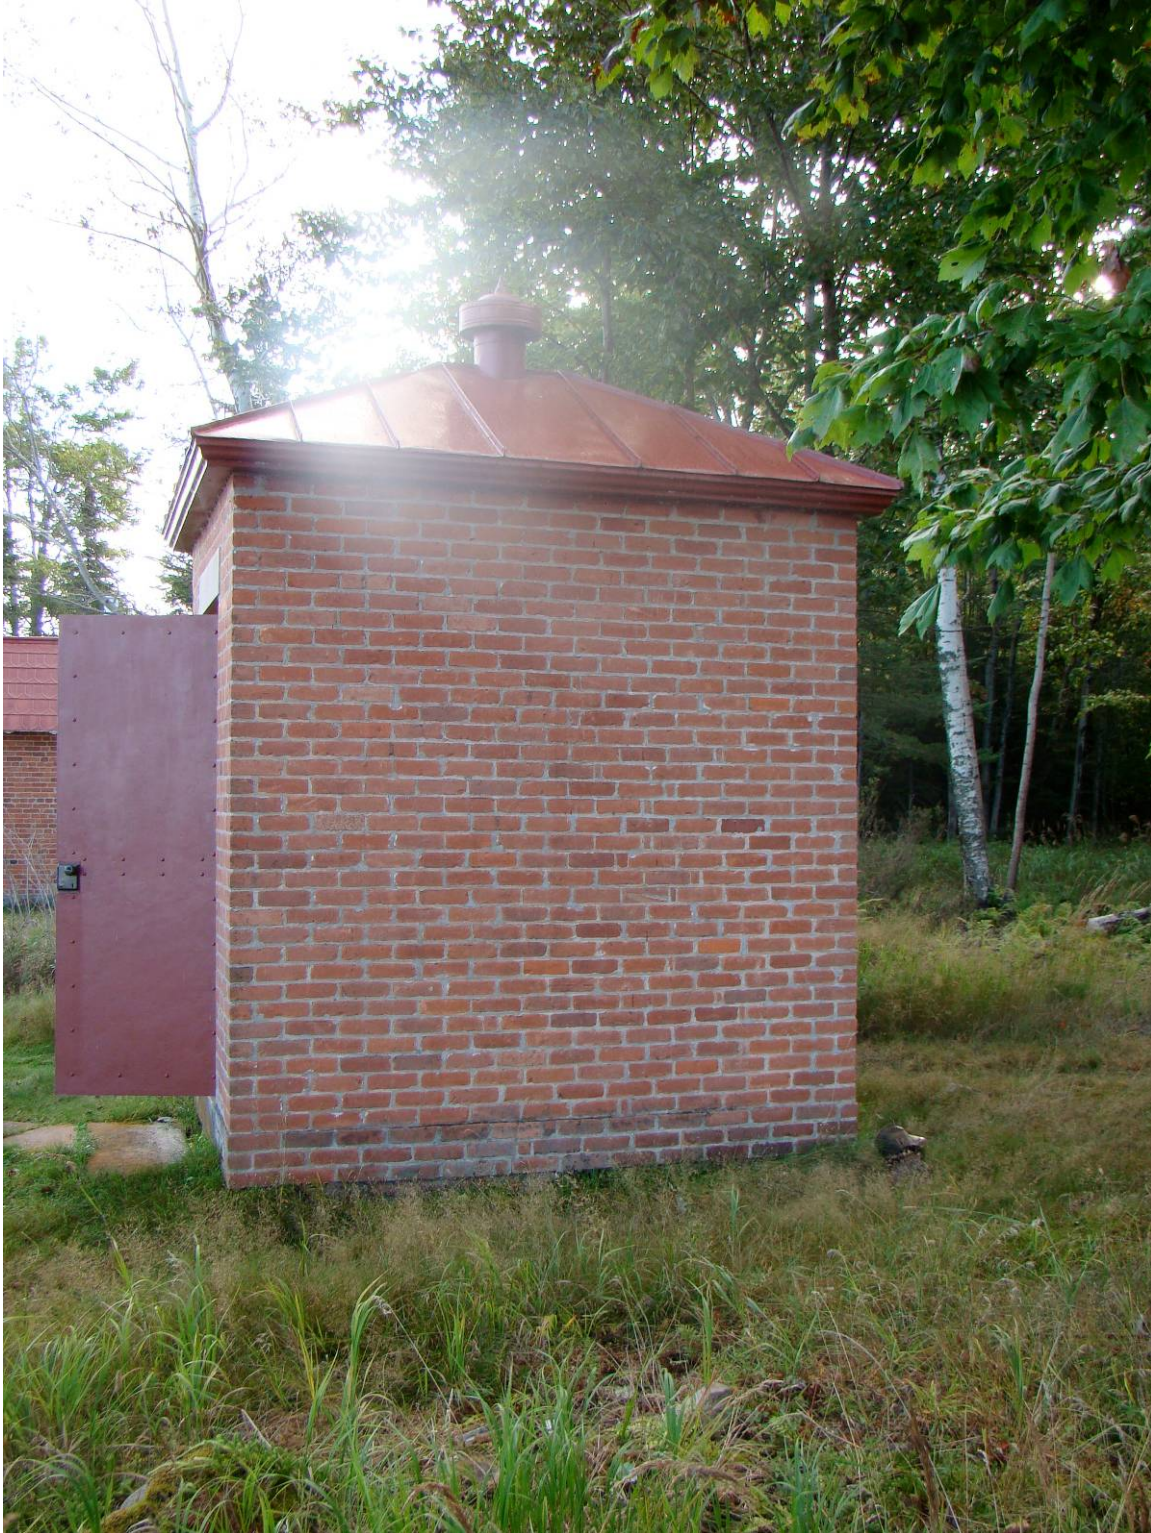
2  
3 *SI-OB-01: North elevation, 2009 (Source: A&A DSC01244)*

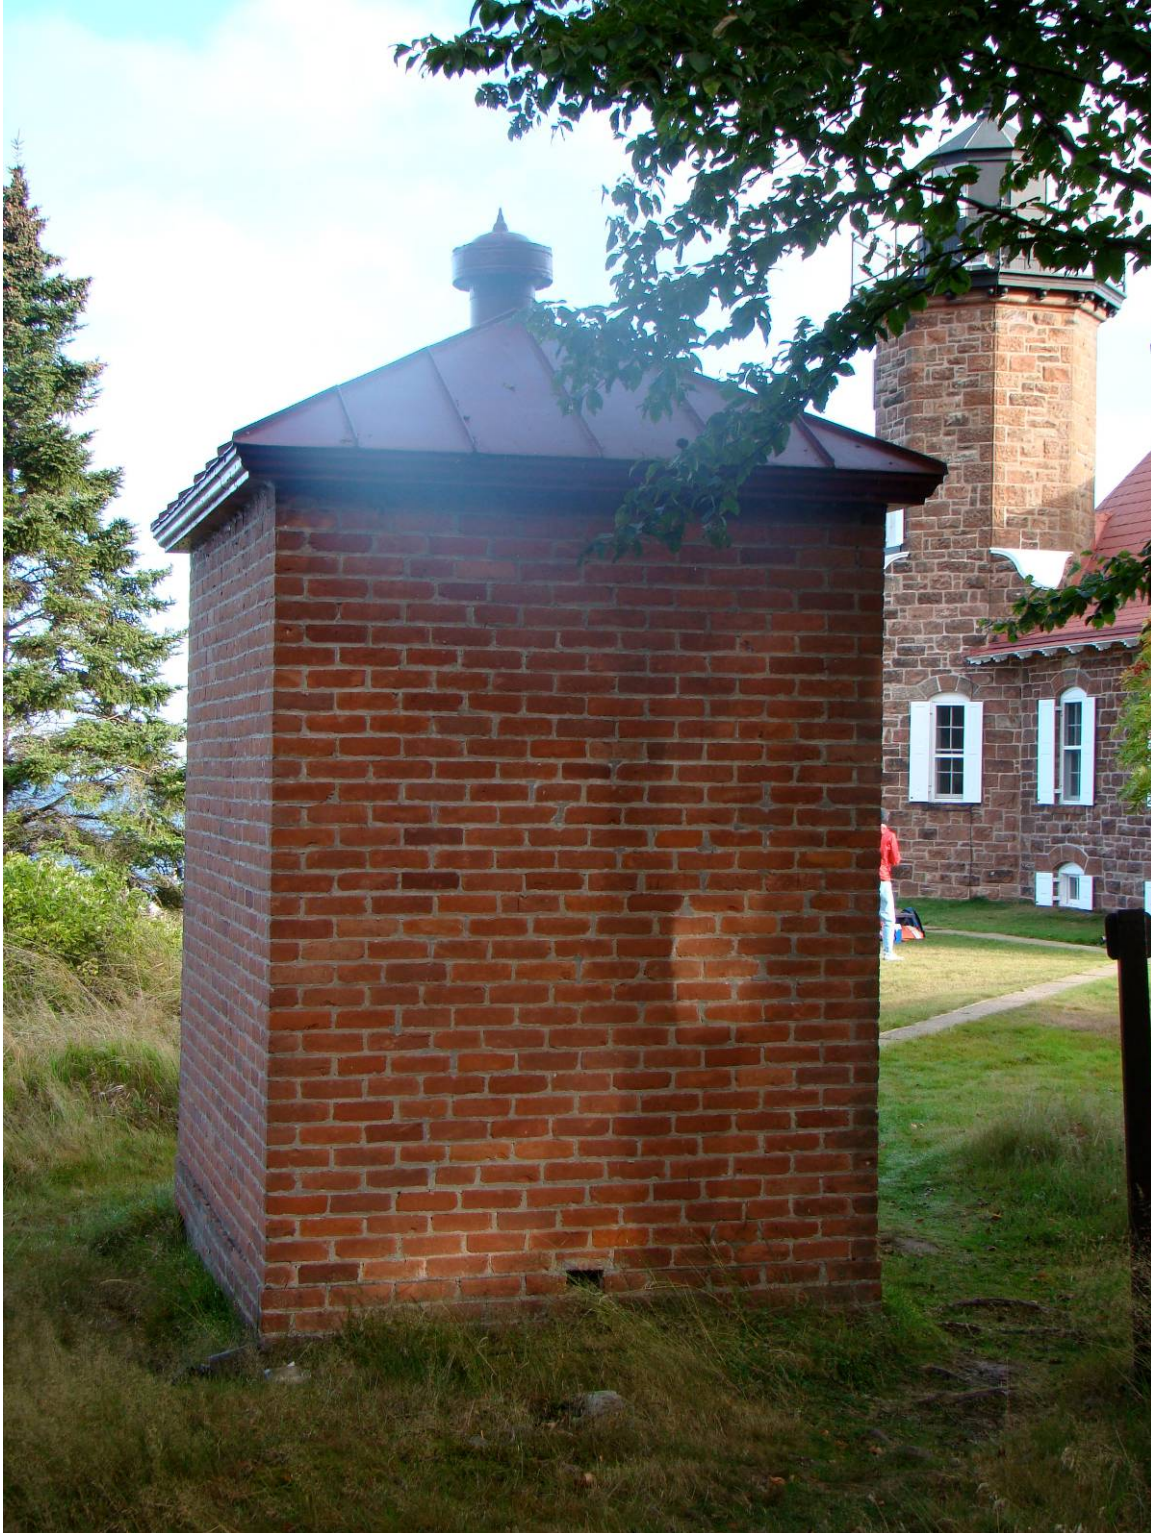
SI-OB-02: West elevation, 2009 (Source: A&A DSC01245)

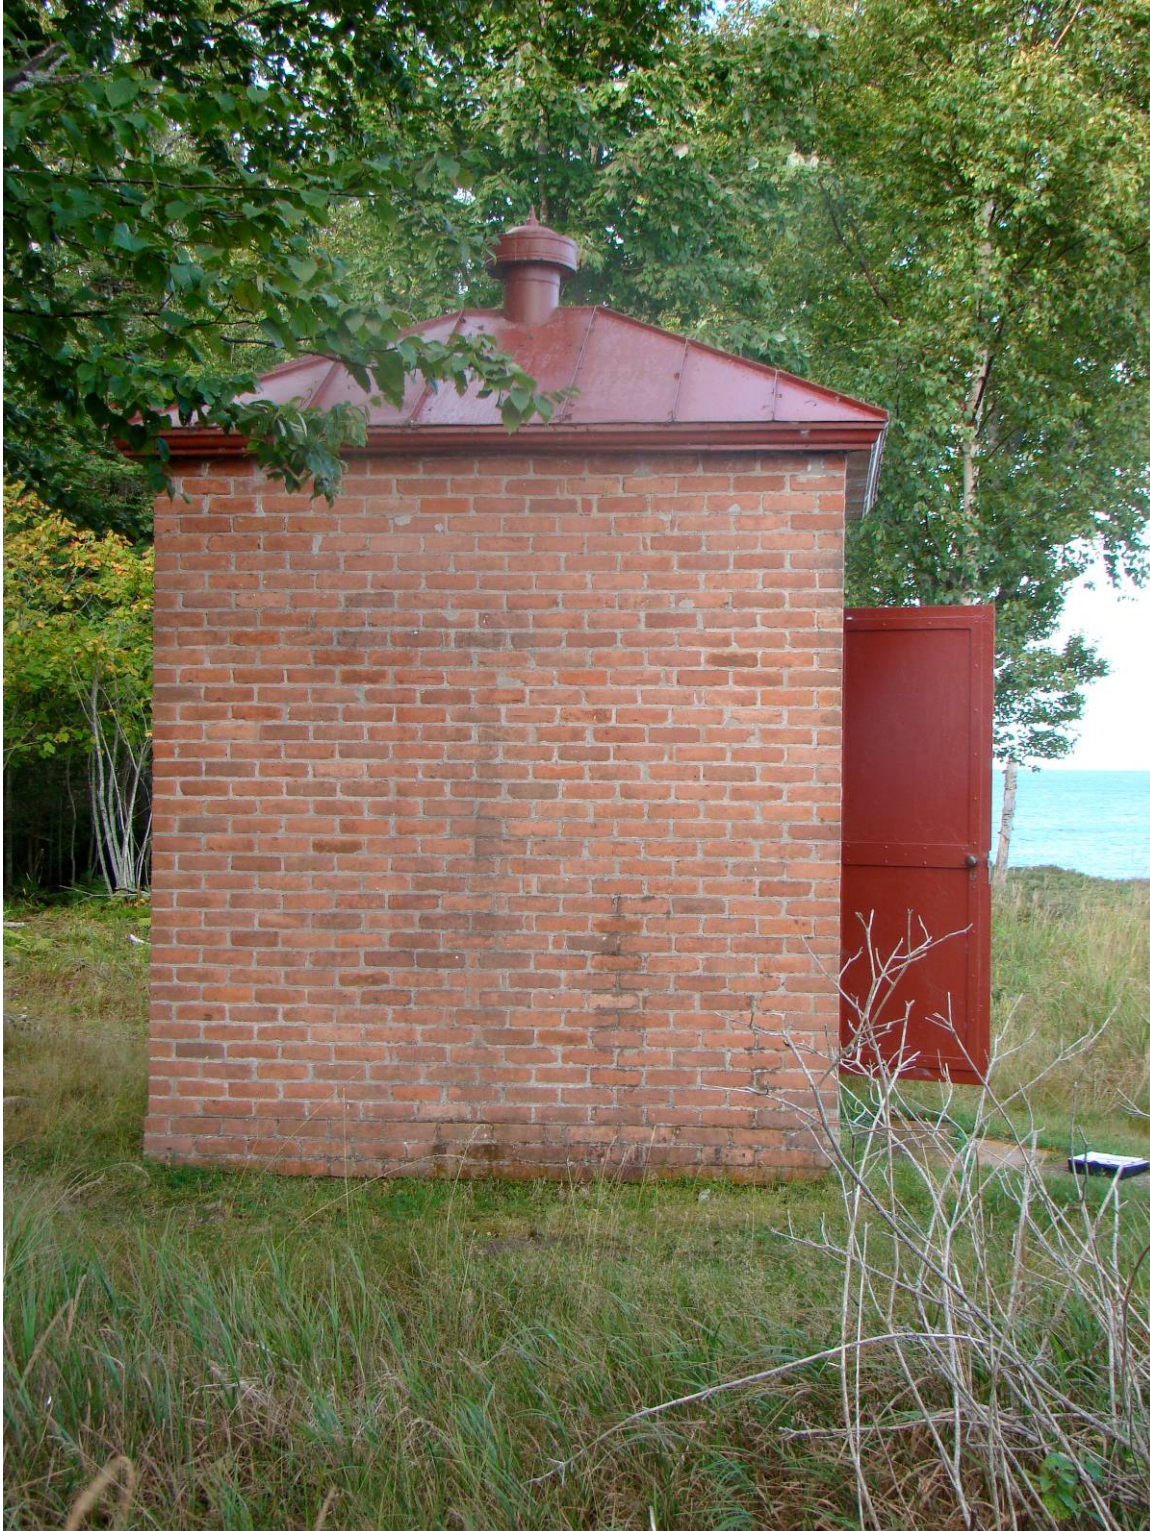
*SI-OB-03: South elevation, 2009 (Source: A&A DSC01246)*

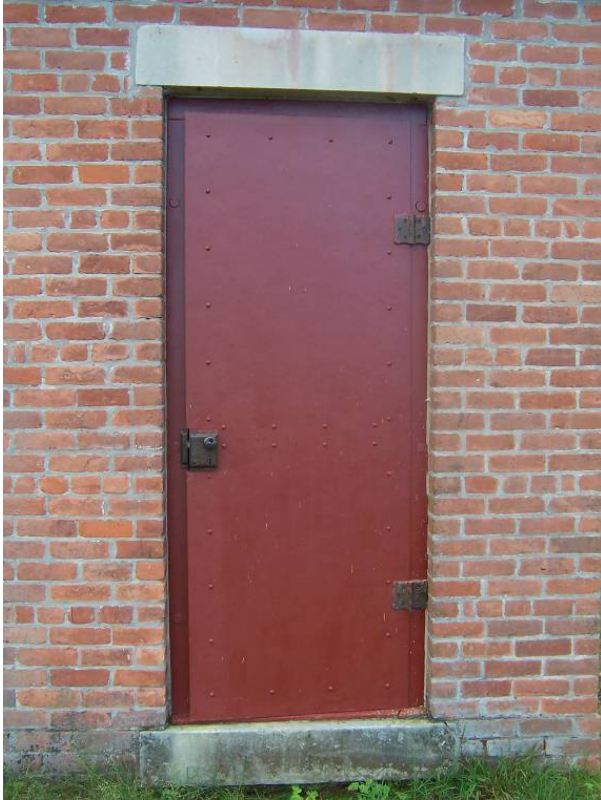
*SI-OB-04: East elevation, 2009 (Source: A&A DSC01247)*

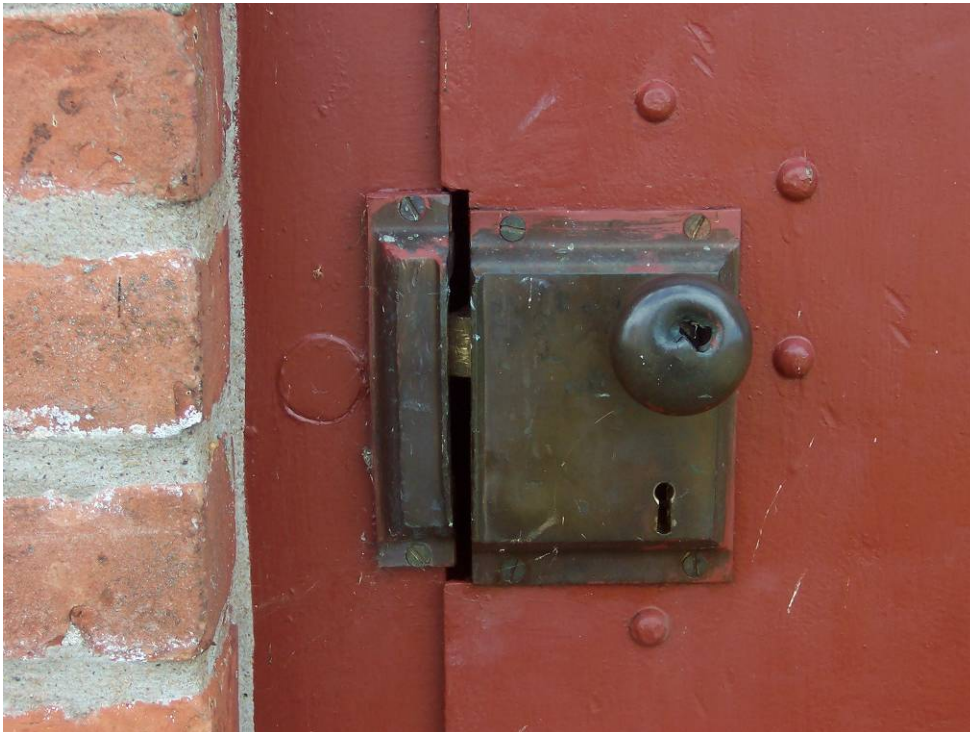
Condition:      *Fair to Poor*

The door knob is damaged and does not function.

SI-OB-05: North entry door (Source: A&A 100\_9876)

Repair the knob and provide operability.

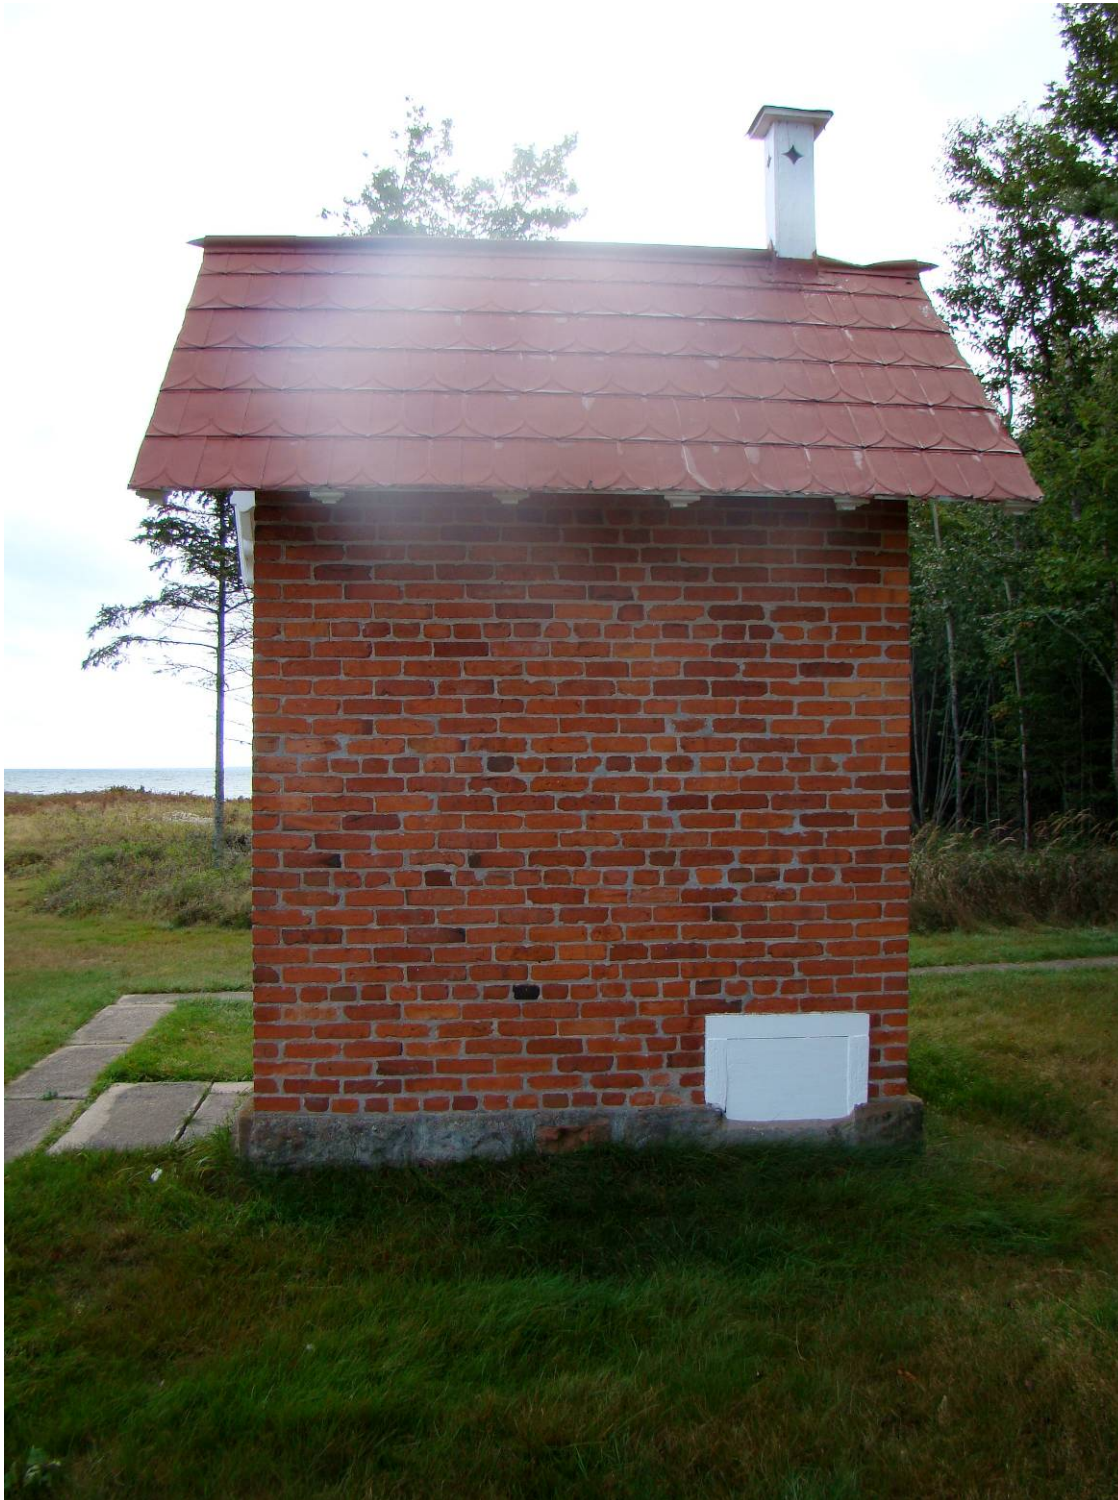
2  
3 *SI-P-01: North elevation aerial, 2009 (Source: A&A IMGP3061)*  
4

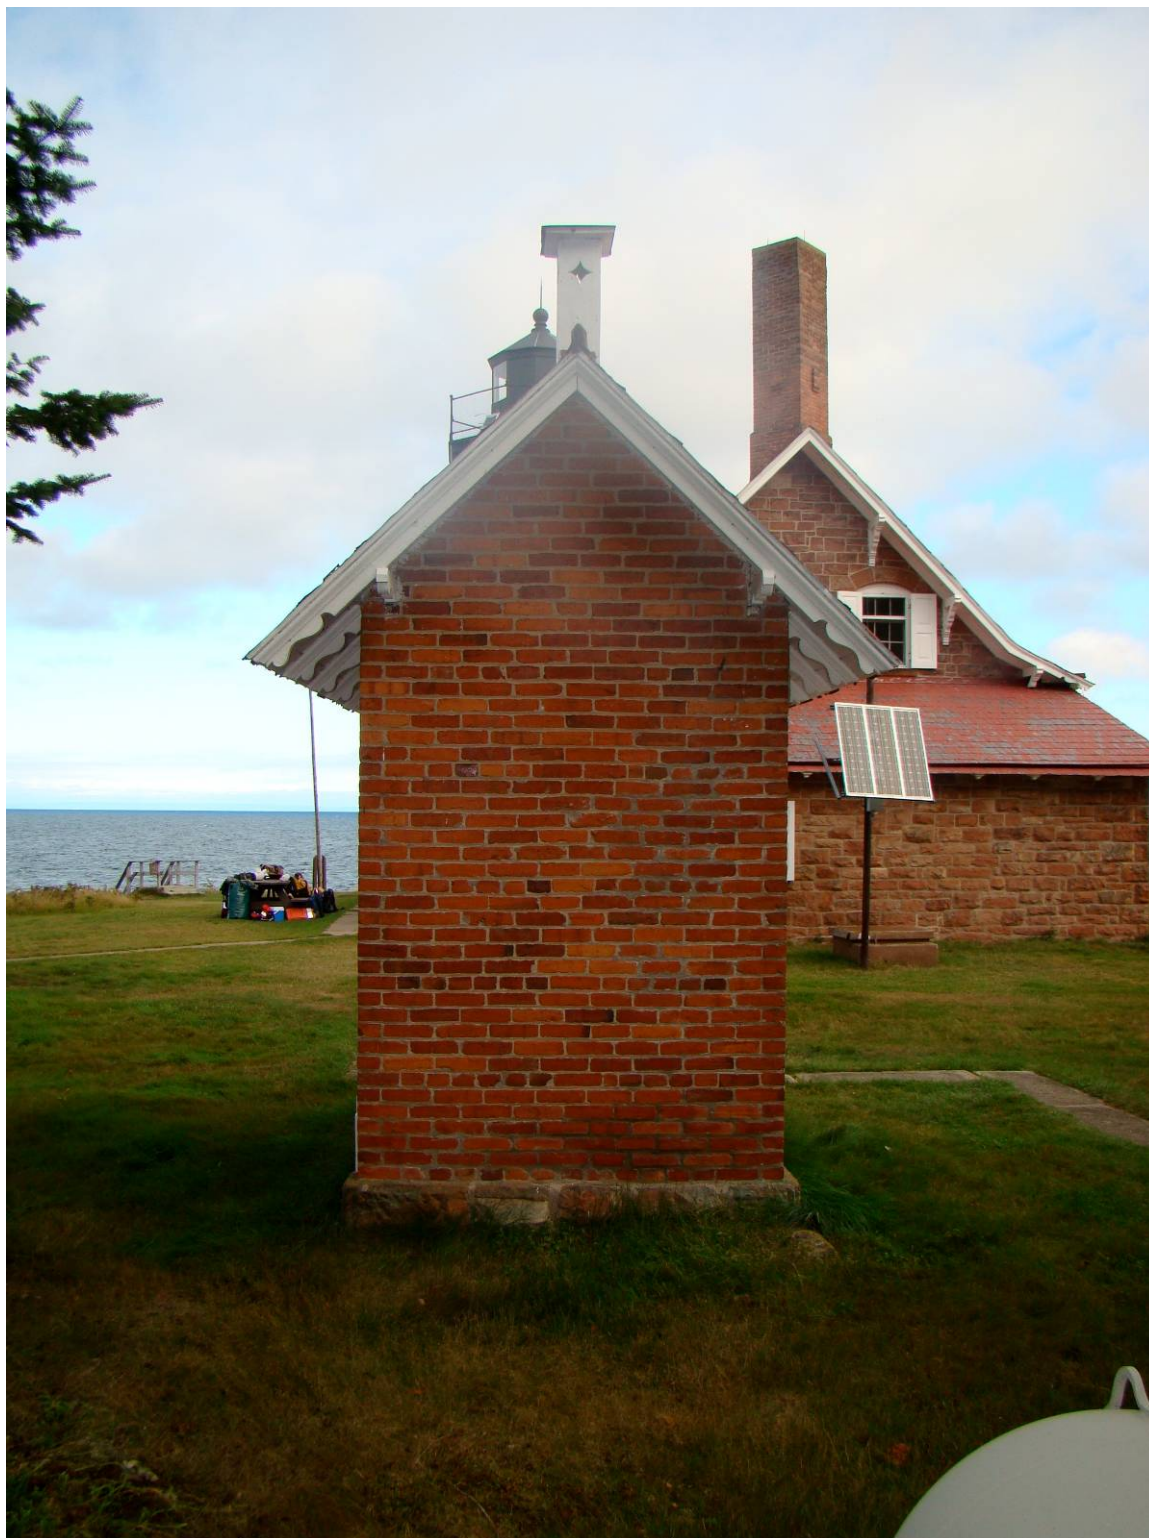
*SI-P-02: West elevation, 2009 (Source: A&A DSC01258)*

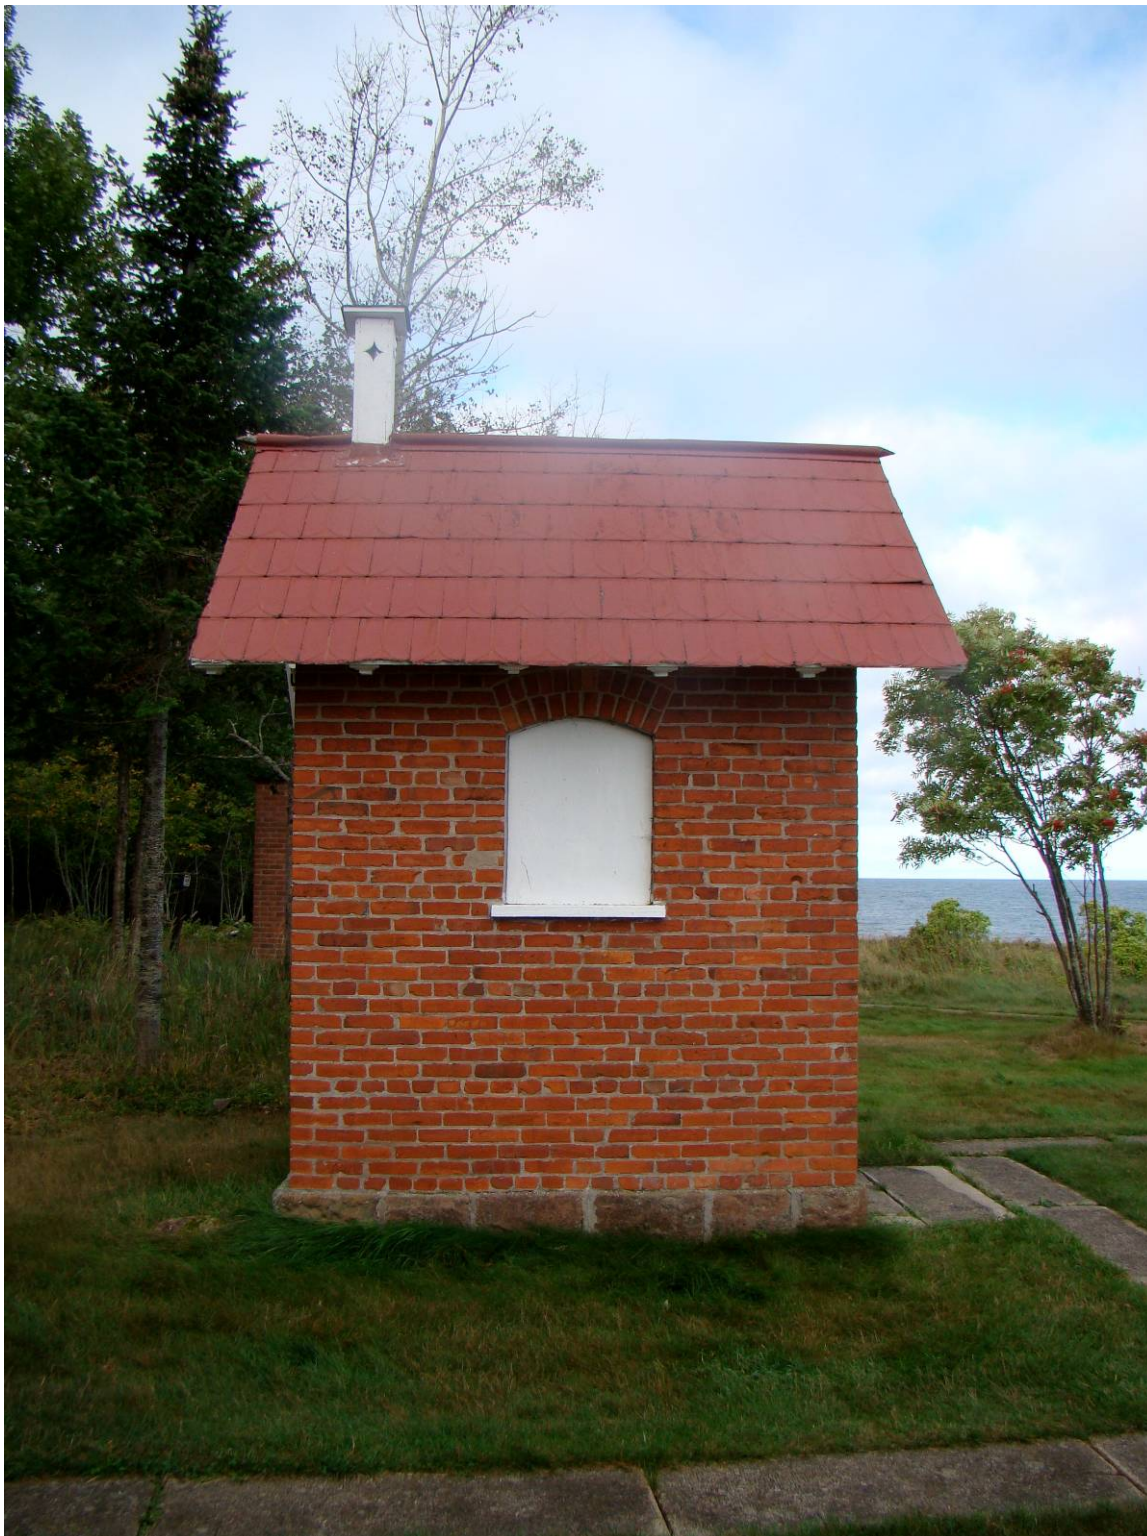
*SI-P-03: South elevation, 2009 (Source: A&A DSC01259)*

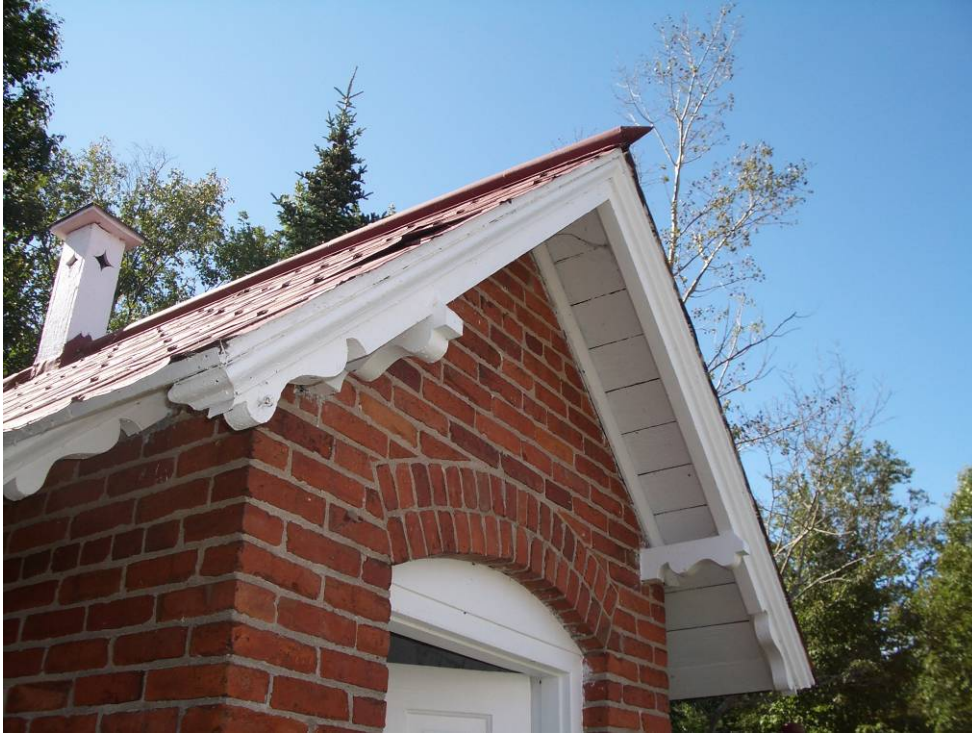
SI-P-05: North elevation trim, roof and vent details (Source: A&A IMGP3081)

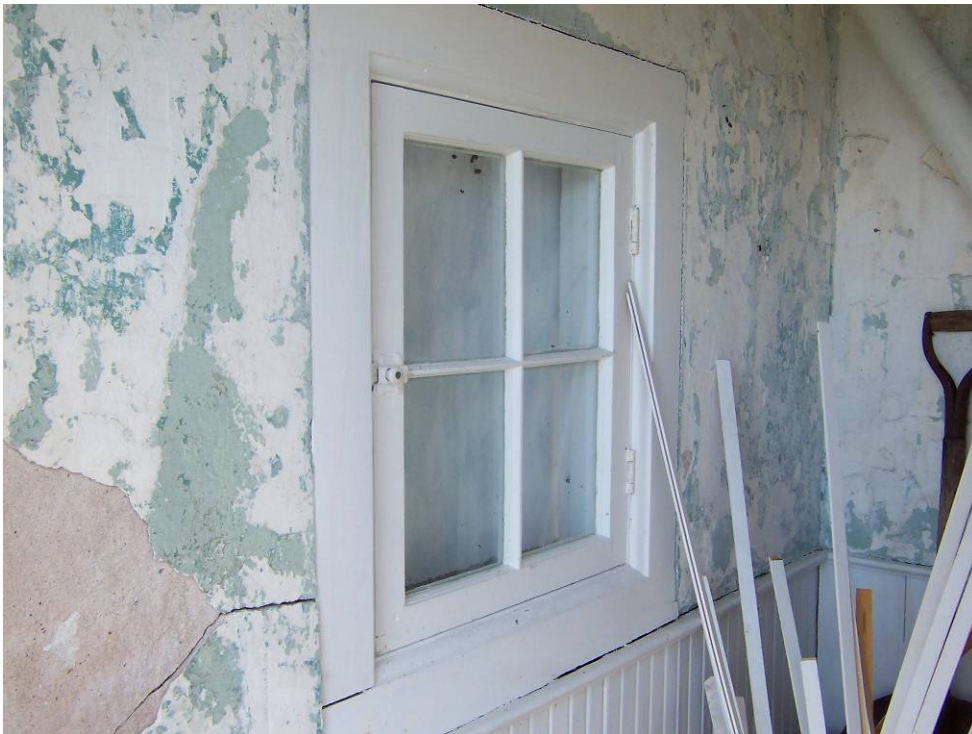
SI-P-06: East wall and window (Source: A&A 100\_9873)

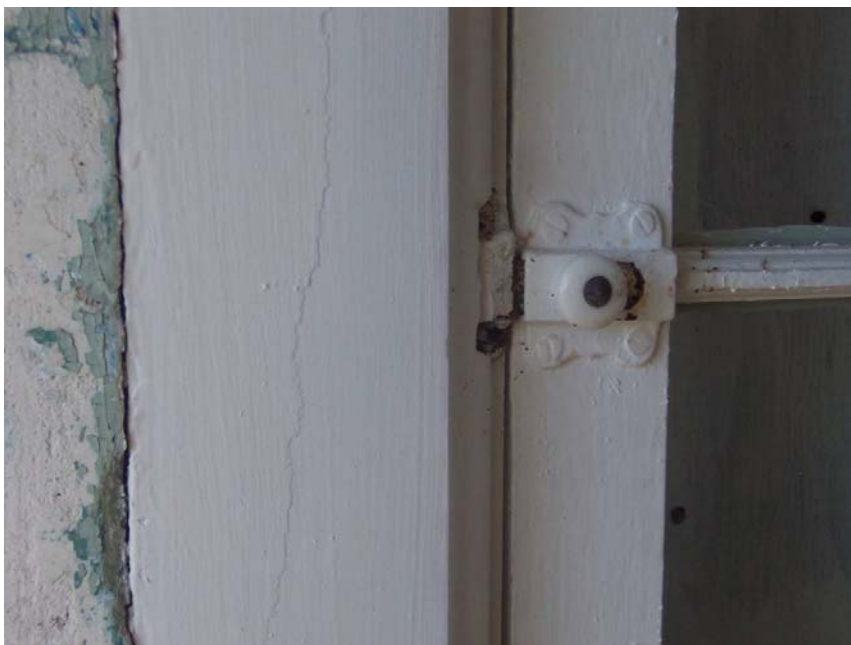
SI-P-07: Window hardware (Source: A&A 100\_9874)

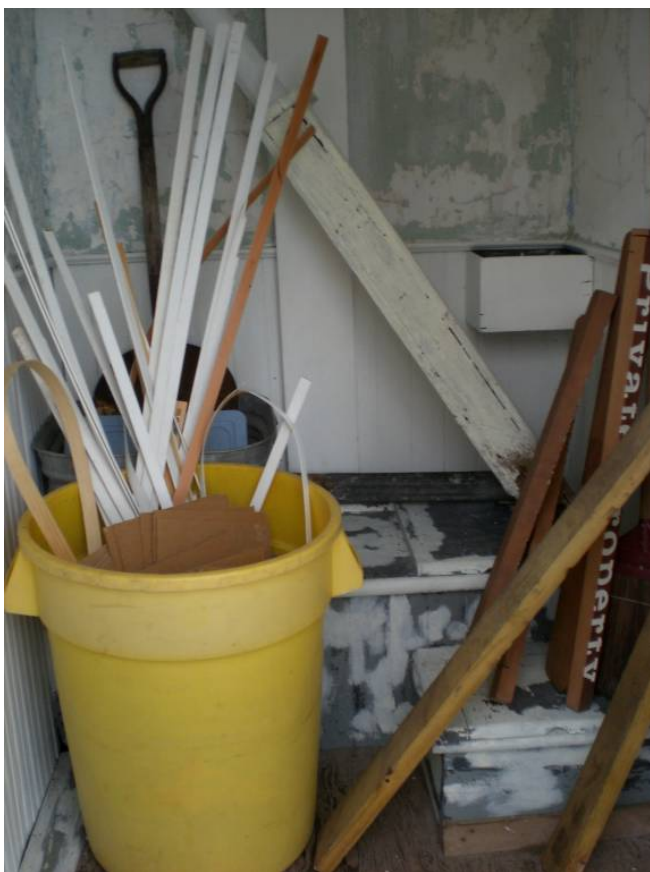
SI-P-08: Interior, south elevation (Source: A&A CIMG4191)

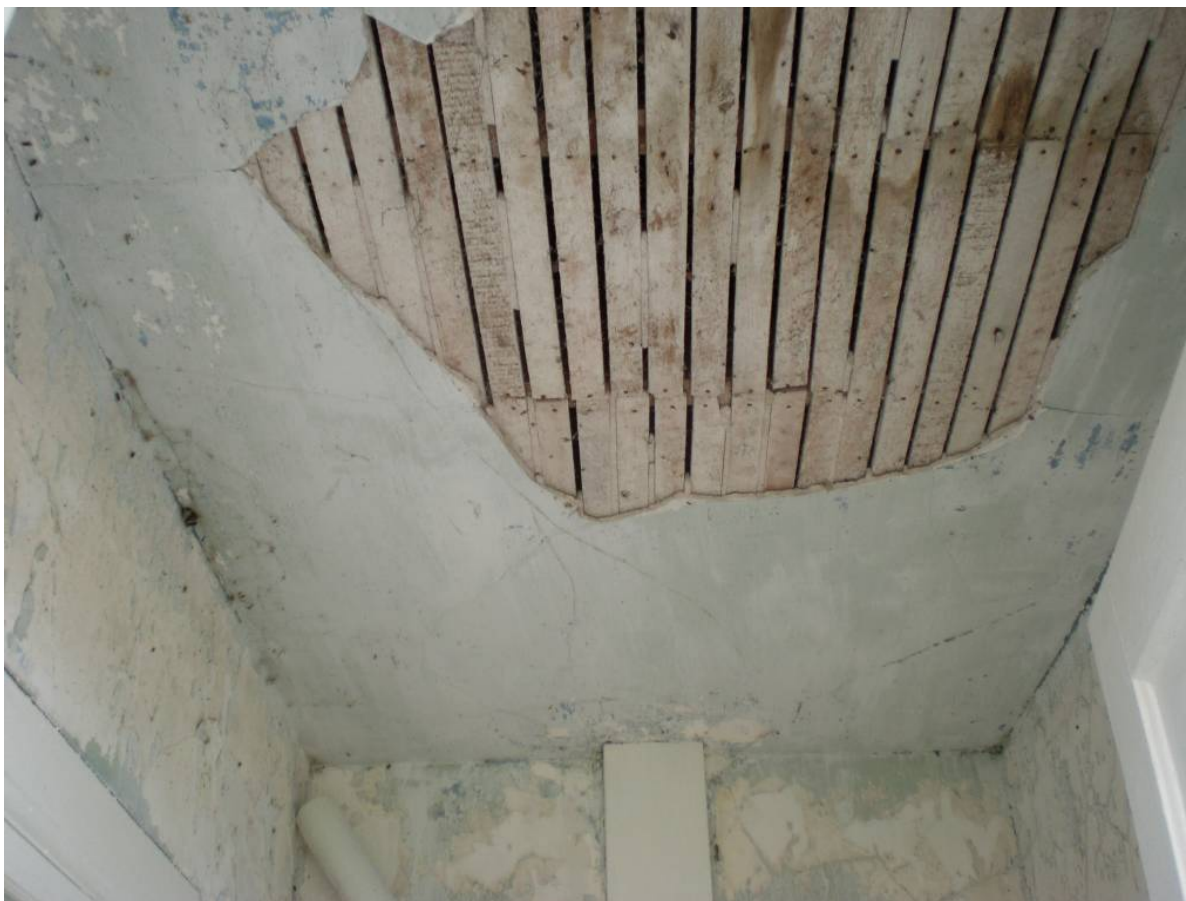
Condition:      *Poor*

The ceiling finish is in poor condition as over half of the plaster is missing and the lath is visible. (SI-P-09)

SI-P-09: Ceiling and vent detail, looking south (Source: A&A CIMG4203)

Repair the damaged plaster and repaint.
