**CONDITION ASSESSMENT
OF MAIN STRUCTURAL
MEMBERS OF**

WAPAMA

- *A Historic Steam Schooner*

February 2006
Project No. 187-6530
NRRI/TR-2006/03

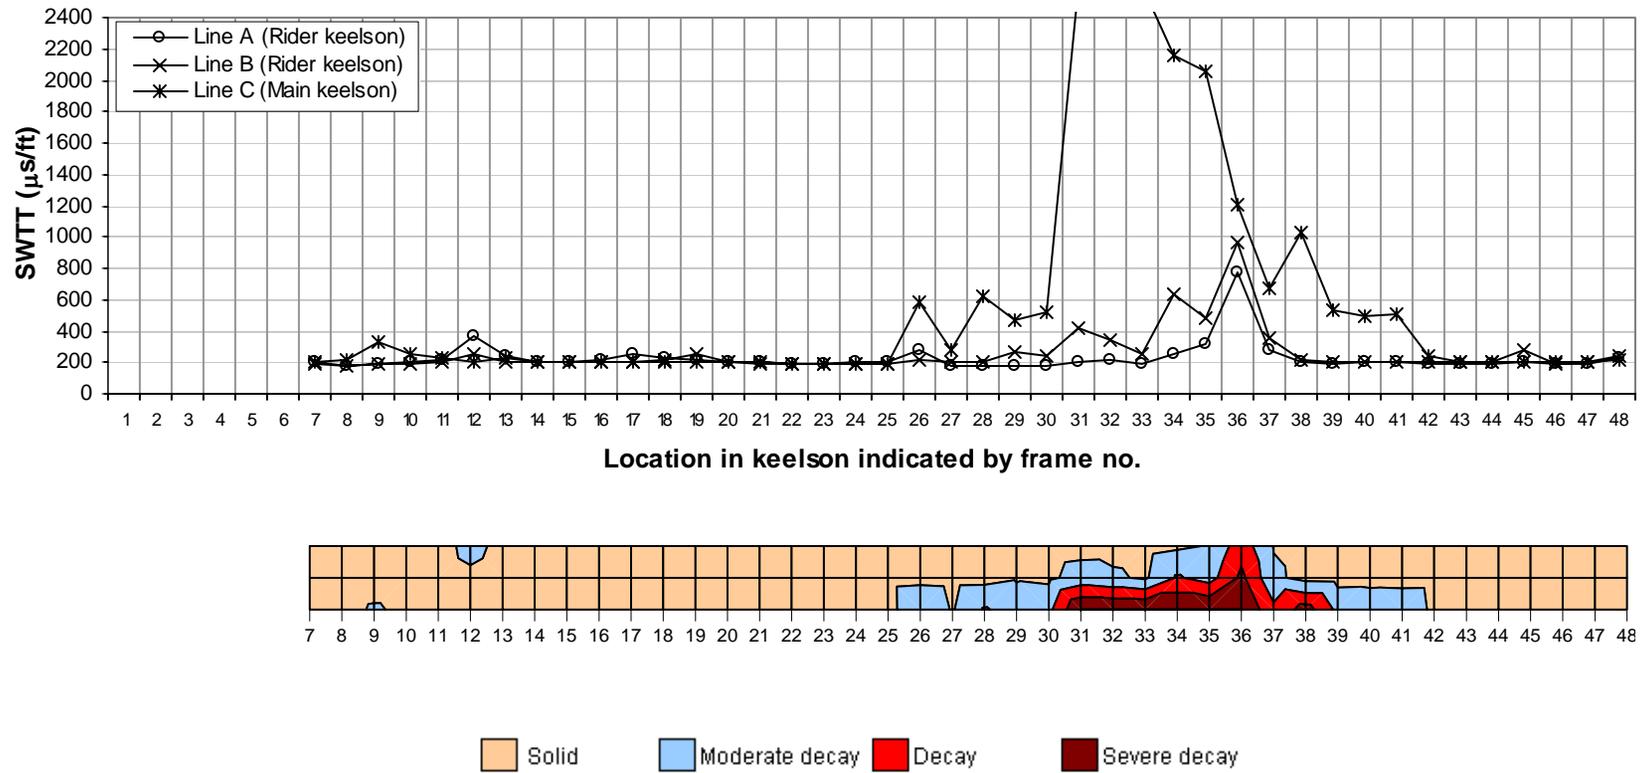
Figure 7. Distribution of stress wave transmission time (SWTT) and mapping of physical conditions of the keelsons.

Figure 7 illustrated the distribution of stress wave transmission time (SWTT) (unit: $\mu\text{s}/\text{ft}$) along the length as well as the mapping of physical conditions of the rider keelson and main keelson. The physical conditions of each test location were rated into four categories by comparing the measured SWTT with the reference SWTT and color-coded as the following:

The deterioration of the keelsons is concentrated between frame 25 and 42 and most severe decay occurred on the main keelson timber between frame 30 and 39. This is also confirmed by resistance micro-drilling tests (Appendix C1). It is likely that rainwater got into this area through the hatch over the years due to failed weather protection and water remained trapped. The water damage in untested portion of the main keelson between frame 30 and 39 and even beyond could also be significant. Deterioration could be further extended and advanced with the current outdated weather protection.

No significant deterioration was found between frame 7 and 25 according to stress wave scanning results. The tween deck, which extends from frame 11 to the forward end of the hatch at frame 26, has apparently protected the keelsons from direct exposure to rainwater dripping from above (through main decking). The Resistograph drill test revealed isolated internal rot (5 ½ - 9 ½ in.) at the location of frame 12. Similar condition at frame 11 was reported in a 1986's survey report (Tri-Coastal Marine, Inc. 1986).

keelsons was concentrated under the main hatch area. The rider keelson was deteriorated between frame 30 through 39, and the main keelson (top tier) was deteriorated between frame 25 through 42. No significant deterioration was detected in the keelsons under the tween deck between frame 7 and 25. Assistant keelsons were evaluated with resistance micro-drilling (topside downward) at frames 8, 32, and 48. Resistance plots indicated only isolated pockets of moderate decay.

Repair or replacement of the temporary roof shelter over the main deck is recommended. The current weather protection over the main deck is clearly ineffective in preventing rainwater as evidenced by water seepage from the underside vents in the outer hull. Moisture is saturating several key structural components on the main deck and in the cargo hold. An effective roof will prevent further decay until restoration work is initiated.

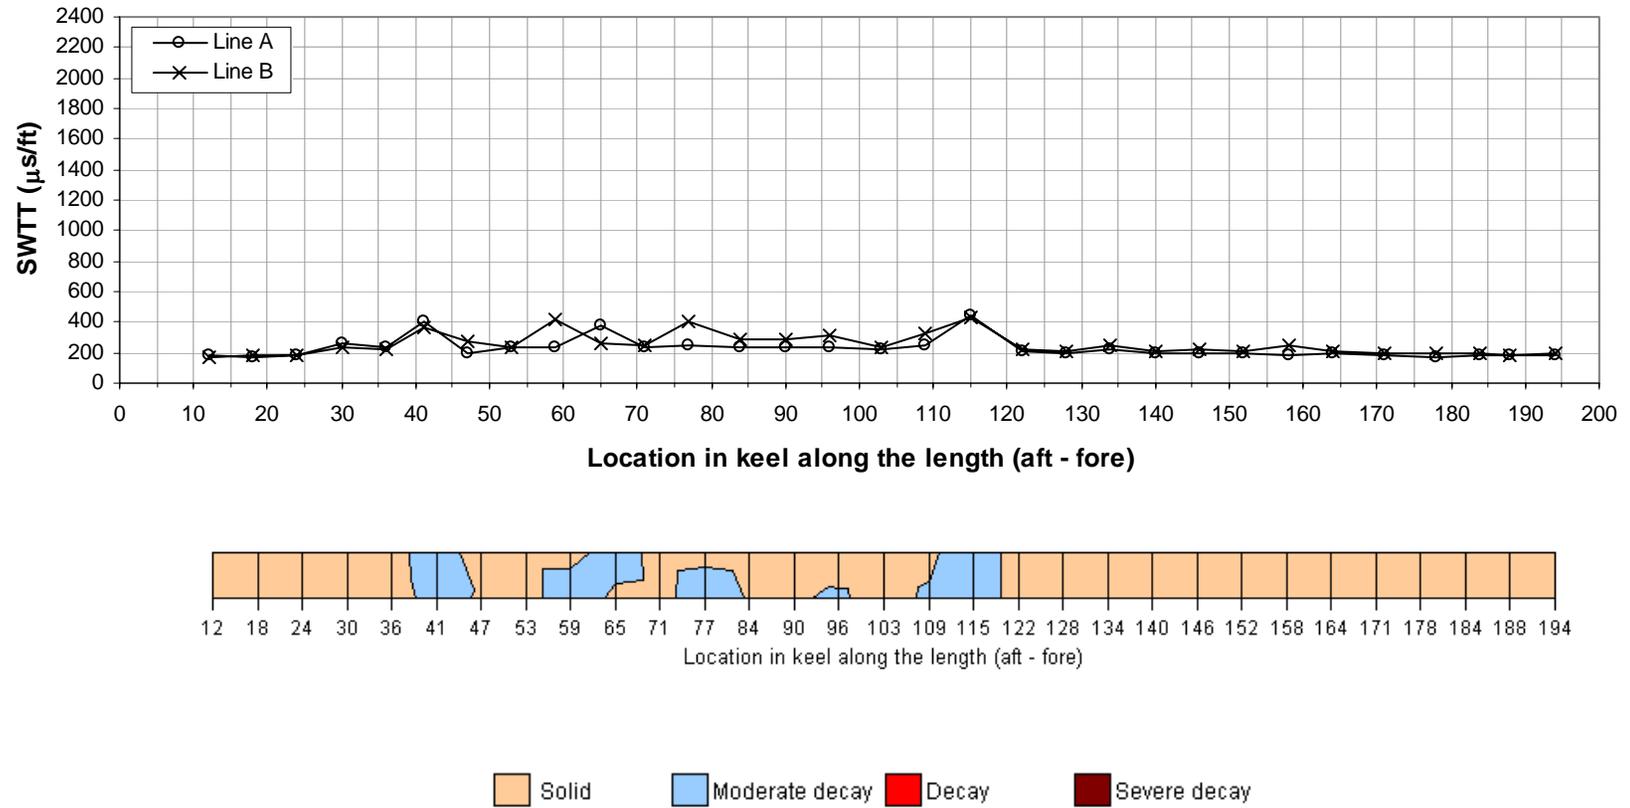
Figure 8. Distribution of stress wave transmission time (SWTT) and mapping of the physical conditions of the keel.

Stress wave scanning and mapping of the keel was done between frame 5 and 79. The scanning pattern is shown in Figure 3b. For the convenience of quickly establishing a scan pattern, we set frame 79 (where the iron tie plate ends) as the starting point and scanning was proceeded along two lines (A and B) from aft to fore. Stress wave transmission time data was collected between the keel blocks and at six feet intervals. Figure 8 shows the distribution of stress wave transmission time (unit: µs/ft) and the mapping of physical conditions of the keel.

Moderate deterioration was found at several areas of the keel as indicated in the mapping. Although no severe decay is present in the keel, the hogging in the mid section of the ship has caused significant mechanical damages (shear failure) to the keel as evidenced by the cracks or splits along the grain. This is also confirmed by previous report that the keel was broken when the ship was placed on the Barge 214 (Tri-Coastal Marine, Inc. 1986).

The keel was evaluated at 6 ft intervals (between the keel blocks) with stress-wave timing and spot-checked with resistance micro-drilling. Moderate deterioration was present at several locations in aft half of the keel. Visual signs of large splits and cracks may indicate that the keel was broken while being lifted onto barge 214.

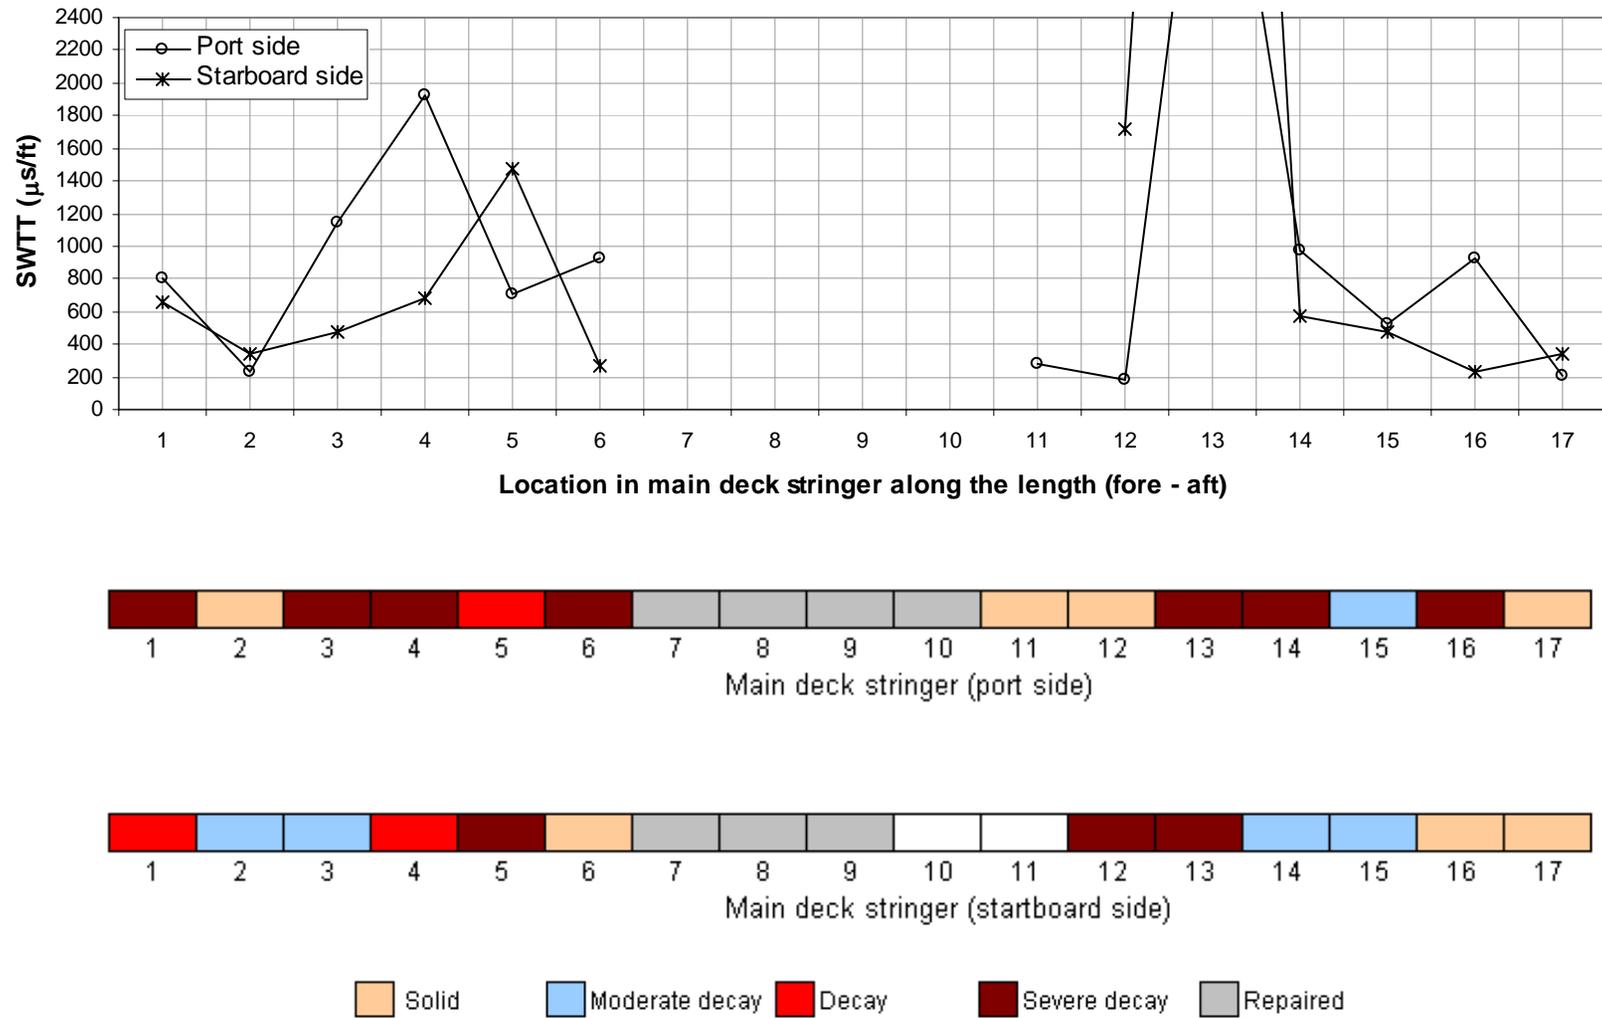
Figure 9. Stress wave transmission time (SWTT) and physical conditions of the main deck stringers.

The main deck stringers have lost most integrity due to severe deterioration. Visual signs of rot, splits, and checks are present in most portions of these members. To quantify the levels of deterioration, stress wave scanning was carried out on two side stringers with a less extensive interval (5 ft) and along the centerline of the member.

Figure 9 shows the distribution of stress wave transmission time (unit: $\mu\text{s}/\text{ft}$) along the length as well as the mapping of physical conditions of the main deck stringers.

The main deck stringers were spot-checked with stress-wave timing and resistance micro-drilling. Severe deterioration was confirmed in both side stringers and assistant stringers. Overall, the main deck stringers have lost nearly all structural integrity.

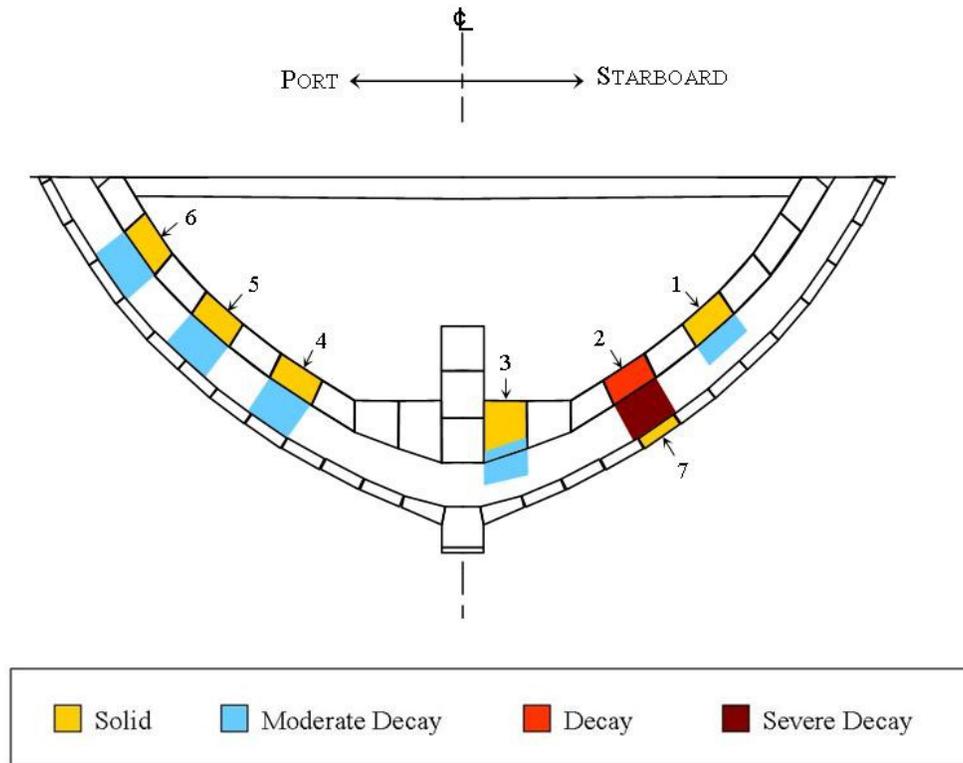
Figure 10. Mapping of physical conditions of the cross-section at frame 8 (Resistograph interpretation).

A schematic summary of micro-drilling resistance data collected at hull frame 8 is provided in Figure 10 (micro-drilling plots for hull frame 8 are provided in Appendix C3). Severe decay was detected at two out of seven (29%) drilling locations at this section. Most of the ceiling planks and the first assistance keelson (starboard) are in good condition, with decay present only in the ceiling plank at drill location no. 2. Moderate decay was detected in the inside upper portions of the hull frame drill locations, with severe decay present at drill location no. 2. There were visual indicators of water seepage through overhead tween and main decks that probably caused this deterioration since the WAPAMA was lifted onto barge 214.

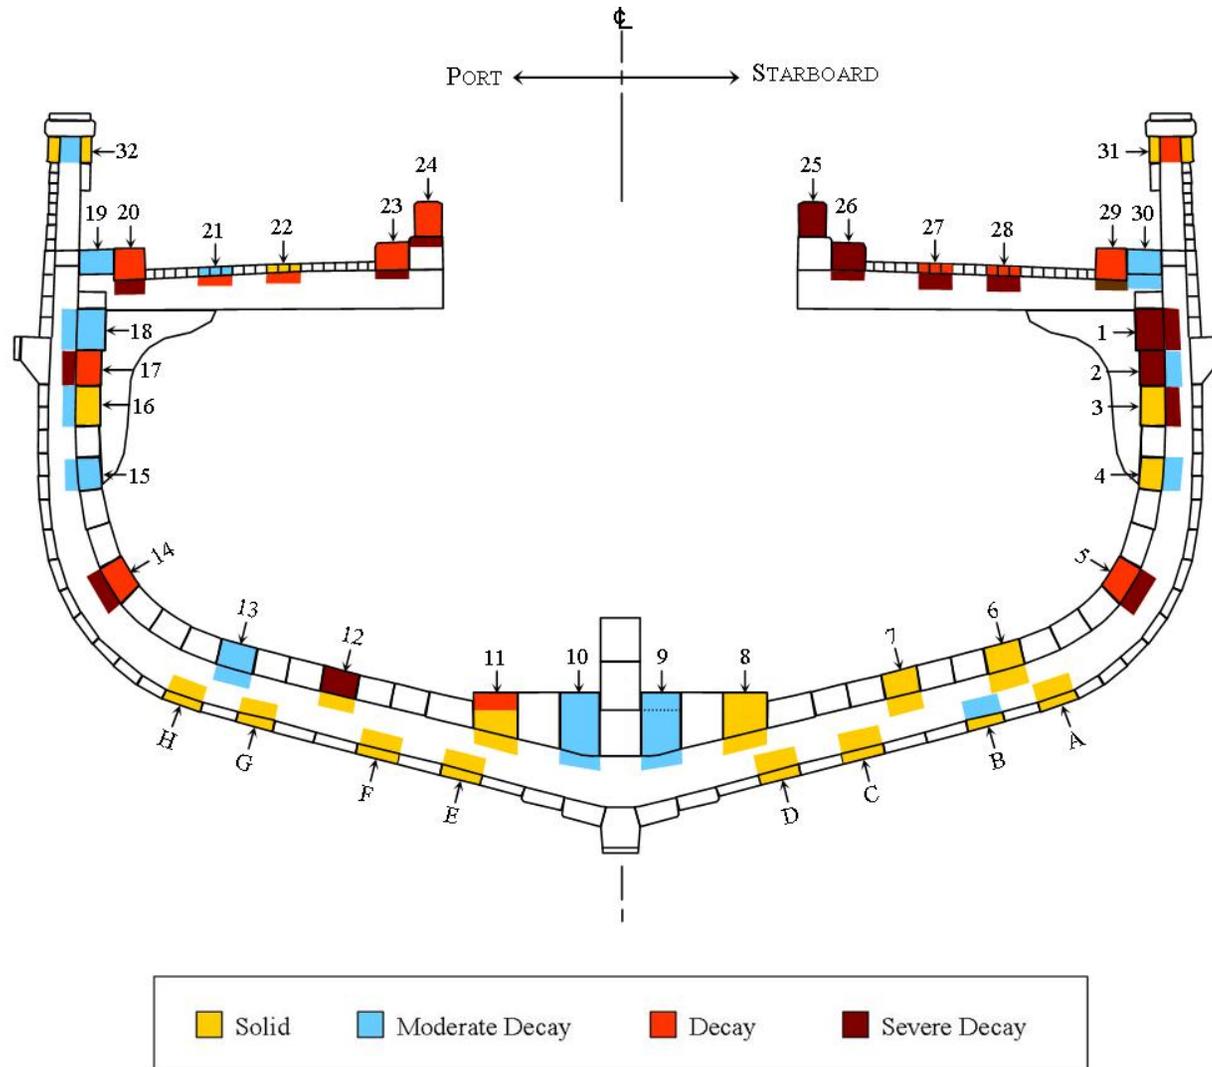
Figure 11. Mapping of physical conditions of the cross-section at frame 32 (Resistograph interpretation).

A schematic summary of micro-drilling resistance data collected at hull frame 32 is provided in Figure 11 (micro-drilling plots for full frame 32 are provided in Appendix C4). Severe decay was detected at fifteen (38%) of all drilling locations with most of these areas located in the members at the main deck level (stringers and main deck beams) or near the main deck level (clamps, hull frame). The deterioration of the lower hull members and keelsons was mostly moderate. Deterioration ranging from decay to severe decay was detected at nearly all drilling locations drilled downward from topside main deck. The outer waterways 19 and 30 and portside main deck planks (21 and 22) showed signs of moderate decay. Deterioration ranging from decay to severe decay was detected in clamps 1, 2, and 17, ceiling planks 5, 12, and 14, the 3rd assistant keelson portside 11), and the inside upper portion of the hull frame 1, 3, 5, 14, and 17. Drillings upward into the outer hull detected mostly sound wood with only moderate decay present in the outer lower hull frame B.

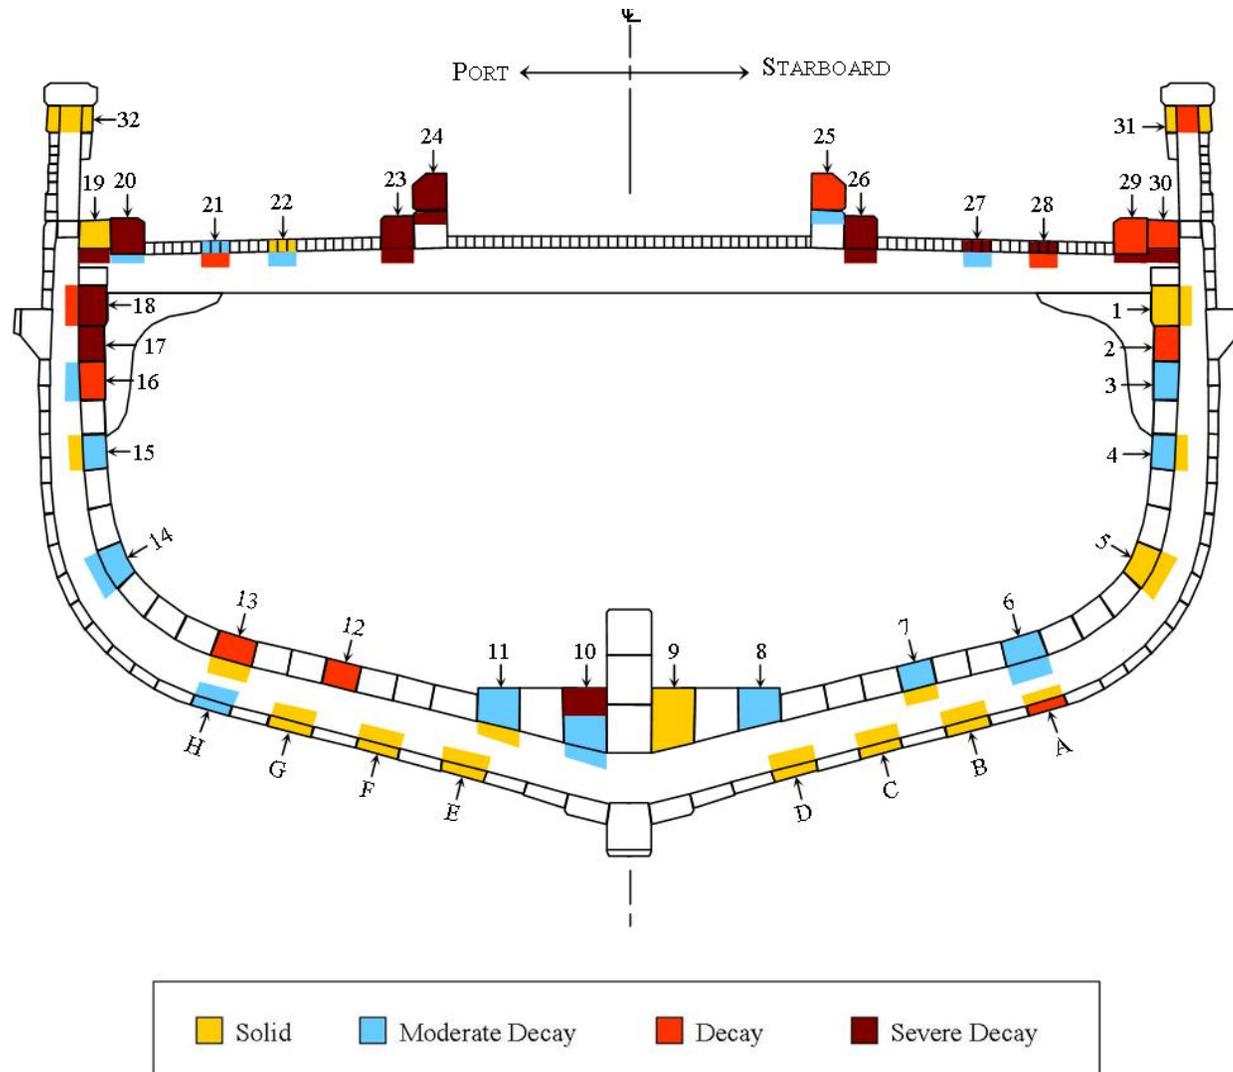
Figure 12. Mapping of physical conditions of the cross-section at frame 48 (Resistograph interpretation).

A schematic summary of micro-drilling resistance data collected at hull frame 48 is provided in Figure 12 (micro-drilling plots for hull frame 48 are provided in Appendix C5). Severe decay was detected at twelve (30%) of all drilling locations with most of these areas located in the members at the main deck level (waterways, stringers, main deck planks, and main deck beams) or near the main deck level (clamps). The deterioration of the lower hull members and keelsons was mostly moderate. Deterioration ranging from decay to severe decay was detected at nearly all drilling locations drilled downward from topside main deck, except main deck plank 22. Deterioration ranging from decay to severe decay was also detected in clamps 2, 16, 17, and 18, the 1st assistant keelson portside (10), ceiling planks 12 and 13, and the inside upper portion of the hull frame 18. Drillings upward into the outer hull detected mostly sound wood with deterioration noted only in outer hull plank A and in outer hull plank/hull frame H.

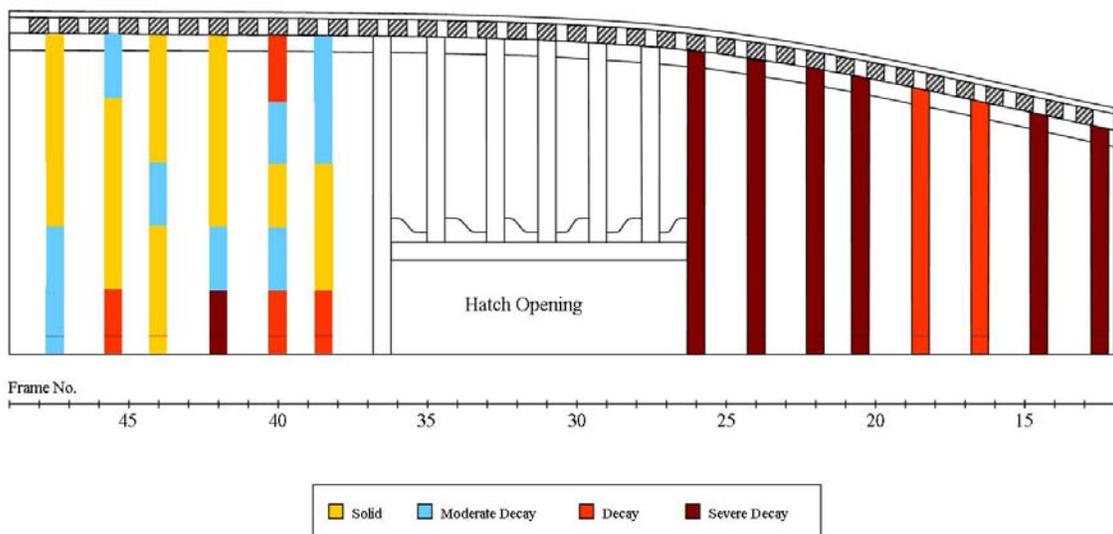
Figure 14. Mapping of physical conditions of portside main deck beams (Plan view).

Stress wave transmission data was collected from the main deck beams at two areas on the ship's portside (Figure 13). Five test locations were located in the main deck beams above the tween deck including some at the hanging knees (Figure 13a). Five test locations were also located in the rear cargo hold between the main hatch and the cabin deck (Figure 13b). A summary of the condition of the main deck beams is provided in Table 2 and Figure 14.

Stress wave transmission data confirmed that the main deck beams above the tween deck are in an advanced state of deterioration. Decay and severe decay were detected at all beams as indicated by the stress wave transmission times in Table 2. Beams located at or near hull frames 13, 15, 20, 22, 24, and 26 have almost lost their entire strength and are considered having zero load capacity. In addition, severe deterioration was found in the hanging knees at frames 15 and 26, which raise serious concerns on the rest of the hanging knees that have not been tested.

The condition of the main deck beams at rear cargo hold varied. Decay to severe decay is present at the beam ends over the stanchion for most beams. The exception is the deck beam located near hull frame 44 which is sound. At the beam ends near the outer hull frame, only the beam at hull frame 40 shows decay, the beams near frames 38 and 46 shows moderate decay and the beams near 42, 44, and 48 are generally sound. The condition of the main deck beams away from their supports is mostly sound with moderate deterioration detected at some beams. The main deck beam in the best condition is at hull frame 44. Severe deterioration was present only at the end support (over the stanchion) at hull frame 42.

The main deck beams at the portside of the vessel were spot-checked with stress wave timing. Severe deterioration was found present in nearly all main deck beams above the tween deck. Test results indicate that these beams have lost entire structural integrity and have potential to collapse in the near future, which poses a significant safety hazard. The main deck beams at the rear cargo hold area are mostly sound, with moderate to severe decay found at the end support areas.

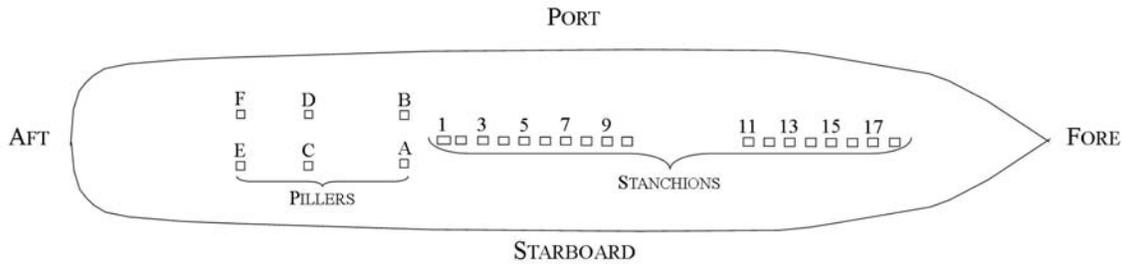
Figure 15. Location of pillars and stanchions on the ship (Plan view).

Deterioration is present in most pillars, but varies at different levels (lower, middle, and upper). Pillars A and B show moderate deterioration in the lower level, decay in the

middle level, and are sound in the upper level. Pillars C and D have areas of moderate deterioration and decay in the lower and/or middle level, while pillars E, and F are found in sound condition in the lower level. Since the pillars E and F could only be accessed and tested at one level of the ship, the testing results are not conclusive for the entire members.

The hold stanchions were first visually assessed for deterioration, then a subset of the members was spot-checked with stress wave transmission testing. The hold stanchions tested were numbers 1-3, 5, 7-10, 13-15, 17, and 20 (Figure 15). Hold stanchions 1, 2, and 3 were found to have moderate decay, with stress wave transmission times ranging from 326 to 584 $\mu\text{s}/\text{ft}$. The remaining hold stanchions were found to be solid with stress wave transmission times ranging from 179 to 200 $\mu\text{s}/\text{ft}$.
