NHL Steam Schooner Wapama
Condition Survey and Preservation Recommendations

Phase 1A Final Report

WAPAMA CONDITION SURVEY

D&P Report No. 2526-001
October 7, 2005

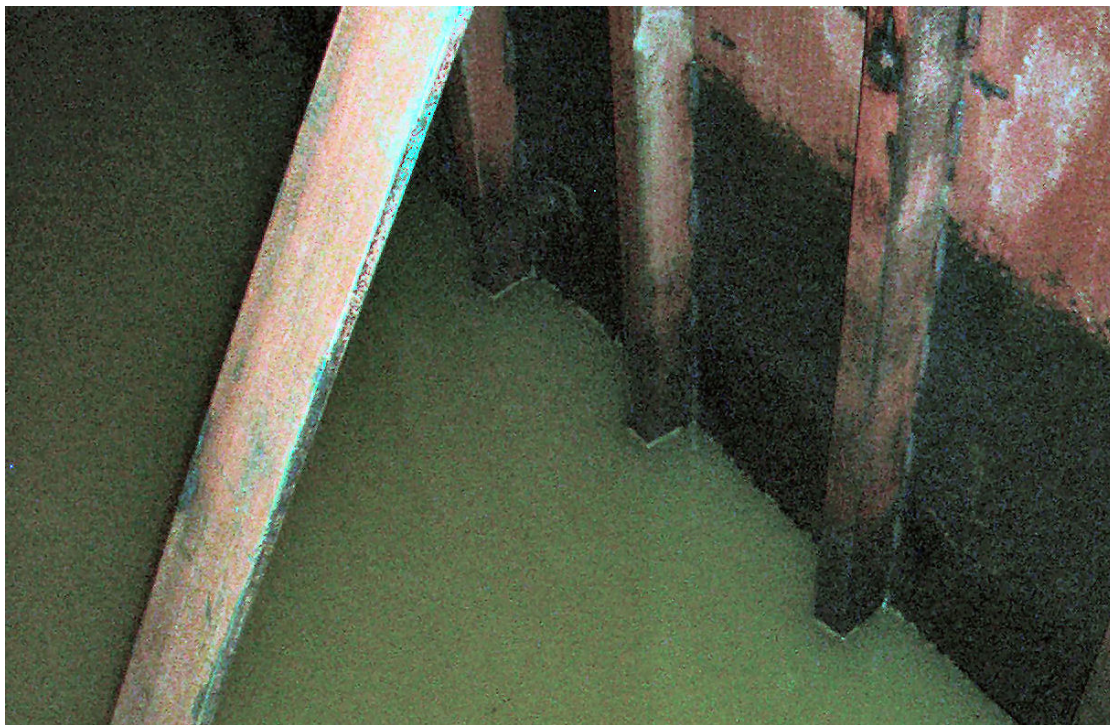
With respect to Barge 214 the rapid structural survey revealed no significant structural problems, although an upward deck deflection amidships was noted and is believed to have been caused during a reported grounding incident, prior to the barge being acquired for use in supporting the *Wapama*. A visual inspection of the tanks indicated the collection of a small amount of water and other fluids in some of the tanks, as shown in Figure 2. It would be necessary to pump these fluids out of the bilges in order to complete the visual inspection. Regular maintenance and some localized repairs are suggested to replace localized bottom damage.

Figure 2 – Example of Fluids in Bilges of Some Tanks on Barge 214

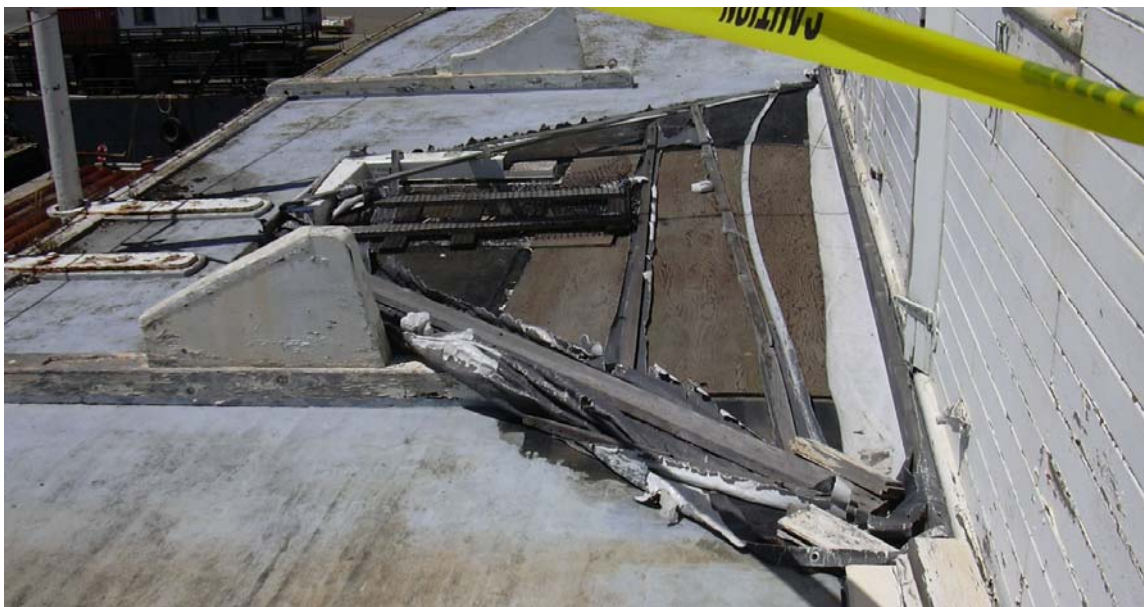
With respect to *Wapama* the rapid structural survey revealed that the after superstructure is in relatively good shape, as shown in Figures 3 through 9, though there is some deterioration/damage in way of the Starboard Side Boat Deck, as shown in Figure 10.

Figure 10 – Deterioration/Damage at the Starboard Side Boat Deck

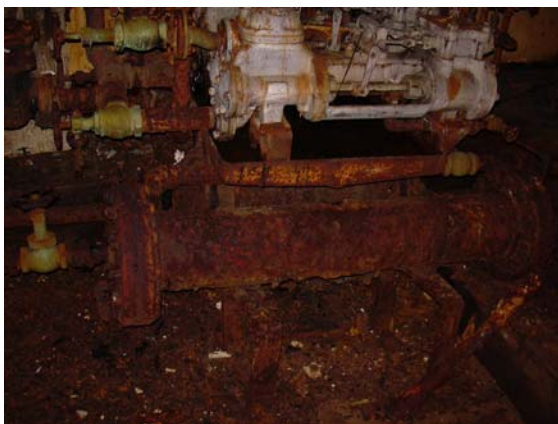
Although the main machinery space shows significant deterioration of some of the auxiliary machinery, metal gratings, and boilers (as shown in Figures 11, 12, & 13) many of the main machinery components, such as the main engine and generators, are presently in very good shape thanks to some dedicated preservation efforts undertaken by NPS /SAFR staff and volunteers, as shown in Figures 14, 15, & 16).

Figure 11 – Deteriorated Machinery

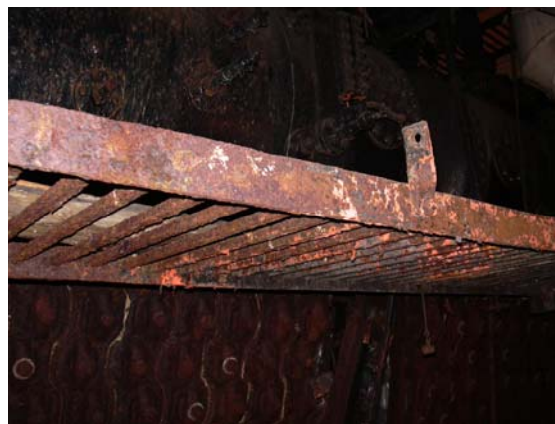
Figure 12 – Deteriorated Grating

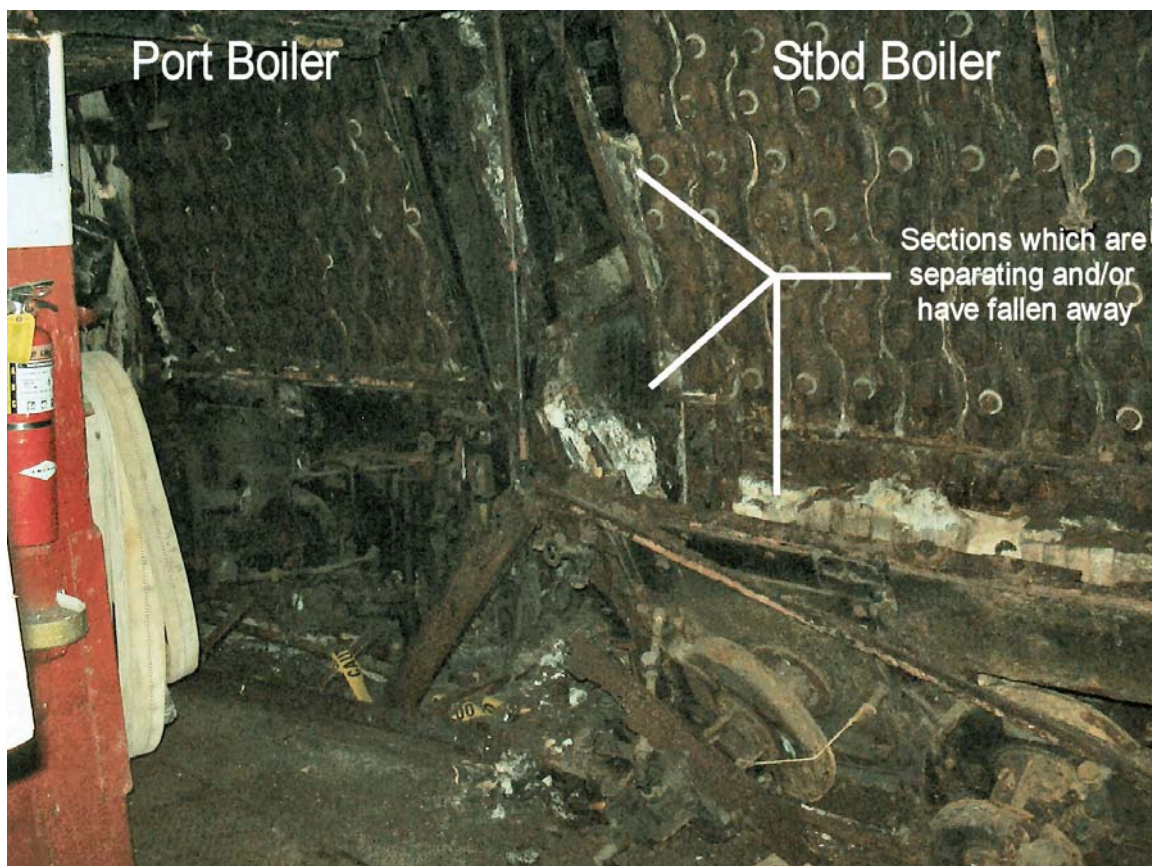
Figure 13 – Current Deteriorated State of Boilers in Engine Room

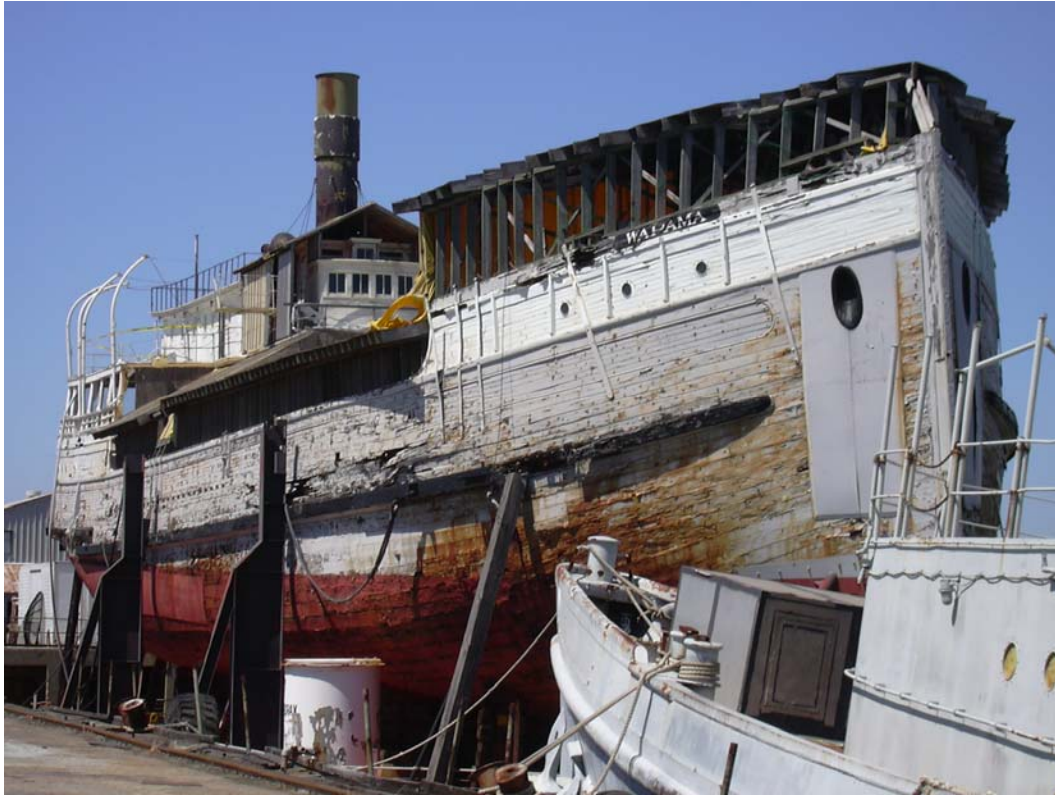
The hull and main deck forward, by comparison, were found to be in an extremely deteriorated state. It was not possible to assess the condition of the main hull frames at this time, however the exterior hull planking and sheathing was found to be disintegrating, as shown in Figure 17.

Figure 17 – Wapama Current Exterior Condition

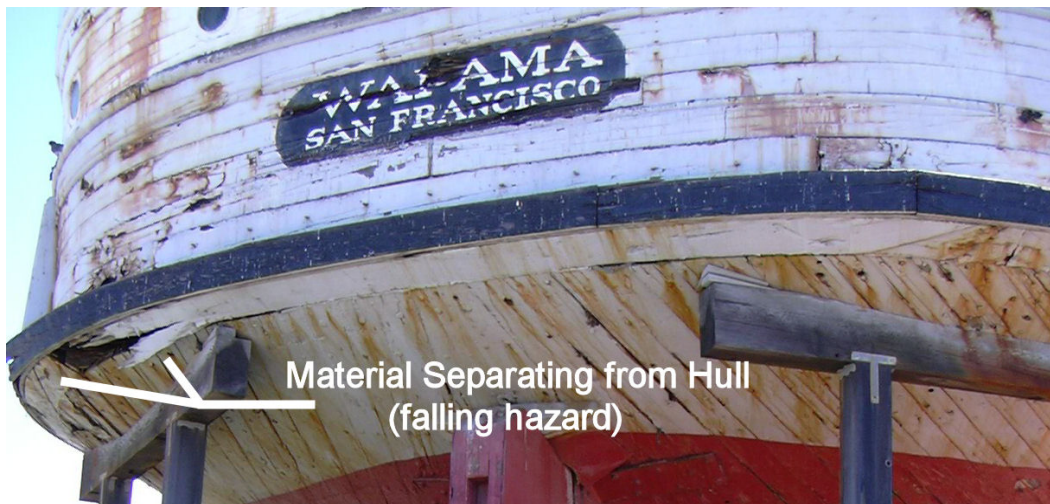
It was reported that pieces of rotten wood are continually falling from the vessel, and the NPS / SAFR maintenance individual indicated that these pieces are becoming bigger as time goes on (see Figures 18 and 19).

Figure 18 – Deterioration of Aft Rub Rail

It is recommended that within the next six months, items that represent an immediate threat of falling, such as the cast iron deck fittings, chain plates, rub rails, etc. should be cataloged and removed from the vessel so that they can be stored for restoration. Any loose or falling wood should also be removed and properly disposed of, which may require special handling because of the presence of asbestos, fuel oil, lead based paints, and other potentially hazardous coatings. Also, a lock should be provided for the gate on the brow to restrict access to the deck of the barge. Access to the forward portion of the vessel should also be restricted by means of signs and barriers.

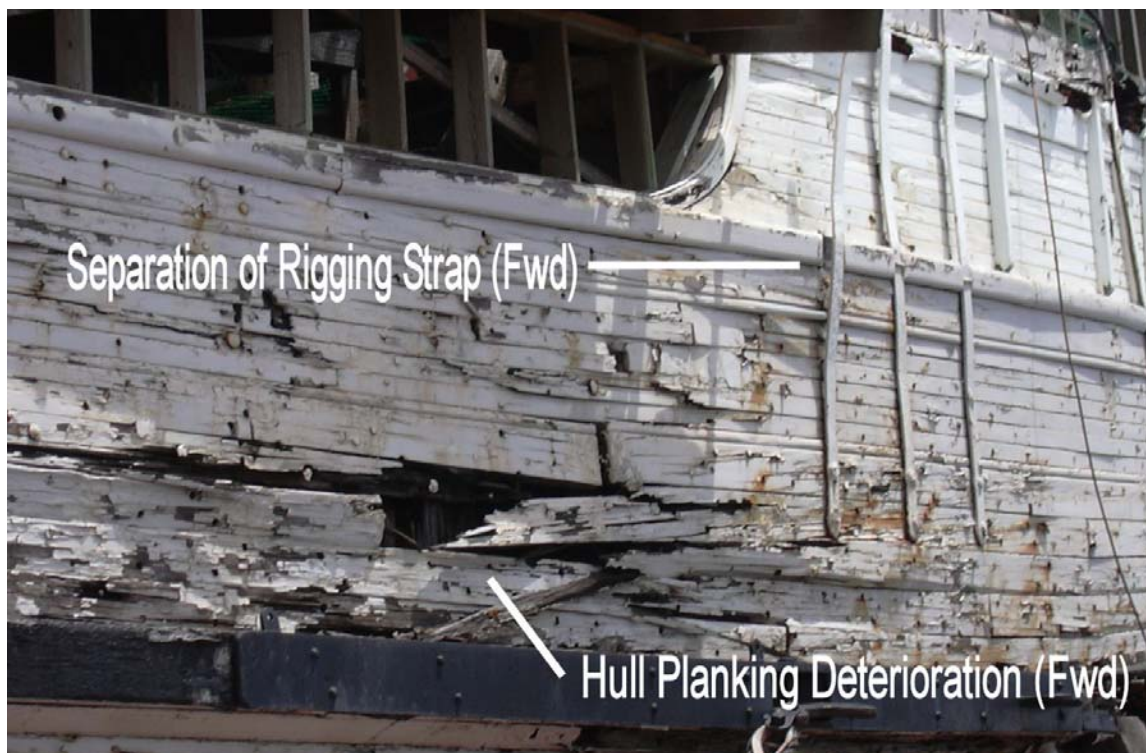
Of particular concern from a personnel and vessel/barge safety point of view are the cast iron fairleads and chain plates on the bow. Deterioration of the deck and side hull planking under these fittings, as shown in Figure 20, have left them in a precarious state where they could fall from their current locations, potentially injuring anyone working on the deck below. Due to their weight and size they could also represent a threat to the watertight integrity of the barge if they were to fall from their present locations.

Figure 19 – Deterioration of Hull & Fittings (Fwd)

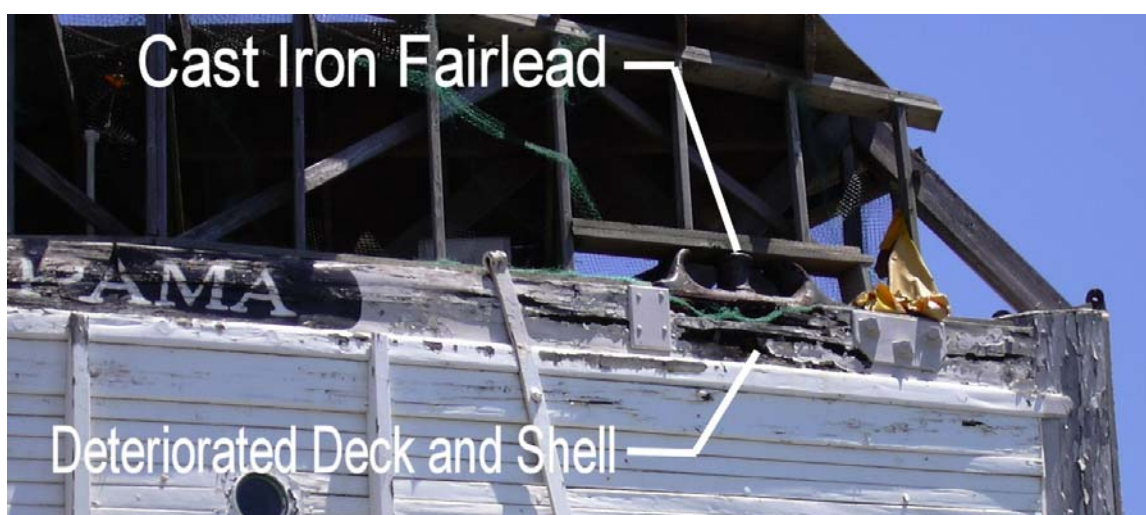
Figure 20 – Deterioration of Deck & Shell at Cast Iron Deck Fittings

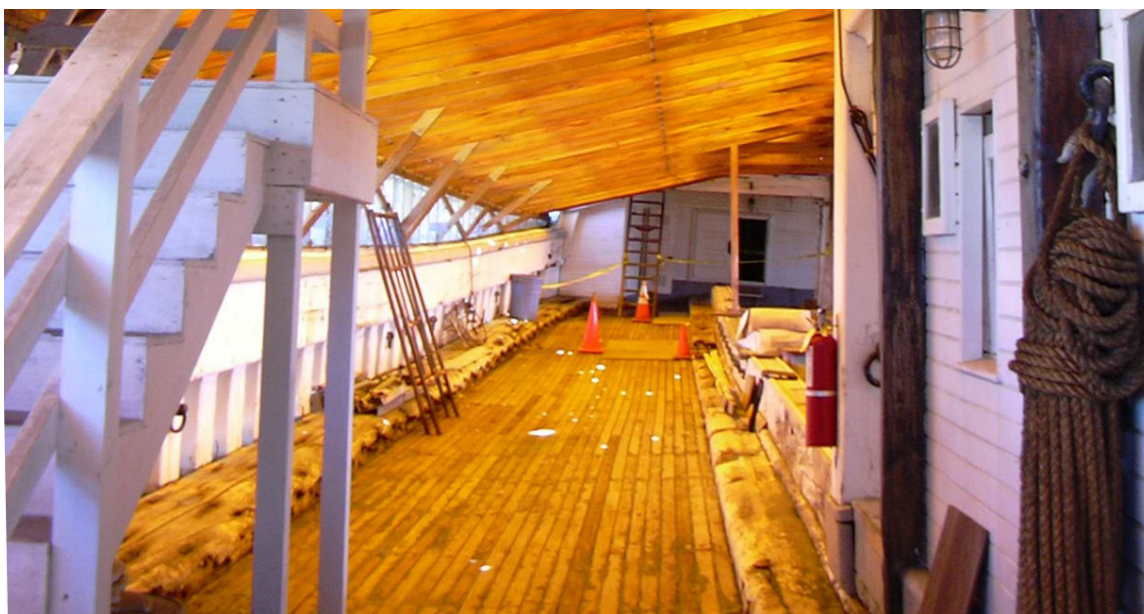
Figure 21 –Main Deck Looking Forward Showing Skew in Bow/Foc'sle

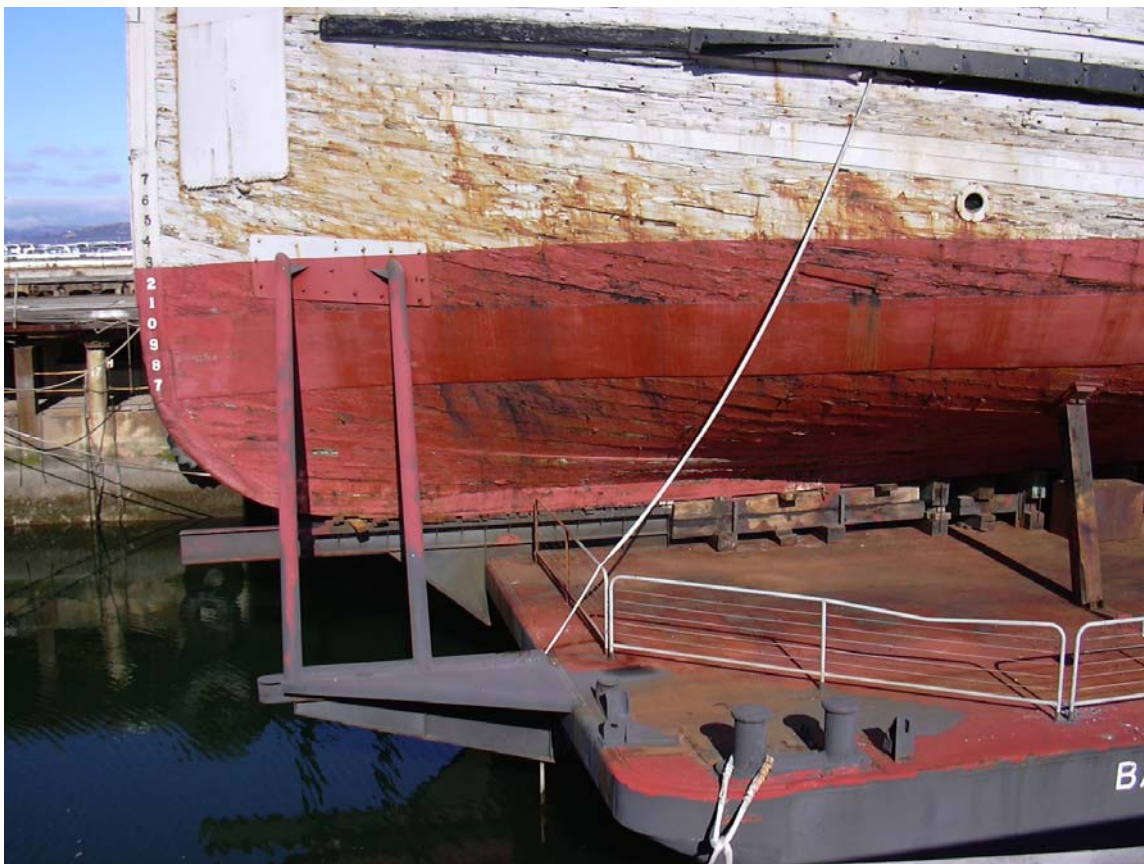
Figure 22 – Bow Overhang with respect to the Barge

As previously noted, the current overall state of the main frames is not known. The tops of these frames in many locations show signs of deterioration, as shown in Figure 34. Based on experience with the *C.A Thayer*, it is expected that many of these frames will have suffered significant deterioration at least to the turn of the bilge. This, combined with the deteriorated state of the main deck and hull planking, and the reported damage to the vessel's keel, have contributed to the bow of the vessel twisting to the starboard (when viewed from astern), as was shown in Figure 21. Attempting to prevent this is made more difficult with the bow hanging over the forward part of the barge, as shown in figure 22.

- External shoring along the hull planking is providing transverse support to keep the *Wapama* in position onboard the barge. Shoring has been added to the bow area, as seen in Figure 22, to prevent this section from continuing to twist in relationship to the rest of the vessel. The deteriorating hull planking remains the weak point to any external shoring scheme. A likely catastrophic failure could be the hull planking collapsing around the external supports, ultimately allowing the bow to separate from the midbody.

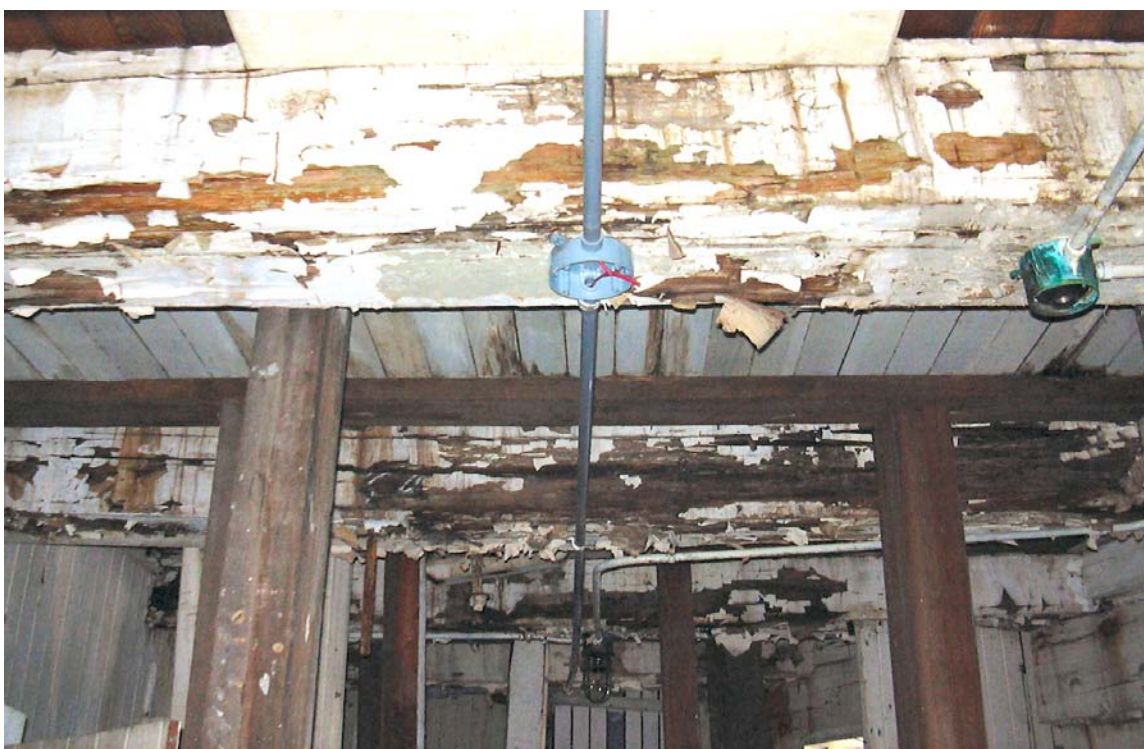
Figure 23 – Deteriorated Deck Structure of the Foc'sle

- Shoring under the foc'sle deck appears to be carrying the load of this deck. The structural members show significant deterioration, and without the shoring this deck would likely have collapsed long ago.

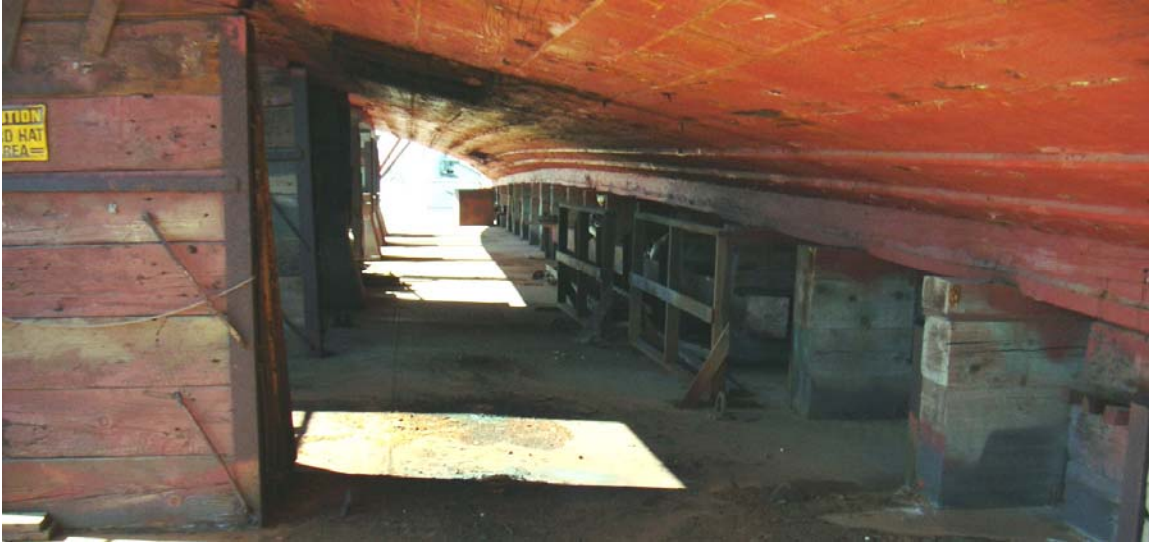
Figure 24 – Keel (looking fwd) Demonstrating Substantial Hog

- The keel was reportedly broken when *Wapama* was placed on the barge. Figure 24 shows the observable keel hog. As such, the ability of the keel to contribute to the longitudinal strength of the vessel is brought into question and expected to be greatly reduced.

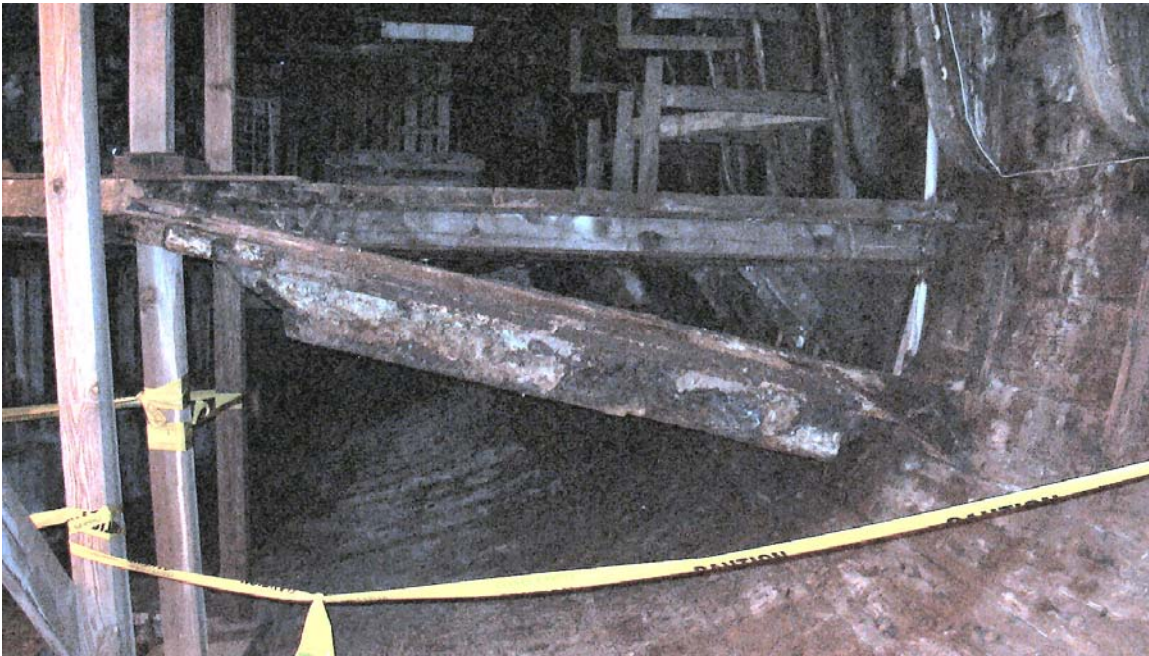
Additionally, within the hold, the aft end of the forward Tween deck is currently falling apart, as shown in Figure 25, and the main deck is showing signs of significant deterioration and decay at the forward end of the hatch. Specifically, the main deck stringers exhibit substantial damage and deterioration and the main deck planking exhibits signs of poorly executed repairs from much earlier in her life, as shown in Figures 26 and 27. All these issues contribute to a very perceptible sag in the main deck and main deck stringers of the main hatch opening, as shown in Figure 28. The bulwark planking, frame heads and deck waterway also show signs of major deterioration at various locations along the main deck, as shown in Figure 29. In order to prevent collapse of the vessel due to the deteriorated state of the deck structure extensive shoring was provided within the hold to support the main deck stringers over most of their length, as shown in Figure 30.

Figure 25 – Collapse of aft end of Forward Tween Deck Supporting Structure within the Main Hold

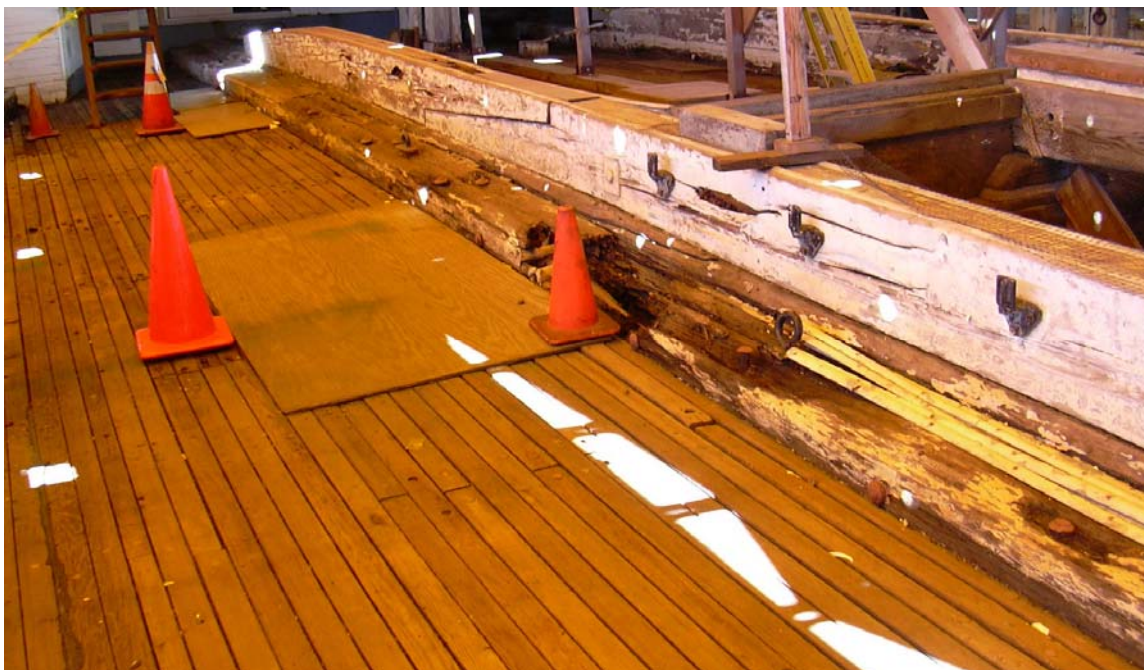
Figure 26 – Deterioration of Main Deck Stringers (Port Side)

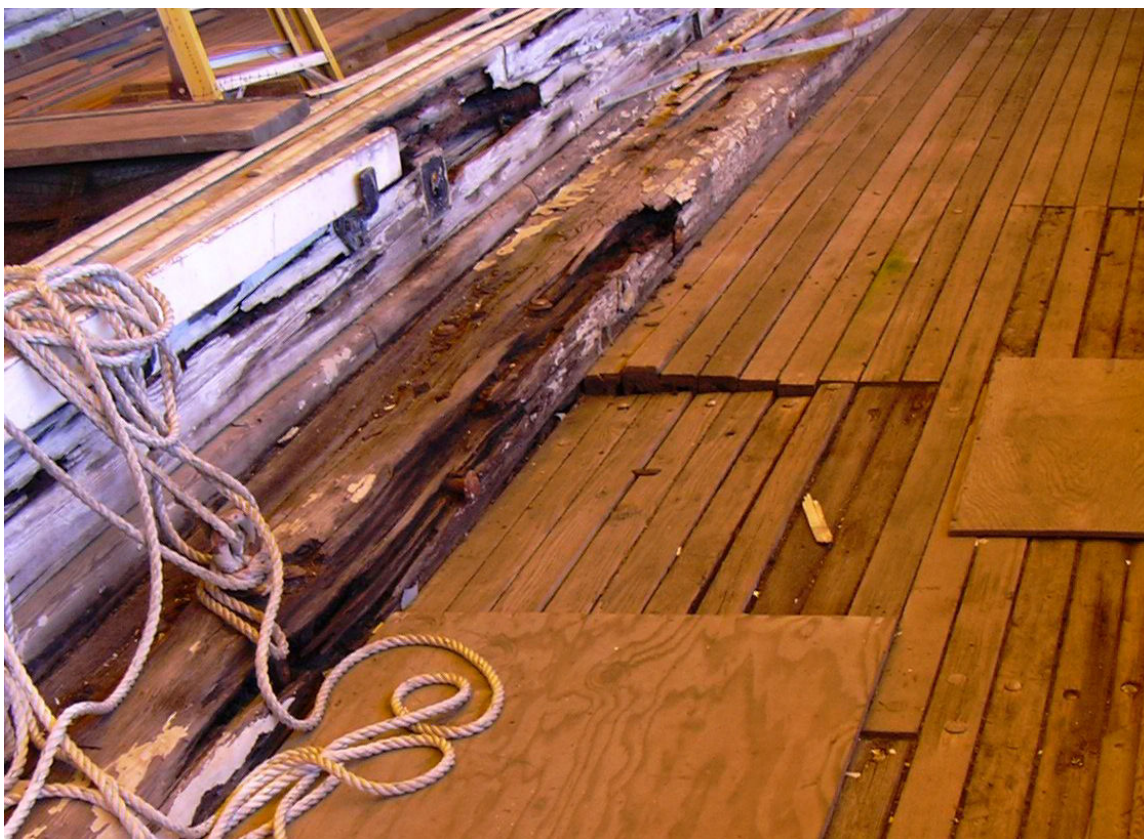
Figure 27 – Deterioration of Main Deck Stringers & Poor Deck Planking Repair (Stbd Side)

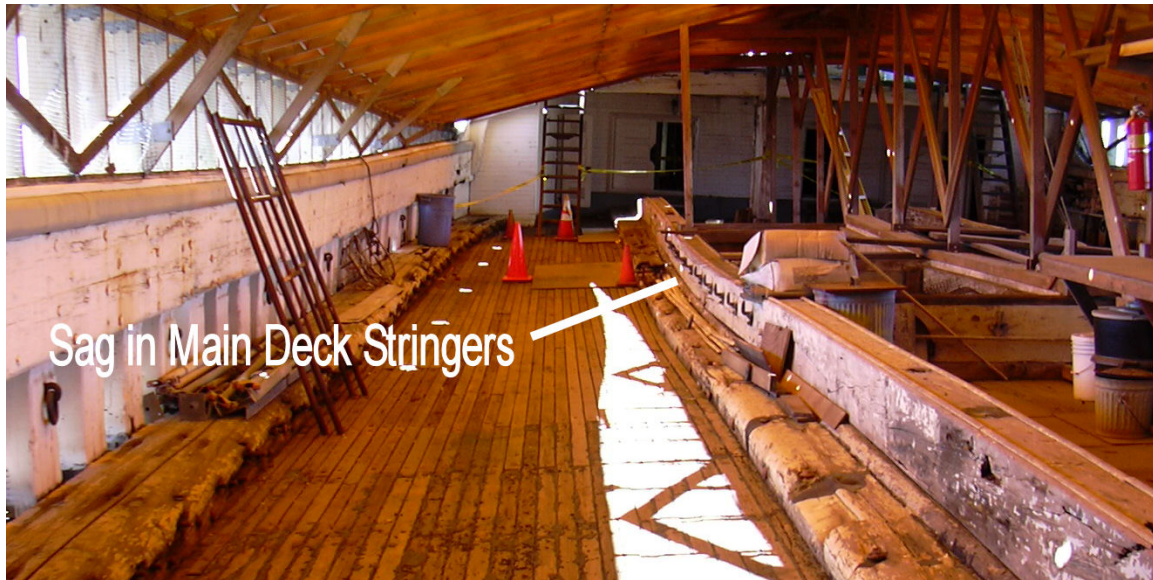
Figure 28 – Sag in Main Deck and Main Deck Stringers next to Hatch Opening

- The main deck has lost much of its structure. The deck planking, deck stringers, and waterways all show significant deterioration. A large opening in the deck forward of the main hatch further weakens the deck. As a result, the deck has begun to sag at the hatch, as seen in Figure 28.

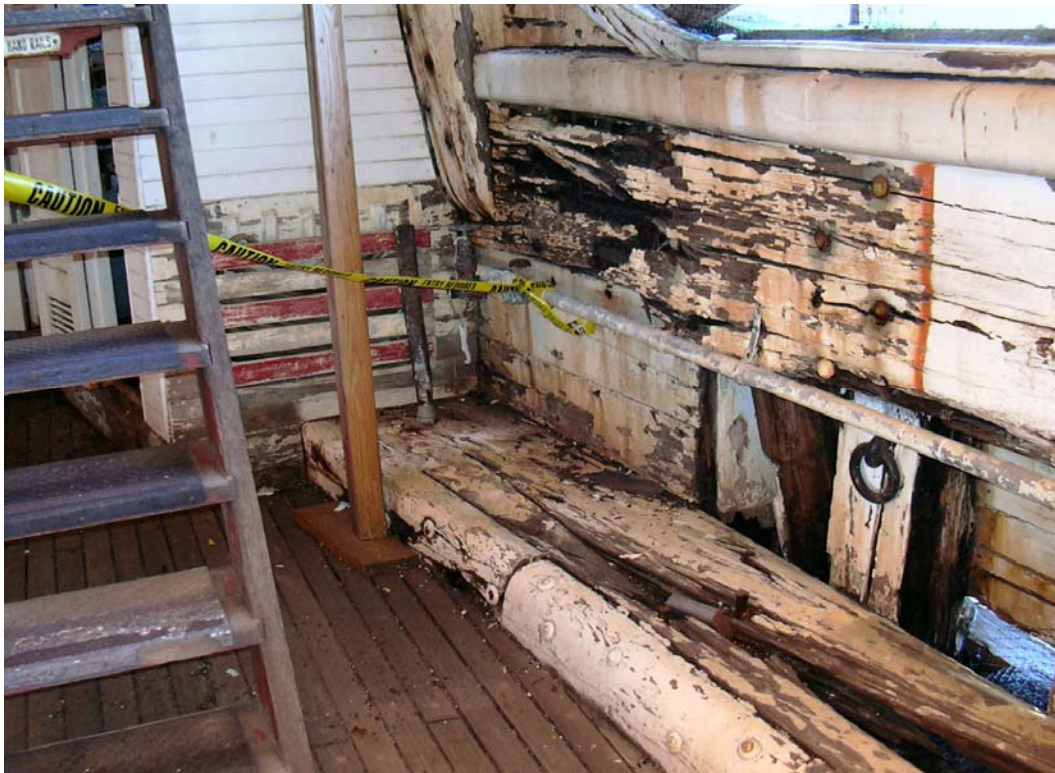
Figure 29 – Deterioration of the Main Deck Bulwark, Frame Heads & Waterway

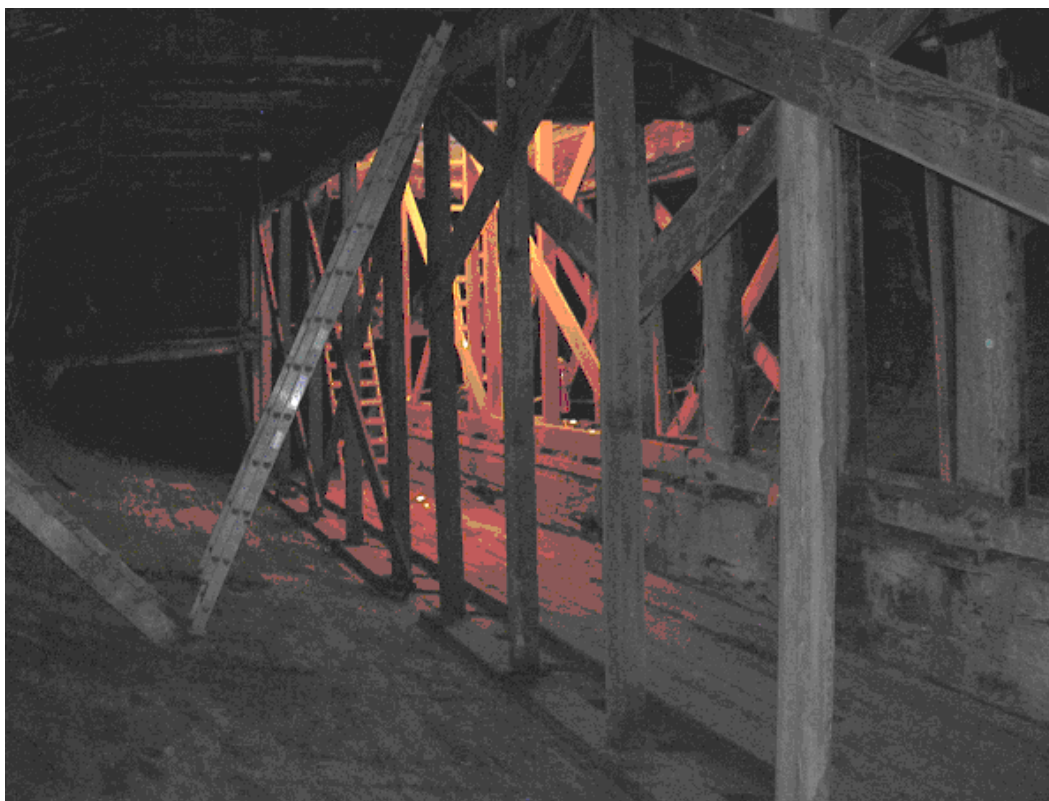
Figure 30 – Shoring within Hold below Deck Stringers

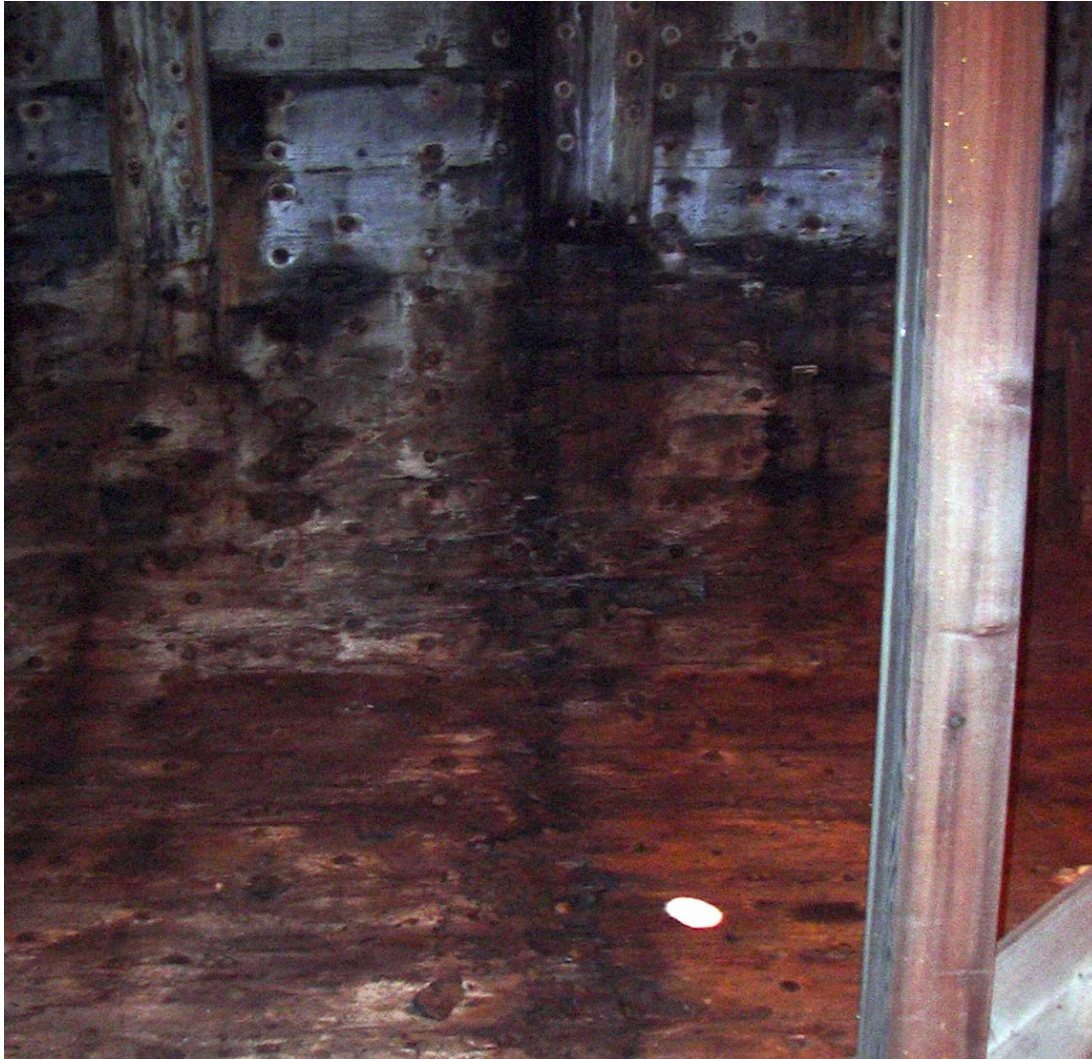
- The ceiling planking, rider keelsons, and assistant keelsons are the primary members contributing to longitudinal strength. The visible surface of the ceiling planking appears to be in relatively good condition. There is evidence of some deterioration from dripping water at the aft end of the hatch opening as shown in Figure 32. This damage dates from the active days as a seagoing vessel. Experience with *C.A. Thayer* suggests that the inner surface of the ceiling planking, at the frames, is likely deteriorated.

Figure 32 – Deterioration of Ceiling Planking below Aft End of Hatch Opening

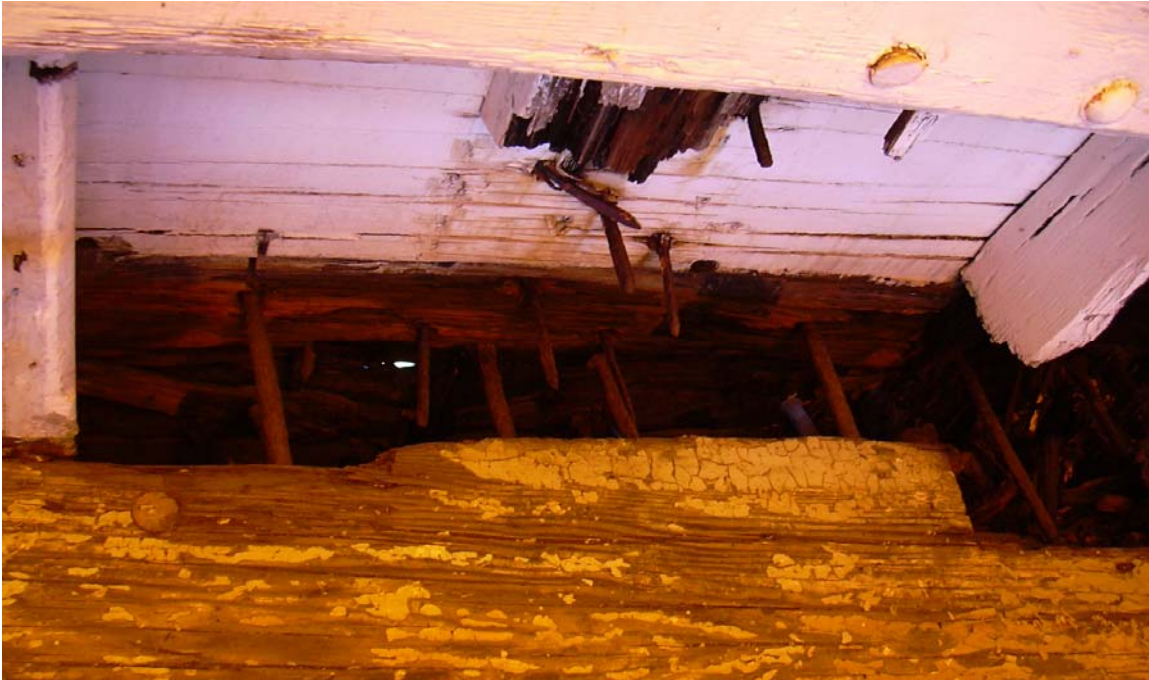
Figure 35 – Wasted Waterway and Frame Tops @ Main Deck Level

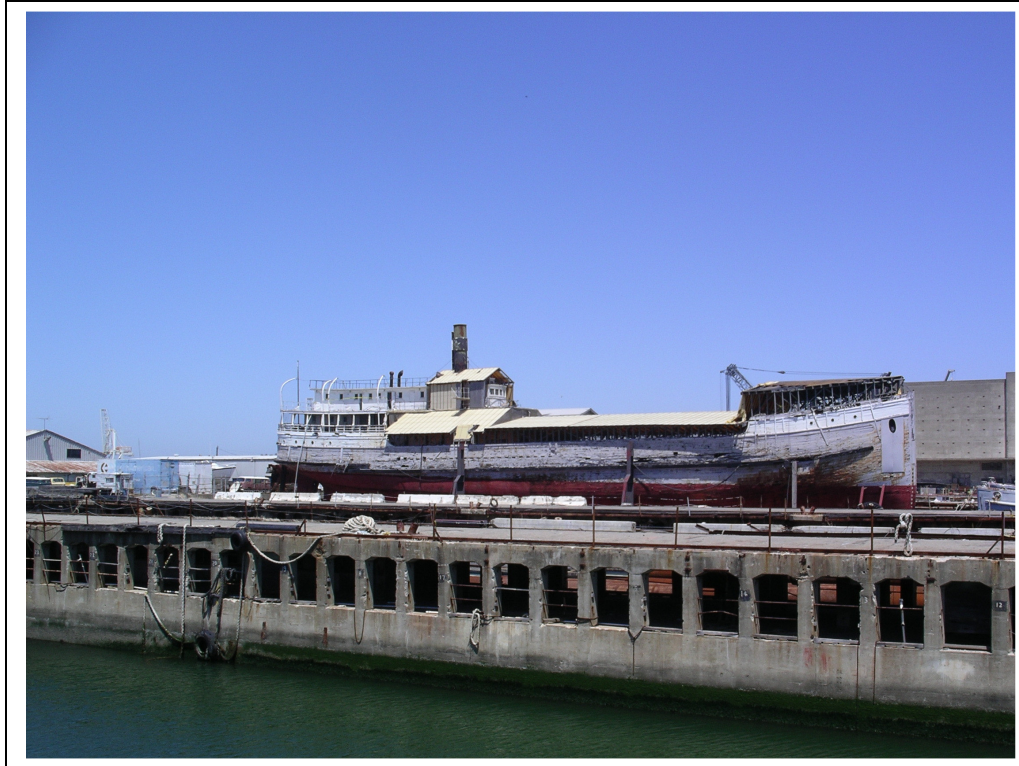
MATERIAL: SS WAPAMA, STBD VIEW – DETERIATED EXTERIOR PAINT
CONTAMINANT: LEAD CONTAINING AND TOXIC MATERIALS

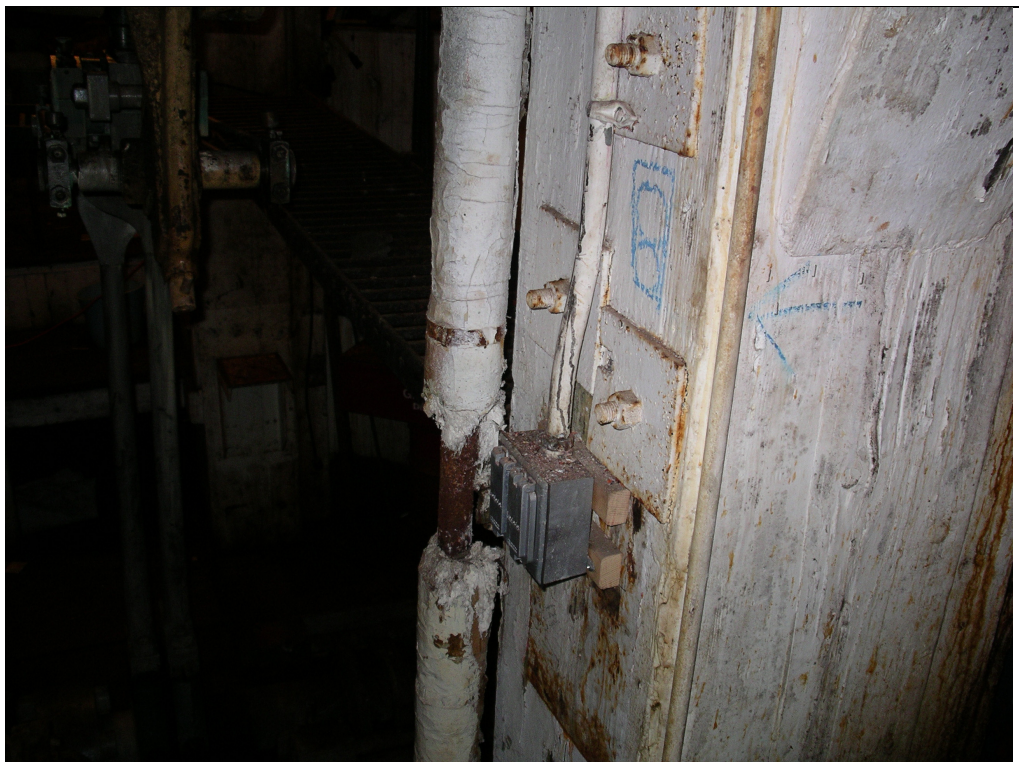
MATERIAL: PIPE RISER WITH DAMAGED INSULATION
CONTAMINANT: ASBESTOS

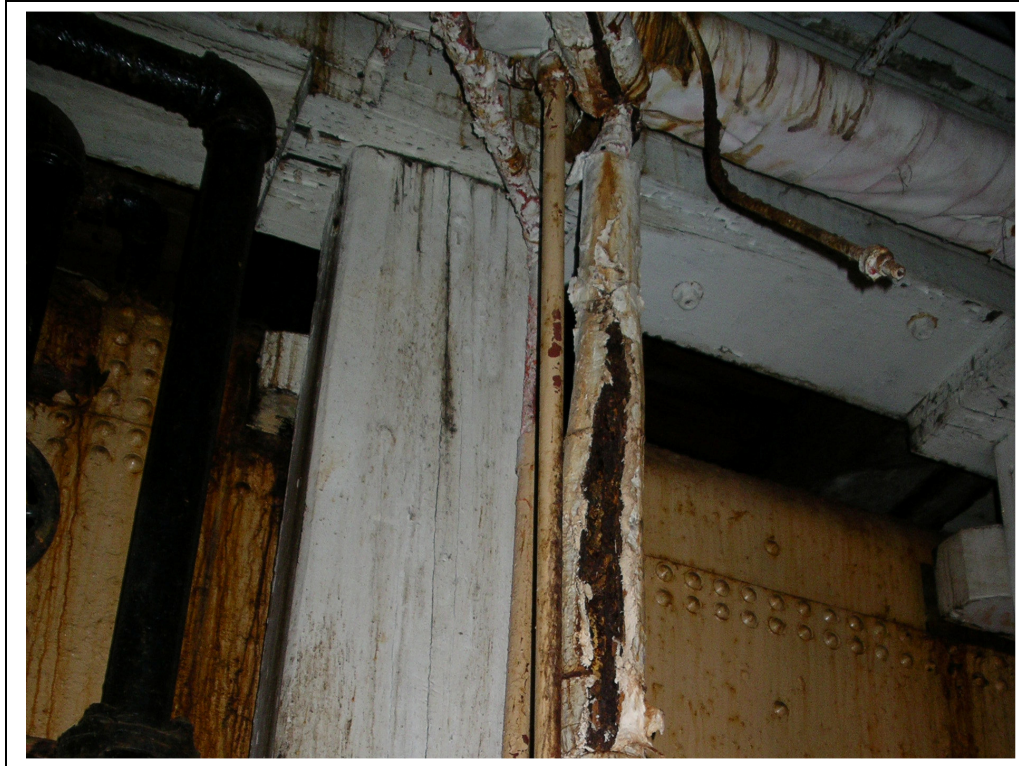
MATERIAL: PIPE RISER WITH DAMAGED INSULATION
CONTAMINANT: ASBESTOS

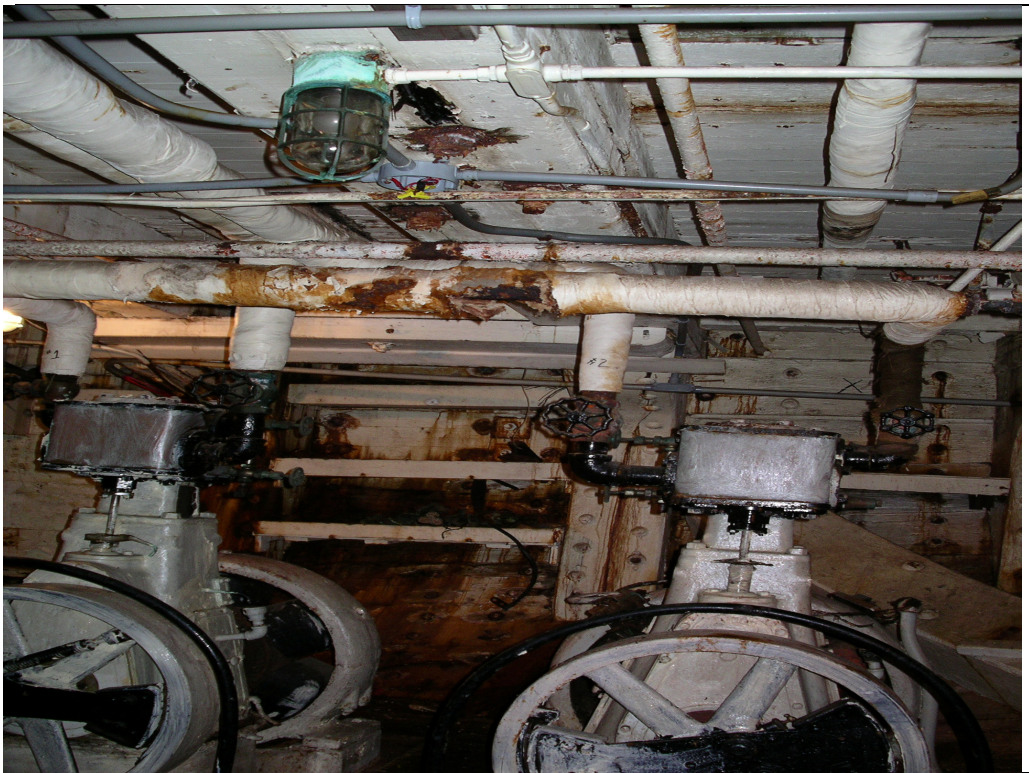
MATERIAL: PIPE INSULATION (DAMAGED) OVER GENERATORS (PORT SIDE)
CONTAMINANT: ASBESTOS

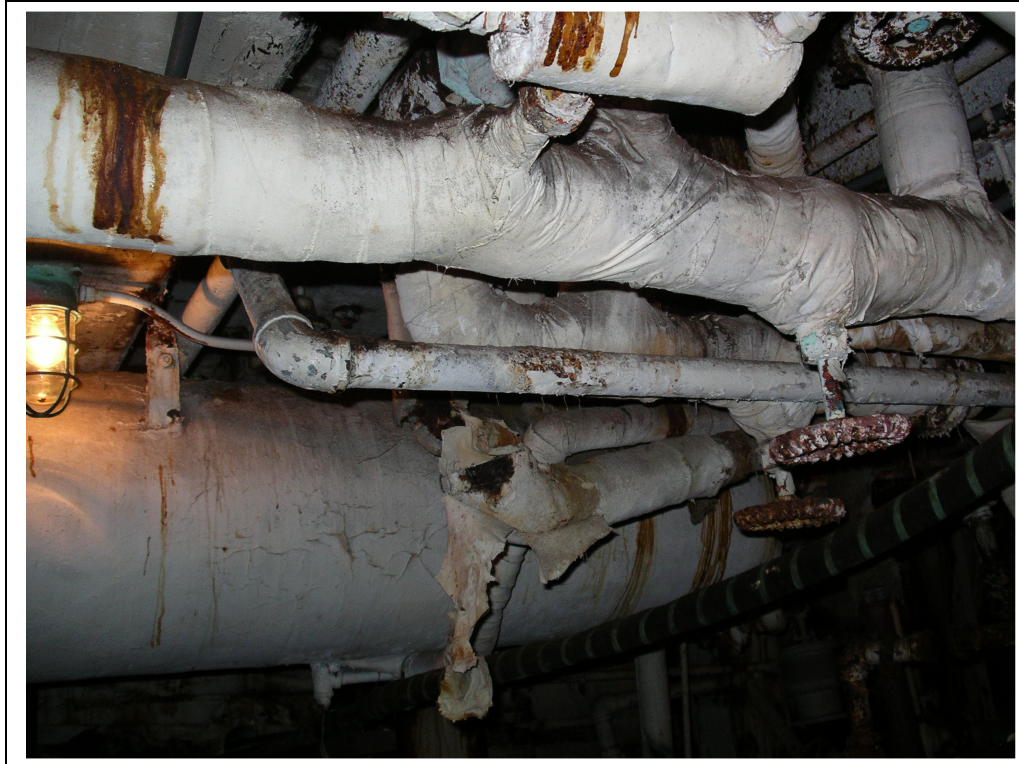
MATERIAL: PIPE INSULATION AT WATER TANK
CONTAMINANT: ASBESTOS

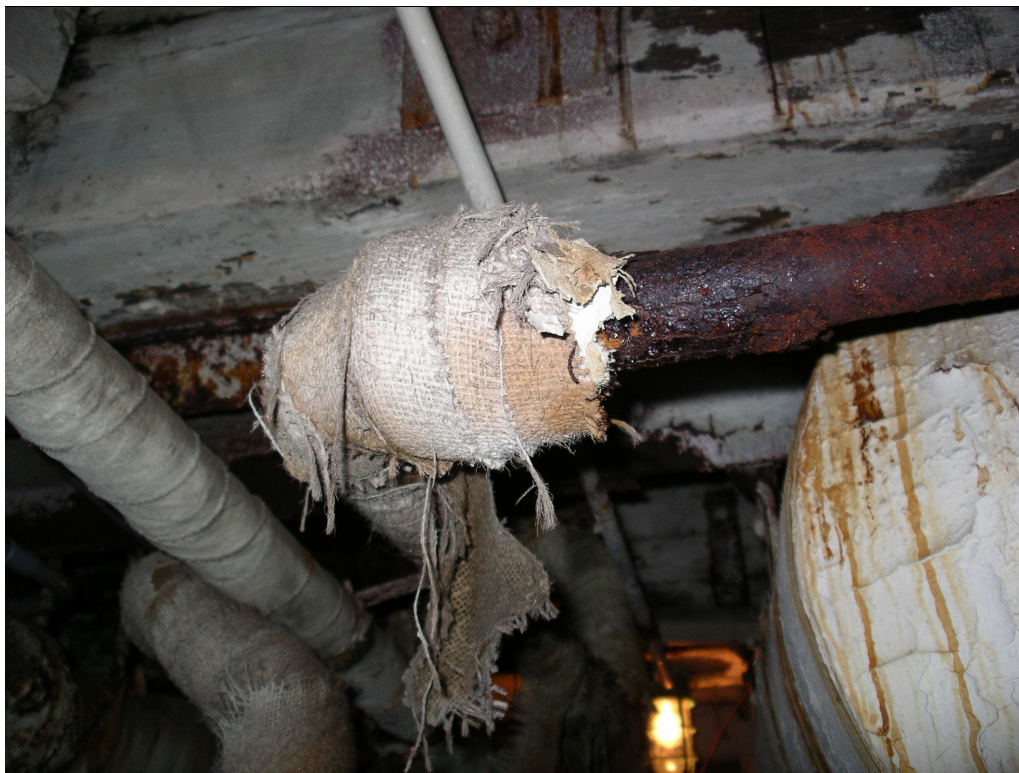
MATERIAL: PIPE INSULATION, DAMAGED
CONTAMINANT: ASBESTOS
